Pakefield Monthly Monitoring Report

Inspection Date & Time: 08/28/2020 10:56 AM

Reason for Inspection: Post weather / high water level event

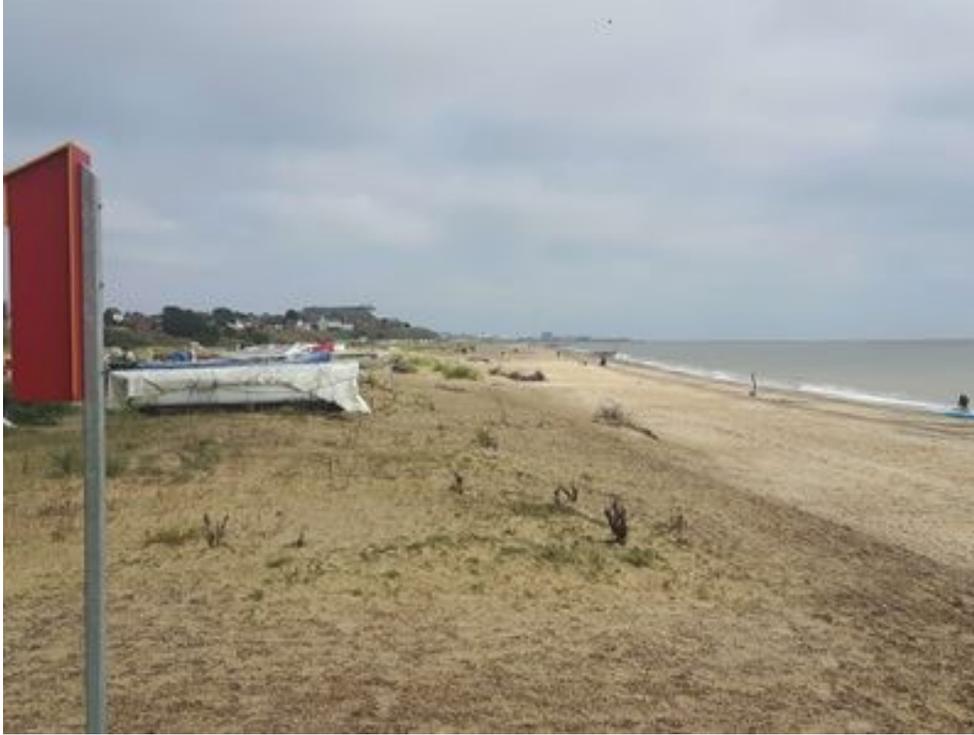
Photo of beach cliff #1 (looking to north Pakefield from life buoy):

Maximum height of beach cliff: 2.5m (appears higher than previous inspection – which can only mean the beach levels are lower).

How has the beach morphology changed since last inspection? Beach Cliff recession indicated by steeper face, with pebbles exposed and vegetation loss from crest. No berms on foreshore but some evidence of cusps in gravel deposits- this indicates edge waves and is a function of obliqueness of incident waves. Freshly fallen trees and overhanging turf along the southerly cliffed section indicate active erosion however base of cliffs appear to have a healthy level- due to slumped material from cliffs. Flat low intertidal area seems excavated by waves - possibly just rotation and reorganization of material than permanent loss. Expect some material back with southerly constructive swell waves.

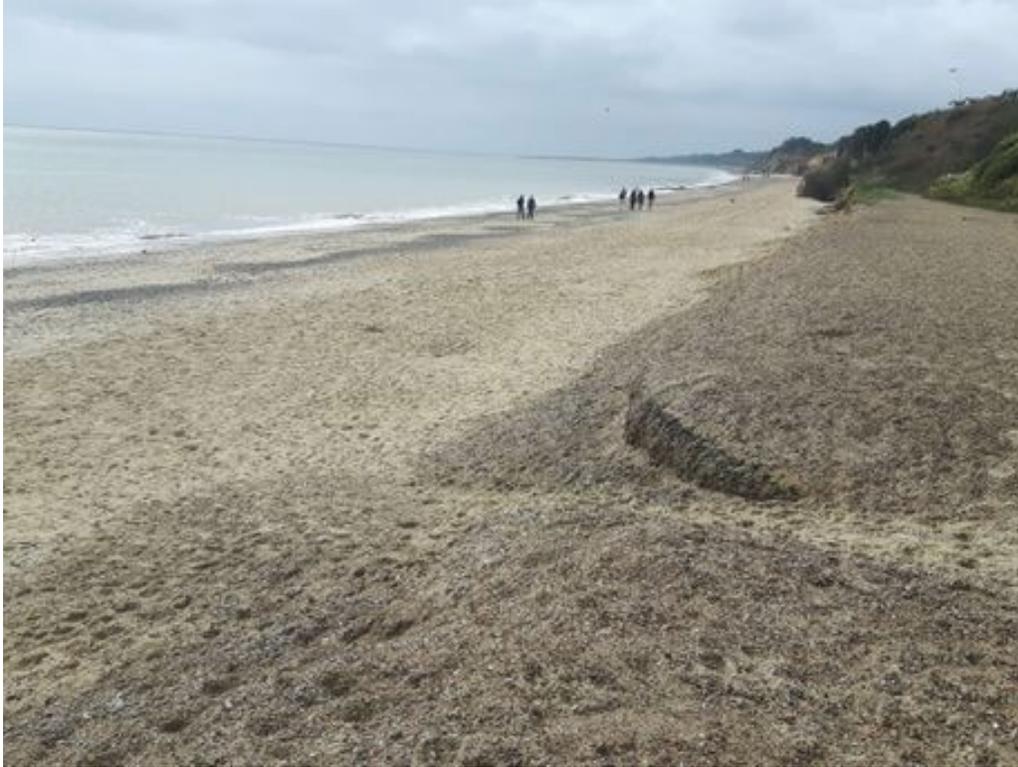
Photo of intertidal zone /cross-beach by sign

Distance from sign to beach cliff edge? 8 – this is one pace less than last inspection evidencing beach cliff retreat. After a hiatus of a few months, this shows the beach cliff is still actively receding back towards the main, vegetated cliff which supports the properties.

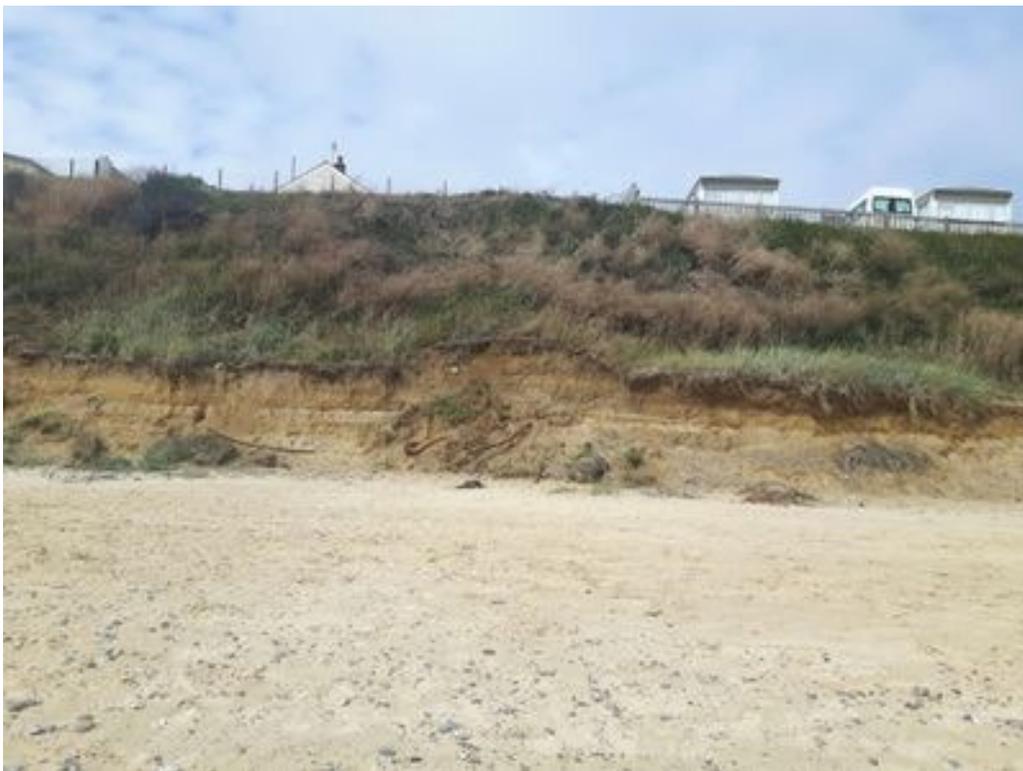
Photo of cliff section below The Rosary:

Comments on cliff top property/assets: The actively eroding cliff face beneath the Rosary has increased in height indicated by a larger expanse of unvegetated cliff face- almost reaching cliff top. There are active back-scars showing mass movement is ongoing and this area is to be kept under close supervision.

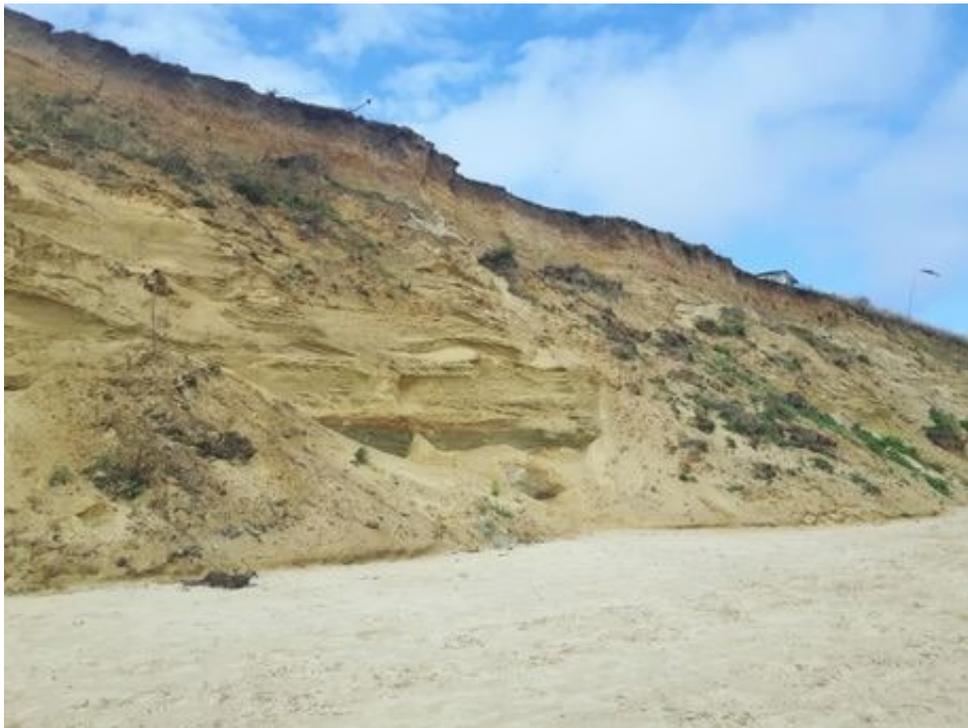
Photo of cliffs #1:

Assessment of cliffs: **Relatively Stable Unstable Highly Unstable** Little recent mass movement

Monitoring cliff recession: Slumps continued

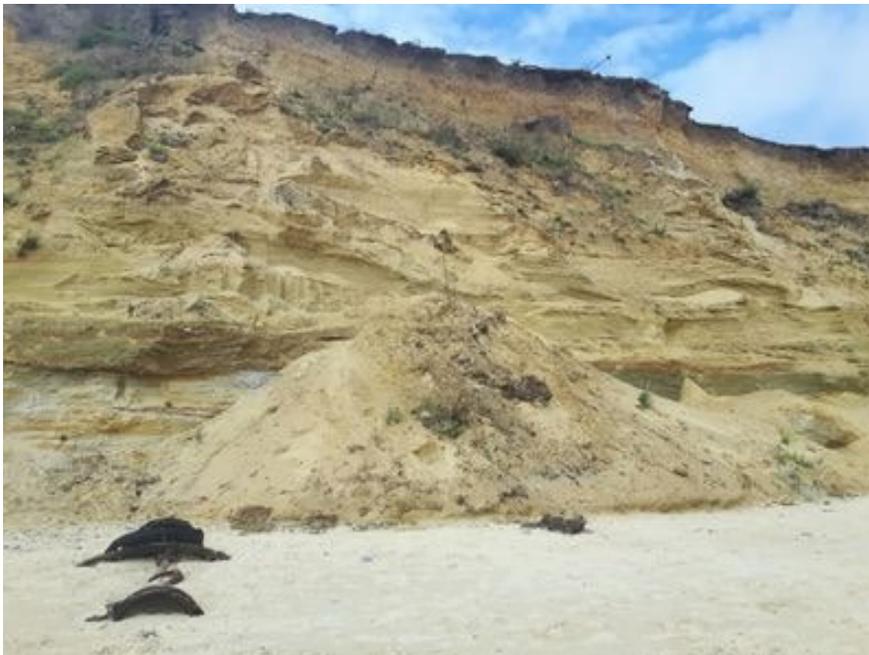
Photo of hazard / debris #1

Hazard / Debris: Partially exposed but more covered than previous inspection to due material slumped from eroding cliffs.

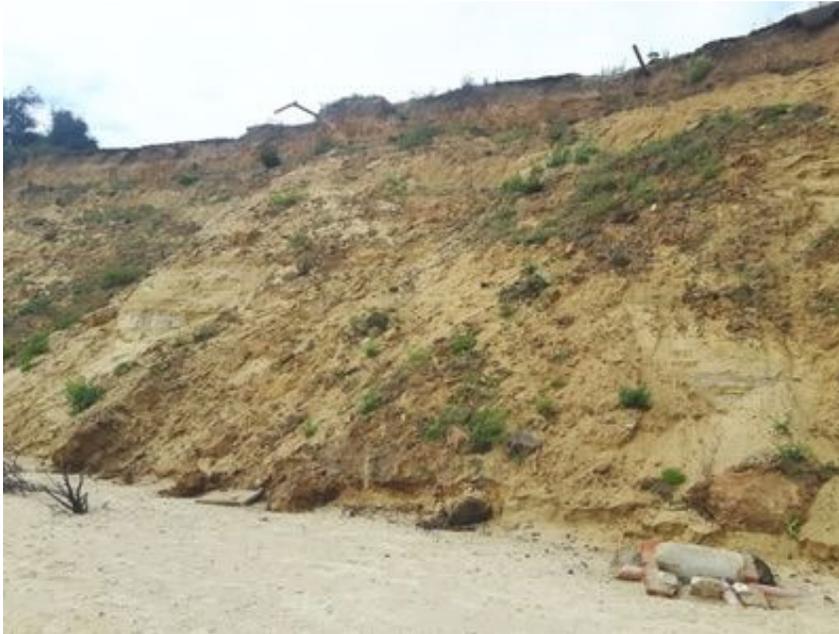
Photo of hazard/debris #2: pipe work and caravan services more exposed on cliff top than seen on previous inspection- indicates active recession over PCP frontage.

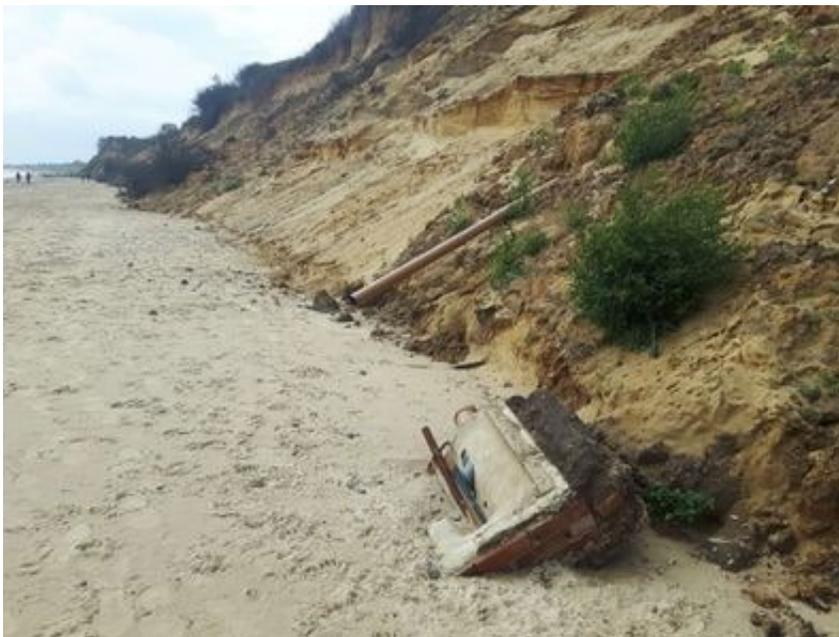
Photo of hazard/debris #3

Comments on beach hazards/debris: No more debris on beach than previous. Mostly buried better at the back beach due to fallen cliff material.
