East Lane Bawdsey

Cliff recession study

Waveney District Council

26 July 2011

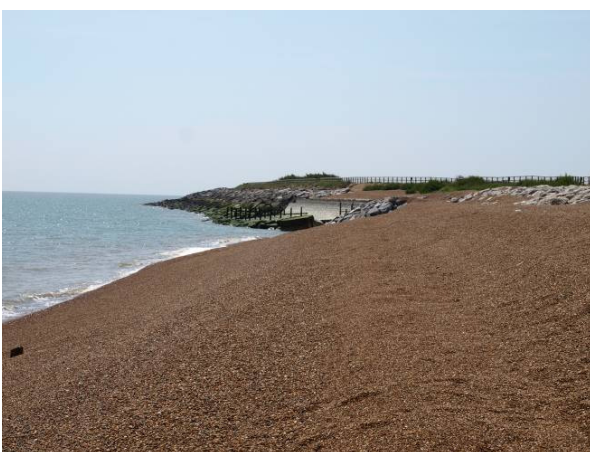
Healthy beach immediately north of East Lane

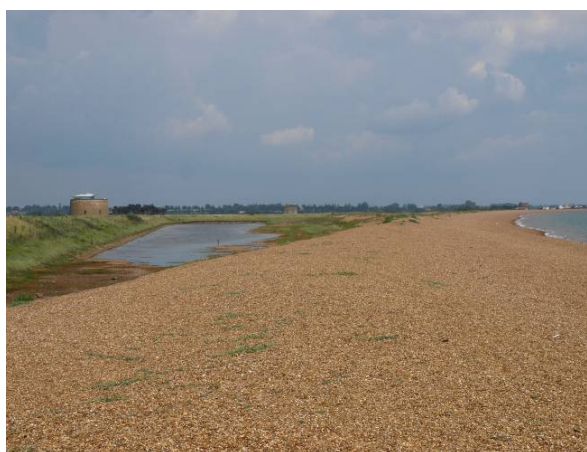
Hollesley Bay, healthy beach looking north. Note saline lagoon formed between beach ridges and coastal flood embankment. The different alignment of the beach and the embankment suggest significant beach progradation.

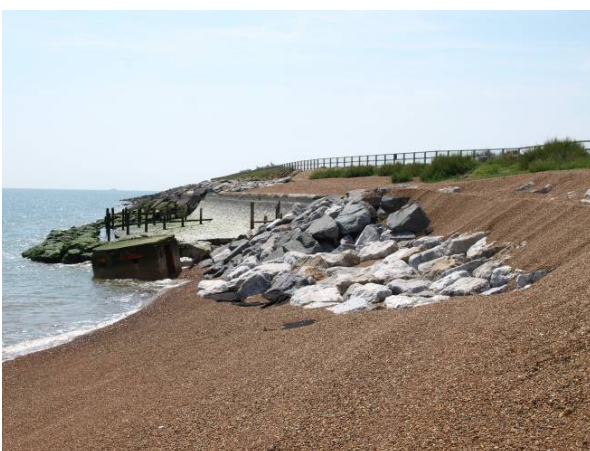
Coastal defences north of East Lane. The wall and apron were observed in the 1992 aerial photos. Note rock armour in foreground to limit outflanking. Aerial photos show this material is occasionally covered by gravel.

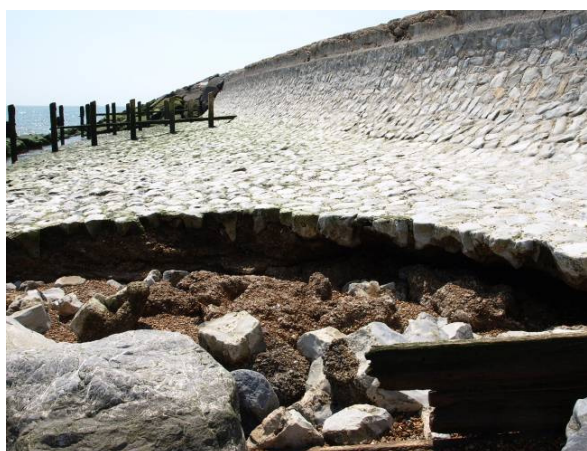
Undercutting of the apron has occurred behind the pill box.

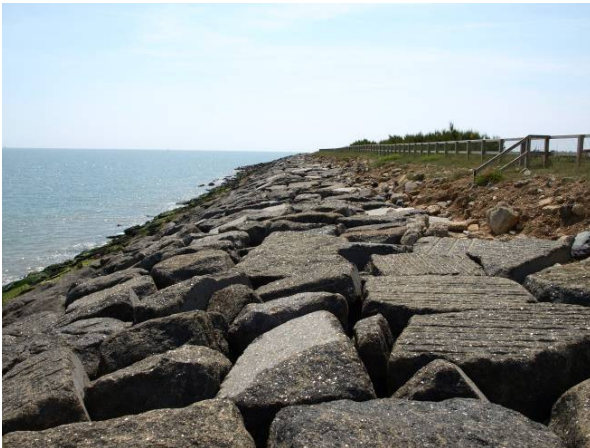
Rock armour of the East Lane headland

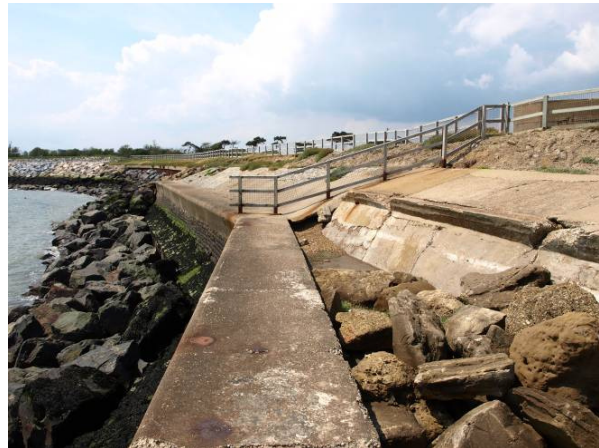
Defences on the south side of the East Lane headland.
Note rock armour covering toe of revetment apron

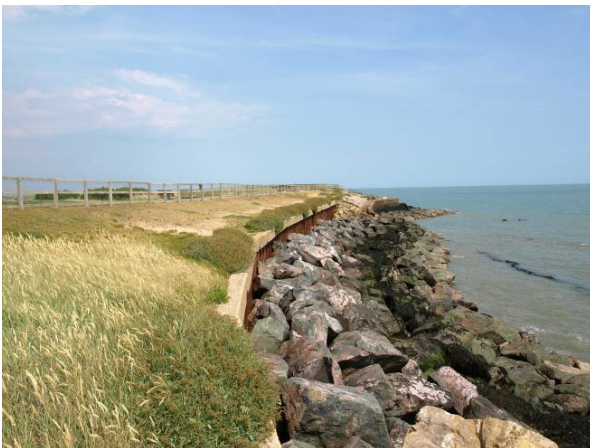
Sheet piles installed in 2009 following overtopping of rock armour and cliff recession.

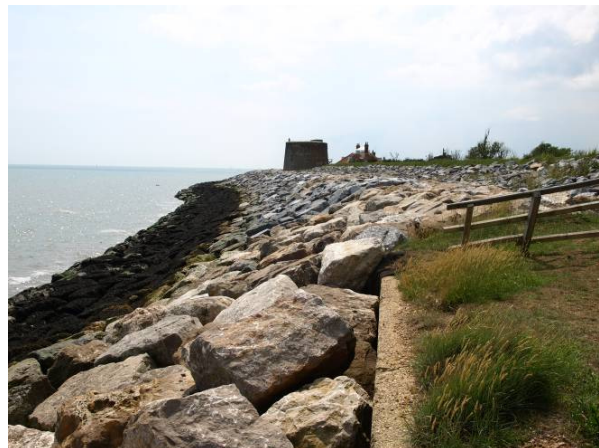
Continuous rock armour to Martello tower.

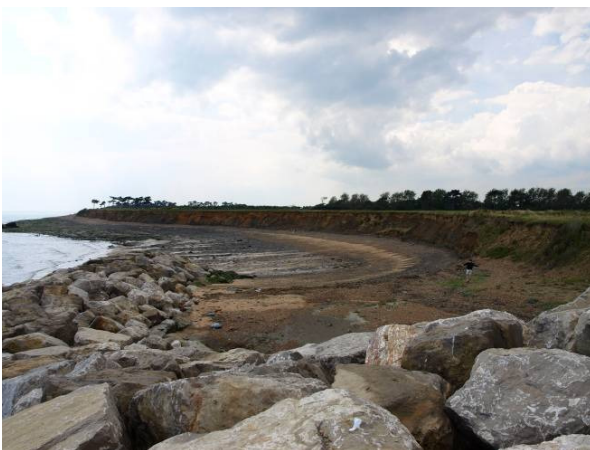
Rock armour end structure, bay formed behind the armour and thin and narrow beach. Tide line shows deeply-indented London Clay shore platform.

- The coastal defences end with a low breakwater designed to limit outflanking by encouraging formation of a stable bay within which a protective beach will accrete. A bay has formed, but the beach is very limited and composed of weak pebbles of clay that are rapidly eroded. Bay formation has been achieved through erosion of the soft London Clay and Red Crag cliffs and episodic landsliding. Landslides were seen to be associated with water seepage from the cliffs that saturates the clay, causing it to fail and remove support to the overlying crag. The whole bay is fronted by a shore platform formed of soft clay that is deeply indented, reflecting the curve of the cliffline.

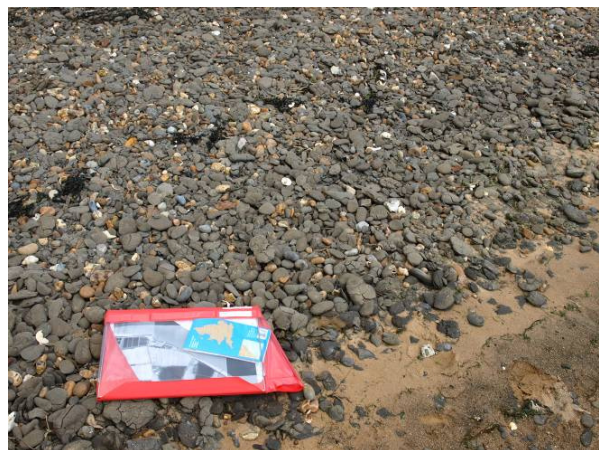
Detail of beach formed in the new bay. Note all grey coloured pebbles are rounded pieces of weak London Clay. Much rarer brown pebbles are flint

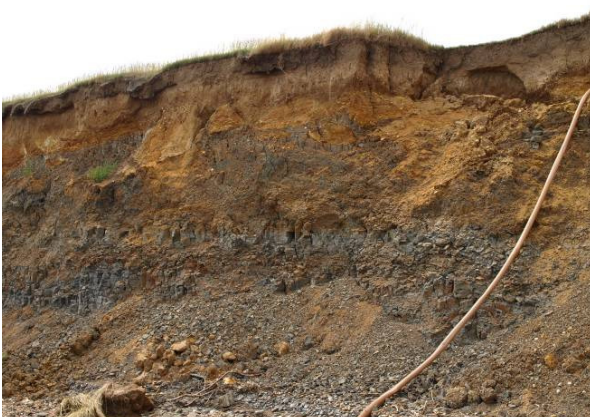
Recently eroded cliff in the bay. Basal grey-brown material is London Clay. Orange-brown material towards the top is Red Crag in which a thin pale brown soil has developed. Note in tact drainage pipe exposed by cliff recession.

Active cliff recession and landslides were observed where land drainage was evident in the cliffs. All of the landslides observed are associated with water seepages. Therefore, it is recommended that land drainage is directed away from the cliffs where possible. A deep c. 2m cut-off drain could be installed parallel to the cliff-top to intercept existing land drainage and divert surface water and shallow groundwater away from the cliffs.

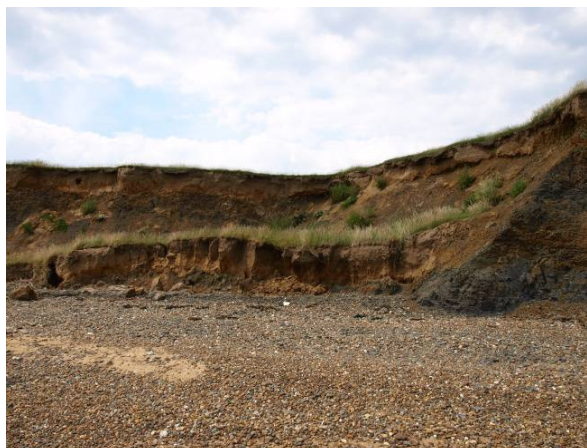
Detail of small landslide within the bay, between profiles 1 and 2. The Red Crag has remained as an intact block and slumped as the underlying London Clay has been extruded and eroded by wave action.

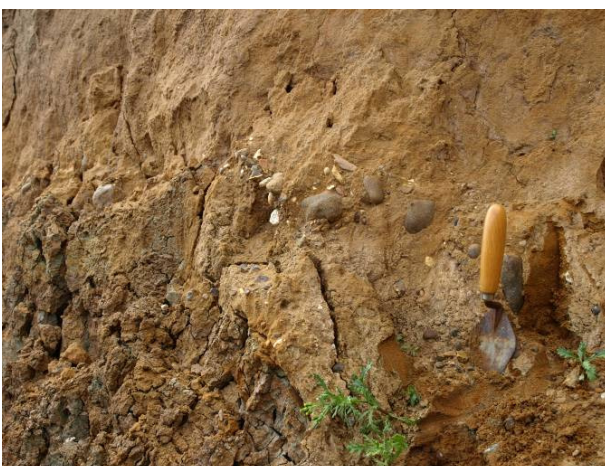
Geological contact between the London Clay and the overlying Red Crag. The photo highlights the thin and discontinuous pebble bed. This bed is the only supply of beach-building material in the cliffs. All other material is transported to the intertidal zone or offshore.

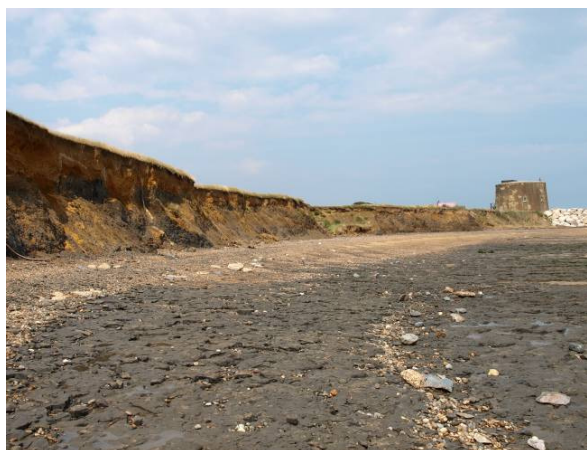
Overview of the bay showing landsliding and cliff erosion, wide exposure of London Clay shore platform and very thin and narrow beach

This most recent phase of accelerated erosion also appears to have been promoted by the localised erosion or excavation of the London Clay shore platform in 2009. This area already had a severely depleted beach, and the lowering of the shore platform has allowed waves to break closer to the shore and directly undercut the base of the cliffs. The cause of the localised lowering or excavation of the shore platform is not certain, but the photographic evidence shows that it occurred during the phase of coastal engineering works in 2009. The evidence is compelling and it appears that the shore platform was excavated to allow barges carrying rock armour to land close to the beach. The excavation does not appear to have been reinstated after the construction works.

Consideration might also be given to reconstruction of the foreshore where localised erosion or excavation has occurred since 2009. Reinstatement and raising the level of the shore platform to the same elevation as *in situ* adjacent platforms might take the form of a rockfill mattress of the order of several metres thickness. Clearly the mattress will need to be properly designed to withstand the wave breaking forces and foundation conditions. The reinstated shore platform will reduce wave impact on the beach and cliffs, thereby reducing the high rates of erosion, landslides and cliff recession experienced in recent years.

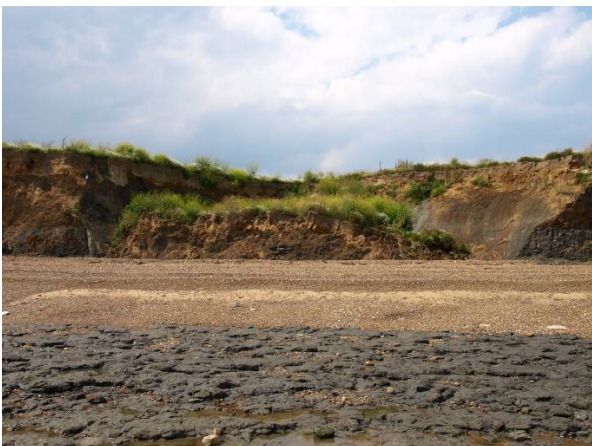
Recent landslide south of the bay near profile 5 in an area with a marginally healthier beach. Note the beach is still relatively narrow with the clay platform exposed beyond the beach toe

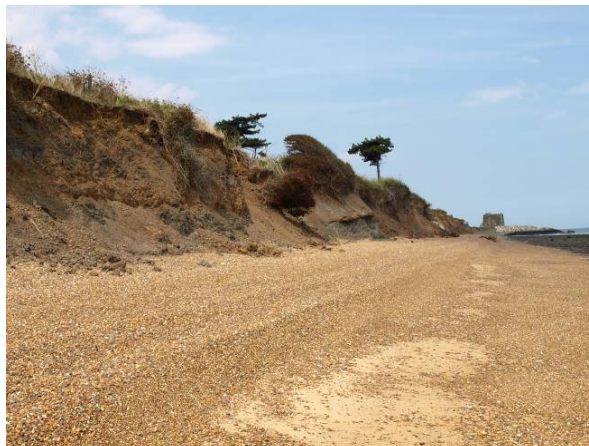
Recently eroded cliffs in location south of the bay between profiles 6 and 7. Note marginally more healthy beach

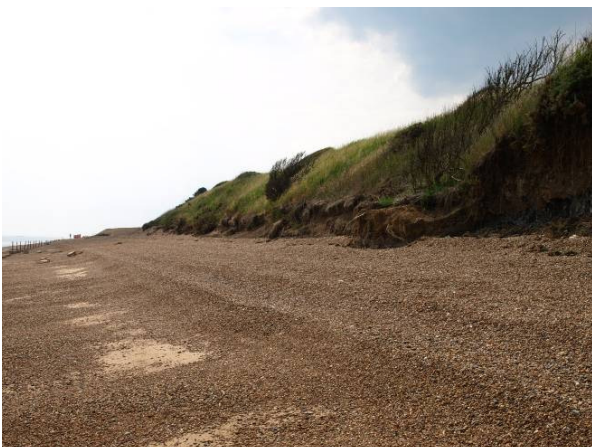
Cliffs and beaches south of the bay, between profiles 7 and 8. Note relatively healthy beach and well-vegetated cliffs with evidence for basal trimming by storm waves. Note step up in maximum beach elevation seen in the distance.

- Further south, the beach increases in width and thickness, and only a small area of shore platform is exposed. Cliffs are degraded and generally well vegetated, but are undercut due to toe erosion

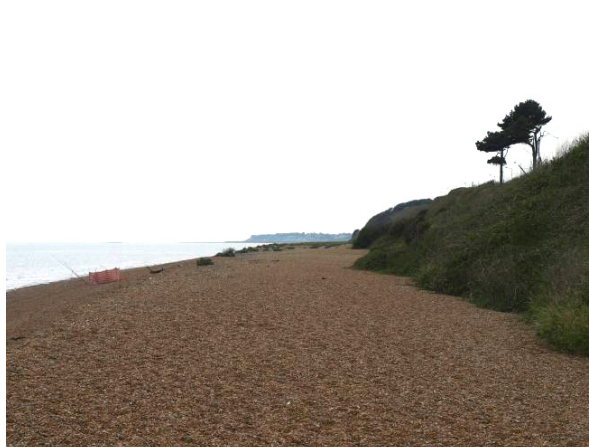
Cliffs and beaches south of profile 8. Note width of upper beach platform that afford protection to the cliffs which are themselves highly degraded and well-vegetated.

- Southwards, beyond the area of active cliffs, the beaches are considerably wider and have a higher elevation. The shore platform is not exposed at low tide. Cliffs are highly degraded and well vegetated with no evidence for toe erosion.
