## Thorpeness Monthly Monitoring V2

Submitted By: lucy.goodman\_CoastalPE

**Date & Time of Survey:** 09/29/2020 4:11 PM

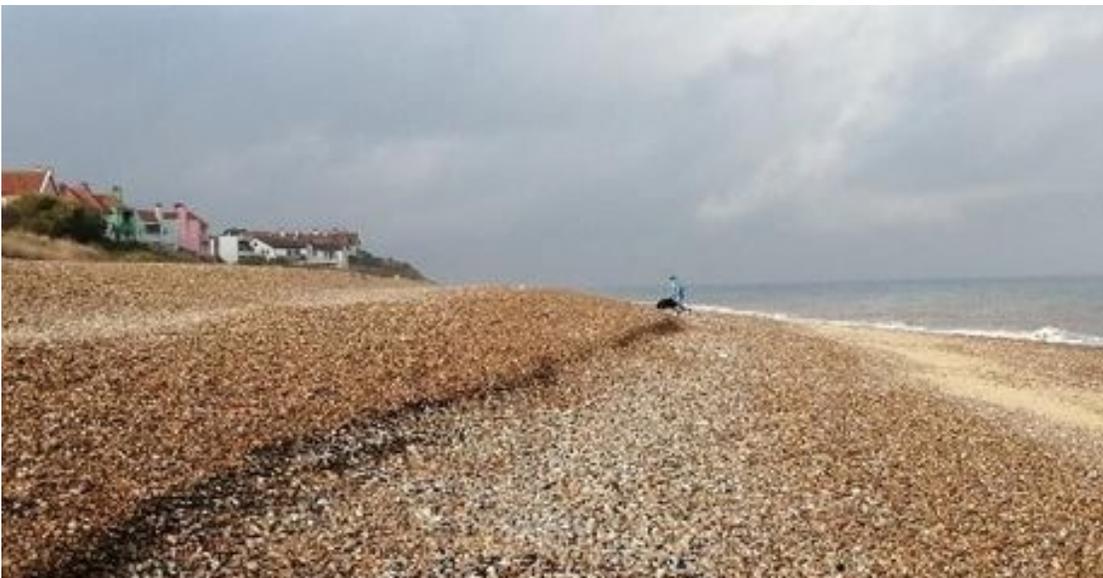
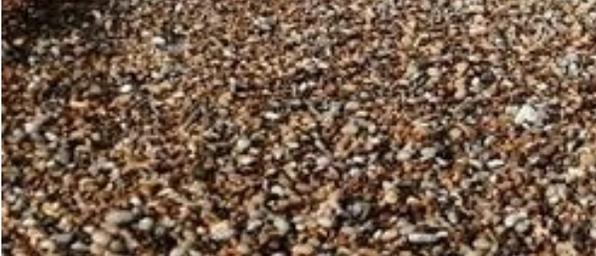
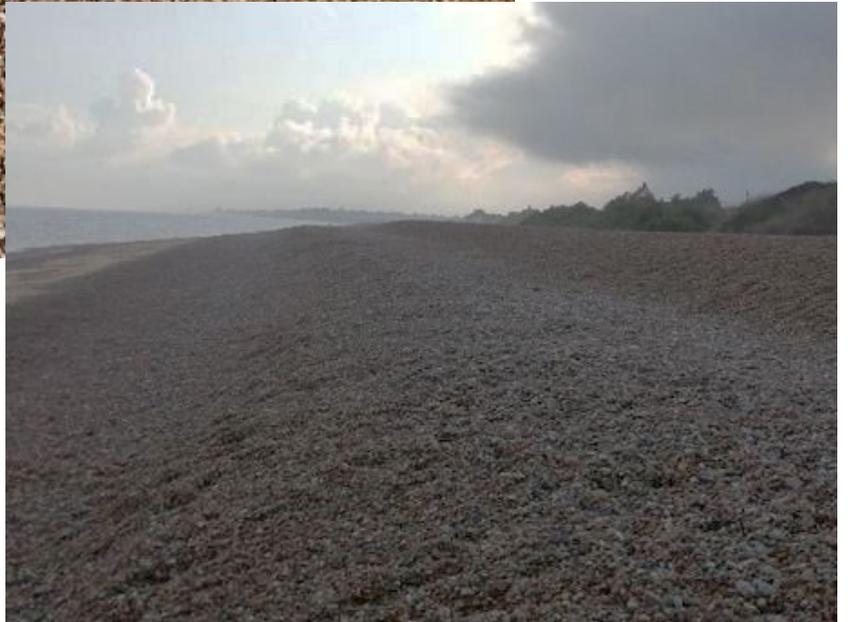
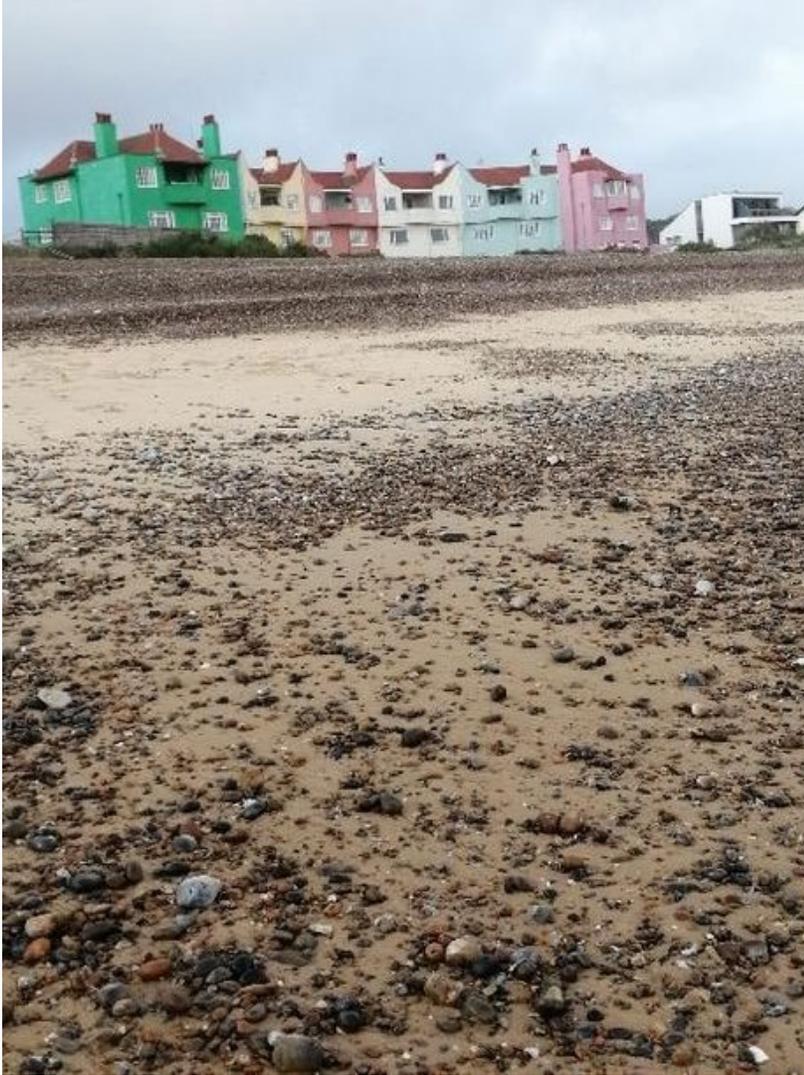
**Images of the southern UNDEFENDED frontage:**

**Beach volume change Southern UNDEFENDED frontage:** No Change in volume but a change in distribution of sediment- flatter intertidal area but heaped up supra-tidal area.

Three distinct berms, laterally continuous along shore (Dunwich to Aldeburgh). Landward storm berm max 1.5m South of Headlands. Steep wide foreshore. Fine shingle on landward berm shows extent of wave run up. More material added to supra tidal beach in front of Headlands. Large cobbles on lower foreshore indicates high energy and sediment transport capacity. No lowering of beach levels, improvement if anything.

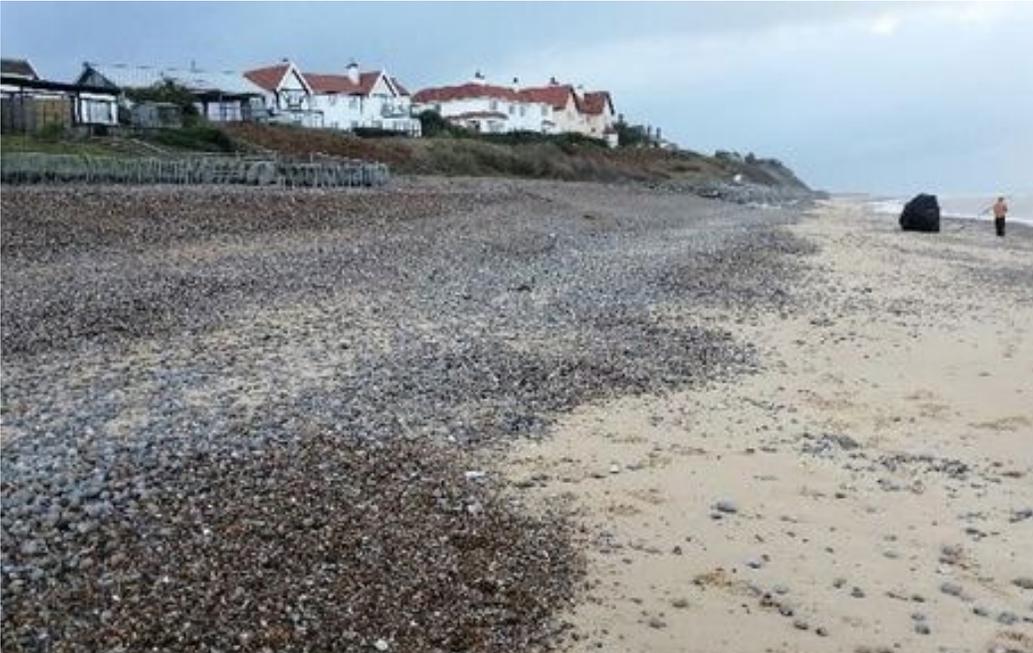
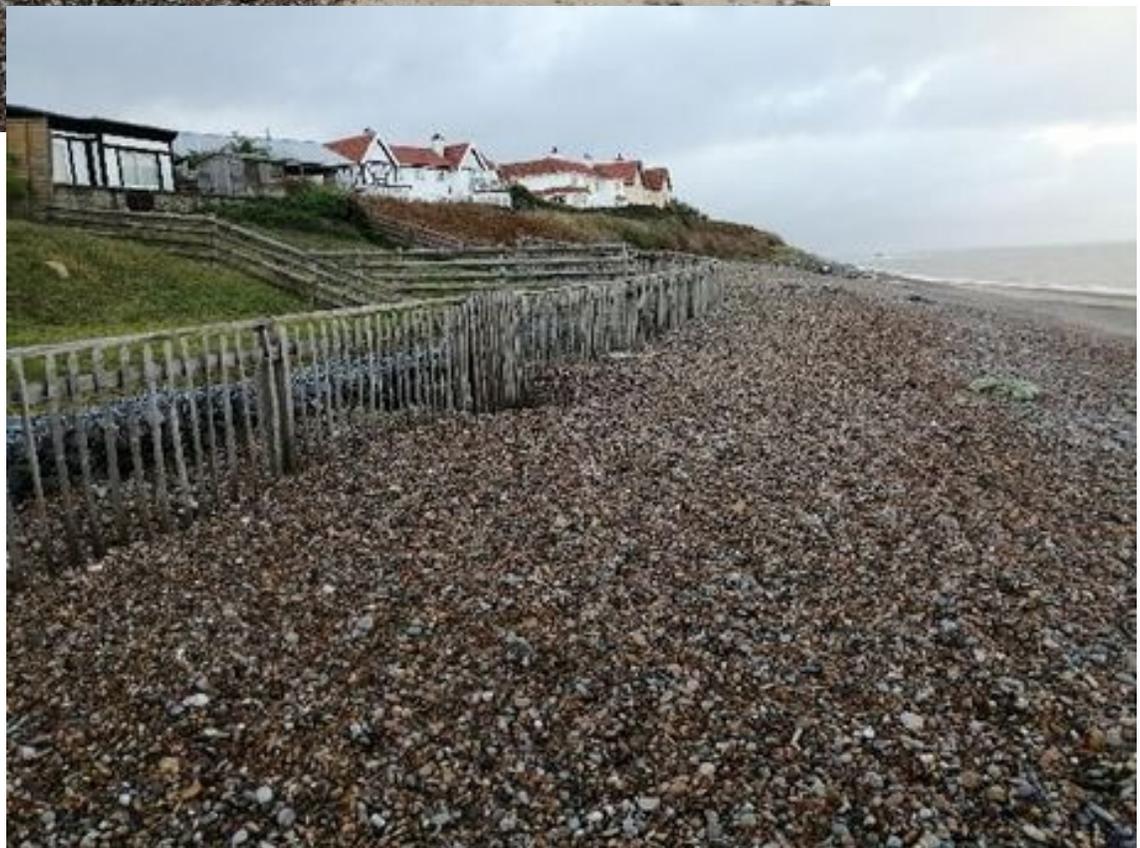
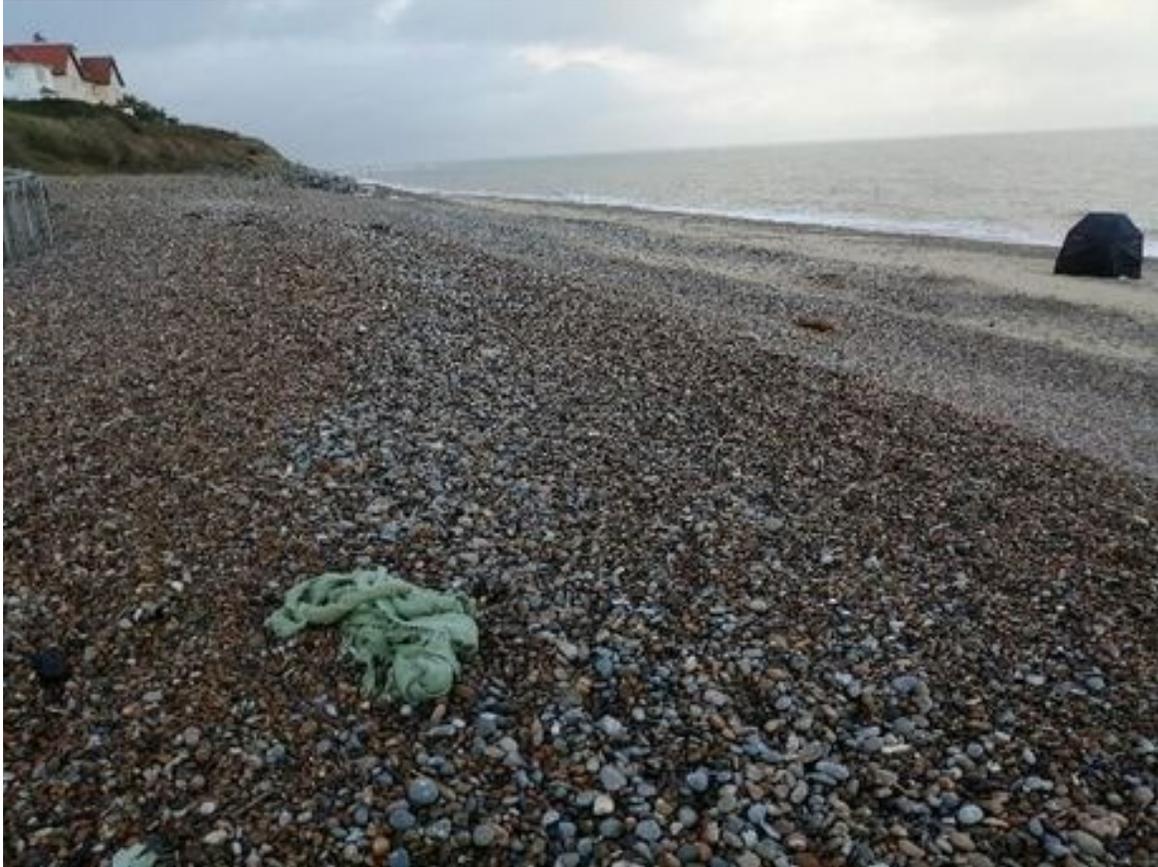
**Images of the northern DEFENDED frontage:** see gravel accumulation in upper beach

**Beach volume change Northern DEFENDED frontage:** Moderately Lower intertidal beach over phase 1 geobag area, but significant lowering over Phase 2 intertidal area. Sediment accretion on upper, supra-tidal beach in both cases.

**Geomorphological change over northern DEFENDED frontage:** Gravel has been pushed landward towards the gardens of the North End Avenue properties – see photo of gravel mound above. Gravel berm face has steepened in the bay before south of gabions. The beach here has been attempting to roll back for some time, but with nowhere to go. There is no room for the beach to develop a protective storm berm over the northern defended frontage (in front of the gabions) due to severe coastal squeeze. Even at low tide there is no dry beach between sea and defences.

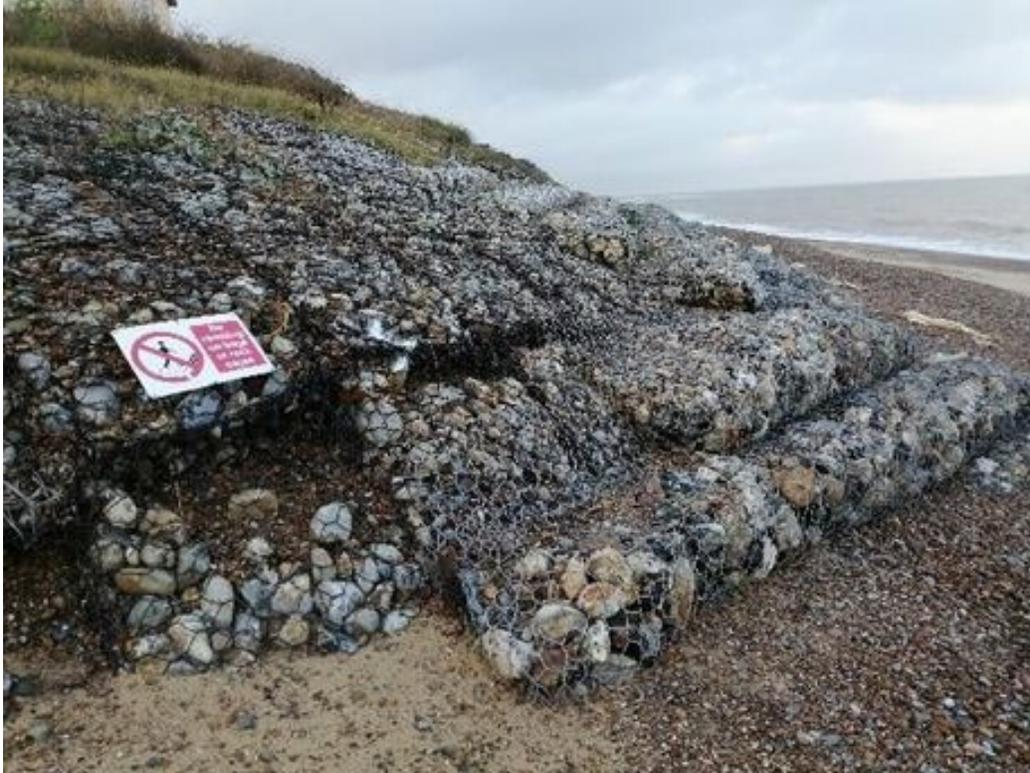
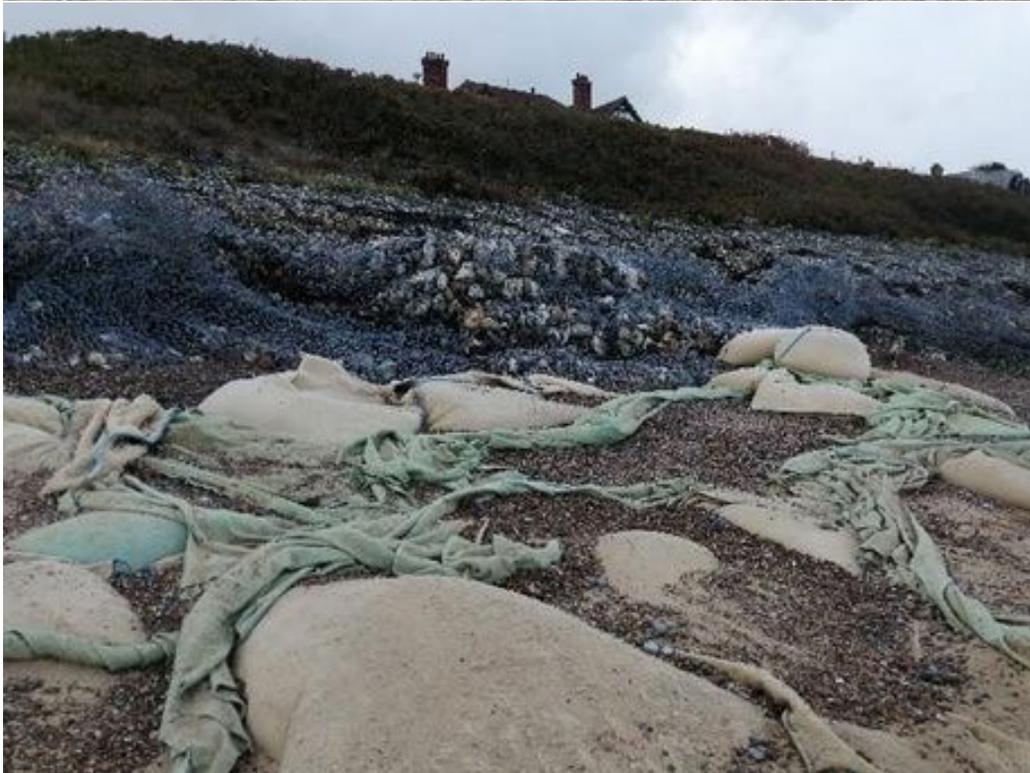
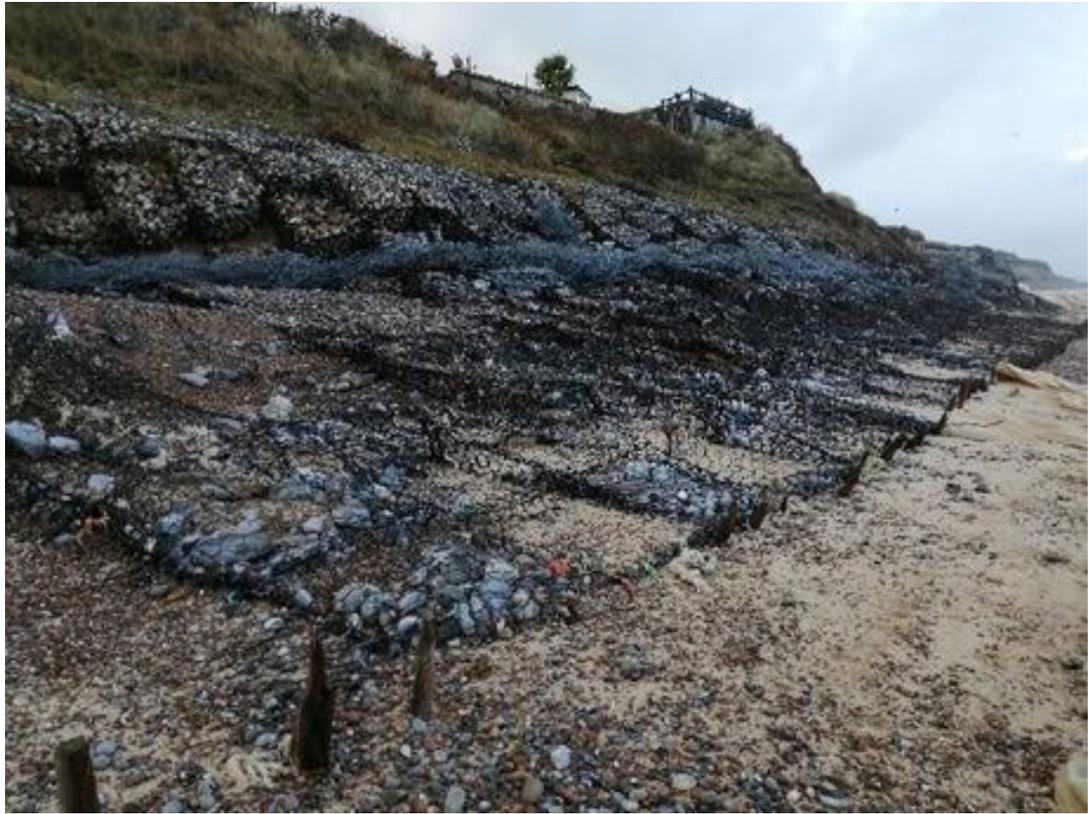
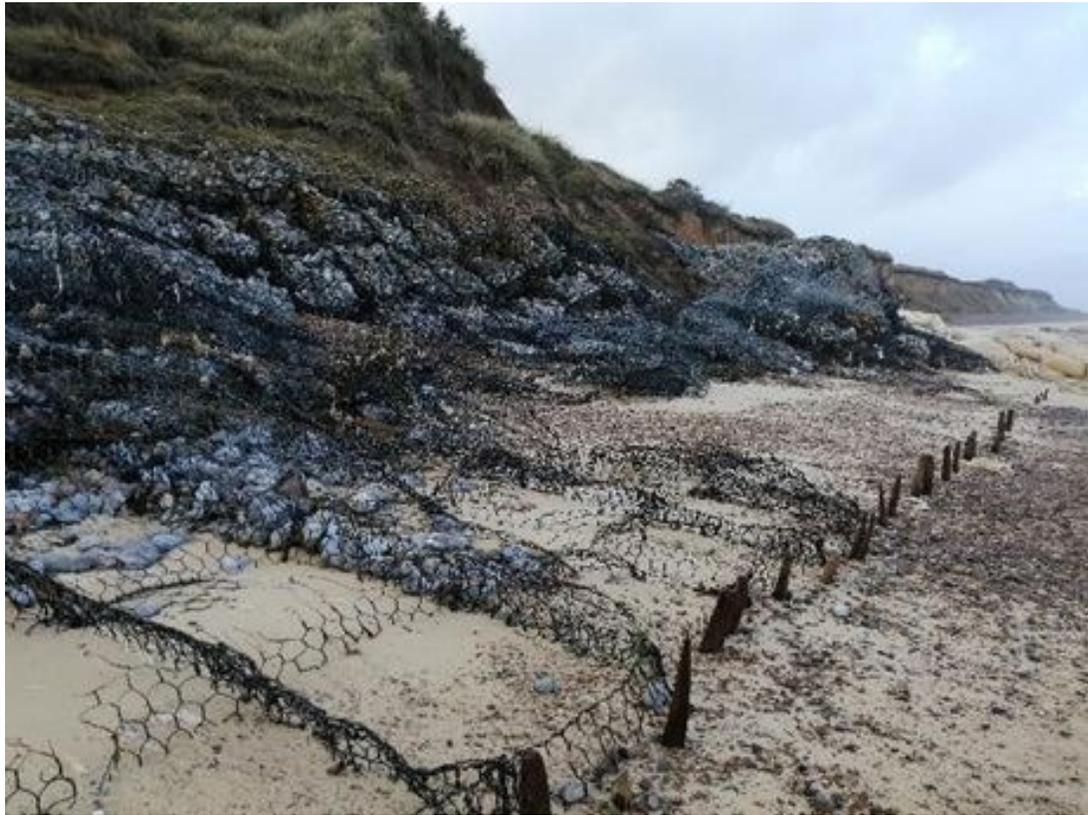
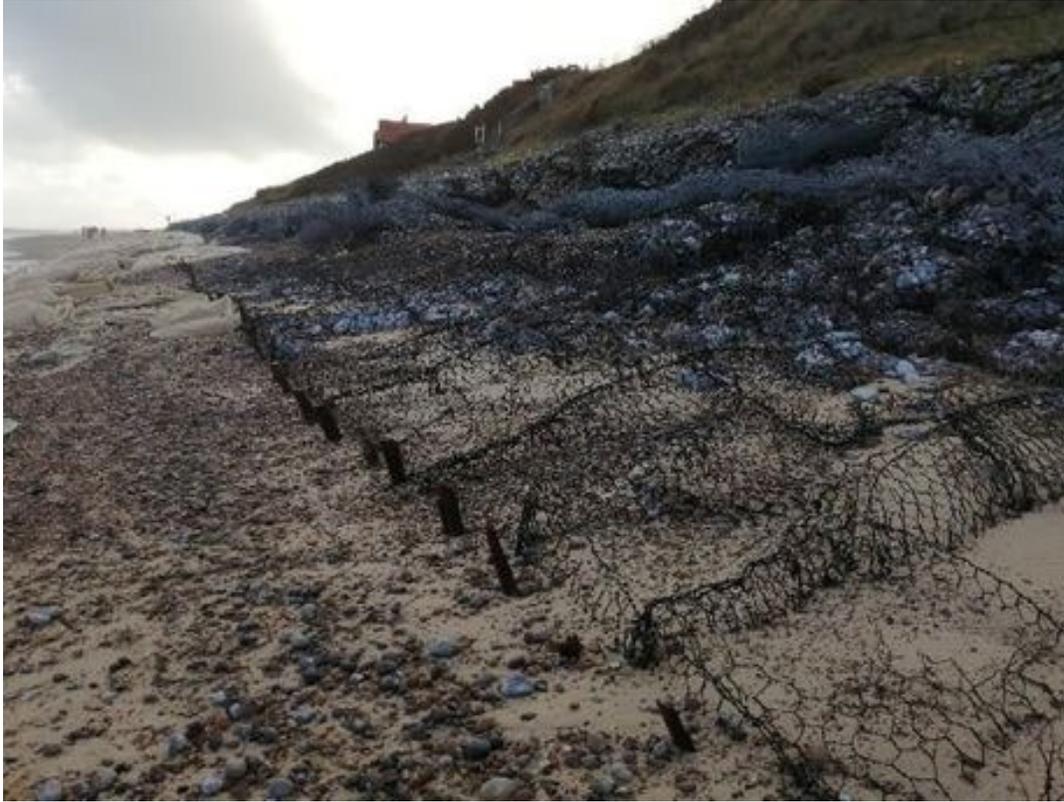
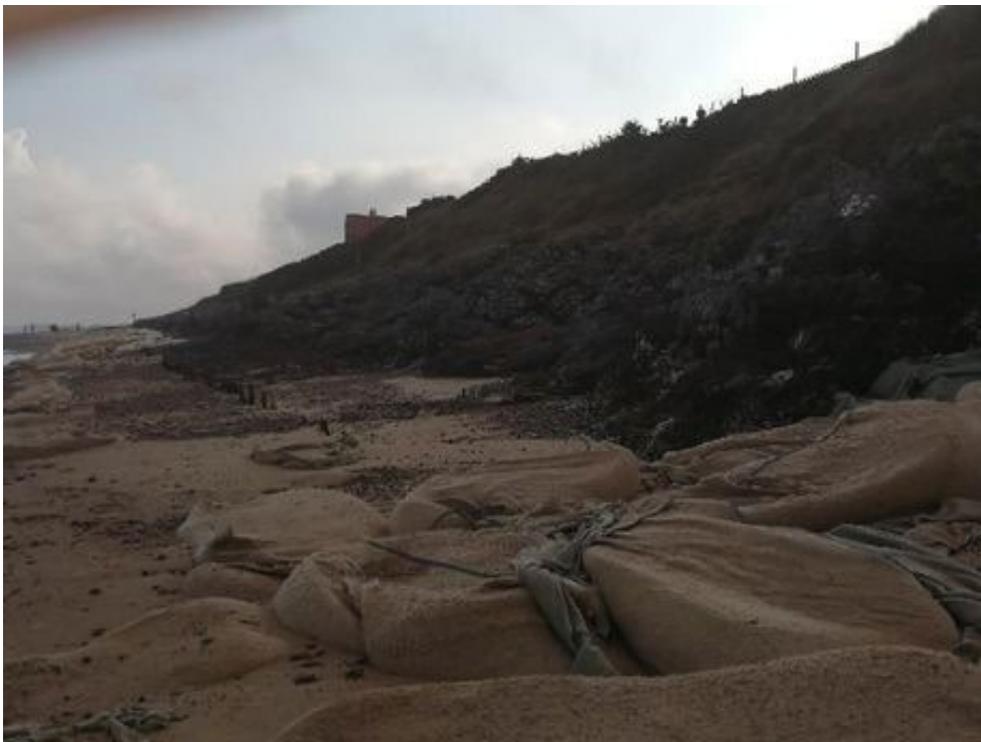
**Images of the gabions:**

The narrowing / lowering of foreshore in front of defences is marked by engineering stake exposure at base of gabions. Dangerously low beach levels here- potential risk of gabions being undermined if it continues to lower. After the destructive conditions of the weekend there has been deposition of finer material pushed landward under yesterday's longer-period constructive swell waves. However, in no way does this replace the large cobbles that have been removed from the gabion baskets over the weekend. See photos of gabions.

**Gabion condition:** no change to 'Fair' condition at south end of gabion wall but 'Very Poor' at north end; severe defects resulting in complete performance failure.

Dramatic change since last inspection, as noted by community. Risk of gabions becoming undermined if beach level continues falling. Most geobags have been displaced below them – but still provide some degree of protection with

regards to absorbing wave energy. No severe risk to public of sharps or spikes due to the power of waves which has further crumpled the mesh landward. Wooden stumps pose a trip hazard,

but this area is closed to public. We have trimmed these wooden stakes to beach level recently, but they have reappeared due to further beach lowering. Any further R&M work to 'tidy' the site may be futile, as more stormy weather approaches.

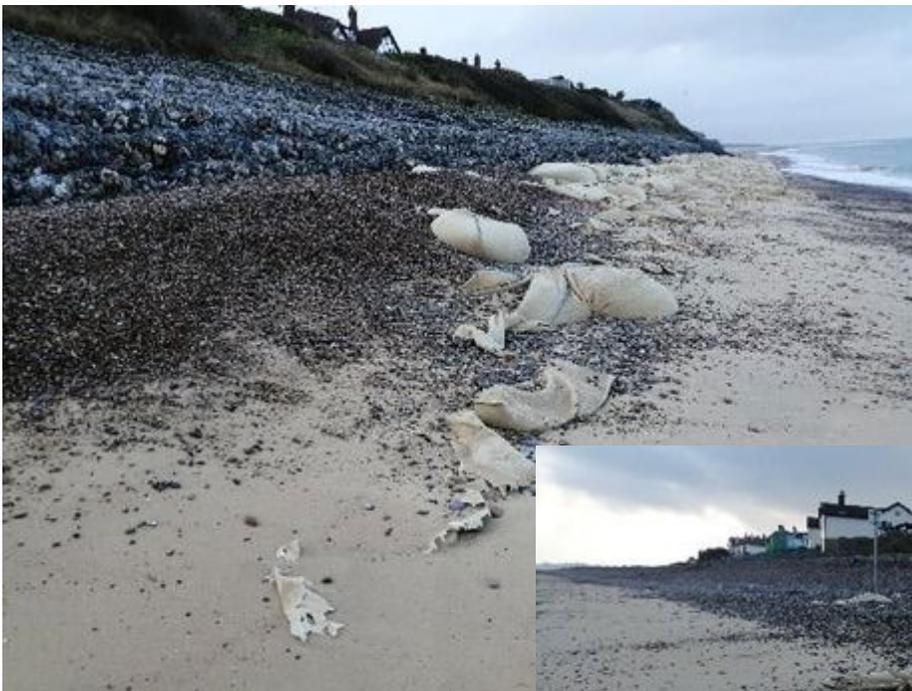
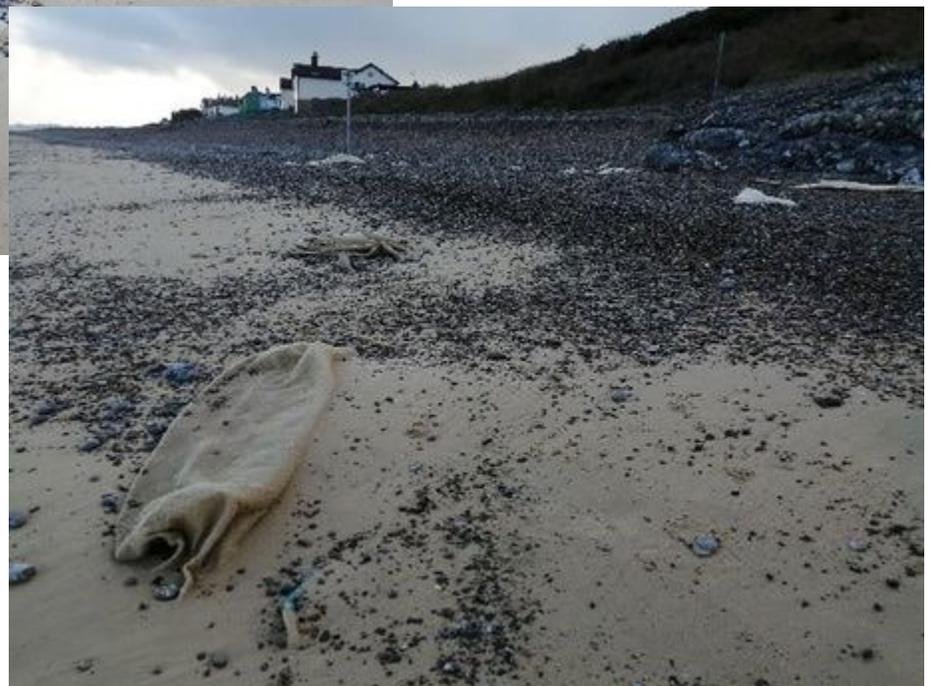
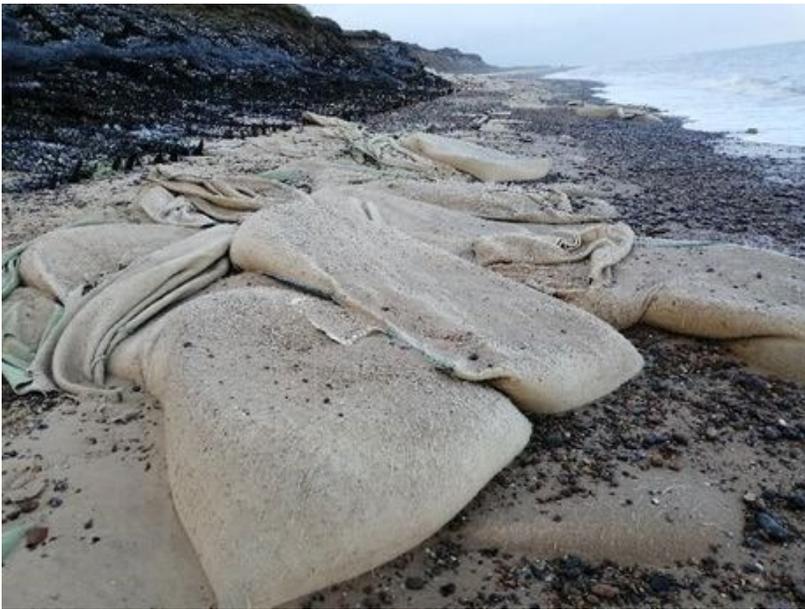
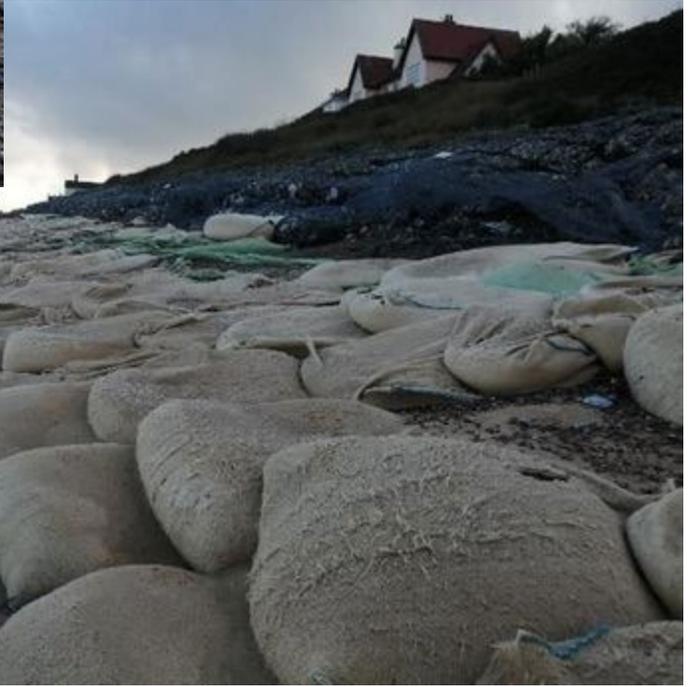
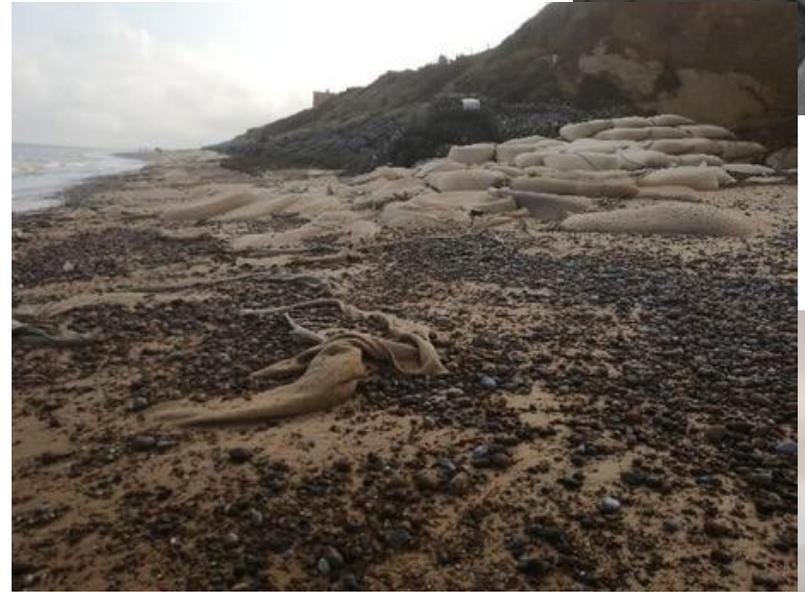
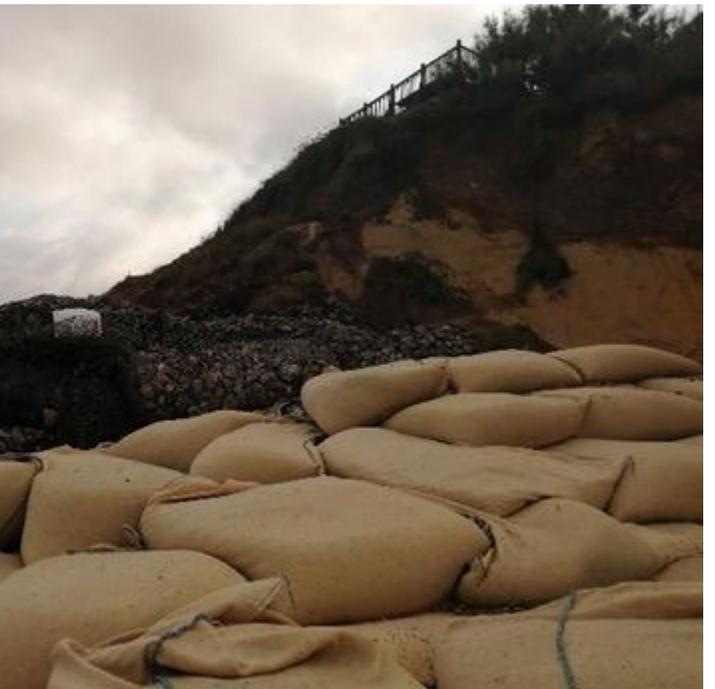
### **Images of Geobags:**

**Phase 1 Geobag (south of gabions) condition:** Exposure and displacement increase since last inspection, but they remain mostly covered over the southern 'North end Ave' portion. Condition of buried bags is assumed Fair; condition of exposed bags is Poor due to defects that reduce performance of asset. A present they are holding their position and trapping gravel in the supra-tidal zone.

**Phase 2 Geobag (north and seaward of gabions) condition:** Poor, very poor and missing. Increase in defense exposure and displacement from structure. Not necessarily more straggling textile in water though.

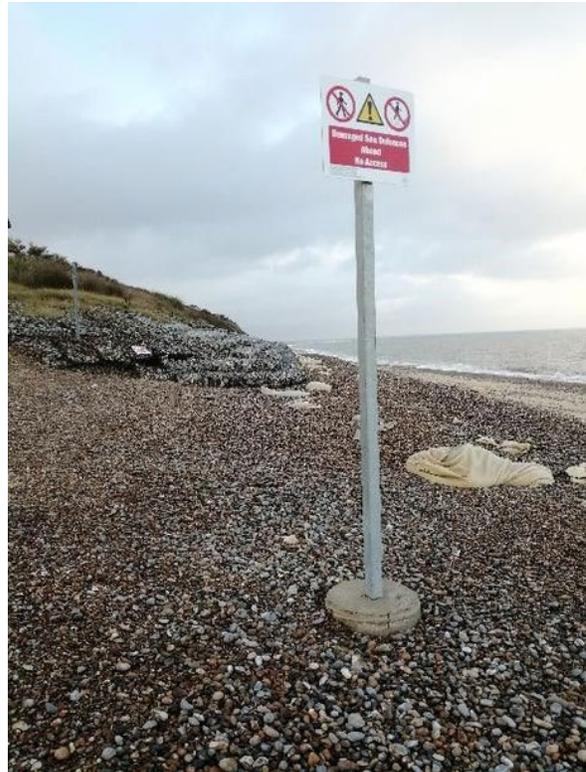
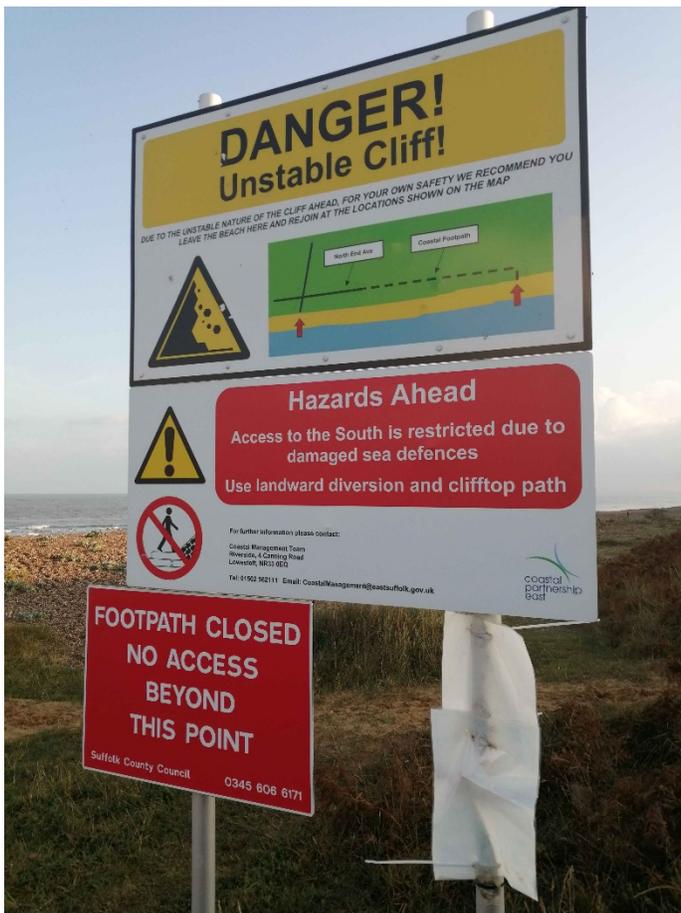
**Comments on signage:** Where signs are present the condition is good i.e. without defects that will not reduce overall performance of asset. Terminal defense signs destroyed. 'No access' and NCOROB sign at northern termination of defences has been completely destroyed. Discuss replacement of this to warn people of route closure.

Concrete base of newly re-positioned sign mid-beach is now exposed but still perfectly upright.

SCC laminated footpath diversion sign at North end of diversion needs removing. See photo below.

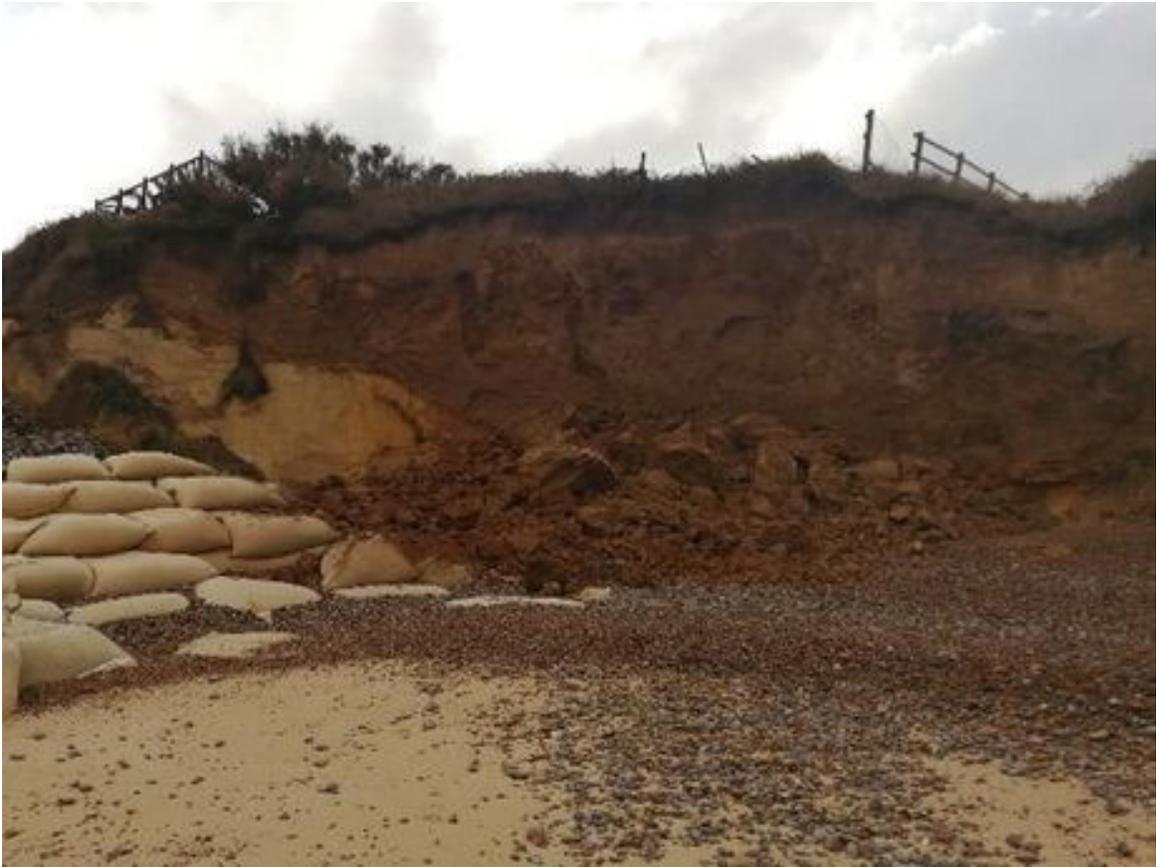
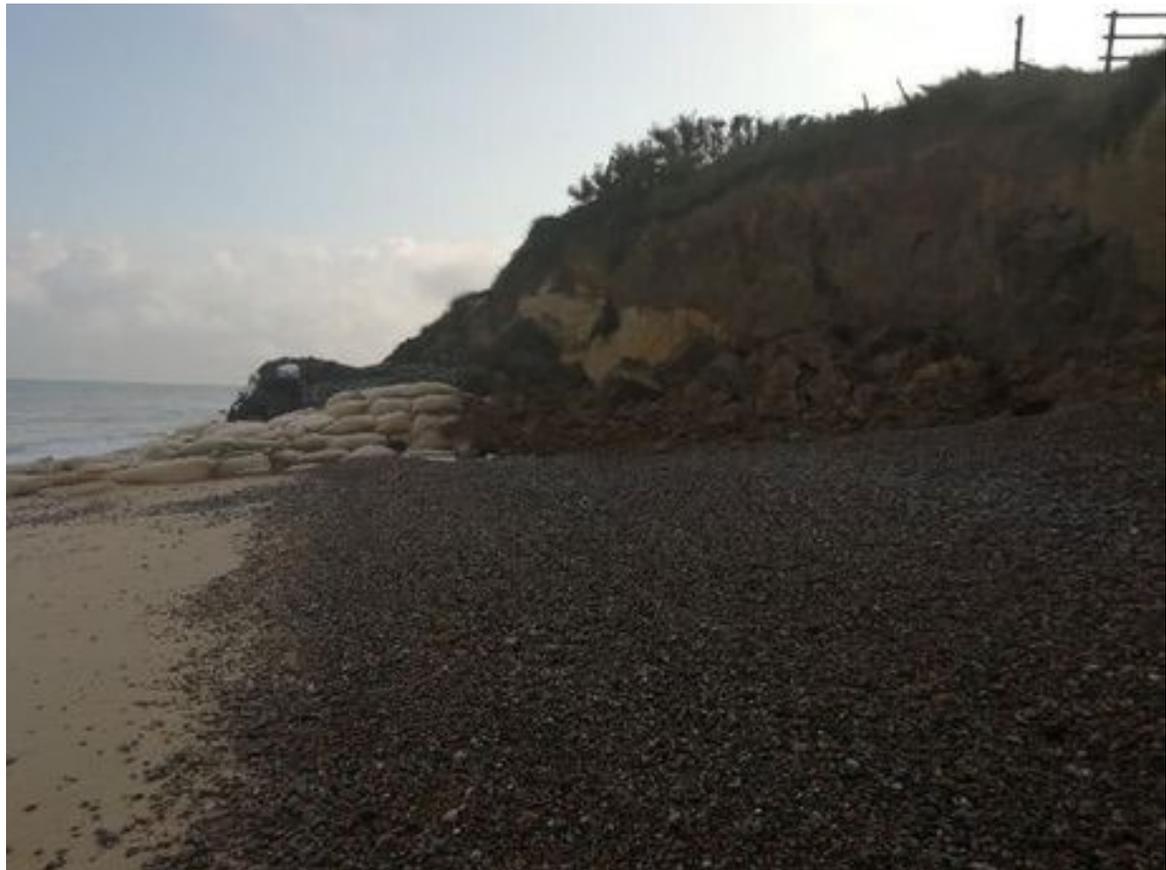
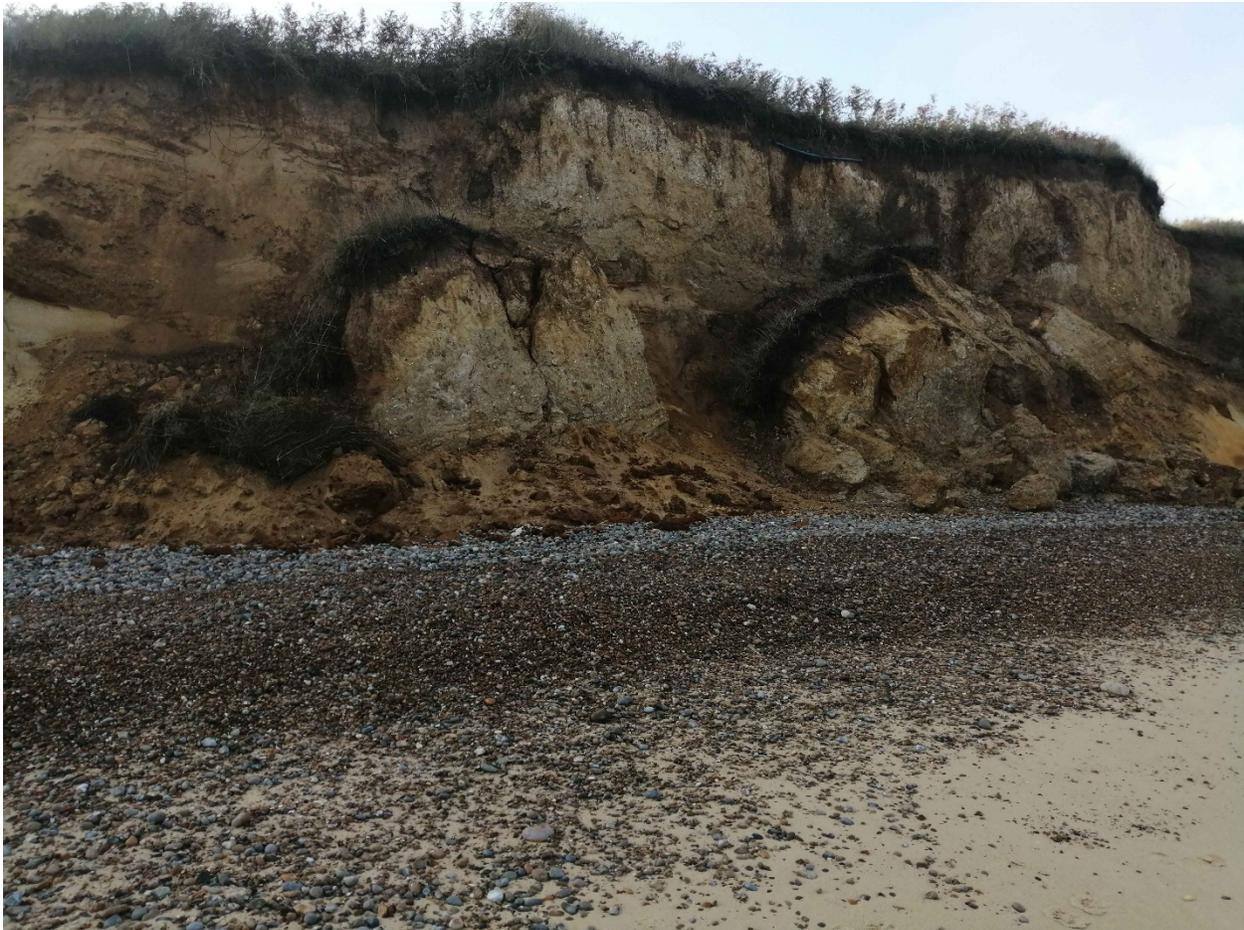
**Cliff erosion north of defended frontage:** Large cliff falls and sediment still actively falling from unstable cliffs. Erosion is progressing toward Red house Deck – failure below it has already occurred.

**Comments on erosion north of defence termination:** Considerable change. Defences washed out. Mass movement below red house deck. Large amount of rock fall adjacent to it in that corner. Gullying indicates rainfall washing material down cliff face. Berms appear again where beach widens.

No Change in volume, perhaps even an increase – perceived by levels around concrete pill box remains on beach. Significant amount of sediment at base of cliff to add to beach budget due to mass movement along cliffed frontage- see photos. Large nearshore sediment deposition around Ness perceptible by shallow, discolored water & breaking waves.
