## **Thorpeness Monthly Walkover Inspection**

**Date & Time of Inspection:** 08/28/2020 12:42 PM

**Inspector:** LG

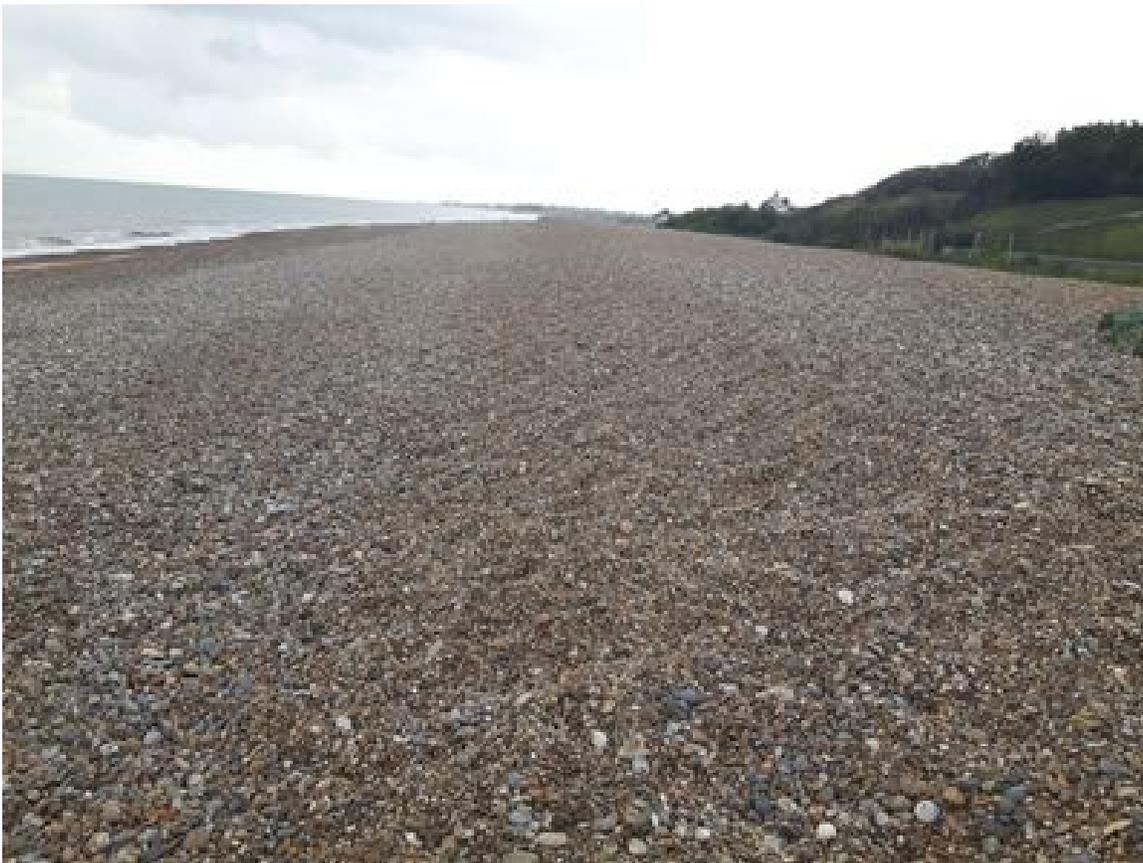
**PHOTO: Thorpeness village frontage (south):**

**Beach levels over UNDEFENDED Village frontage (South):** Negligible - No change

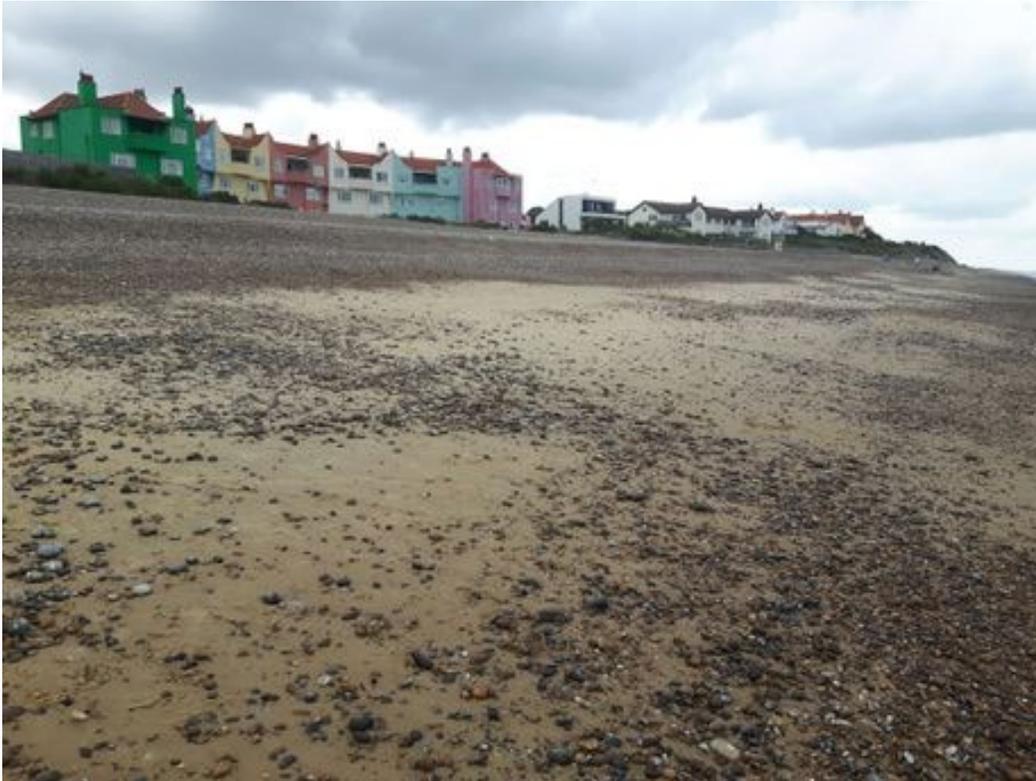
**PHOTO: In front of Headlands**

**Describe the current beach morphology in front of the Headlands:** Little change. Large berm peters out in front of headlands. Smaller berms to seaward. Mixed sand gravel foreshore: Fairly steep but wider than previous due to lower tidal level. Some shallow cusps in gravel at low watermark. No evidence of alteration by wave action.

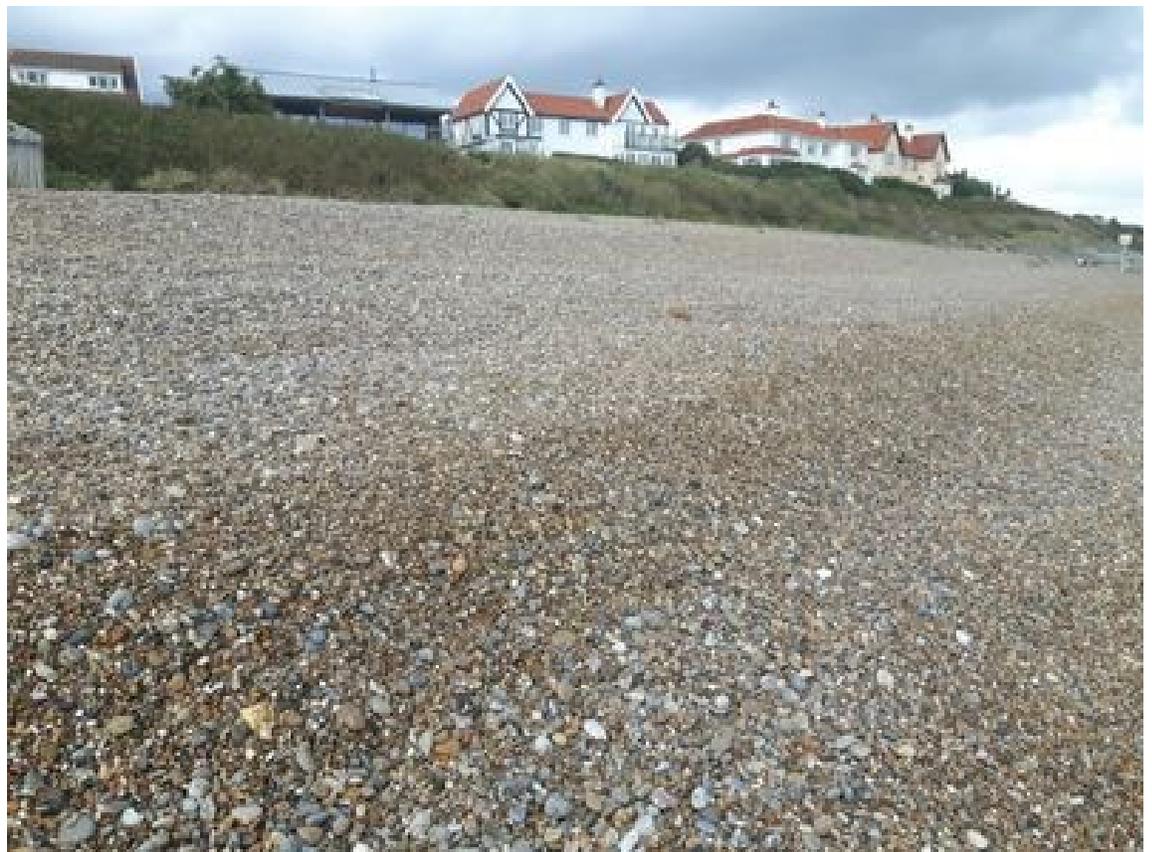
Same as southern frontage but with more gravel on foreshore. Much more gravel on back beach in recess before gabions. Positive first impressions.

**PHOTO: significant morphological feature** – yet more gravel pushed in to the recess south of the gabions. This indicates the beach is naturally trying to roll back but is constrained by the properties.

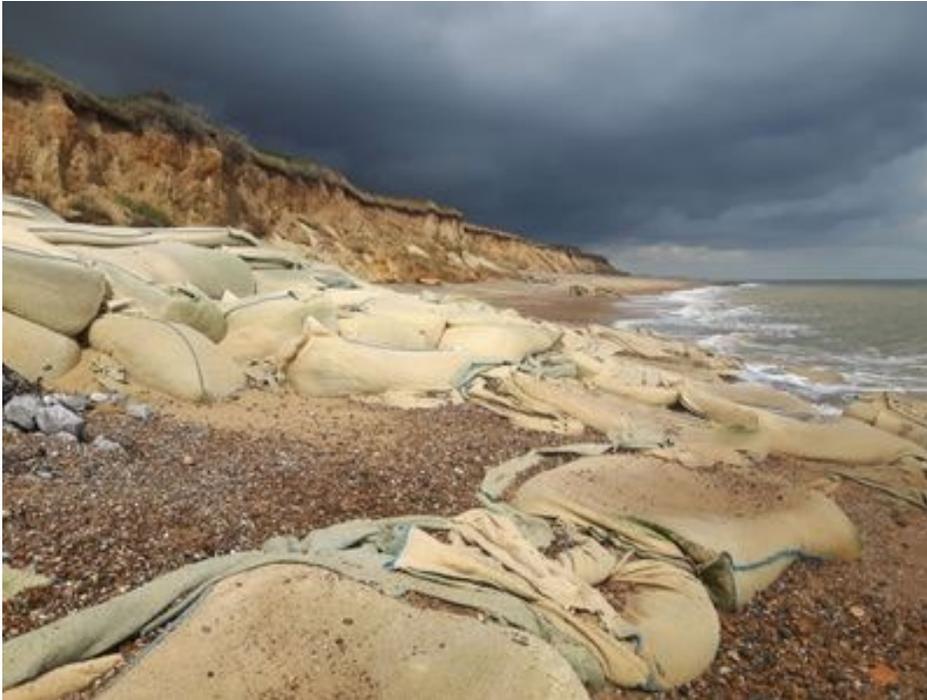
**PHOTO: Thorpeness village frontage (North):**

**Beach levels over DEFENDED Village frontage (North):** Modest accretion (defences all or partly covered)

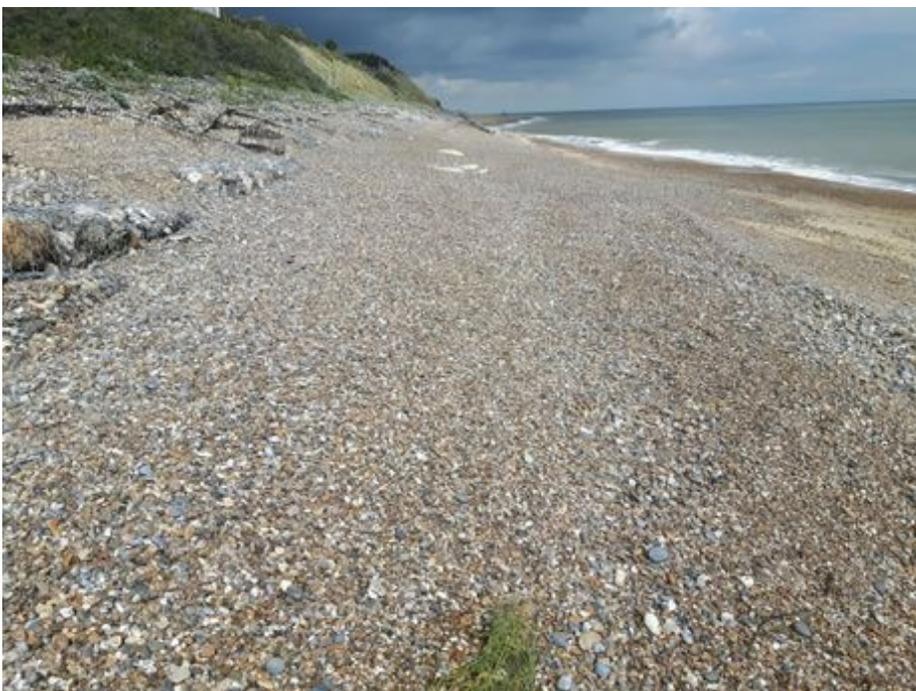
**PHOTO: Phase 1 Geobags**

**Condition of Phase 1 Geobags:** Geobags all or partially buried - minor defects

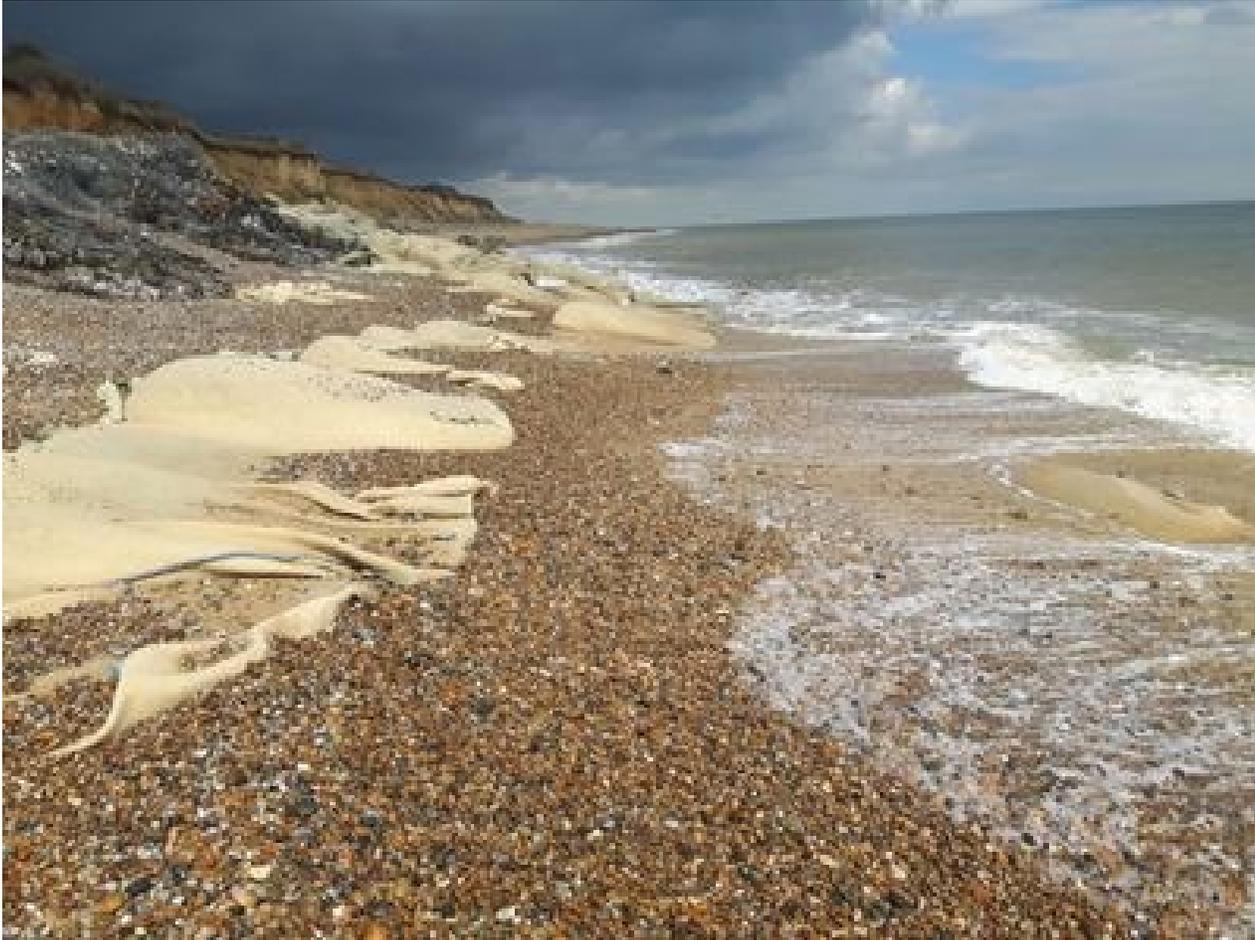
**PHOTO: Phase 2 Geobags:**

**Condition of Phase 2 Geobags:** Geobags all or partially exposed - major defects

**Phase 2 Geobags:** Holed , Loss of Fill, Displaced

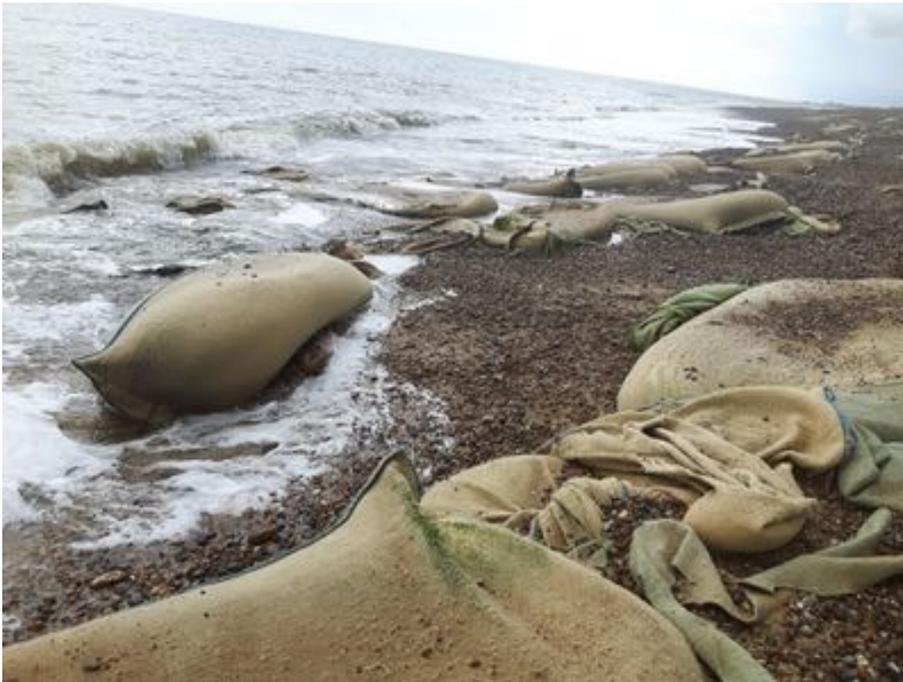
**PHOTO: Geobag debris on foreshore:**

**Comments on defended village frontage:** Much improved since WMA tidy up, although many geobags are still exposed in the intertidal zone there are no long straggly bits visible.

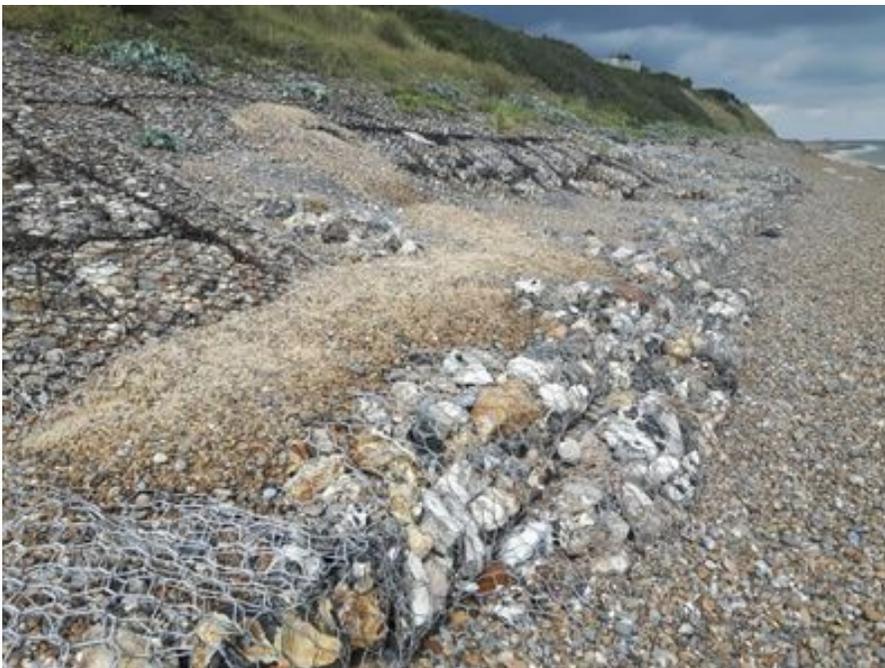
**PHOTO of Gabions:**

**Condition of (1976) Gabions:** 4) Poor -Defects that would significantly reduce performance of asset. Sharps / spikes, Gaps in mesh, Loss of fill, Loss of structural integrity

**Comments on Gabions:** Sediment infilling voids. Tidying by WMA looks good, wooden stumps successfully removed, but possible further destruction from storm Francis has reshaped mesh.

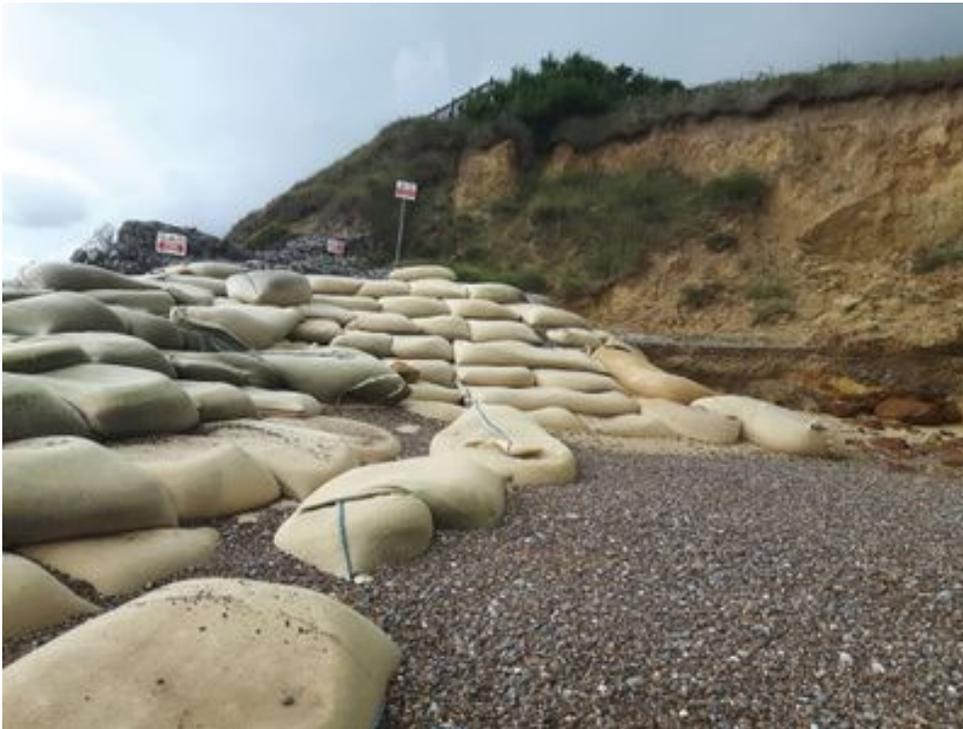
**PHOTO of termination of defences at north end:**

**Comment on the north end termination/transition:** Serious erosion at north end caused by large NE swell waves.

**Inspection Follow up:** Share report and knowledge of active beach cliffing and cliff recession at the northern end. Discuss consequences of the outflanking of terminal geobag defense on Red House's protruding deck area.

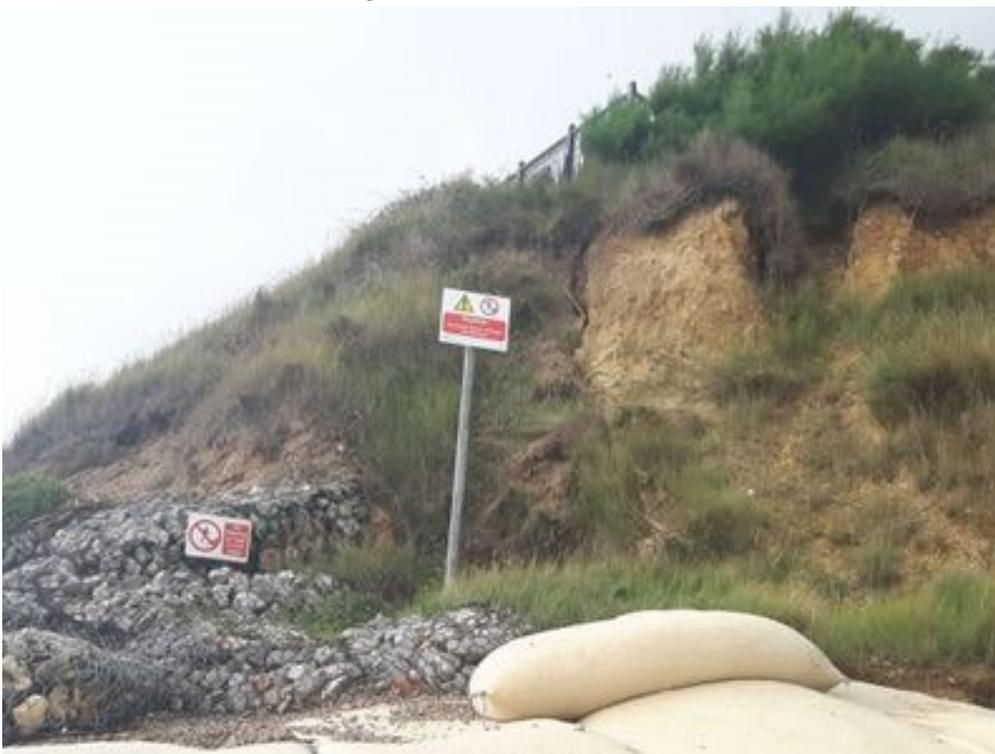
**PHOTO of cliff instability beneath Red House's deck:**

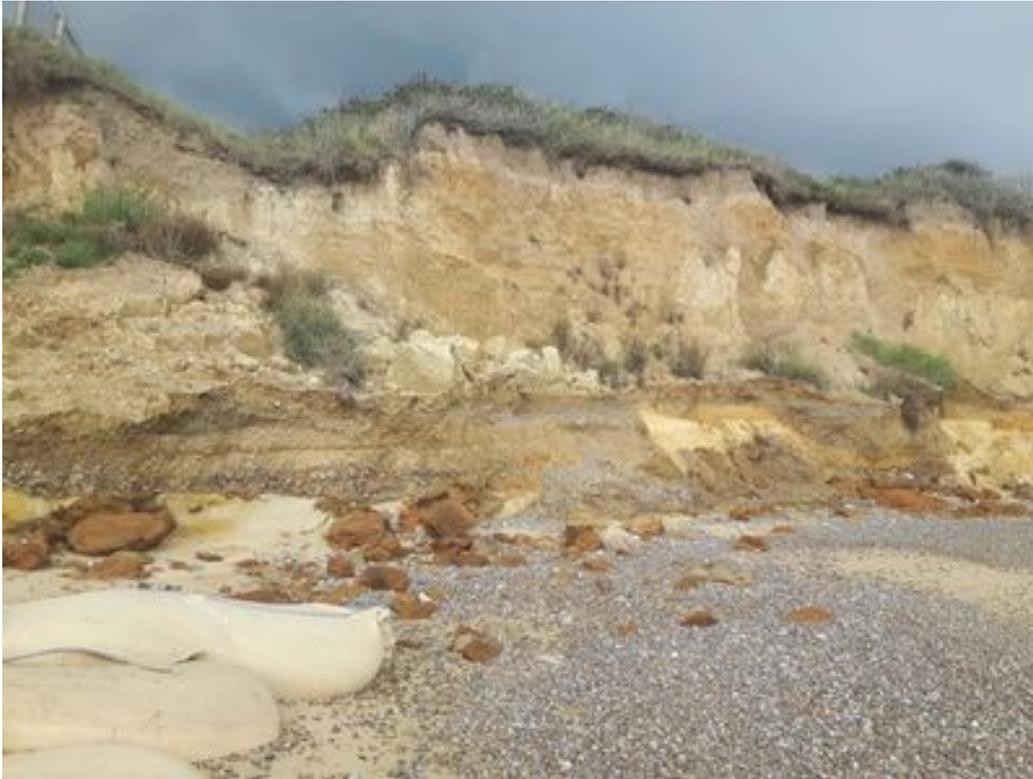
**PHOTO of cliff erosion beyond north end defences:**

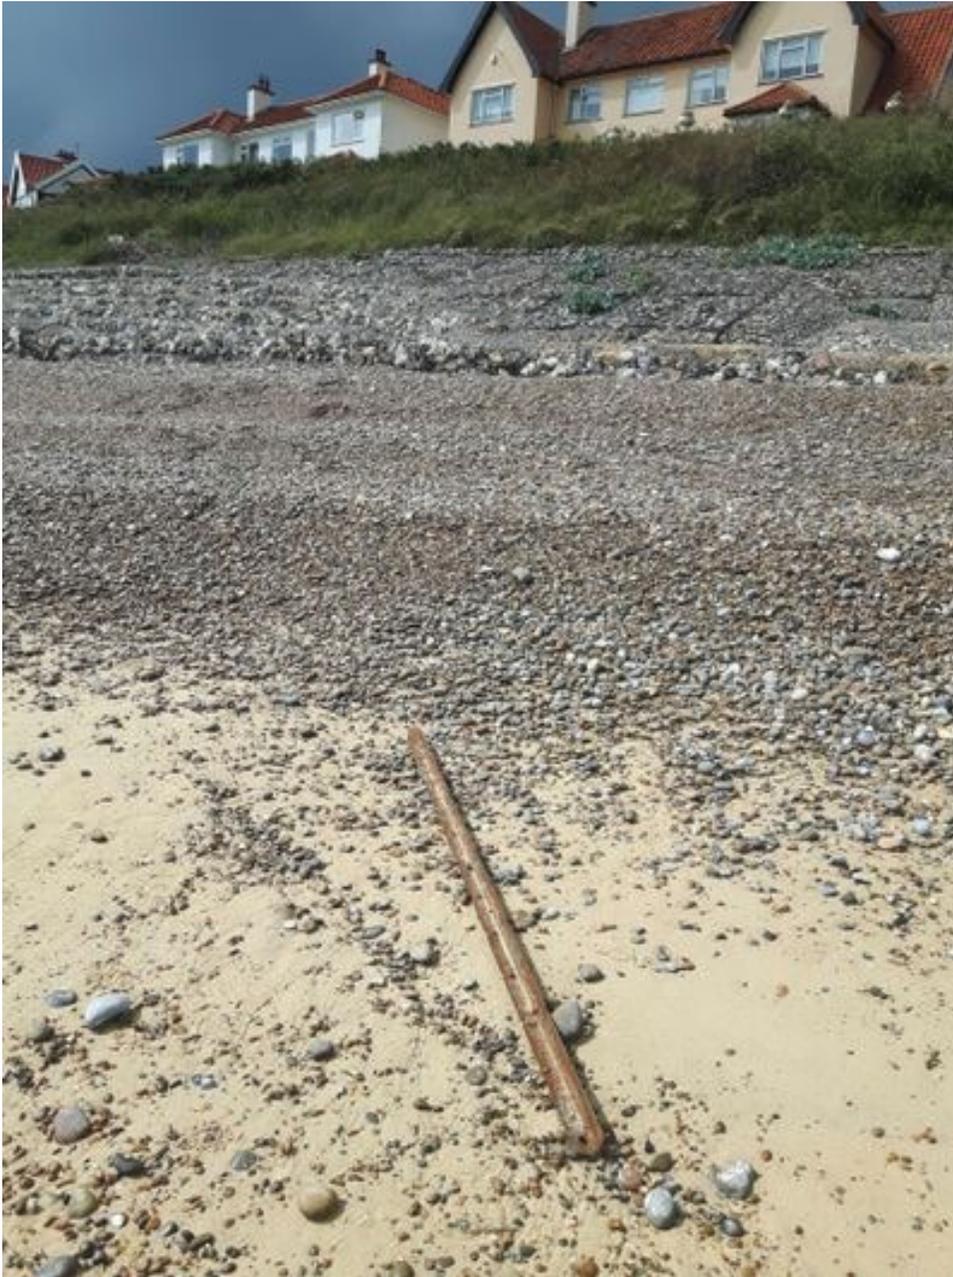
**PHOTO of any significant hazard to public safety:** Metal debris washed up by storm Francis?

Object moved to top of gabions to avoid footfall.

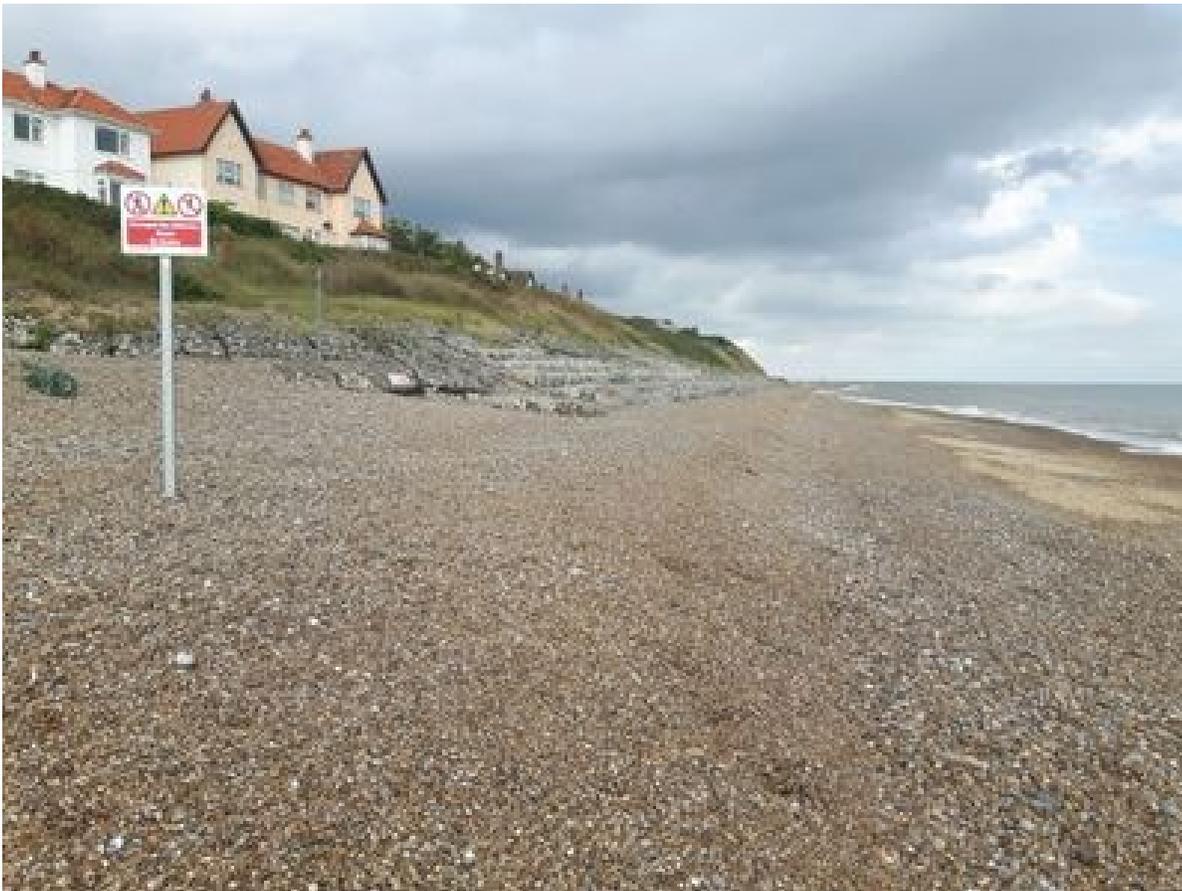
**Condition of signage:** Asset/s present - no defects

**Comments on signage:** New sign installed in a more obvious position. Looks good. Clear and legible.

**PHOTO of signage:** Warning signage moved to more prominent position.
