## **Thorpeness Monthly Walkover Inspection**

**Date & Time of Inspection:** 07/14/2020 12:15 PM

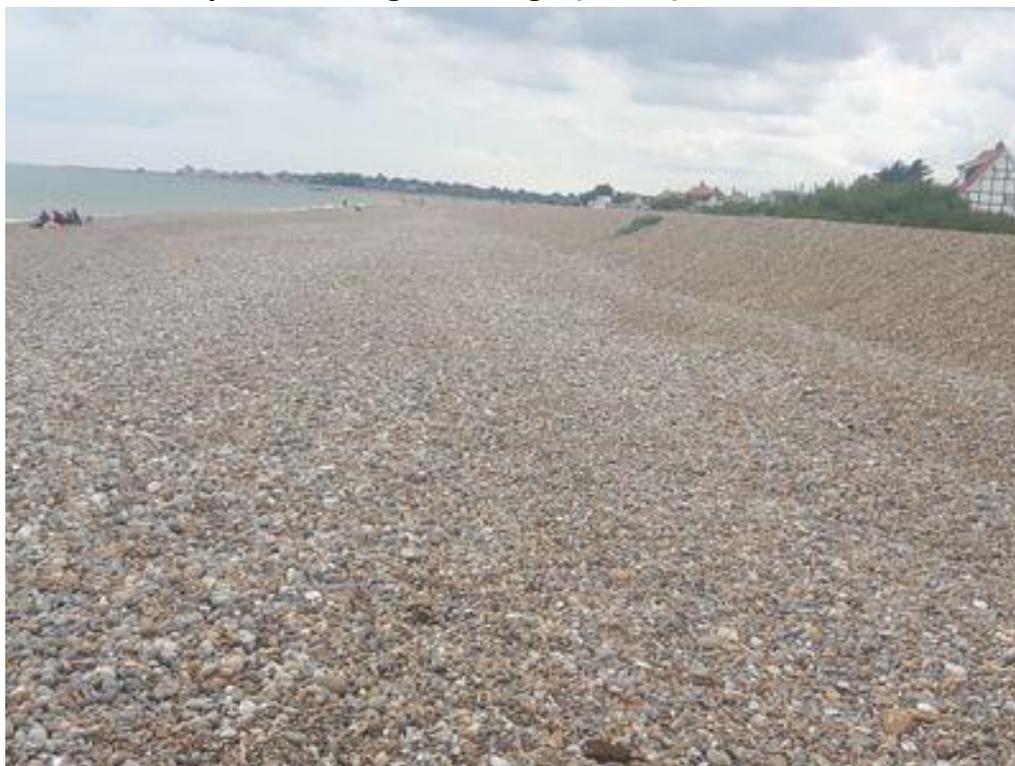
**PHOTO: Thorpeness village frontage (south)**

**Beach levels over UNDEFENDED Village frontage (South):** Marginal lowering and reshaping

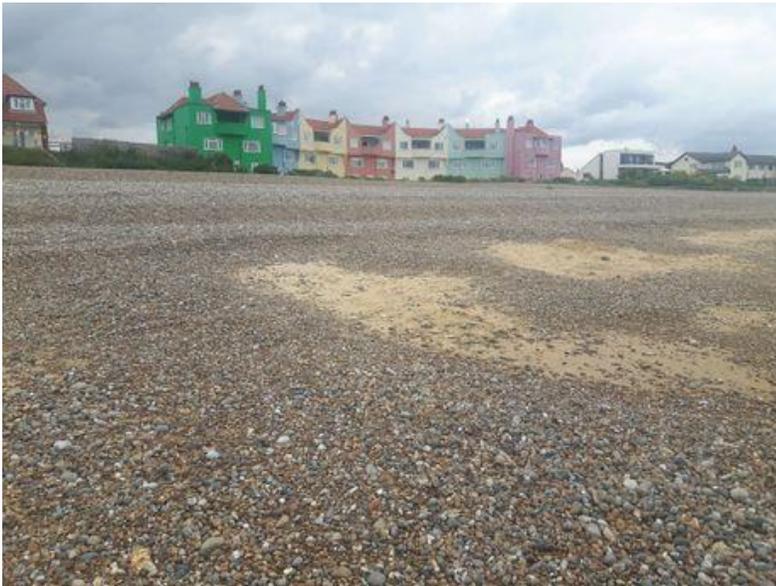
**PHOTO: In front of Headlands**

**Describe the current beach morphology in front of the Headlands:** Pronounced berm on back beach still with >1m crest height and steeper stoss slope than last month – indicates reworking by long period waves. Successive smaller HW bems in front of it. Wider lower shoreface this month. Gravel covering almost entire lower-intertidal shoreface ie. little sand. Beach cusps in formation.

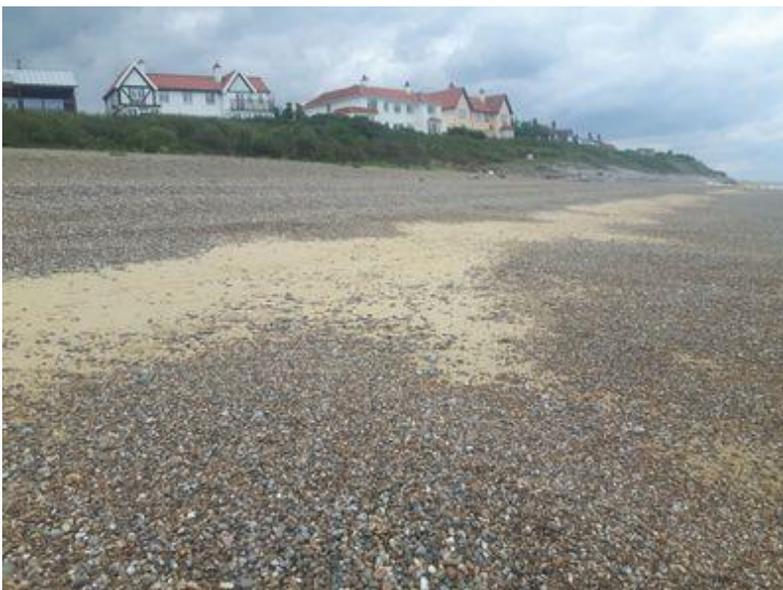
**PHOTO: Thorpeness village frontage (North)**

**Describe the current beach morphology over the DEFENDED frontage:** less than 1 hour after low water and there's no beach in front of geobags. Steep intertidal shoreface. Big berm with steep stoss slope on back beach in front of gardens. Evidence of large swell waves reaching upper beach. Scouring to the north of the defences is serious. >1m gravel beach cliff formed below the vulnerable section immediately north of red house. Prolonged Rain has moistened cliff top and there's evidence of freshly fallen and slumped material.

**Beach levels over DEFENDED Village frontage (North):** Modest lowering of foreshore (defences all or partly exposed)

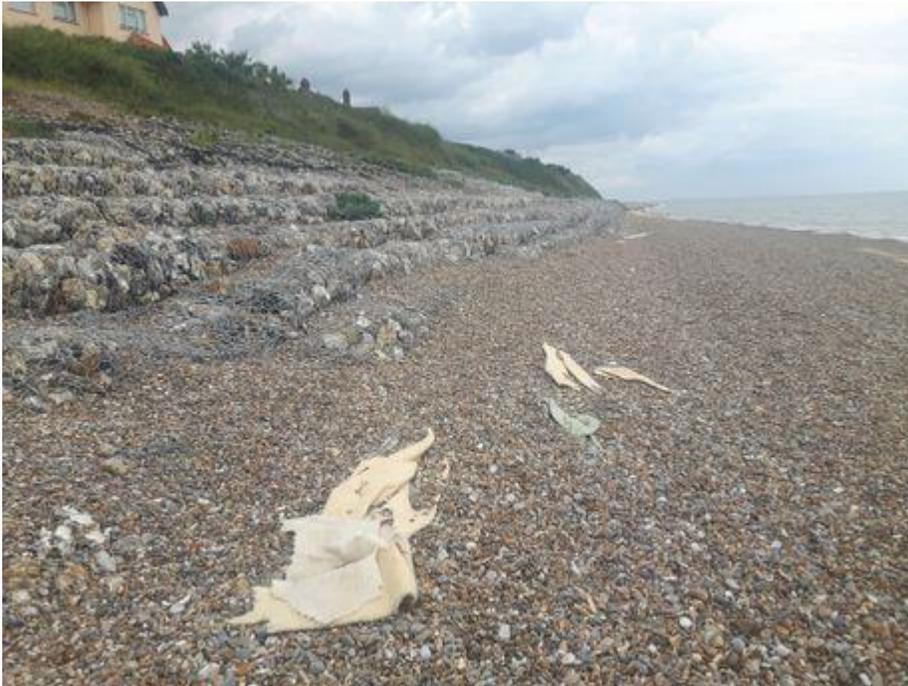
**PHOTO: Phase 1 Geobags**

**Condition of Phase 1 Geobags:** Geobags partially buried - defects

**Phase 1 Geobags:** Holed , Loss of Fill, Displaced, Geotextile strands on shoreface, Geotextile debris far from source

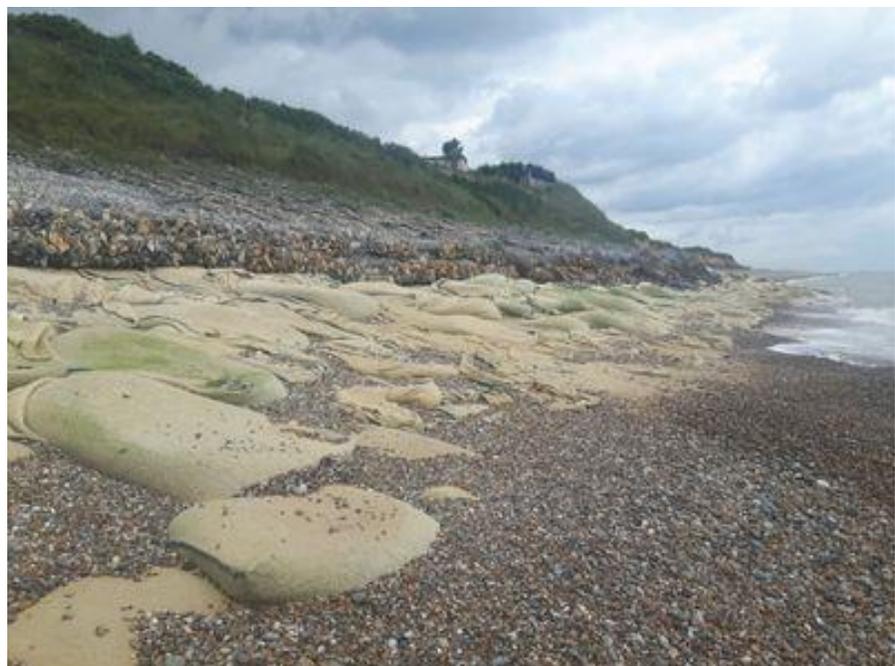
**PHOTO: Phase 2 Geobags**

**Geobags:** Geobags all or partially exposed – major defects

**Phase 2 Geobags:** Holed , Loss of Fill, Displaced, Geotextile strands on shoreface - far from source

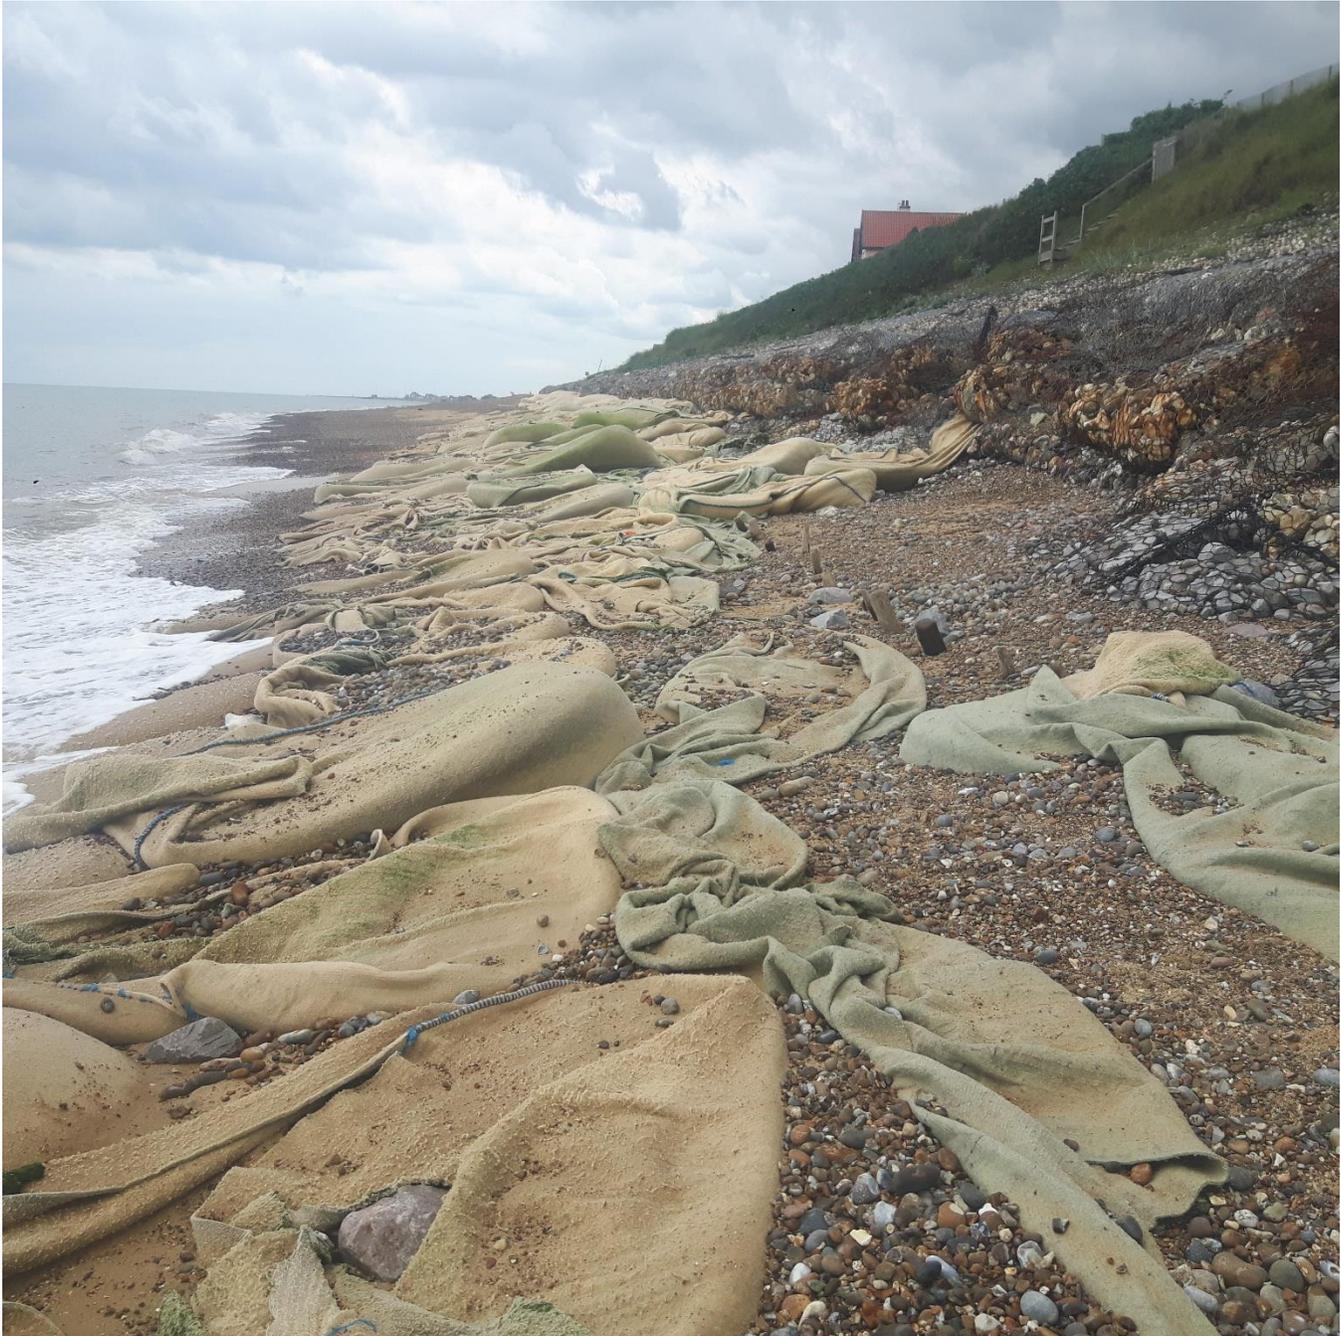
**PHOTO: Defences (North end)**

**Comments on defended village frontage:** People climbing on bags. Gabion wire mesh has taken wave impact - broken with sharps. Wooden stumps at base of gabions exposed further. Beach scouring north of defence termination has formed a grave/sand cliff. Potential danger of cliff toe being undermined and significant mass movement, if beach scouring continues.

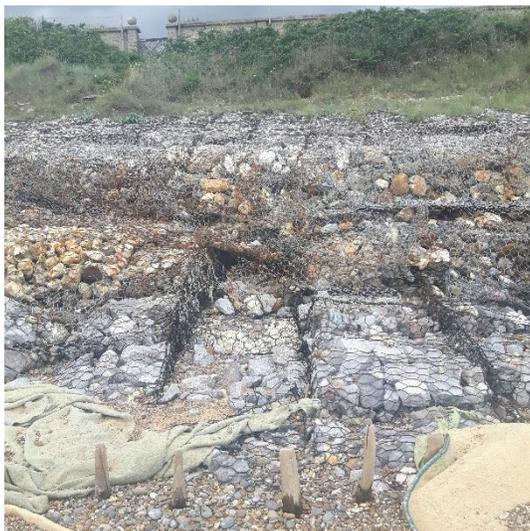
**Condition of (1976) Gabions:** 5) Very Poor - Severe defects at the north end resulting in performance failure. Deterioration since last inspection

**Gabion condition:** Sharps / spikes, Gaps in mesh, Loss of fill, Loss of structural integrity

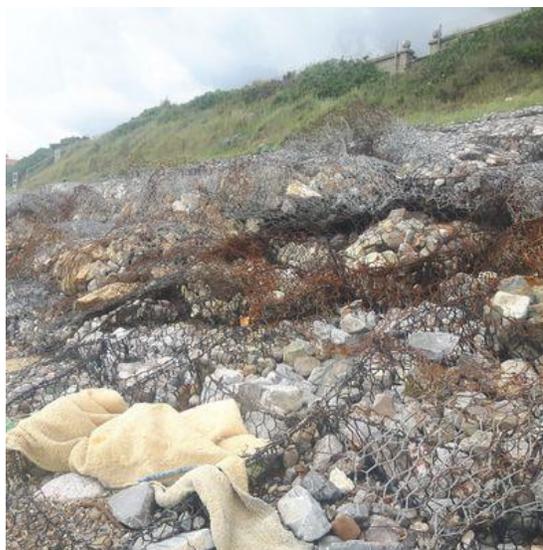
**PHOTO of Gabions:**

**Comments on Gabions:** Further wave impact since last inspection has deteriorated their condition at the north end particularly. More wooden stakes (left) on show indicating further loss of material by destructive waves.

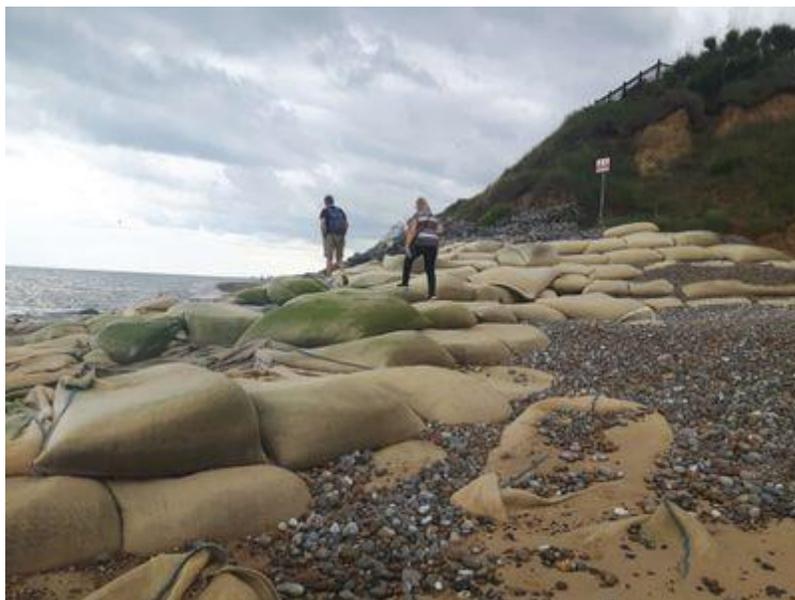
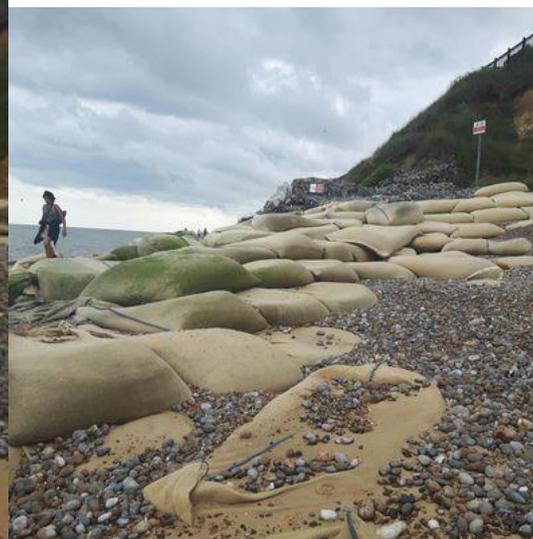
**PHOTO of termination of defences at north end:**

**Comment on the north end termination/transition:** Beach scouring and cliffing. Geobags appear heaped up which indicates drop in beach levels. Geobags in tact around gabion termination.

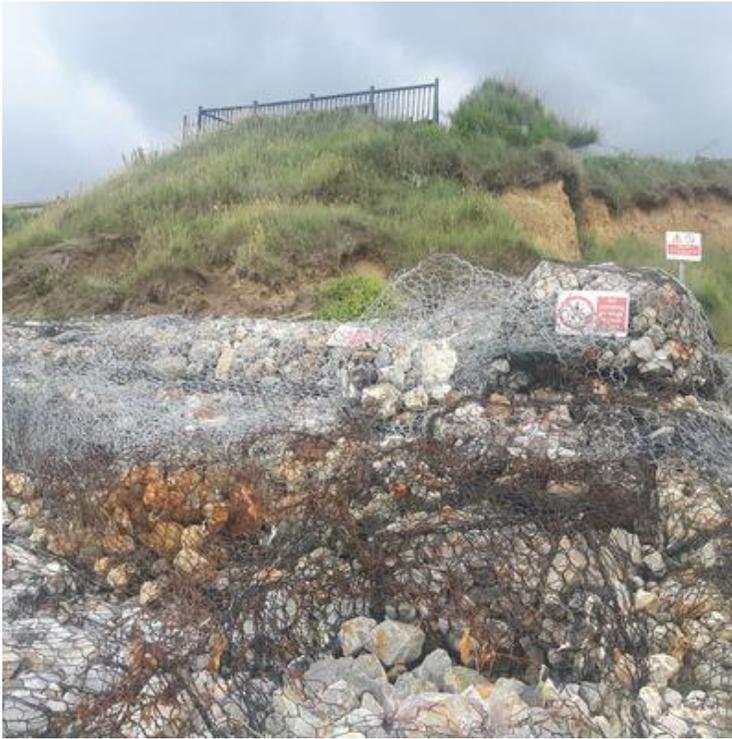
**PHOTO of cliff instability beneath Red House's protruding deck:** Some minor mass movement

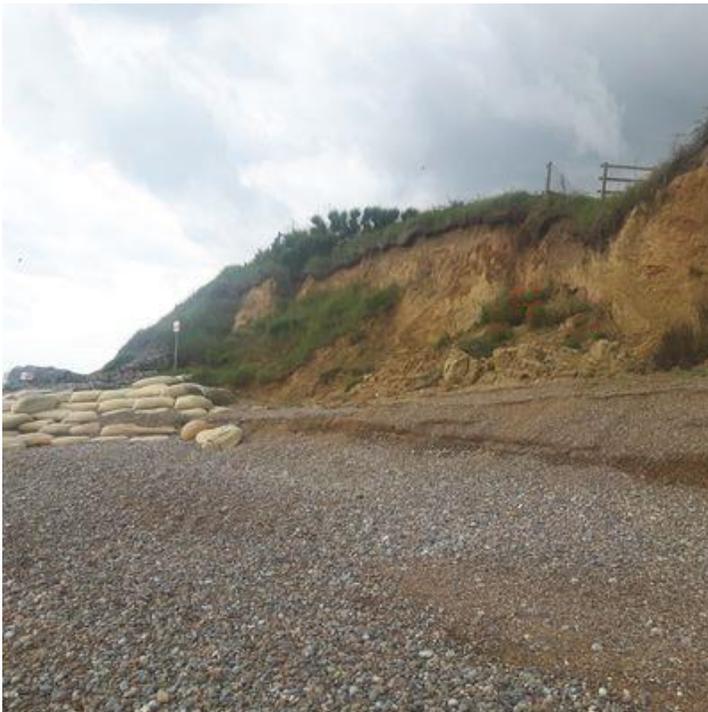
**PHOTO of cliff erosion beyond north end defences:**

Prolonged rain event has washed material down cliff and generated new slumps.

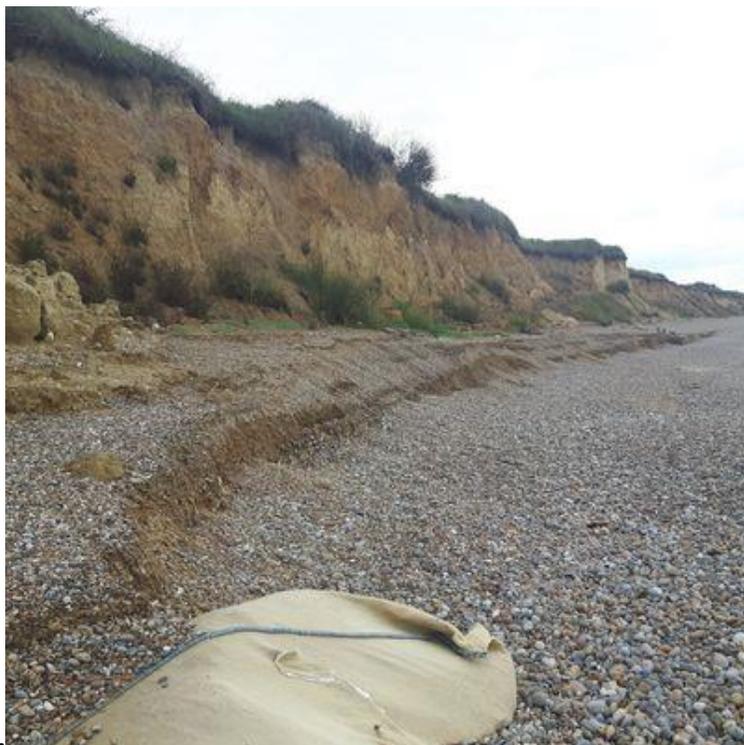
**PHOTO of beach/cliffs looking north to Thorpe-Ness:** New beach cliff – indicates removal of gravel over whole intertidal range.

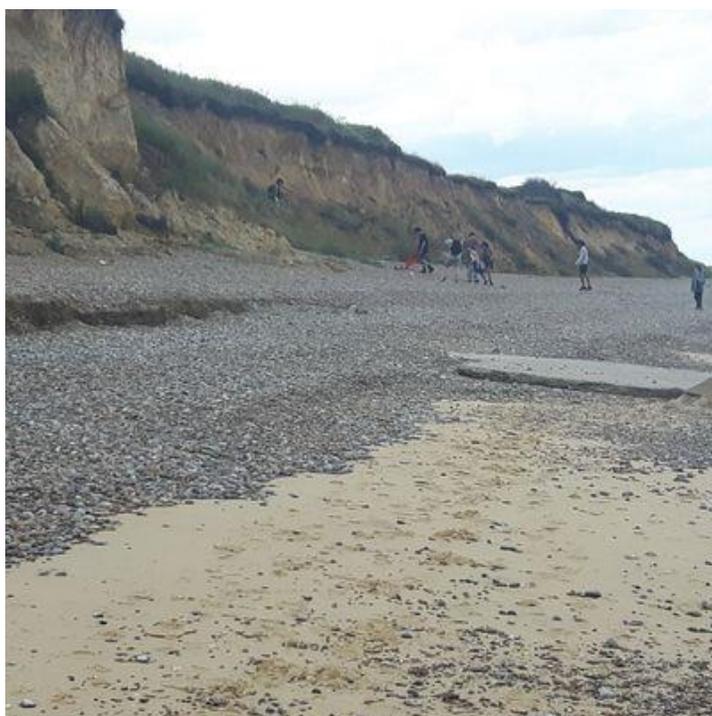
**PHOTO of any significant hazard to public safety:** People climbing on cliffs that have recently fallen/slumped.

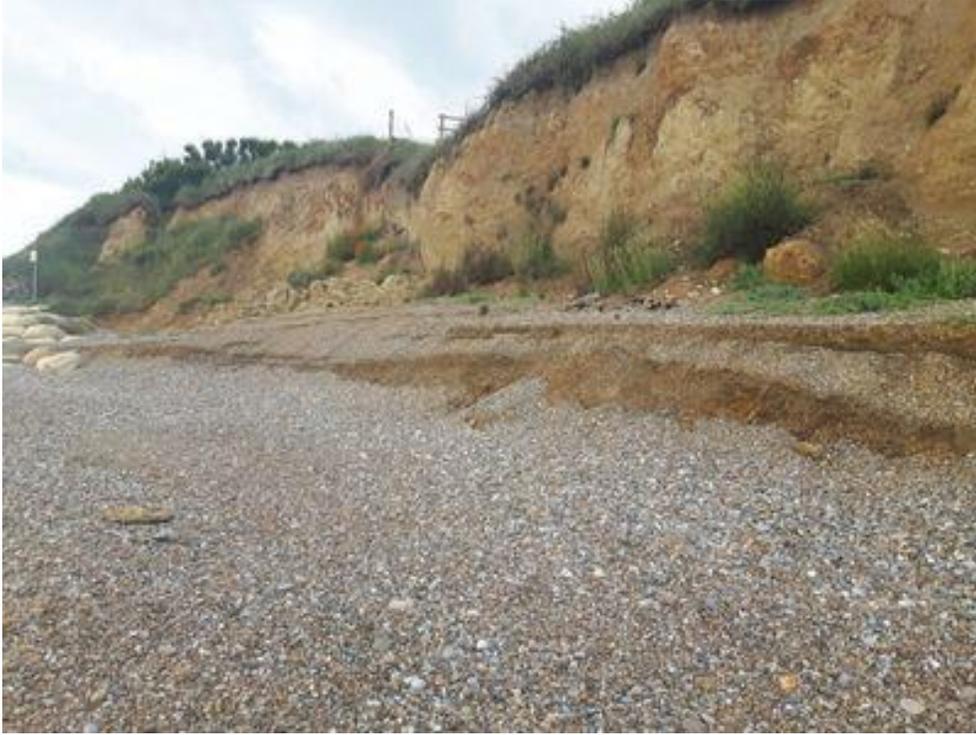
**PHOTO: significant new geomorphological feature – beach cliffing**
