Thorpeness Monthly Monitoring

Date & Time of Survey: February 16th 2021 8:10 AM

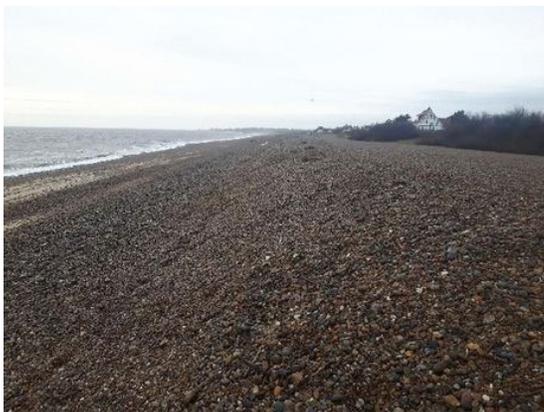
Left: This laterally continuous storm berm extends from Aldeburgh to in front of the Headlands properties. It ranges from 5 to 10ft high. The seaward face of the berm has variable gradient 45° to near vertical in places e.g., in the pocket adjacent to the southern end of the gabions.

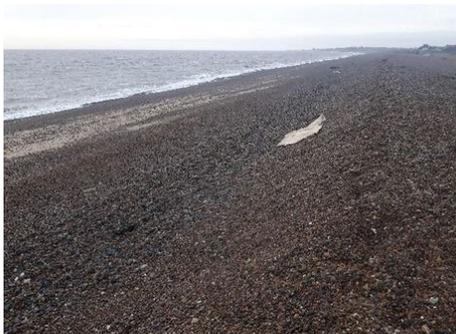
Below: Note displaced geotextile bag debris in front of the country club and further south (also found on Aldeburgh village frontage).

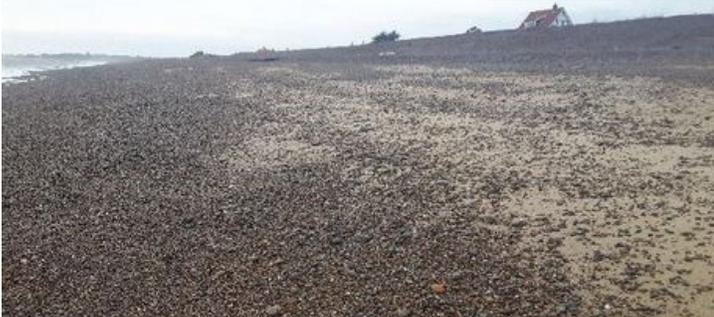
Below: The storm berm in front of the Headlands and the wide low gradient foreshore (30mins after low tide).

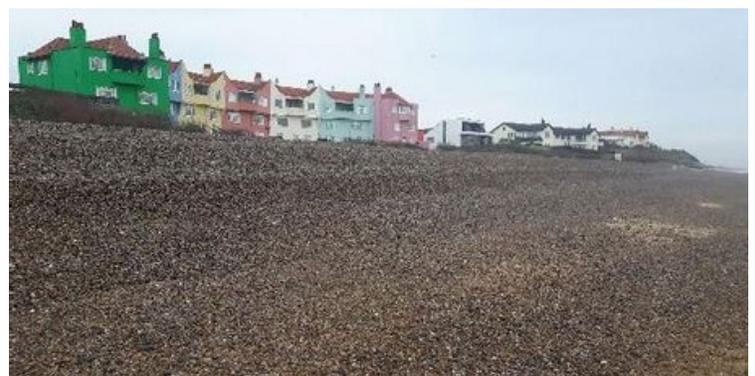
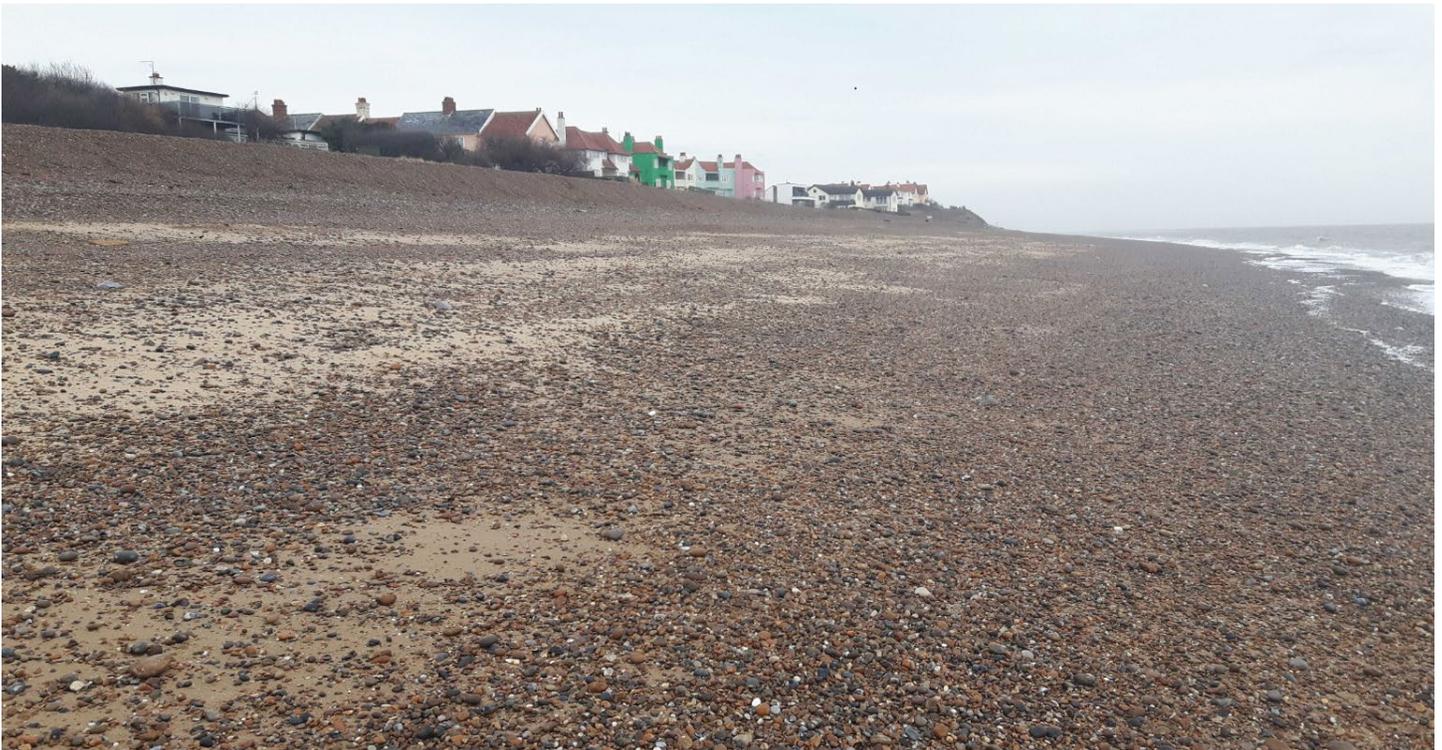
Above: Loss of intertidal beach material and existing gravel berms over southern frontage.

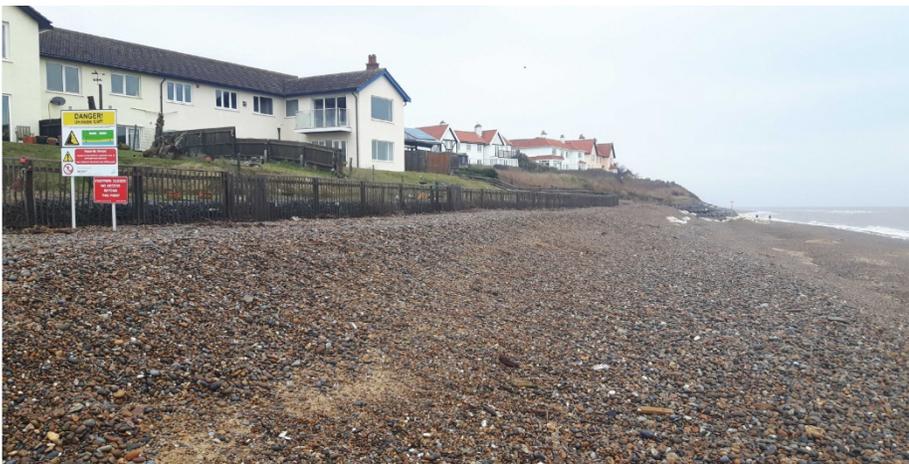
Left: Continuous berm is constrained by beach front properties. Phase 1 geobags emerging but remain in situ.

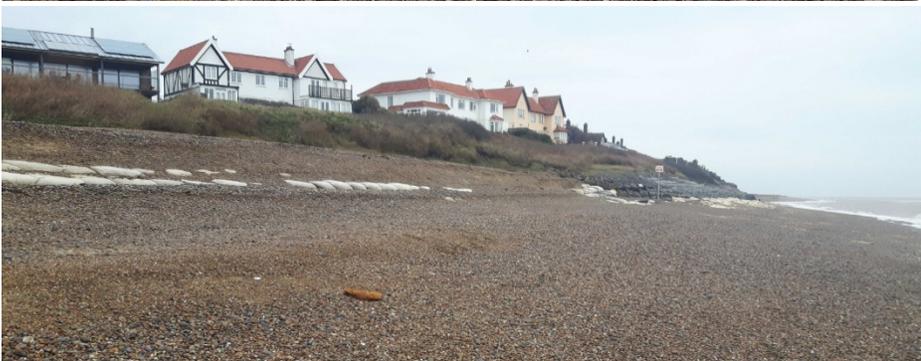
Left: Note height and steepness of berm and exposure of Phase 1 geobags.

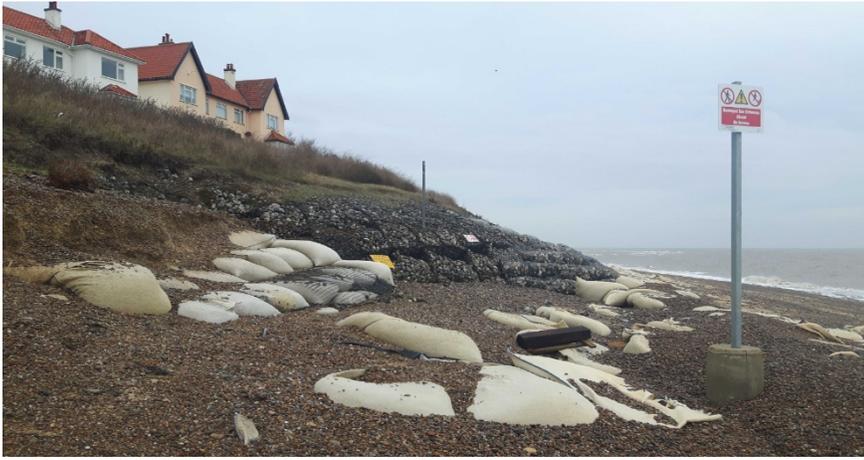
Left: Phase 1 geobags revealed adjacent to gabions, debris accumulation and uncovering of concrete sign base evidence loss of gravel from this area.

Gravel more consolidated and interbedded with sand. Geobags remain in situ and the line of defence, adjoining the gabions, seems to have worked well.

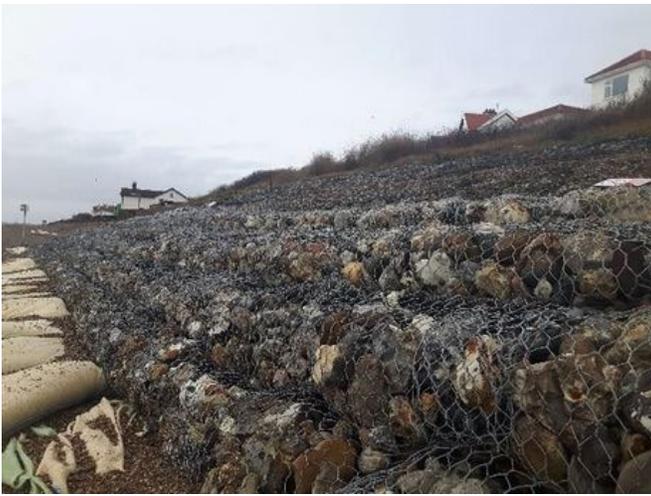
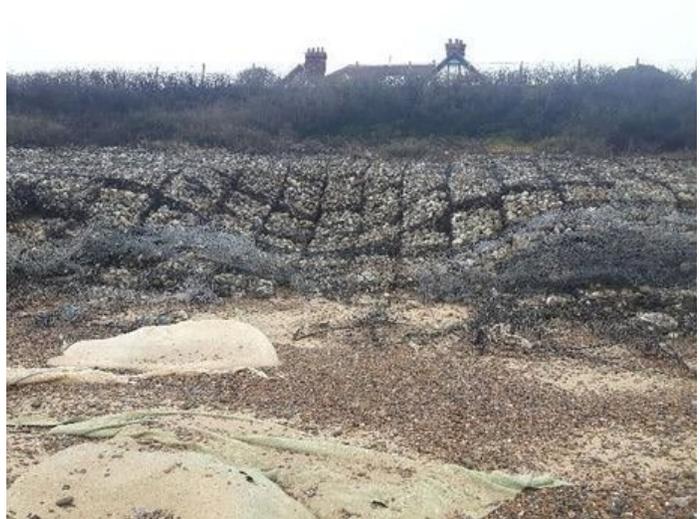
Gabion condition: Very Poor: Severe defects resulting in complete performance failure over the northern frontage.

Below: Gabions are intact over the southern frontage but show weakening and loss of integrity. The gabions are failing from north to south.

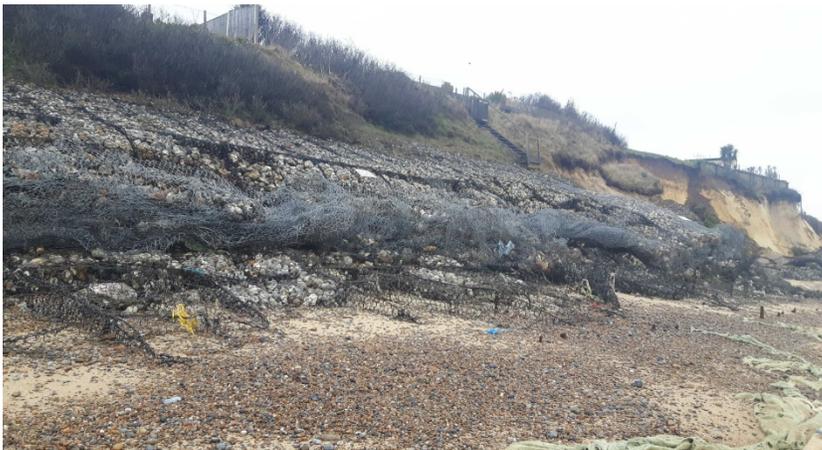
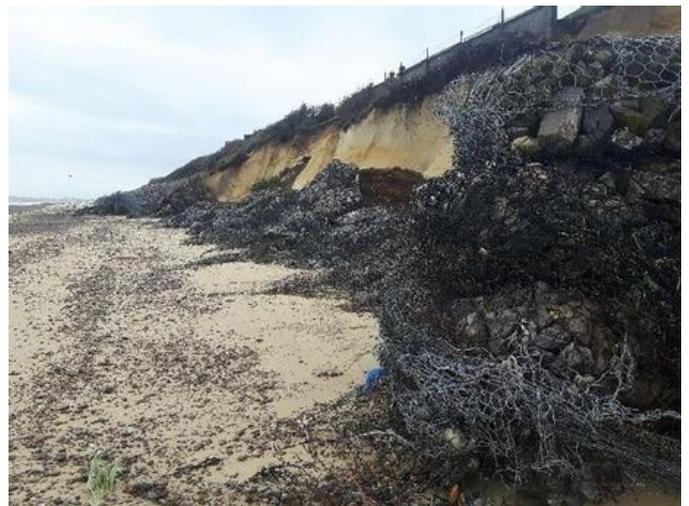
Below: Gabions at the northern end are so crumpled by wave action that their previous structure is unrecognizable.

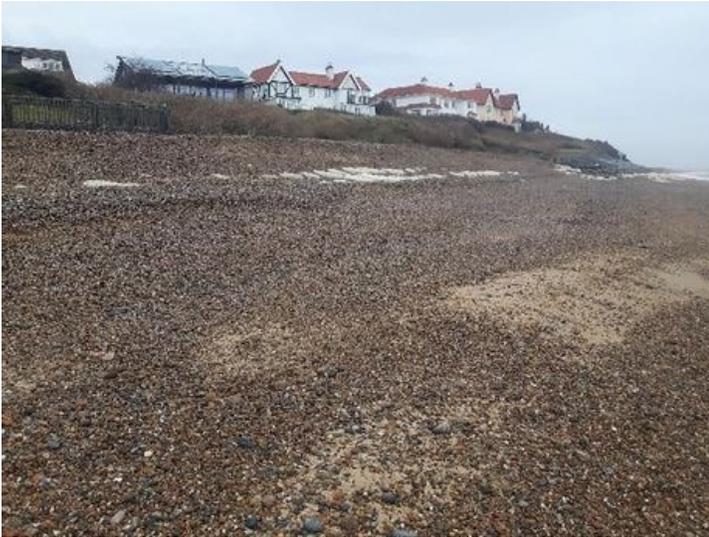
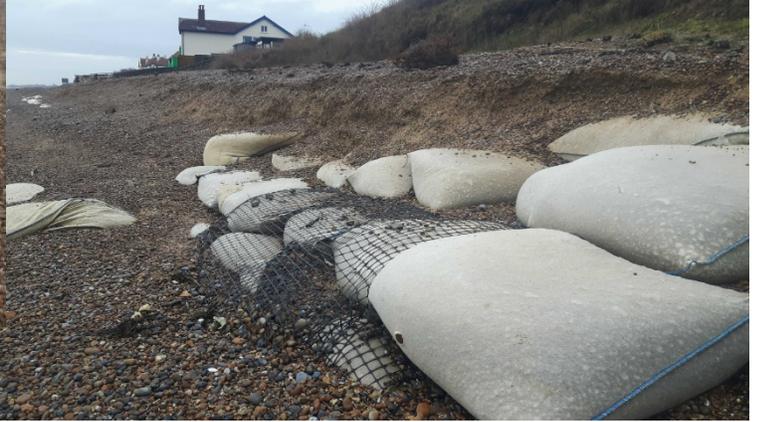
Phase 1 Geobag condition: Fair: Defects that could reduce performance of asset. Some exposed or partially exposed but they remain in formation still partially buried by storm berm.

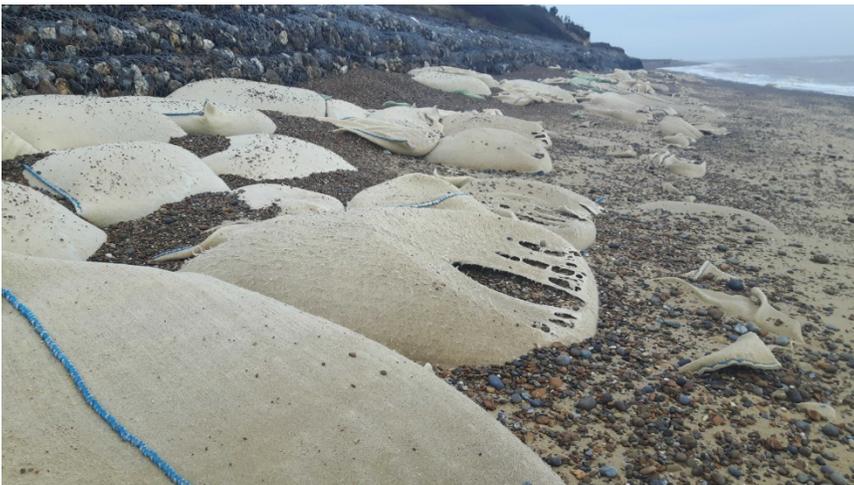
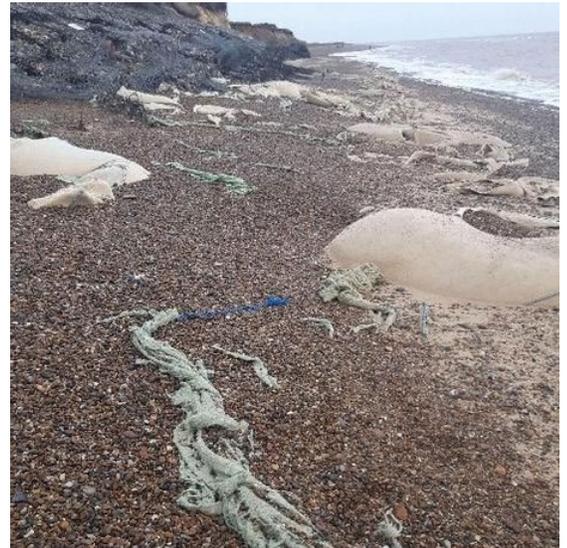
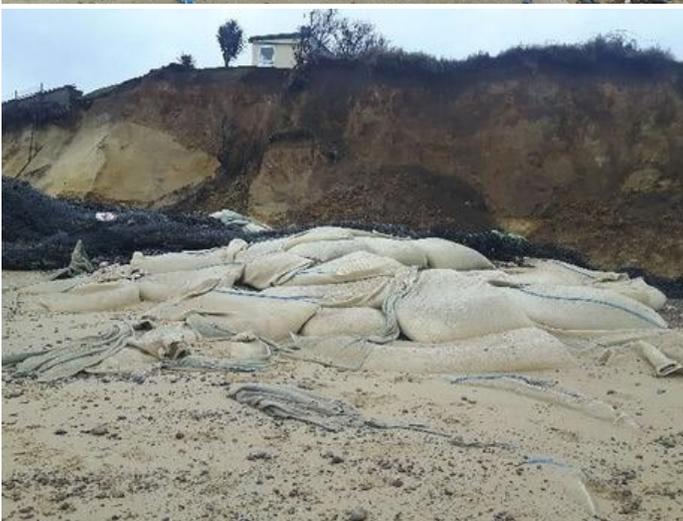
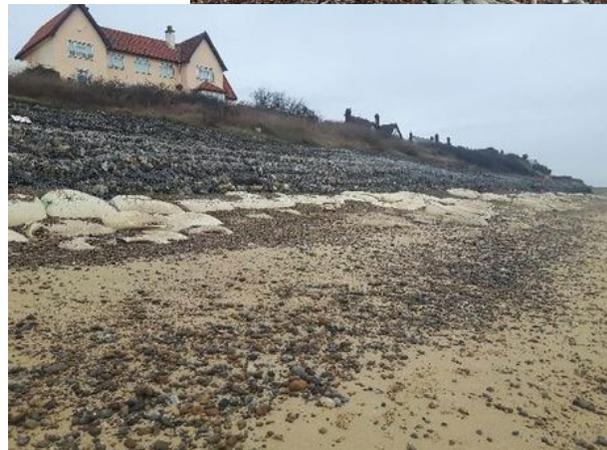
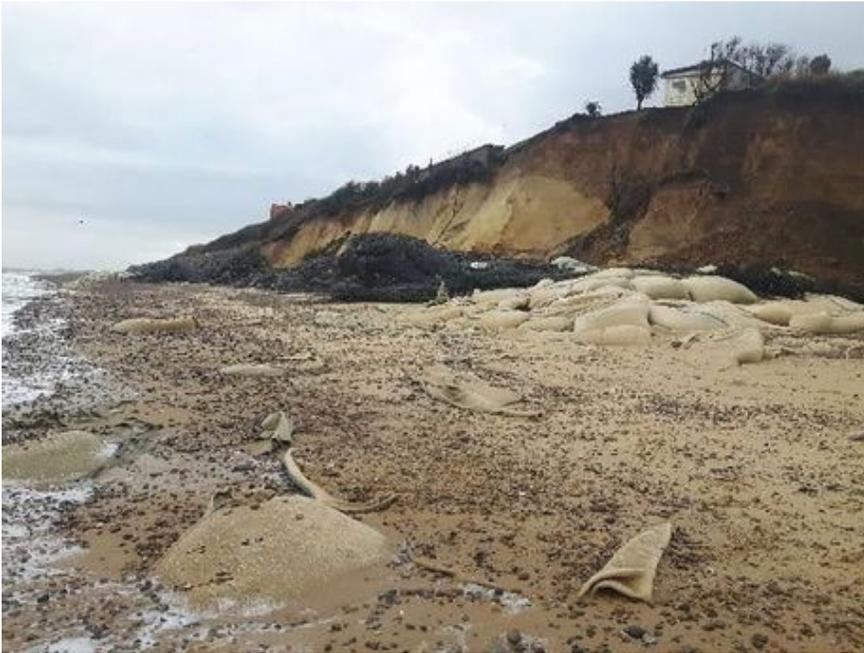
Phase 2 Geobag condition: Very Poor: Severe defects resulting in complete performance failure. More displacement, loss of fill, holes in bags. Remedial action required to gather any straggling geotextile from shoreface.

Comments on Phase 2 Geobags: The geobags have maintained a level of protection throughout this destructive event and absorbed a great deal of wave energy. Much green geotextile is exposed indicating a great deal of displaced bags - due to the mobility of this underlying fabric. Around the terminal defence feature some geobags are still stacked and whole but most show holes and loss of fill. Many stray bags on the shoreface far from their source.

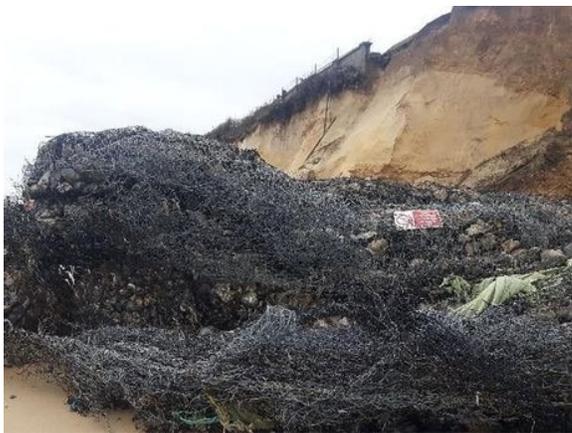
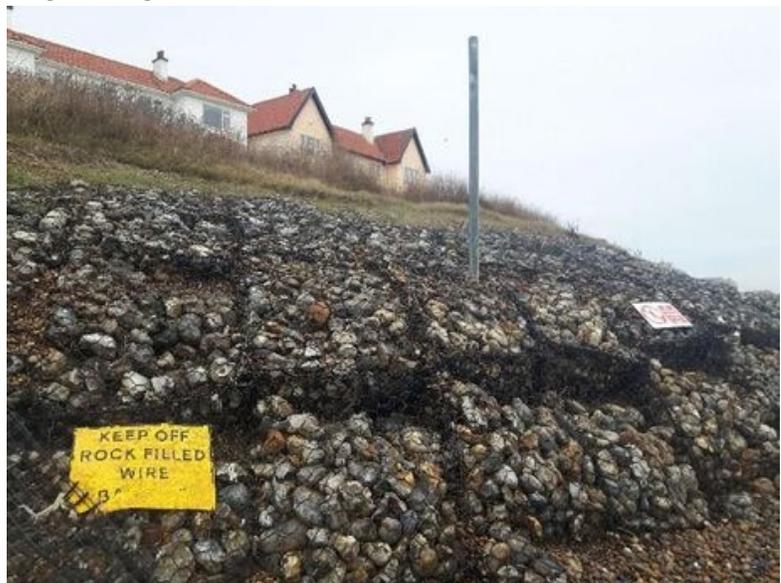
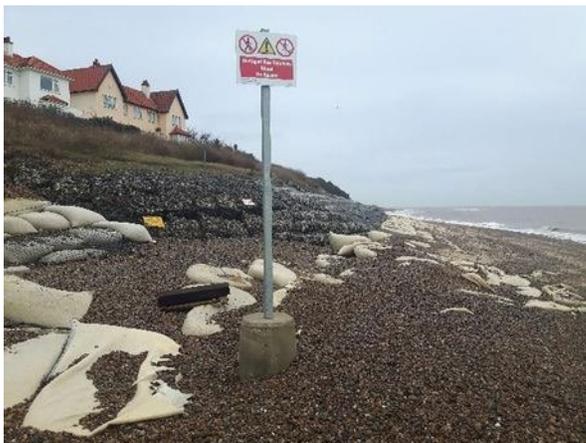
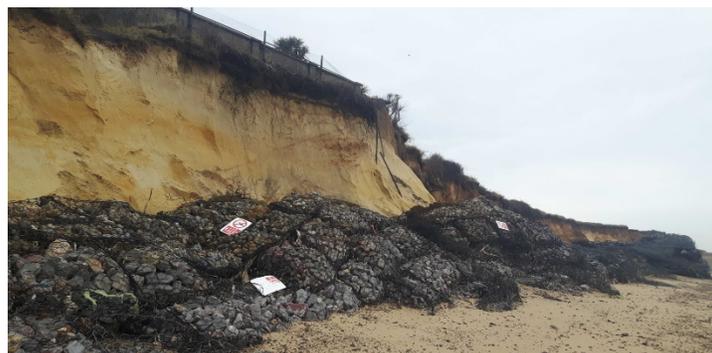
Signage condition: Fair: Defects that could reduce performance of asset.

Comments on signage: Where signs are still present their condition is good and they function well (south end). In other locations (north end) the signage is completely destroyed. The concrete base of the sign on a post is uncovered at the south gabions (see photo below). One recently installed sign on post near to the cliff toe, north of the defences, is missing.

Inspection Follow-up: Continue to monitor Thorpeness frontage closely and frequently. Share report and photos with ESC team and Thorpeness community to facilitate decision making on actions to take. Recommend signage is reinstated to deter beach visitors unfamiliar with the area. Gabion mesh has some sharps and wooden stumps at base are trip hazard – to consider as part of a much larger tidy-up operation. Check sustainability of existing sigs and replace missing signs. Right: see concrete base emerging due to lowering of foreshore. Southerly waves at present could bring *some* remedial benefits to the shoreface.

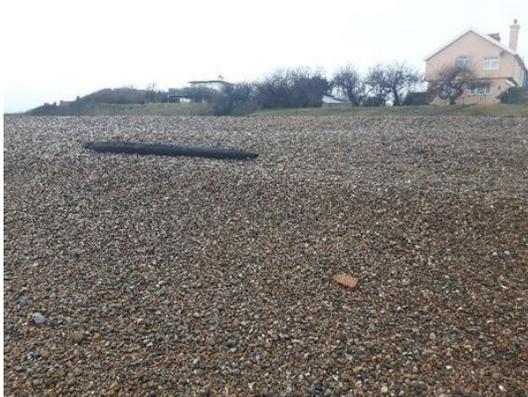
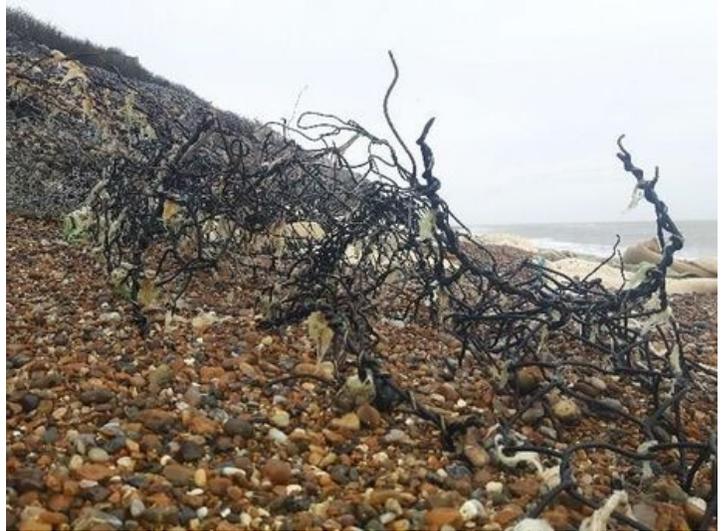
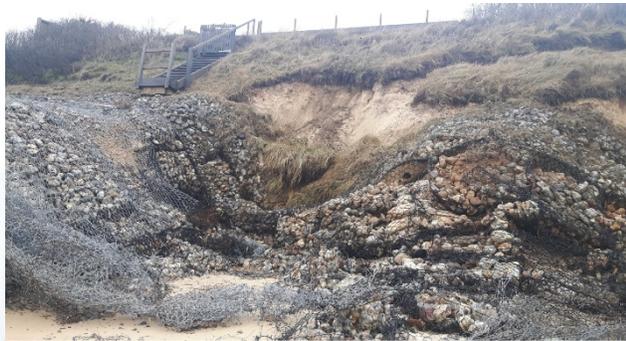
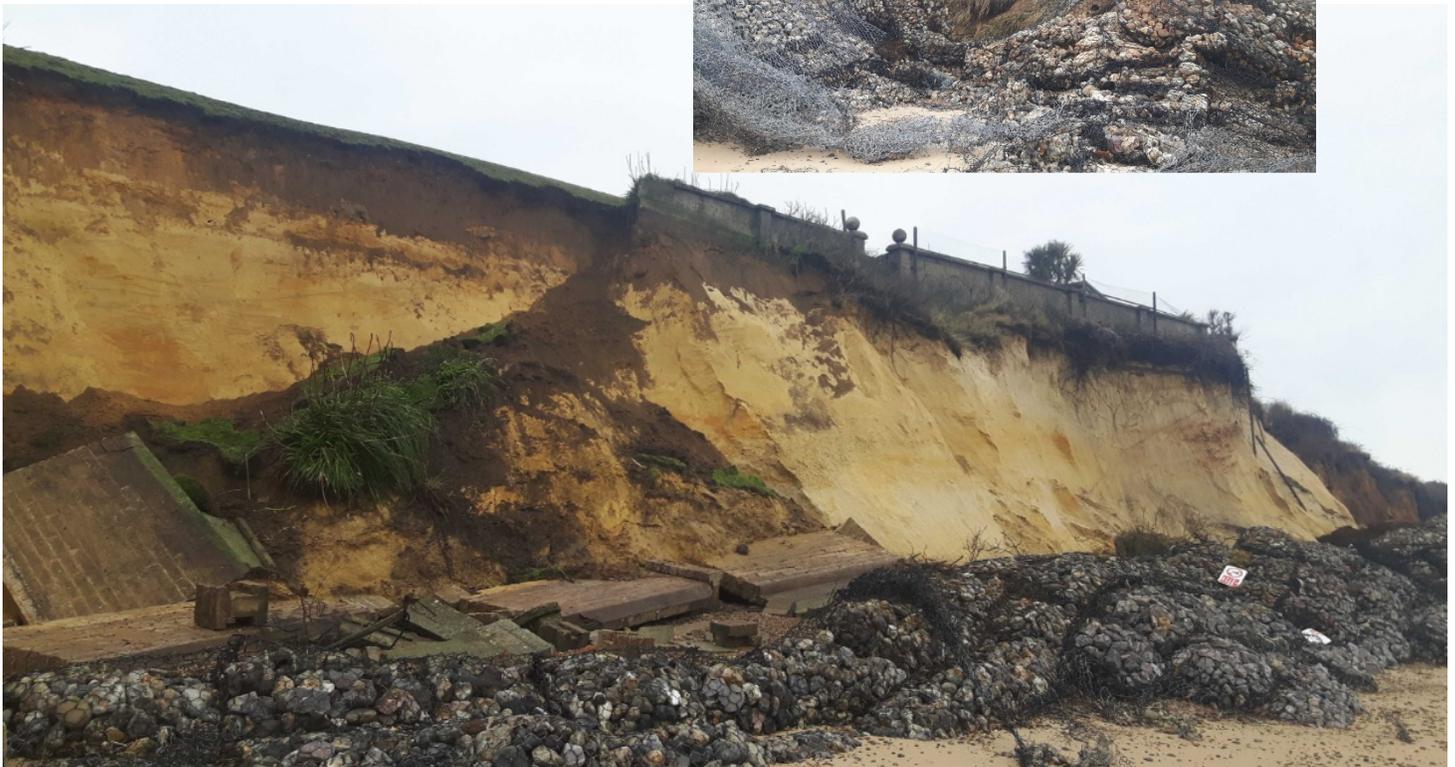
Hazards: Hazards include geotextile debris partially buried in shoreface as far south as Aldeburgh village. More wooden stumps at base of gabions are exposed - trip hazard at high tide (despite the fact that hazard warning signage advises the public that this area is closed). There are sharps on the gabion mesh and the deformation of the gabions means that all private access steps from north end avenue gardens are unsafe and impractical to use for beach access. The major hazard is currently the Red House's unstable garden wall, now hanging on to the sandy cliff edge with a sheer drop below. The cliffs to the north of the defences are all actively eroding. The beach has formed an embayment and the width is narrow in the center of this embayment - potentially squeezing walkers towards the cliffs. Fishing nets and line make up some of the detritus on shoreface. Other hazards like the large piece of timber seen below also prevent a hazard to navigation, if allowed to refloat.

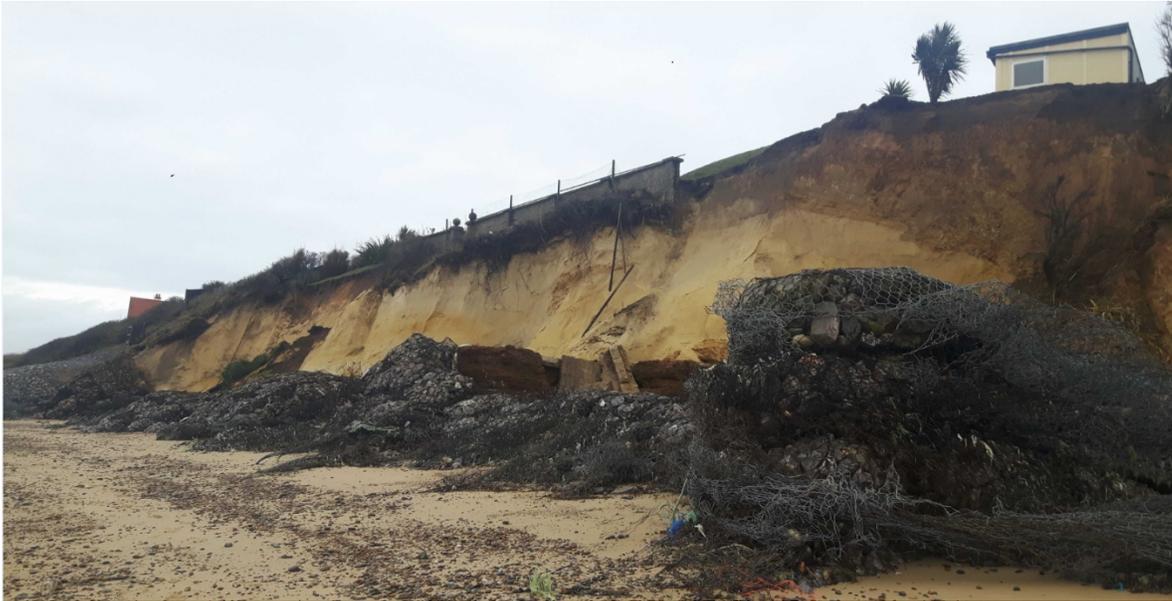
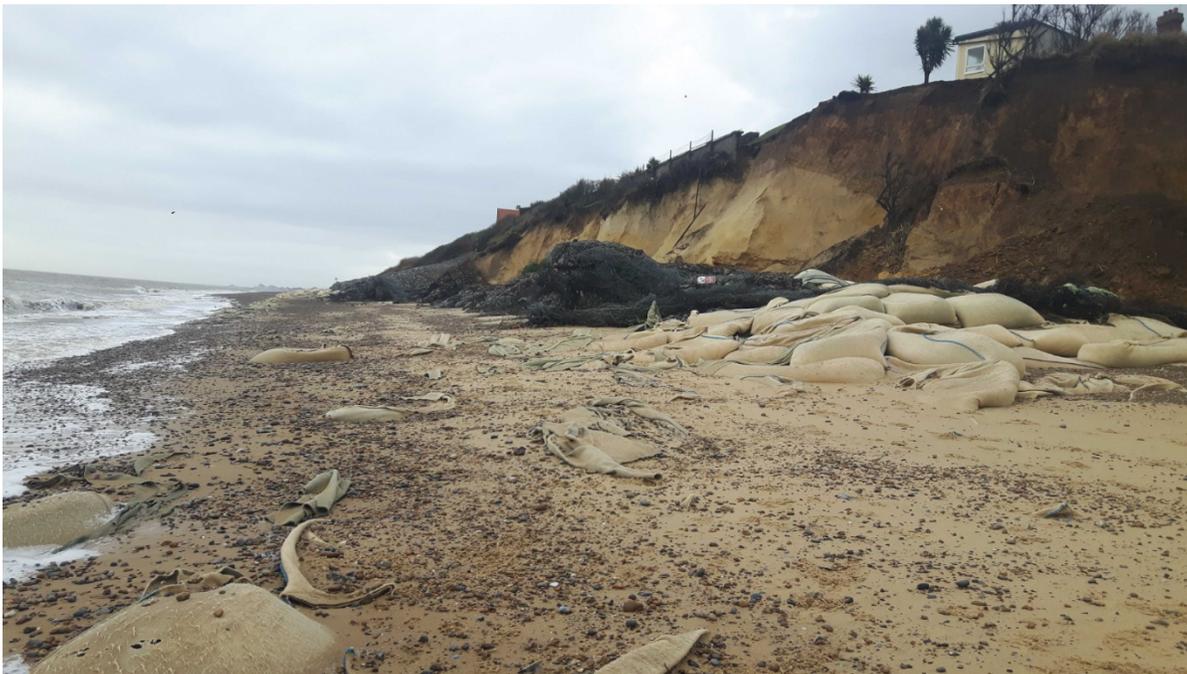
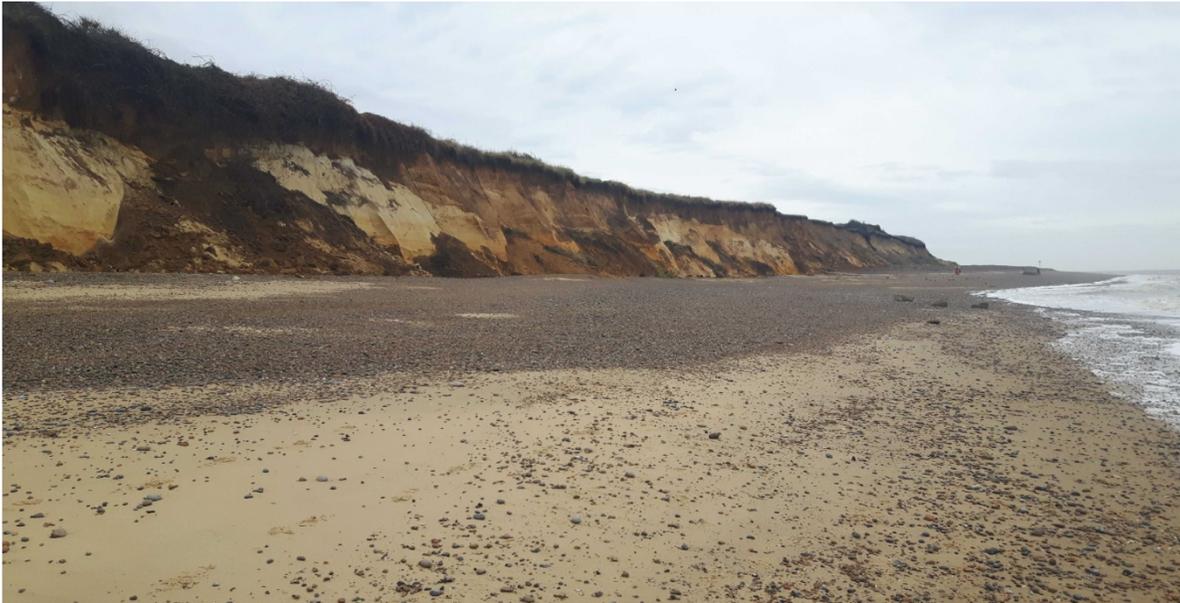
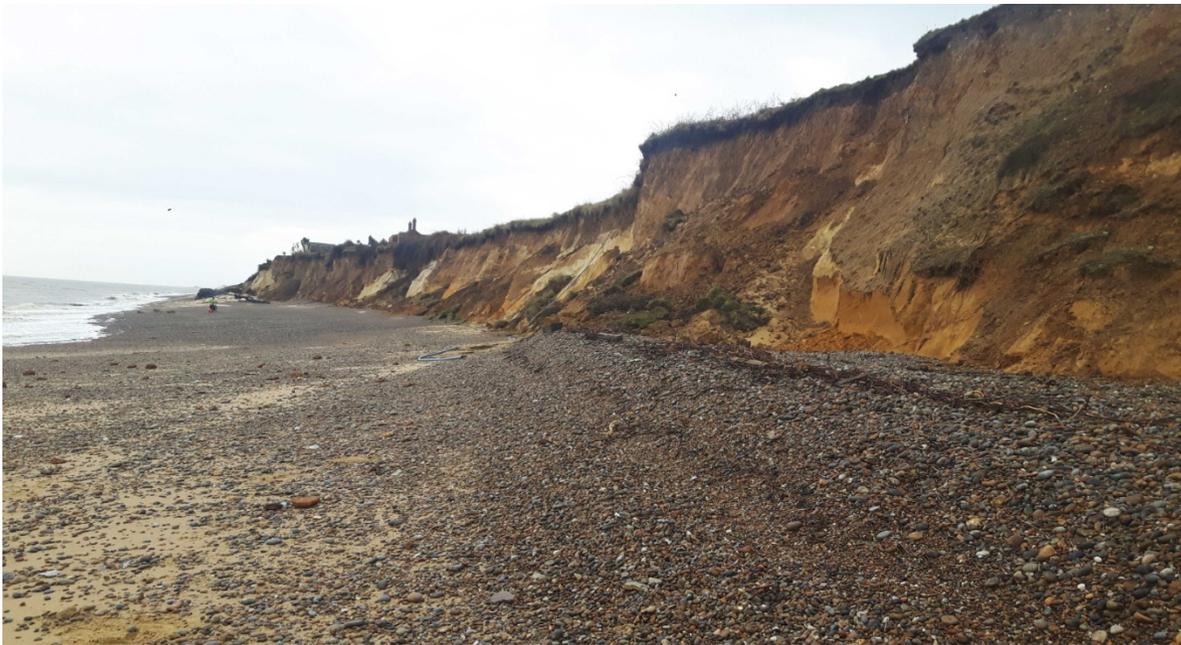
Cliff top and cliff toe recession. The erosion of the cliffs has persisted and accelerated. Outflanking of the terminal defence feature has caused a few meters of recession into the Red House's garden. New structures now appear on the cliff edge and the house itself is visible from the beach. The strong easterly winds and waves yielded some aggressive erosion of the cliffs directly below the Red House. The frontage within 200m north of this area has been the focus of erosion and suffered the greatest losses of material. The cliffs are near vertical and an enclave in the beach has formed. Beach levels to the north of the defences are not particularly low due to this addition of sediment from the cliffs. A large and prominent embayment between the Red House and the Ness has emerged and beach width is very narrow in the middle of the now concave shoreline. Beach cliffing has occurred to the north of this section but where the beach width eventually widens, towards the Ness, the large gravel storm berm reappears. The berm is not as high or steep here as it is over the southern village frontage. There is no evidence of wave run-up reaching the sandy dune foot.
