# Initial Assessment Report

Scheme or project location name	Southwold FCRM Southwold, Suffolk
---------------------------------	--------------------------------------

Date	(December 2018)
Version	0

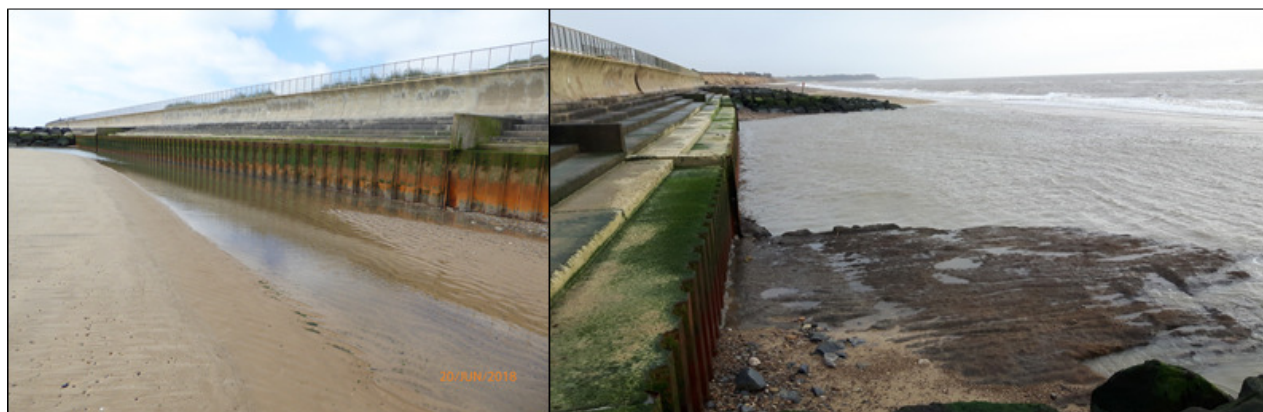
At the EA Easton Marshes seawall and embayments (R5-R8) and the most northerly WDC Easton Marshes embayment (R4-R5), recent observations of the beach show that the sheet pile toe of the seawall continues to be exposed (see Figure 14). This has likely been caused by cross-shore processes stripping the beach and the prevailing conditions not being conducive to moving any longshore accumulations of material back into the bays. The increased exposure of the toe has led to localised exposure and further deterioration of the sheet pile by saltwater corrosion and abrasion from the mechanical action of stone and shingle onto the sheet pile (see Figure 15 to Figure 17), much of which has been in-situ since the 1960s and 1970s (note: to address the imminent risk of failure, the EA are undertaking repairs to 24 m of the worst affected areas of sheet pile seawall toe in the form of steel plating with 60 m<sup>3</sup> of concrete and grout expected to be drilled and injected into the voids behind. WDC has holed piles and damaged concrete wall apron that they plan to investigate and repair by Spring 2019). The exposure of the vertical piling and the resulting wave impacts and reflections are not conducive to sediment deposition at the wall toe, and are likely to be exacerbating foreshore erosion at the toe.

Figure 14 EA Easton Marshes seawall, Left – looking from R8 towards R7 (taken 20 June 2018), Right – lowered level with indications of exposed clay (taken 2 May 2018)

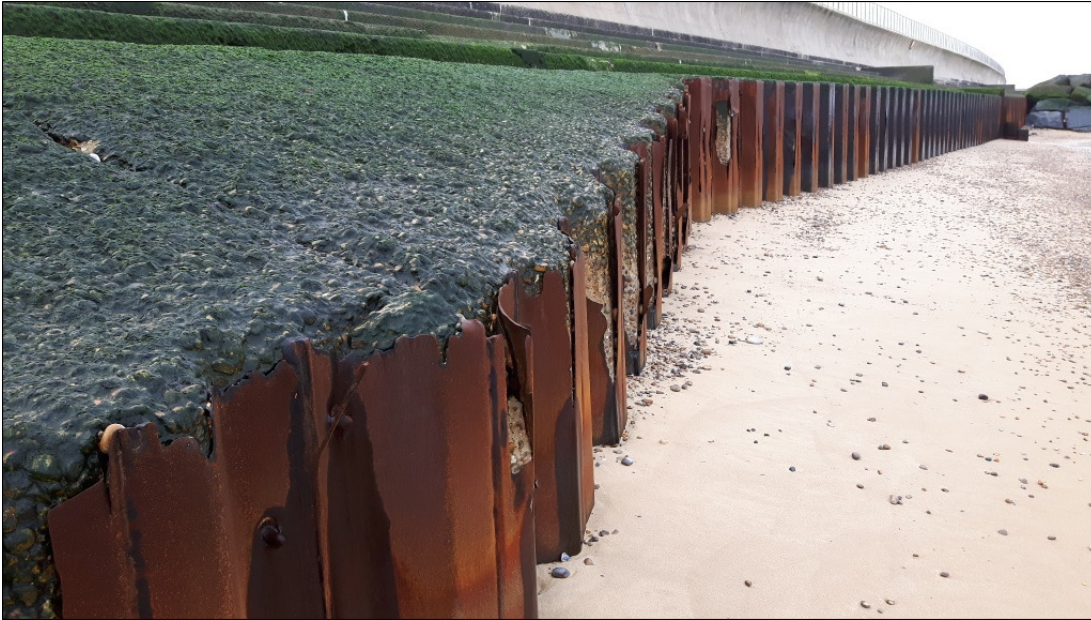
*Figure 15 Sheet pile deterioration along EA seawall at location near to access ramp (picture taken 16 April 2018)*

In 2018, at the time of writing, limited remedial repair works are planned for a 24m long section of sheet toe pile close to the access ramp at the WDC/EA Easton Marshes interface. The works

involve the application of steel plates with concrete infill to the existing corroded toe piles, to protect against pile failure along the worst eroded length. Investigation and repair works are also planned for the worst parts of the WDC sheet pile and concrete apron north of R4 in Spring 2019.

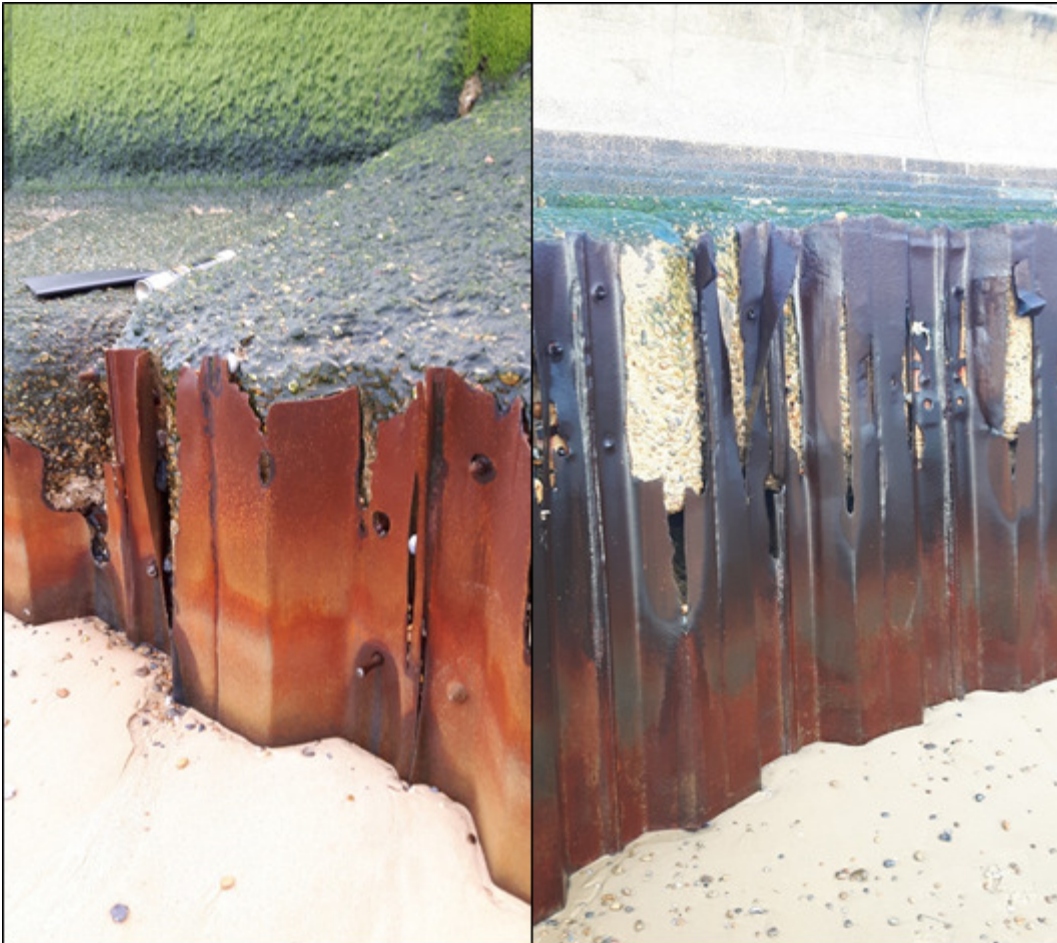
*Figure 16 Sheet pile deterioration close to access ramp (Left, taken 16 April 2018, Right, taken 6 March 2018)*

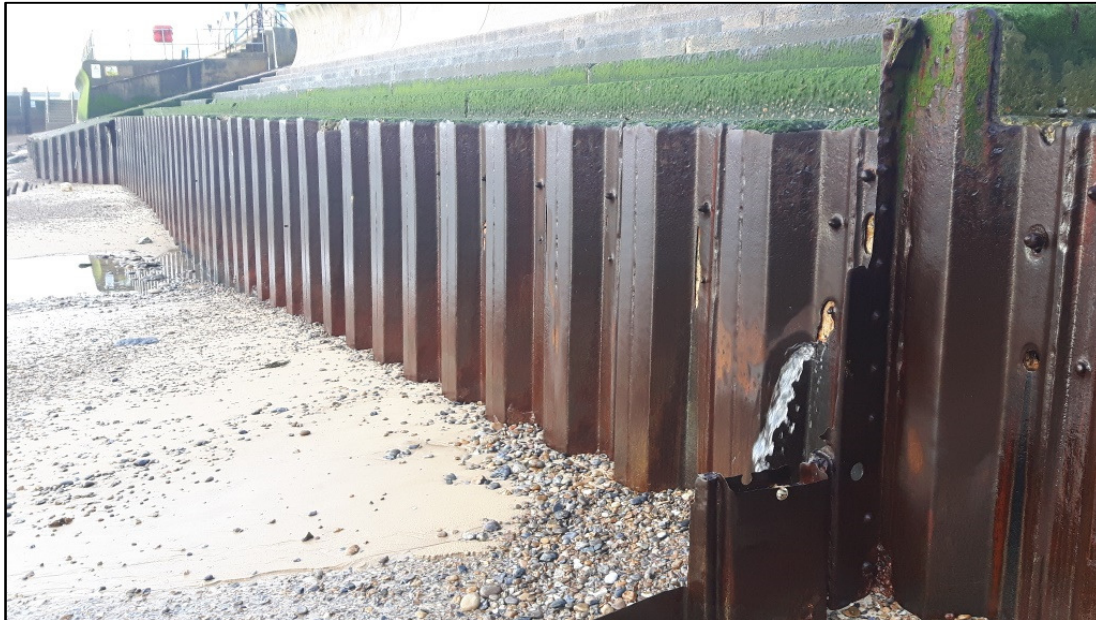
*Figure 17 Sheet pile damage close to groyne R5 (taken 6 March 2018)*

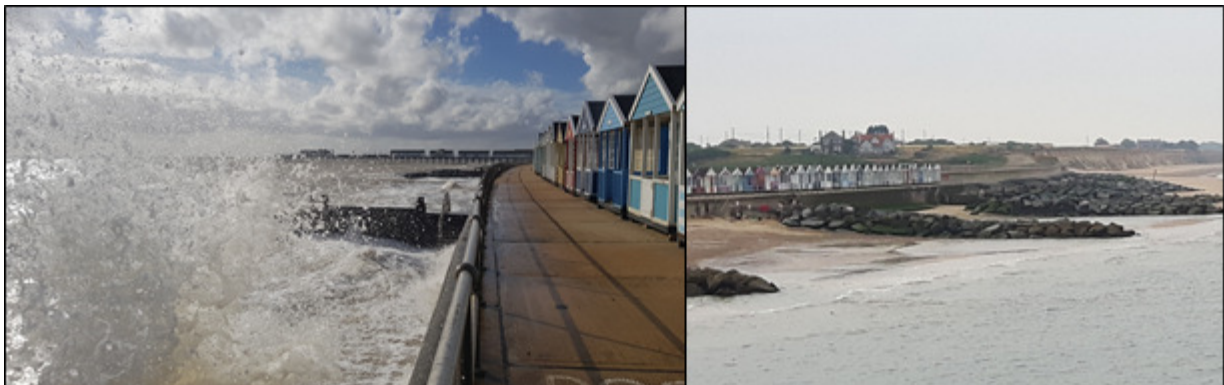
Along the WDC Easton Marsh Seawall (R1-R4), concerns have been raised by owners of the beach huts regarding the overtopping spray and algae risk causing slips on the promenade (ENBE, 2016). The beach in this area is not as low as between R4-R8, suggesting the bays are more stable; however, levels still appear lower than the 2006 scheme levels, post beach nourishment (see Figure 18).

*Figure 18 Left - Spray at WDC Easton Marshes Seawall (taken 28 September 2018), Right - Variability in bays looking from pier (taken 16 July 2018)*

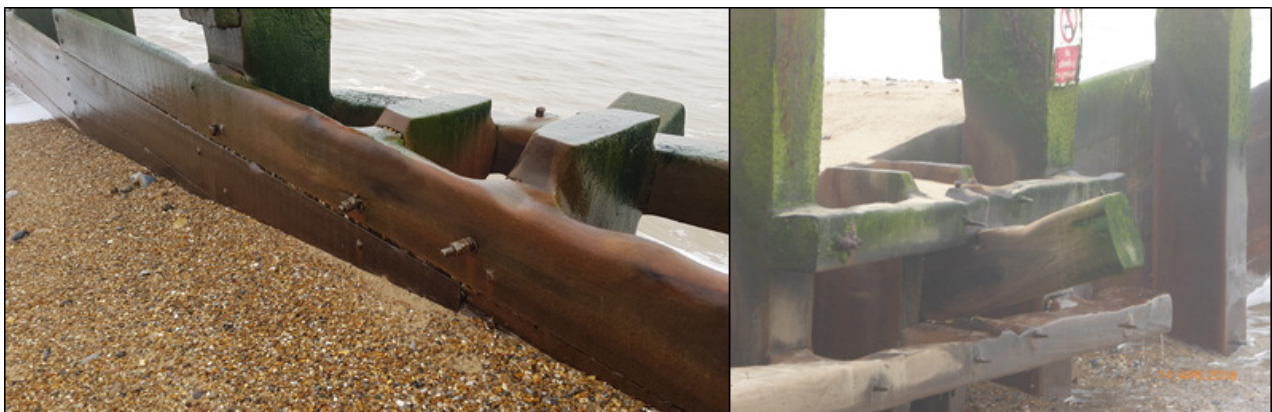
South of the pier, bays for the first 200 m south of the pier (incorporating bays T6-T7 and T7-T8) show signs of volatility; however, the seawall sheet piles are still protected. There are visible signs of wear to the timber groyne boards and piles (see Figure 19). T1-T6 seem to be performing well and the beaches appear to be full and effectively trapping sediment.

*Figure 19 Left & Right - Pictures of wear on groyne T8 (taken 11 April 2018)*

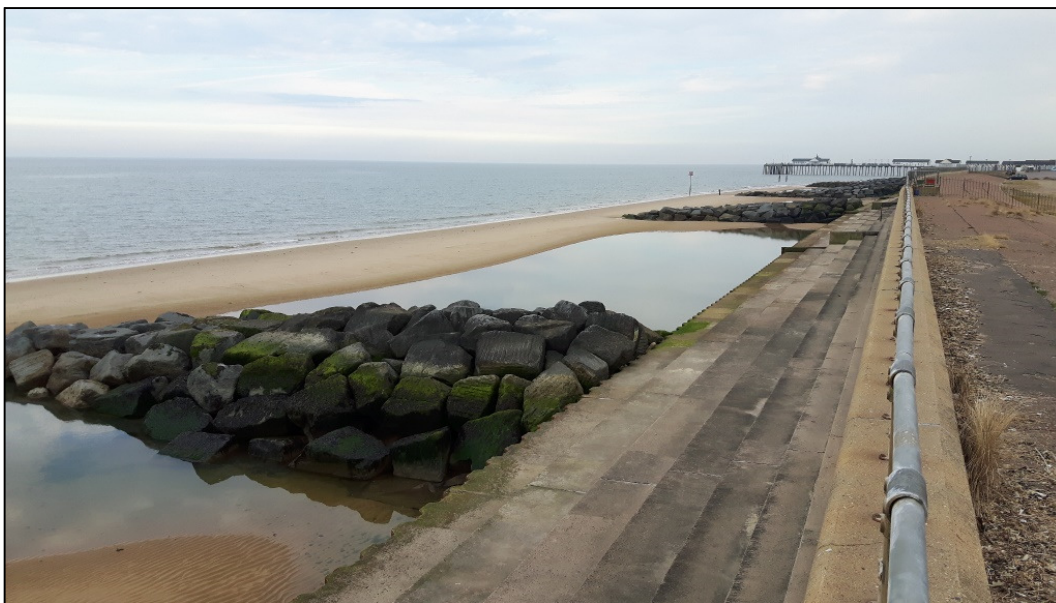
Figure 26 Showing result of prolonged southerly drift across seaward ends of Easton Marsh groynes (photo taken 16 July 2018)

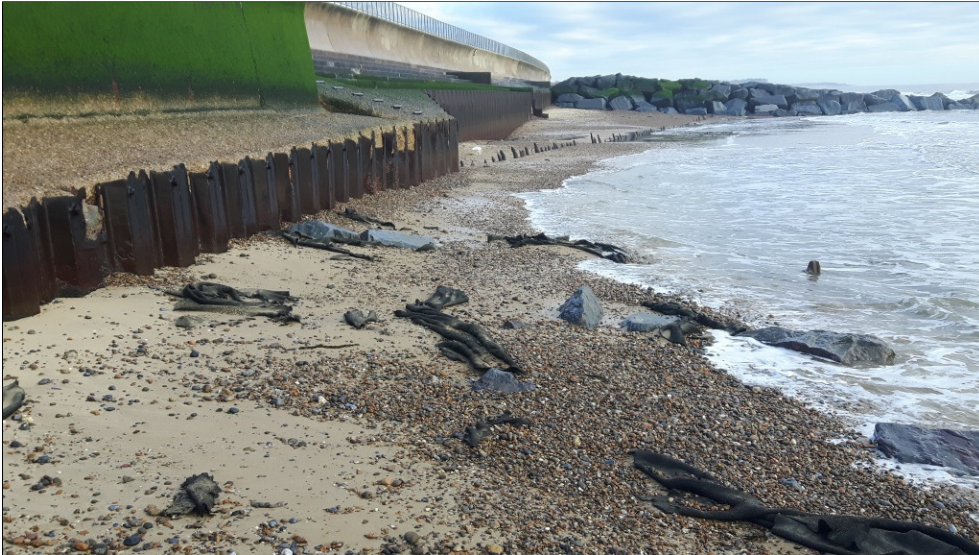
The beach access ramp is located immediately to the north of groyne R4 (Figure 28) and marks the transition between the WDC and EA frontage. At this location the beach is significantly lower than the seaward end of the ramp (Figure 27 and Figure 29) making plant access to the beach very difficult. The sheet pile is exposed and showing visible signs of significant deterioration (see Figure 15 and Figure 16). Beach Profile SW21 is located closest to this location and the survey data suggests that the profile is now at the levels shown before the PAR scheme (see beach volatility analysis). This profile also shows the greatest erosion rate likely due to its location at the change of alignment of the seawall at the location of the ramp (ENBE, 2016).

*Figure 27 View towards ramp from WDC frontage, geotextile in foreground from previous revetment works, change of section noticeable (picture taken 6 March 2018)*

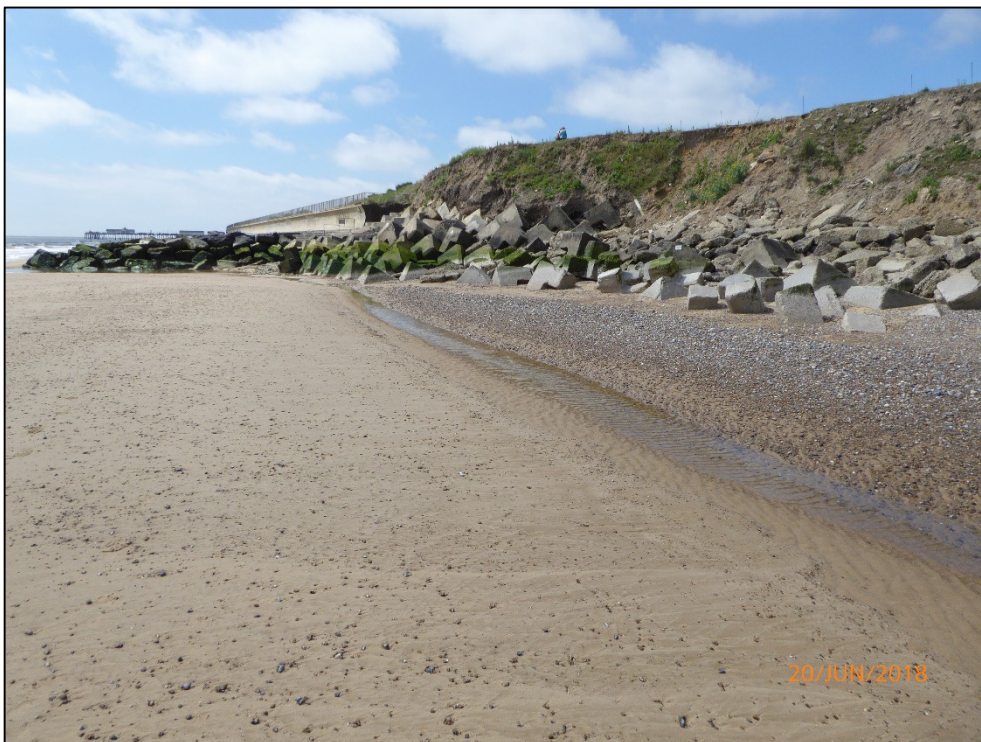
Where the EA seawall at Easton Marshes transitions to the Easton Bavents cliffs (Figure 30) a risk of outflanking exists as the cliffs continue to erode due to the ongoing action of the waves. As this process continues, the hard defences at Southwold will increasingly cause it to behave as a headland. The seawall terminates with a sheet pile installed perpendicular to the defence line (Figure 31). The sheet pile return is protected by a number of tripod concrete armour units formed as a revetment along the transition point and the remains of material deposited there between 2002 and 2005 (Figure 32) although the sheet pile does show indications of weathering (Figure 34) there are currently no visible signs of this defence being outflanked (Figure 35 and Figure 36). Either the sheet pile failing or outflanking would cause the seawall to lose stability resulting in failure. The cliff/EA sea wall transition will also become more of a trap to southerly sediment flows in the future, potentially reducing the supply available to Southwold frontage, as the cliffs continue to erode back relative to the fixed end of the seawall and the beach widens. If the area immediately north of the EA wall becomes a sediment store, then it could also become a potential source of sediment to feed the beaches to the south, although the logistics of moving material from this location would need consideration.

*Figure 30 Looking from Easton Bvents towards termination of Easton Marshes seawall (picture taken 20 June 2018)*

A new access point could be provided in the form of a plant ramp or public access steps attached to the end of the seawall on to the beach at the transition point. An alternative could be formed by excavating into the material deposited behind the tripod units, close to the cliff face. Creating a 'soft' access ramp excavated into the existing material in this way has the advantage of being more flexible and easily maintained in the light on anticipated future changes in beach level and orientation of the cliff line. Any access (plant or public) would be subject to discussions with landowners.

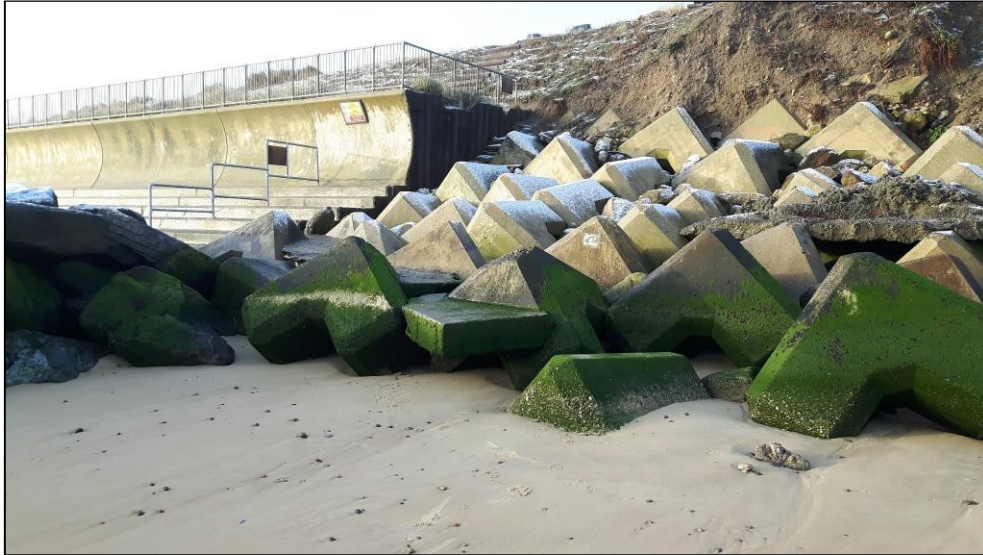
*Figure 31 Termination of Easton Marshes seawall protected by Tripod concrete armour units (picture taken 12 December 2017)*

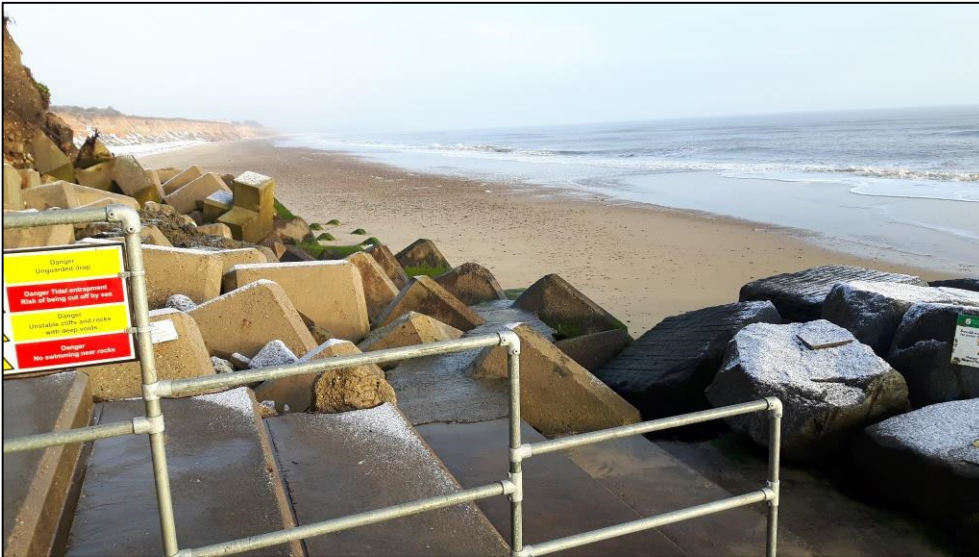
**Figure 33 Ad hoc beach access arrangement at termination of Easton Barents seawall (picture taken 12 December 2017)**

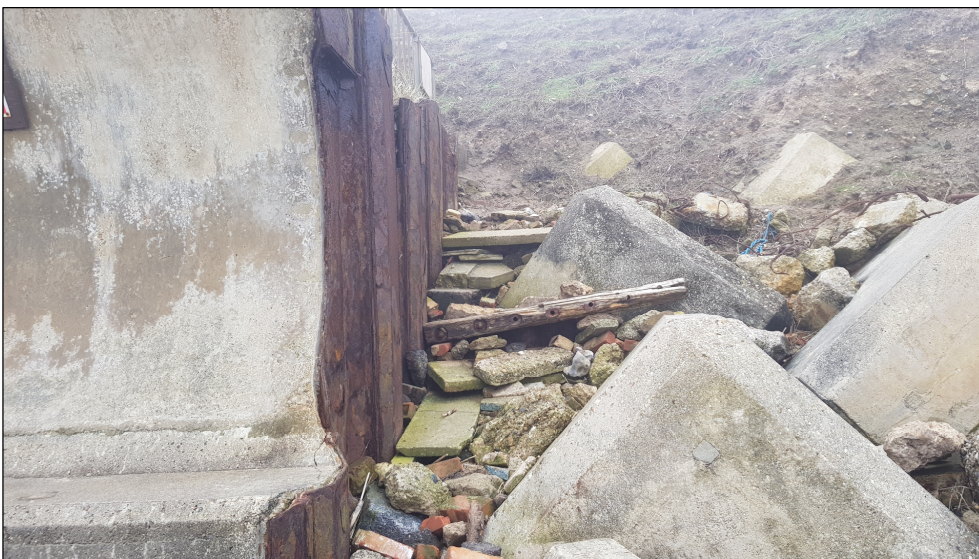
**Figure 34 Condition of sheet pile at termination of Easton Marshes seawall and ad-hoc beach access (picture taken 12 April 2018)**

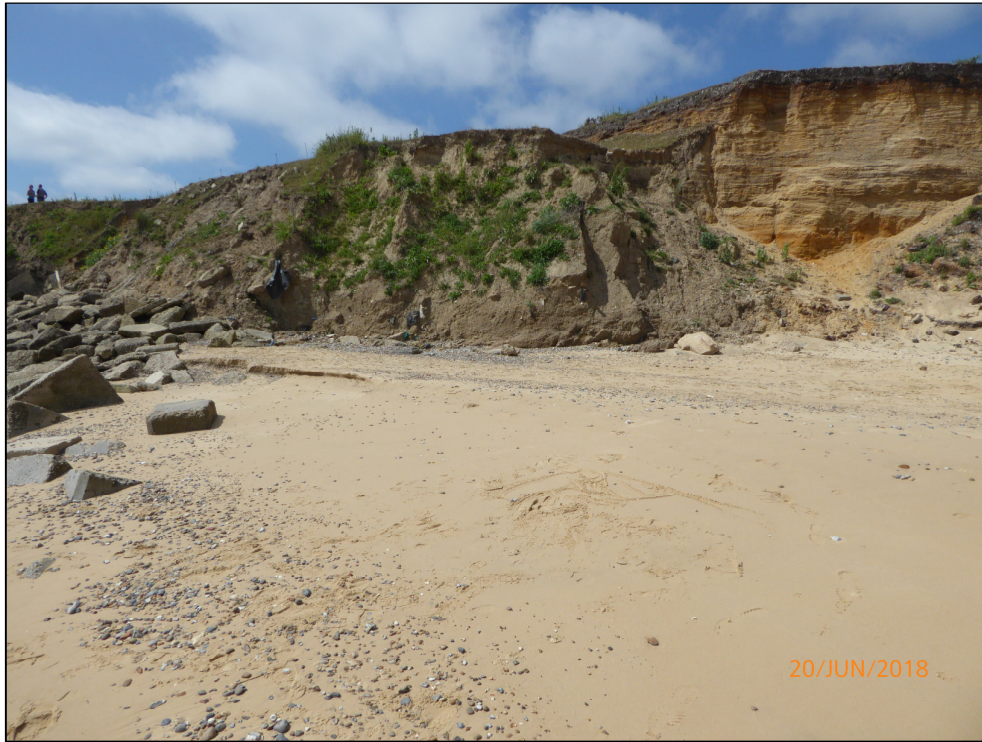
**Figure 35 Easton Bvents cliffs and promontory formed from remains of material deposited in 2002-2005 (picture taken 20 June 2018)**
