# Thorpeness Monthly Monitoring Report

**Date & Time of Survey:** March 26, 2021 4:10 PM

**Inspector:** lucy.goodman\_CoastalPE

Monthly inspection of the frontage between Thorpeness Village and Ness. The purpose is to check signage, flag any hazards relating to public safety, inspect condition and exposure of defences and monitor geomorphological changes. This report is used to inform Coastal Management decision making and will be shared with the community. For best access, inspections should be done at low tide with due regard to the weather and sea state.

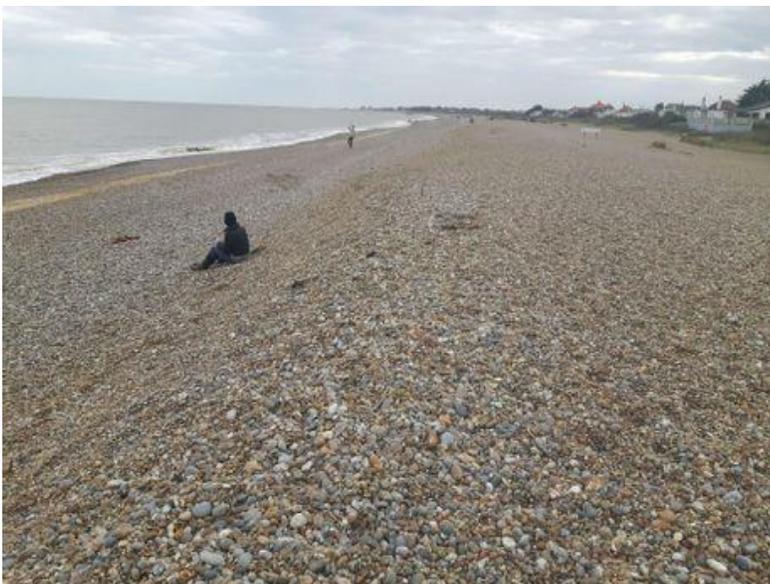
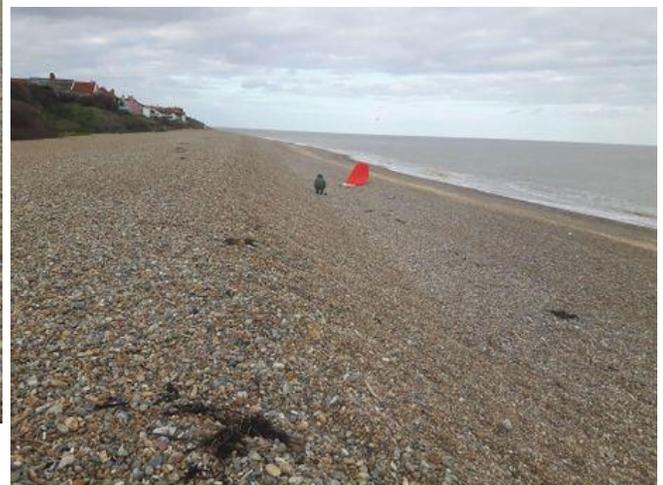
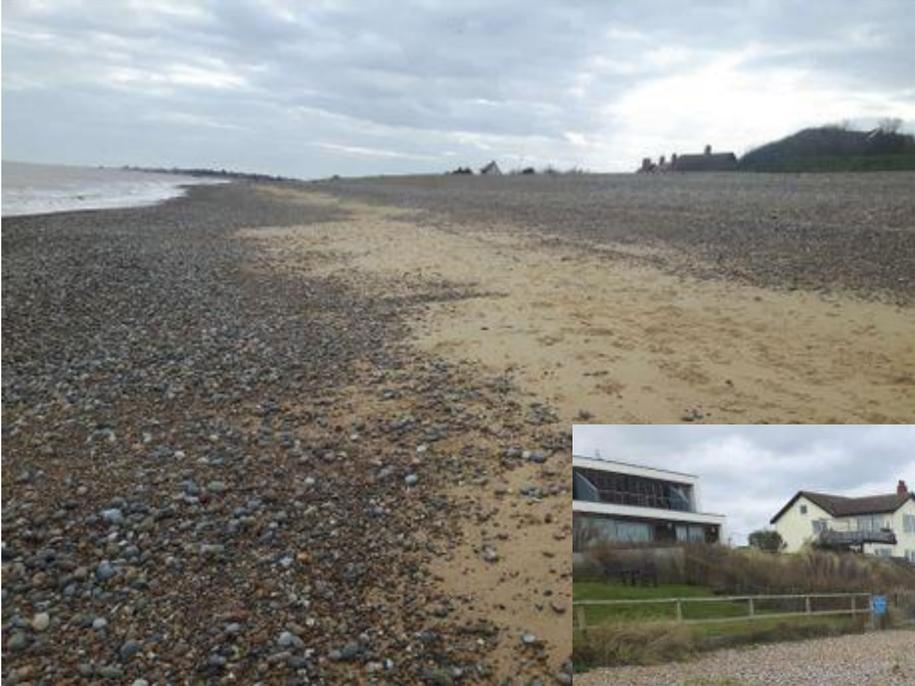
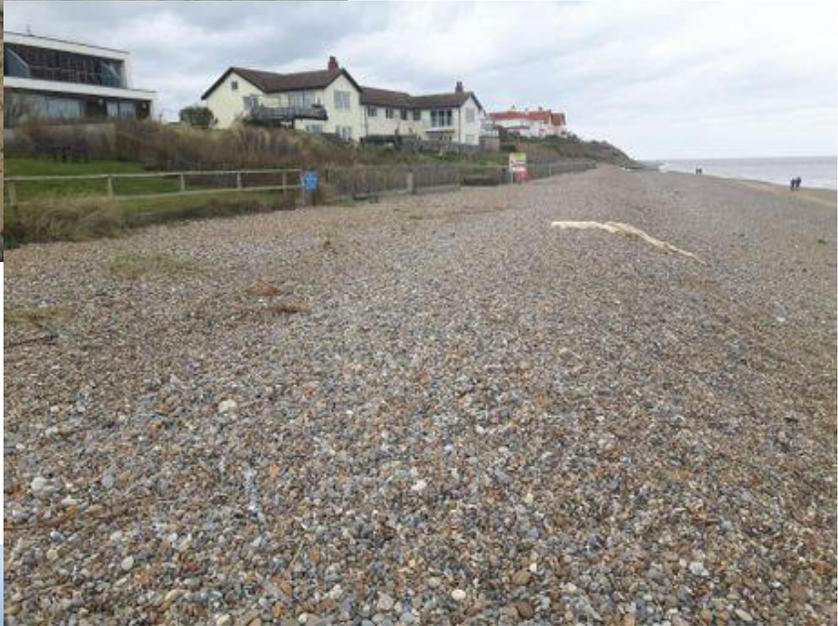
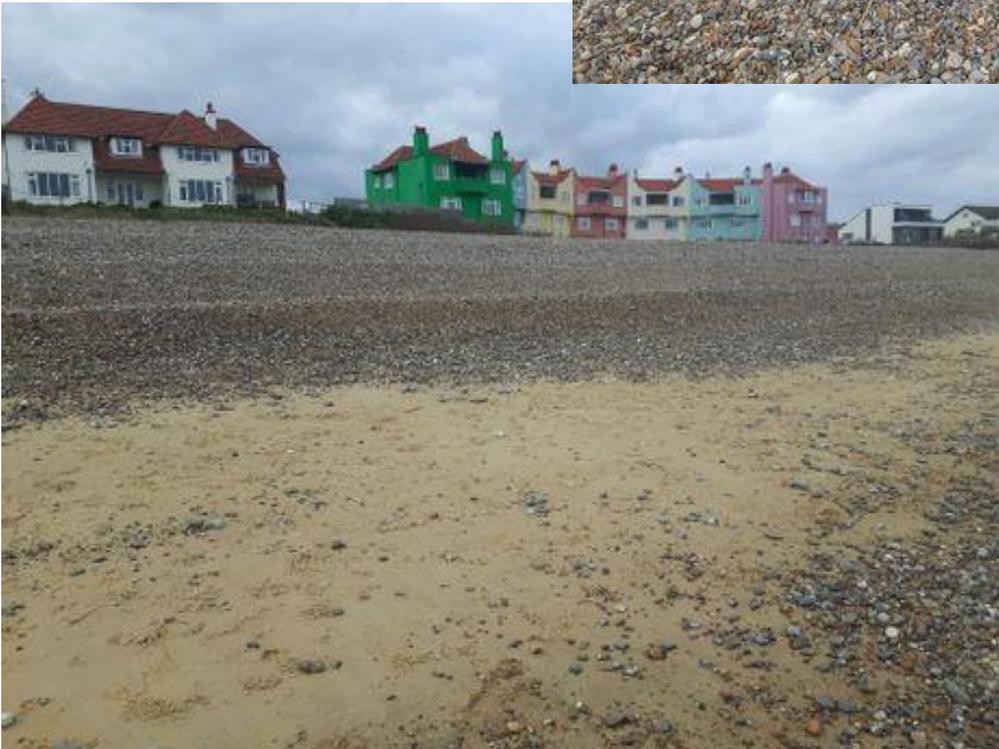
Images of the southern UNDEFENDED frontage:

Steeper intertidal beach looks stripped of gravel. Sandy patches and beach cusps present. Embayment deepening between tress and Aldeburgh. Largest gravel berm is >2m high. Smaller berms preceding it to seaward. Akin to Aldeburgh frontage but with less volume of gravel. Berm diminishes in front of the Headlands in to a series of gravel ripples. Much larger beach cusps appear on shoreline towards the northern frontage. Foreshore wider and lower gradient in front of Headlands but supratidal beach width is narrower.

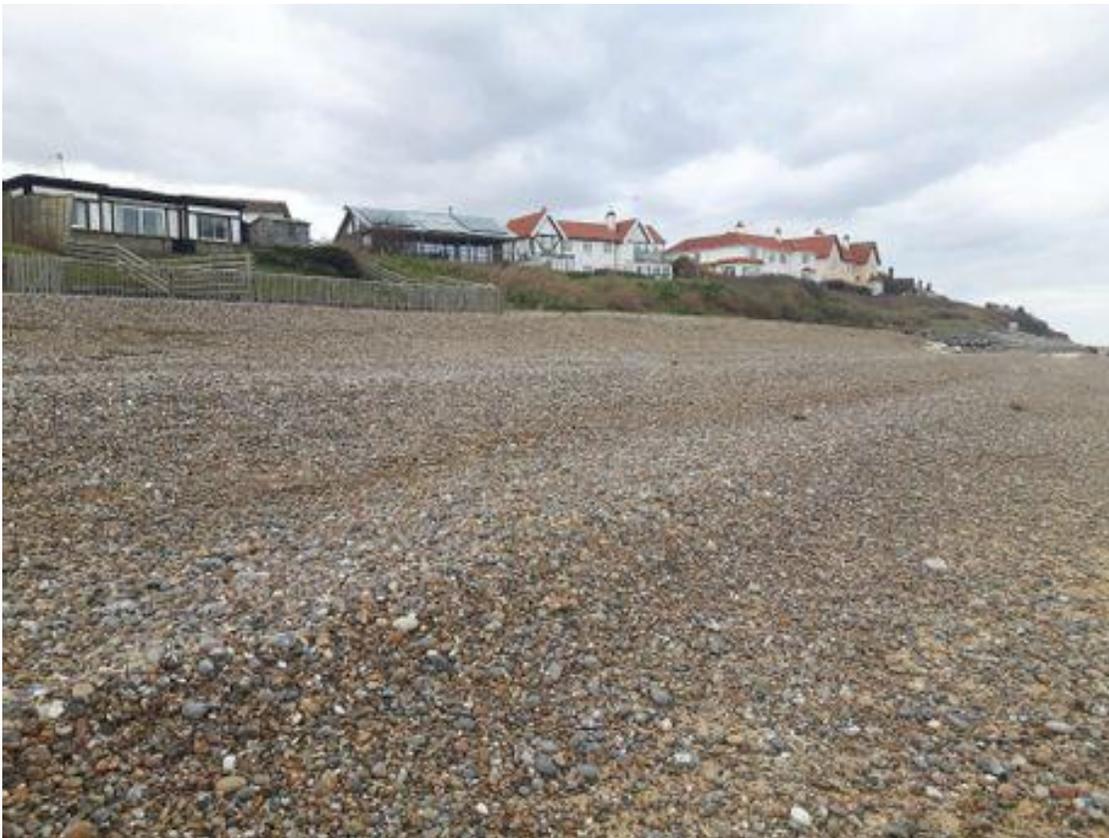
Images of the DEFENDED frontage:

Comments on the geomorphological change over the DEFENDED frontage: Gravel berms x3 rolling landward. Largest berm in line with North end avenue property fences. These garden fences are constraining the natural beach processes. The highest section of the gravel berm >2m and the scoured face is steep/vertical at gabion abutment. This seaward face of the berm partially exposes some phase 1 geobags. The foreshore in front of the 'pocket beach' is wider and slightly flatter than further south. The beach cusps are larger and more sinuous than further south. The slight change of geomorphology reflects changes in the beach's aspect, composition, and human interventions in this area of the beach.

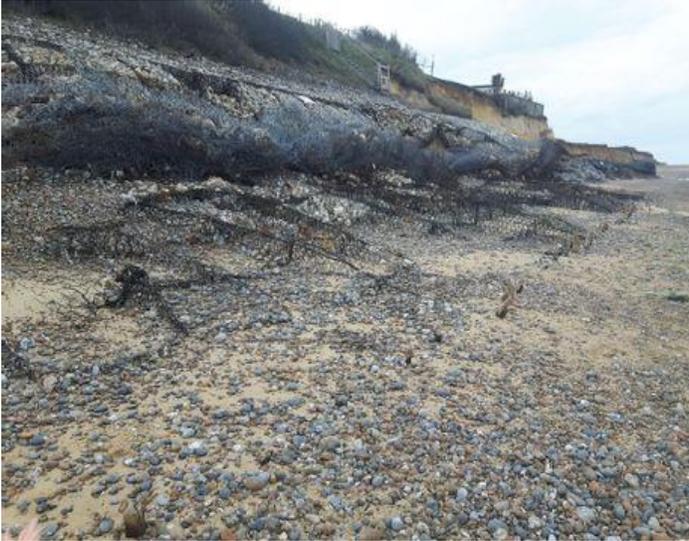
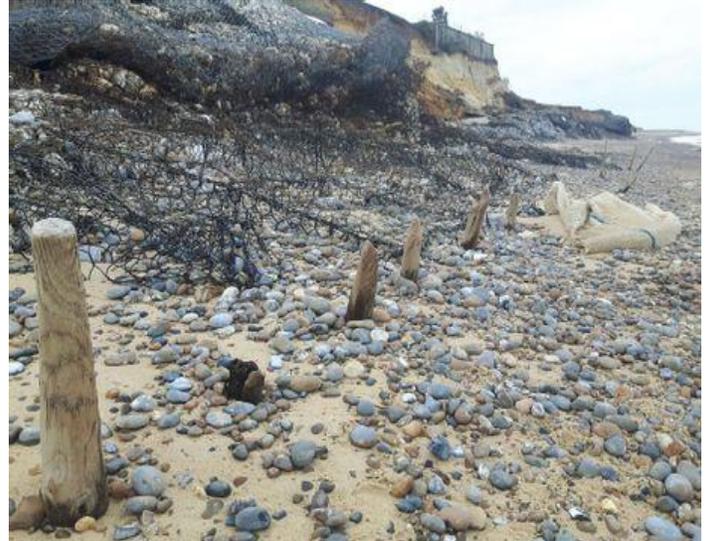
Images of the gabions:

Comments on Gabion condition: Almost entire length of gabions now failing. upper most layer adjoining to gardens remain in tact. loss of fill is ubiquitous.

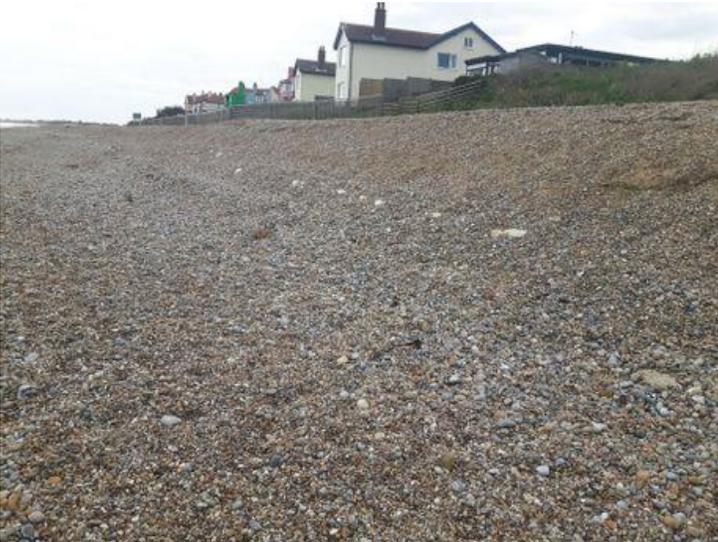
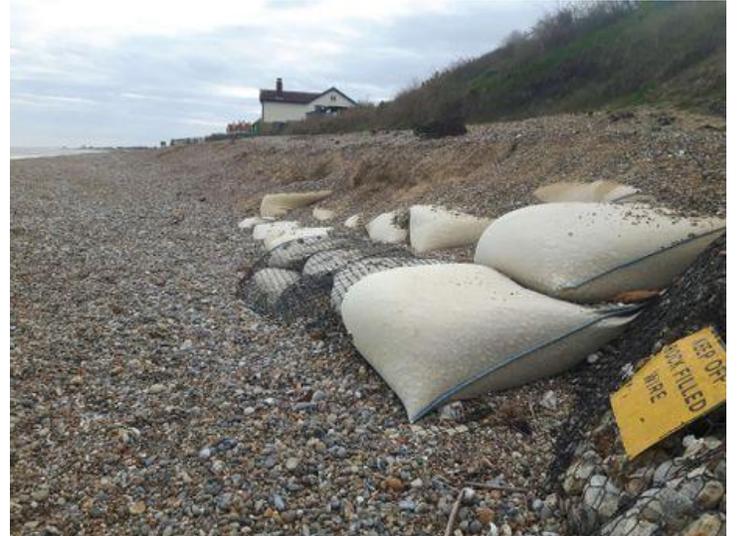
Images of Phase 1 Geobags:

Comments on Phase 1 Geobag condition: some exposure of the upper-most, seaward facing bags in the 'pocket beach'- see photo below. All phase 1 bags appear to be in-tact, without holes or loss of fill. The defensive line still has integrity and has not been undermined, as the Phase 2 defence has.

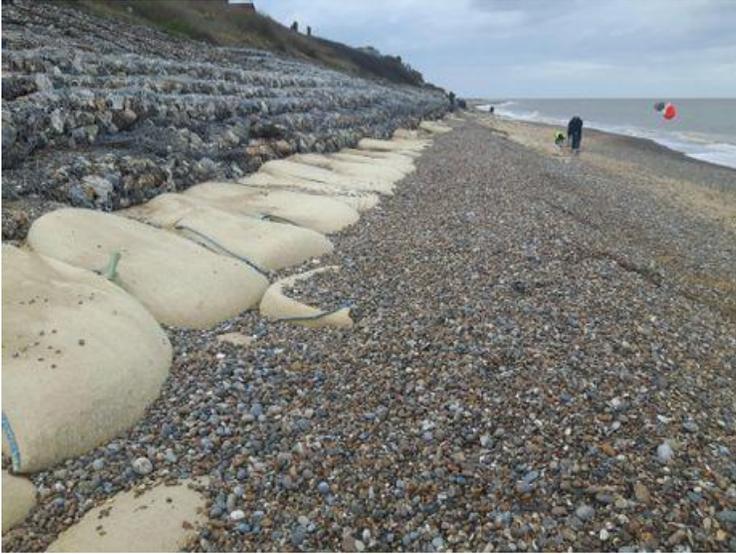
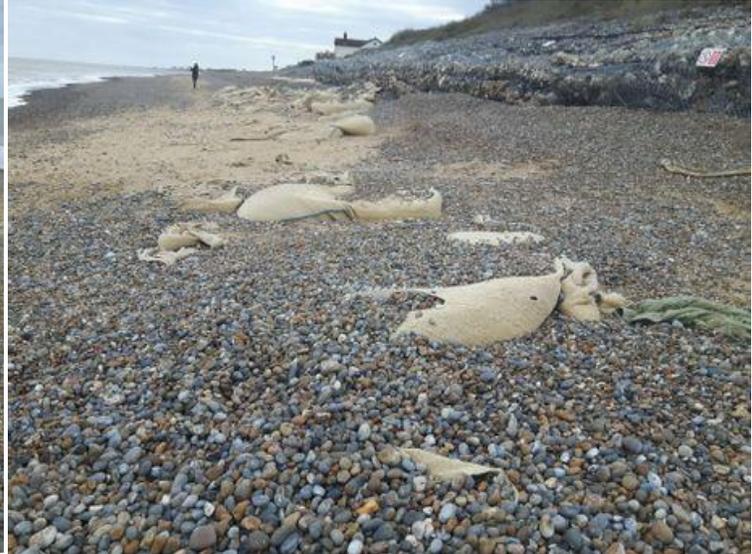
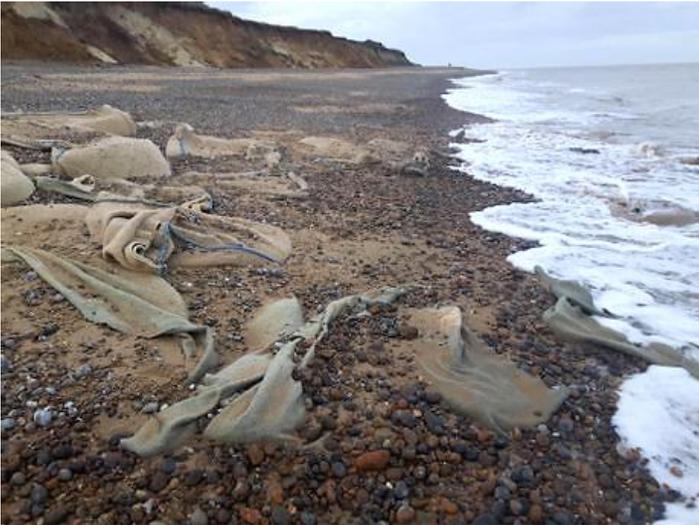
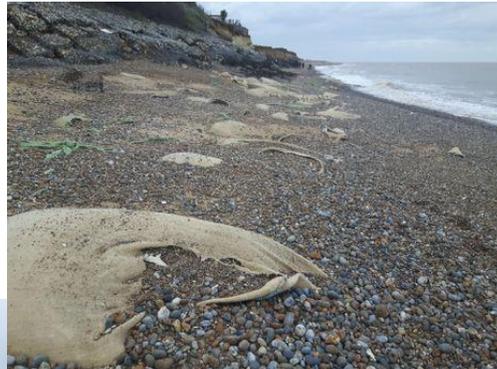
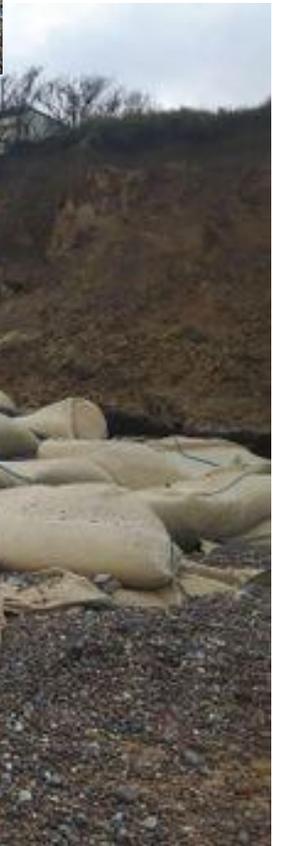
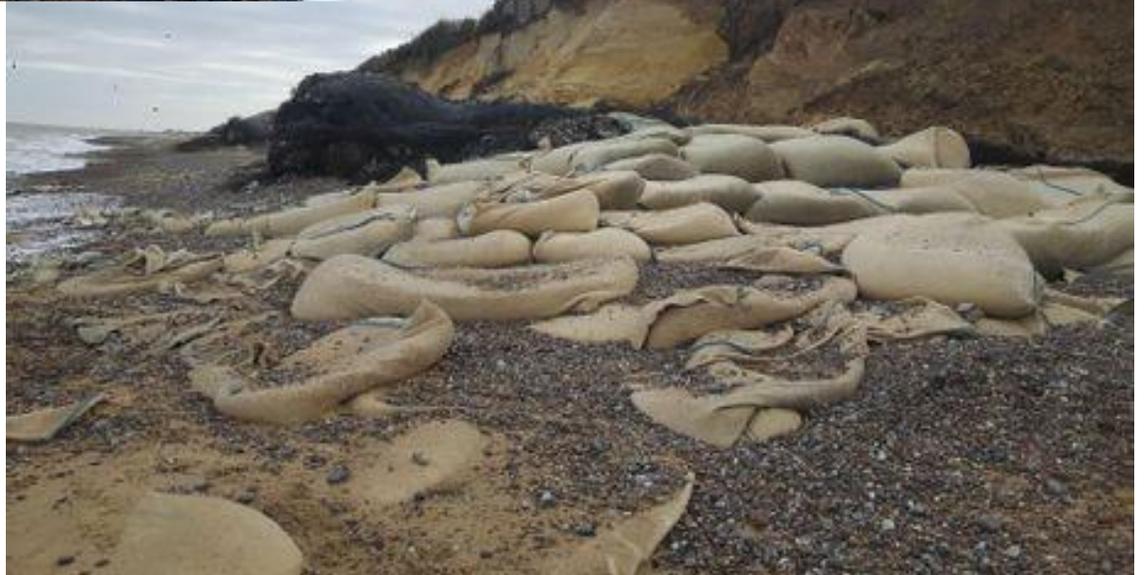
Images of Phase 2 Geobags:

Comments on Phase 2 Geobag condition: loss of many bags indicated by widespread green geotextile exposure.

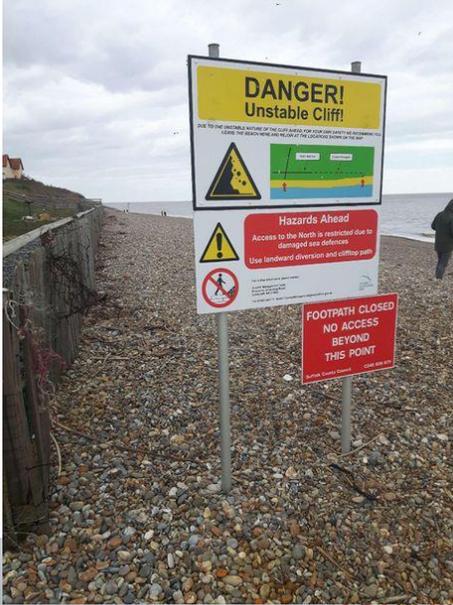
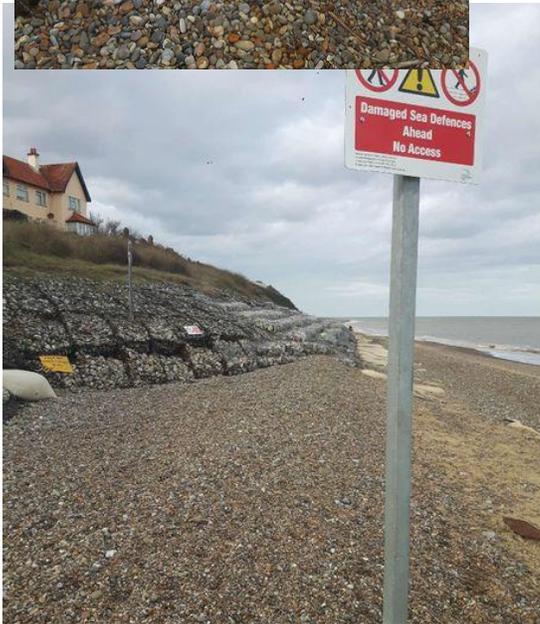
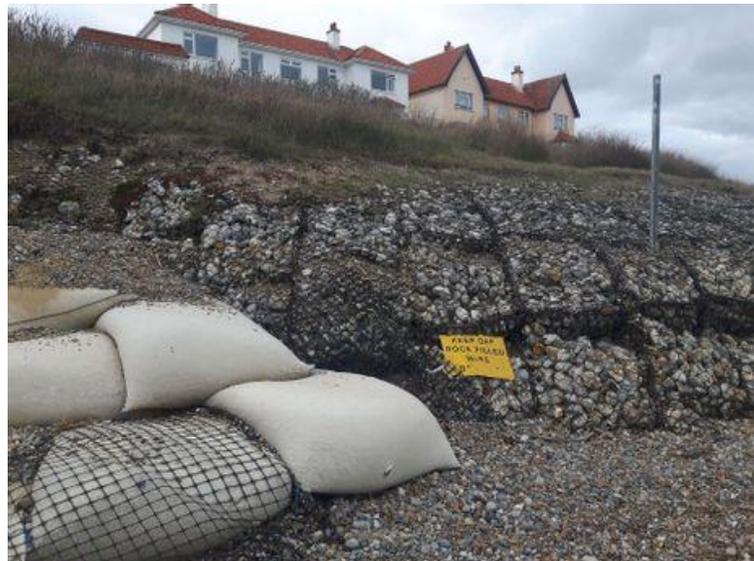
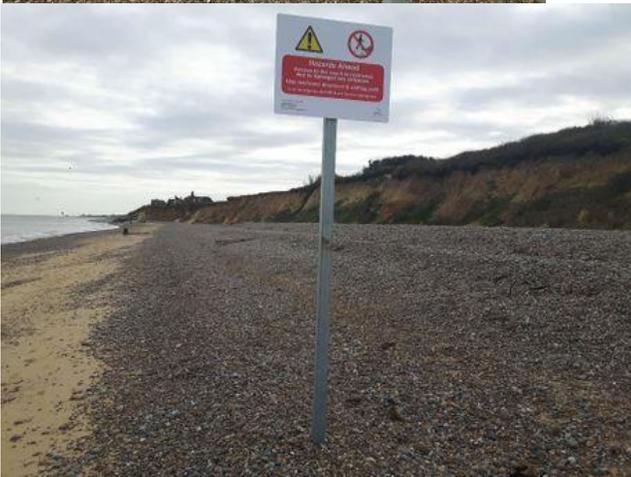
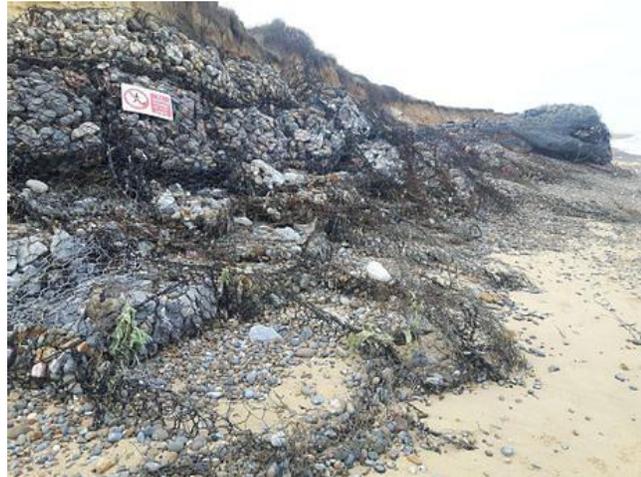
Images of signs:

Comments on signage: The sign missing at the northern end of the gabions has now been reinstalled. Most signs on the gabions are still visible and functioning. Most signs are missing from around the defence termination due to complete failure of gabions under Red House and crumpled mesh. The area is not recognizable but not at all appealing to would-be climbers. All other signs further north to the Ness and around the cliff top/coastal path access are fine. Debris remains at their base and the SCC laminated paper diversion sign is still attached. (I will take action to remove next inspection as it serves no purpose).

**Inspection Follow-up:** Geobags in front of country club and Headlands to remove. Sign to be reattached to post at north end of gabions. Continue to monitor weather and cliff stability, with particular regard to the Red House and surrounding area. Discuss R&M requirements with CPE team and replacement of sign north of defence termination.

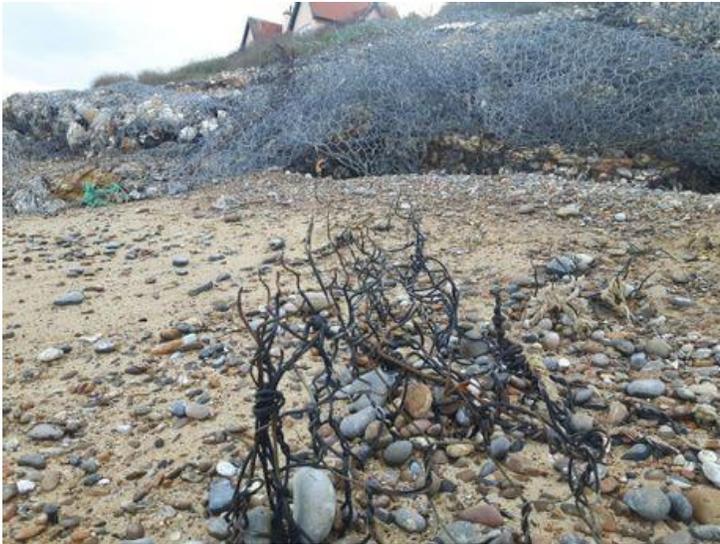
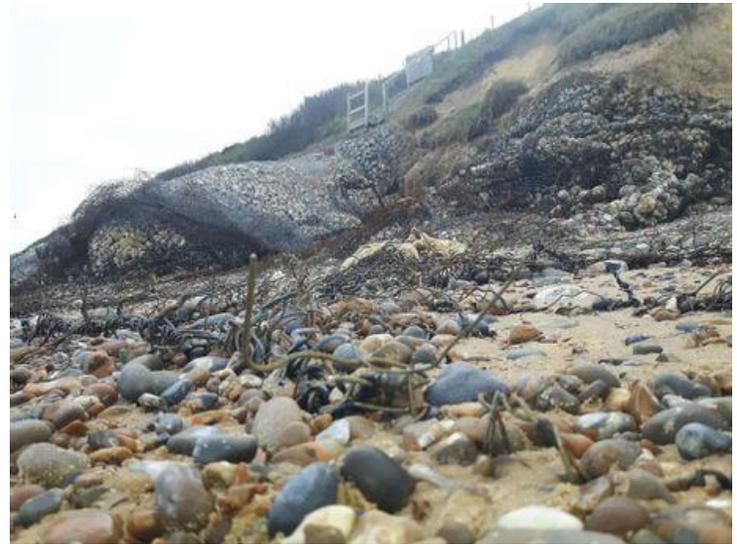
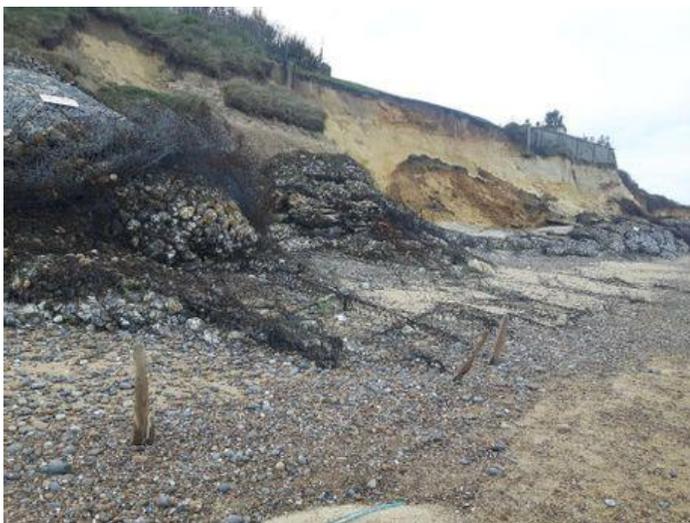
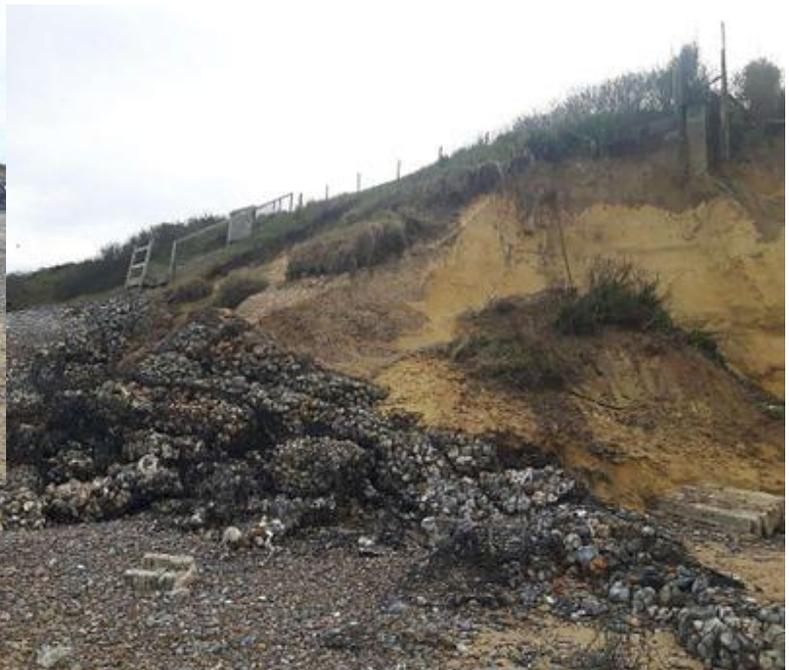
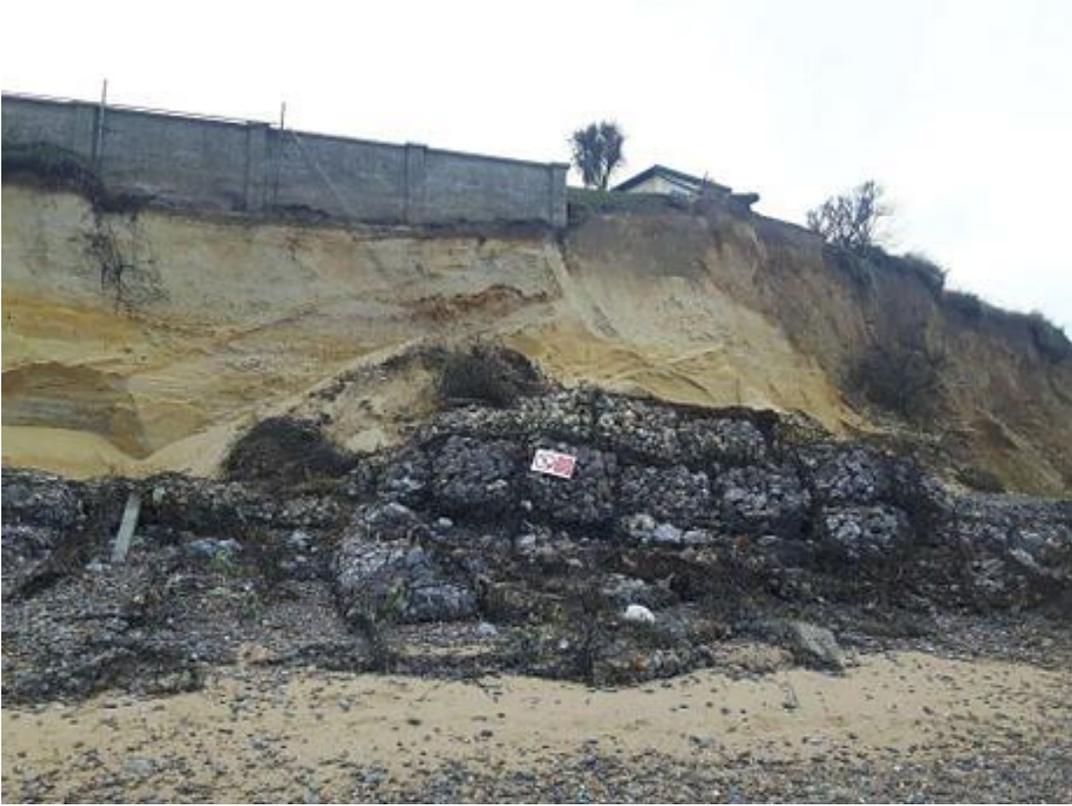
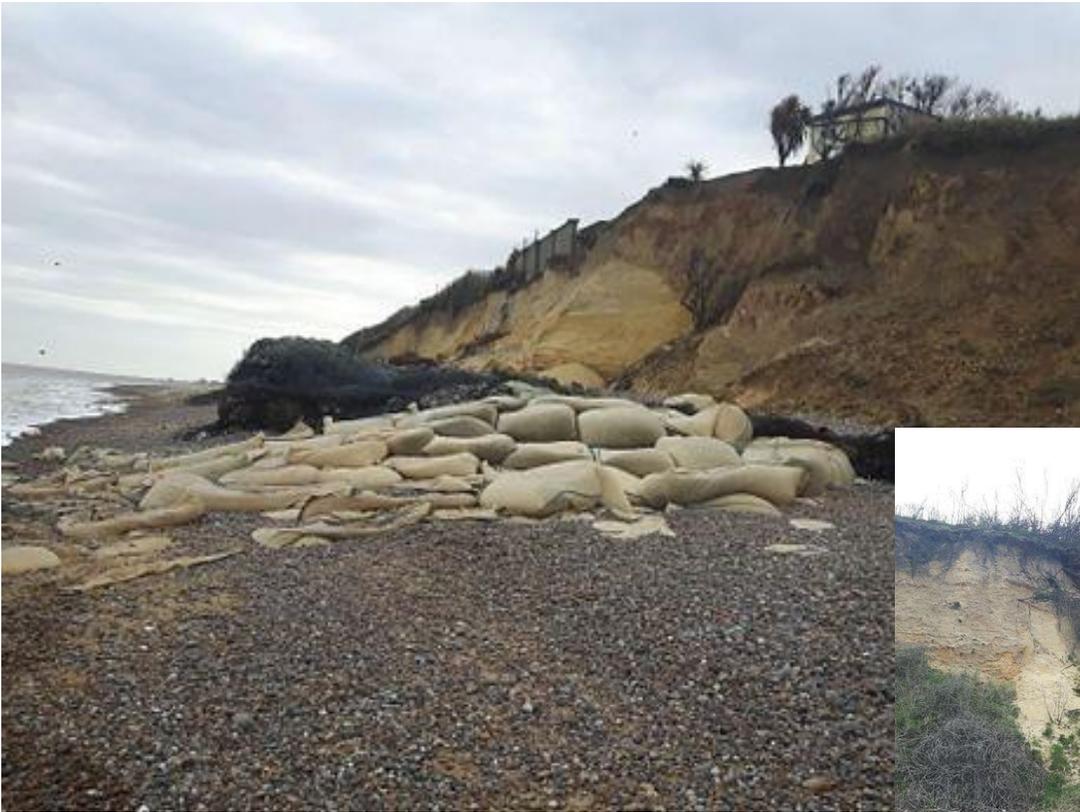
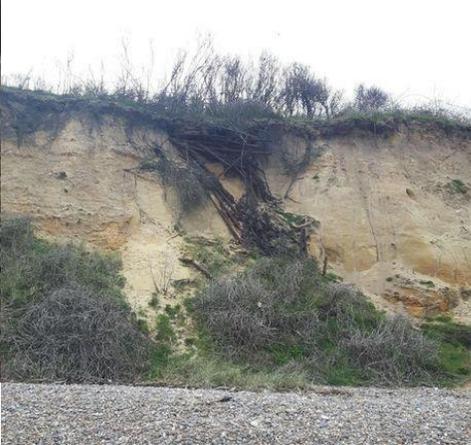
Images of Hazards:

Comments on Hazards: Gabion mesh has many sharps protruding the beach surface. There are also numerous wooden stakes protruding from beach level, beneath the Red House. The wall at the seaward end of the Red House's garden is at risk of imminent failure. The wall could topple or fall but is likely to slide on to gabions below. Many walkers continue to cross the section despite clear warning signs and are therefore at some risk if squeezed towards the defences by the wave run up. Lots of geotextile bags are strewn over the intertidal area - many are flailing but not floating in the water. There is no beach between defences and shoreline around the defence termination, so walkers must pick their way through and over the damaged defences. Continuing north (Ogilvie land), there are fence posts, metal scaffolding poles and service pipes that either overhang or hang down from the receding cliffs.

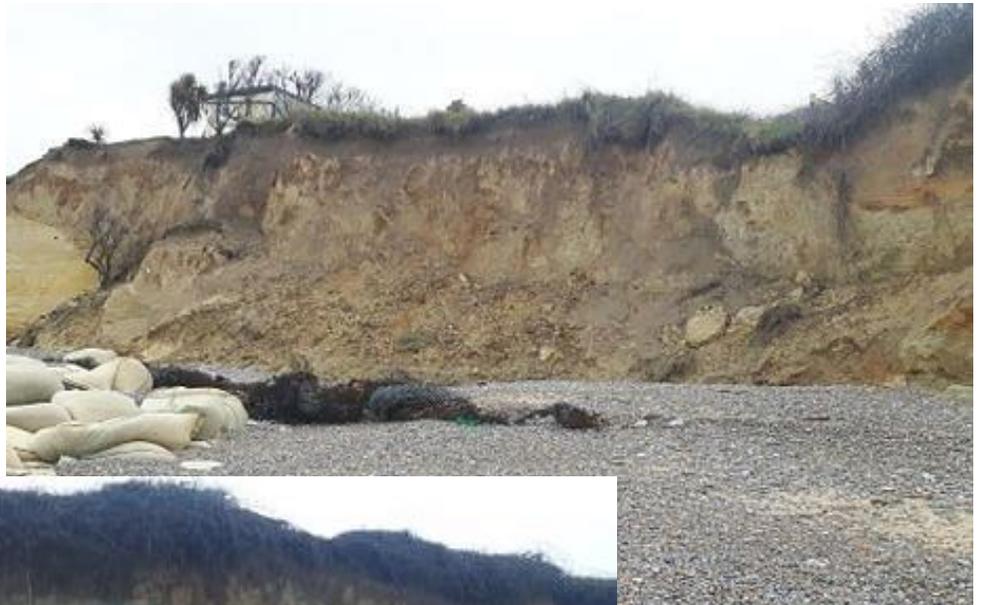
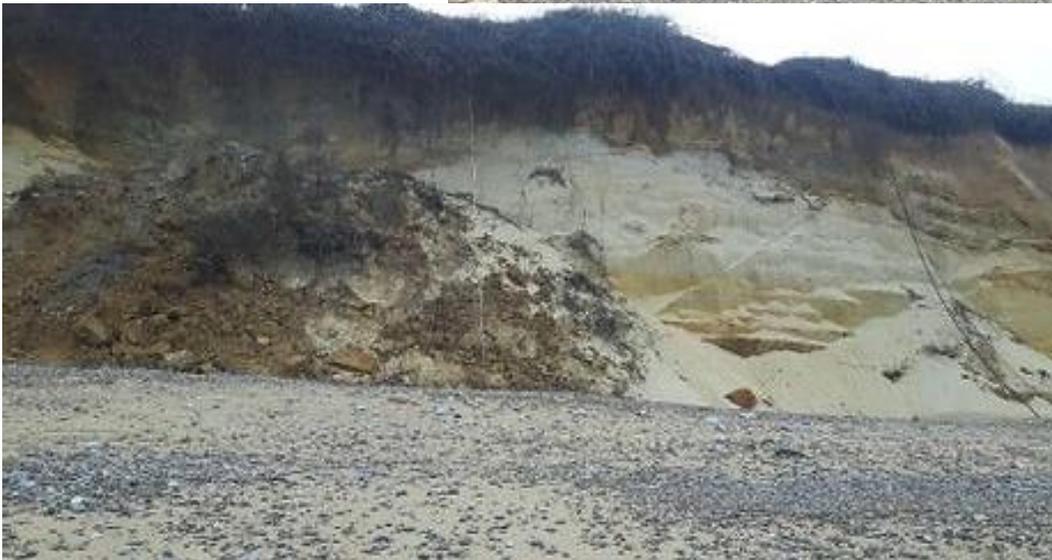
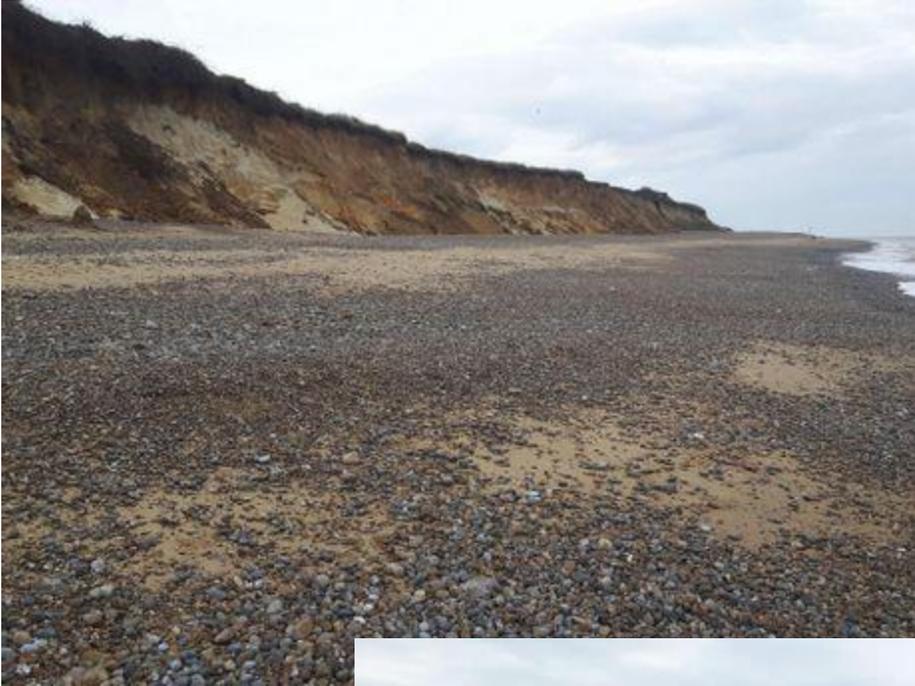
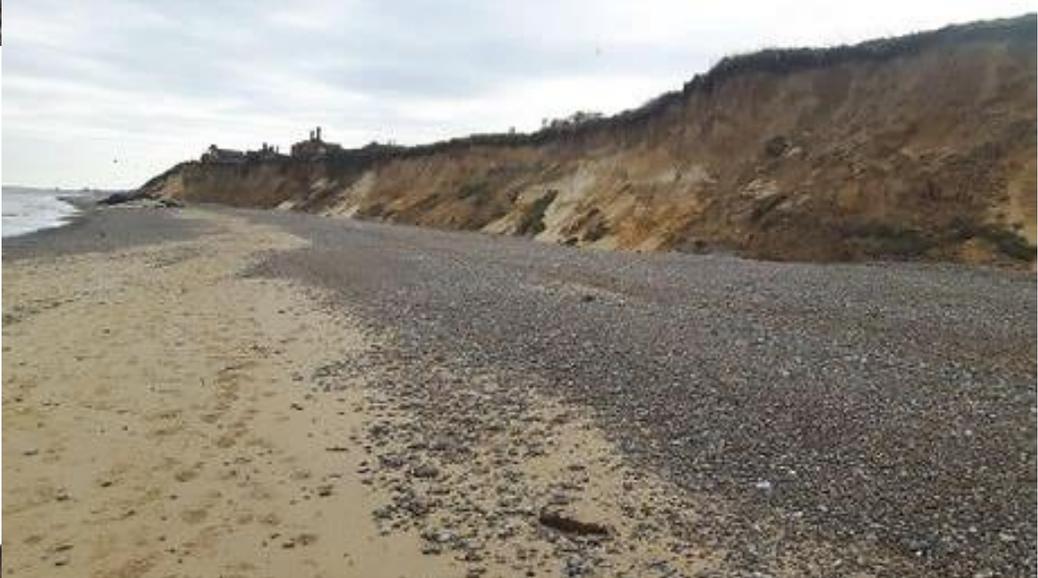
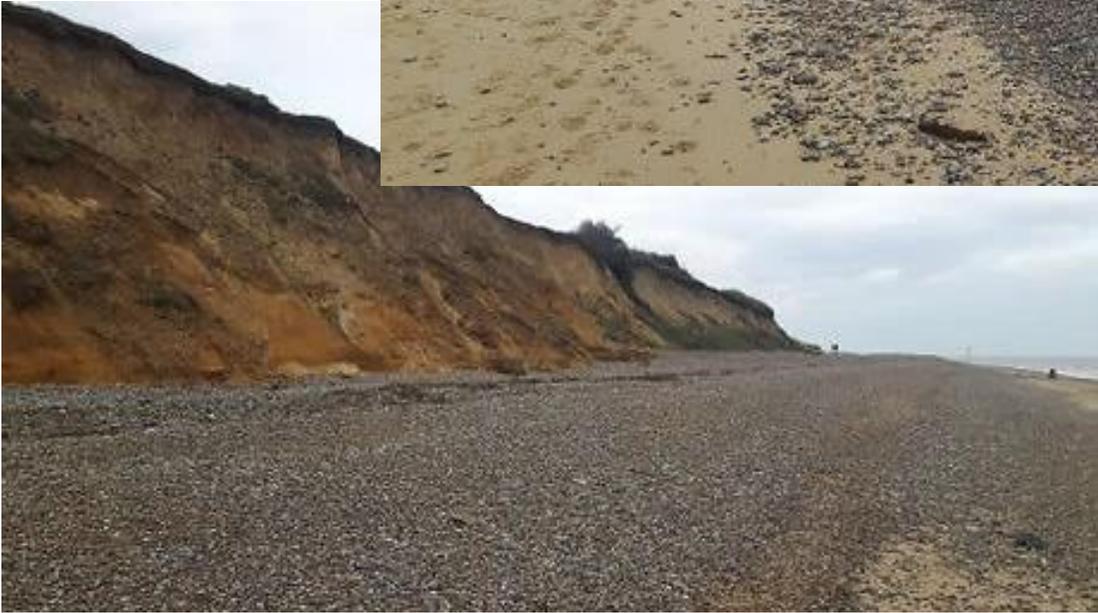
Images of the Northern UNDEFENDED Frontage:

Geomorphological change north of defence termination: Cliff top recession, Cliff toe recession, overhanging cliffs, Some beach recovery, Active cliff erosion, Debris exposed.

Comments on the geomorphological change north of defence termination: concrete pill box is mostly covered indicating some intertidal beach material, gravel, has returned since last inspection. The supratidal beach level looks reasonably good as it has been fed by fallen cliff material. The sea water level and waves have not reached the cliff toe to undermine it. Despite this, the cliffs are in an obvious state of continued recession. The Red Houses chalet on cliff top is fully visible as the cliff edge approaches it. The embayment between the Red House and the Ness is well established. Looking in the nearshore zone around the Ness, the muddy brown discoloration of the water is larger than usual. This sub-surface, sand repository has no doubt accumulated during the recent bout of strong southerly winds. This sediment has been trafficked from further south but remains in the system and returnable.
