Thorpeness Monthly Monitoring Report

Date & Time of Survey: April 26, 2021 5:00 PM

Inspector: lucy.goodman_CPE

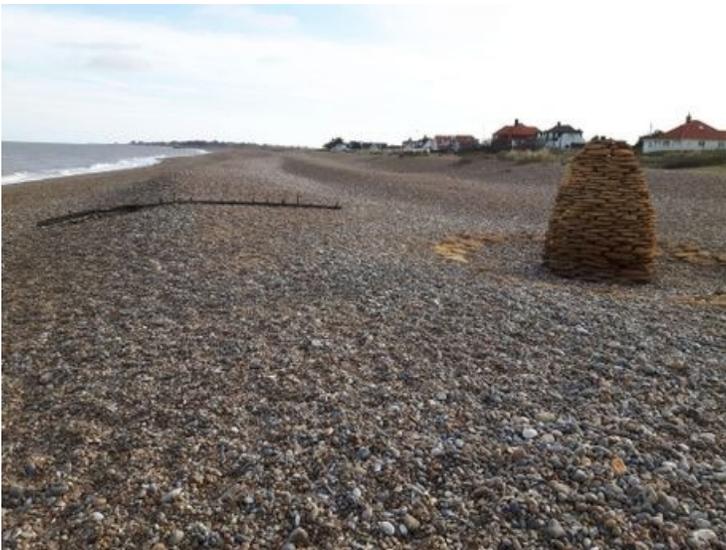
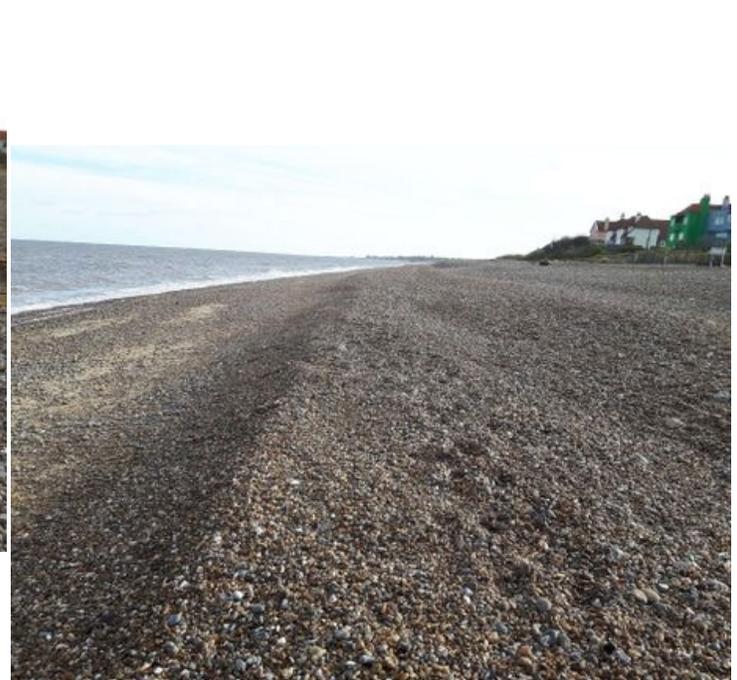
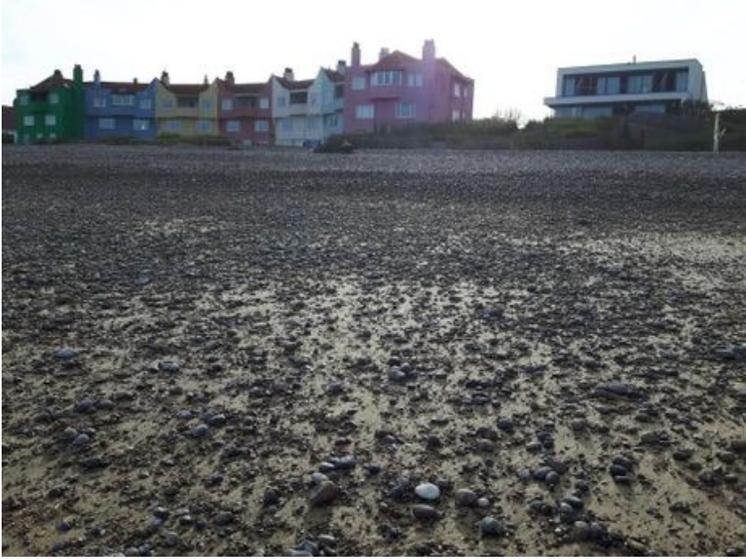
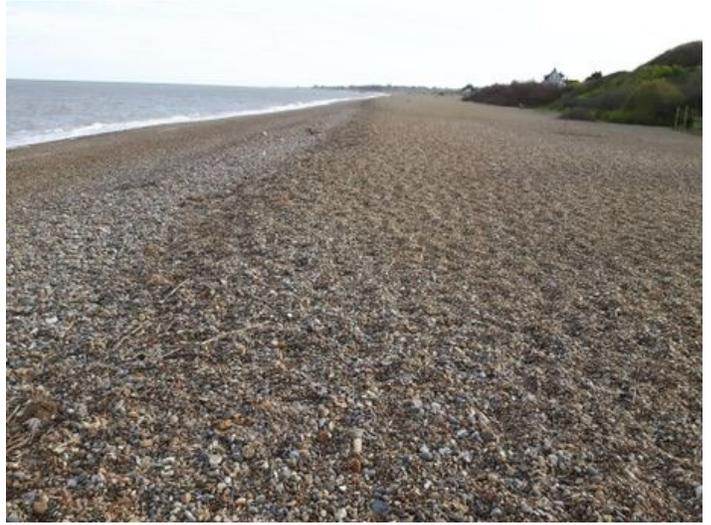
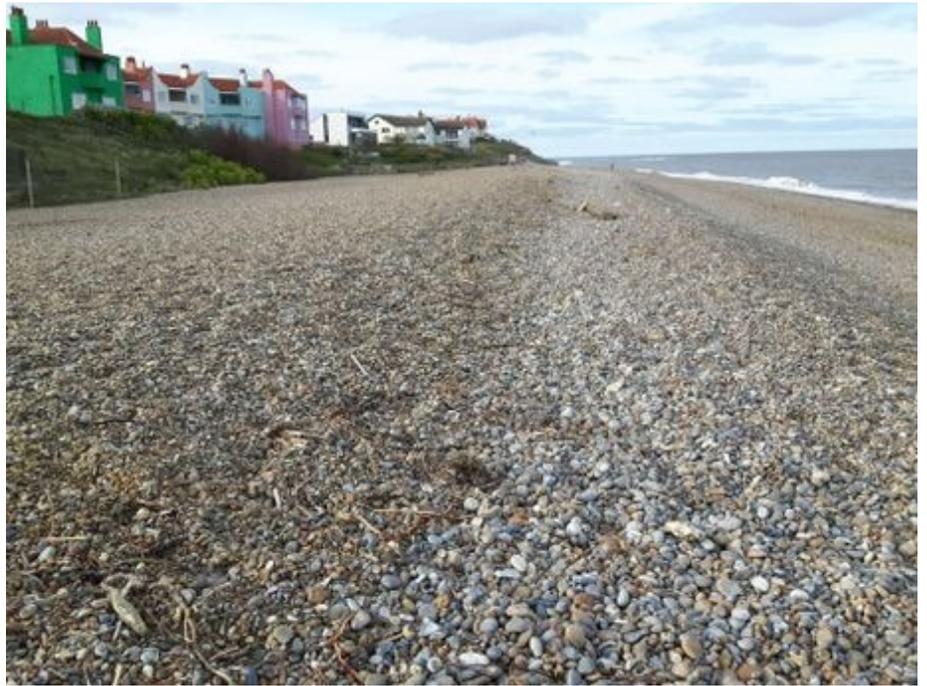
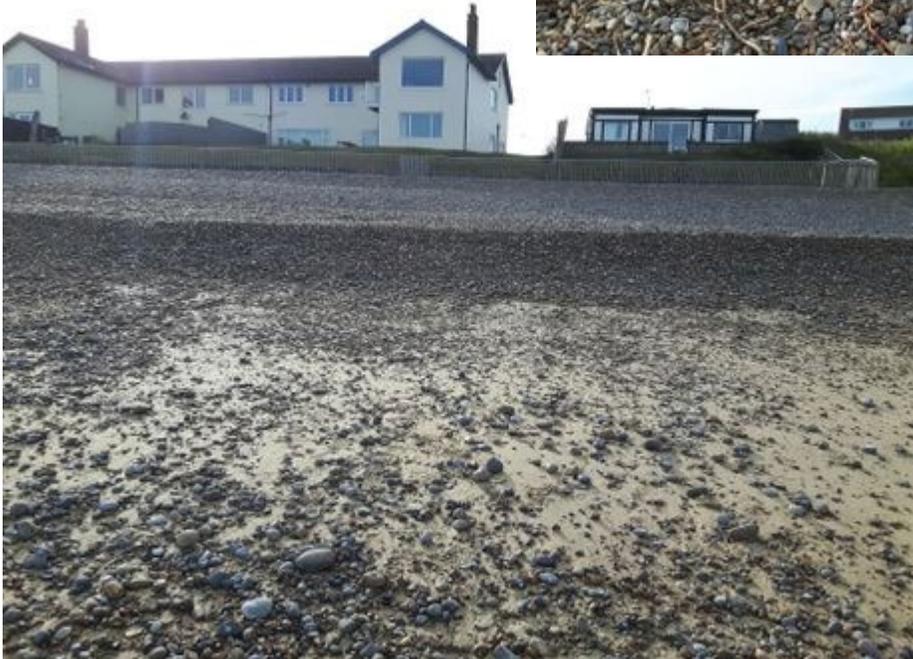
Images of the southern UNDEFENDED frontage:

berm reappears in front of the Headlands where it doesn't further north. good amount of gravel on foreshore and back beach compared to last inspection. Fine gravel deposited in front of the Headlands gardens indicates some redistribution of material across whole beach.

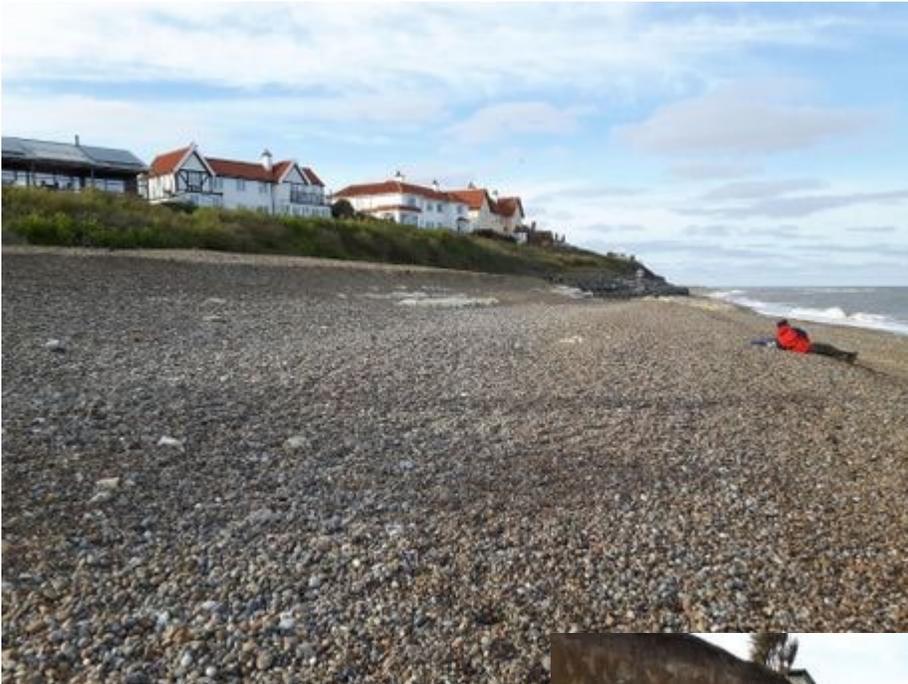
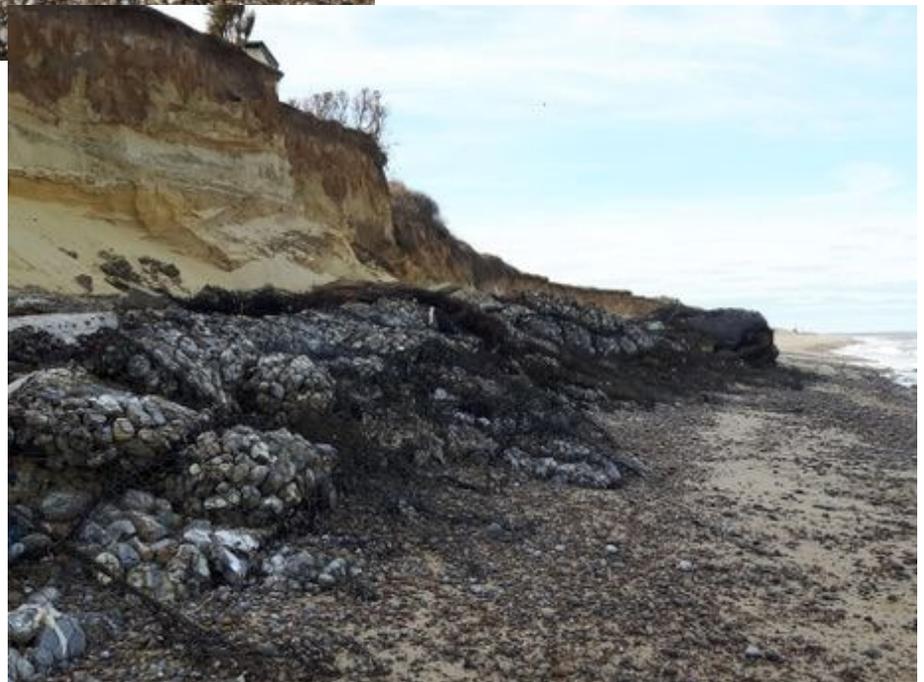
Images of the DEFENDED frontage:

Comments on the geomorphological change over the DEFENDED frontage: this area has seen the focus of wave energy. Recent swell waves have not served to construct the beach in front of the defences but to deteriorate them further. Beach is very narrow. Mean sea level has risen here relative to other areas. Phase 2 geobags are in the water. Erosion of the cliffs behind the gabions has spread south of the Red House to affect neighbouring properties' access steps. Debris overhanging cliff edge.

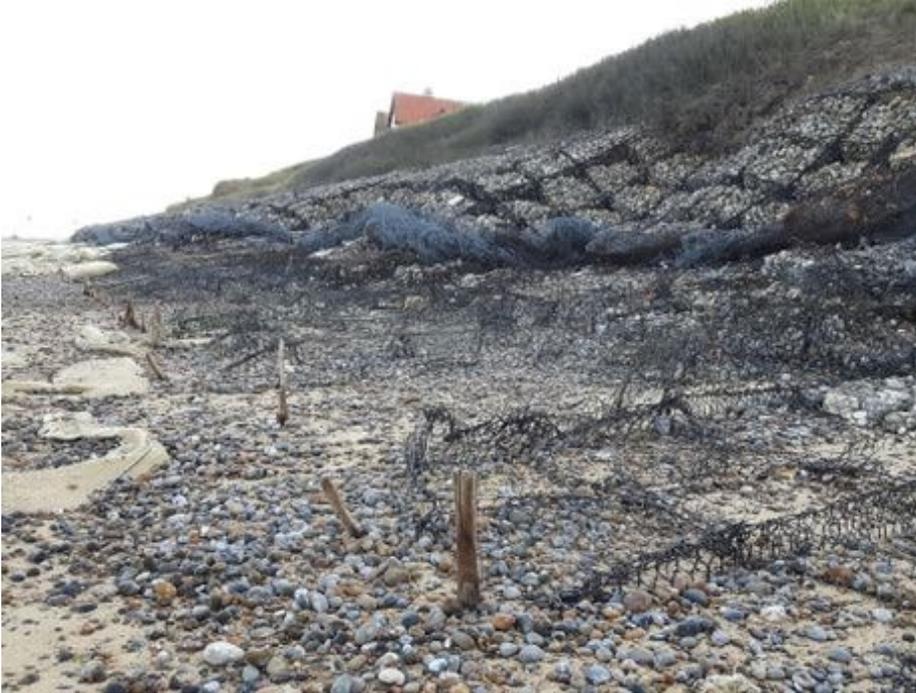
Images of the gabions:

Comments on Gabion condition: only intact at southern most end - junction with phase 1 geobags.

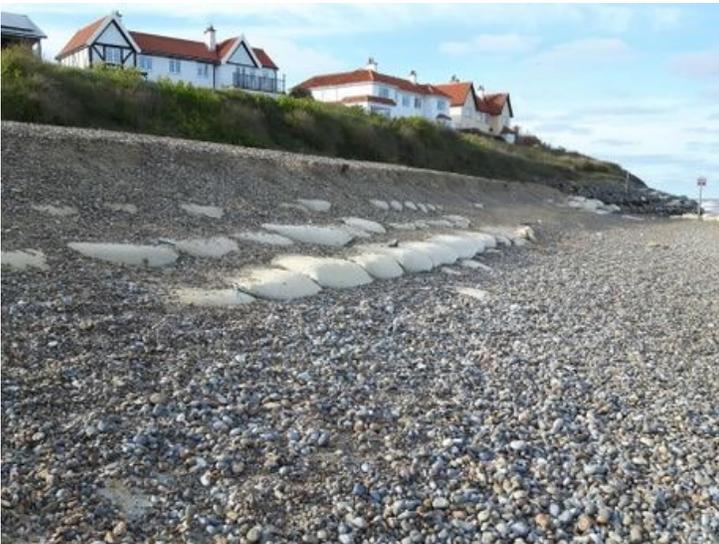
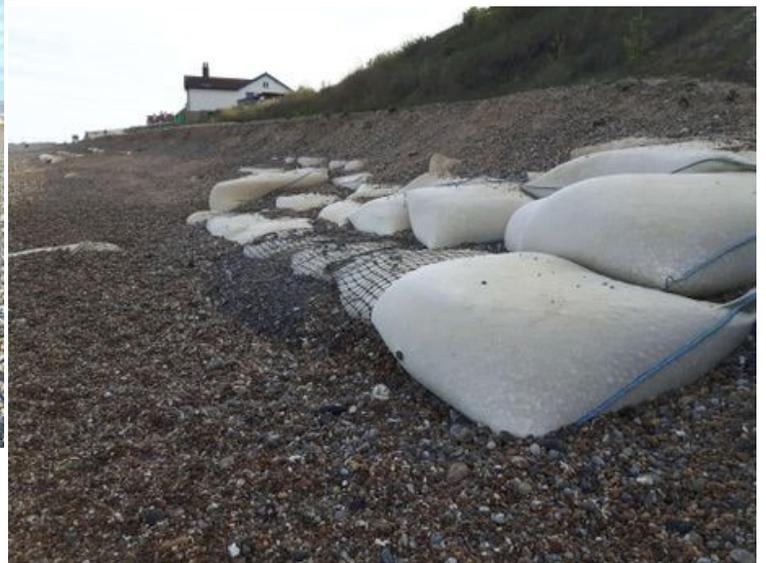
Images of Phase 1 Geobags:

Comments on Phase 1 Geobag condition: more exposure of phase 1 bags due to recession and scouring off gravel berm.

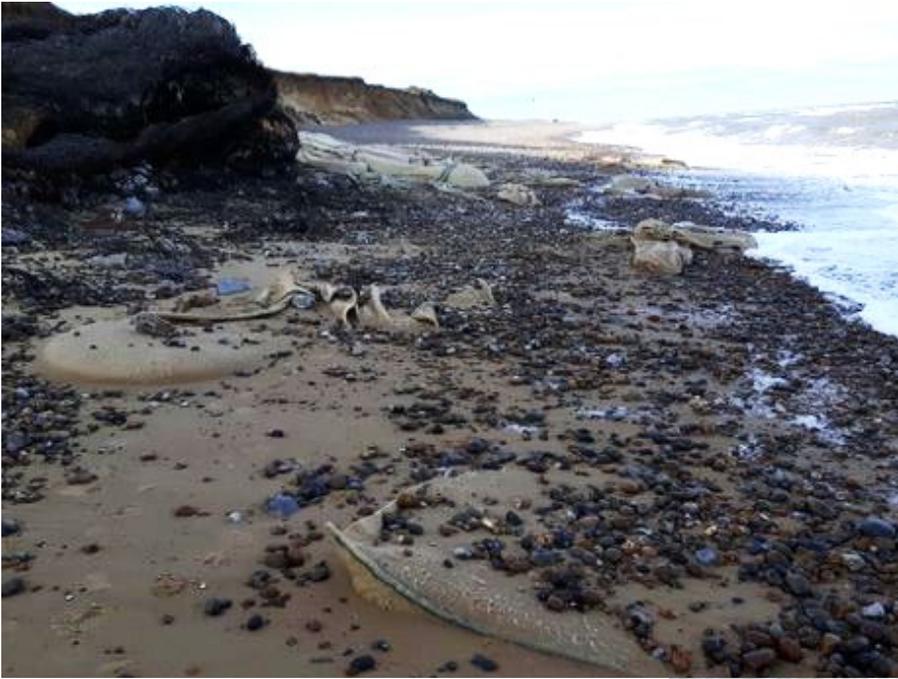
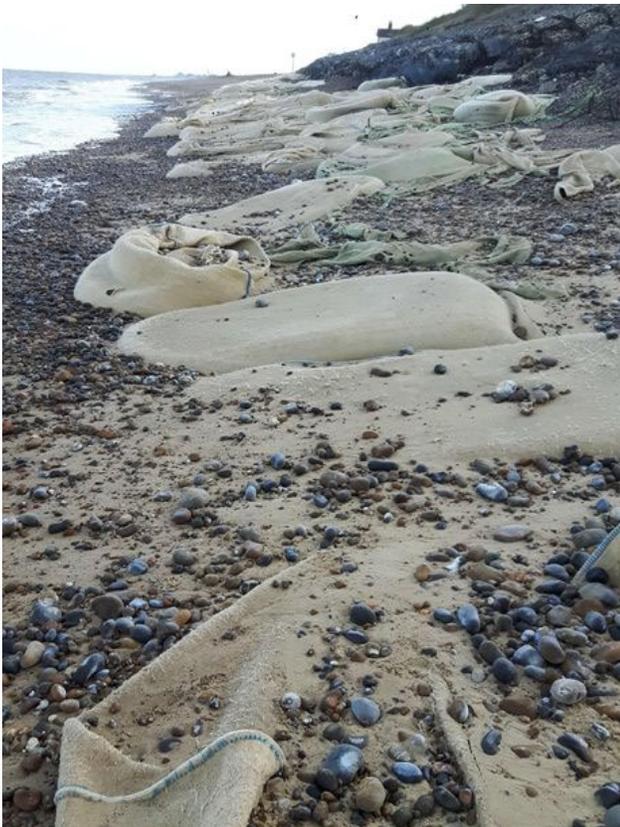
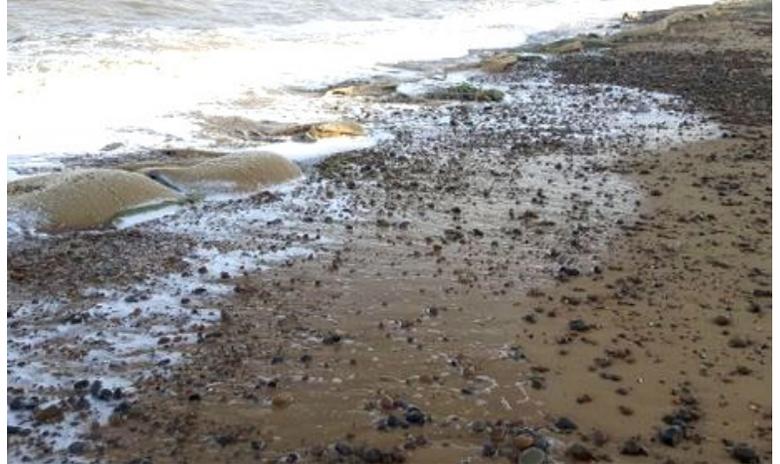
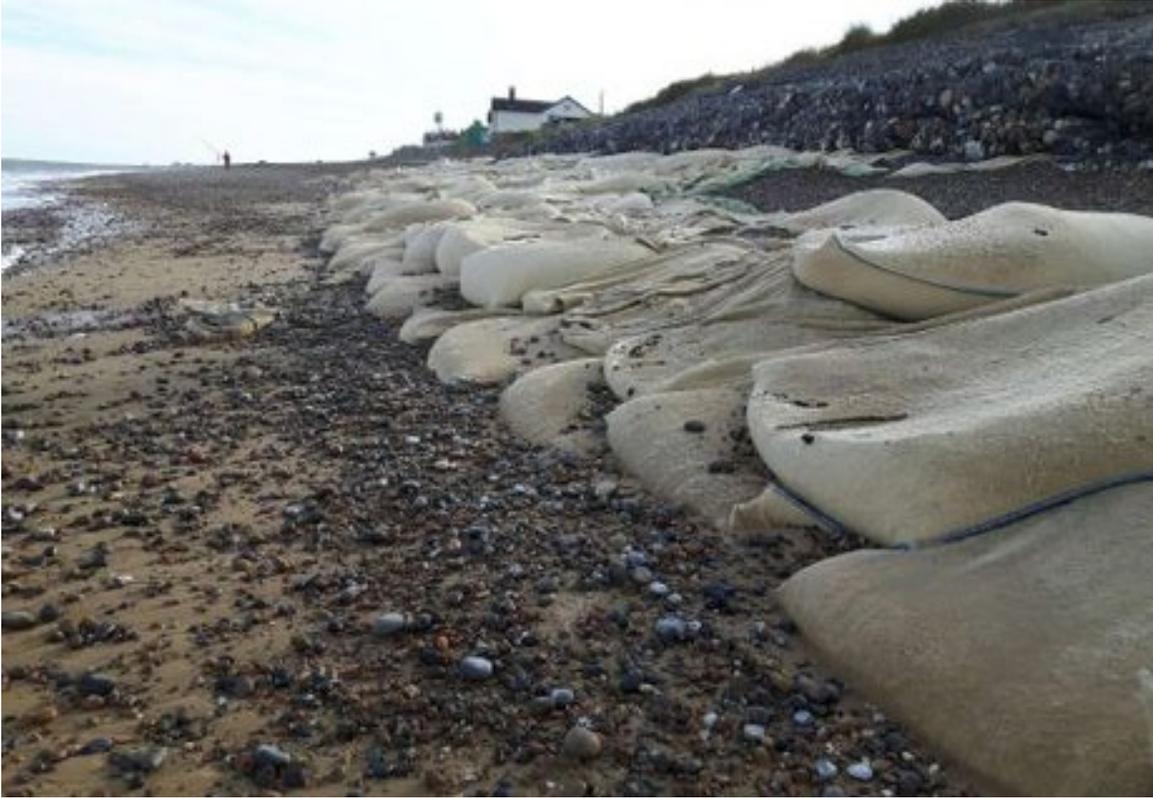
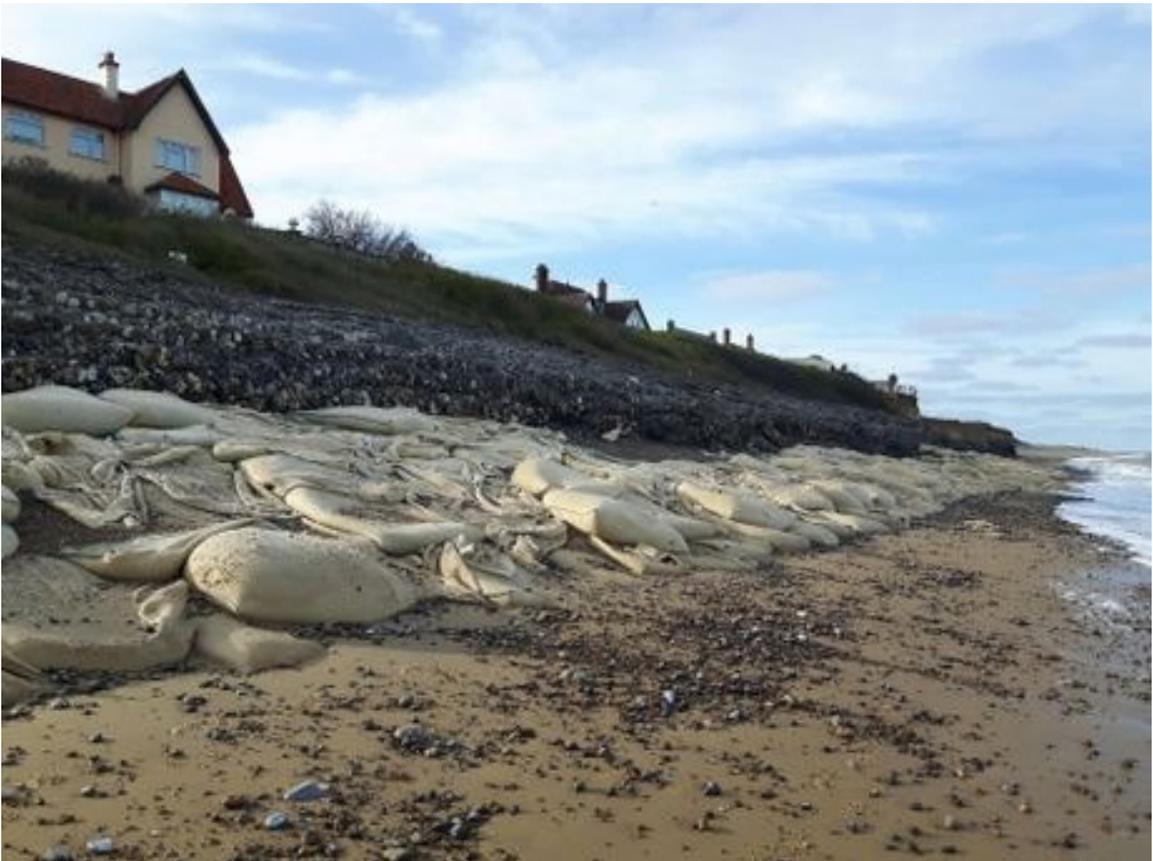
Images of Phase 2 Geobags:

Comments on Phase 2 Geobag condition: The geobags are holding a line. they are in the water at low tide. Loss of fill affecting 80%. Green geotextile is loose indicating displacement of upper layers of bags. general poor condition.

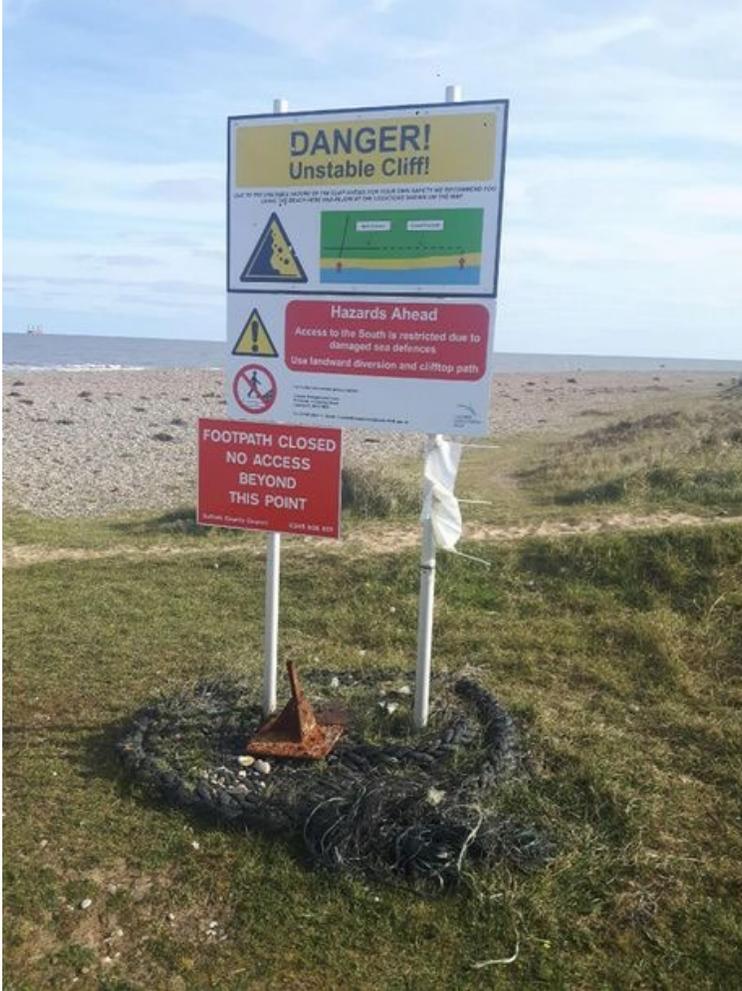
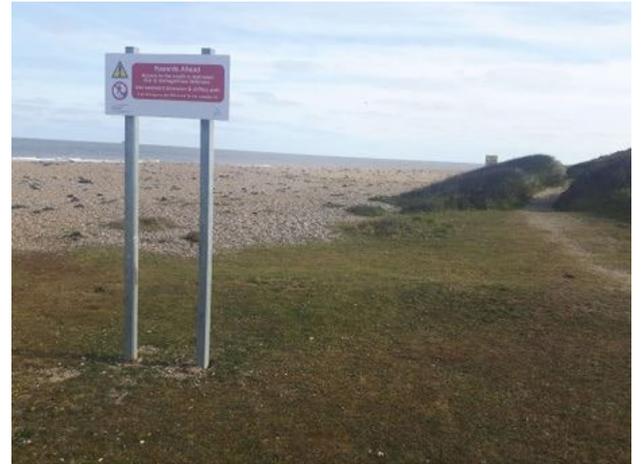
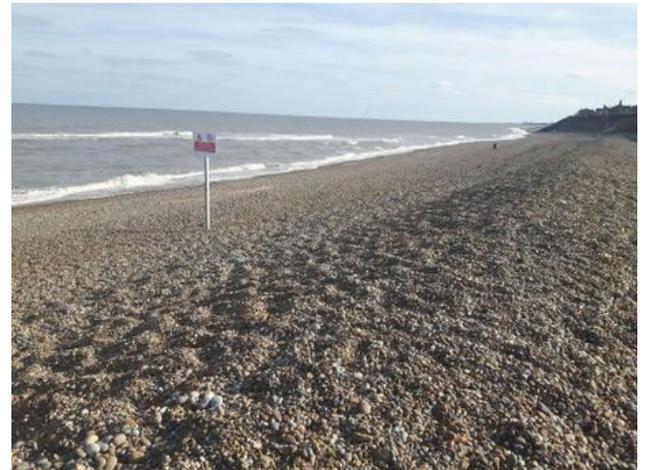
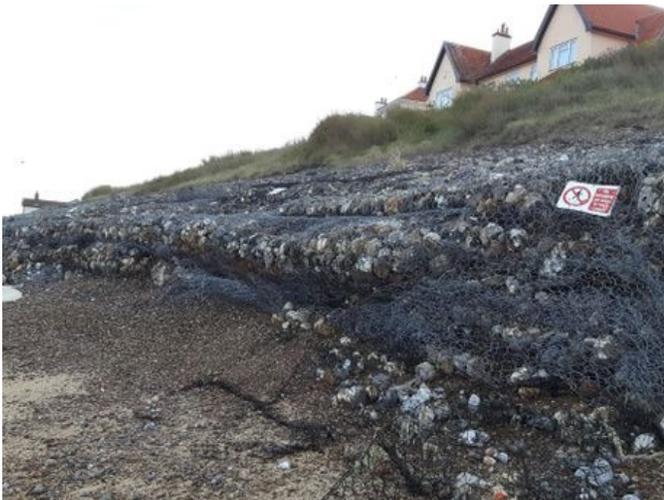
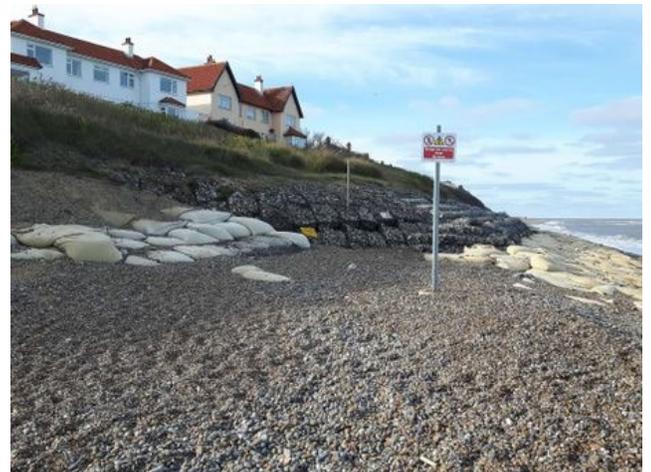
Images of signs:

Comments on signage: SCC laminated paper still needs cutting off from northern footpath diversion sign as it's useless and untidy (image below). Other signs on posts are all in place and functioning. Many signs on gabion baskets are redundant.

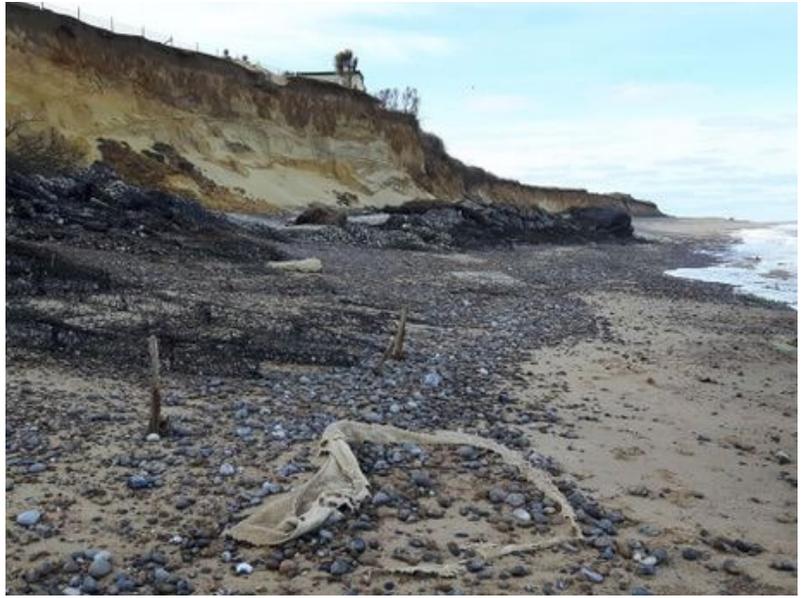
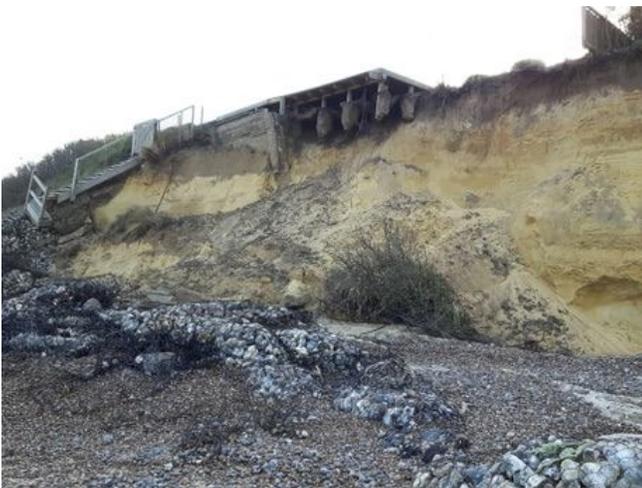
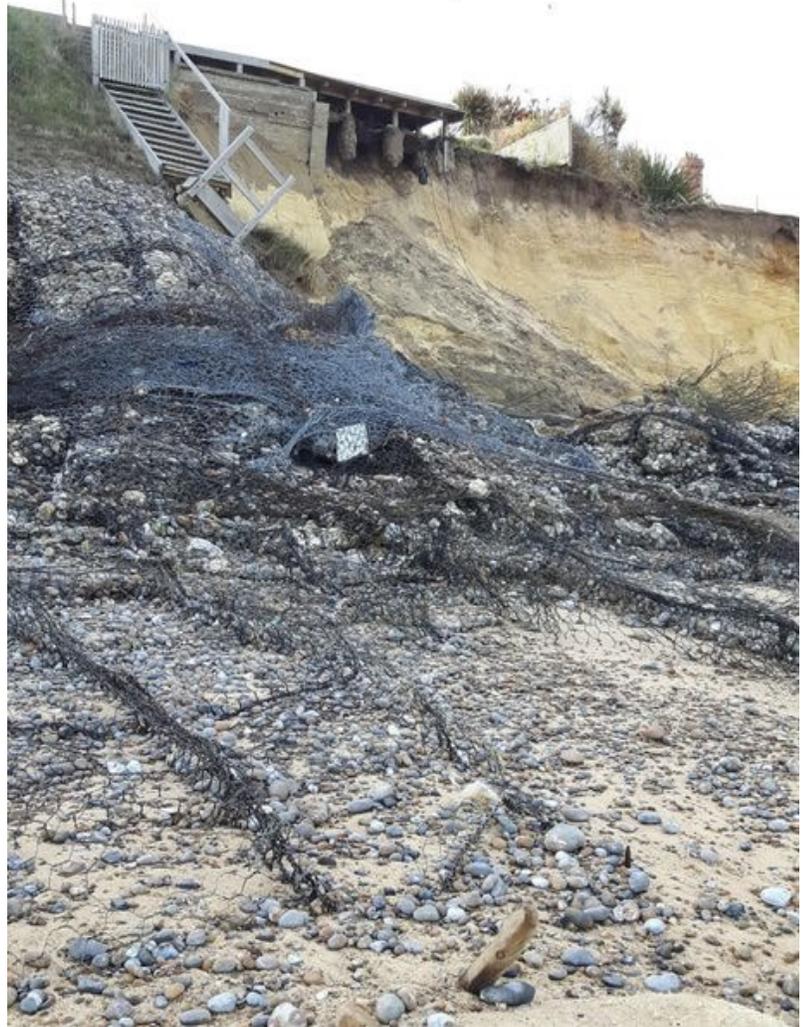
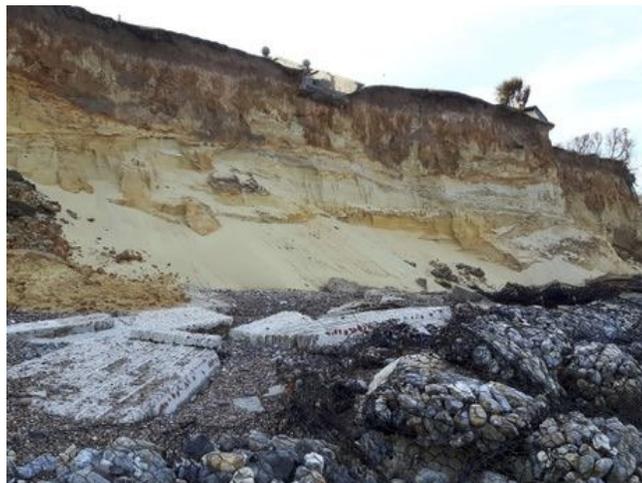
Images of Hazards:

Comments on hazards: narrow beach despite low tide. Cliffs still finding stability. Debris falling from cliff edge around Red House adding to copious broken defences on beach. Yellow summer house *may* need pulling back this summer, in the unfortunate event of another high wave energy event. The summer house still has a few meters in front of it. Wooden stumps at base of broken gabion mesh. No beach area at low tide (-1m odn) to walk safely along shore due to wave run up.

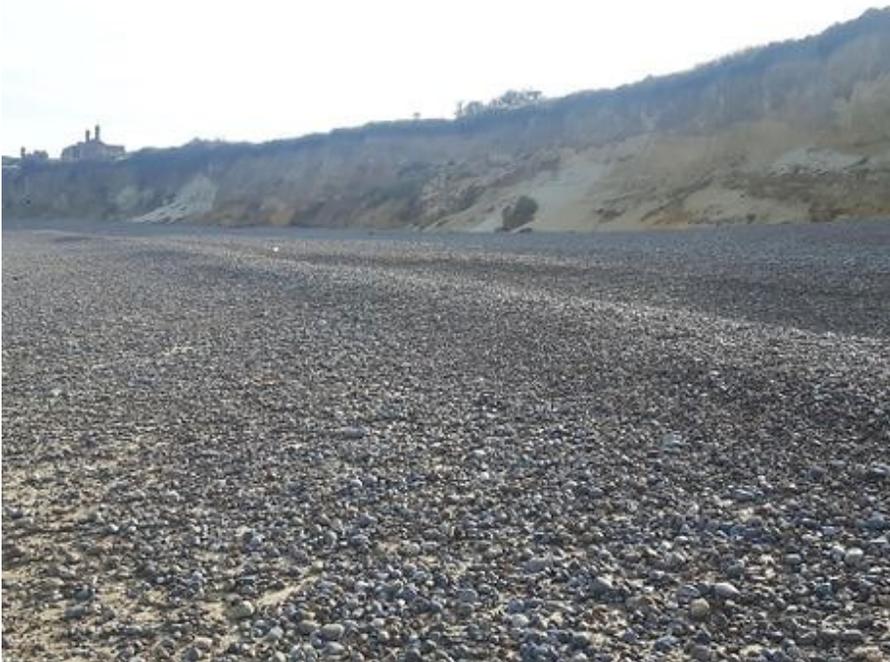
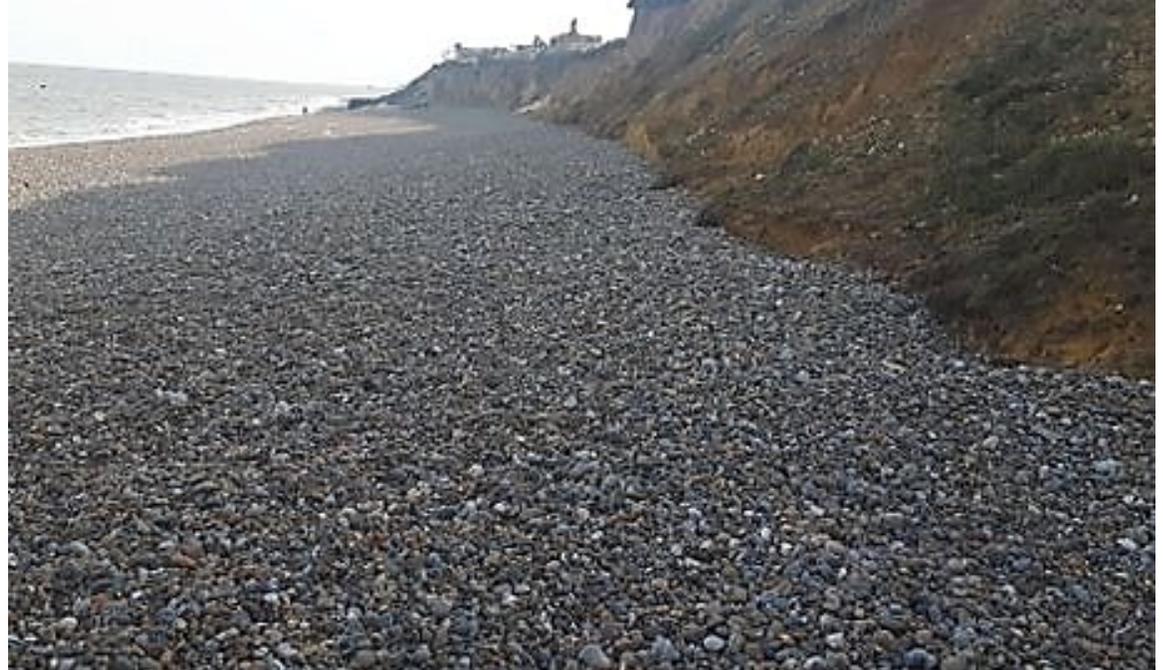
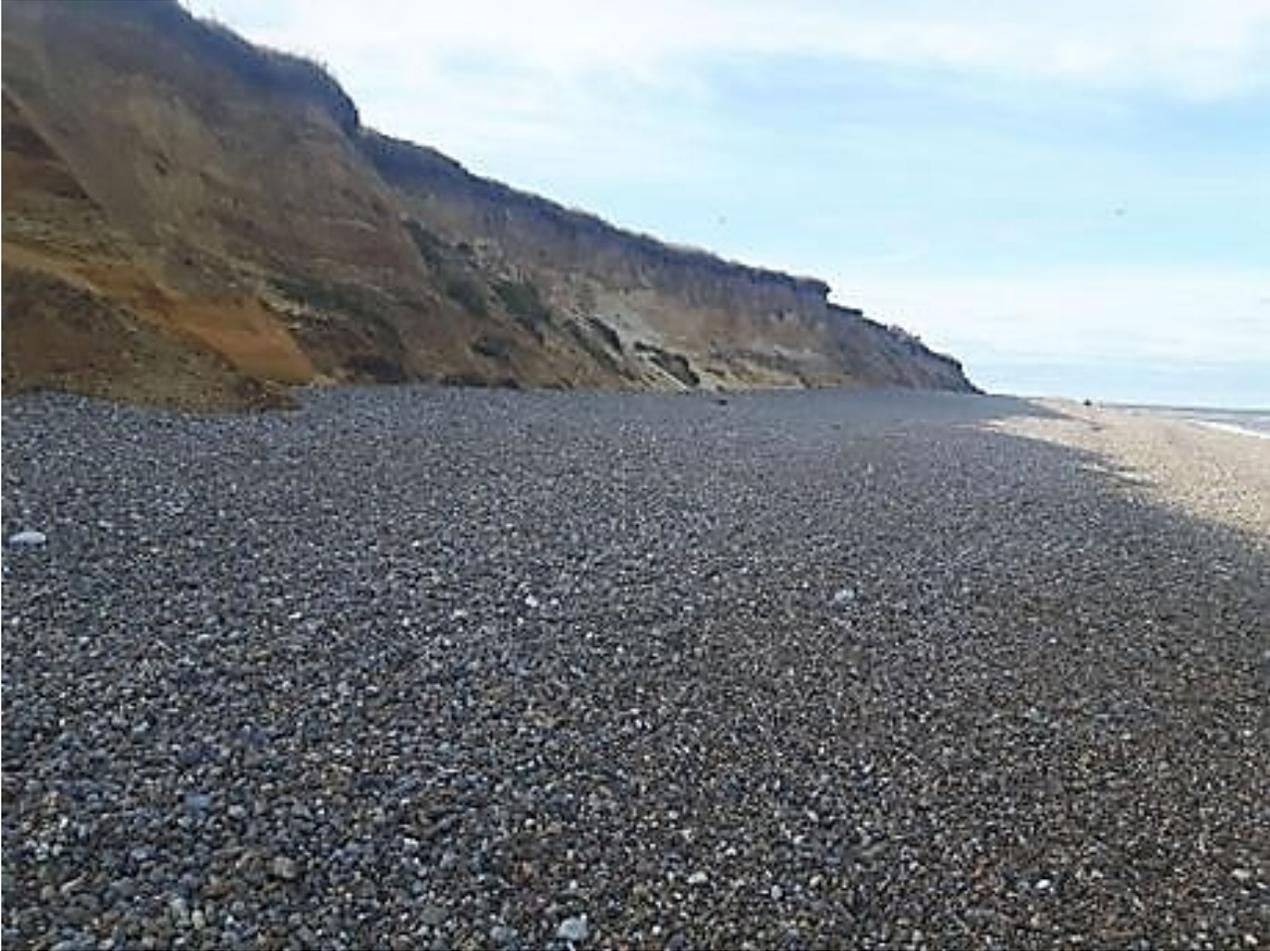
Images of the Northern UNDEFENDED Frontage:

Comments on the geomorphological change north of defence termination: prominent berm with minor berms supra imposed to seaward. Major beach 'recovery' across northern, cliffed frontage. Infilling of intertidal and supratidal beach with gravel. Cobbles at cliff toe curenly stabilising cliffs. The previously prominent embayment between Red House and Thorpe Ness has also been infilled so that shoreline is more linear than concave once again.
