Pakefield Monthly Monitoring Report

Date & Time of Survey: January 25, 2022 08:52

Inspector: Keith Roper

Reason for Inspection: Scheduled

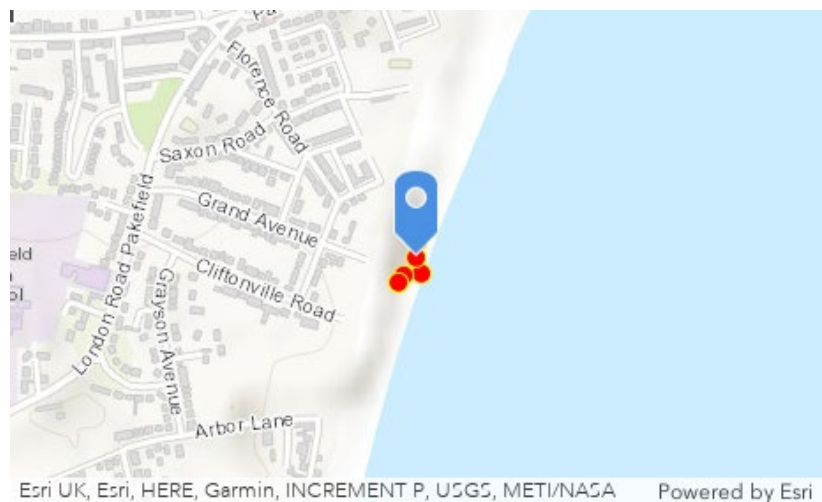
Erosion continuing where beaches are relatively narrow and therefore vulnerable to increased tide levels or significant wave action.

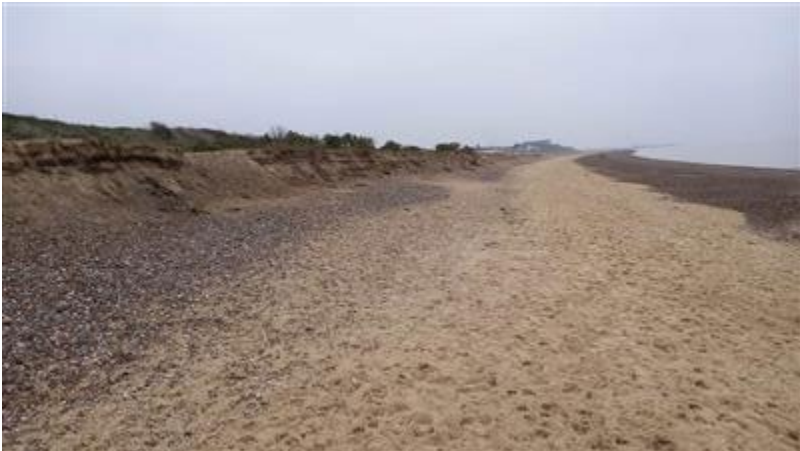
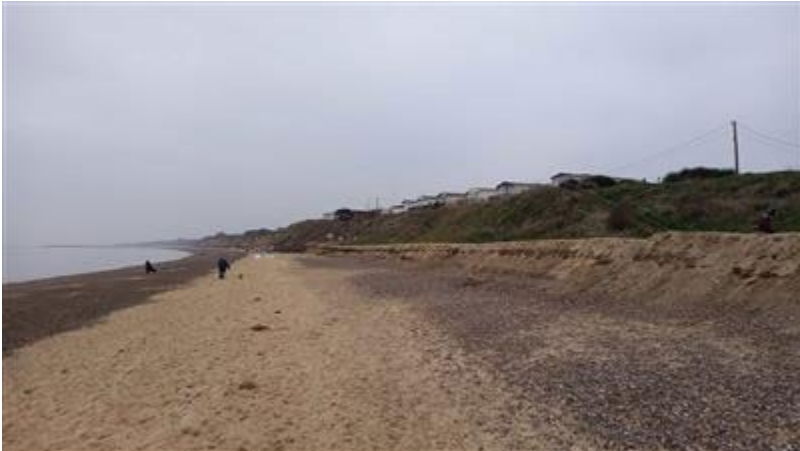
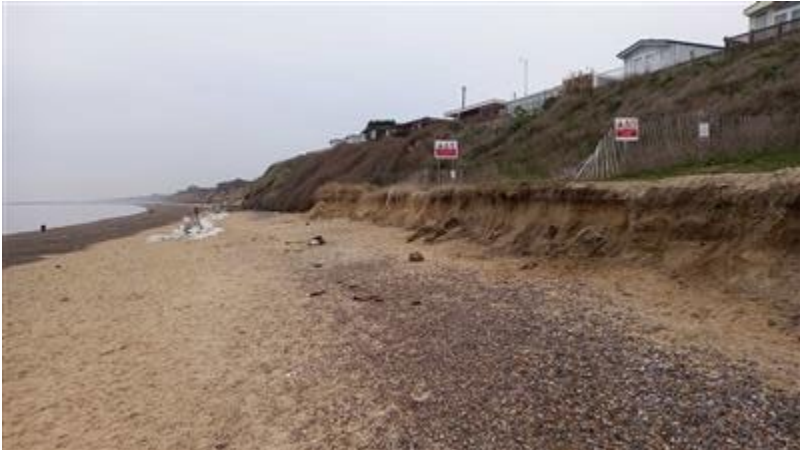
Photos of beach cliff:

Northern extent of beach cliff:
Seaward of Grand Avenue. Recent conditions described above have caused beach cliff erosion to seaward and south side of Cliftonville Road.

Maximum height of beach cliff face: 2 m

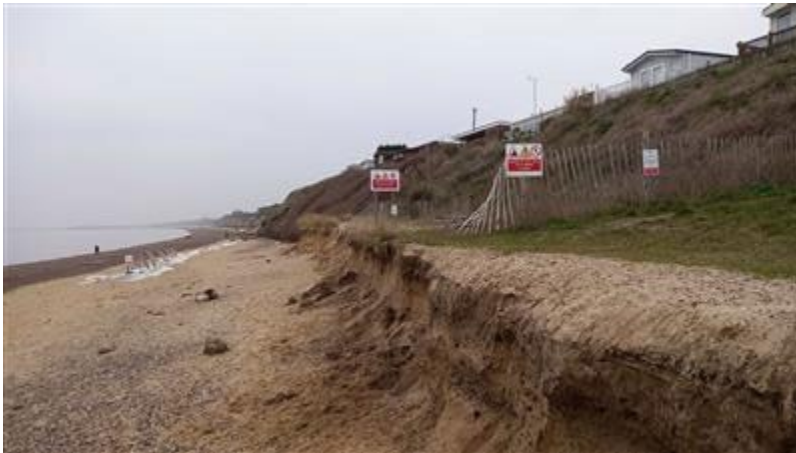
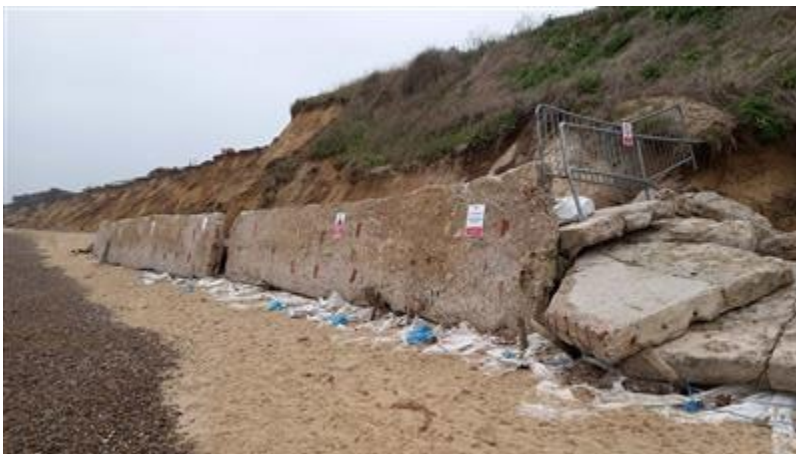
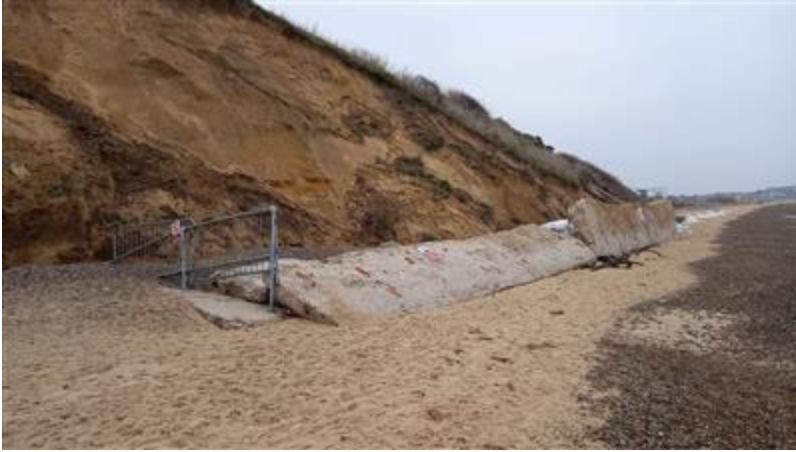
Images of signage:

Condition of signage: Signage necessary is in good condition.

The original large sign with two posts is now close to the eroding front edge of the beach cliff. The fallen sign on northern paling fence has been replaced. Beach signage below former rifle range has been removed. New signs regarding recent timber stake theft have been installed and are in place. Loss of timber stakes appears to have stopped.

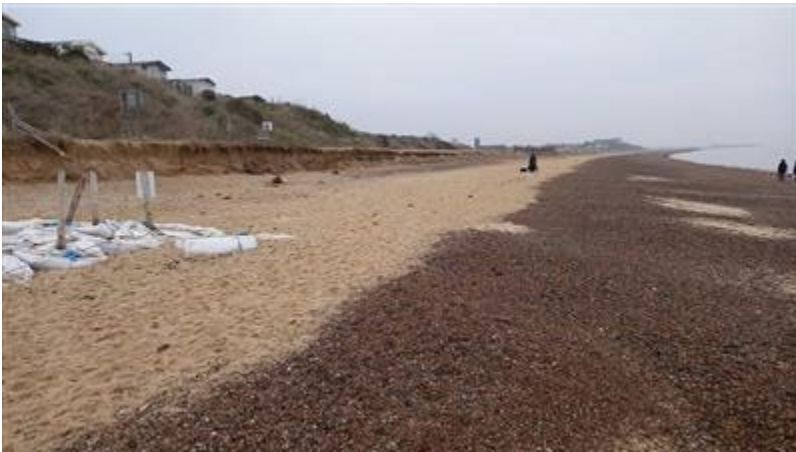
Photos of intertidal beach:

Impression of intertidal beach volume: Moderately greater

Upper beaches remain relatively healthy. Intertidal beaches have recently been improved by deposition of shingle rich material seaward from mean high water mark.

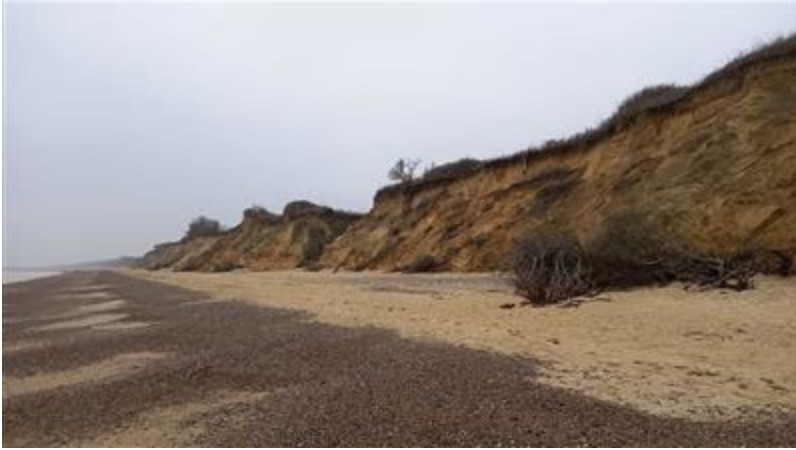
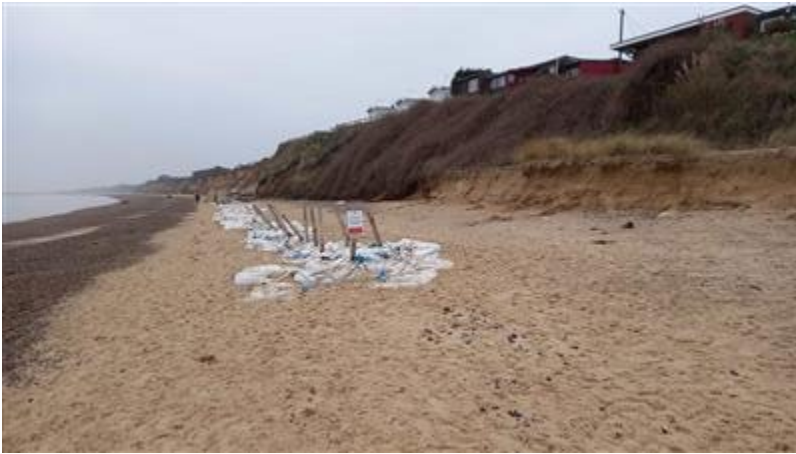
Photos of supratidal beach:

Impression of supratidal beach volume: In most southern areas, fallen cliff material is tending to maintain upper beach levels. Upper beach gradient is being maintained by material adjacent dune faces.

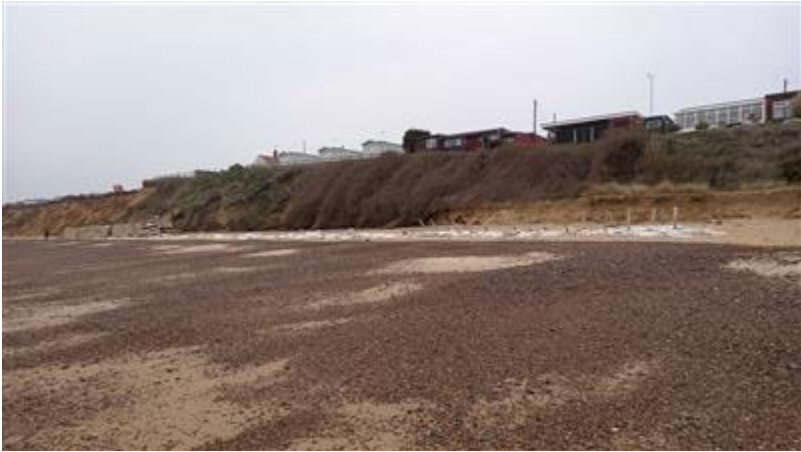
Photos of 'The Cliffs' properties:

Temporary concrete walling has created a cliff face promontory by reducing erosion. Erosion has however encroached behind the southern end walling section which itself is now cracked centrally, probably due to movement caused by waves. Cliff face loss to north side of walling has increased with falls in some areas now as high as the cliff top. Remaining cliff face in this area is likely to be unstable due to its steep angle. Note overhanging vegetation partially obscuring extent of erosion in places.

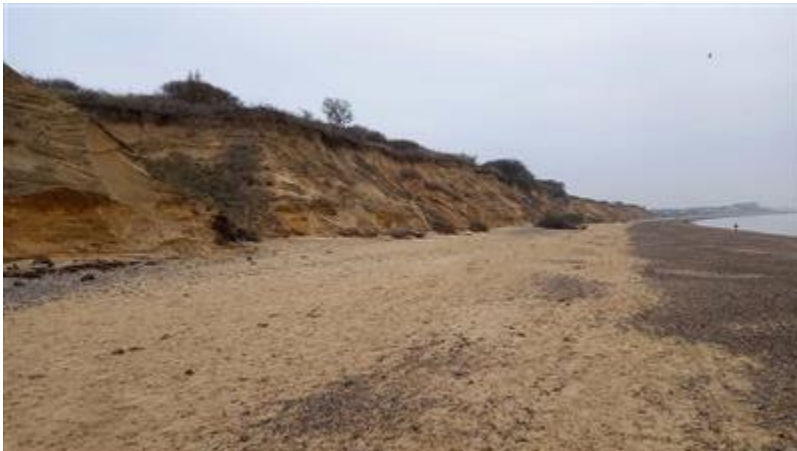
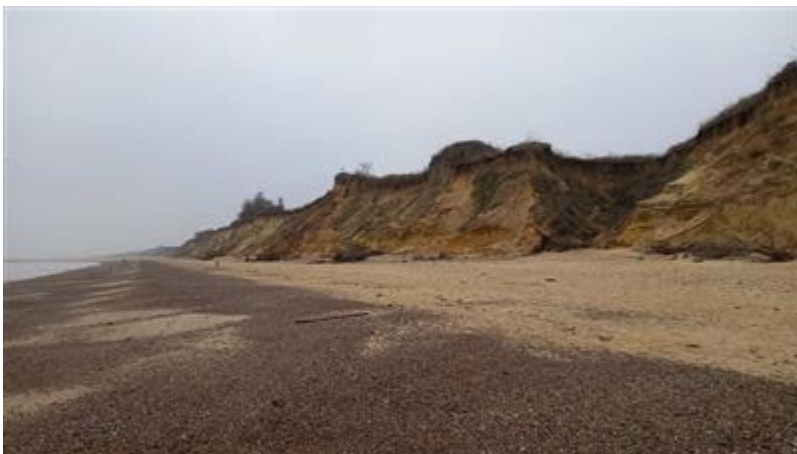
Photos of cliffs north of rifle range wall:

Cliffs from Pontins south benefitting from increasing beach width. Northern cliffs remain vulnerable to increased sea levels and significant wave action.

Conditions earlier this month, described above, have caused significantly more cliff erosion and loss.

- Evident cliff top recession

- Overhanging cliffs
- Cliff toe recession
- Active cliff erosion supplying supratidal beach material
- Severe continued erosion of cliff face
- Natural regrading of cliff face
- Slumping
- Sliding
- Topples and falls
- Active scree slope
- Accretionary wedge at cliff toe
- New debris exposed on cliff face
- New vegetation at base of cliff

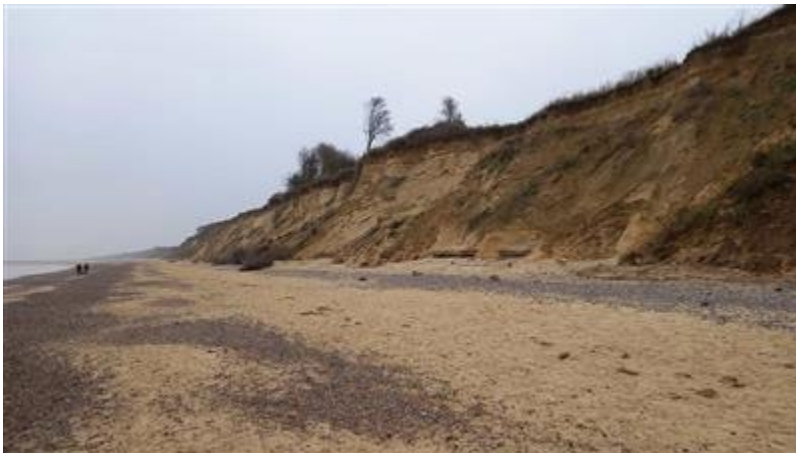
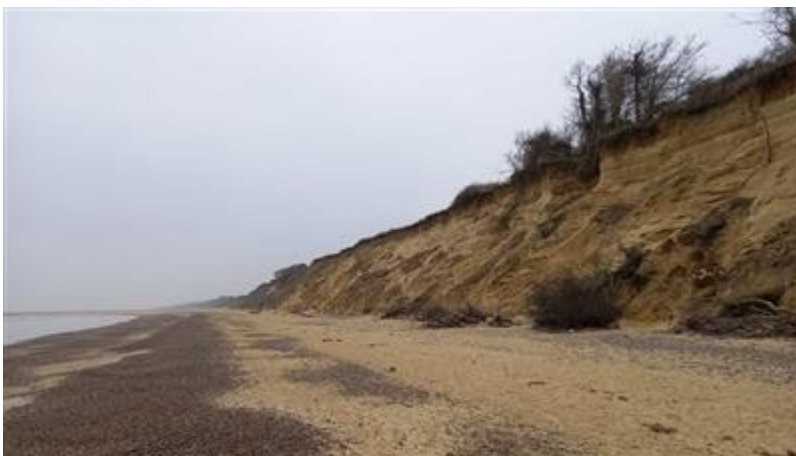
Photos of cliffs south of rifle range wall:

- Beach cliff meeting unvegetated cliff face
- Evident cliff top recession
- Overhanging cliffs
- Cliff toe recession
- Active cliff erosion supplying supratidal beach material
- Severe continued erosion of cliff face
- Natural regrading of cliff face
- Slumping
- Sliding
- Topples and falls
- Active scree slope
- Accretionary wedge at cliff toe
- New vegetation at base of cliff

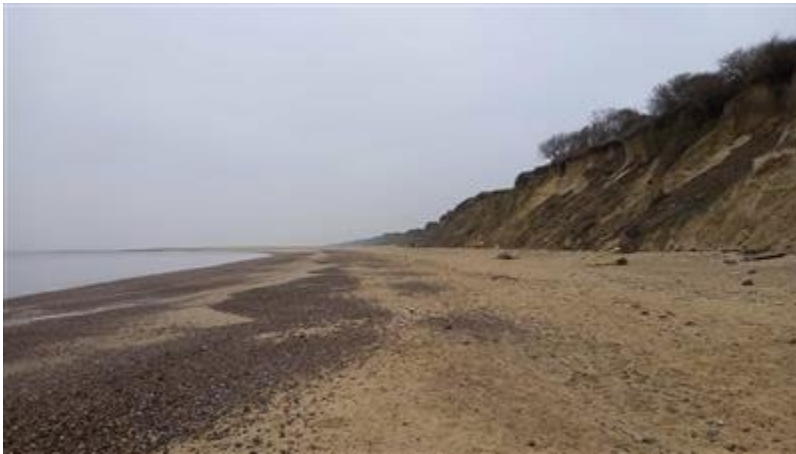
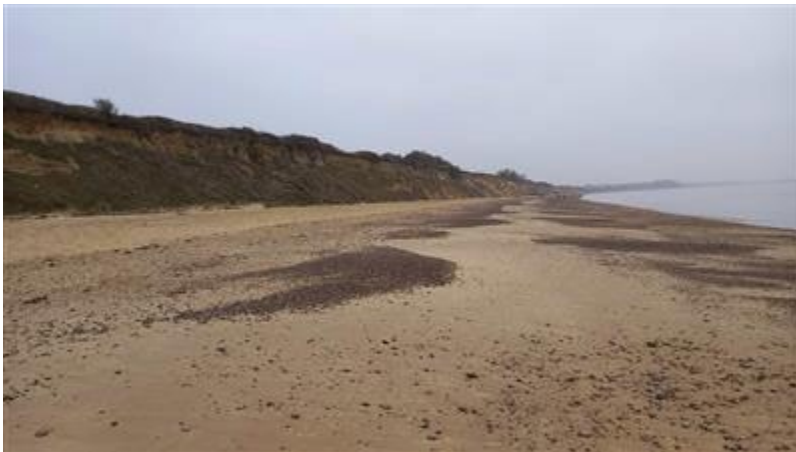
Photo of Benacre Ness and Pontins frontage:

Pontins benefitting from increasing beach width immediately north of migrating Ness with upper beach at base of cliff stabilising and becoming colonised by marram grass. Surface water drainage outflow at Pontins access currently unable to maintain clear channel across beach to sea. Extreme north end of Ness appears possibly narrowed towards cliffs.

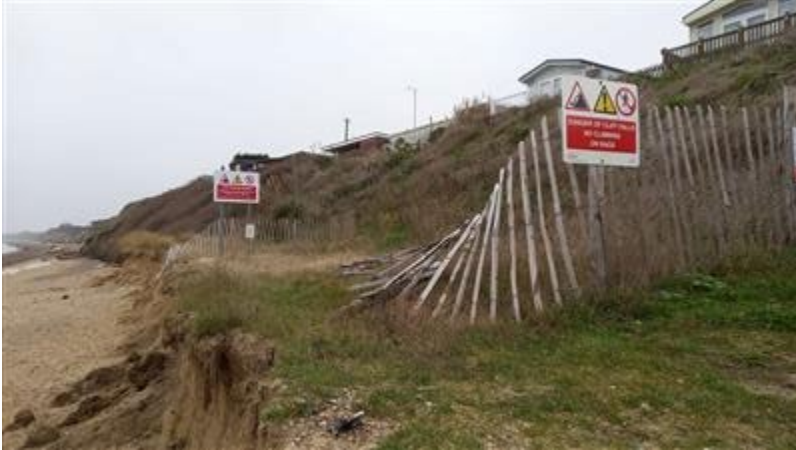
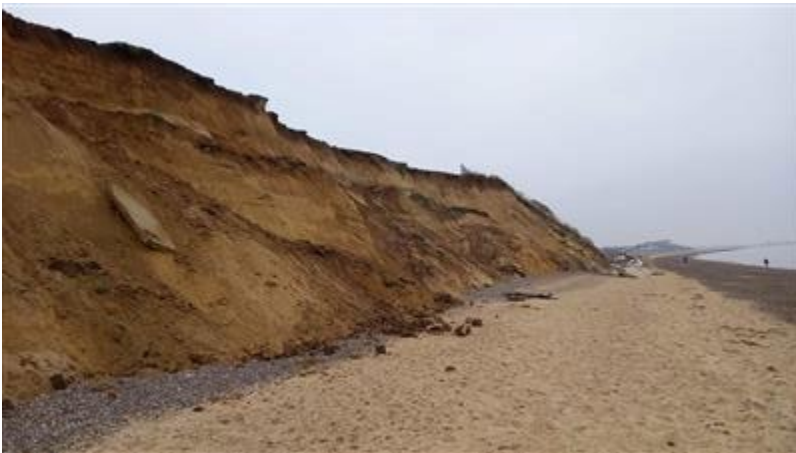
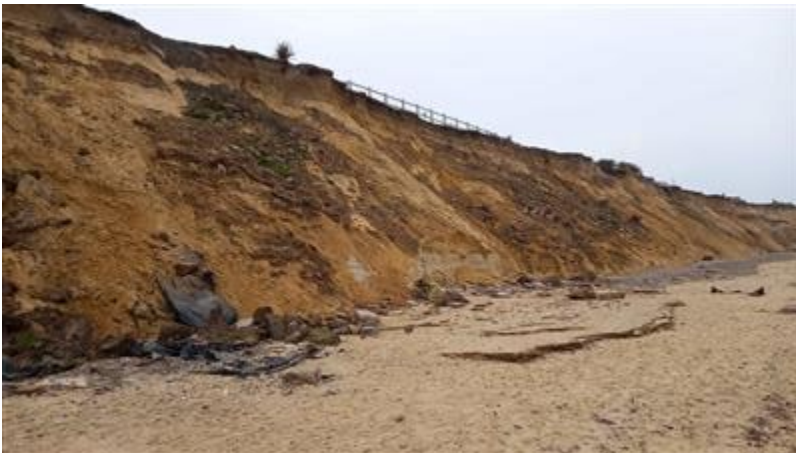
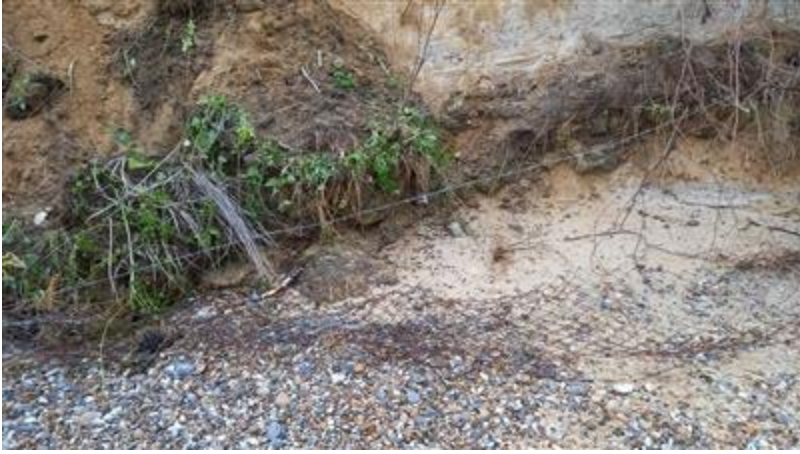
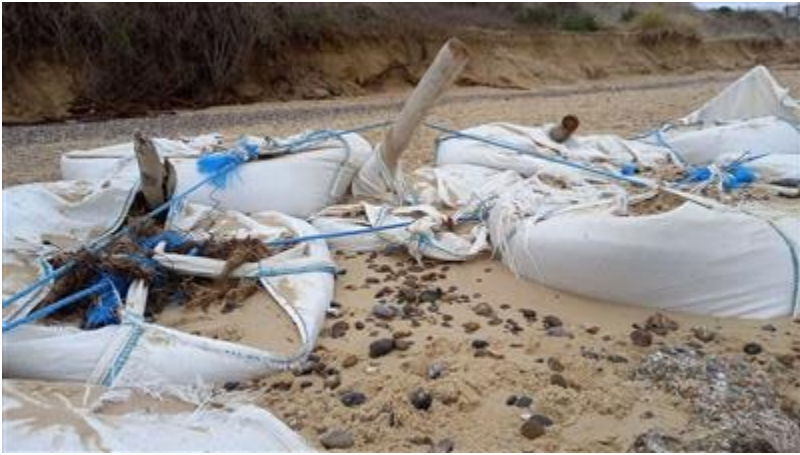
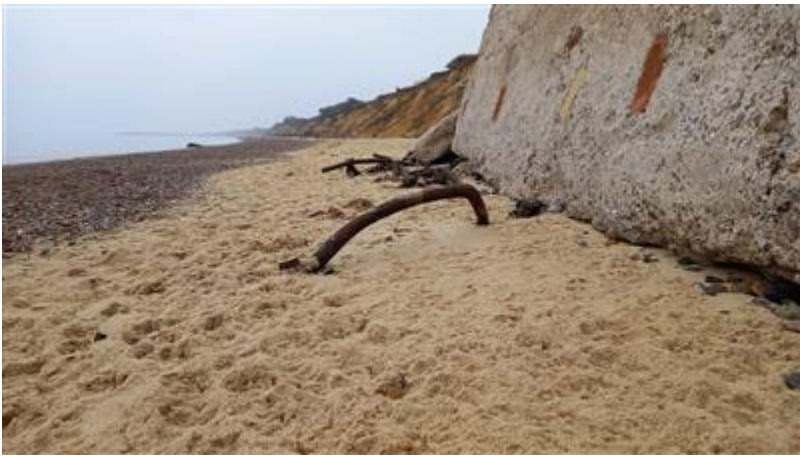
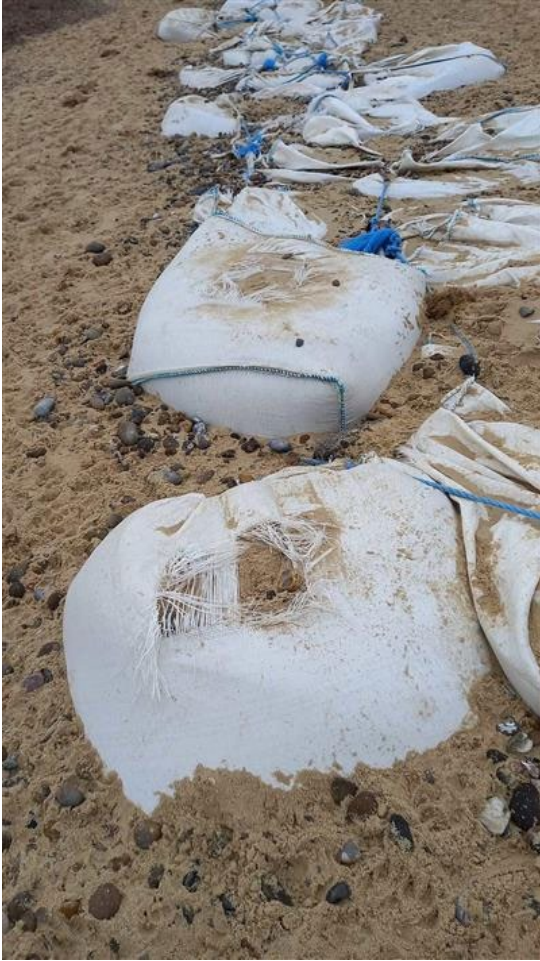
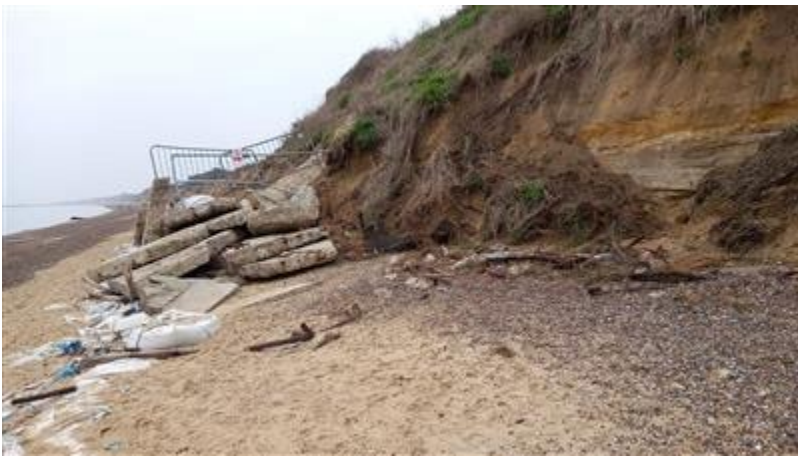
Images of hazards and/or debris

Some cliff faces vertical and yet to attain more stable angle of repose and much fallen vegetation remains on beaches. Large concrete slab on beach below the south end of Pakefield Caravan Park (PCP) is now exposed and has old fixings projections. Various materials continue to fall from PCP cliff top assets; however, PCP are understood to be clearing debris and have been removing vulnerable assets near cliff edge. Risk from previously overhanging concrete slab now greatly reduced. Current relatively healthy beach levels probably bury more debris than is visible, although many pieces of corroded steel are exposed. Fallen material on north side of concrete walling includes barbed wire. Overhang of

southern masonry exposed in cliff face, not worse. Temporary bag defences continue to deteriorate in condition.
