Thorpeness Monthly Monitoring Report

Date & Time of Survey: Feb 25, 2022; 09.30

Inspector: Keith Roper

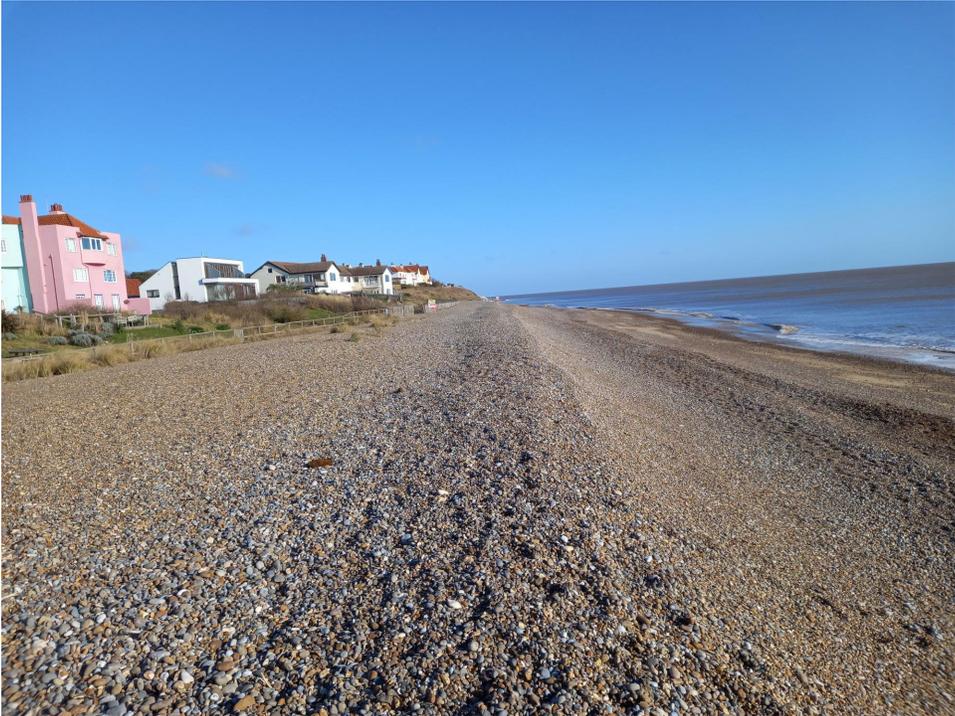
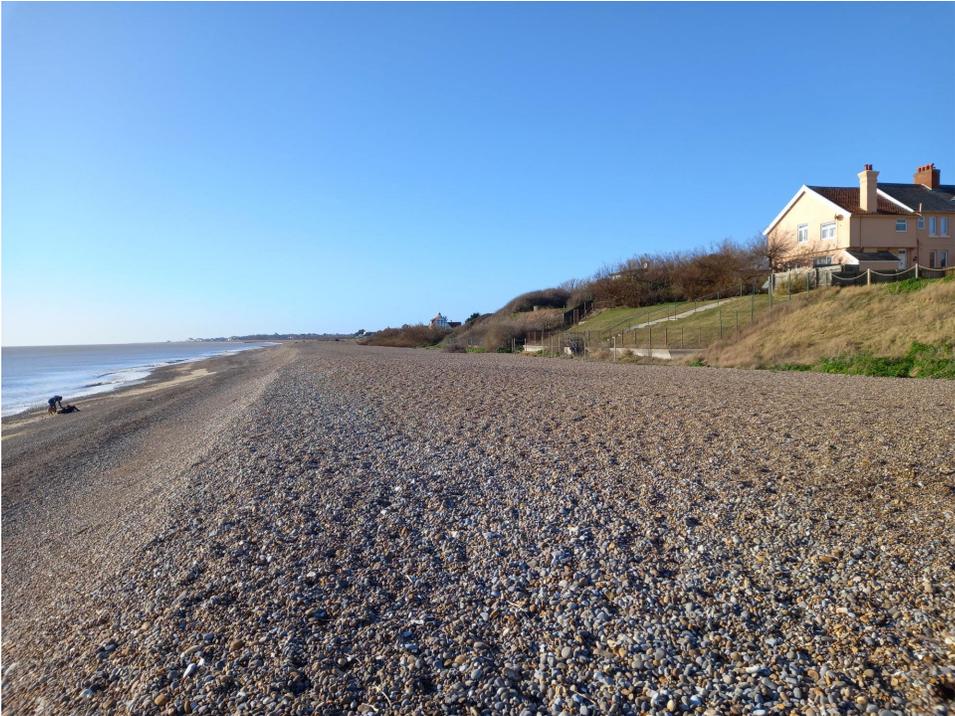
Images of the southern UNDEFENDED frontage:

The upper beach berm remains narrowed, similar to previous, with some loss and steepening of seaward face. Sinuous foreshore alignment has developed with shingle rich deposits around, and just above, the mean high water mark.

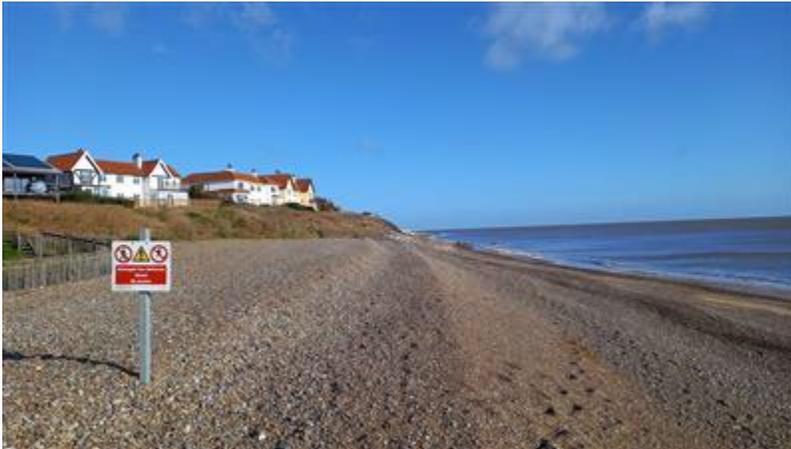
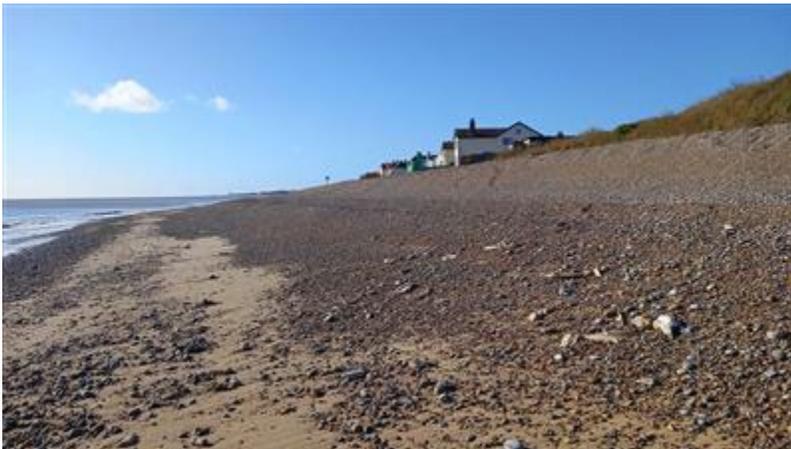
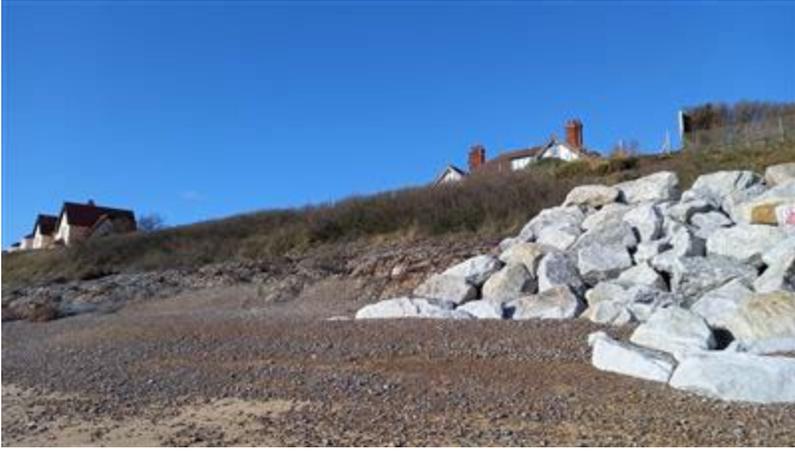
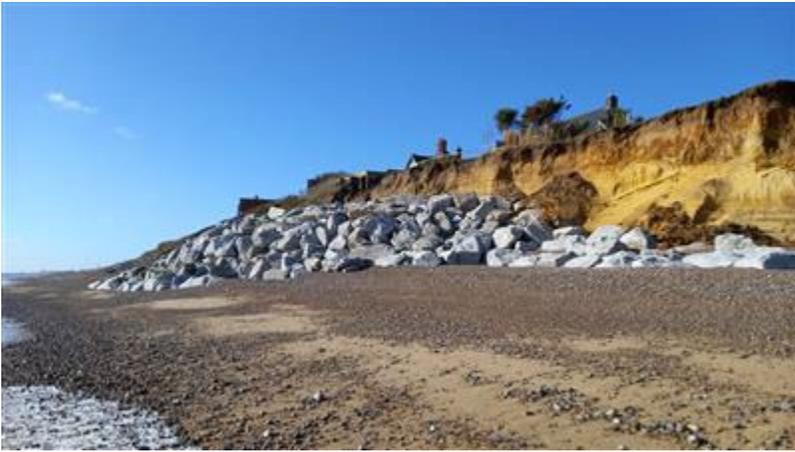
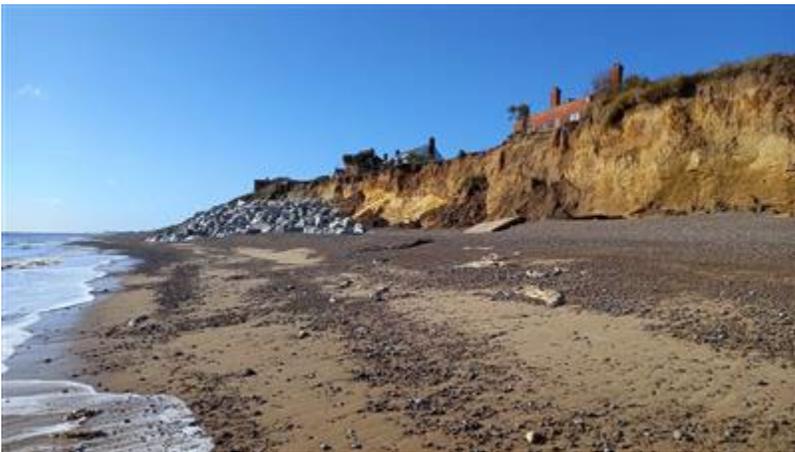
Images of the Central Defended frontage:

There has been recovery of beach levels, particularly to the south side of the temporary rock structure and extending to the northern parts of the Phase 1 defences. The shingle rich berm to the north side of the rocks has persisted. The sinuous foreshore alignment continues from the southern frontage.

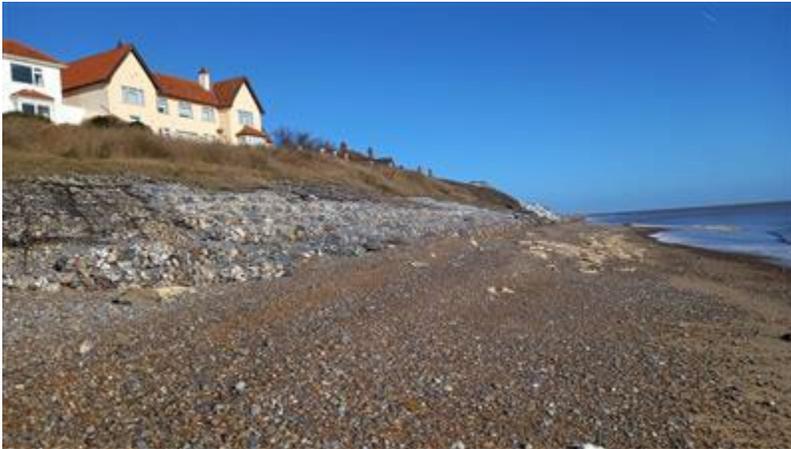
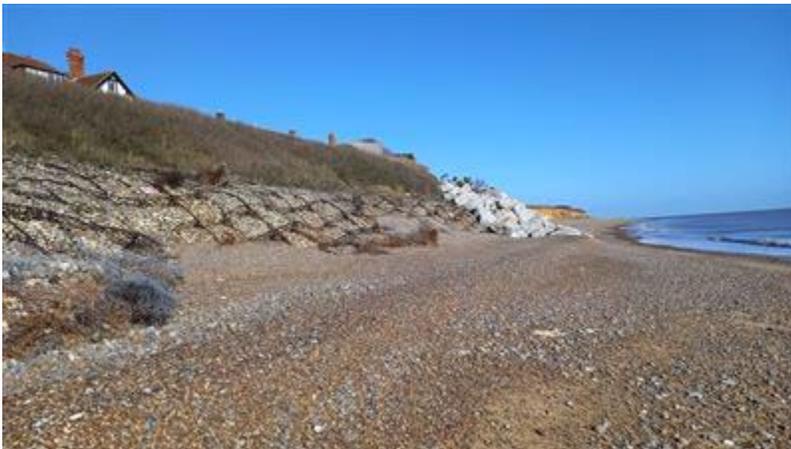
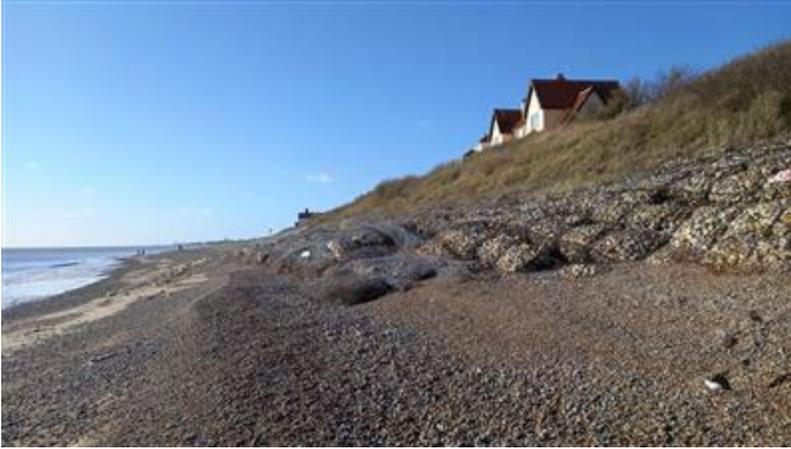
Images of the gabions:

Southern end similar to previous with some protection likely from recent beach accretion. The worst damaged remaining northern gabions are currently substantially buried. The imported aggregate material was not visible and is assumed buried.

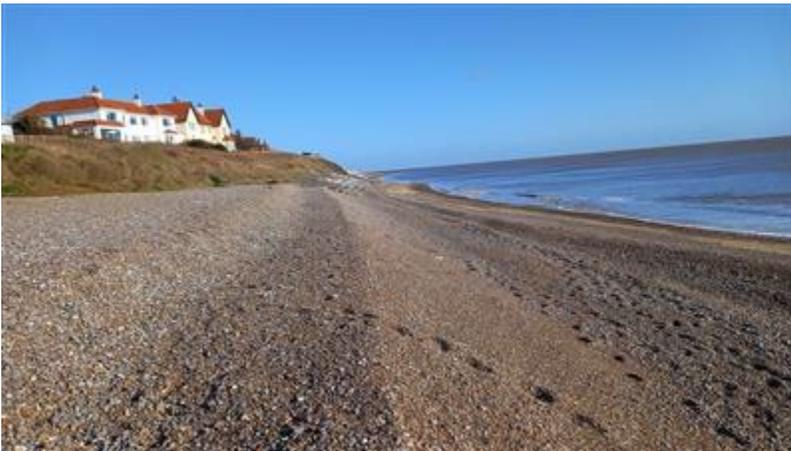
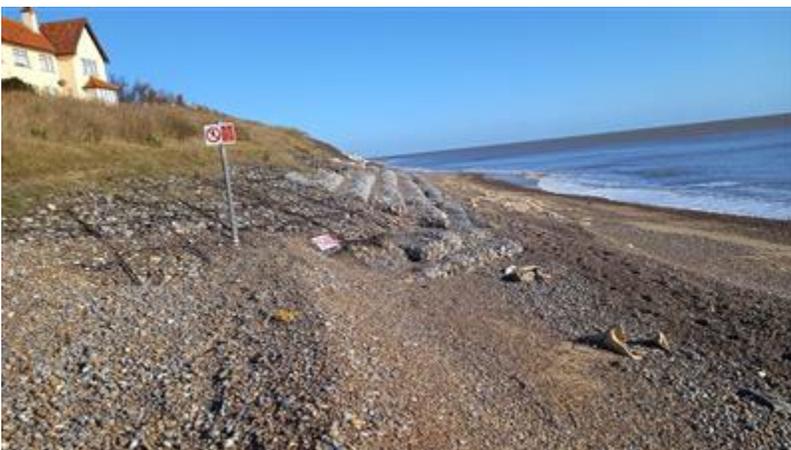
Images of Phase 1 Geobags:

Comments on Phase 1 Geobag condition: Almost entirely buried with recent shingle deposits above the mean high water mark at the north end, below the main upper beach berm.

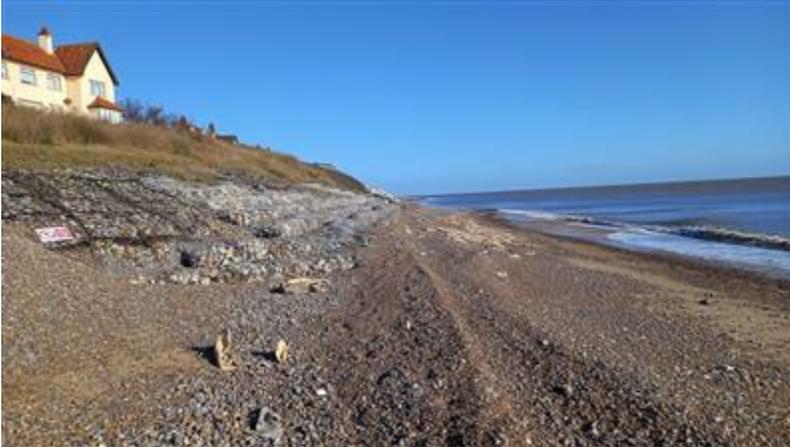
Images of Phase 2 Geobags:

Remains are partially exposed at southern and northern ends of Phase 2 but improved inter tidal beach levels have covered many of those seen during the previous inspection.

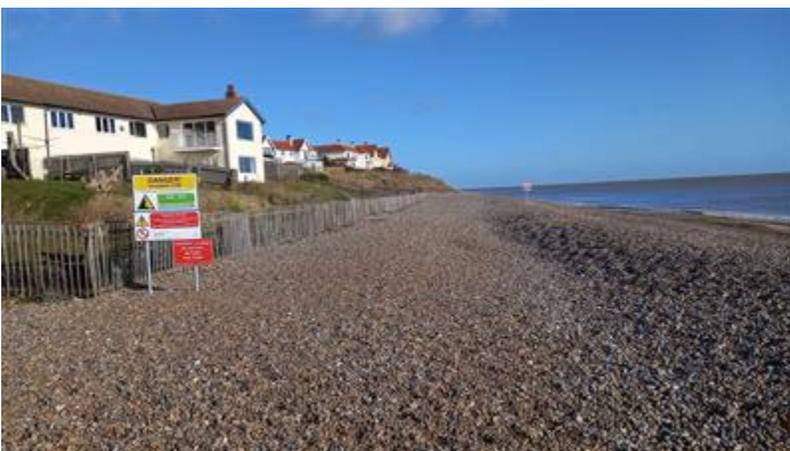
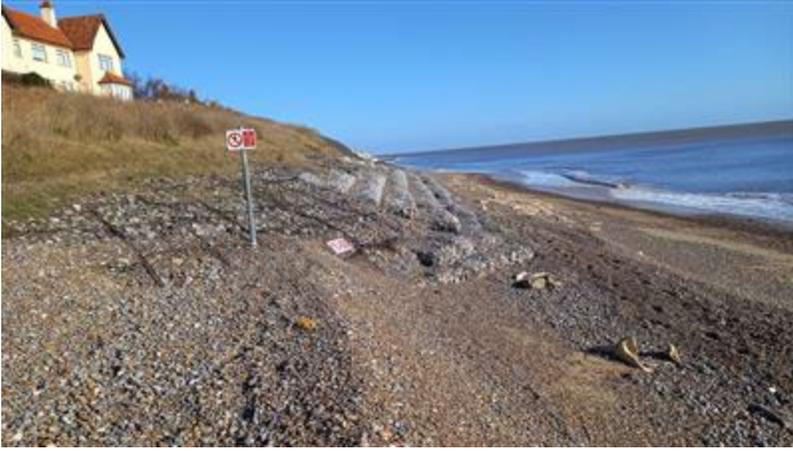
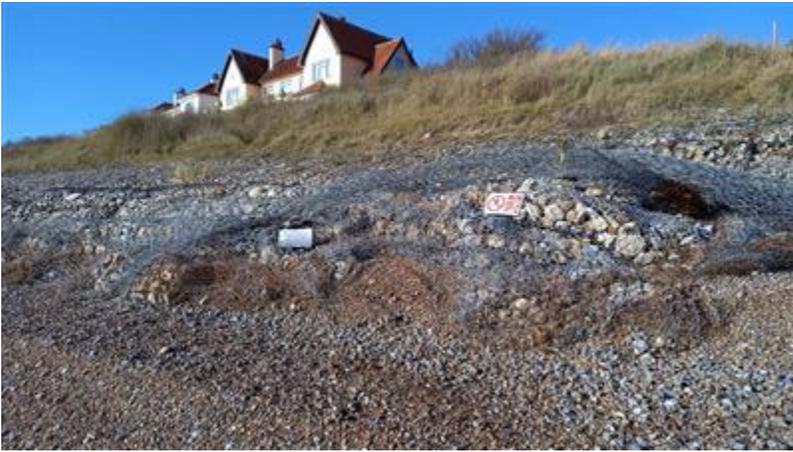
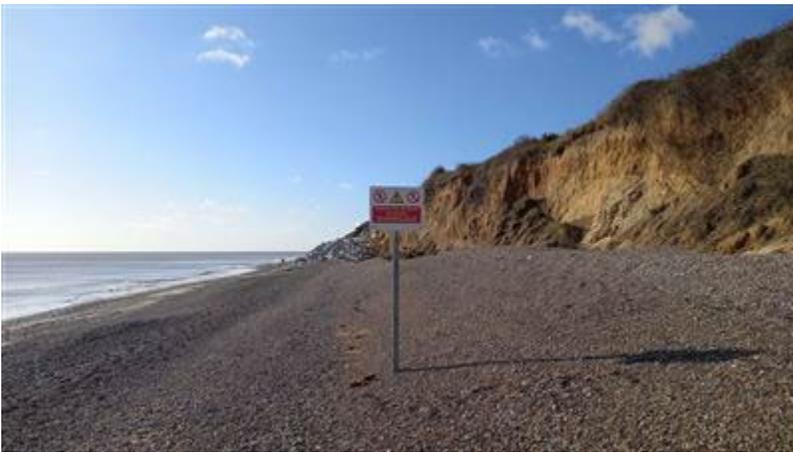
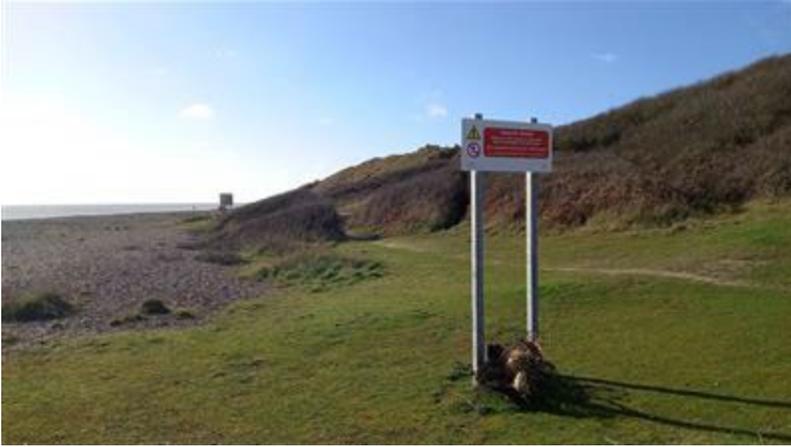
Images of signs:

Comments on signage: Signage in place and satisfactory except for a small minority on the remaining gabions

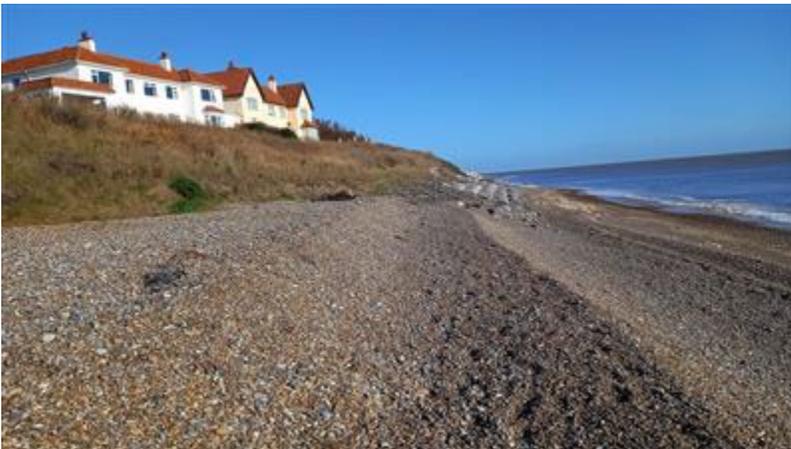
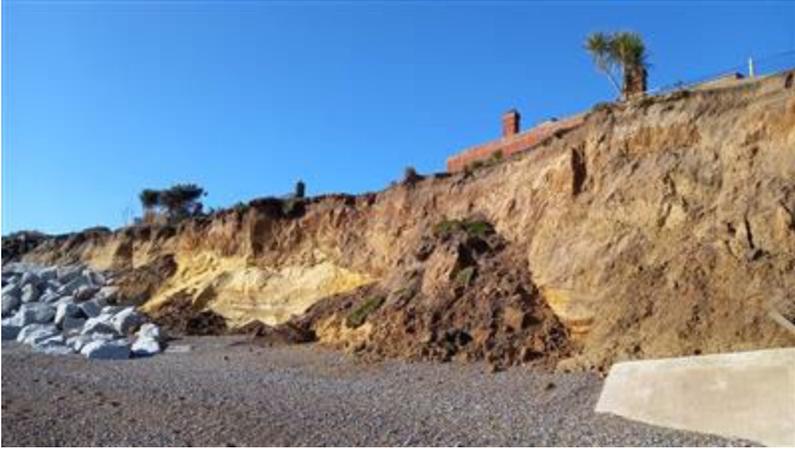
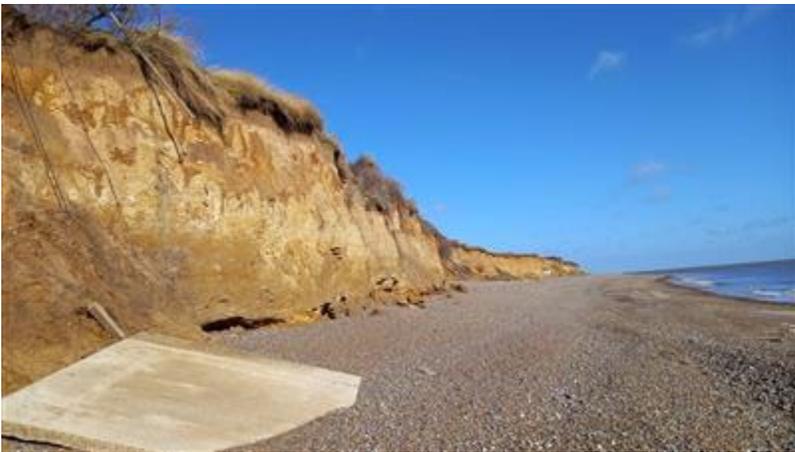
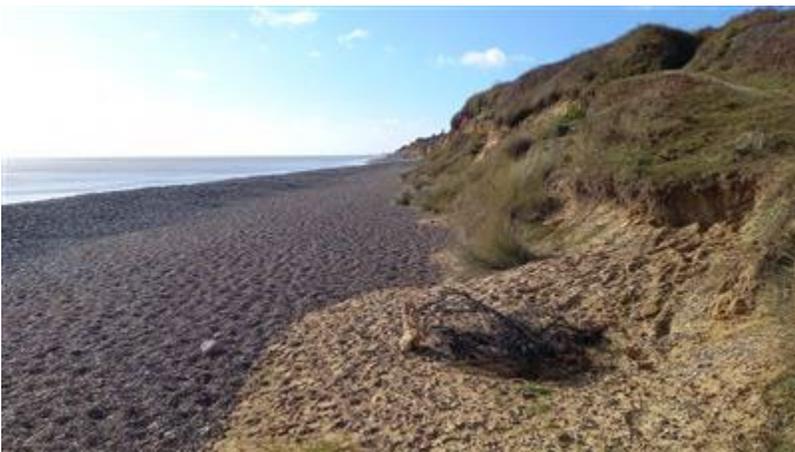
Images of Hazards/Debris: Examples recorded on inspection below.

Loose gabion wire remains on the upper beach berm to the southern end of Phase 2 defences and on the northern undefended frontages. Beach accretion on the south side of the emergency rock has covered exposed wires and stakes noted previously. There are currently vertical and overhanging cliffs below Red House and immediately north, with some bases undercut where exposed by a comparatively low beach.

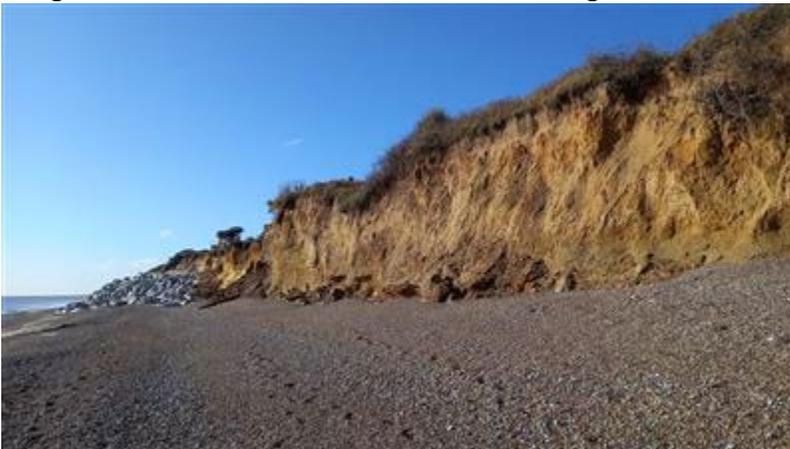
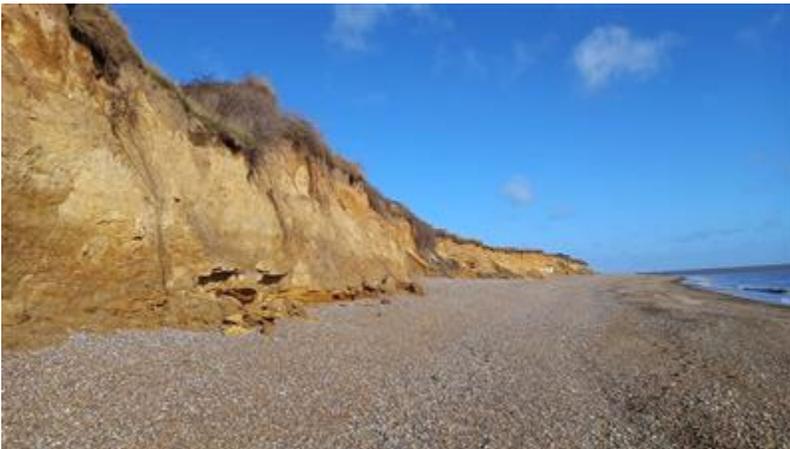
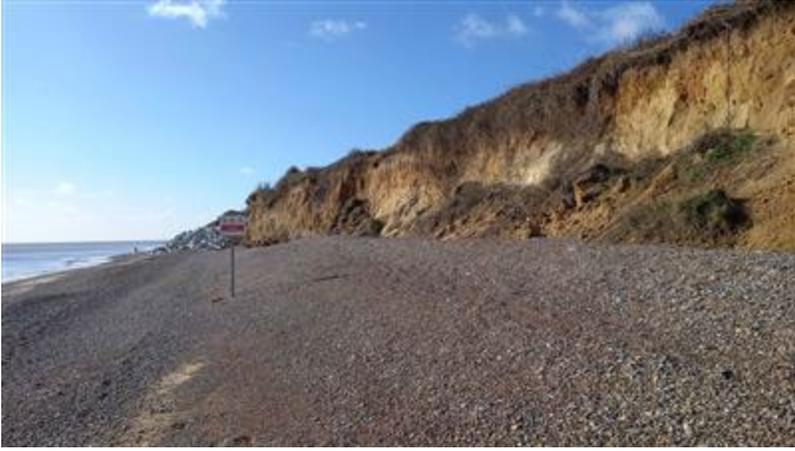
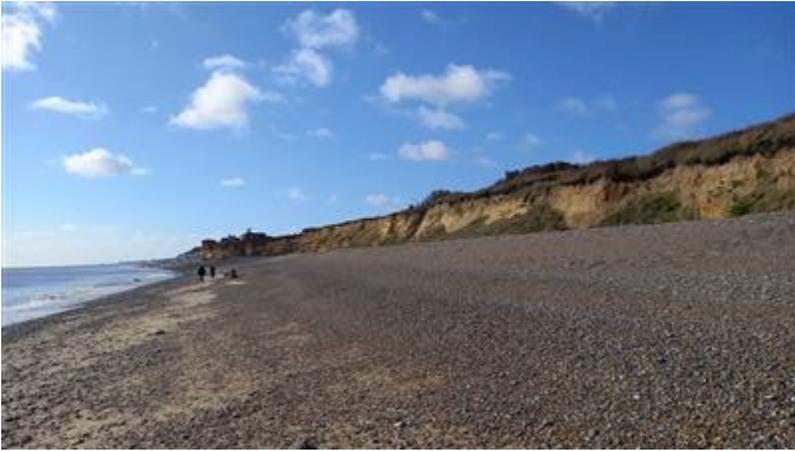
Images of the Northern UNDEFENDED Frontage:

A noticeable recovery of beaches and the supratidal material has been disturbed and pushed landward, meeting cliff bases and affording them some protection in the south. This is not the case in the extreme south, just north of the failed defences, where cliffs have been undercut causing falls. The gradient of the front face slope of the upper berm remains shallow and now more closely matches the overall beach profile.
