Thorpeness Monthly Monitoring Report

Date & Time of Survey: Feb 1, 2022, 15:00

Inspector: Keith Roper

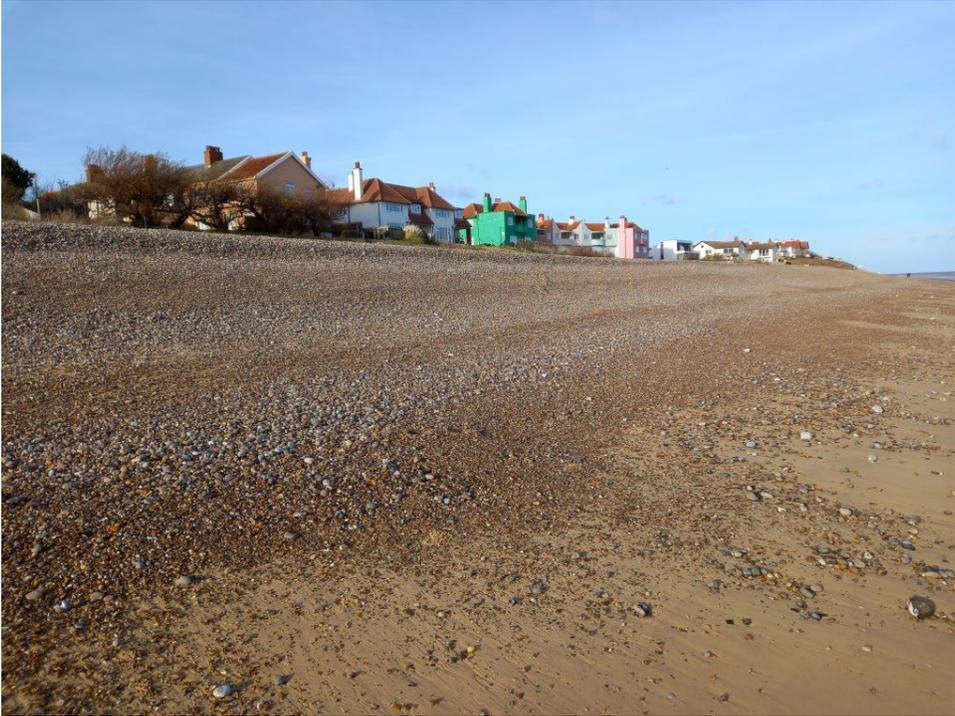
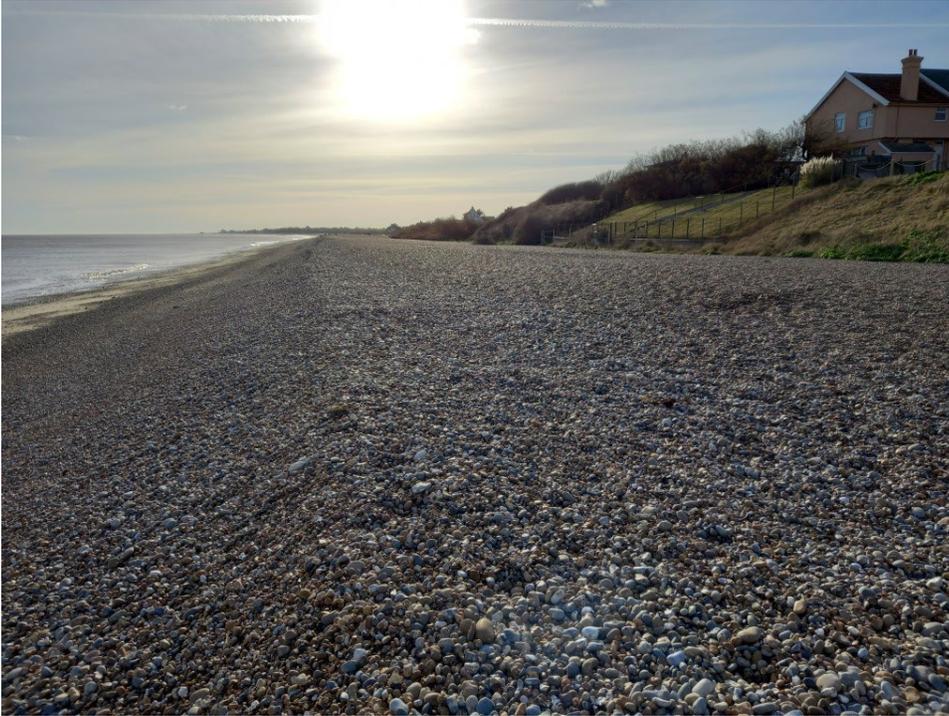
Images of the southern UNDEFENDED frontage:

Main upper beach berm has narrowed and the seaward face is characterised by an approximately 45 degree angled slope to the foreshore, which has lost previously established modest shingle berms. The top of the upper berm has been increased in height along seaward edge in some locations, for example near Tinkers End (probably the effects of significant wave action).

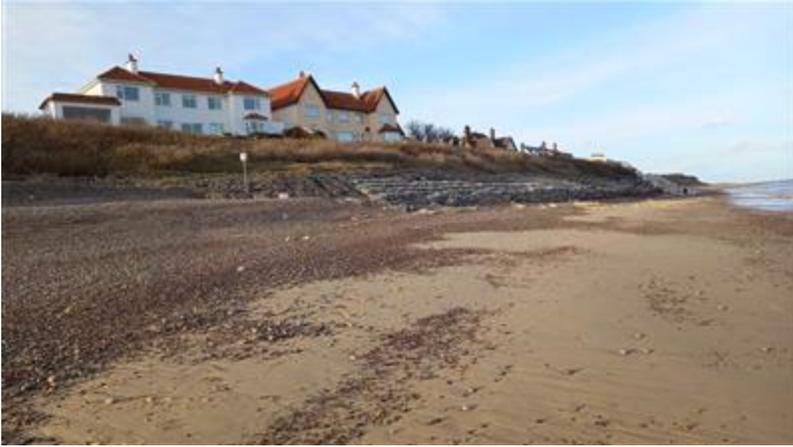
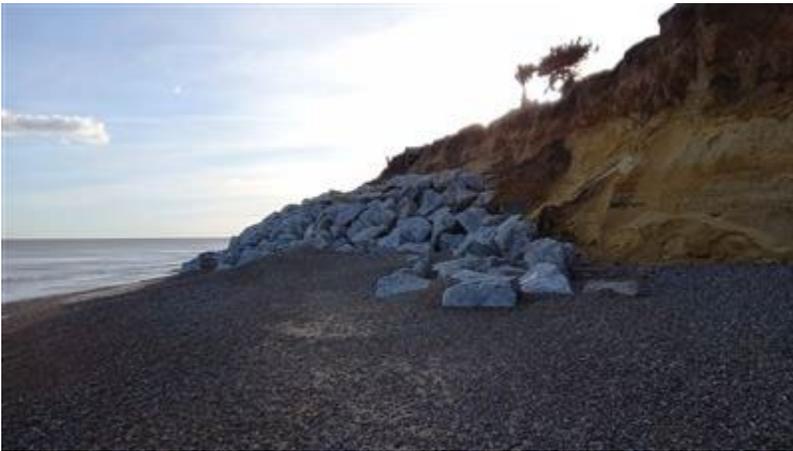
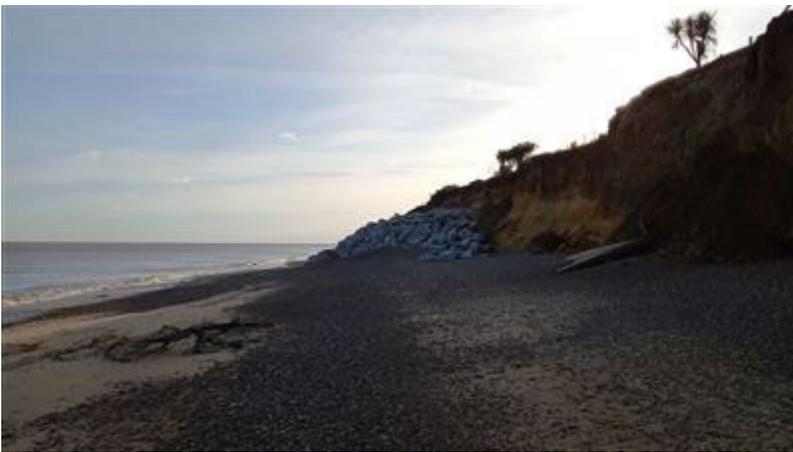
Images of the Central Defended frontage:

There has been a loss of foreshore material and beach levels lowered adjacent the Phase 2 defences. The previously noted lower foreshore beach promontory near the new rock structure was no longer apparent on inspection. A ridge of shingle rich material has persisted on the north side of the rocks below No. 22.

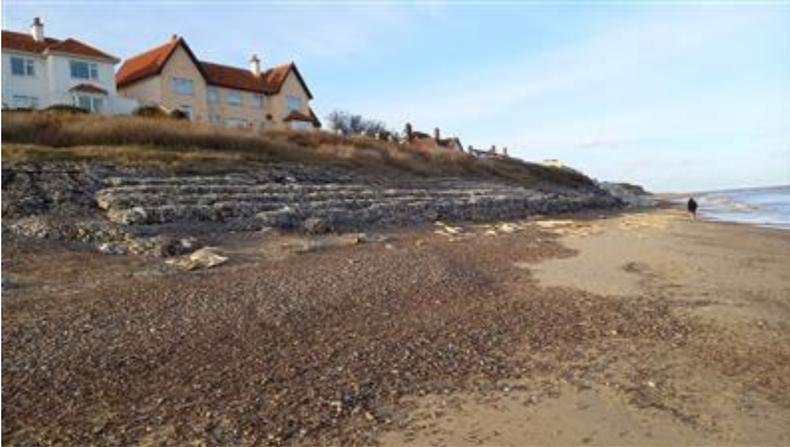
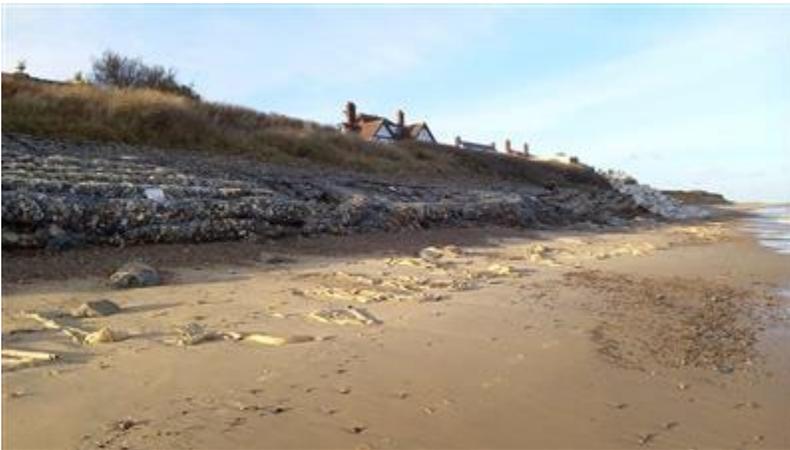
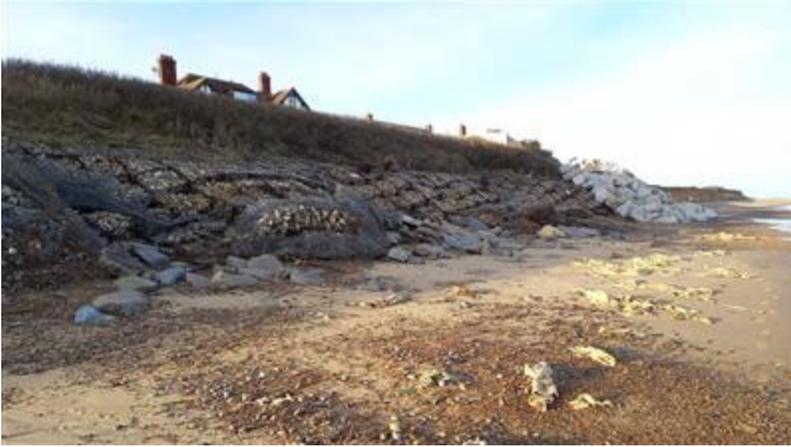
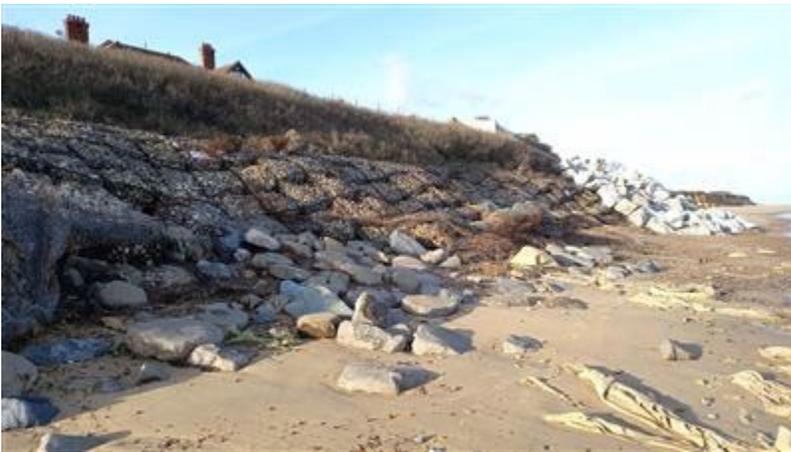
Images of the gabions:

There has been more damage and deterioration to northern areas, probably due to reduced foreshore level, narrowed beach, and greater wave exposure during recent increased high tide levels. The supplementary aggregate added last year is now extensively dislodged and being dispersed on the foreshore.

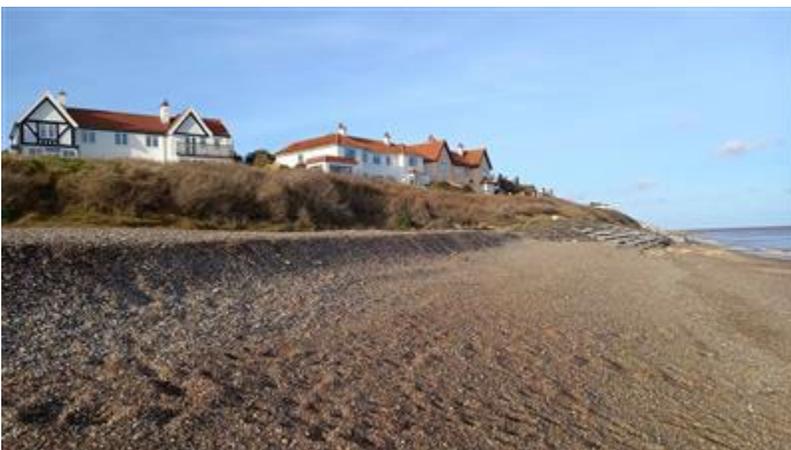
Comments on Phase 1 Geobag condition: Buried
Images of Phase 1 Geobags: (upper shingle berm coverage)

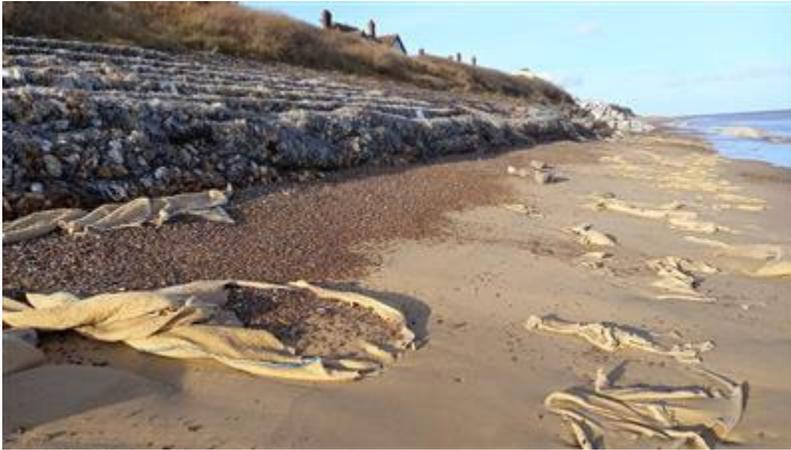
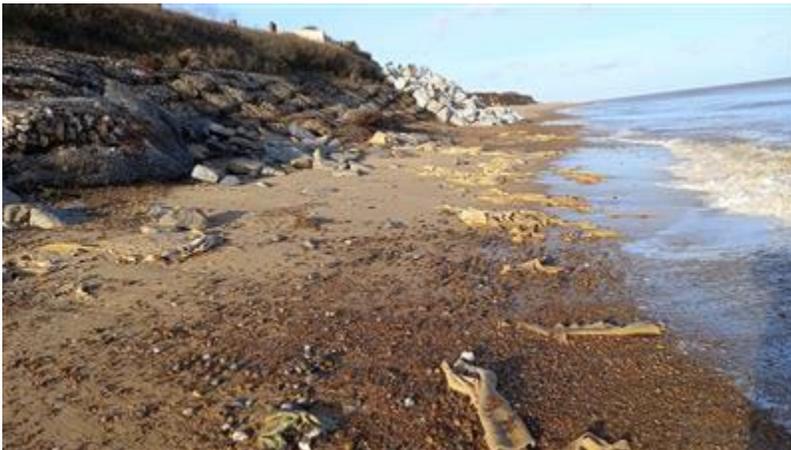
Images of Phase 2 Geobags:

Lowered foreshore has exposed remains of bags and geotextile fabric with some lying just north of defences termination.

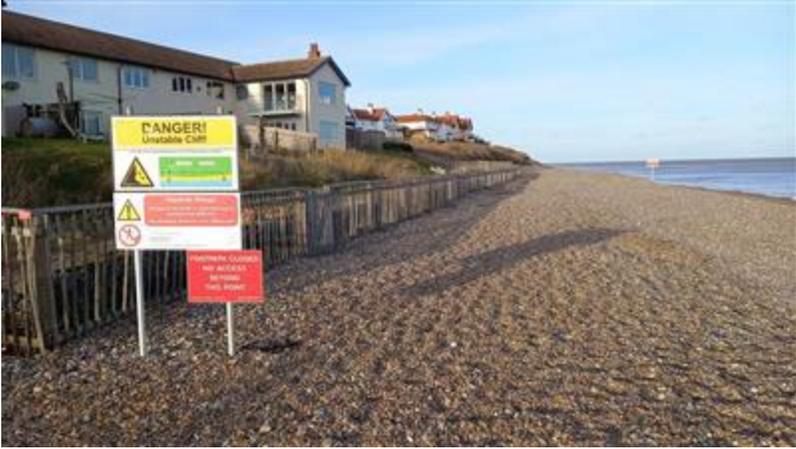
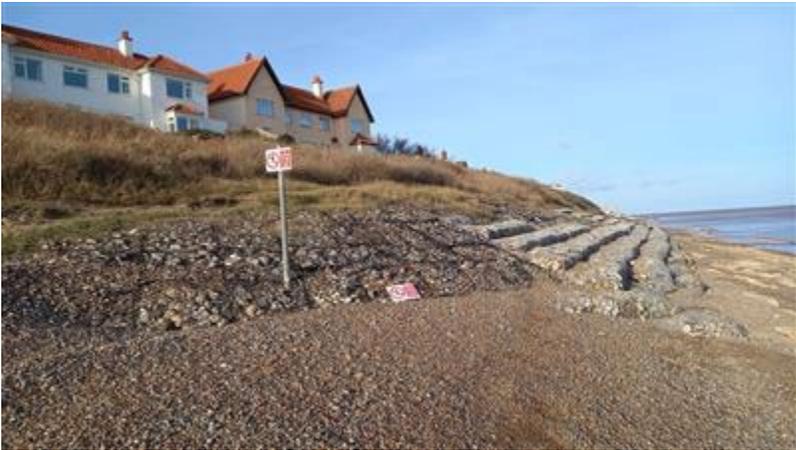
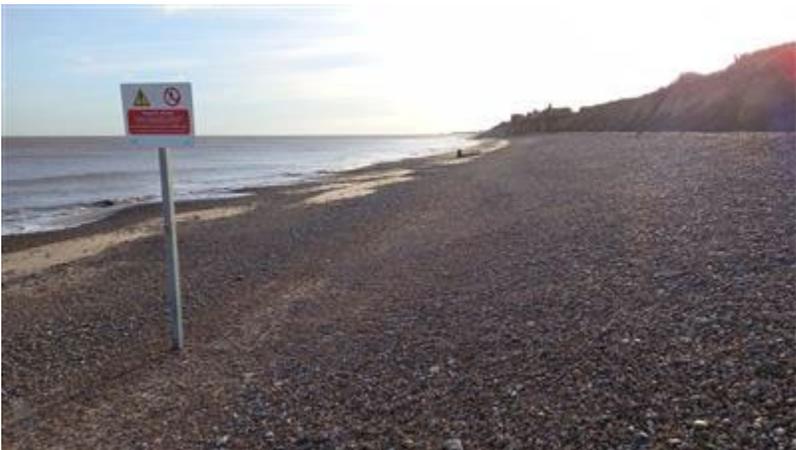
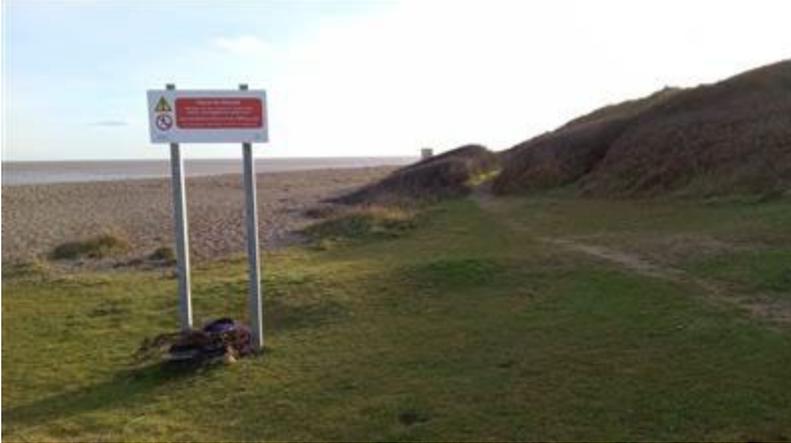
Images of signs:

Comments on signage: Diversion and prohibitive signage in place, mostly legible, and displaying clear messages. Two of the many signs on gabions have been noted as requiring replacement.

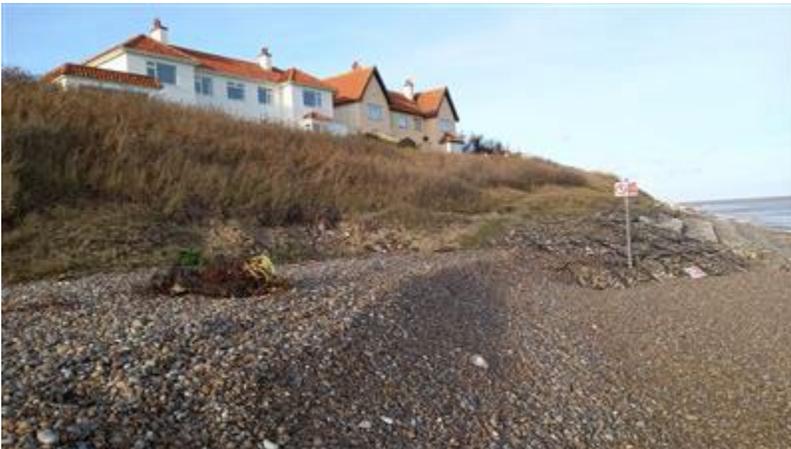
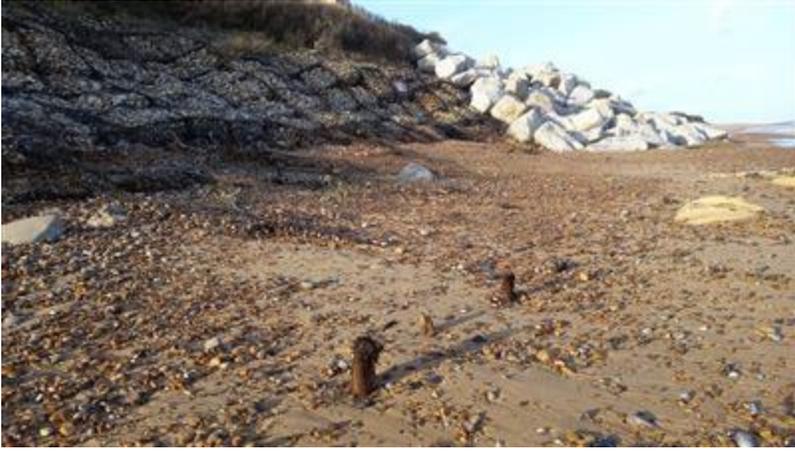
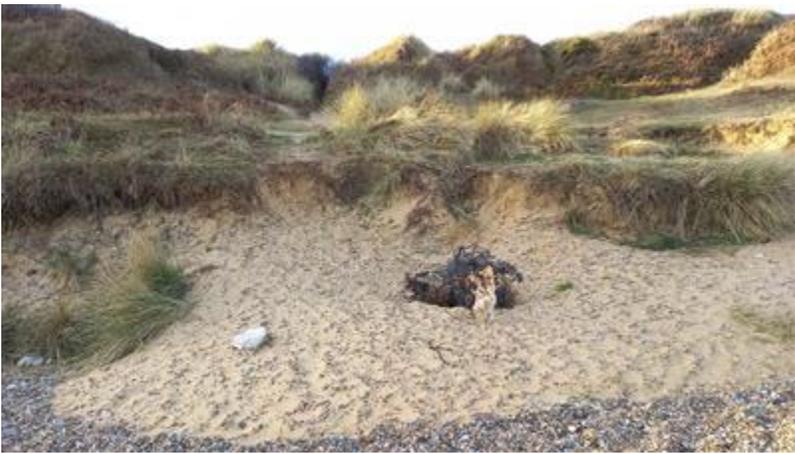
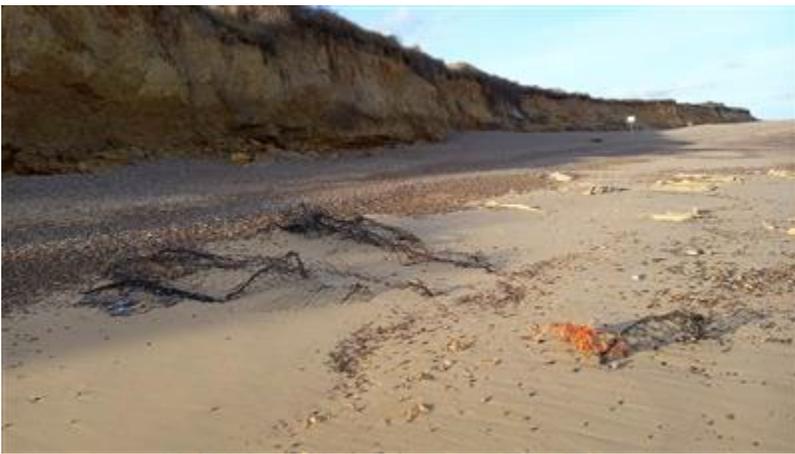
Images of Hazards/Debris: Examples recorded on inspection below.

Several small pieces of detached gabion wire and other minor debris lie in various locations along frontages – some are likely to have been collected by walkers in the area. Lowered beach levels have exposed more gabion basket remains and tops of timber stakes.

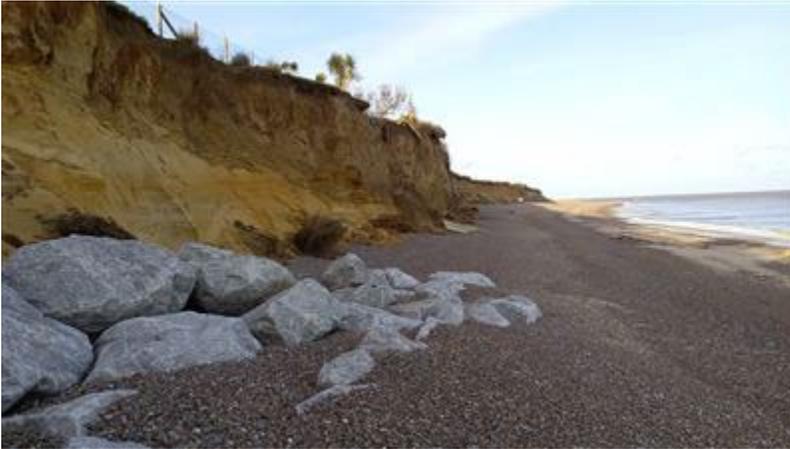
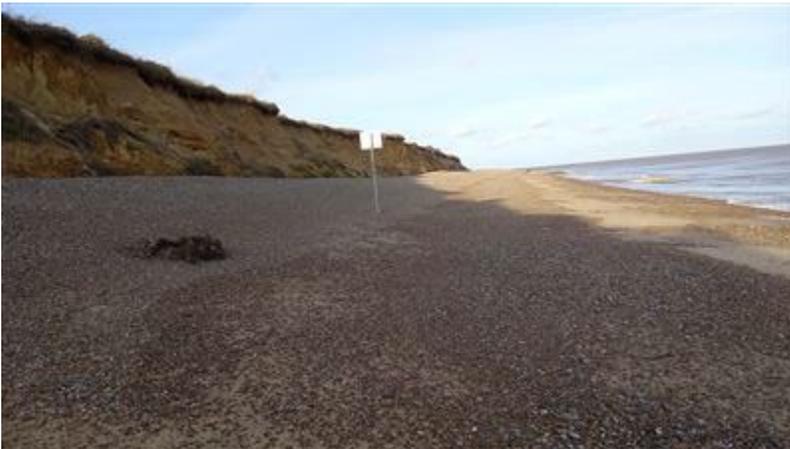
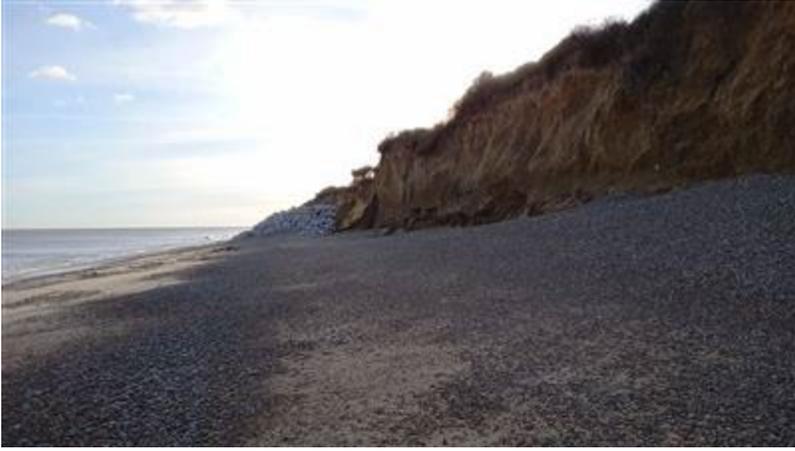
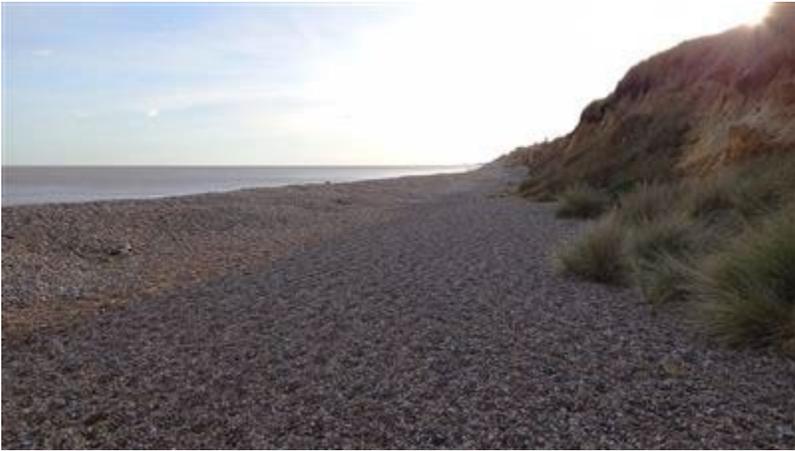
Images of the Northern UNDEFENDED Frontage:

Lower foreshore level has been reduced. Upper berm has been narrowed with the remaining material pushed landward maintaining a relatively high level near the cliff base, except below and north of Red House where the cliff base could be more vulnerable to seas. The northern upper berm is currently characterised by a shallow angled face sloping seaward.
