## **Gunton and Corton Options Appraisal**

### **Appendix B - Cliff Instability Assessment**

**Document No. 03 | 2.0**

**Coastal Partnership East**

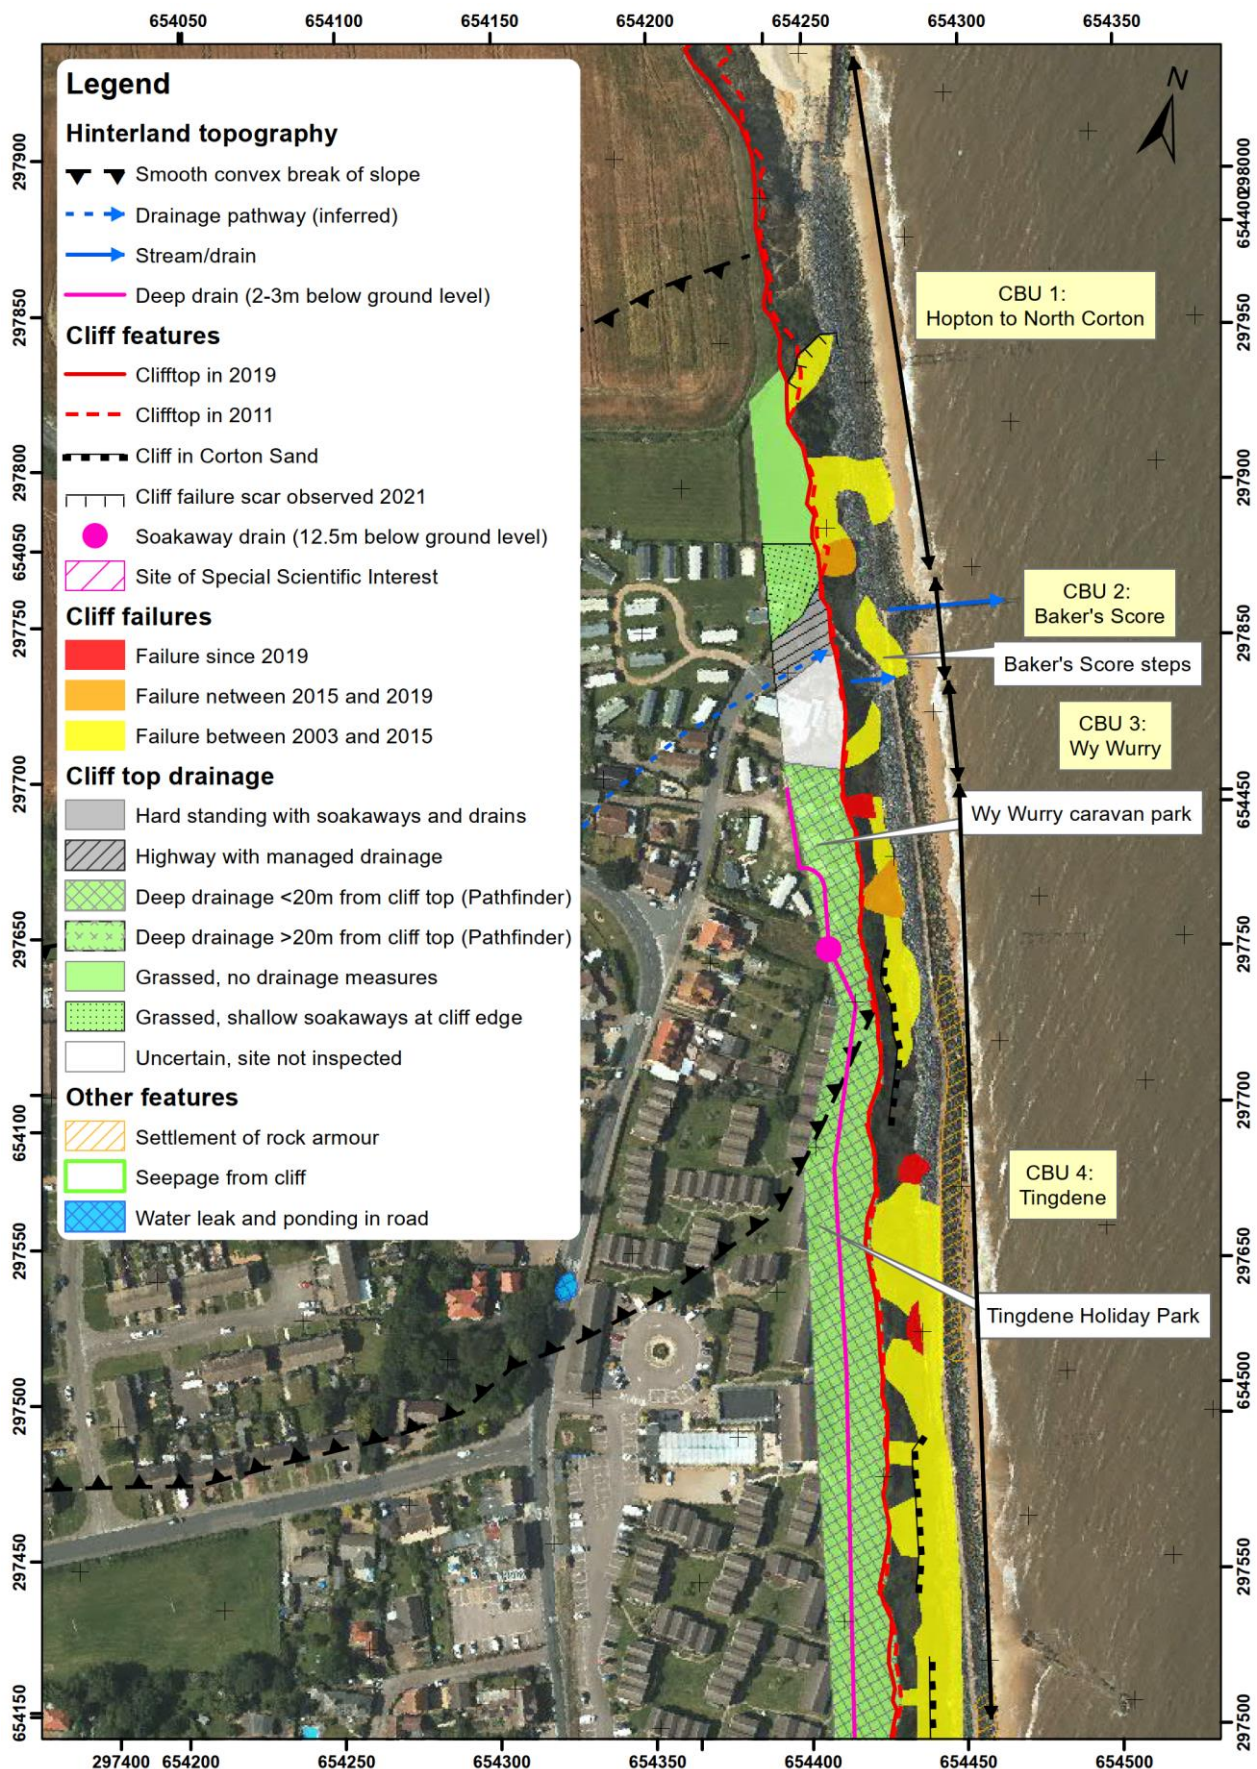
Figure 2-5a. Geomorphology, cliff activity and drainage, Baker's Score to Tingdene Holiday Park. Note: section is divided into Cliff Behaviour Units (CBU)

- The area north of Baker's Score steps fronting the caravan park and adjacent grassland. Runout of debris (sediment from the cliff) over the rock protection on the lower cliff face has occurred and much of the upper cliff has experienced cliff failure through slumping and mudslides prior to 2019, but no recent activity was observed during the site inspection. This reflects localised failure of the debris apron that mantles the cliff.

- Cliffs fronting the Wy Wurry caravan park have experienced widespread erosion immediately above the rock protection prior to 2015, and large cliff failures of the upper cliff have occurred since 2015, including recent retreat of the clifftop and slumping of the debris apron that was observed during the site inspection.

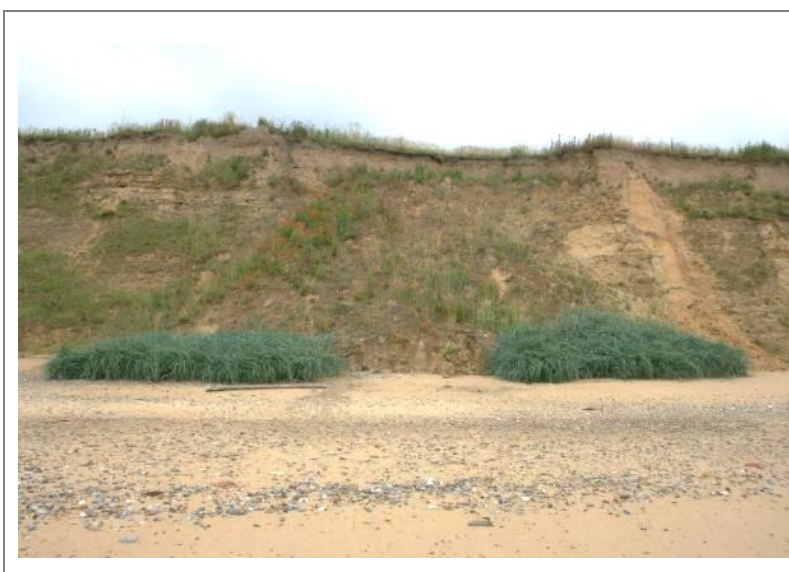
Figure 3.1a. CBU 1a. Degraded, partially-vegetated cliffs fronting caravan park. Vegetation has established at the cliff toe suggesting wave erosion has not occurred for several months at this particular location. The Cromer Till is below the level of the beach and the Lowestoft Till is thin, meaning most of the cliff is formed of Corton Sand.

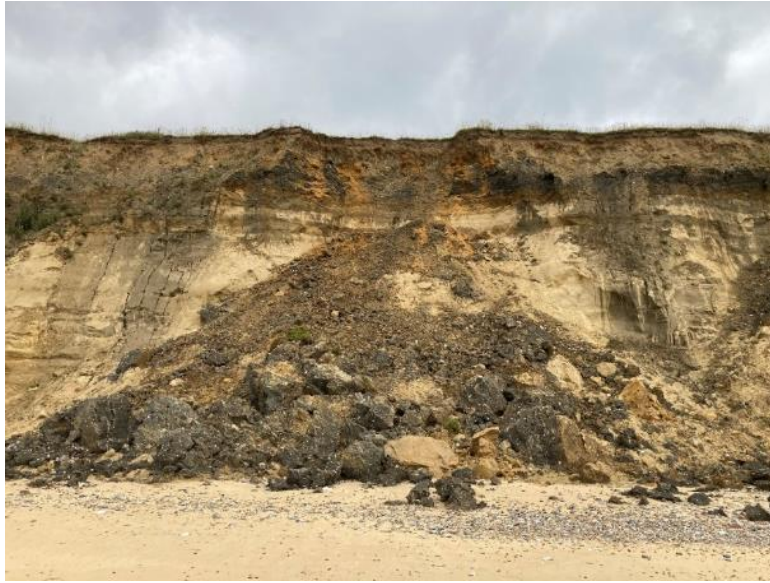
Figure 3.1b. CBU 1a. Active cliffs south of Hopton. The Cromer Till is below the level of the beach. The cliff is formed of Corton Sand with a 2 m capping of Lowestoft Till and Plateau Gravel. Note the darker silt/clay beds in the upper part of the Corton Sand that create local perched water tables. Cliff failure comprises collapse of the whole cliff and retreat of the clifftop.

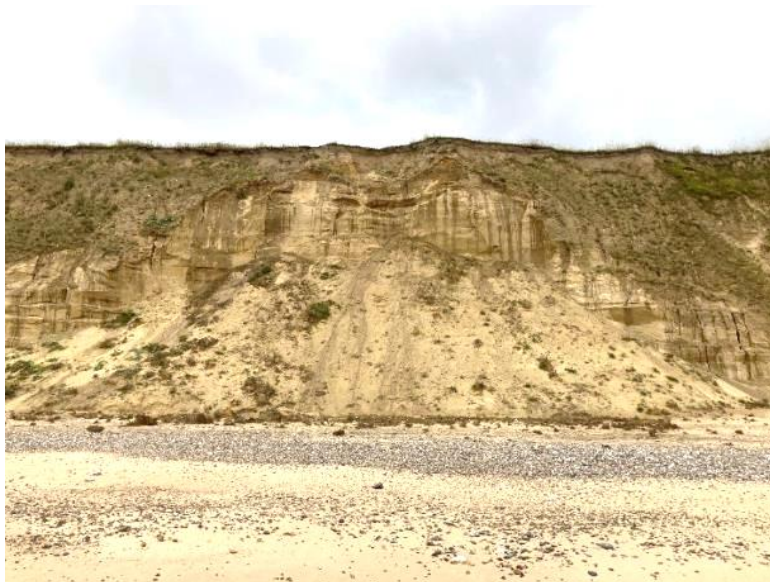
Figure 3.1c. CBU 1a. Active cliffs south of Hopton. The Cromer Till is below the level of the beach. The cliff is formed of Corton Sand with a thin (<1 m) capping of Lowestoft Till and Plateau Gravel. Cliff failure comprises collapse of the cliff formed in Corton Sand with limited retreat of the clifftop.

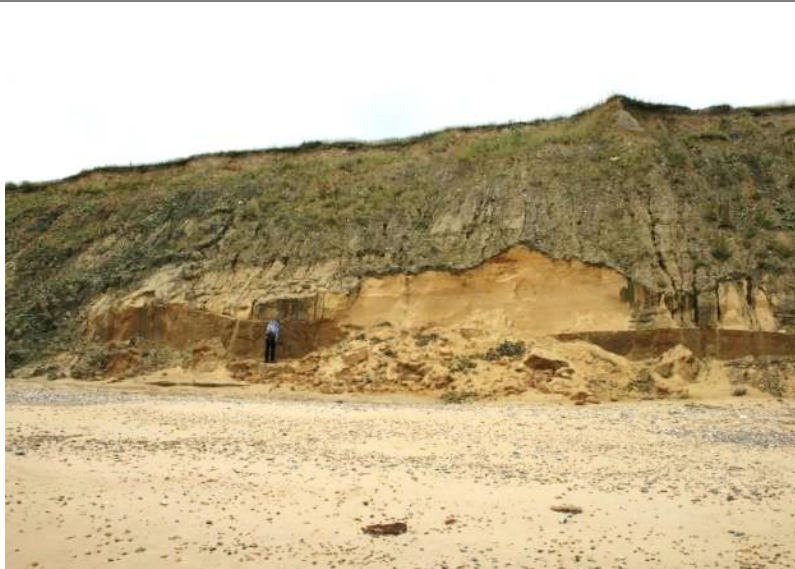
The cliff is very active, with widespread evidence for toe erosion and collapse to form a debris apron and numerous fresh to degraded slump scars in the upper cliff. Where the Cromer Till is absent, the debris apron is larger (Figure 3-1a-c) than locations where the till is present (Figure 3-1d), reflecting the increased protection this material affords to the cliff base. Some debris apron slopes are well-vegetated (Figure 3-1a), suggesting that toe erosion only occurs periodically. The upper part of the cliff is generally sub-vertical and degraded, often with a drape of Lowestoft Till that has been mobilised by rainfall (Figure 3-1d).

Figure 3.1d. CBU 1a. Partially active cliffs north of Baker's Score. 1 to 2.5 m of Cromer Till is present above the beach. The cliff is formed of Corton Sand with a thin cap of Lowestoft Till that has slumped over the upper part of cliff. Erosion of the base of the cliff has caused collapse of the Corton Sand Cliff. The upper cliff is degraded and probably experiences slumping in wet weather. Note the rills and gullies eroded by surface water runoff down the cliff face

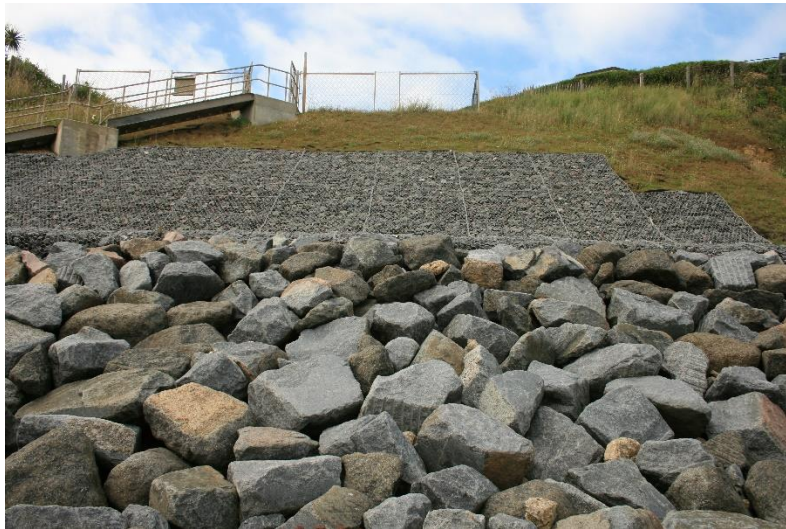
Figure 3.1e. CBU 2. Defended cliffs at Baker's Score. This section of cliff has rock armour below and above a concrete walkway. The cliff has been regraded and protected with gabion baskets.

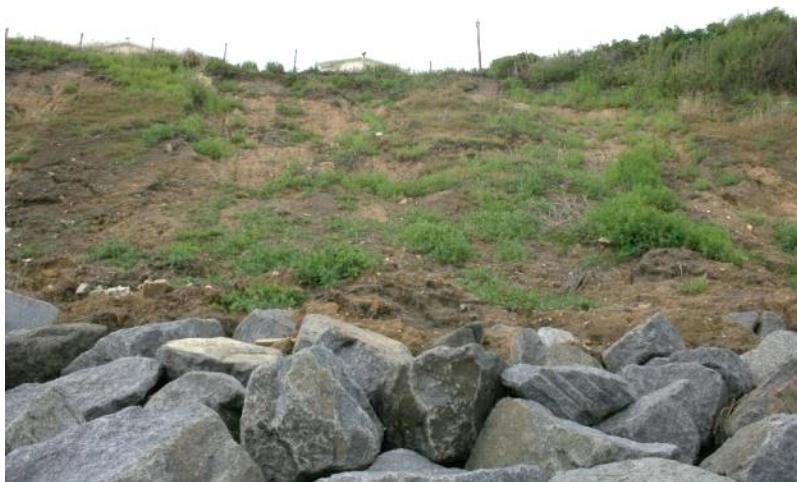
The cliffs are at a lower angle than the freely eroding frontage north of Corton and are mantled with a debris apron. This reflects a lower overall level of erosion and slumping (Figure 3-1e, f). Most of the cliff is mantled with a well-vegetated debris apron, but there is widespread evidence for erosion and slumping, and locally steeper sections at the base of the cliff where the debris apron has been eroded and the in situ geology can be seen (Figure 3-1i, j and k). The Cromer Till is rarely visible above the defences, but was observed at two short sections of cliff below the Tingdene Holiday Park and Warner Holiday Park, where its upper surface lay at around 7 m OD (Figure 3-1k and l). Most of the cliff is formed from Corton Sand with a 2 to 3 m thick cap of Lowestoft Till. The

Figure 3.1f. CBU 3. Degraded cliff fronting the Wy-Wurry Caravan Park. This section of cliff experience headscarp retreat and slumping of debris in the storm surge of 3rd April 2021. The Cromer Till is below the level of the rock armour, with the cliff formed of Corton Sand with a thin cap (<1 m) of Lowestoft Till.

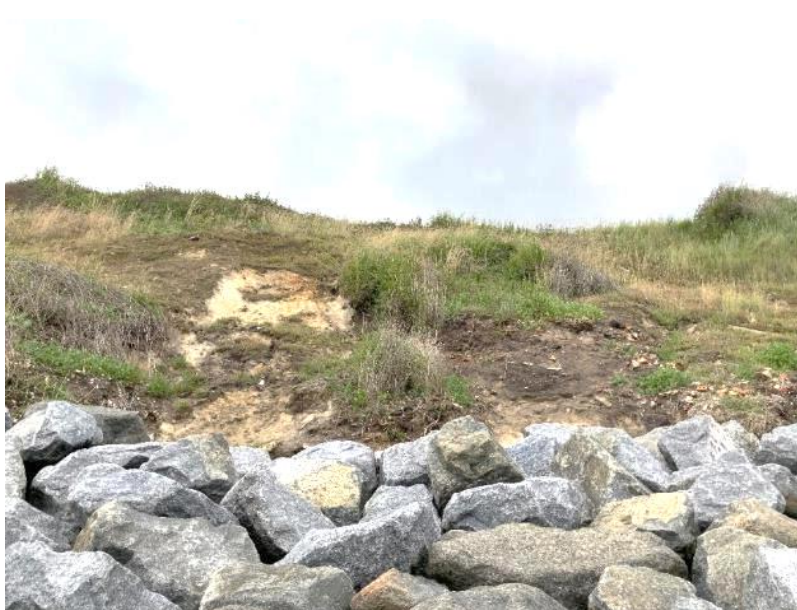
Figure 3.1g. CBU 4. Degraded, locally active cliff fronting the northern part of the Tingdene caravan site. The Cromer Till is below the level of the rock armour and the cliff is formed of Corton Sand with a thin cap (<1 m) of Lowestoft Till and made ground. Note the bricks in the debris that mantles the cliff. Recent activity comprises small slumps of this debris on the lower cliff. The upper cliff is well-vegetated and degraded.

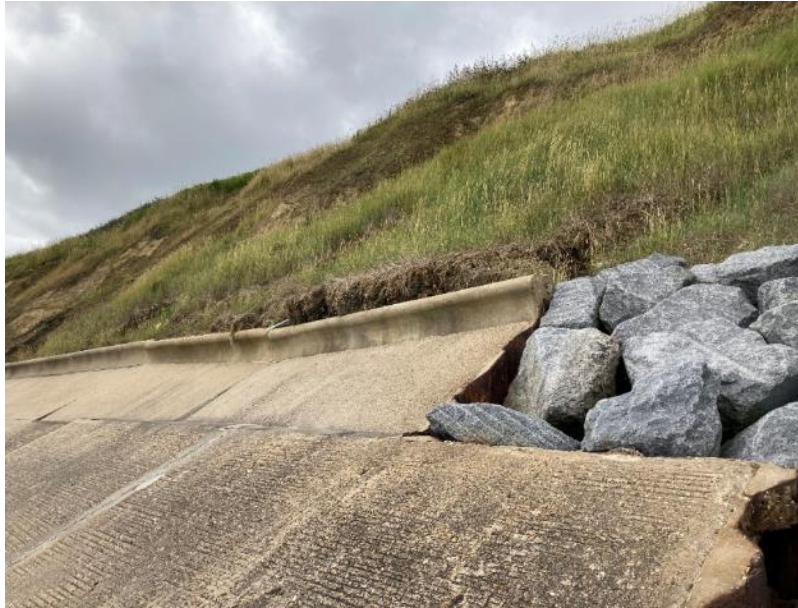
Figure 3.1h. CBU 4. Degraded, locally active cliff fronting the northern part of the Tingdene caravan site. The cliff is formed of Corton Sand with a thin cap ( $<1$  m) of Lowestoft Till. Recent activity comprises slumps over the concrete apron and toe protection. Note damaged sections of concrete apron have been infilled with rock. Sheet piles have been used at the edges of the concrete slabs to stop water washing beneath.

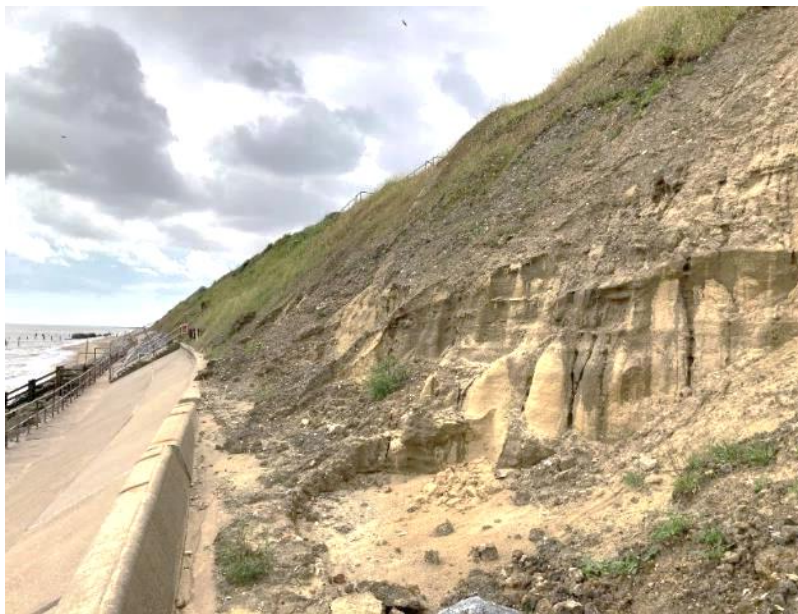
Figure 3.1i. CBU 4. Degraded, locally active cliff fronting the south of the Tingdene site, near Tibbenham's Score. The cliff is formed of Corton Sand with a thin cap ( $<1$  m) of Lowestoft Till. The cliff is mantled with slumped and vegetated Lowestoft Till that has locally remobilised. The cliff base in Corton Sand is locally free of debris, suggesting recent wave overtopping and erosion. Note the wave return wall has been dislodged by fallen debris.

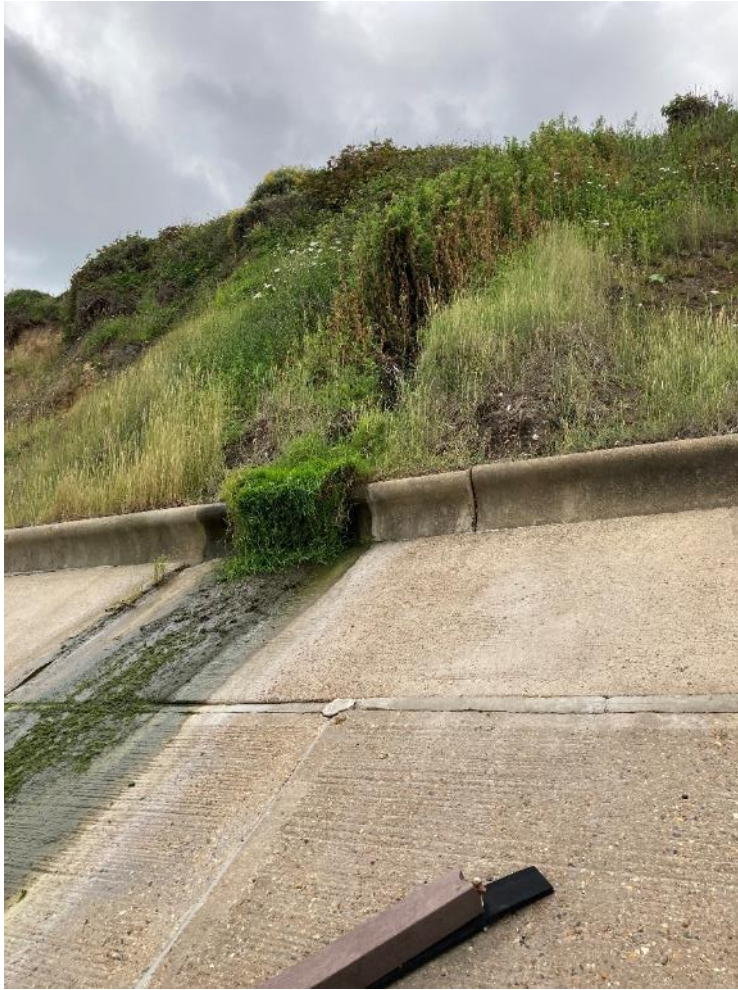
Figure 3.1j. CBU 5. Seepage from drainage outfall from upper cliff at the northern part of the Warner holiday camp, south of Tibbenham's Score. The cliff is degraded and well-vegetated. It is mantled with debris that is saturated with water and which has pushed out the wave return wall. A car park is present on the cliff top, which is not covered by the deep drainage scheme.

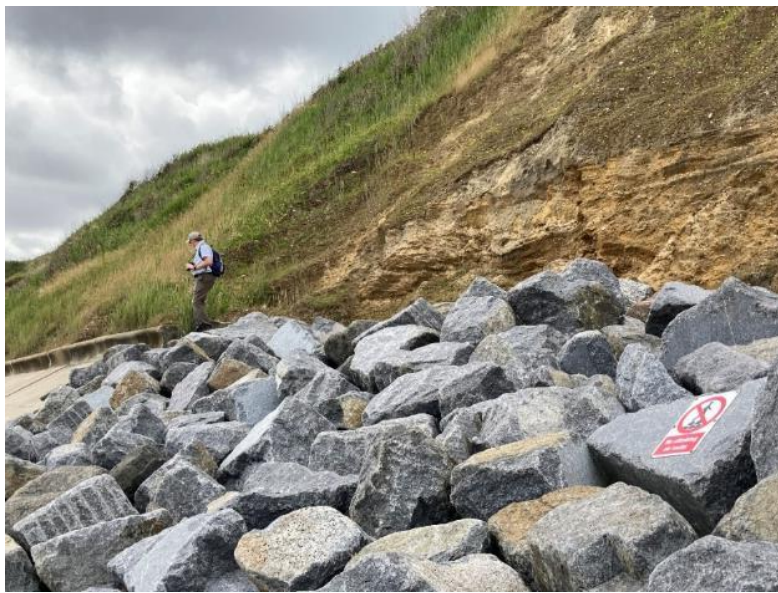
Figure 3.1k. CBU 6. Warner holiday camp. The cliff is locally active, showing areas that are degraded and well-vegetated, and others that show evidence for recent slumping of debris and toe erosion from wave overtopping. The sediments exposed at the base of the cliff comprise 1 m of banded and gravelly Cromer Till. The majority of the cliff is formed of Corton Sand.

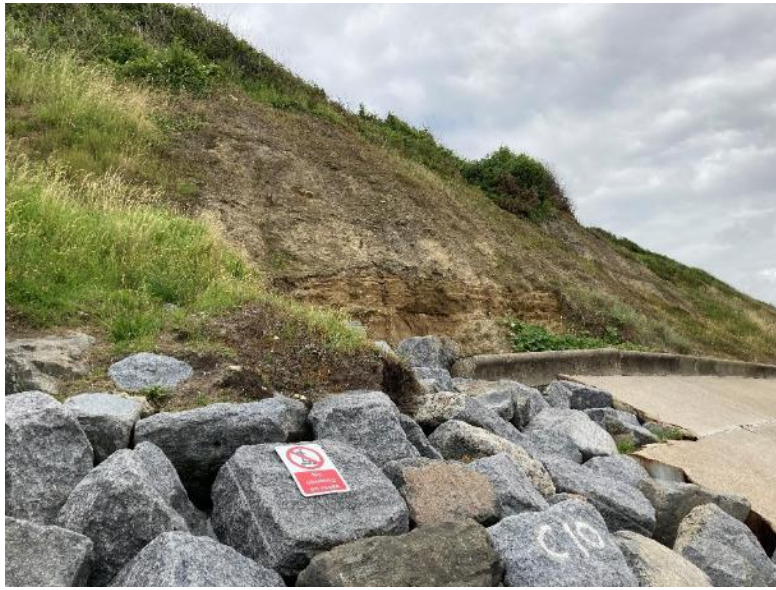
Figure 3.1l. CBU 6. Warner holiday camp south. The cliff is locally active, showing areas that are degraded and well-vegetated, and others that show evidence for recent slumping of debris over the upper rock, and erosion from overtopping waves. The sediments exposed in the base of the cliff comprise around 1 m of banded and gravelly Cromer Till overlain by Corton Sand and a thin cap of Lowestoft Till and Plateau Gravel.

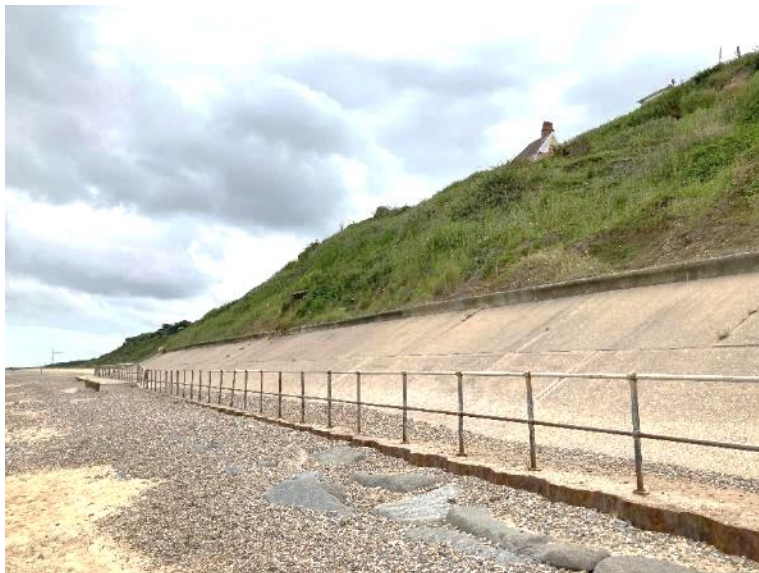
Figure 3.1m. CBU 7. Cliff House to Azure Sea. The cliff is degraded and well-vegetated with a mantle of debris apron. Periodic activity comprises slumping of debris apron in response to wet weather.

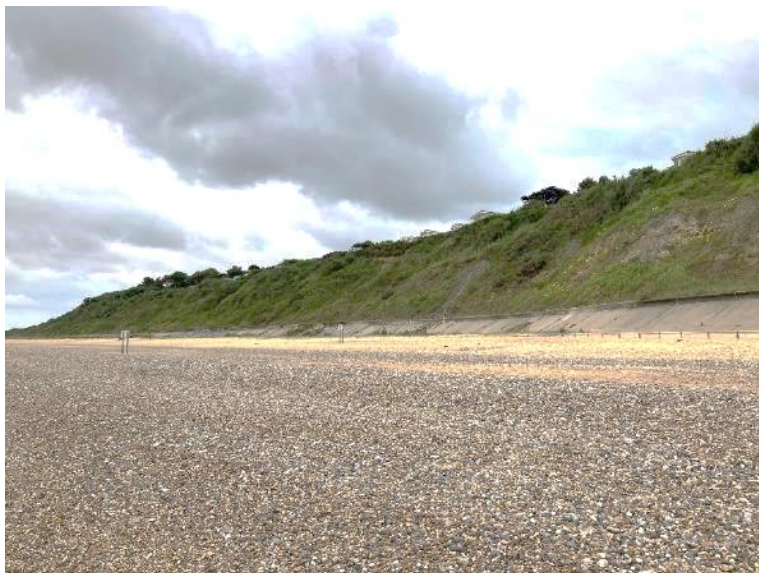
Figure 3.1n. CBU 8. Azure Sea north. The cliff is degraded and well-vegetated with a mantle of debris apron that is marginally stable. Periodic activity comprises slumping of debris apron over the toe protection measures in response to wet weather. Seepage is often observed draining over the concrete apron along this section of coast. Note the particularly wide beach at this southern extent of Corton, which monitoring shows has accreted in the last 5 years.
