Thorpeness Monthly Monitoring Report

Date and Time of Survey: July 25, 2022; 08.06

Inspector: Chris Finbow/Thomas Hayden

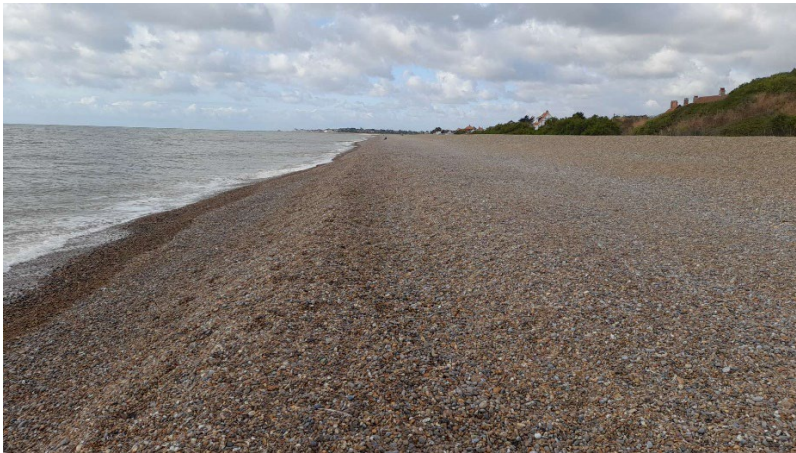
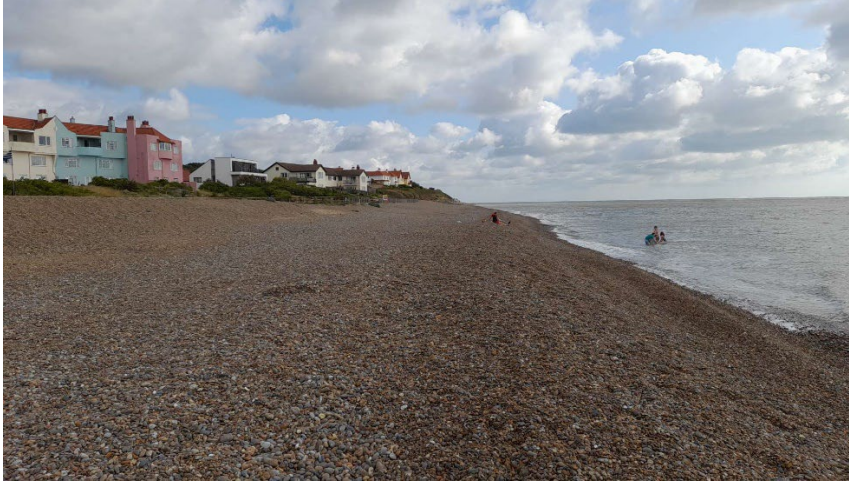
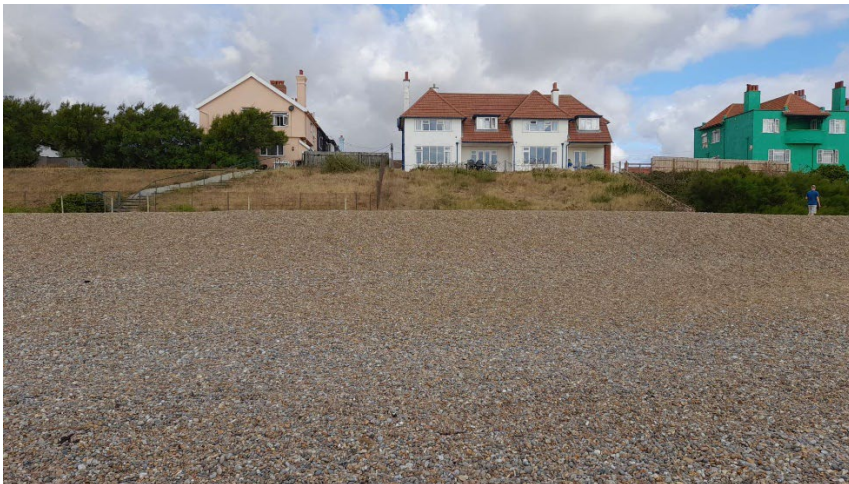
Images of the southern UNDEFENDED frontage:

Intertidal Beach volume change: No change

Supratidal Beach volume change: No change

Comments on the geomorphological change over the southern UNDEFENDED frontage: Similar profile to previous.

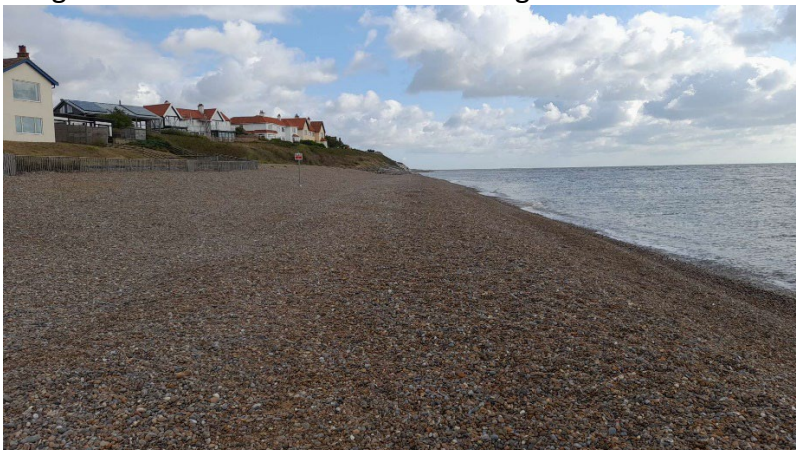
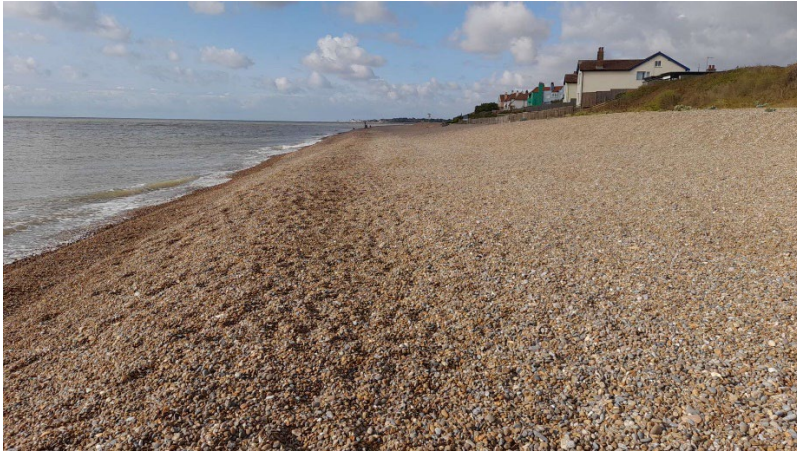
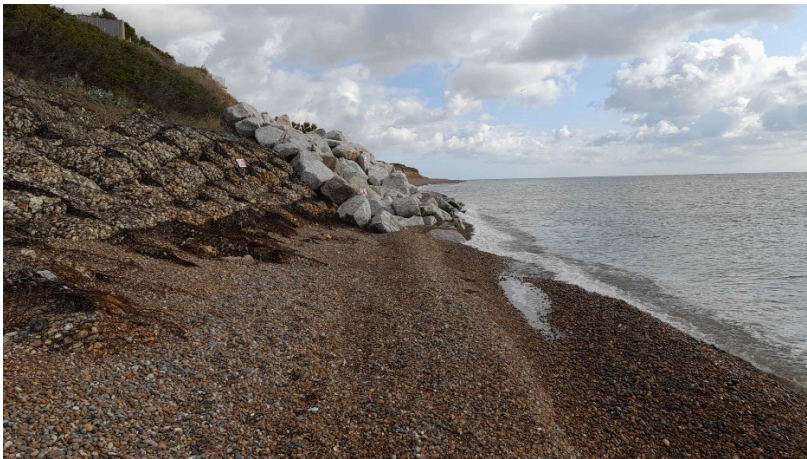
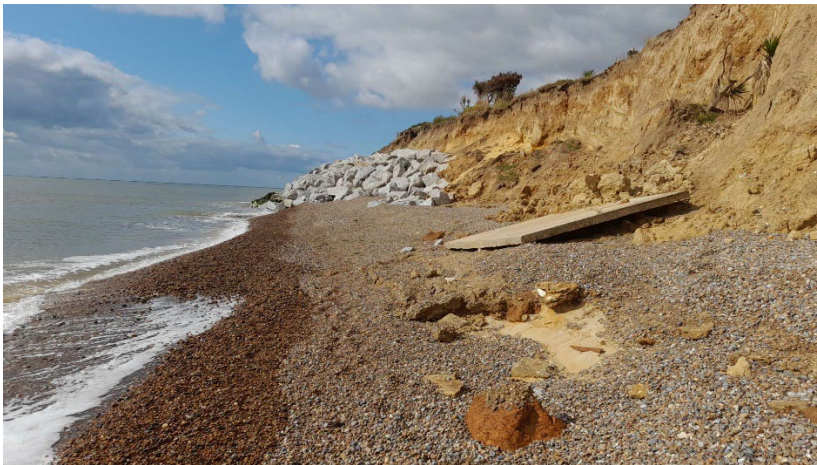
Images of the central DEFENDED frontage:

Intertidal Beach volume change: No change

Supratidal Beach volume change: No change

Comments on the geomorphological change over the DEFENDED frontage: Similar profile to previous

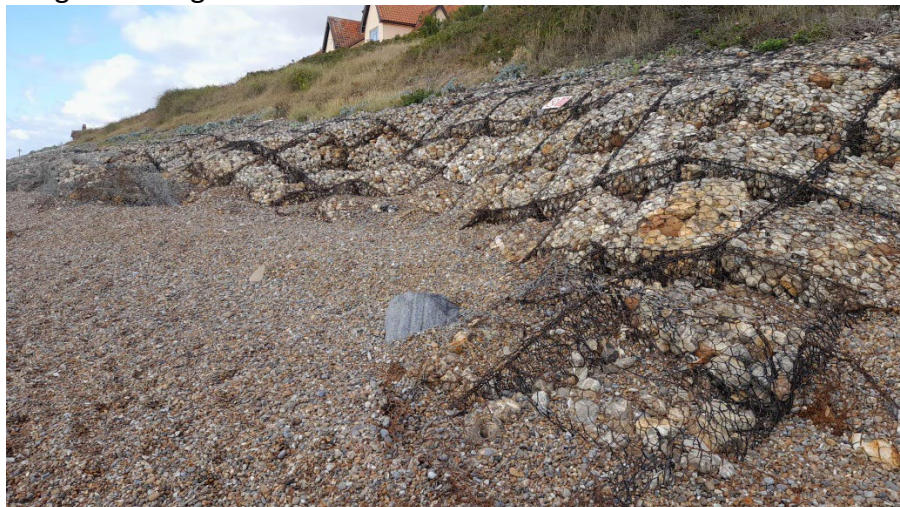
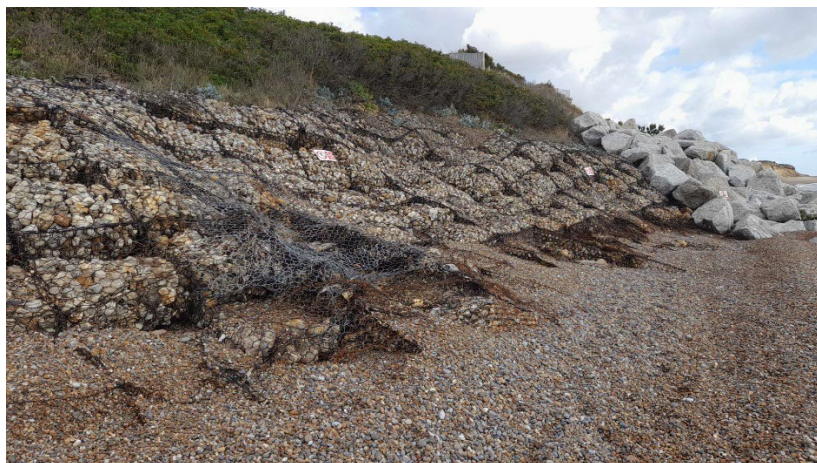
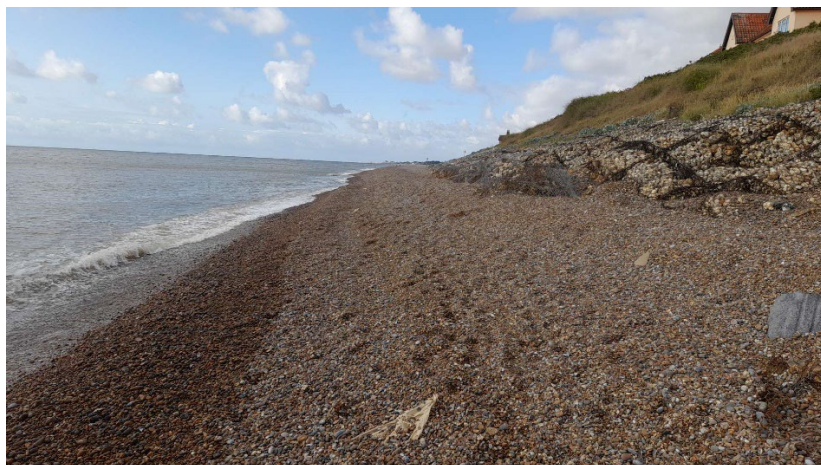
Images of the gabions:

Comments on Gabion condition: Majority of the remaining gabions are still benefitting from relatively healthy beach levels although these do diminish at the northern end. Lower damaged parts of gabions

have been filled with shingle but disturbance of material has exposed the previously imported aggregate in one location.

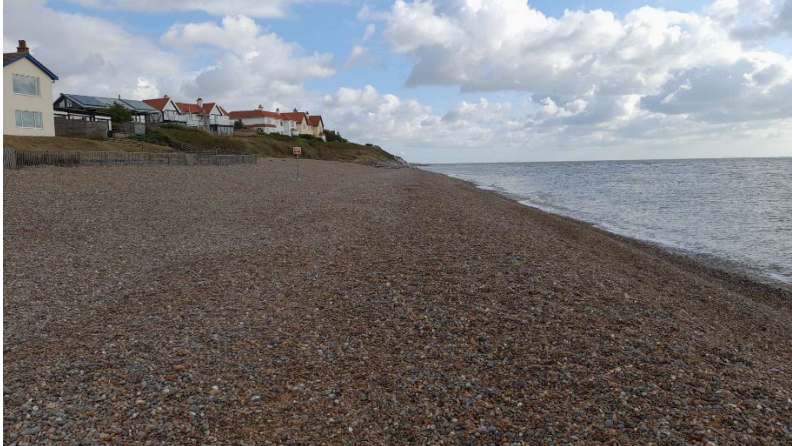
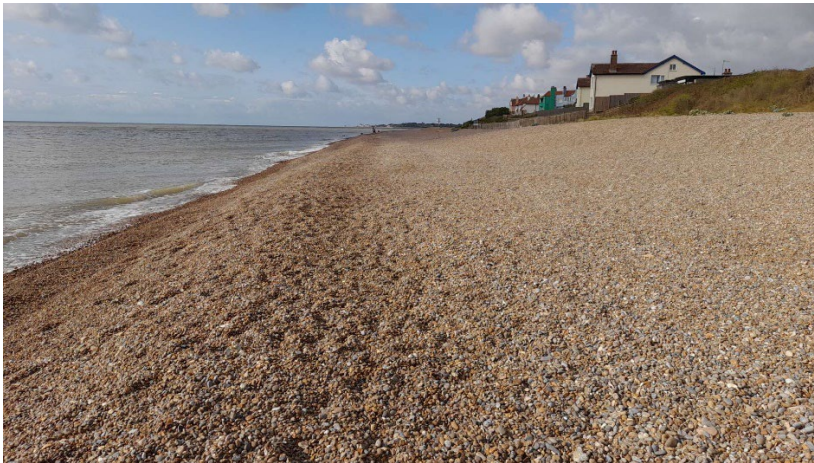
Images of Phase 1 Geobags:

Comments on Phase 1 Geobag condition: Geobags Currently benefit from a healthy covering of beach material.

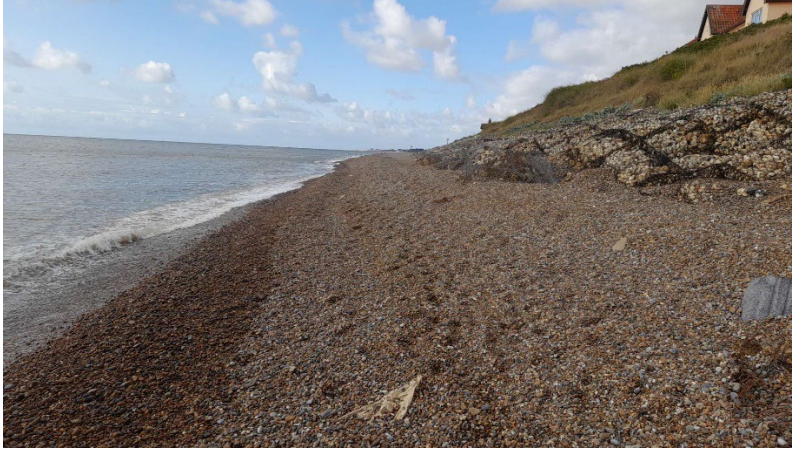
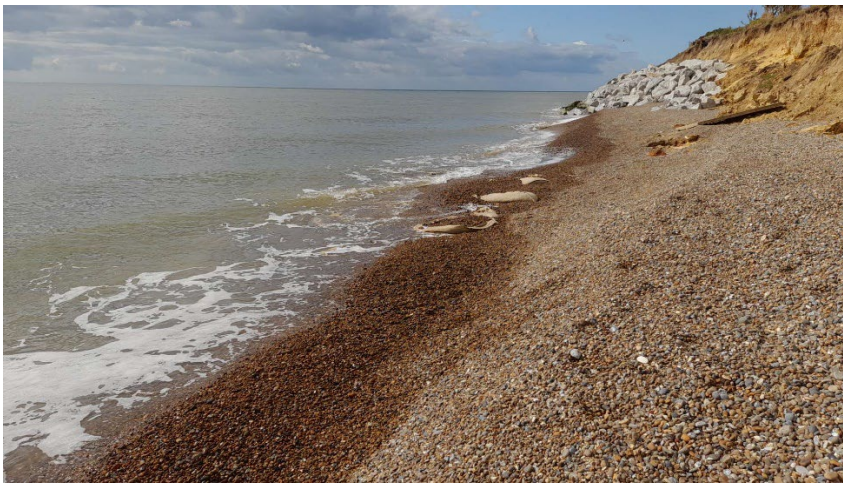
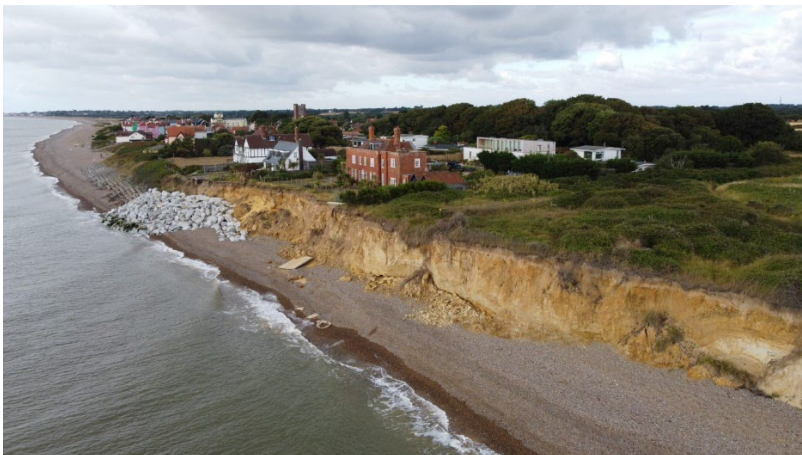
Images of Phase 2 Geobags:

Comments on Phase 2 Geobag condition: Geobags currently benefit from a healthy covering of beach material.

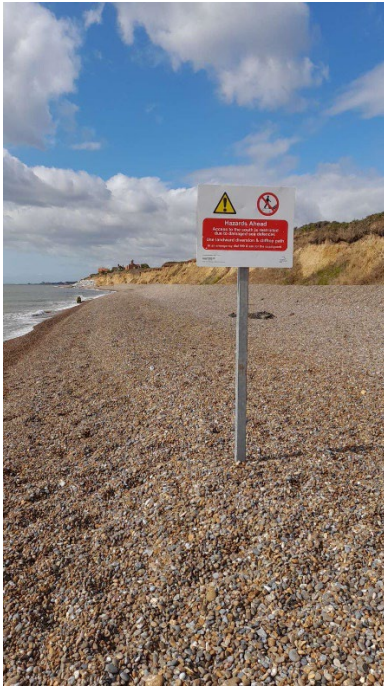
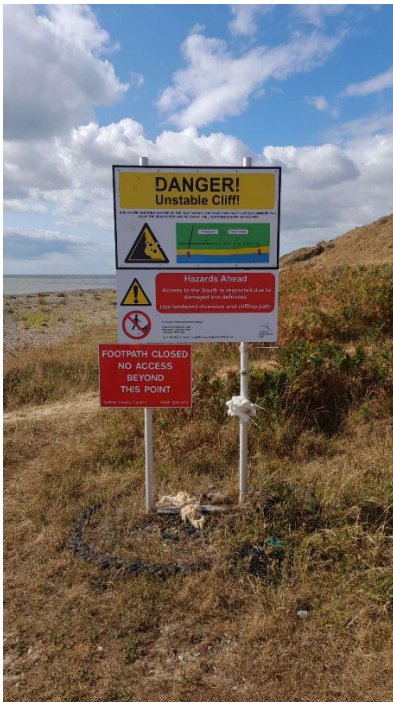
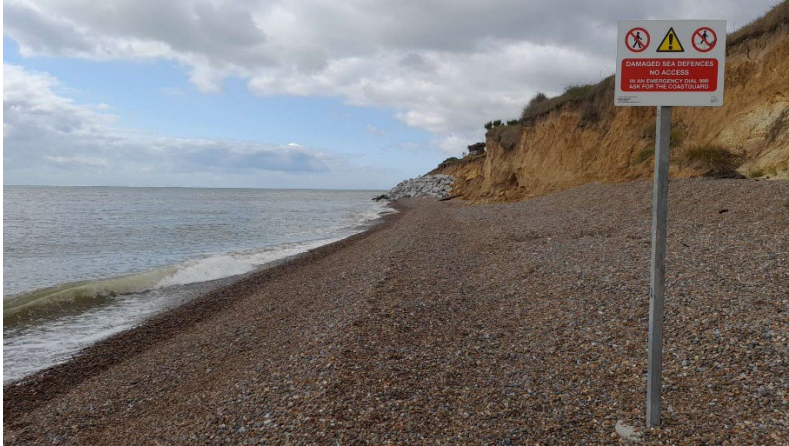
Images of signs:

Signage condition: Good

Comments on signage: Adequate and informative

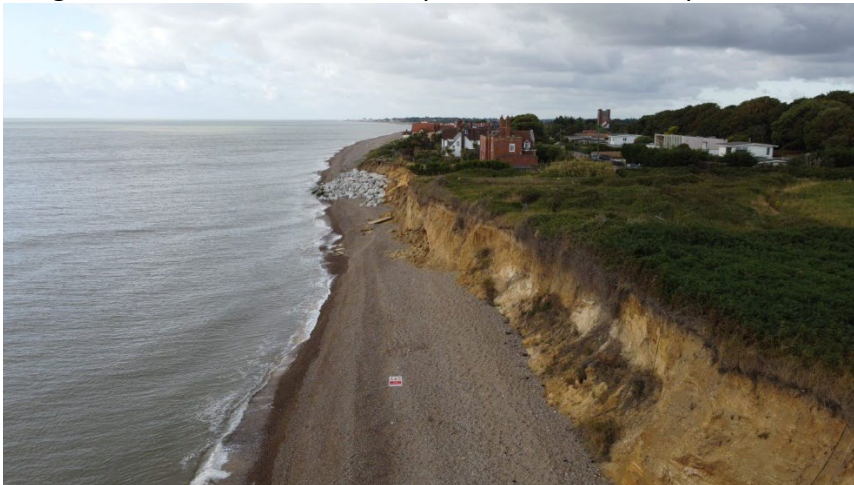
Images of Hazards/Debris: Examples recorded on inspection below.

Comments on Hazards/Debris: Cliffs retaining vertical or overhanging faces in some areas below, and to the north of Red House. Further falls have occurred and are likely to continue. Beach levels have remained stable over the last inspection period.

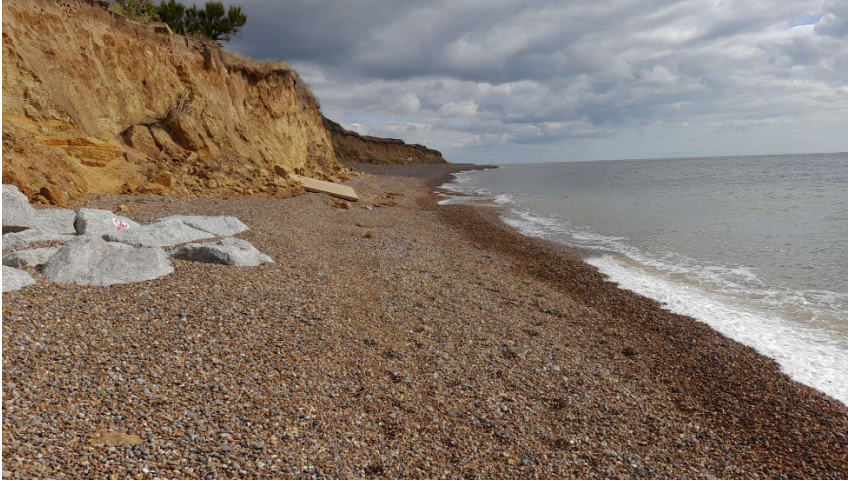
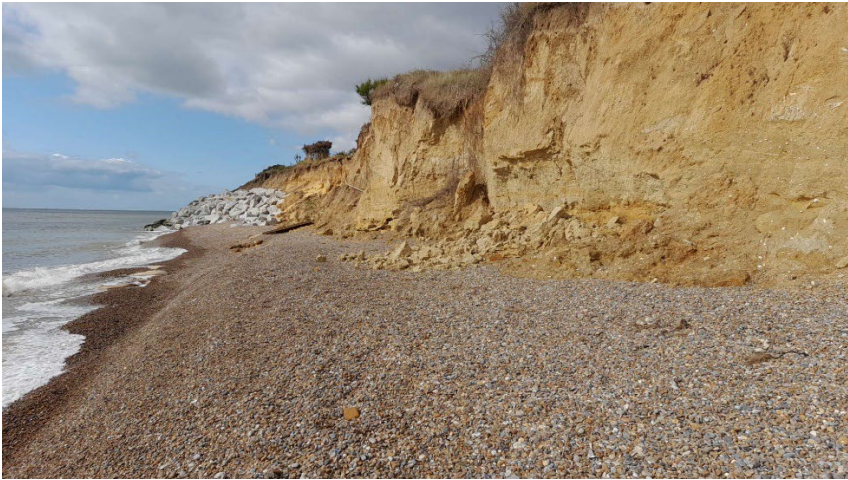
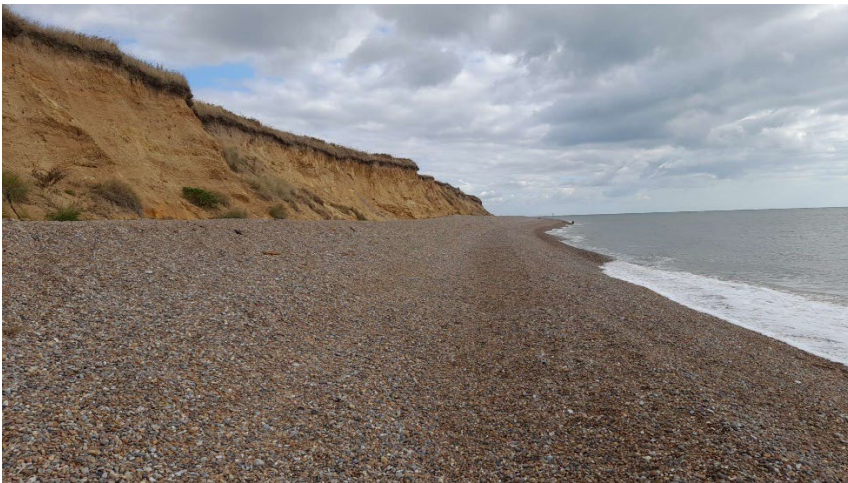
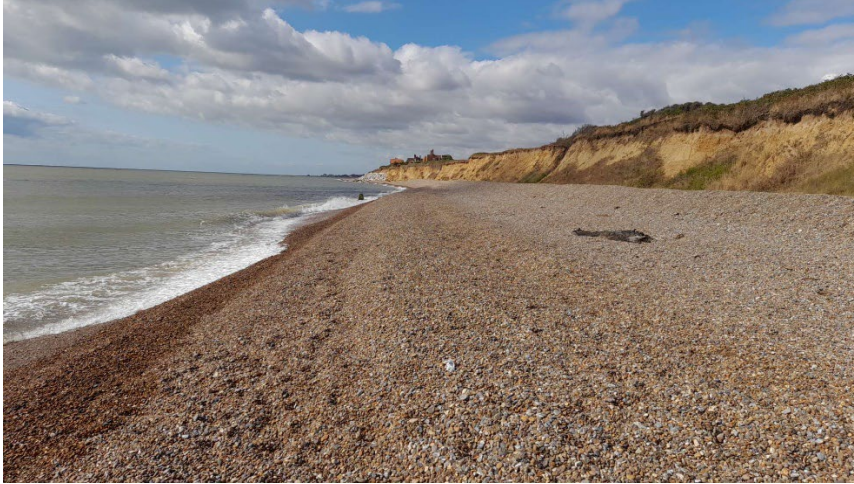
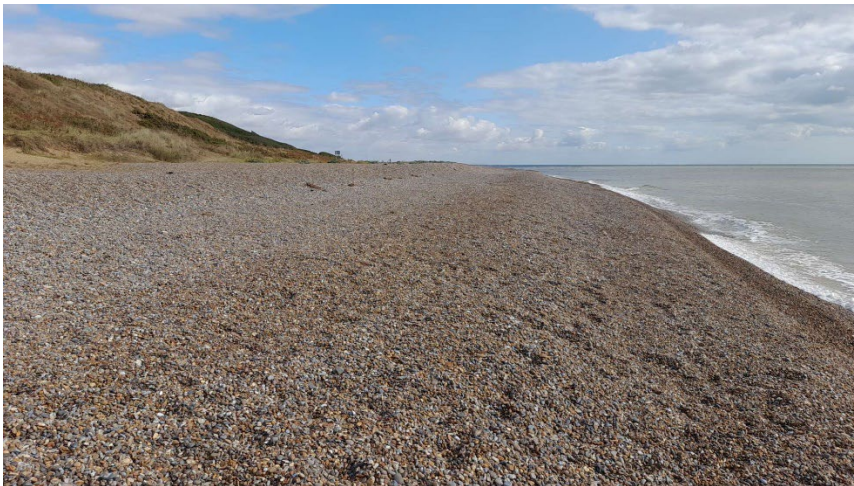
Images of the Northern UNDEFENDED Frontage:

Intertidal Beach volume, north of defence termination: No change

Supratidal Beach volume, north of defence termination: No significant change

Comments on the geomorphological change, north of defence termination: Similar profiles to previous.
