## **Thorpeness Monthly Monitoring Report**

**Date and Time of Survey:** September 22, 2022; 15:30

**Inspector:** Chris Finbow/Thomas Hayden

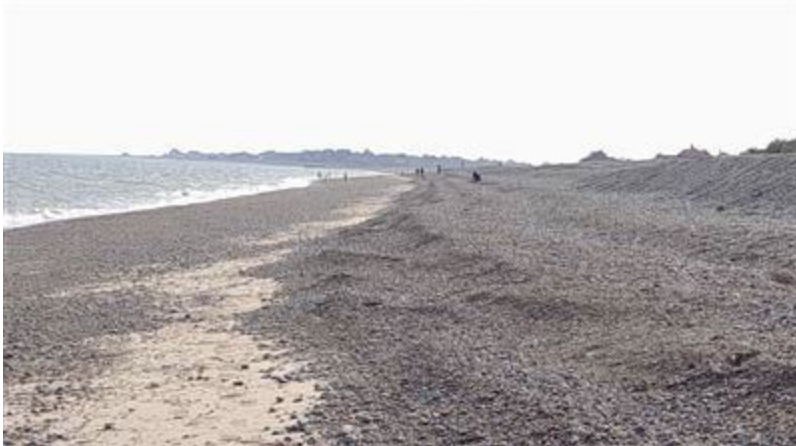
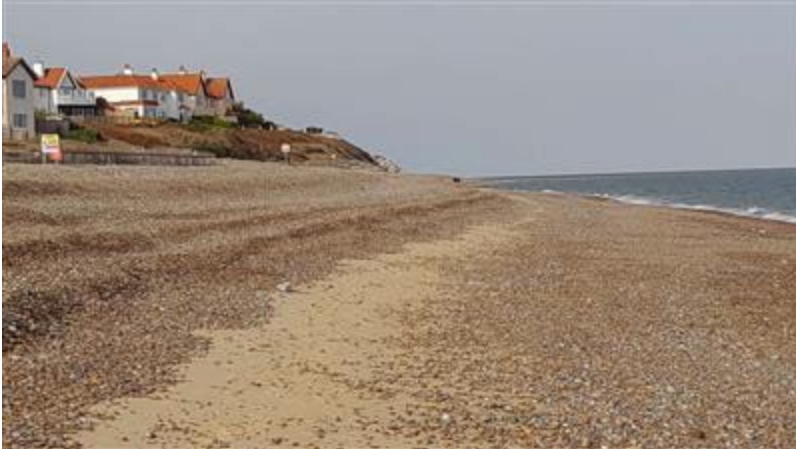
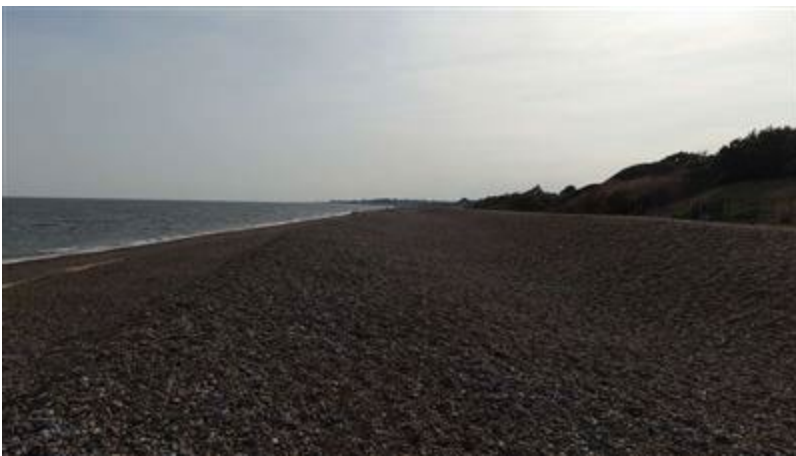
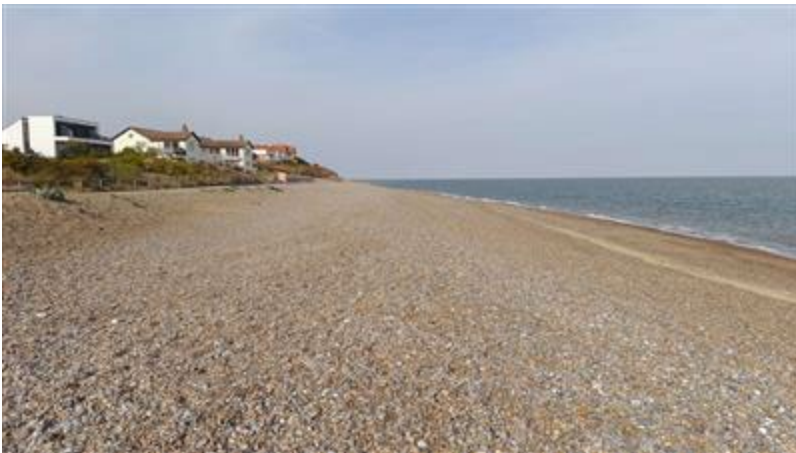
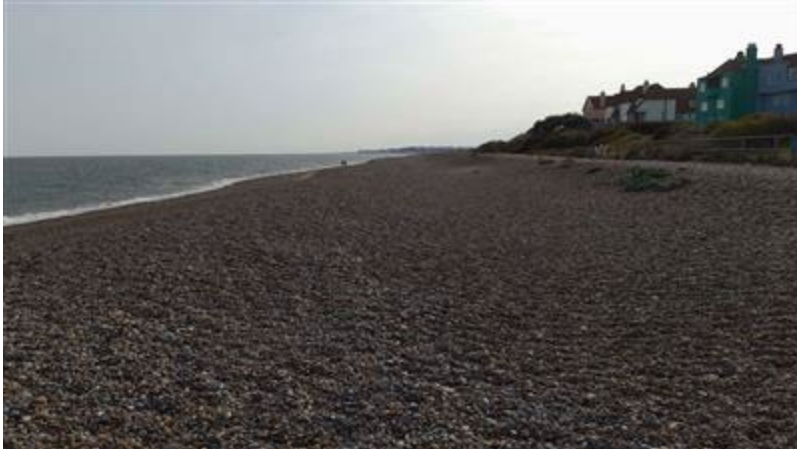
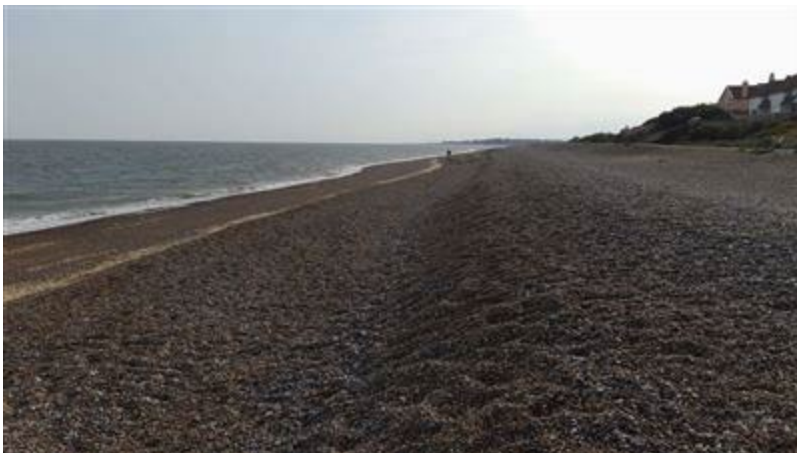
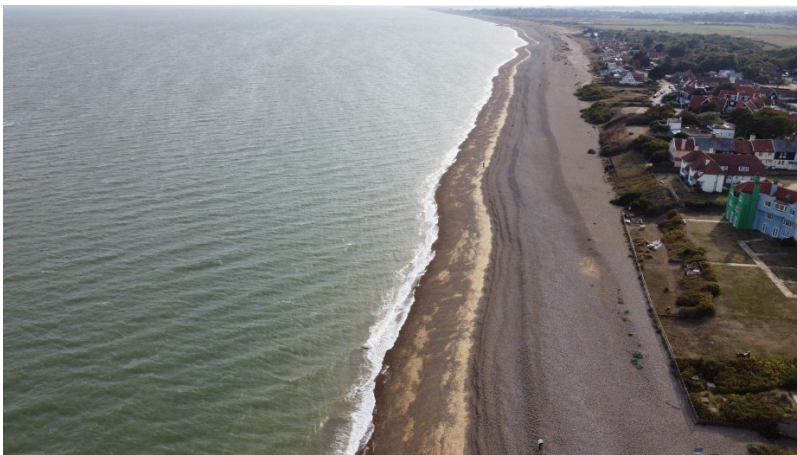
Images of the southern UNDEFENDED frontage:

**Comments on the geomorphological change over the southern UNDEFENDED frontage:** There has been a notable loss of beach material on the lower beach profile.

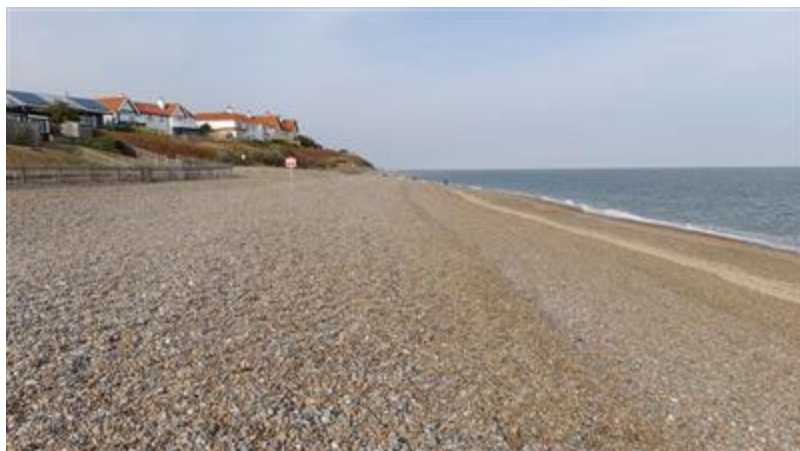
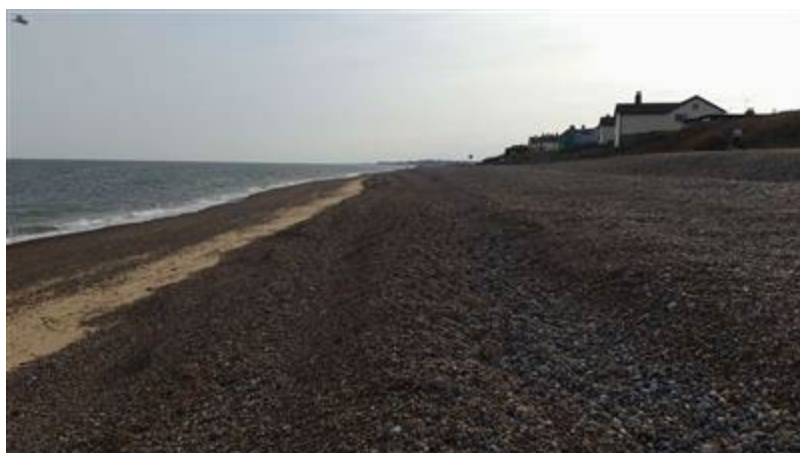
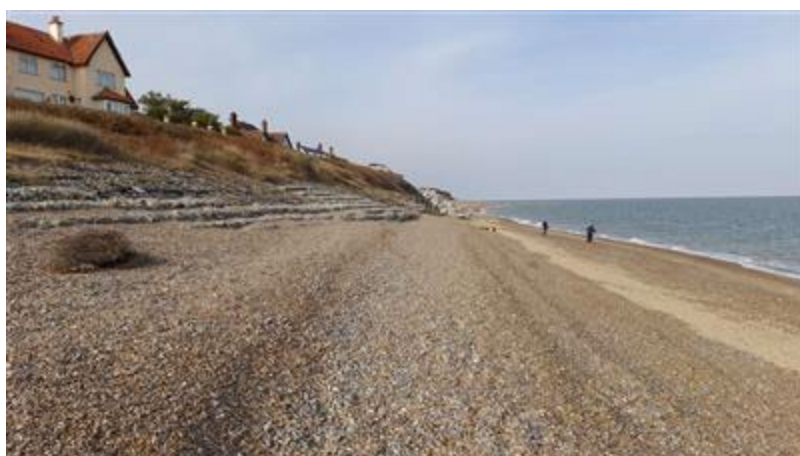
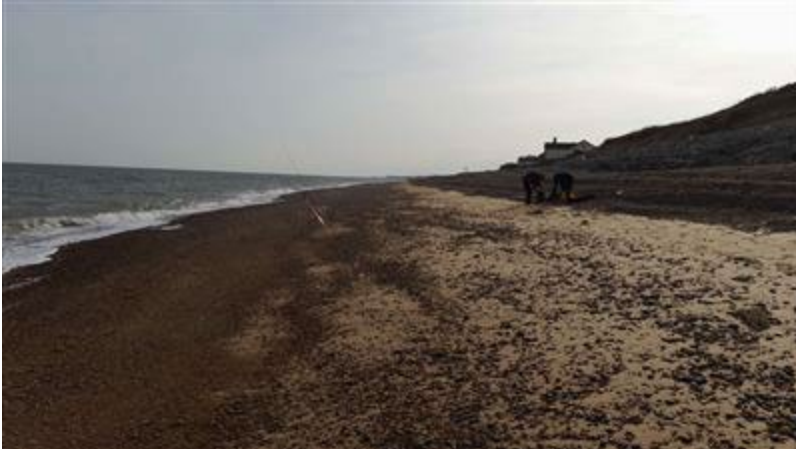
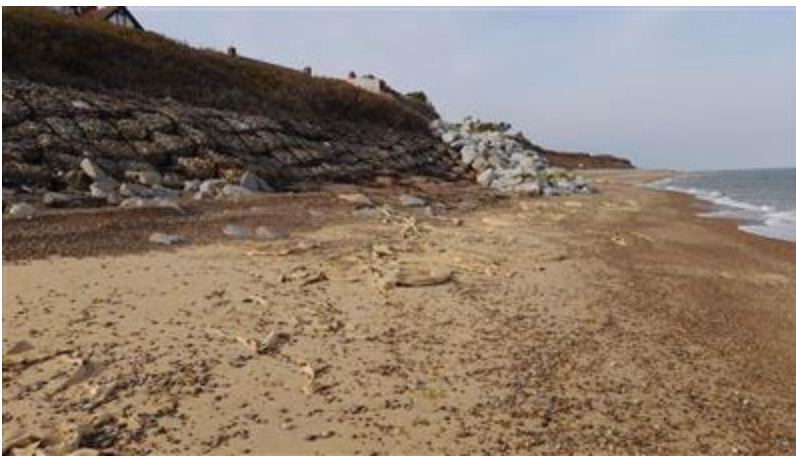
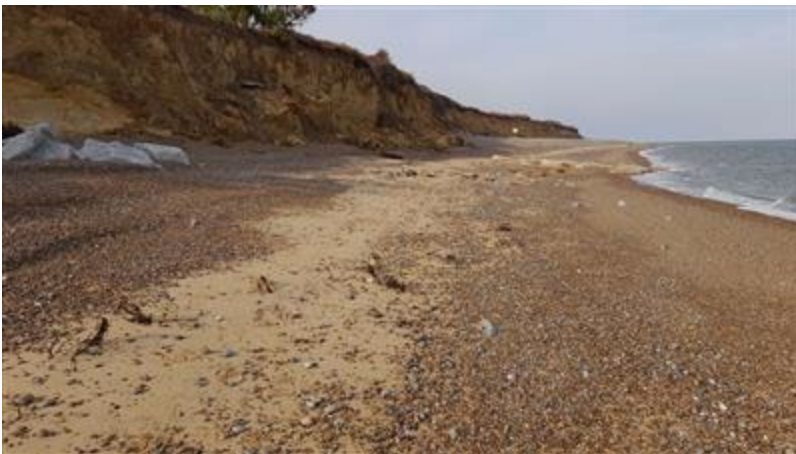
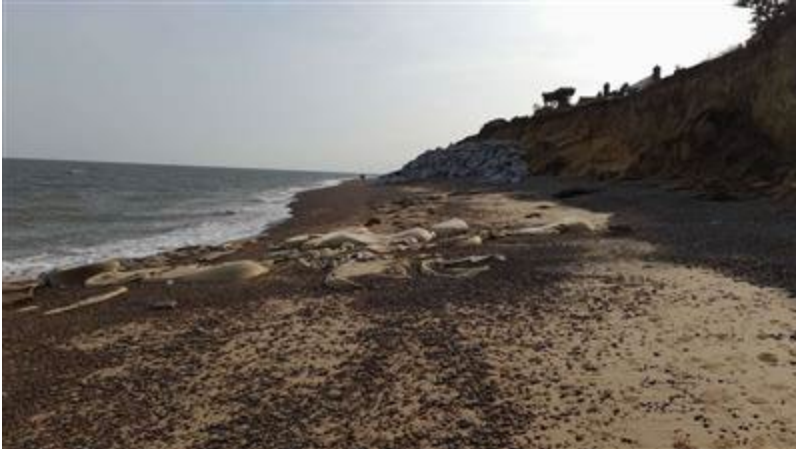
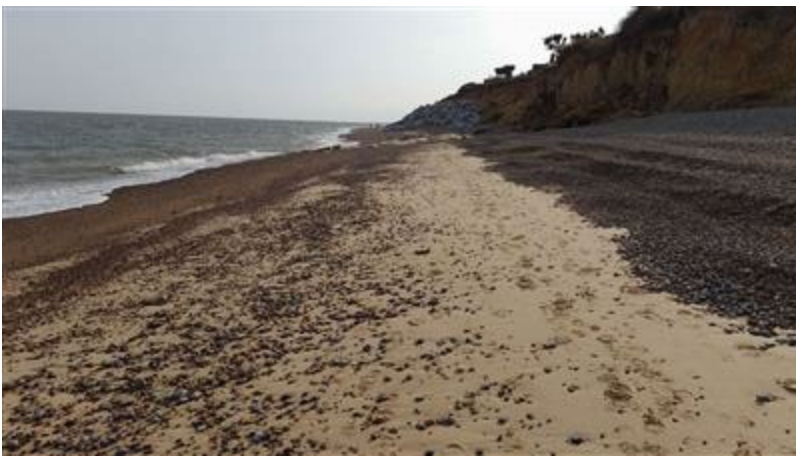
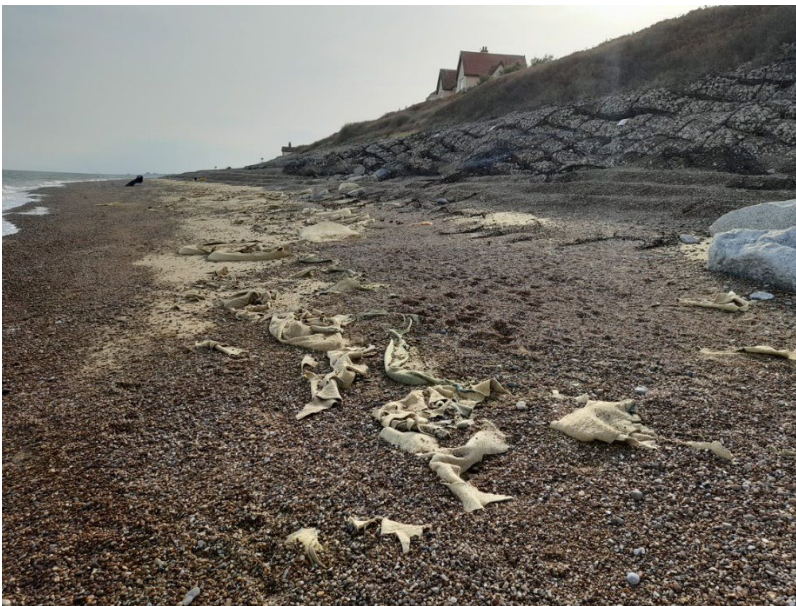
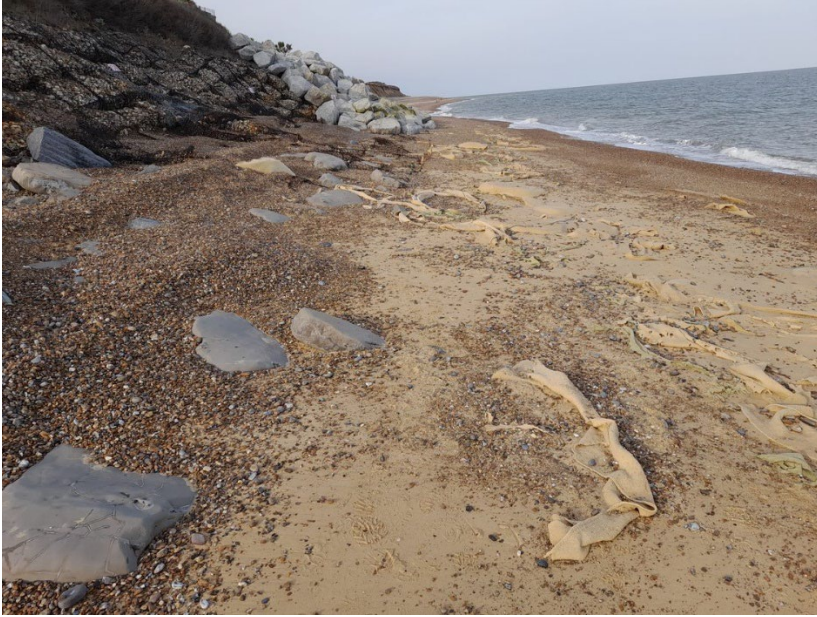
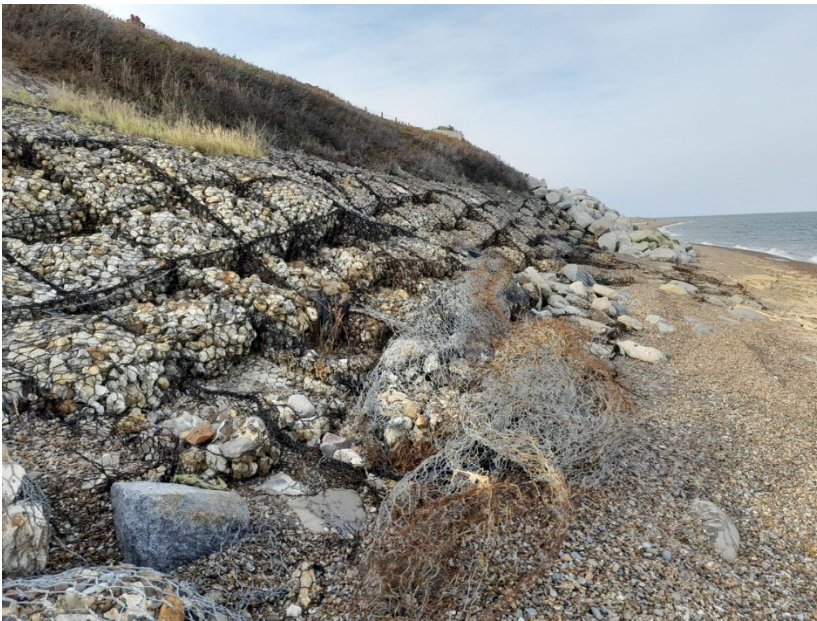
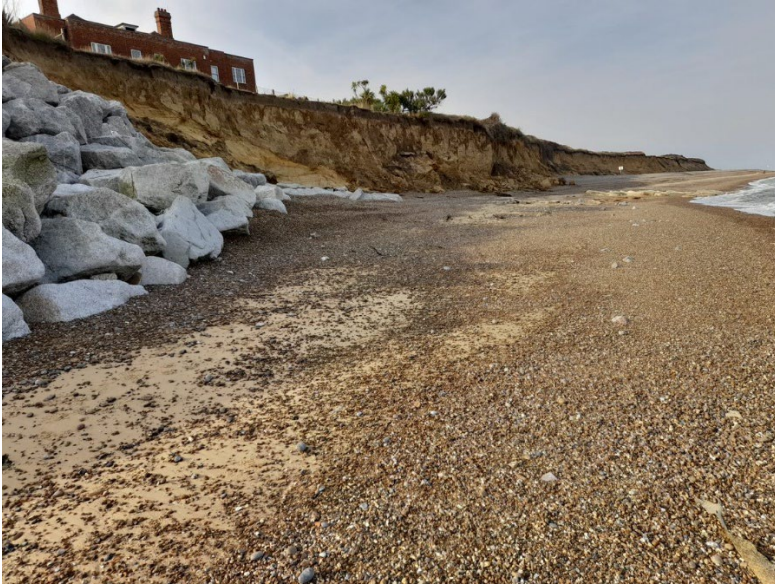
Images of the central DEFENDED frontage:

**Comments on the geomorphological change over the DEFENDED frontage:** Notable loss of beach material in front of the gabions, with one metre loss at the gabion to rock transition. Beach loss reduces the further south you go.

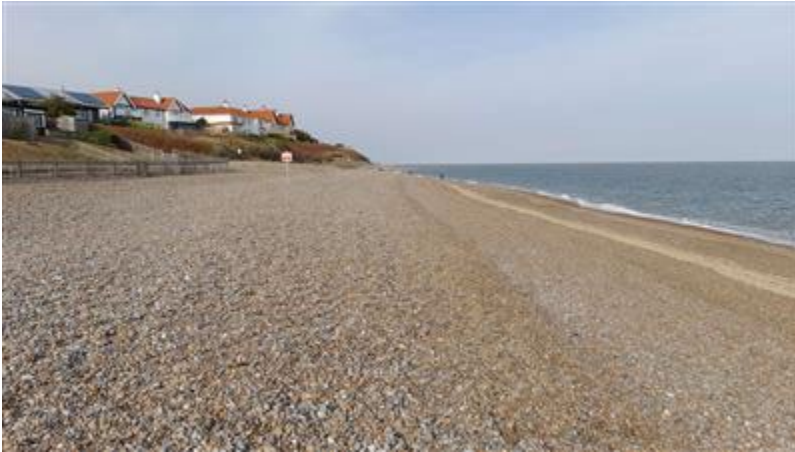
Images of Phase 1 Geobags:

Phase 1 Geobags still buried.

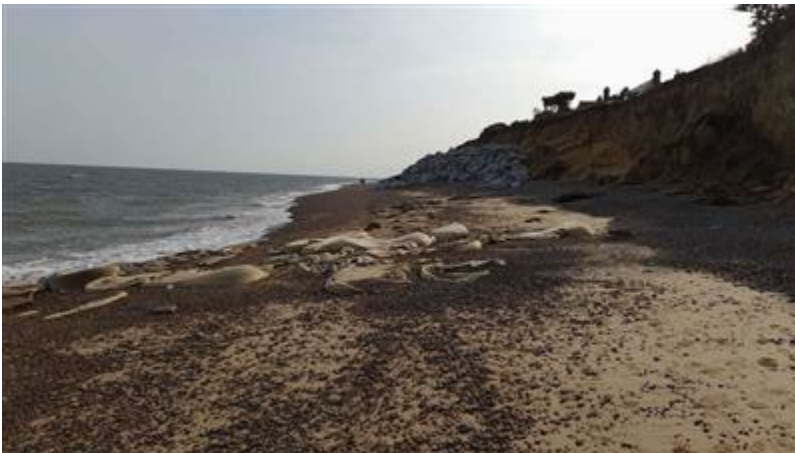
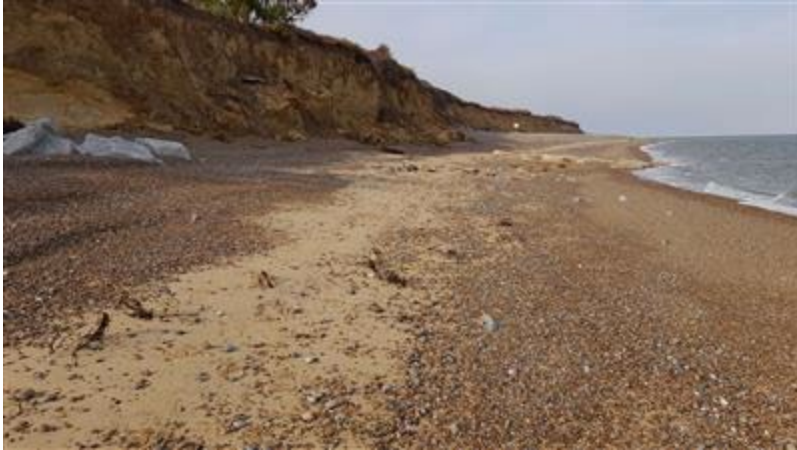
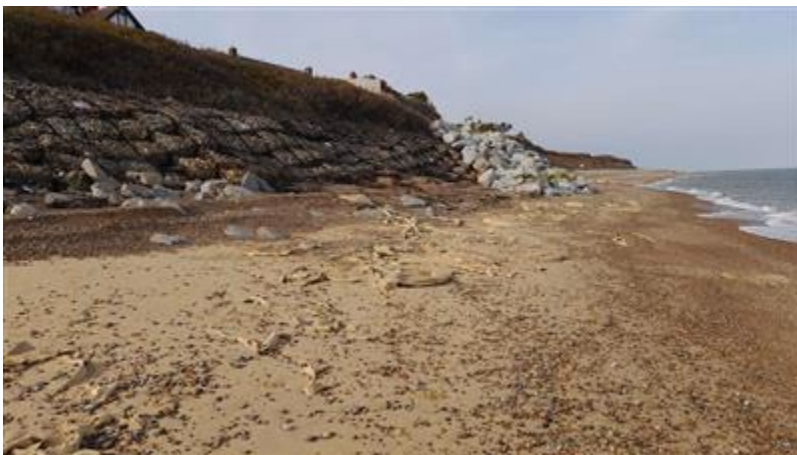
Images of Phase 2 Geobags:

Comments on Phase 2 Geobag Condition: Loss of lower beach material has increased exposure of the geobags.

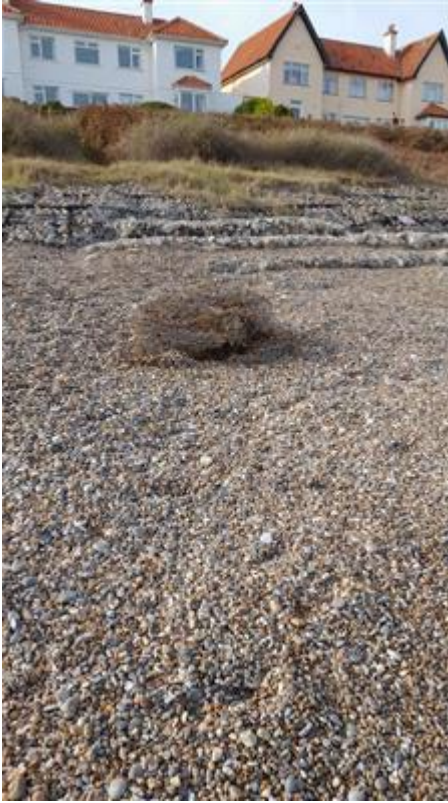
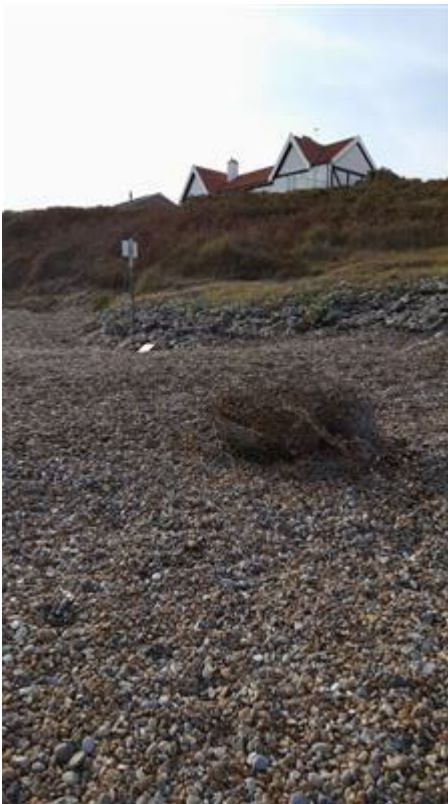
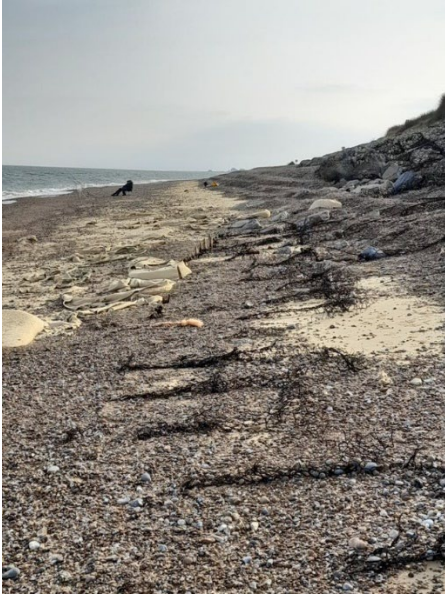
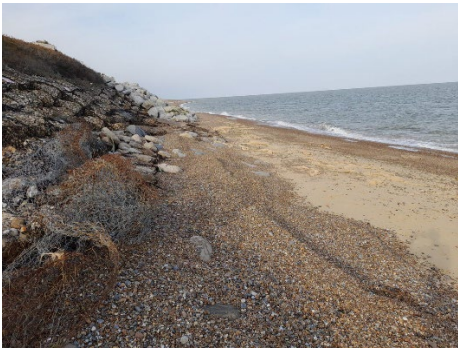
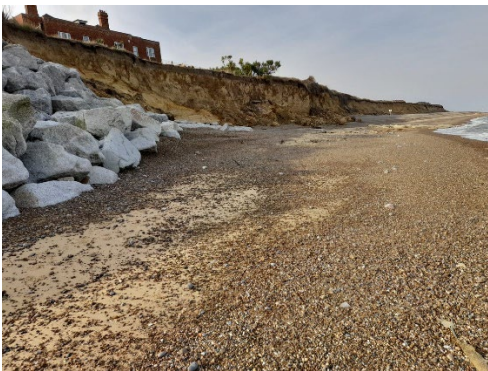
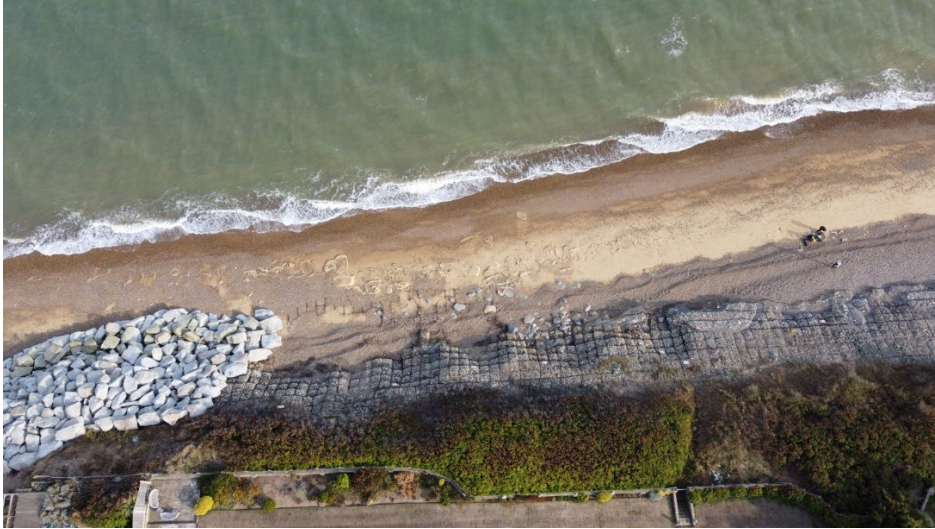
Images of Hazards/Debris: Examples recorded on inspection below.

Comments on Hazards/Debris: Some gabion wire has been moved/re-distributed. Beach lowering in the intertidal zone has meant that there are more of the northern geobags and lower gabions exposed.

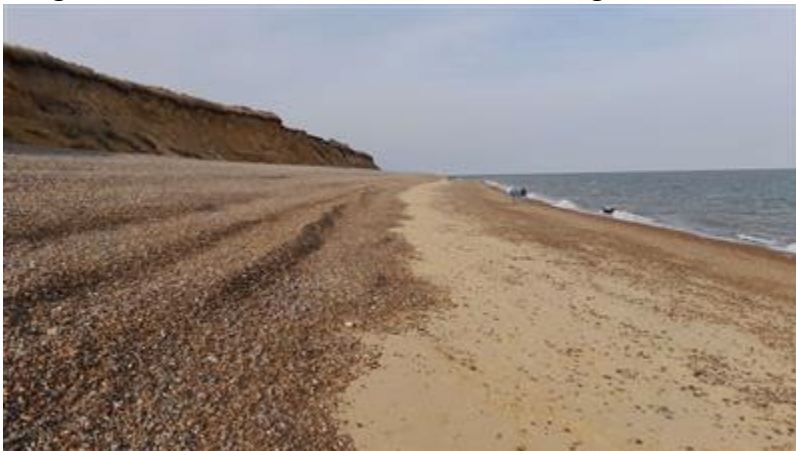
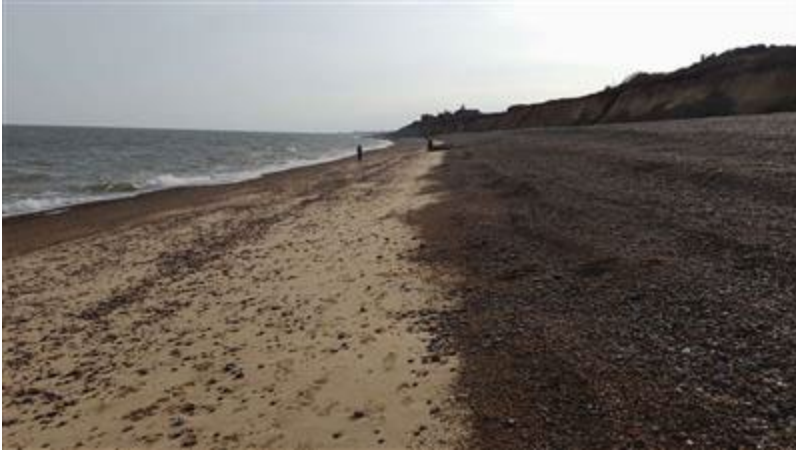
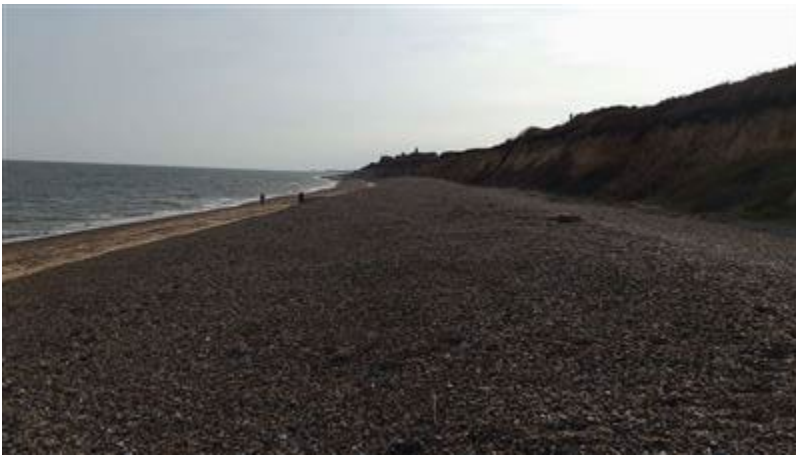
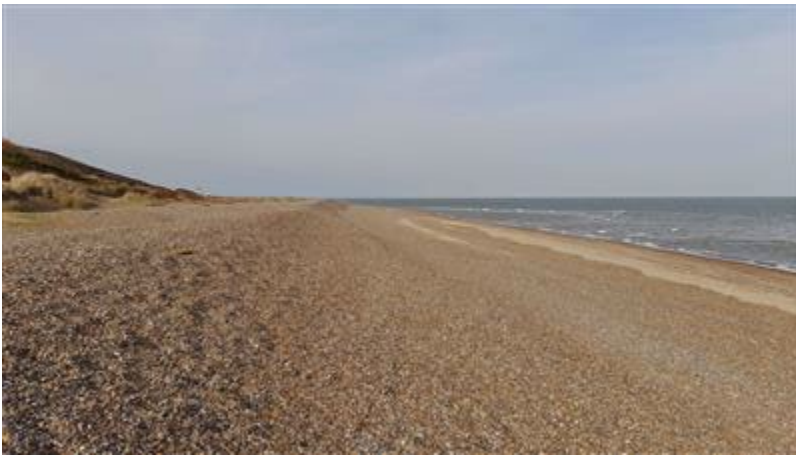
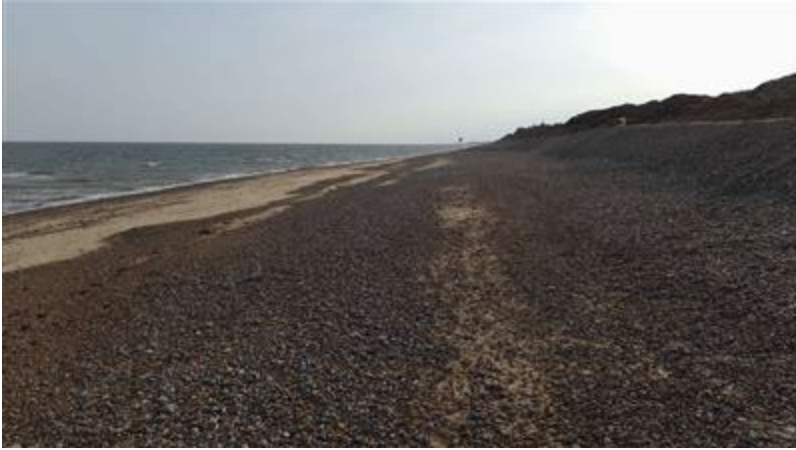
Images of the Northern UNDEFENDED Frontage:

Comments on the geomorphological change, north of defence termination: Beach lowering, cliff top recession, overhanging cliffs, active cliff erosion, debris at base of cliff, debris exposed.
