Thorpeness Monthly Monitoring Report

Date and Time of Survey: 31st October, 2022; 09:40 Time of Low Tide: 08:00

Inspector: Chris Finbow/Thomas Hayden

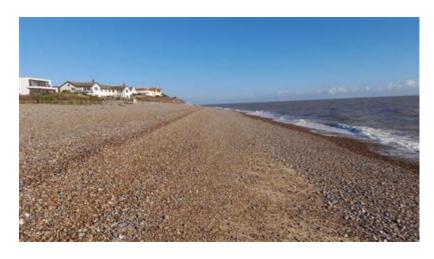
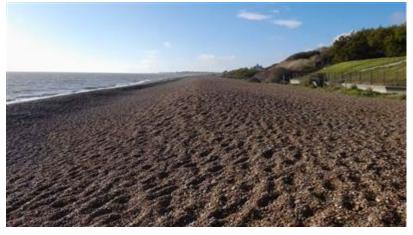
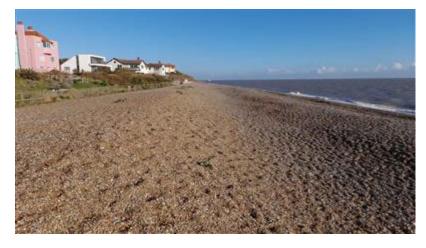
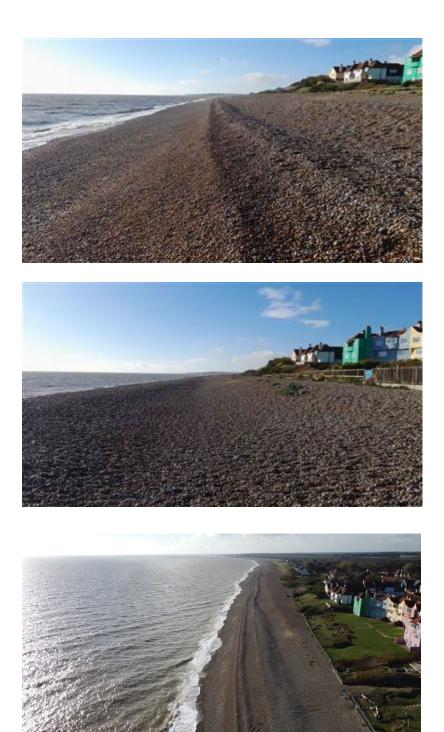
Images of the southern UNDEFENDED frontage:

Comments on the geomorphological change over the southern UNDEFENDED frontage: Some accretion of the upper beach over the last inspection period.

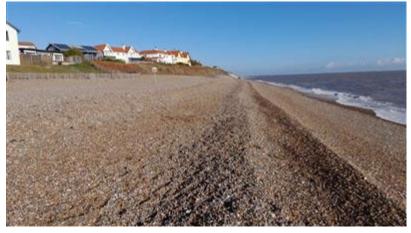
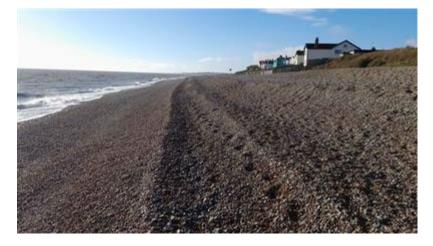
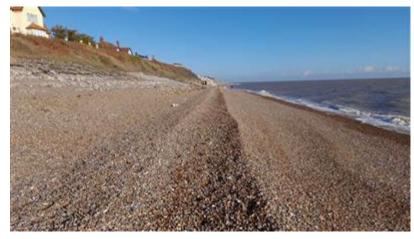
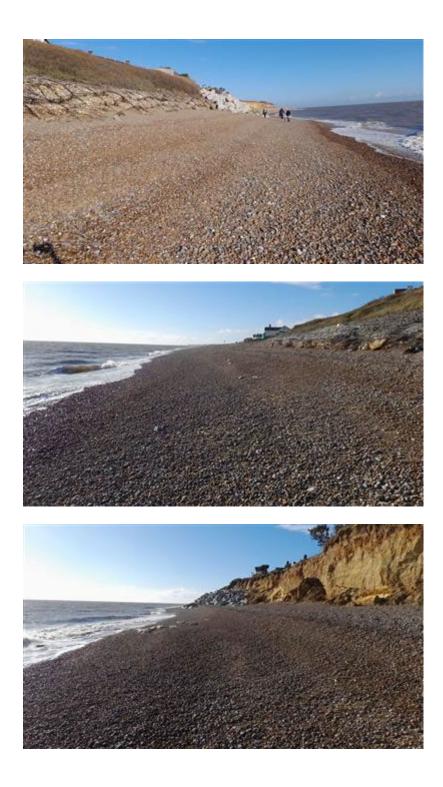
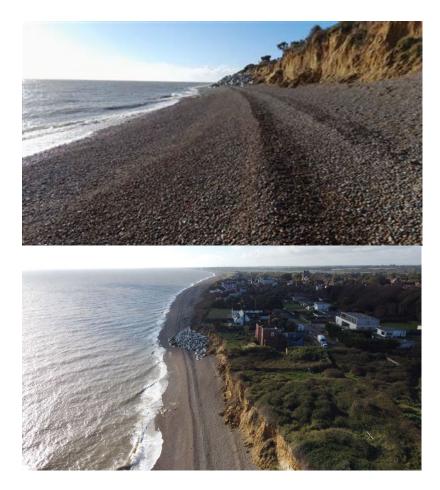
Images of the central DEFENDED frontage:

Comments on the geomorphological change over the DEFENDED frontage: Beaches have built over the defended frontage, mostly covering the northern end geobag defence termination. The lower gabion baskets have also been re-covered.

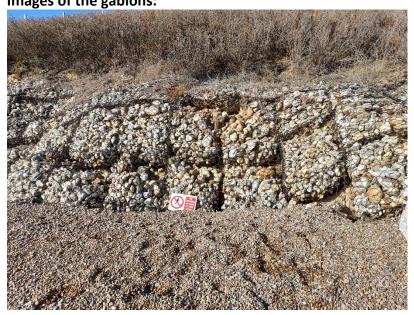
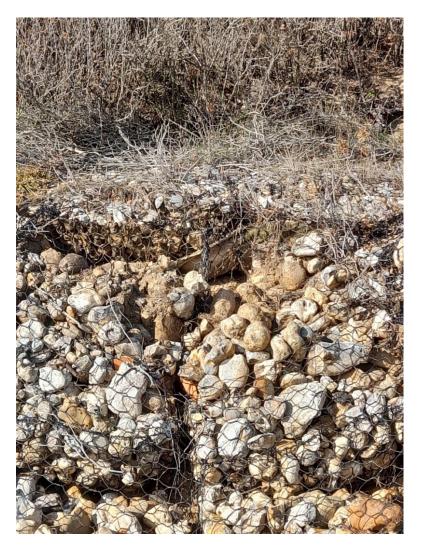
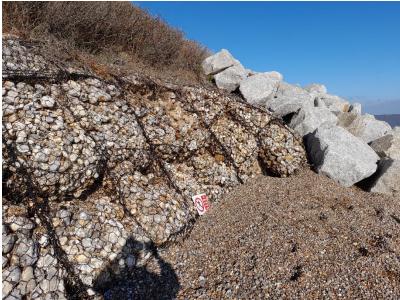
Comments on gabion Condition: Localised steepening of the gabions immediately south of the rock field. The lower gabions have been covered by a recovery of beach material. **Images of the gabions:**

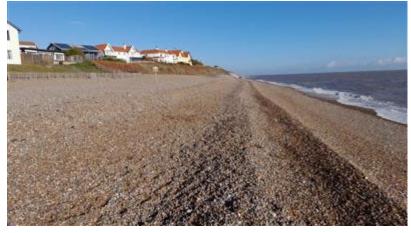
Images of Phase 1 Geobags:

Phase 1 Geobags still buried.

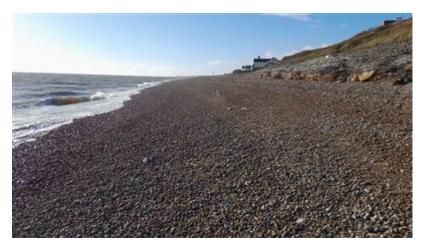
Images of Phase 2 Geobags:

Comments on Phase 2 Geobag Condition: Phase two geobags have been mostly covered by a recovering beach.

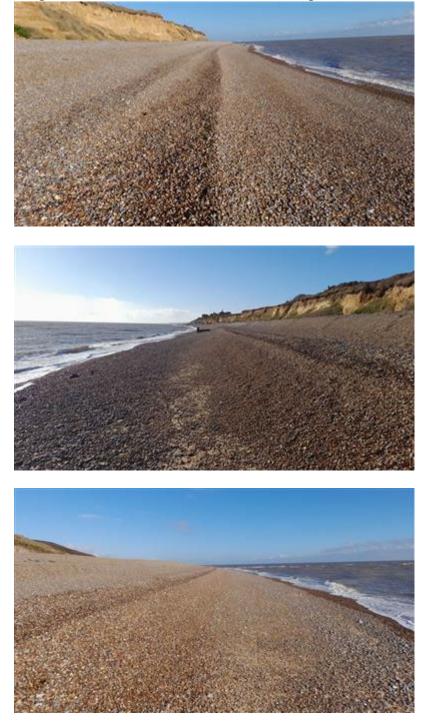
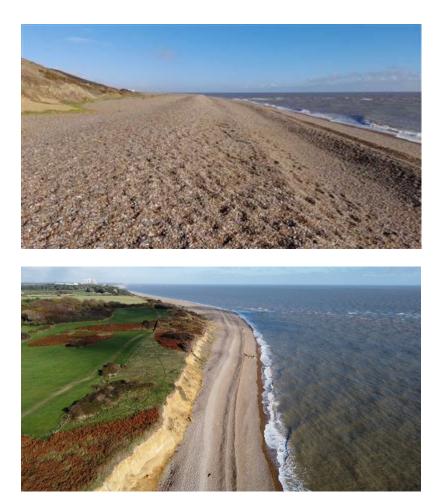
Images of the Northern UNDEFENDED Frontage:

Intertidal Beach volume, north of defence termination: No significant change Supratidal Beach volume, north of defence termination: Moderate increase
