Thorpeness Monthly Monitoring Report

Date and Time of Survey: April 12 2024, 08:24

Inspector: Thomas Hayden

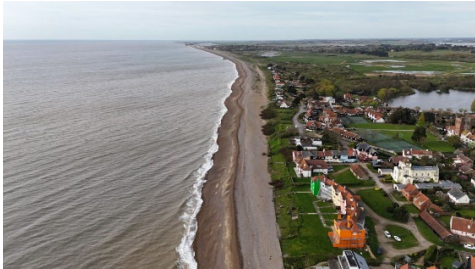
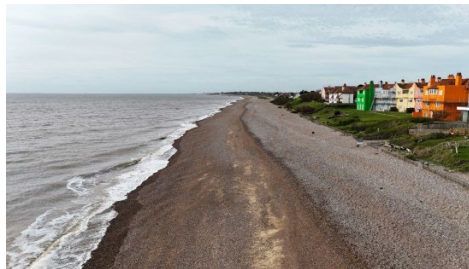
Photos of the southern UNDEFENDED frontage:

Comments on the Current Beach Levels over the southern UNDEFENDED frontage: Lower beach has lost a small amount of material, leading to a shallower beach profile up to the high tide line. This high tide mark is higher up the beach than has been seen previously, owing to the shallower profile of the lower beach.

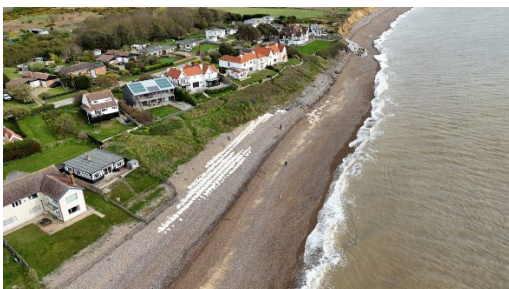
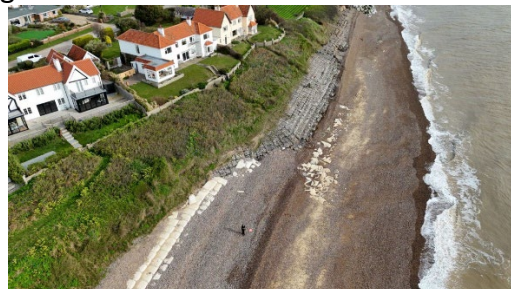
Photos of the Central DEFENDED frontage:

Comments on the current beach levels over the DEFENDED frontage: Beach levels have built slightly over the defended frontage. This is evidenced from the natural recovering of the defences, as the lower geobags and gabion baskets are now not visible. The high tide mark has moved closer to the base of the defences, meaning that there is a shallower lower beach profile than has been seen previously.

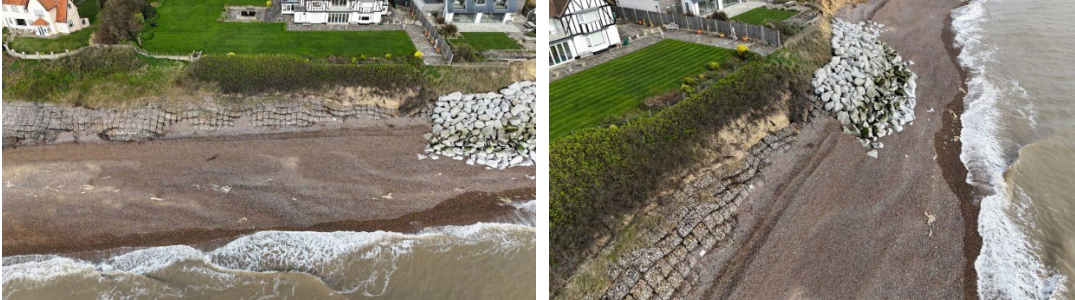
Photos of the gabions:

Comments on gabion condition: Lower gabion baskets have been covered by a build up of material. Upper gabion baskets remain in place with minimal movement.

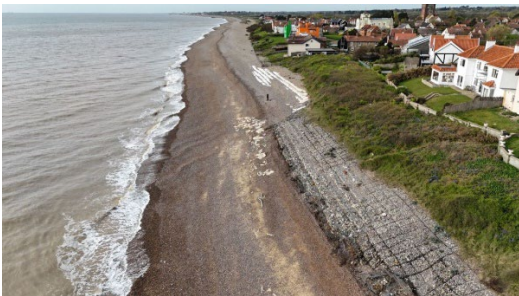
Photos of Phase 1 Geobags:

Comments on Phase 1 Geobag condition: Phase 1 geobags have been partially recovered naturally. The lower rows of bags are no longer visible. The upper rows of bags remain exposed, however not to the extent that has been seen previously.

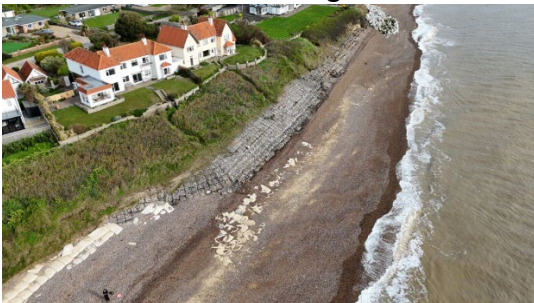
Photos of Phase 2 Geobags:

Comments on Phase 2 Geobag condition: Geobags at the southern end of the gabion field remain partially exposed. However, most of the bags have been covered up by beach material. The defence termination north of the rock has been partially exposed since the last visit.

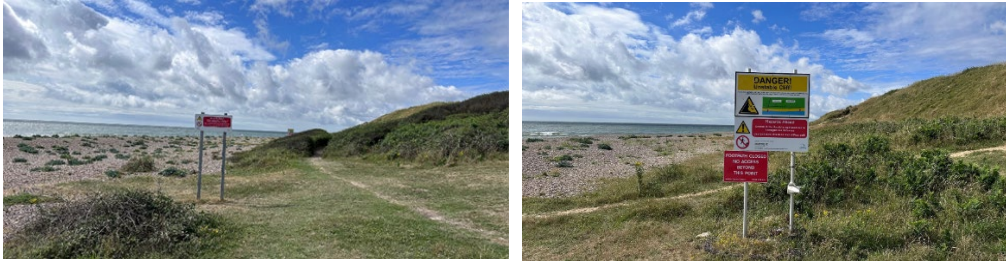
Signage condition: Good

All signage remains in place and legible.

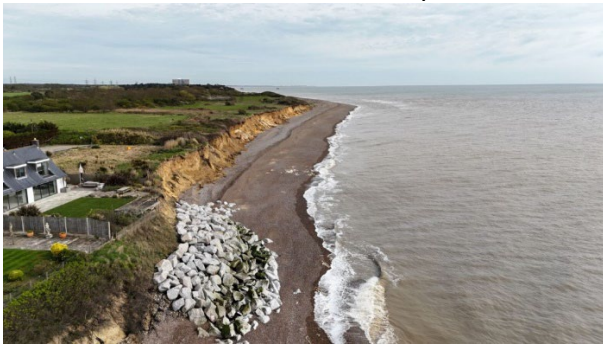
Photos of Hazards/Debris: Examples recorded on inspection below.

Comments on Hazards/Debris: Cliffs immediately north of the rock are overhanging and undercut. However, there has not been the scale of erosion between visits that has been seen previously. Erosion deposits remain at the base of the cliff. Further north the cliffs are more vegetated, indicating that there has been less erosion.

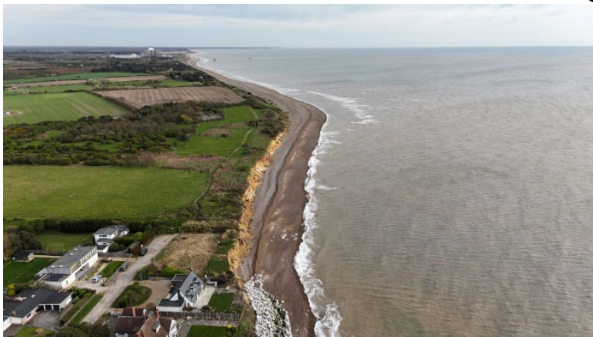
Photos of the Northern UNDEFENDED Frontage:

Comments on the current beach levels, north of defence termination: Lower beach profile has shallowed out and the high tide mark has moved further towards the cliff. This has created a steeper slope up to the high tide line. This means that the upper beach has seen material build up immediately north of the rock. Further north, the beach is growing, so the cliffs are more protected.
