Thorpeness Monthly Monitoring Report

Date and Time of Survey: April 26 2024, 08:00

Inspector: Chris Finbow/Thomas Hayden

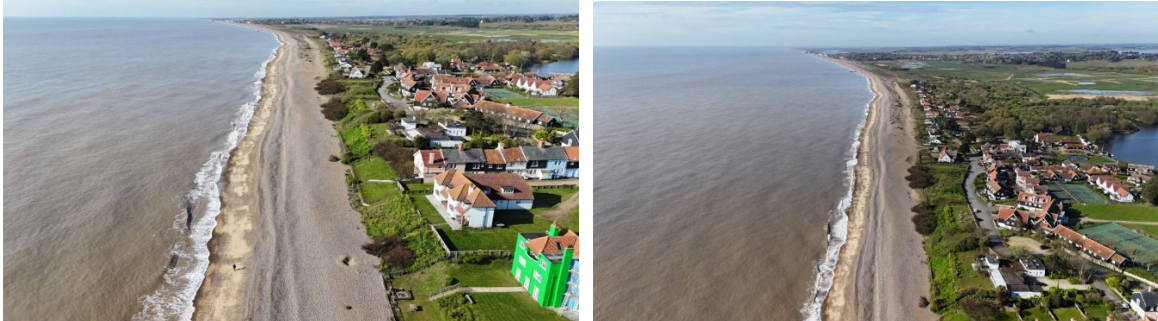
Photos of the southern UNDEFENDED frontage:

Upper Beach Levels: Slight Decrease

Lower Beach Levels: Significant Decrease

Comments on the Current Beach Levels over the southern UNDEFENDED frontage: Lower beach levels have reduced, although the upper beach has not lost too much material.

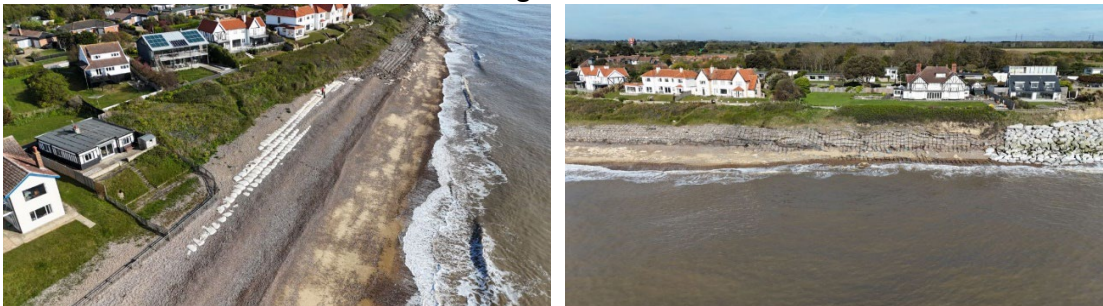
Photos of the Central DEFENDED frontage:

Upper Beach Levels: Slight Decrease

Lower Beach Levels: Significant Decrease

Comments on the current beach levels over the DEFENDED frontage: The beach levels have suffered as a result of the recent storm and high tide conditions. The beach levels have lowered, so that the lower gabion baskets and leftover wooden stakes are visible. The lower gabion baskets have lost more material and have sustained more damage. Beach levels have reduced across the length of the frontage.

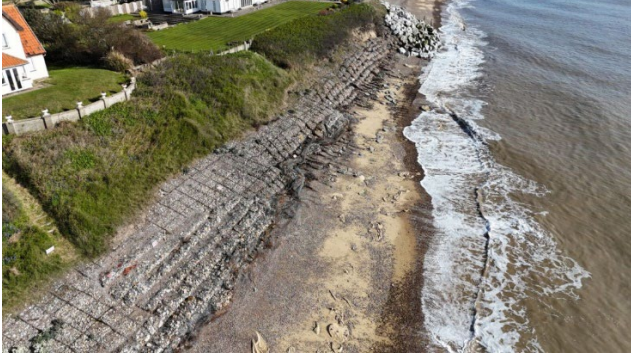
Photos of the gabions:

Comments on gabion condition: As a result of the lower beach levels, lower baskets have been exposed. More damage has occurred, leading to a loss of beach material. Remaining wooden stakes at the toe of the gabions are also visible.

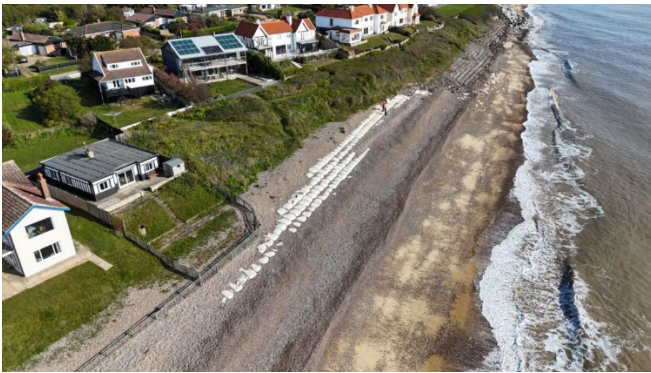
Photos of Phase 1 Geobags:

Comments on Phase 1 Geobag condition: Phase 1 geobags continue to be recovered. Some of the upper bags are still showing, but more bags are covered, compared to the last visit.

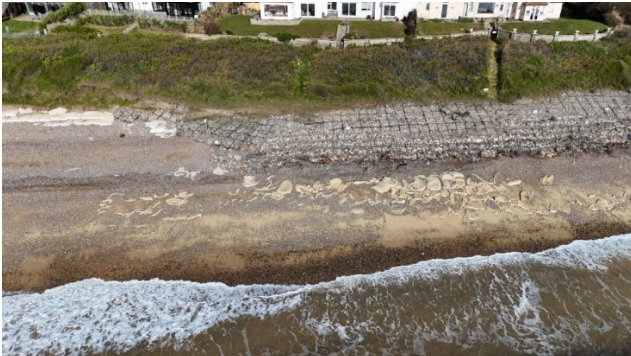
Photos of Phase 2 Geobags:

Comments on Phase 2 Geobag condition: Due to a drop in lower beach levels, the phase 2 geobags are more exposed/uncovered. The bags at the southern end of the gabion field have sustained some minor damage since being exposed.

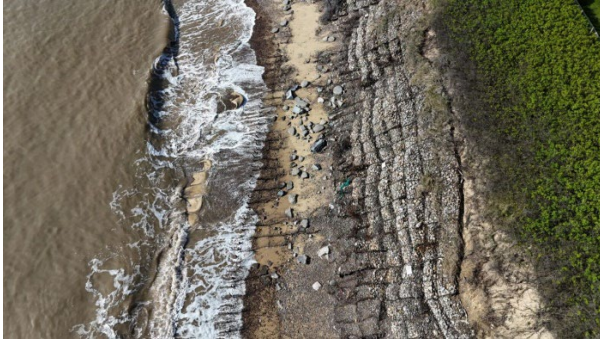
Photos of Hazards/Debris: Examples recorded on inspection below.

Comments on Hazards/Debris: Exposed wooden stakes and wire from the gabion baskets are causing a trip hazard. Debris is running south from the rock. Geofabric from the exposed geobags at the southern end of the gabion field is also a potential trip hazard.

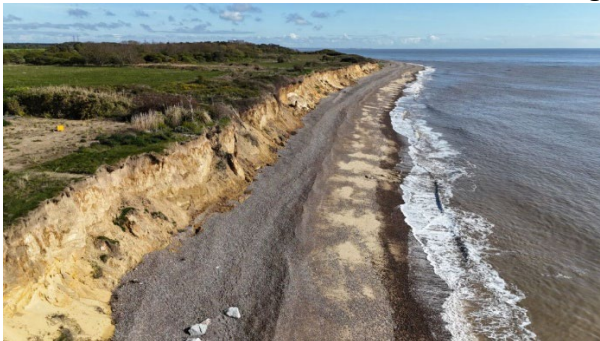
Photos of the Northern UNDEFENDED Frontage:

Upper Beach Levels: Slight Decrease

Lower Beach Levels: Significant Decrease

Comments on the current beach levels, north of defence termination: Lower beach level has dropped due to the recent storm conditions. The upper beach has lost some material but is still acting as a buffer between the sea and the toe of the cliffs. Some material has naturally fallen from the cliff.
