## **Thorpeness Monthly Monitoring Report**

**Date and Time of Survey:** May 29 2024, 09:00

**Inspector:** Thomas Hayden

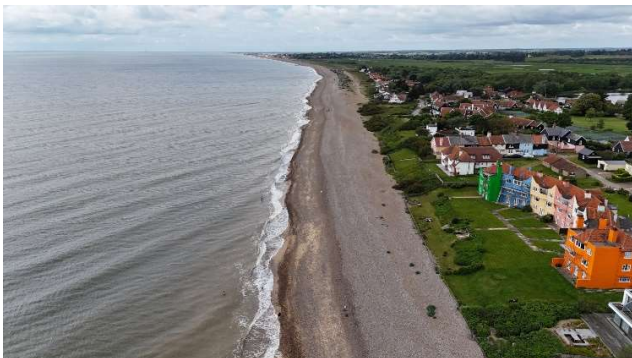
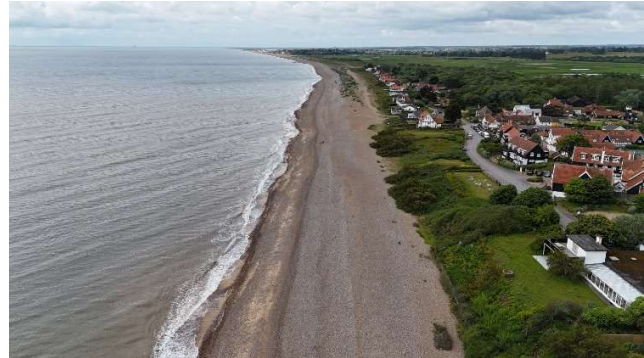
Photos of the southern UNDEFENDED frontage:

Upper Beach Levels: Moderate Increase

Lower Beach Levels: Moderate Increase

Comments on the Current Beach Levels over the southern UNDEFENDED frontage: The high tide mark has moved seaward slightly, meaning that there is more material on the upper beach. The lower beach has also built.

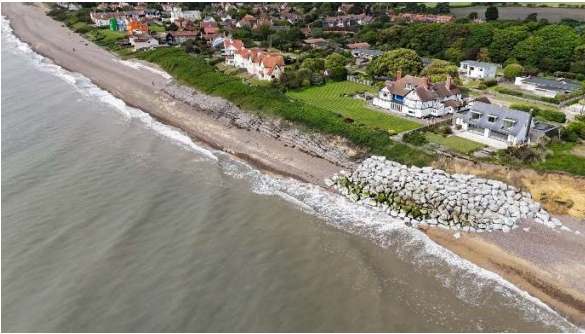
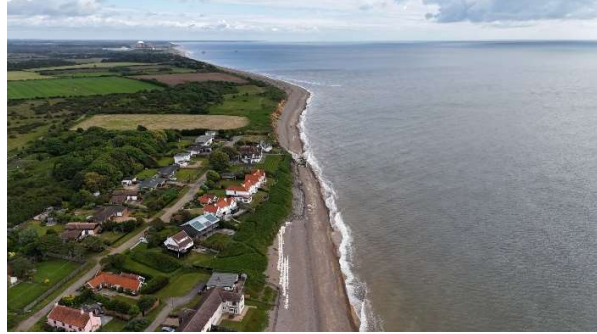
Photos of the Central DEFENDED frontage:

Upper Beach Levels: Moderate Increase

Lower Beach Levels: Moderate Increase

Comments on the current beach levels over the DEFENDED frontage: Beach levels have recovered, which is the trend along the whole frontage. The upper beach has built more than the lower beach, meaning that there is material covering the lower gabions. The lower beach has not recovered as much, meaning that, although some of the exposed wooden stakes at the base of the baskets are now covered, some metal from gabion baskets and a small number of wooden stakes are still visible below the high tide mark.

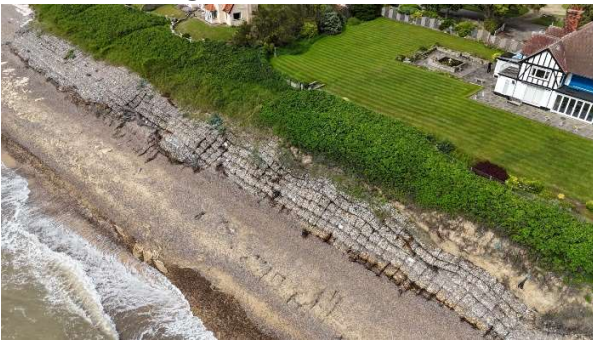
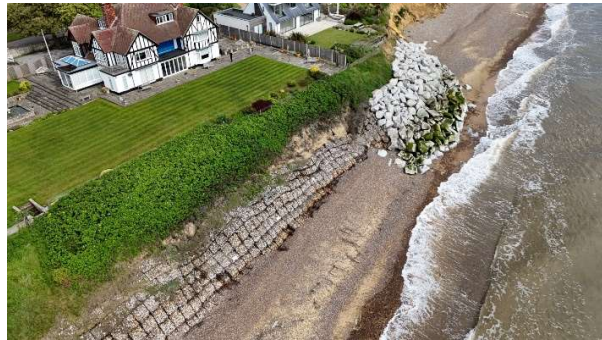
Photos of the gabions:

Comments on gabion condition: Lower gabion baskets have been reburied from the build-up in beach material. Some wire still showing out of the beach in front of the gabion baskets, along with the wooden stakes originally used to secure them. The baskets adjacent the south side of the rock has slipped further. This extends further south now towards the geobags. Some further material has also been lost from the gabion field.

Comments on Hazards/Debris: Small amount of gabion wire and wooden stakes visible and protruding from the beach adjacent the southern side of the rock.

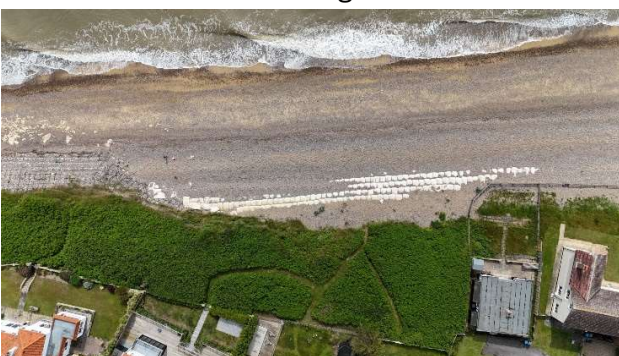
Photos of Phase 1 Geobags:

Comments on Phase 1 Geobag condition: Phase 1 geobags remain in a similar condition and state to the previous inspection.

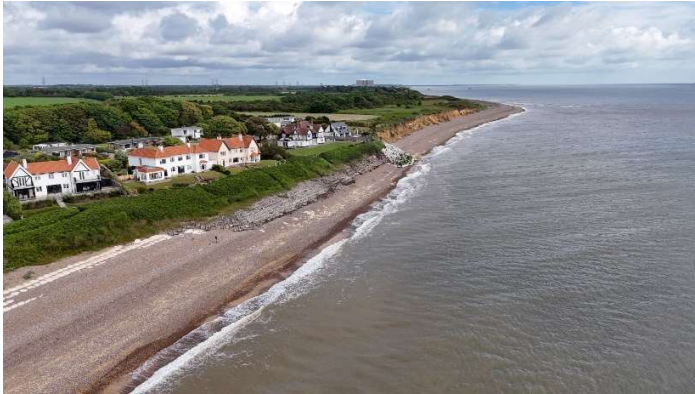
Photos of Phase 2 Geobags:

Comments on Phase 2 Geobag condition: Most of these geobags have been covered up again, owing to the increase in beach levels. The southern most bags remain partially exposed, due to the current state of fabric.

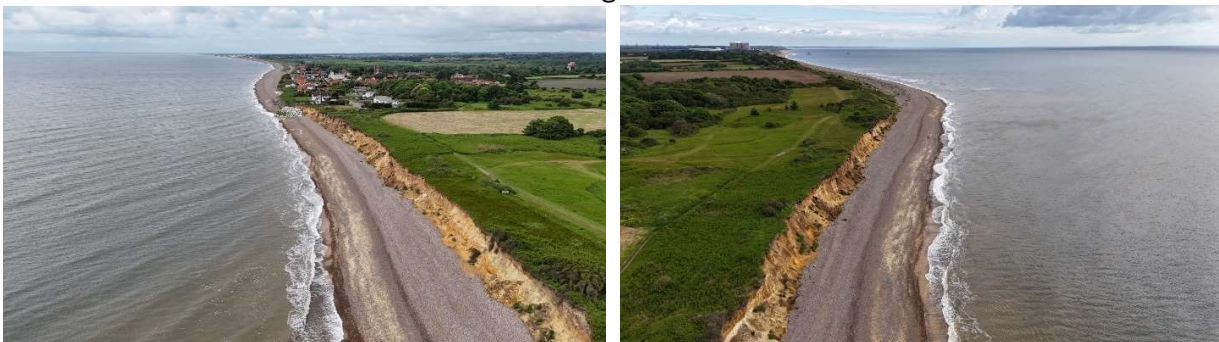
Photos of the northern UNDEFENDED Frontage:

Upper Beach Levels: Moderate Increase

Lower Beach Levels: Moderate Increase

Comments on the current beach levels, north of defence termination: Beach material has built both the upper and lower beaches. The high tide mark has moved further seaward, similar to the southern undefended frontage. However, there appears to have been more cliff loss immediately north of the rock, although this is on a much smaller scale than has been previously seen.
