Pakefield Monthly Monitoring Report

Date and Time of survey: July 3, 2024 11:33

Inspector Name: Keith Roper

Reason for Inspection: Scheduled

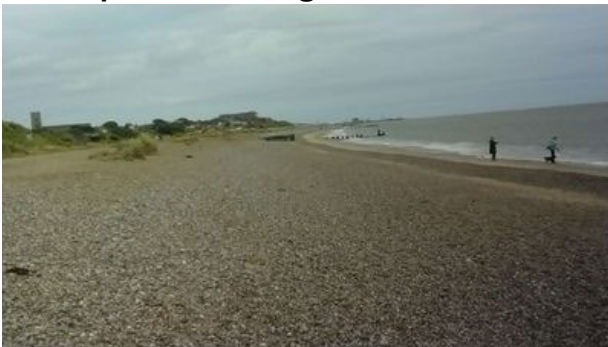
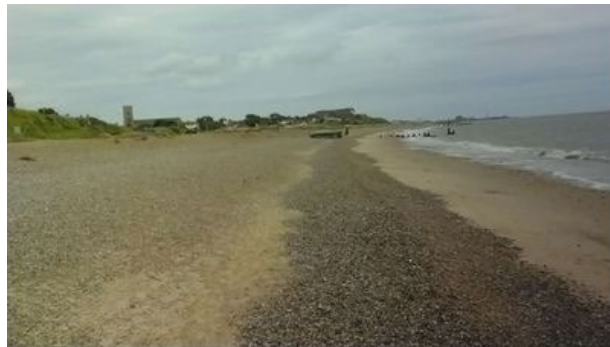
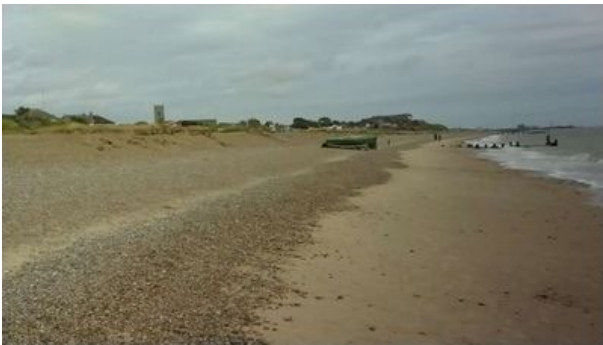
Beach photos looking north:

Extension of beach cliffing alongshore: Negligible change

Landward recession of beach cliff: Slight landward recession (trampling)

Change in gradient of beach cliff face: Slightly flatter

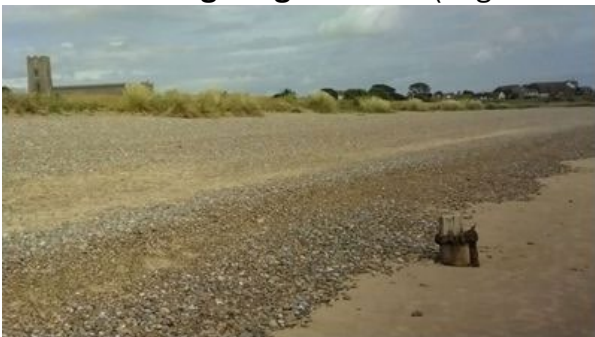
Beach photos below taken further north than usual inspection area showing new timber exposure – seaward of Nightingale Road: (Slight reduction in beach level)

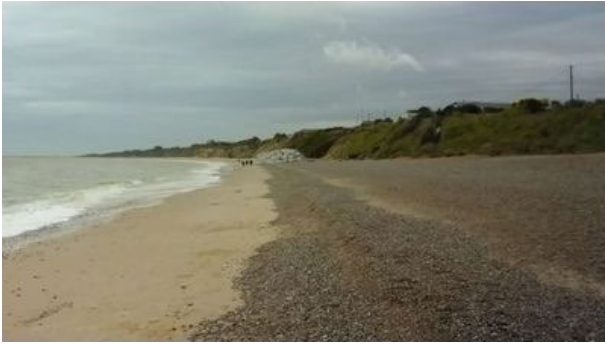
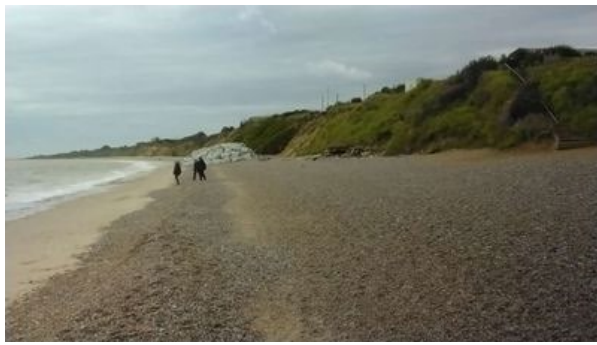
Beach photos looking south:

Comments on change in beach geomorphology: Similar to the previous month, a clearly defined berm, characterised by shingle, runs approximately along the high water mark. It has been narrowed by recent wave action but there appears to have been little disturbance of the upper beaches. There has been the usual trampling and resultant disturbance along the remaining dune face.

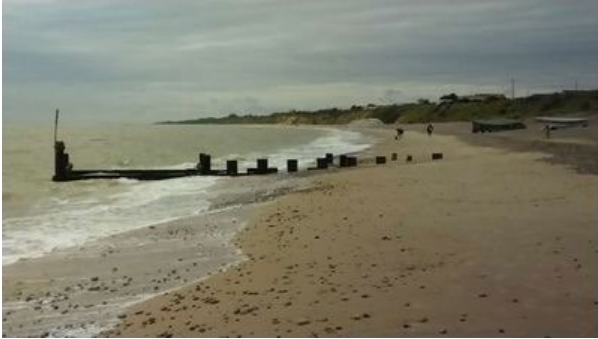
Photo of exposed timber groyne:

Change in beach level relative to exposed timber groyne opposite Grand Avenue: Slight reduction

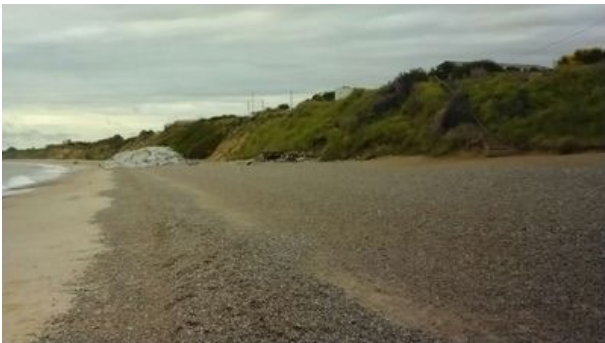
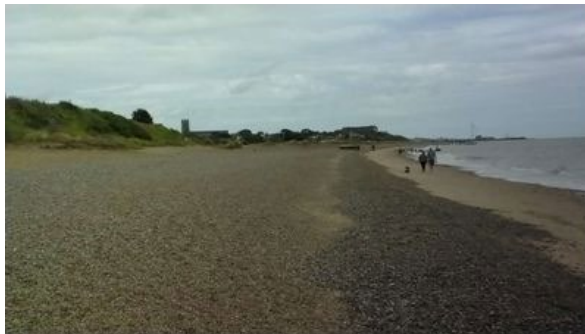
Photos of beach north of Arbor Lane:

General impression of beach volume: Slightly decreased

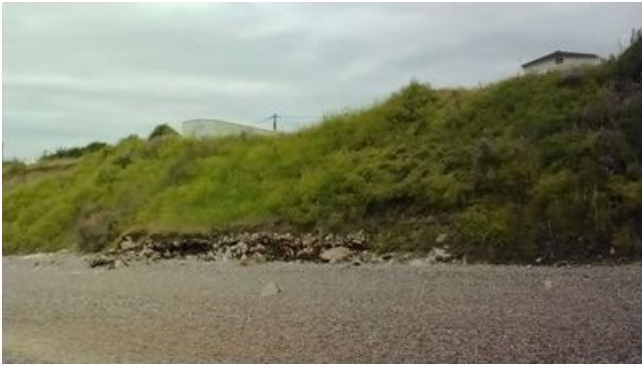
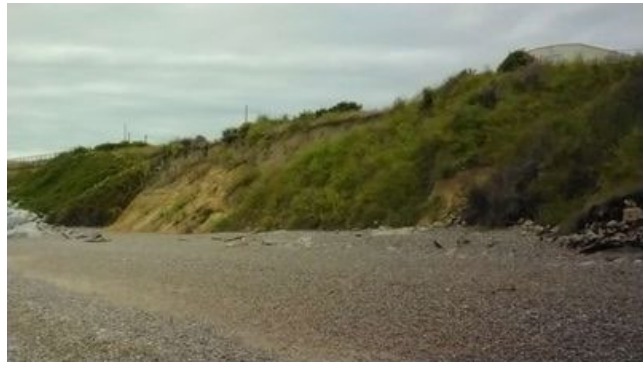
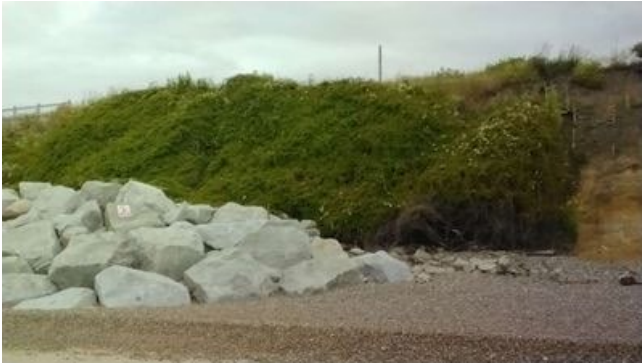
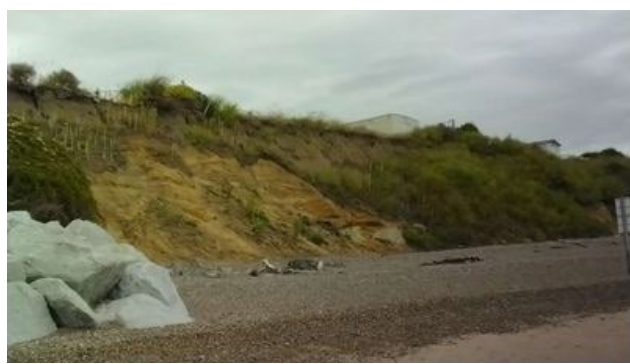
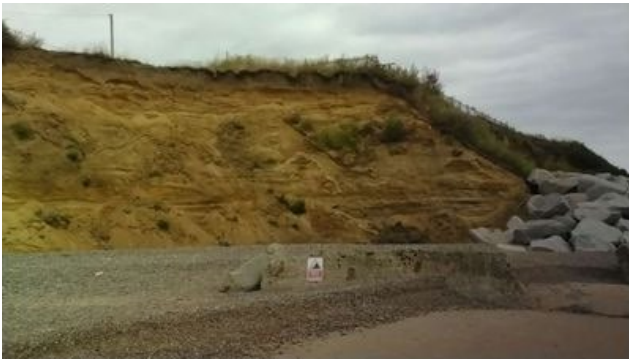
Photos of cliffs supporting property:

Changes to cliffs supporting property north of rock armour: Slumped material on cliff face; denuding and loss of vegetation; cliff-face steepening and overhanging; scree at base of cliff; fallen vegetation at base of cliff.

Changes to cliffs supporting property south of rock armour: Slumped material on cliff face; denuding and loss of vegetation; cliff-face steepening and overhanging; scree at base of cliff; fallen vegetation at base of cliff.

Comments on risk to cliff-top assets: There were two caravans on the seaward side of The Cliffs access road - one adjacent the seaward end of Arbor Lane and one other, to the south, showing it is due for removal from site. There was no evidence cliffs were reached by seas during June and no significant change to issues recorded previously.

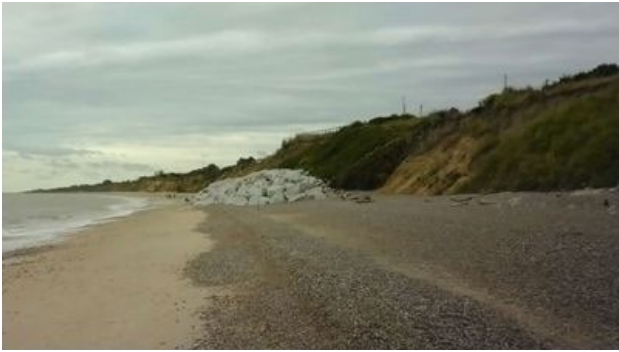
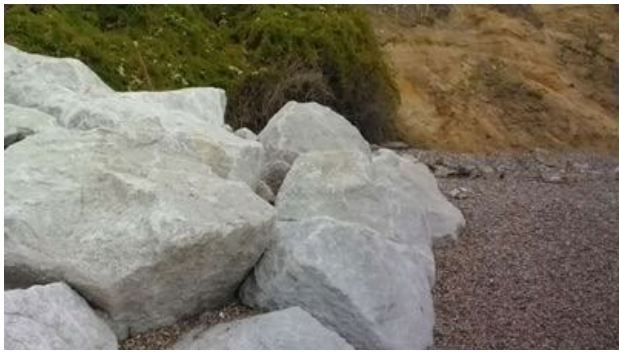
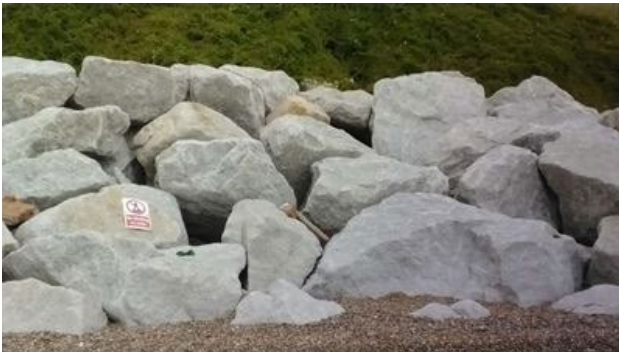
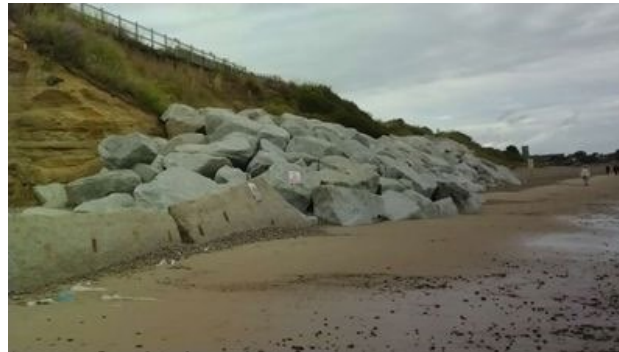
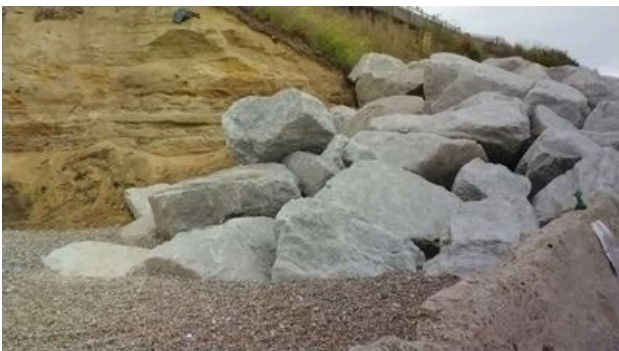
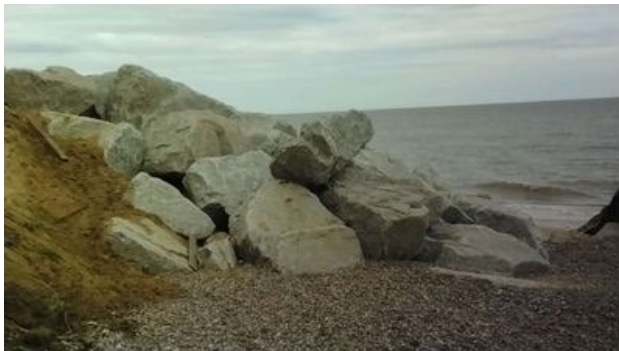
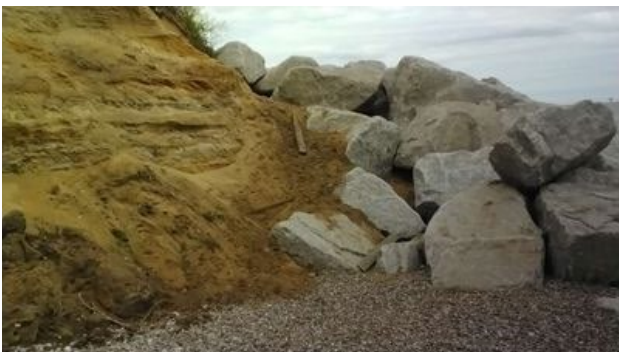
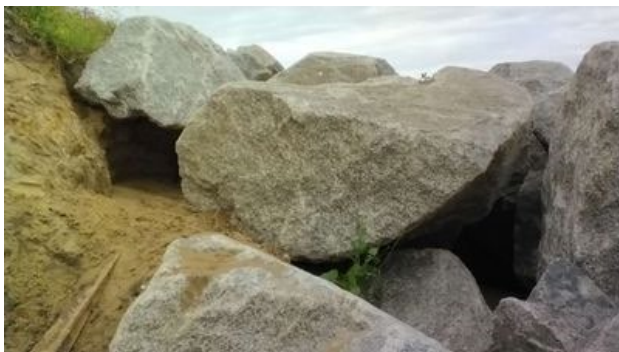
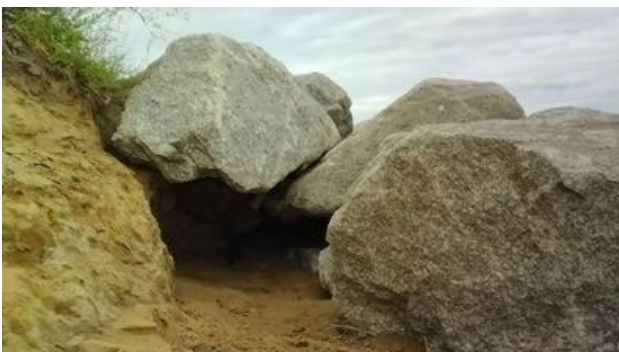
Photos of rock armour:

Displacement of rock from structure: Yes - Some - Monitor

Settlement, movement, undermining of structure: Yes - Some - Monitor

Exposure of geotextile: Yes - Some - Monitor

Hazards/debris within structure: Yes - Some - Monitor

Stability of cliff behind rock armour: No obvious change apparent from the beach behind the main rock body. Issues at the north and south ends of the rock have been noted previously.

Asset condition grade: 2 Good; minor defects that do not reduce overall performance

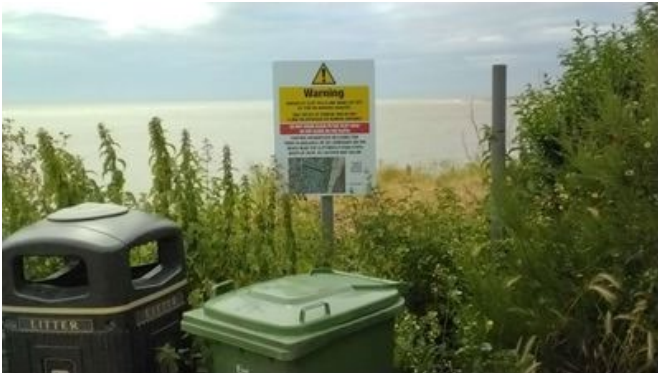
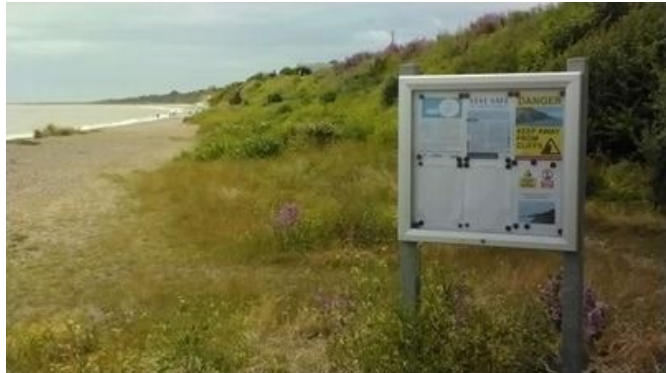
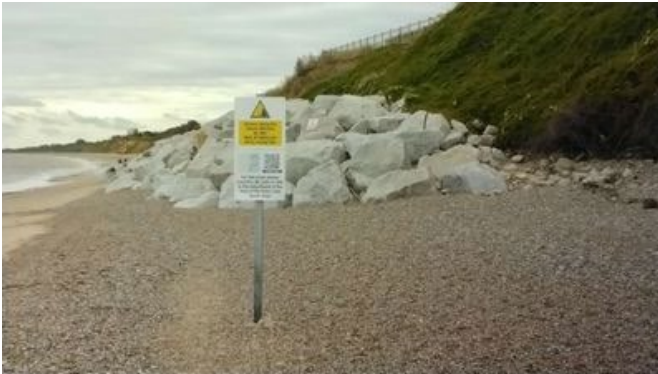
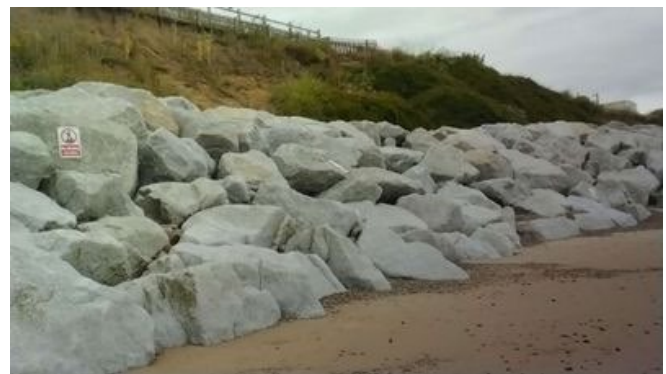
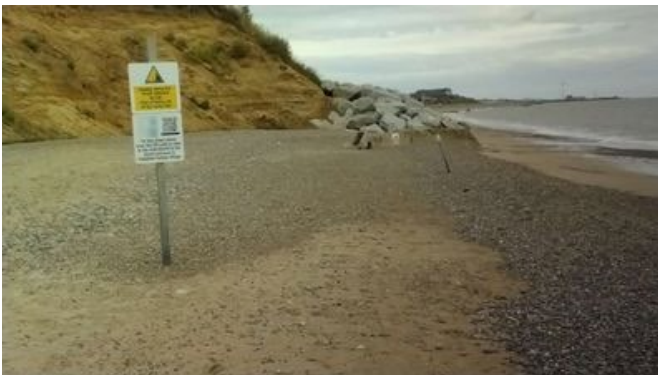
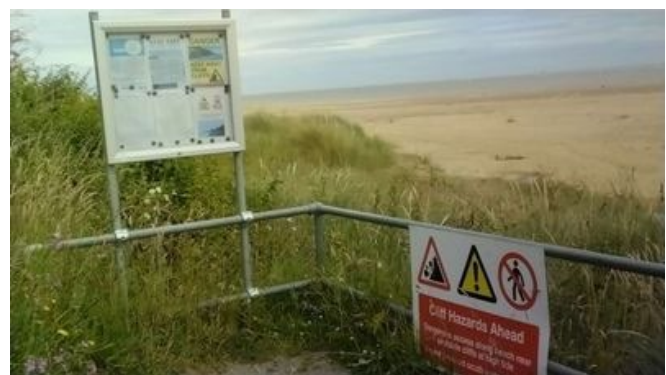
Photos of signage and any issues:

Provision of tidal information: Up to date and legible

Comments on signage: The information signage provided at the seaward end of Arbor Lane was visible.

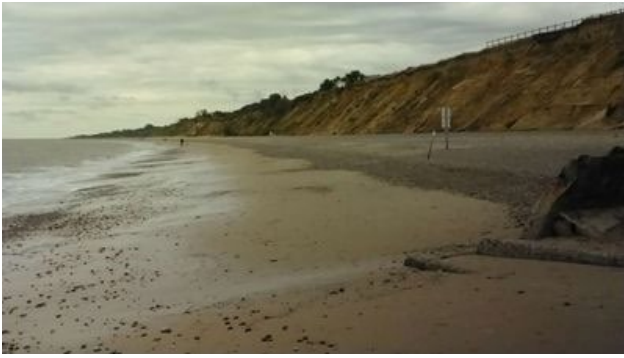
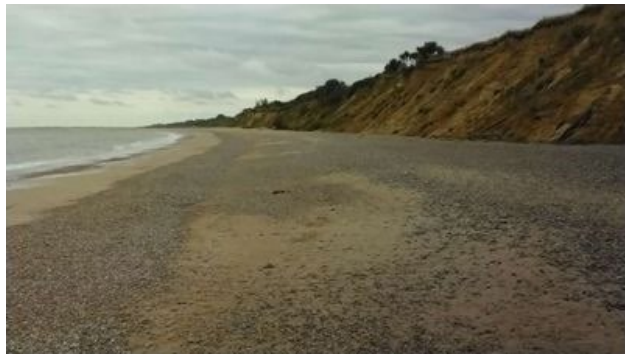
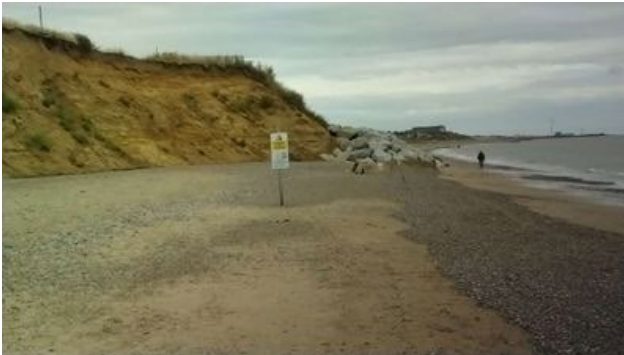
Photos of southern beach:

General impression of beach volume: Slightly reduced

Comments on change to southern beach: There was evidence of a re-working and redistribution of foreshore material, with a narrowed shingle berm near the high water mark which was consistent with the feature to the north. The berm is consistent and continuous along the frontage.

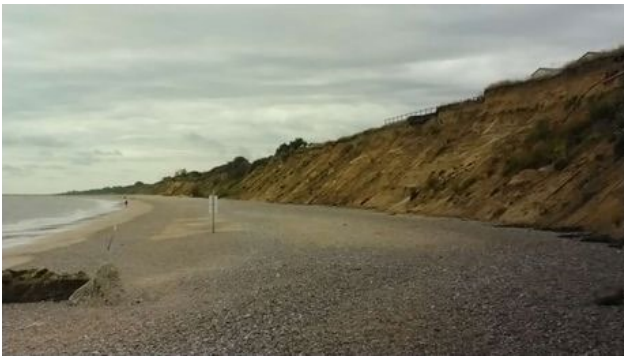
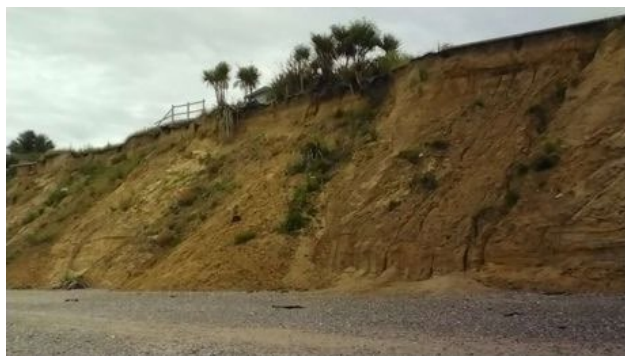
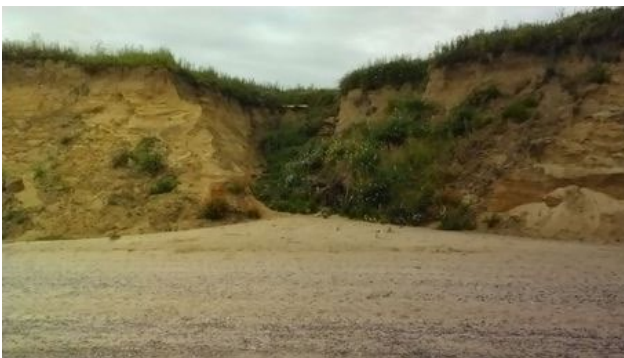
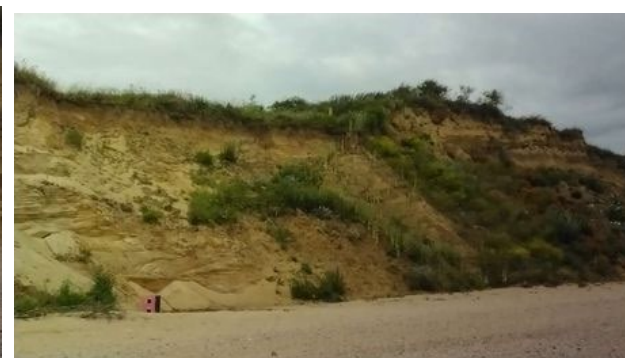
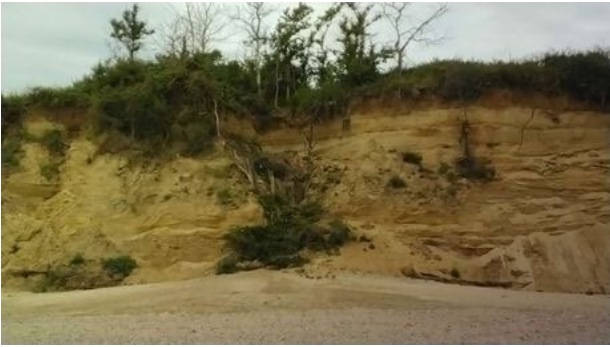
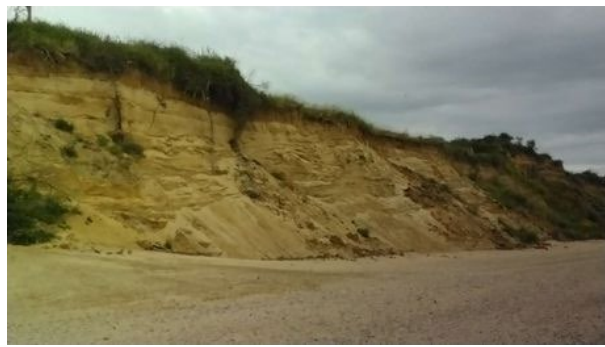
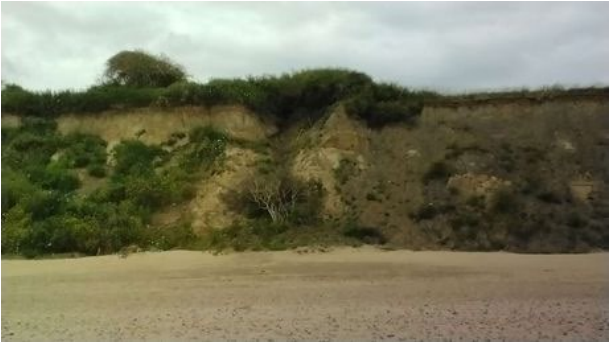
Photos of southern cliffs:

Changes to southern cliffs: Slumped material on cliff face; denuding and loss of vegetation; cliff-face steepening and overhanging; scree at base of cliff; fallen vegetation at base of cliff.

Comments on cliff change and any risk posed: Cliff bases have not been impacted by seas and the cliffs retain the characteristics recorded previously.

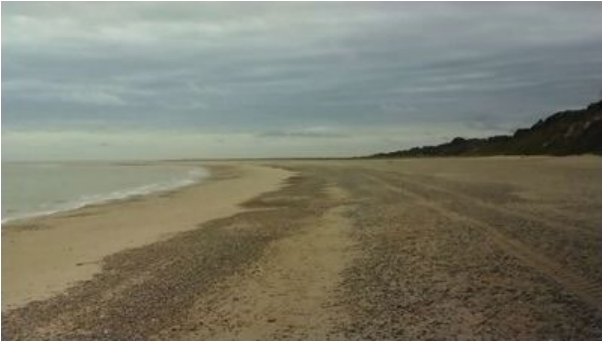
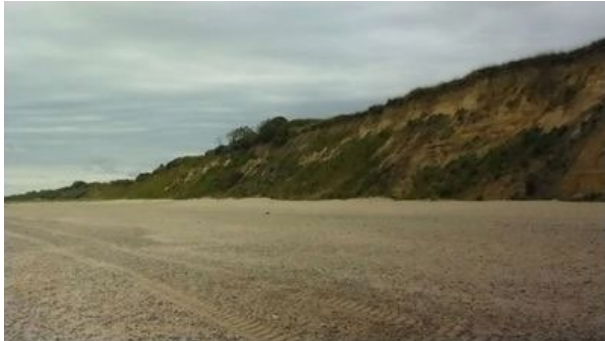
Photos of Pontins frontage and Benacre Ness:

Changes to beach geomorphology: Beaches appear to be continuing to widen.

Comments on change at Benacre Ness: Trend of widening beaches continuing and the northeast Ness projection point is probably moving northward. The month has been relatively dry and the surface water outflow rate adjacent Pontins access was greatly reduced. There was very little standing water on The Ness in the areas inspected.

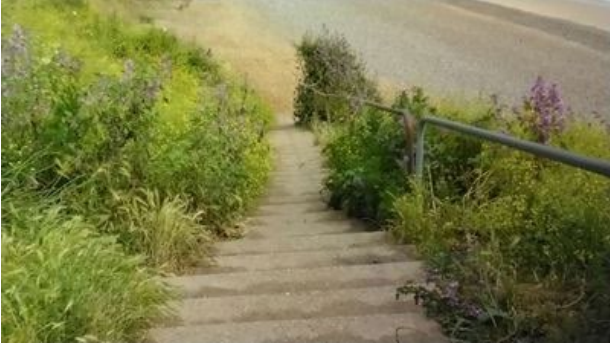
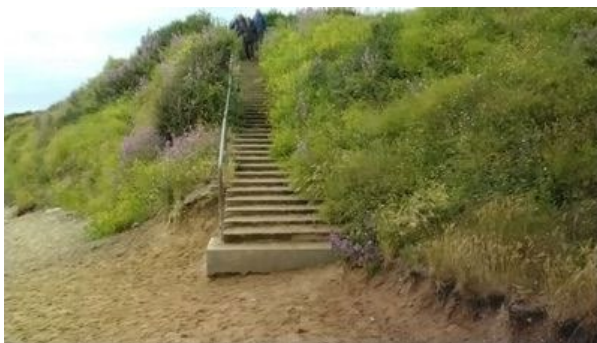
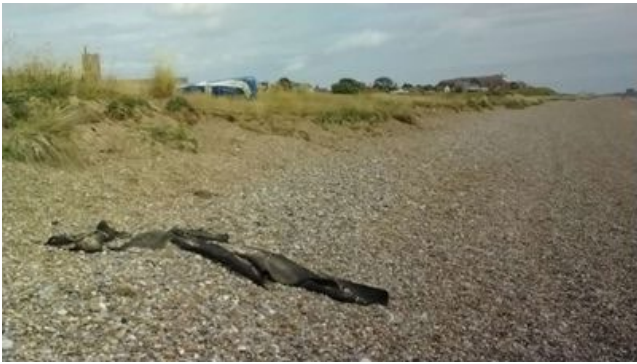
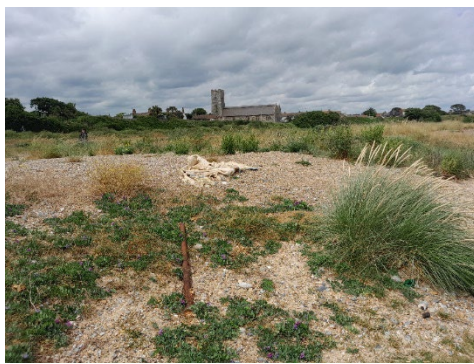
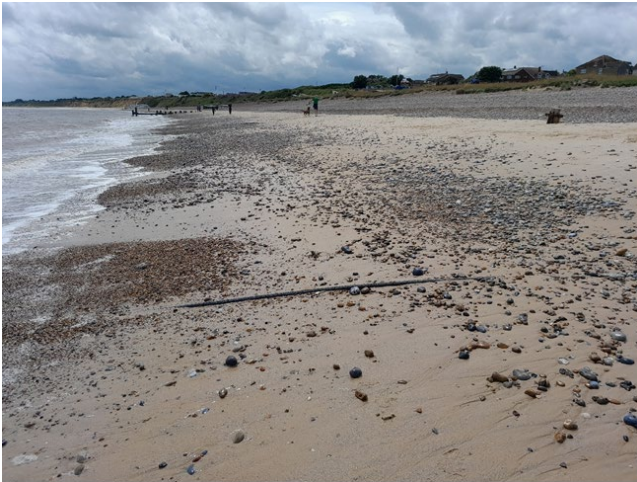
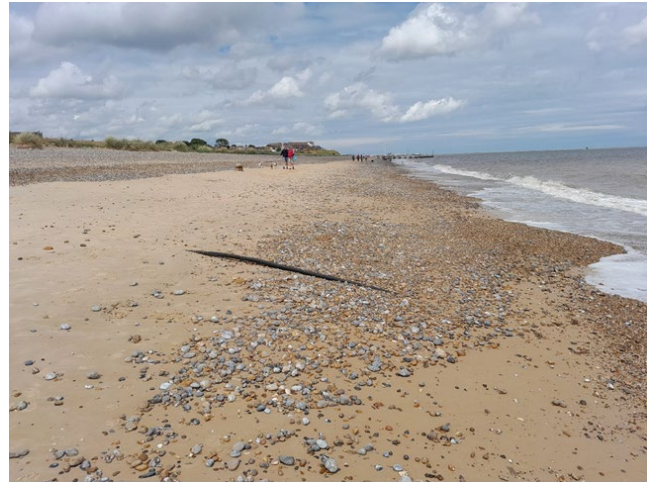
Photos of hazard/debris:

Comments on hazard/debris: Beach access steps seaward end of Arbor Lane remain partially overgrown. Two cables were seen approximately seaward of Nightingale Road and those thought to have management responsibility have been notified.

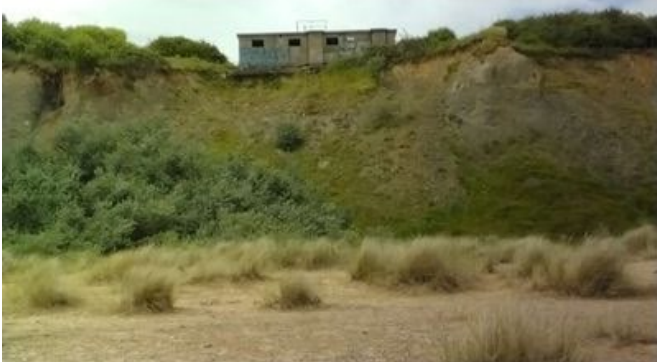
Changes in cliff stability: No obvious change apparent from beach
