Thorpeness Monthly Monitoring Report

Date and Time of Survey: October 4 2024, 08:30

Inspector: Thomas Hayden

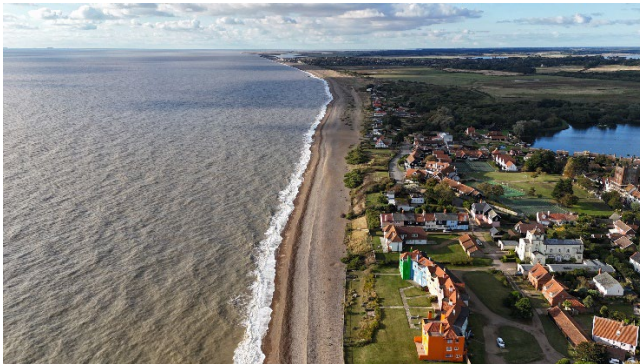
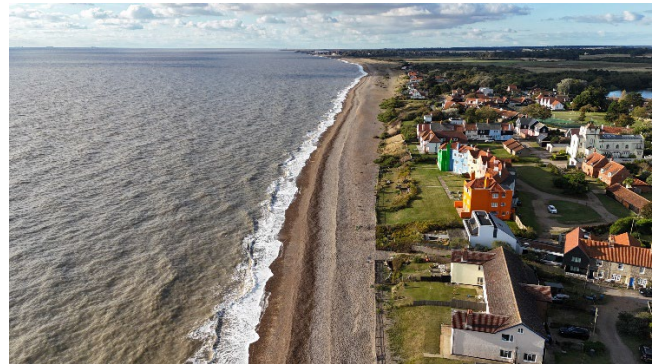
Photos of the southern UNDEFENDED frontage:

Upper Beach Levels: Moderate Decrease

Lower Beach Levels: Moderate Decrease

Comments on the Current Beach Levels over the southern UNDEFENDED frontage: Beach levels have decreased over the last inspection period, due to a period of adverse weather conditions. Lower beach levels have had more of a reduction than the upper beach levels.

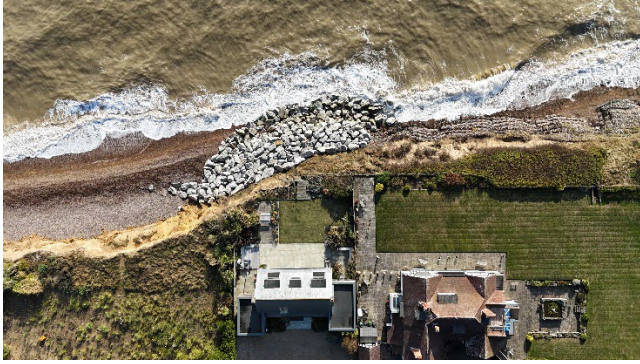
Comments on the current beach levels over the DEFENDED frontage: Beach levels have reduced since the last inspection. The lower beach has reduced significantly, with the wave run up reaching the lower gabions. The upper beach has also reduced, due to the increased impact of wave action

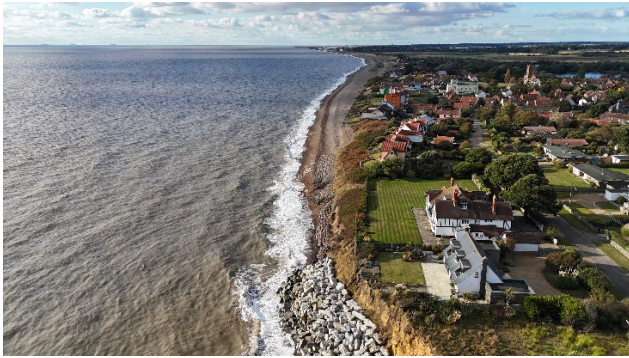
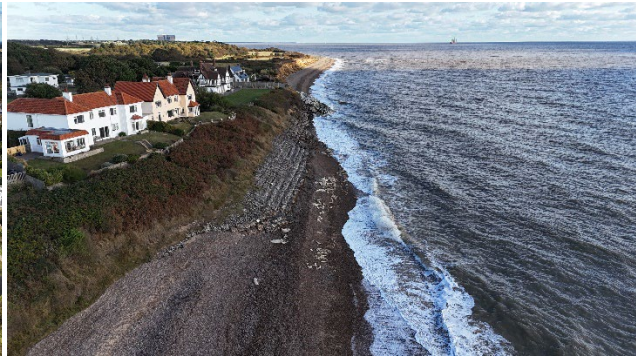
Photos of the central DEFENDED frontage:

Upper Beach Levels: Moderate Decrease

Lower Beach Levels: Moderate Decrease

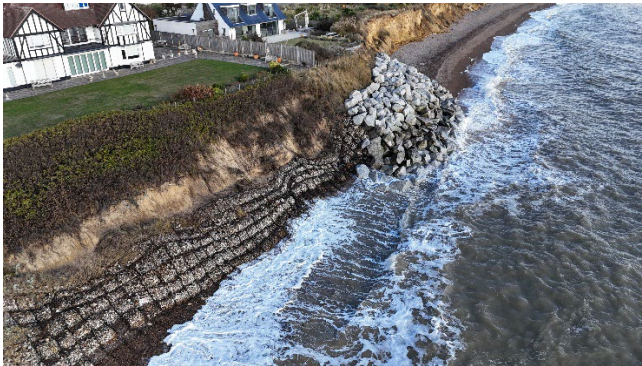
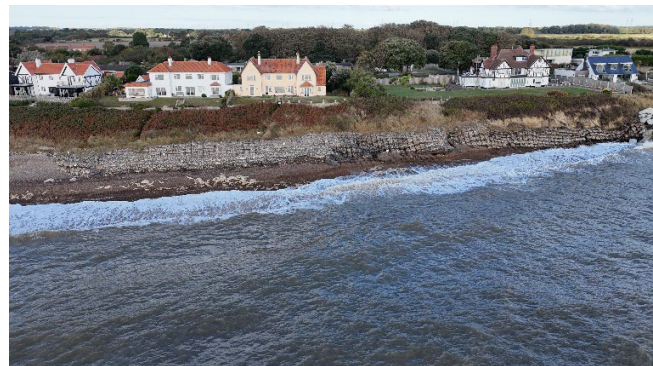
Photos of the gabions:

Comments on gabion condition: A larger proportion of gabions south of the rock have now slipped, as a result of the period of adverse weather. However, they are still affording protection to the land behind, as they are still preventing a vast majority of the wave energy from getting through.

Comments on Hazards/Debris: Gabion baskets have shifted, so some of the wire is now visible through the beach, creating a trip hazard. Phase 2 Geobags that have been damaged have left material visible, again creating a trip hazard.

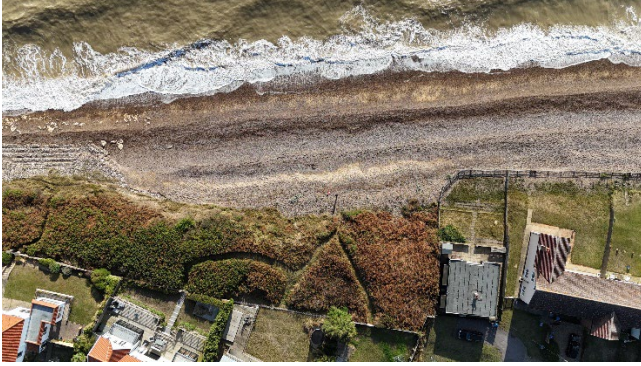
Photos of Phase 1 Geobags:

Comments on Phase 1 Geobag condition: Phase 1 geobags remain covered. The high tide mark is below the bottom of the geobags and a healthy ridge of beach material remains over the top of the bags.

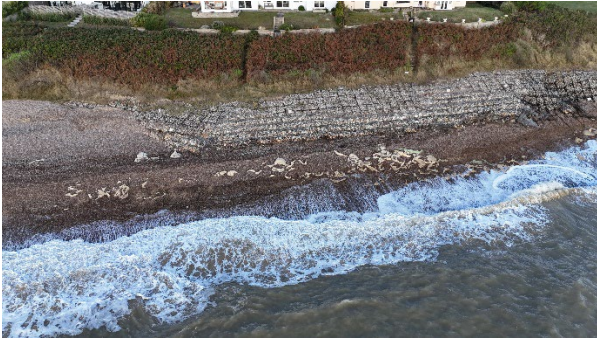
Photos of Phase 2 Geobags:

Comments on Phase 2 Geobag condition: Phase 2 geobags have been uncovered, owing to their positioning on the lower beach. The bags have been partially damaged as a result of the recent adverse weather. However, some of the damage may have been caused by previous weather events and covered up when the beach built previously.

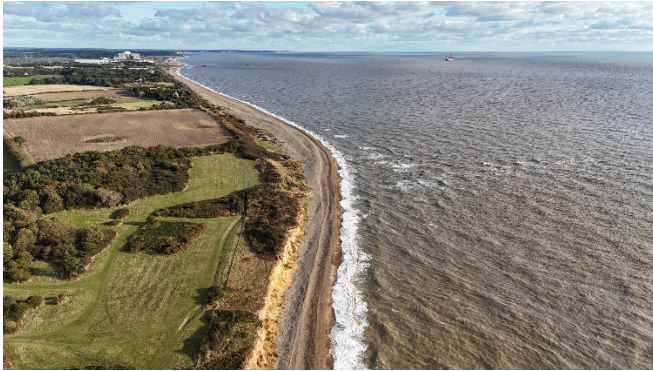
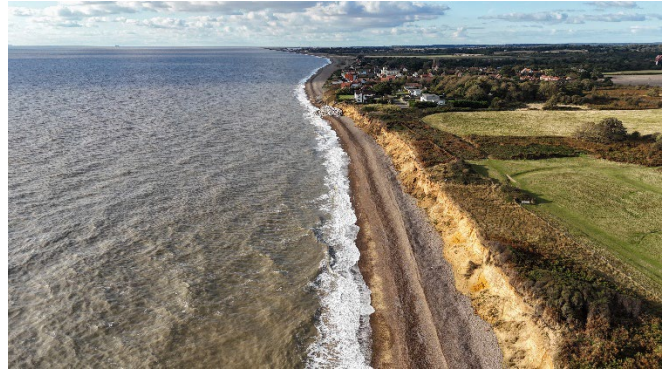
Photos of the northern UNDEFENDED Frontage:

Upper Beach Levels: Moderate Decrease

Lower Beach Levels: Moderate Decrease

Comments on the current beach levels, north of defence termination: As is the trend across the frontage at this inspection, the beach levels have reduced. There is still a ridge of beach material between the high tide mark and the toe of the cliff. However this is closer to the toe of the cliff than has been seen previously.
