Pakefield Monthly Monitoring Report

Date and Time of survey: September 25, 2024 07:38

Reason for Inspection: Scheduled

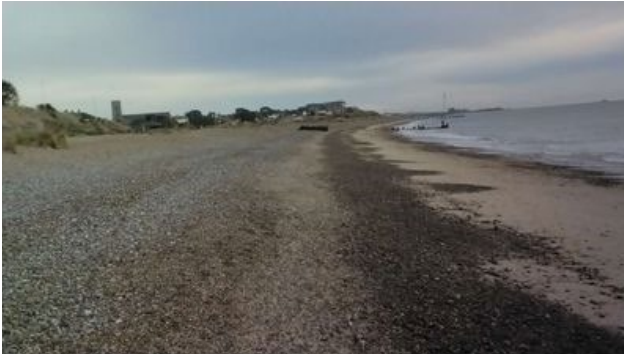
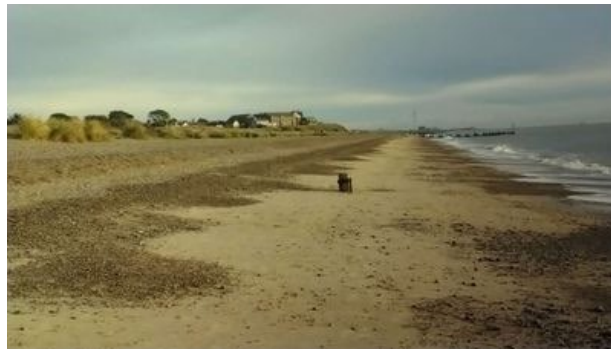
Beach photos looking north:

Extension of beach cliffing alongshore: Negligible change

Landward recession of beach cliff: Negligible change

Change in gradient of beach cliff face: Slightly flatter (accumulation or trampling)

Maximum height of beach cliff (m): 1.5

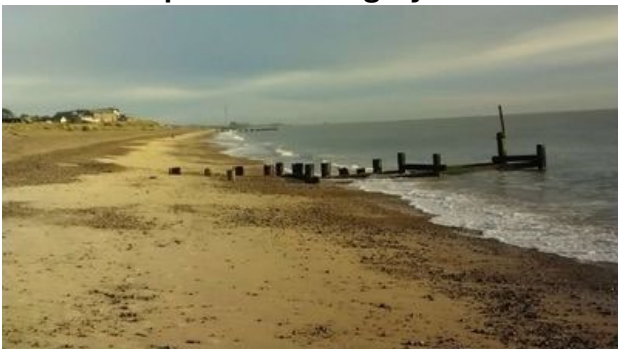
Photo of exposed timber groyne:

Change in beach level relative to exposed timber groyne opposite Grand Avenue: Slight increase

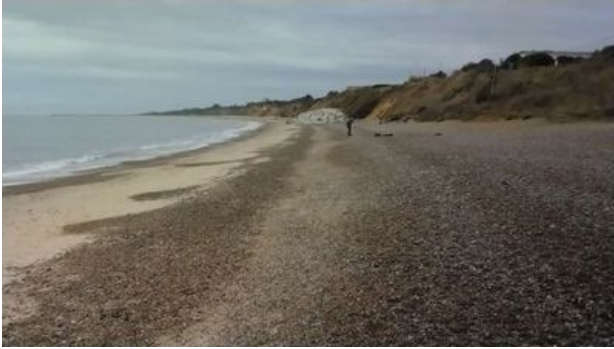
Photos of beach north of Arbor Lane:

General impression of beach volume: Moderately Higher

Comments on change in beach geomorphology: The foreshore retains its characteristic steepened gradient. Shingle rich material has been accreted above the mean high-water mark, re-establishing a berm.

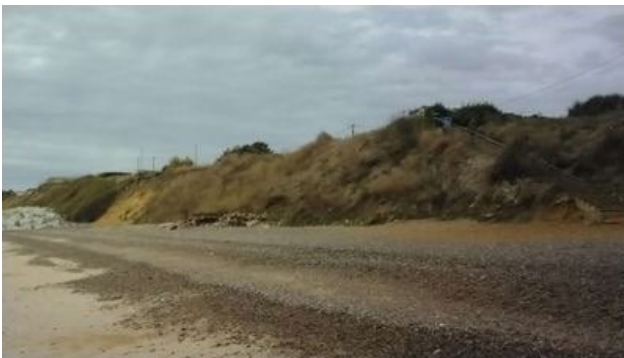
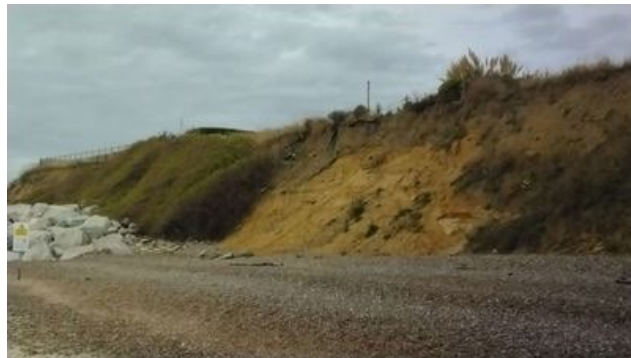
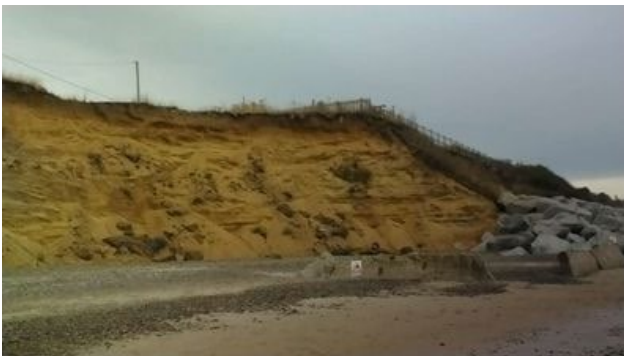
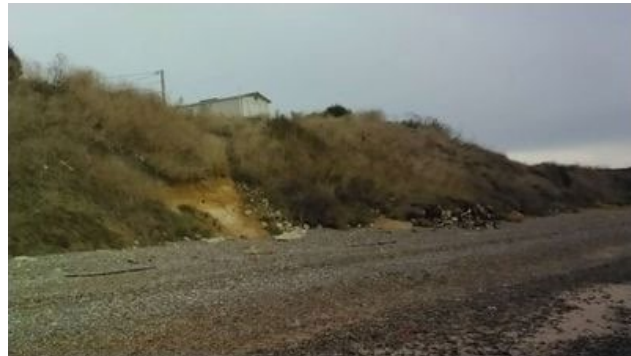
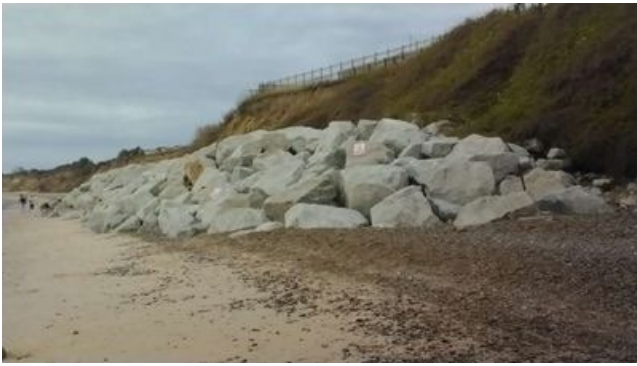
Photos of soft unconsolidated sand cliffs:

Changes to soft unconsolidated sand cliffs north of rock armour: Slumped material on cliff face; denuding and loss of vegetation; cliff-face steepening and overhanging; scree at base of cliff; fallen vegetation at base of cliff.

Changes to soft unconsolidated sand cliffs south of rock armour: Slumped material on cliff face; denuding and loss of vegetation; evident cliff top recession; cliff-face steepening and overhanging; scree at base of cliff; fallen vegetation at base of cliff.

Seas have not reached the cliff bases this past month prior to inspection, but losses from the cliff face of very dry material, and upper topsoil layers, remain ongoing. The east-west cliff top fencing above the south end of rock structure is likely to be undermined should recession of the cliff continue. The exposed cliff face immediately north of the rock also continues to see gradual losses through similar processes. The southernmost caravan was present seaward of The Cliffs access road.

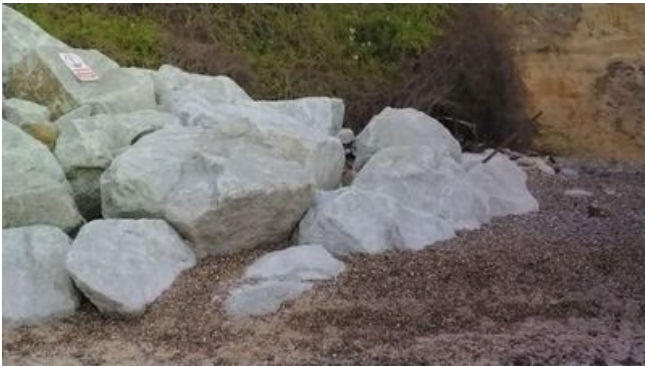
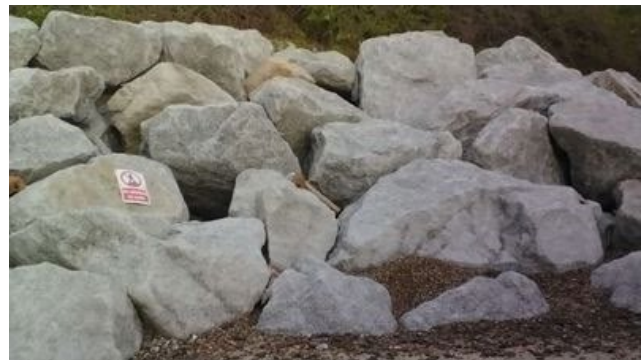
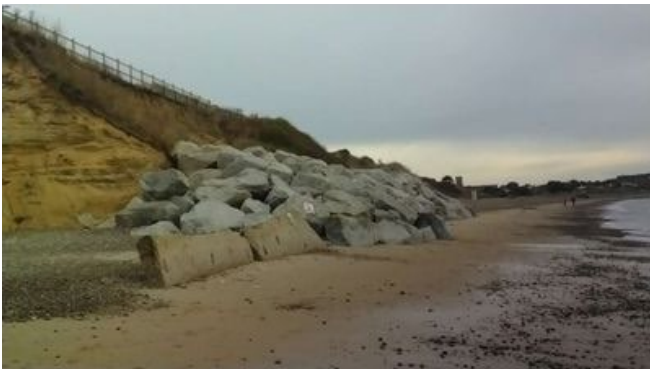
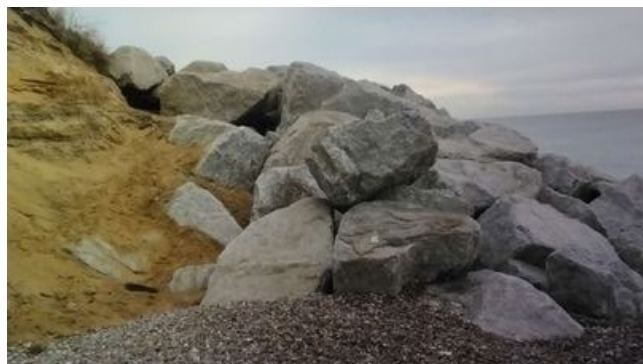
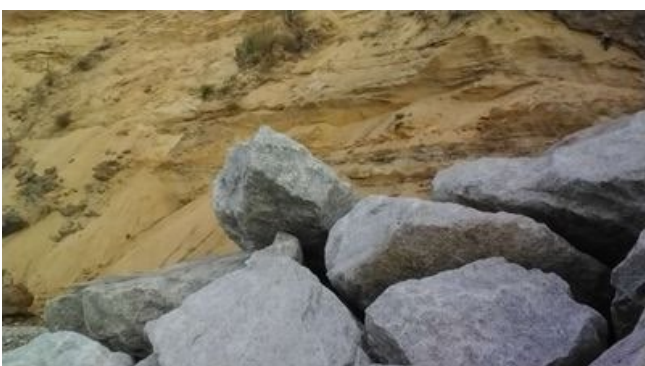
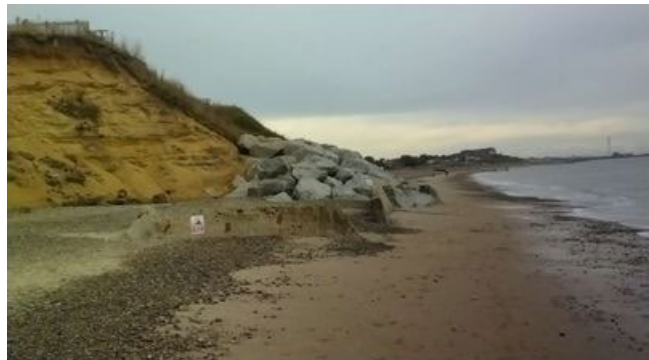
Photos of rock armour:

Packing of rock: Overall satisfactory

Cross-sectional profile: Satisfactory

Beach levels surrounding rock armour: Average

Stability of cliff behind rock armour: As previous, no obvious change apparent behind the main rock structure, as viewed from the beach (vegetation growth obscures part of the cliff face).

Asset condition grade: 2 Good; rock armour condition satisfactory; no change in protection

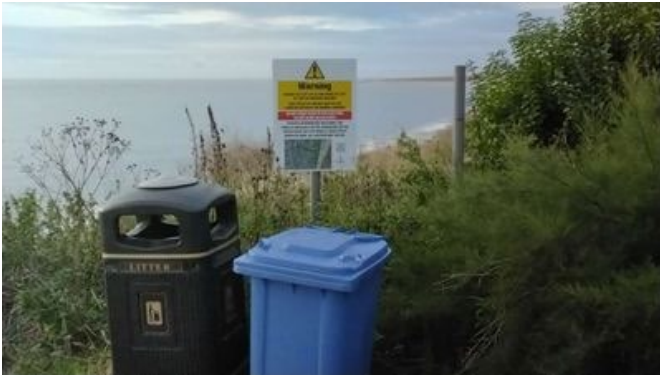
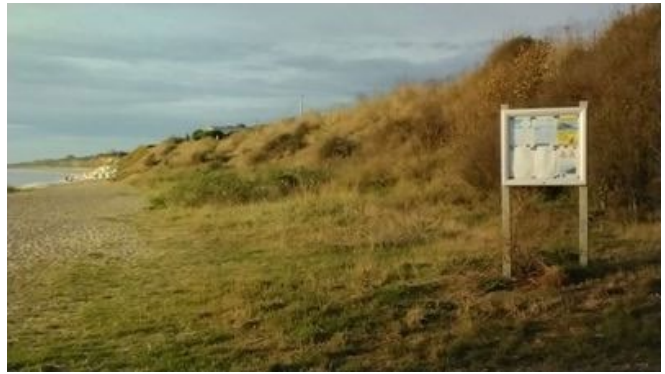
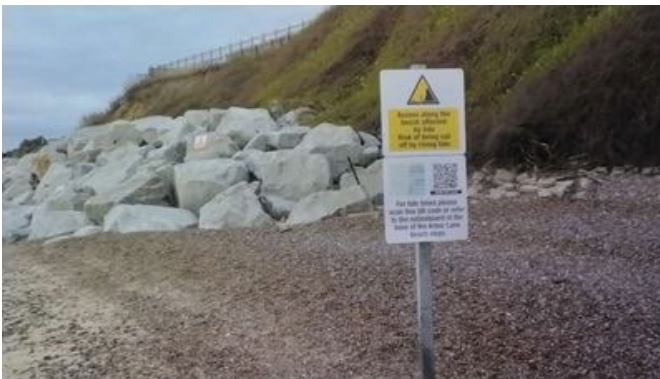
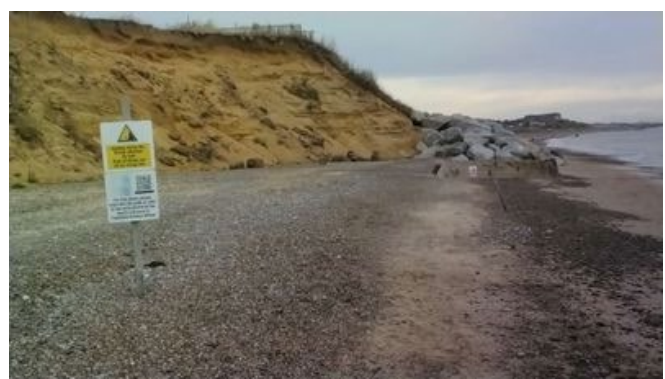
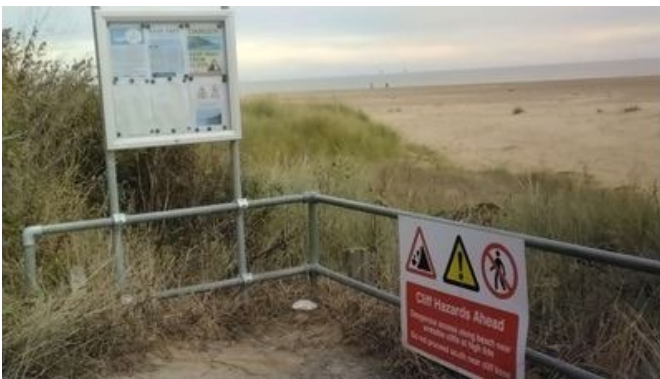
Photos of signage:

Provision of tidal information: Up to date and legible – Monitor.

Comments on signage: Information signage near the seaward end of Arbor Lane is visible.

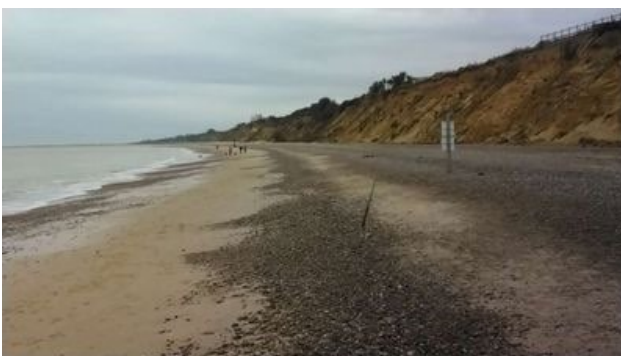
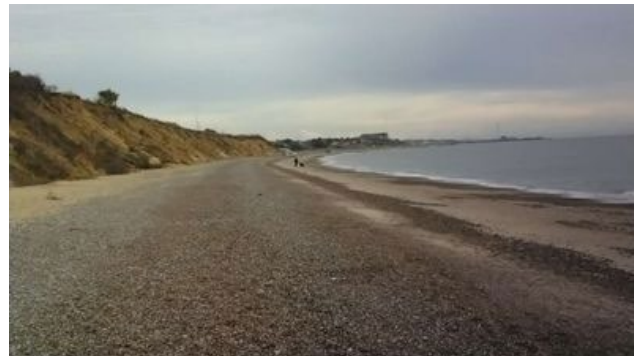
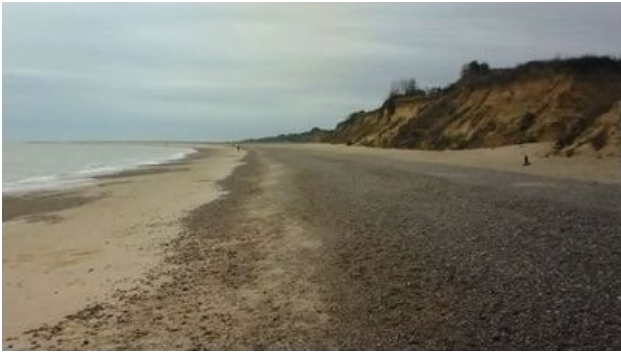
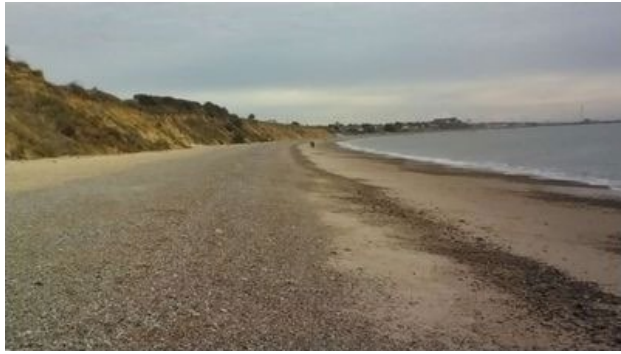
Photos of southern beach:

General impression of beach volume: Moderately Higher

Comments on change to southern beach: Consistent with beaches to the north, a shingle rich berm has been created above mean high water mark.

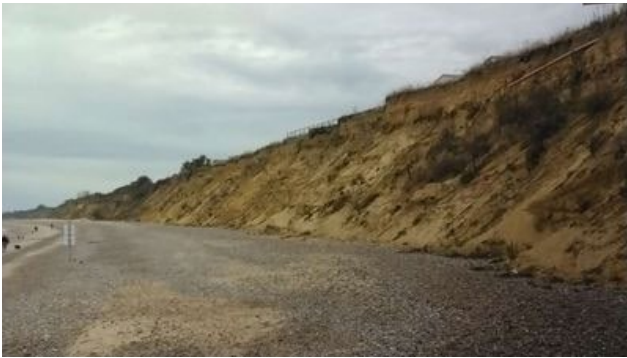
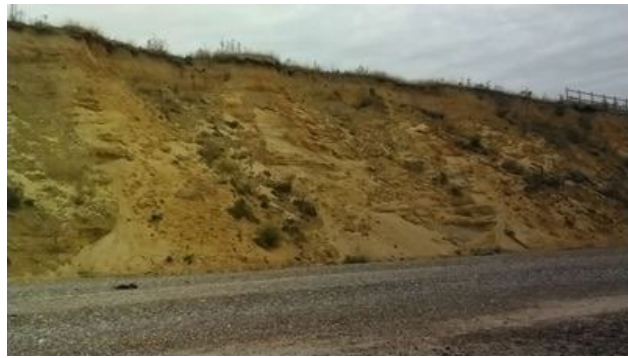
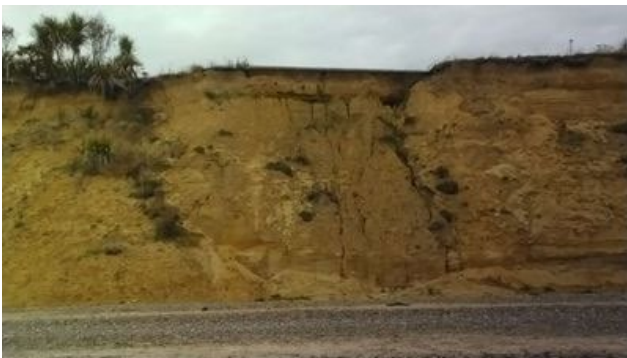
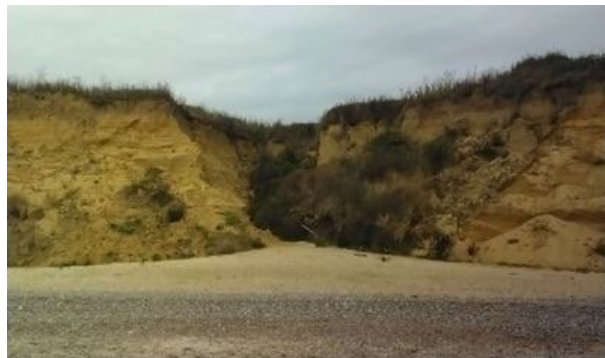
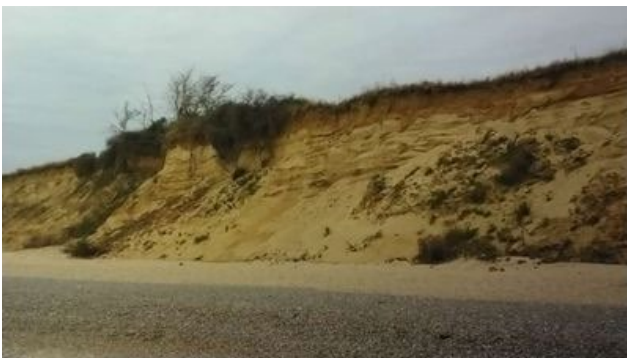
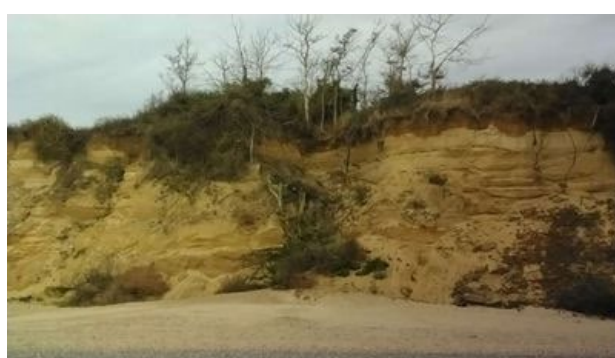
Photos of southern cliffs:

Changes to southern cliffs: Slumped material on cliff face; denuding and loss of vegetation; cliff-face steepening and overhanging; scree at base of cliff; fallen vegetation at base of cliff.

Comments on cliff change and any risk posed: As last month, there has been another period where cliffs have not been reached by seas. Loss of dry and poorly consolidated material from cliff faces continues in places.

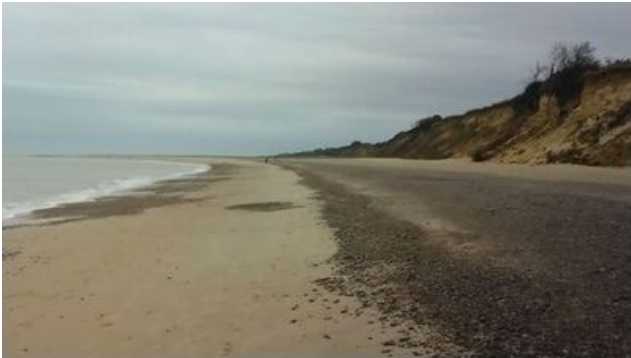
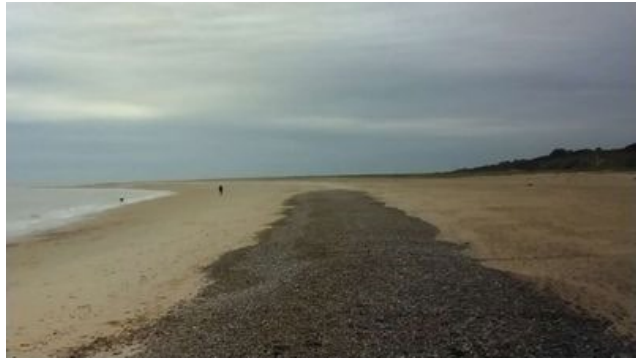
Photos of Pontins frontage and Benacre Ness:

Changes to beach geomorphology: Impression is of a continuation of gradual beach widening.

Comments on change at Benacre Ness: Processes described previously appear likely to be continuing.

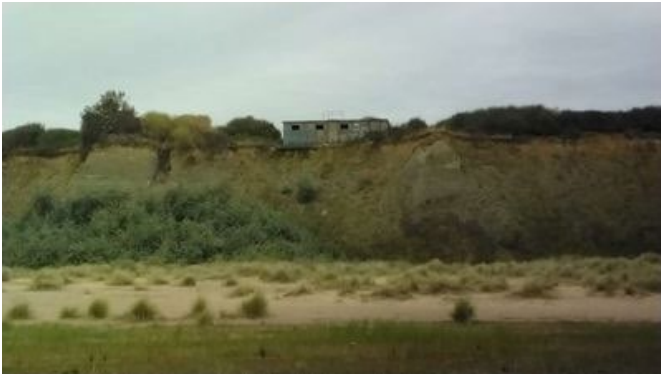
Photo of cliff top structure:

Changes in cliff stability: No obvious change
