Pakefield Monthly Monitoring Report

Date and time of survey: May 29, 2024 06:46

Inspector Name: Keith Roper

Reason for Inspection: Scheduled

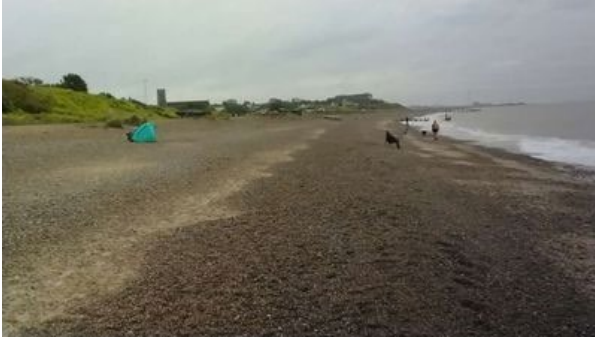
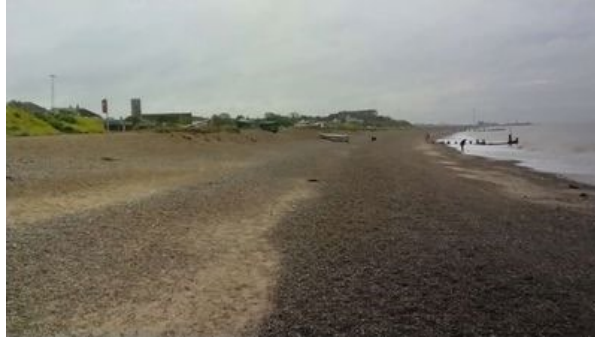
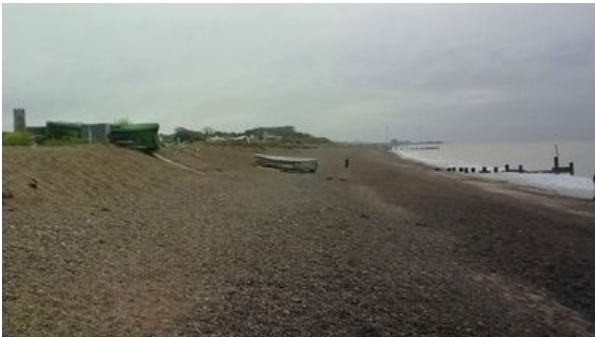
Beach photos looking north:

Extension of beach cliffing alongshore: Negligible change

Landward recession of beach cliff: Negligible change

Change in gradient of beach cliff face: Negligible change

Maximum height of beach cliff (m): 2

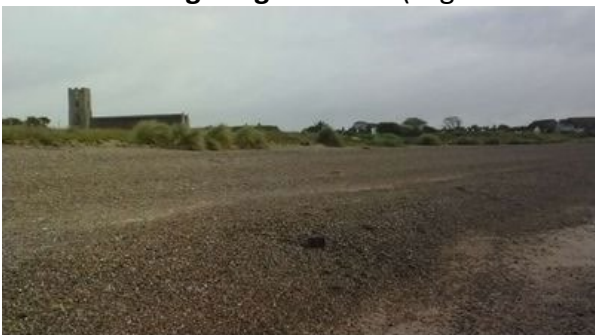
Beach photos below taken further north than usual inspection area showing new timber exposure – seaward of Nightingale Road: (Slight increase in beach level)

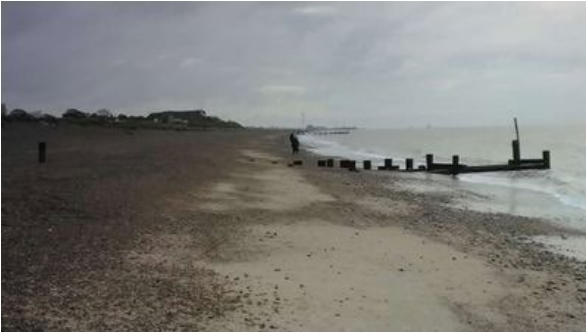
Change in beach level relative to exposed timber groyne opposite Grand Avenue: Negligible change
Photo of exposed timber groyne:

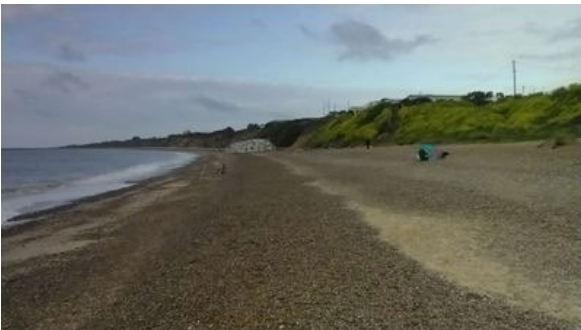
General impression of beach volume: Moderately Higher
Photos of beach north of Arbor Lane:

Comments on change in beach geomorphology: The lower foreshore retains its characteristic relatively steep gradient. There has been reworking of material and a shingle berm has been formed, approximately at the high water mark. Less change to the upper beach and no significant change to dune face.

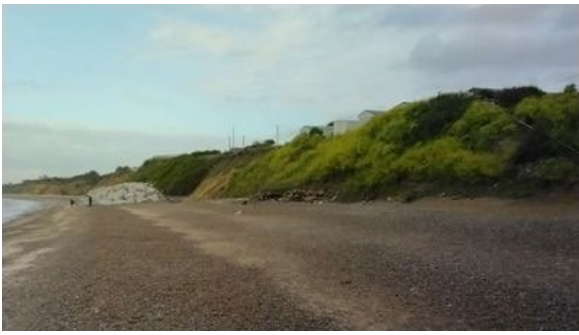
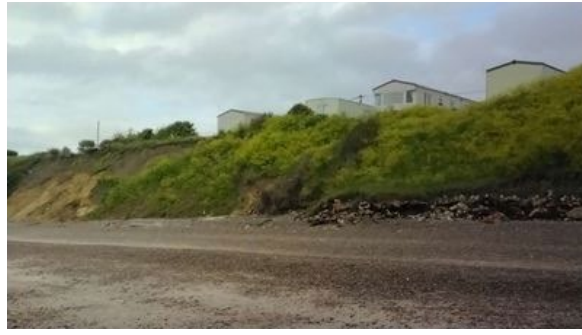
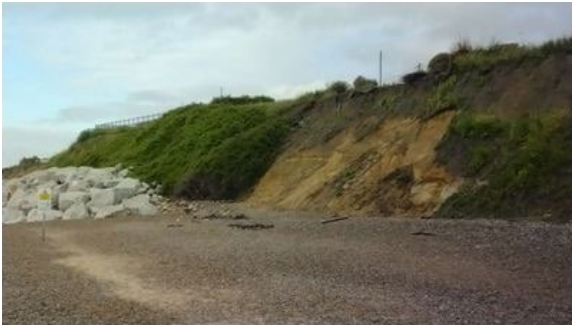
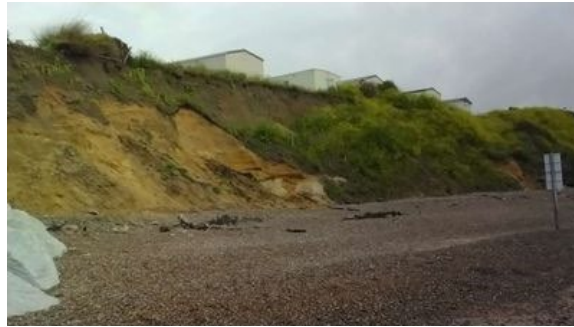
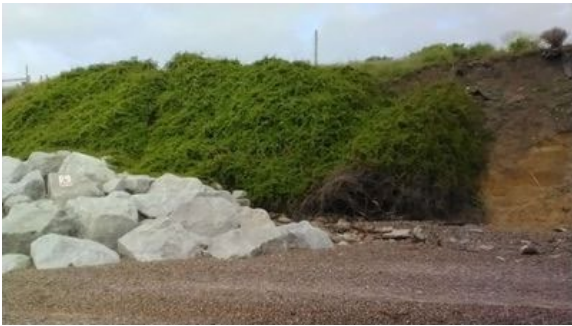
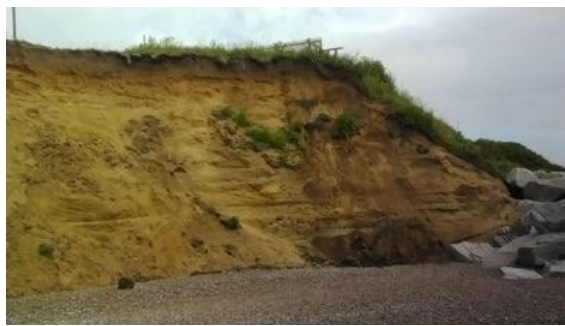
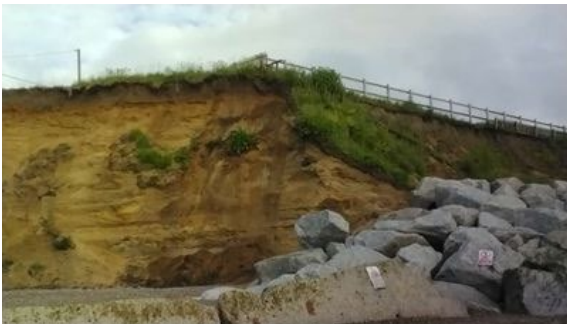
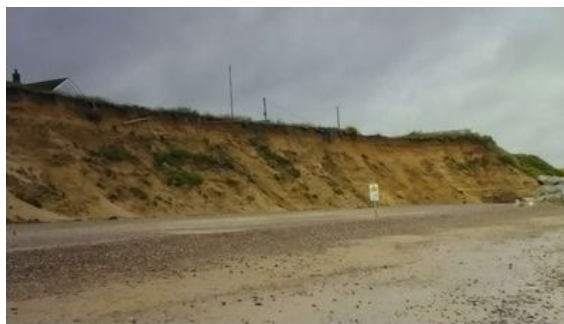
Photos of cliffs supporting property:

Changes to cliffs supporting property north of rock armour: Slumped material on cliff face; denuding and loss of vegetation; cliff-face steepening and overhanging; scree at base of cliff

Changes to cliffs supporting property south of rock armour: Slumped material on cliff face; denuding and loss of vegetation; cliff-face steepening and overhanging; scree at base of cliff; fallen vegetation at base of cliff

Comments on risk to cliff-top assets: Five caravans were located seaward side of The Cliffs. The vertical cliff face at the south end of rock persists, and there have been obvious recent falls. Near here, topsoil material continues to slip on the seaward face projection. The vegetated cliff face near the north end of the rock appears to have features which may indicate movement of the face.

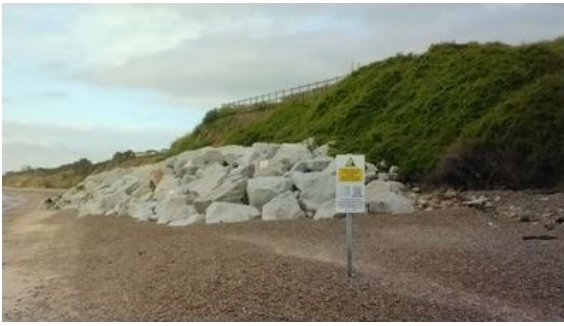
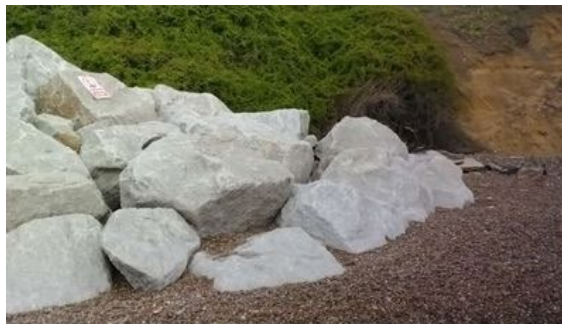
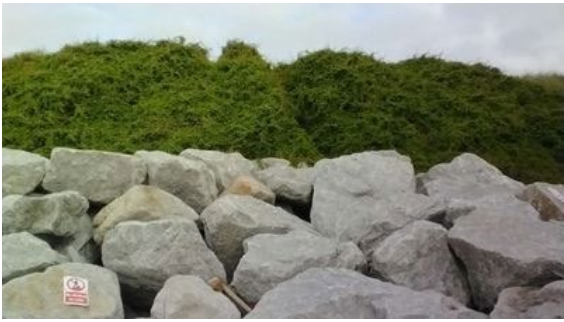
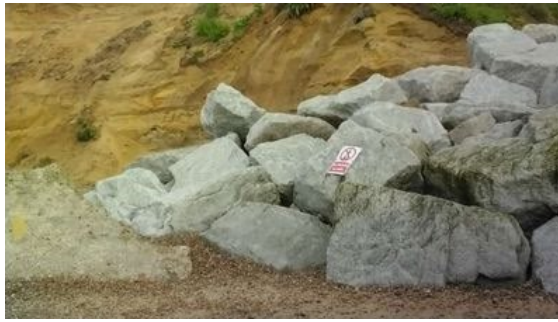
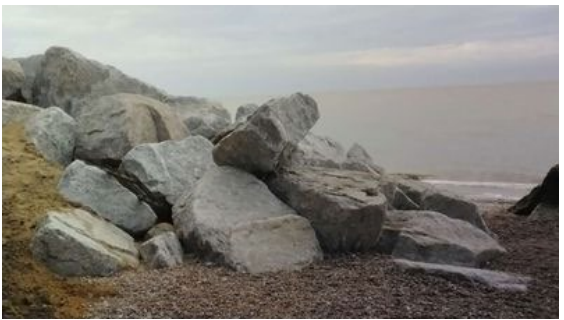
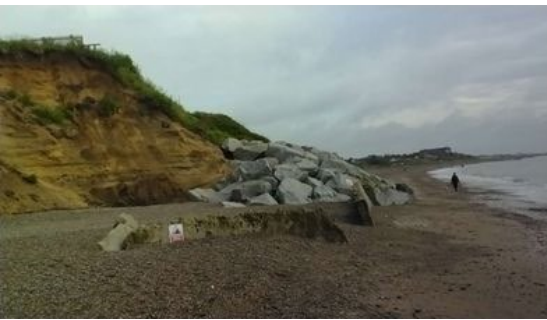
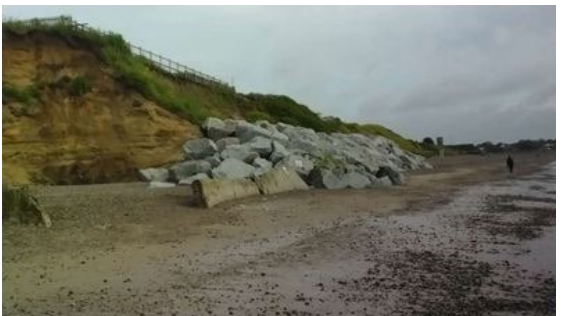
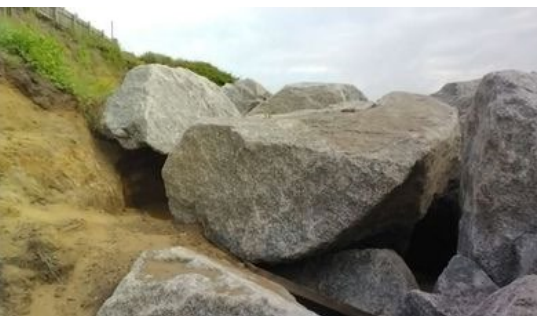
Photos of rock armour:

Displacement of rock from structure: Yes - Some - Monitor

Packing of rock: Loosely packed or voids: Monitor

Settlement, movement, undermining of structure: Yes - Some - Monitor

Exposure of geotextile: Yes - Some - Monitor

Hazards/debris within structure: Yes - Some - Monitor

Asset condition grade: 2 Good; minor defects that do not reduce overall performance

Comments on condition of, or risk posed by rock armour: Impression is of ongoing gradual settlement although the current relatively healthy beach levels are probably beneficial. The displaced rock and cave like opening at the south end were reported previously. Note also the additional void (right side of above photo).

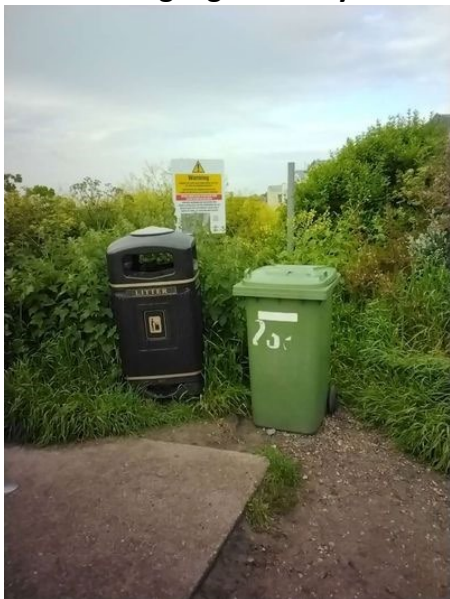
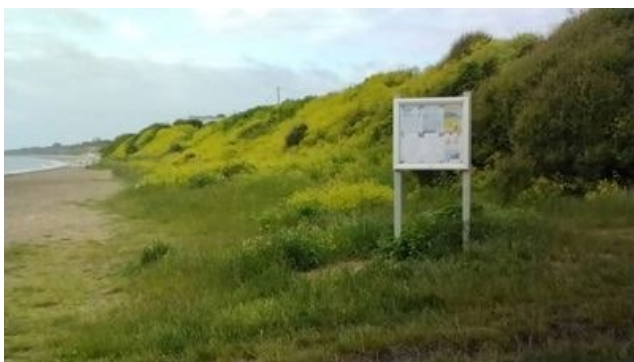
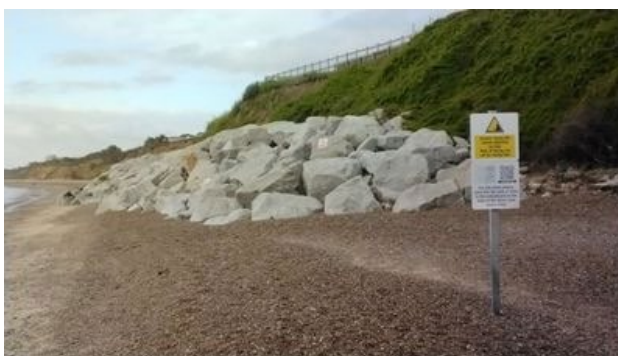
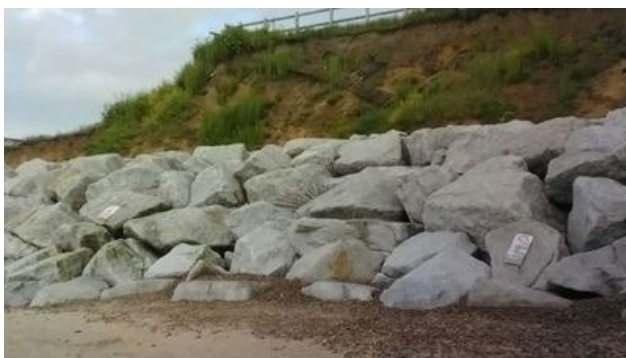
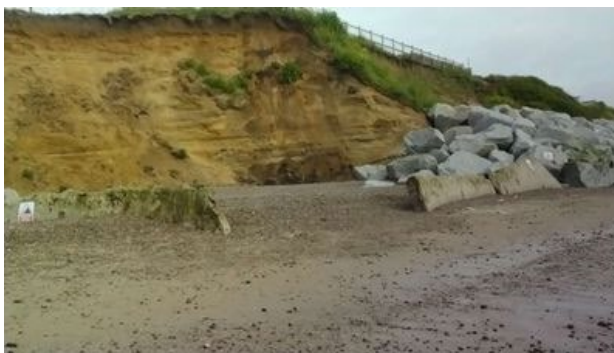
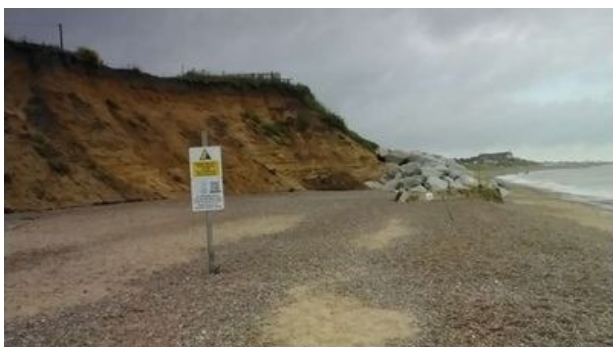
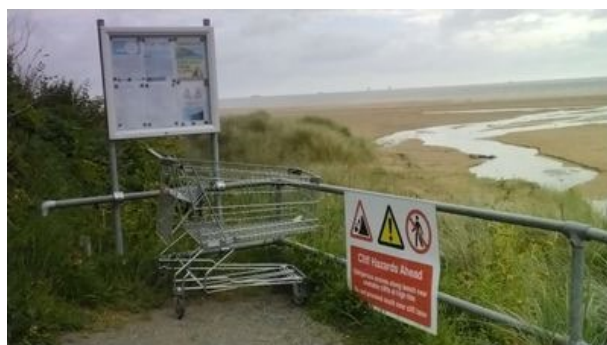
Photos of signage and any issues:

Comments on signage: The sign at the seaward end of Arbor Lane is possibly becoming obscured by vegetation. Photo of signage at Pontins beach access shows an abandoned shopping trolley.

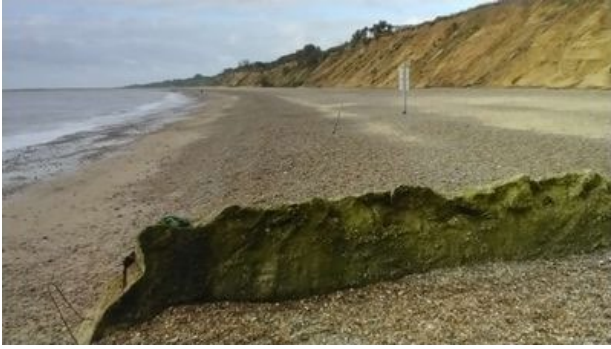
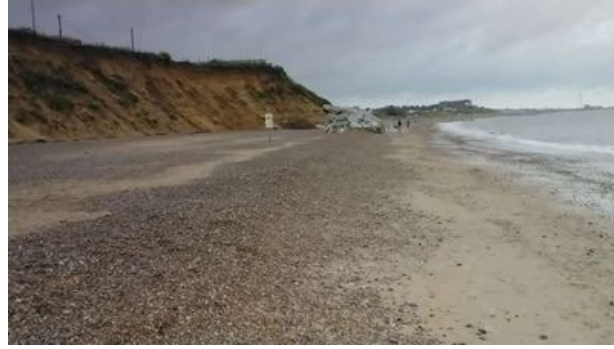
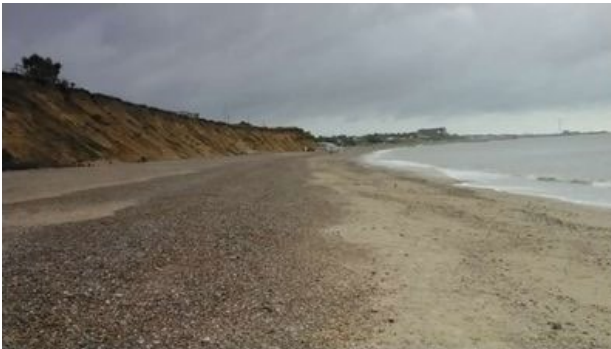
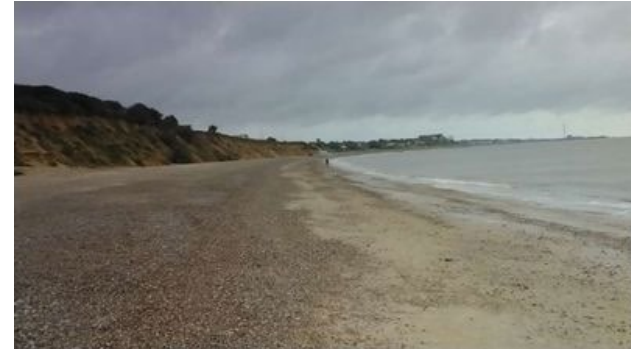
Photos of southern beach:

General impression of beach volume: Moderately Higher

Comments on change to southern beach: Recent conditions have not impacted beach levels and the shingle berm noted above continues south.

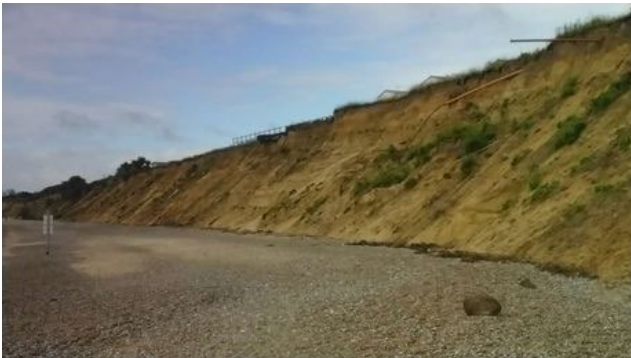
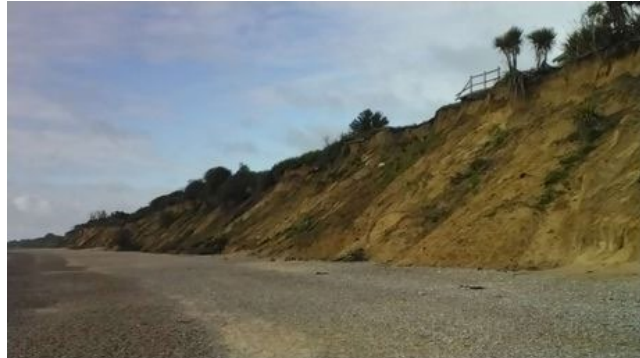
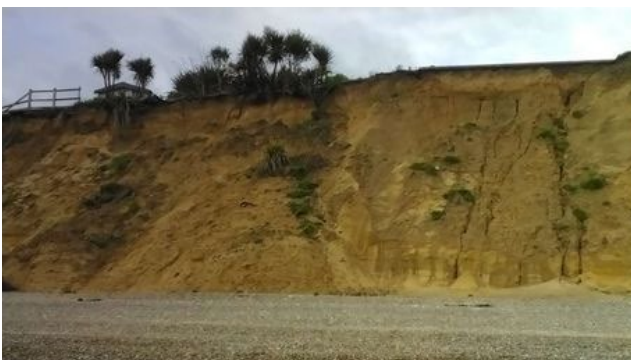
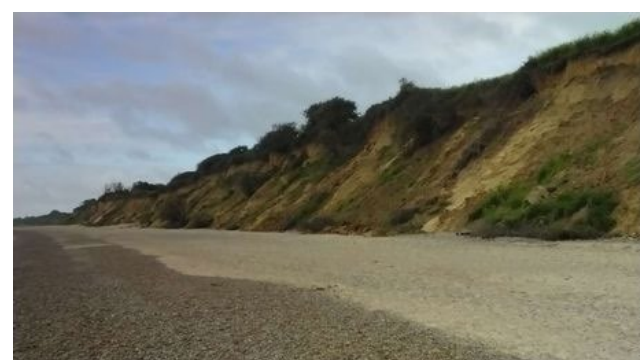
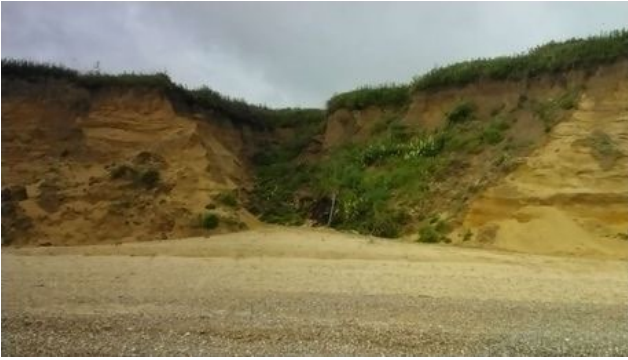
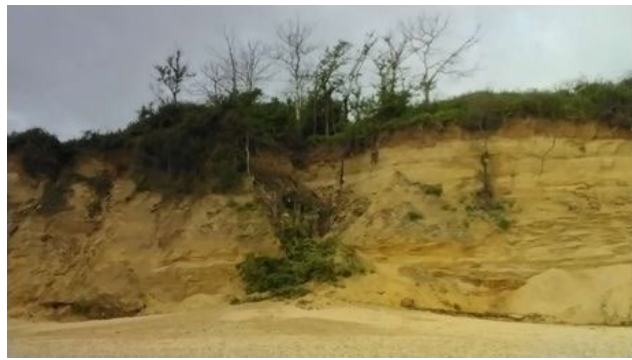
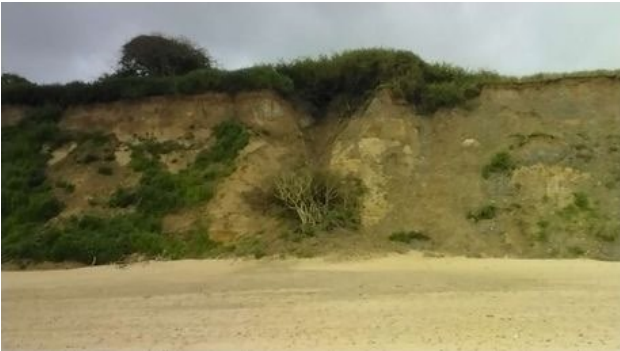
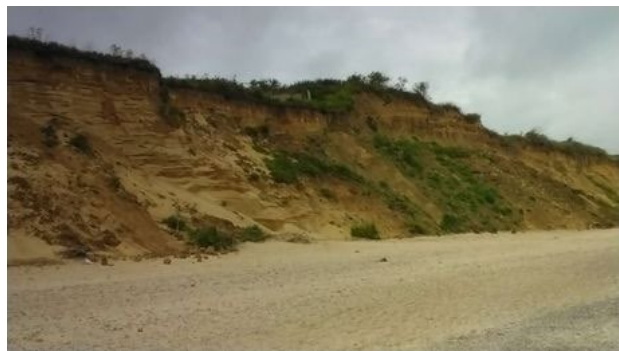
Photos of southern cliffs:

Changes to southern cliffs: Slumped material on cliff face; denuding and loss of vegetation; establishment of vegetation in some areas; cliff-face steepening and overhanging; scree at base of cliff; fallen vegetation at base of cliff

Comments on cliff change and any risk posed: South of Pakefield Caravan Park there was evidence of a more stable angle of repose in places and vegetation establishing. Upper cliff faces however remained vertical, with falls having occurred. Below the former rifle range there are particularly steep cliff faces and material is very dry with tendency to fall. Masonry walling is visible here on the cliff top (last of photos above).

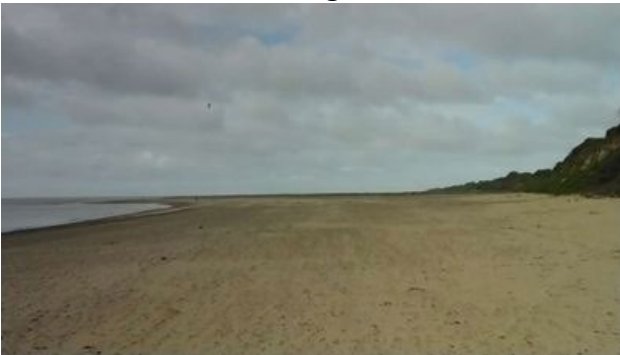
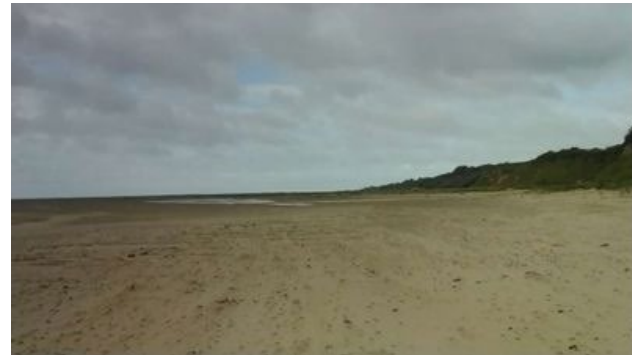
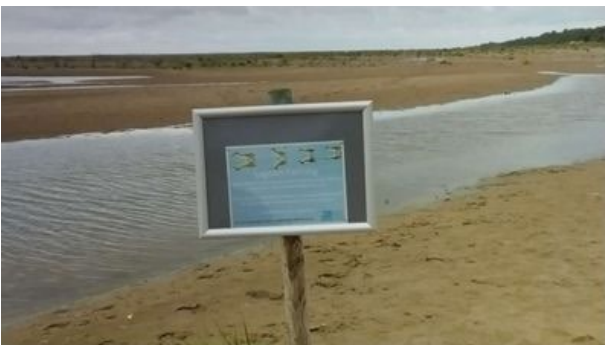
Photos of Pontins frontage and Benacre Ness:

Changes to beach geomorphology: Impression is of progression north of widening beaches.

Comments on change at Benacre Ness: Surface water discharge at Pontins beach access is tending to run south onto the main Ness feature as it progresses north. RSPB information signage has been installed, presumably for the bird nesting season.

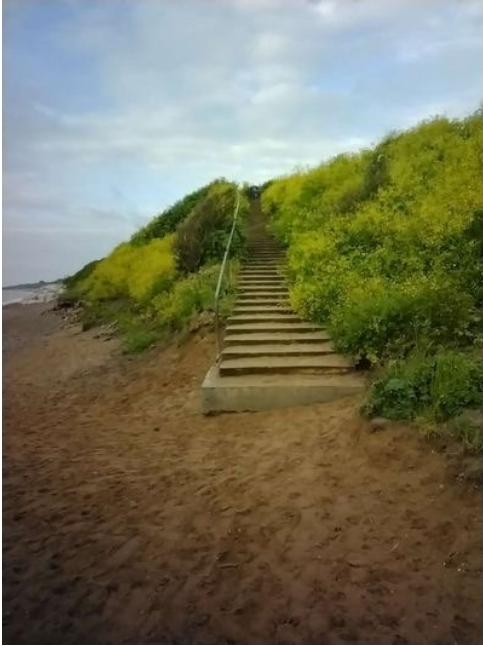
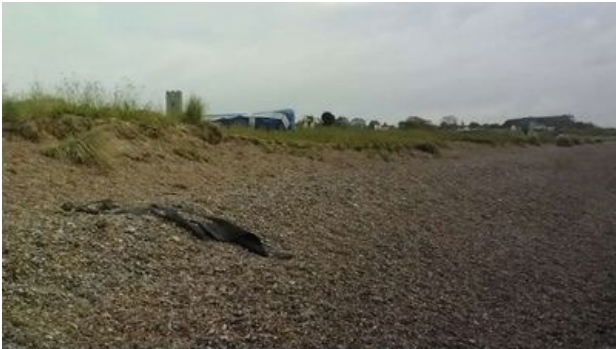
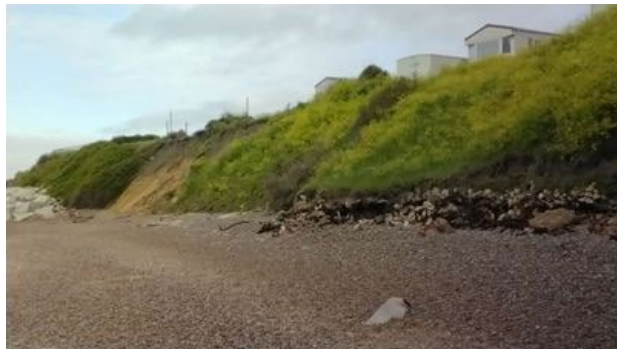
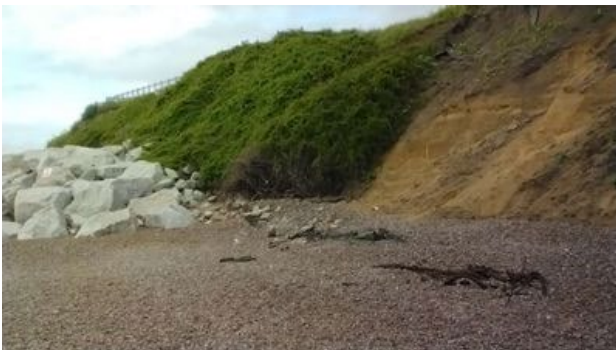
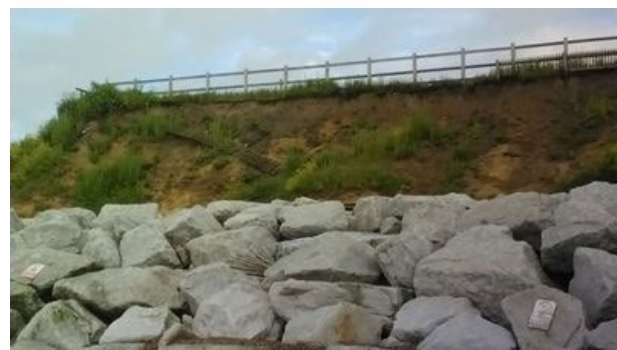
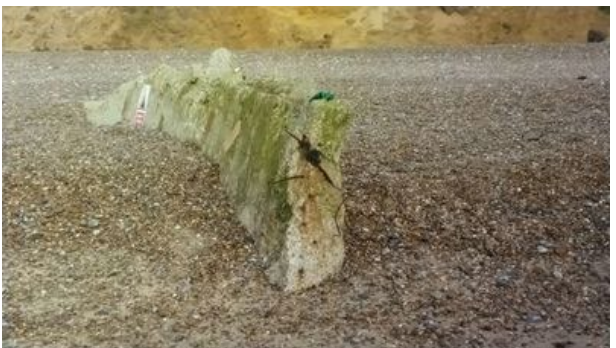
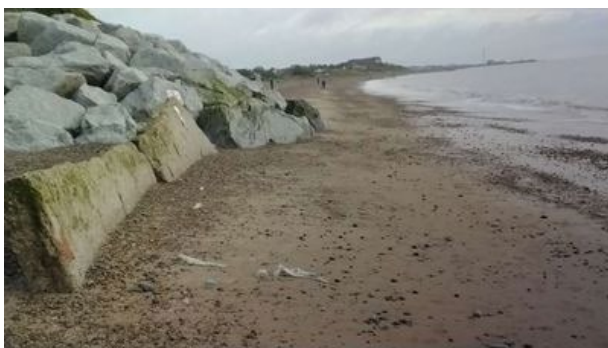
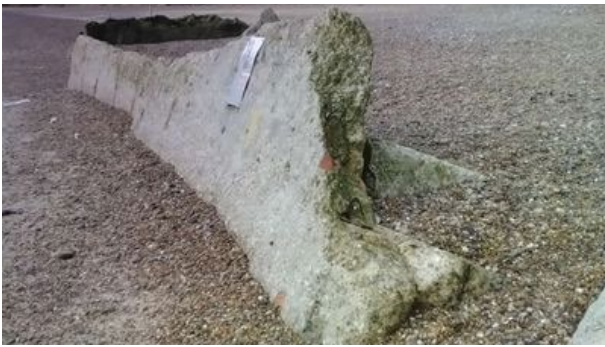
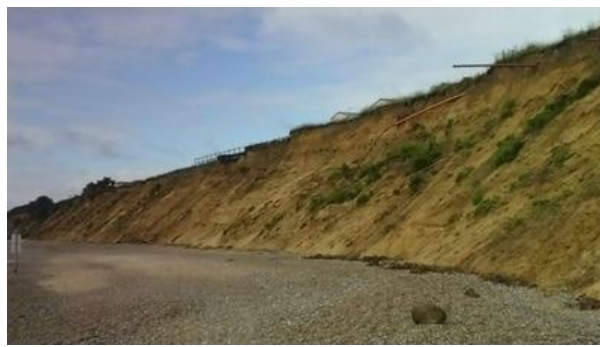
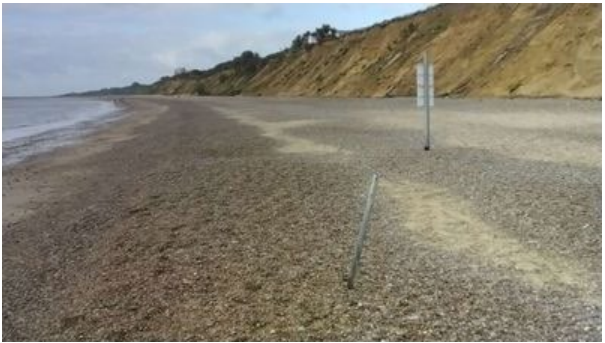
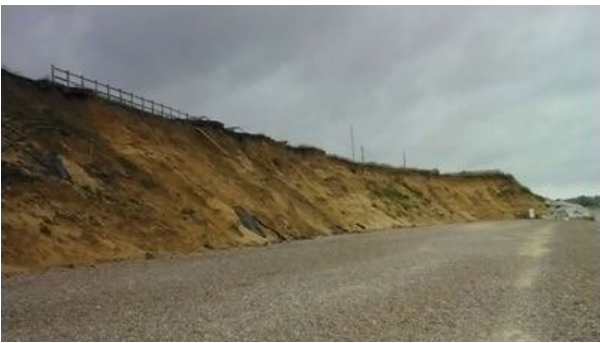
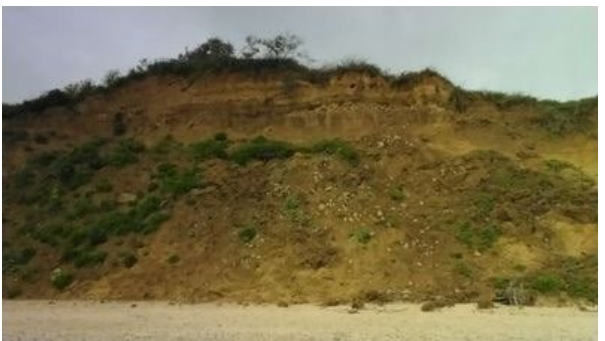
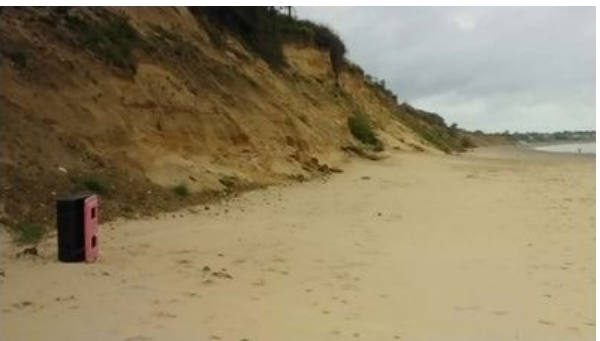
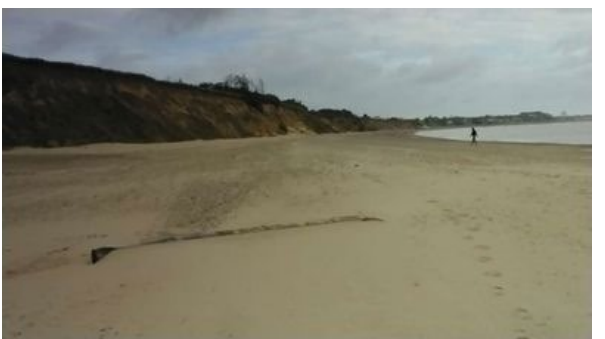
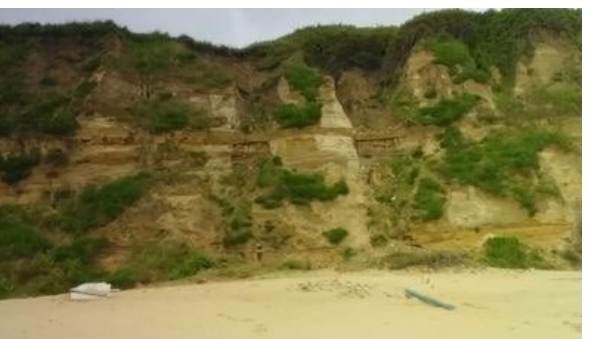
Photos of hazard/debris:

Comments on hazard/debris: Beach access steps at Arbor Lane are becoming overgrown.

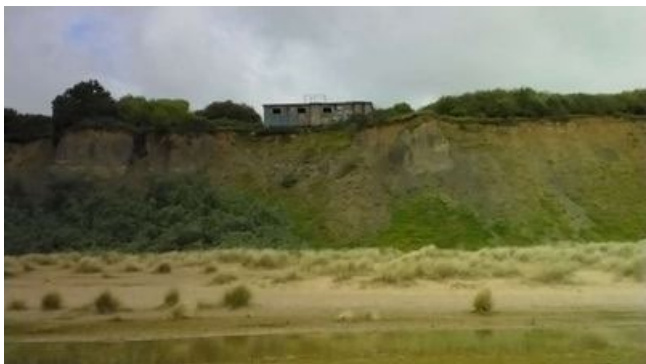
Photo of cliff top structure:

Changes in cliff stability: No obvious change apparent from beach

Comments on cliff top structure: Nothing to add to previous.
