Thorpeness Monthly Monitoring Report

Date and Time of Survey: December 11 2024, 10:30

Inspector: Thomas Hayden

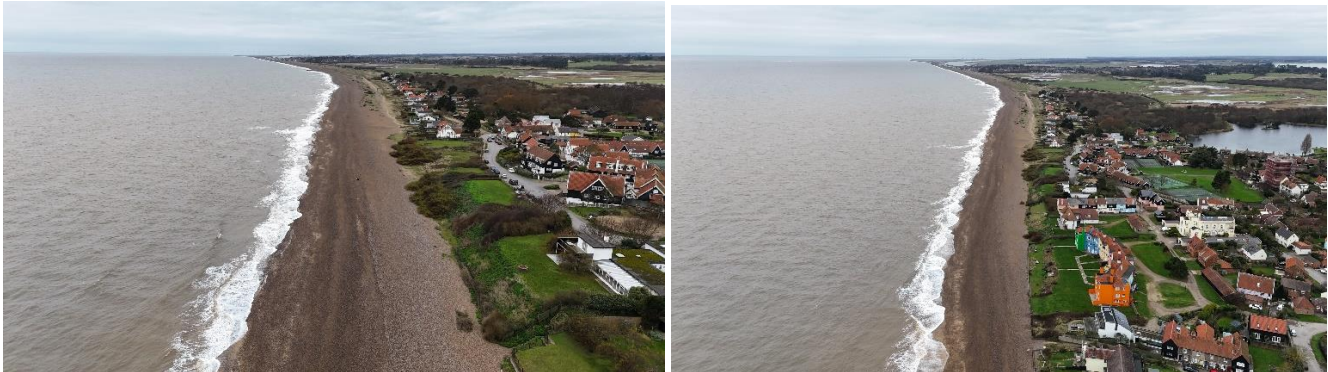
Photos of the southern UNDEFENDED frontage:

Upper Beach Levels: Moderate Decrease

Lower Beach Levels: Significant Decrease

Comments on the Current Beach Levels over the southern UNDEFENDED frontage: Beach levels have changed a lot over the last inspection period. This is most likely due to the most recent storm (Storm Darragh). The lower beach has lost material, which has caused the high tide mark to move landward. This has also caused a reduction in the level of the upper beach.

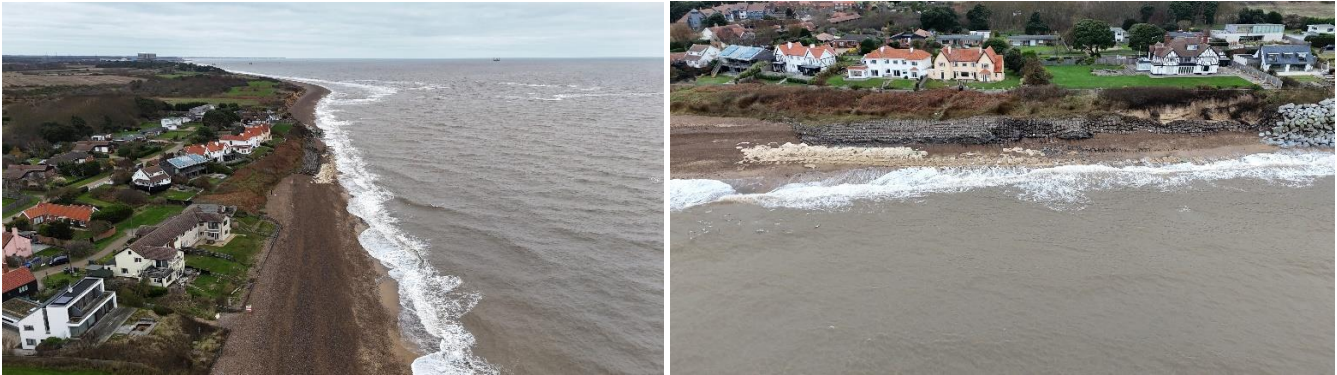
Photos of the central DEFENDED frontage:

Upper Beach Levels: Significant Decrease

Lower Beach Levels: Significant Decrease

Comments on the current beach levels over the DEFENDED frontage: Due to the beach being narrower in front of the defences, there is less material to reduce the wave energy. Therefore, the loss of material in this area of the frontage appears to be more significant. The lower beach has a very shallow profile, leading to loss of material from the upper beach. This means that defences that had previously been covered by beach material are now exposed.

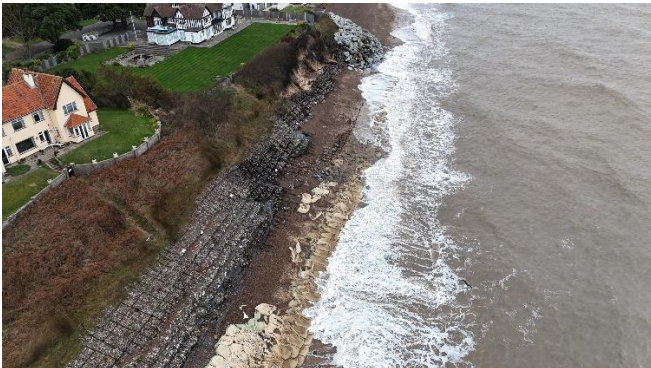
Photos of the gabions:

Comments on gabion condition: The gabions have not moved between inspections. However, more of the lower gabions that had been covered by beach material are now exposed, due to lower beach levels. Wave energy has eroded part of the exposed face above the gabions.

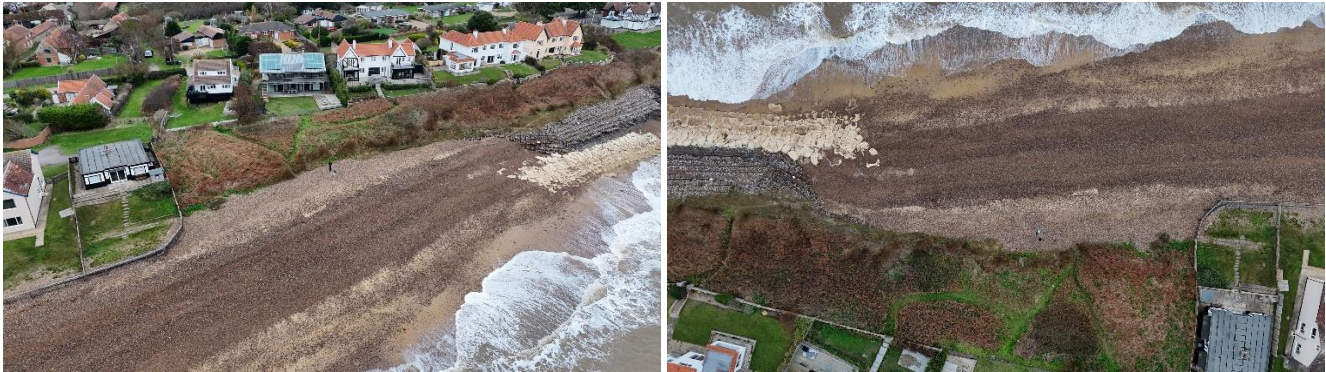
Photos of Phase 1 Geobags:

Comments on Phase 1 Geobag condition: Phase 1 geobags remain mostly covered. A small amount of geofabric may be visible through the beach, due to lower beach levels not being able to sustain the volume of the upper beach. However, the bags are still predominantly covered.

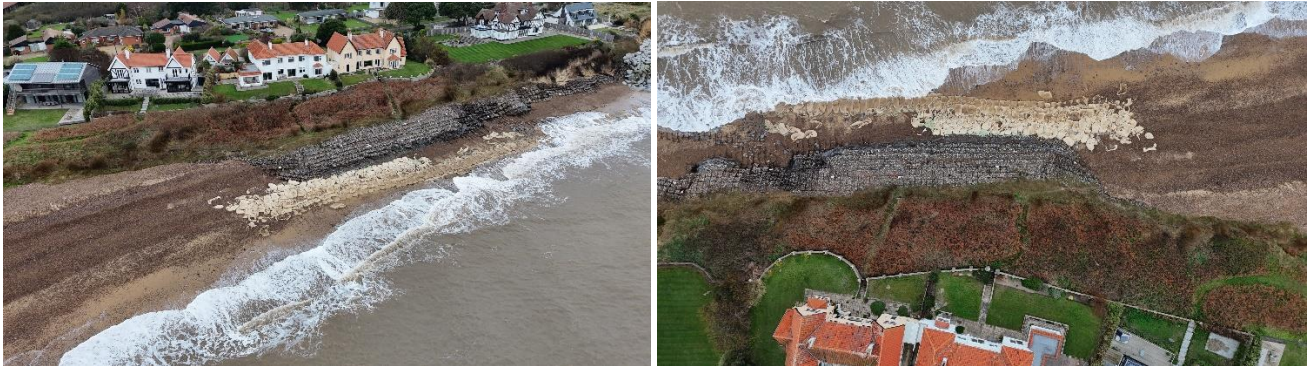
Photos of Phase 2 Geobags:

Comments on Phase 2 Geobag condition: Phase 2 geobags have uncovered further. A minor amount of movement has occurred to some of the bags, due to larger waves with more energy. Some further damage has been caused as a result of the bags being further uncovered, as well as the weather caused by Storm Darragh.

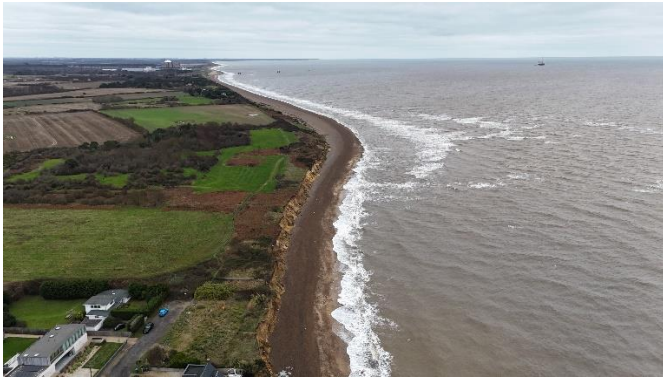
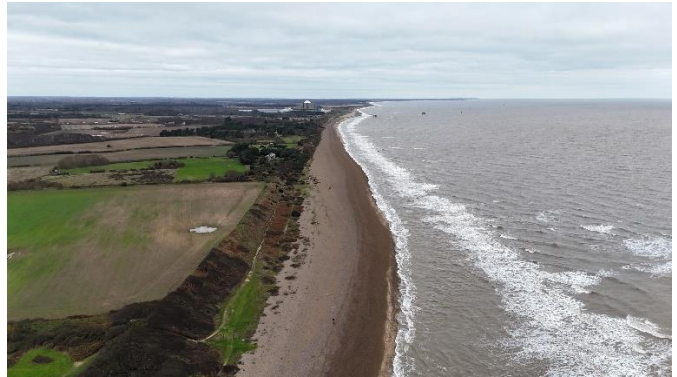
Photos of the northern UNDEFENDED Frontage:

Upper Beach Levels: Moderate Decrease

Lower Beach Levels: Significant Decrease

Comments on the current beach levels, north of defence termination: Beach levels along the northern undefended frontage have lost material, owing to the conditions from Storm Darragh. The high tide line has moved back to the base of the cliff immediately north of the rock. There has also been some cliff loss long the length of the frontage, up to the point where the ness begins to afford some protection to the beach.
