Pakefield Monthly Monitoring Report

Date & Time of survey: December 3, 2024 14:13

Reason for Inspection: Scheduled

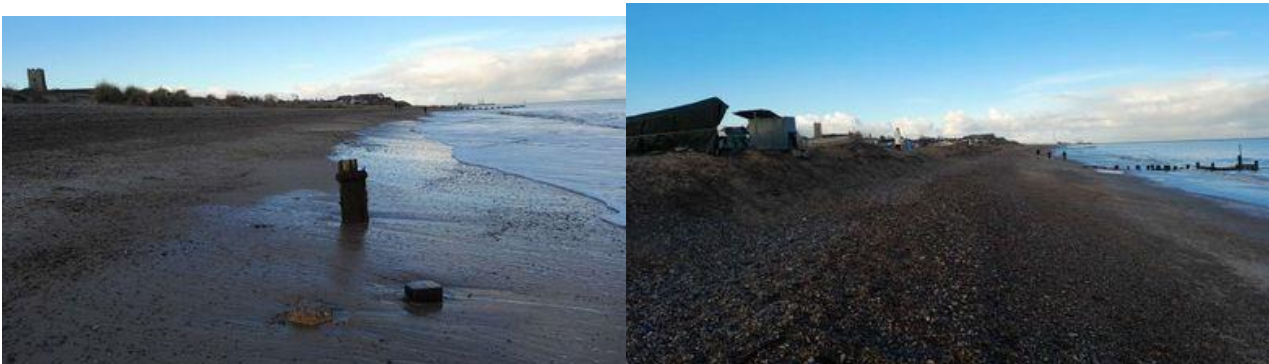
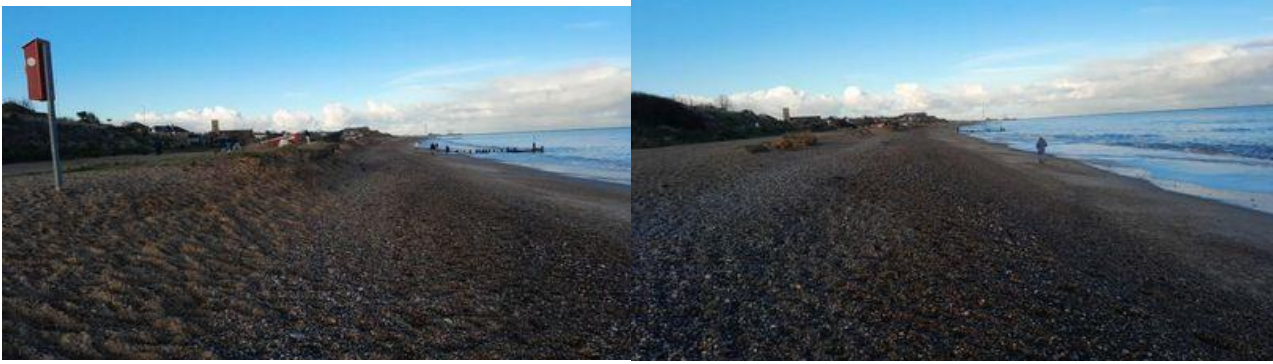
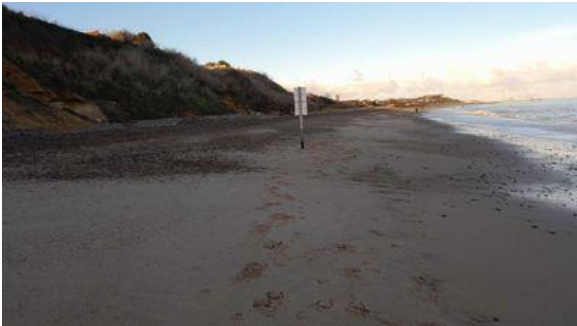
Beach photos looking north

Extension of beach cliffing alongshore: Slight northward extension

Landward recession of beach cliff: Slight landward recession

Change in gradient of beach cliff face: Steepened by seas over the past month, with recent trampling

Comments on change in beach geomorphology: There has been cliffing of the dune face (and subsequent trampling), from around Grand Avenue and to the north. Most recent sea conditions have deposited shingle rich material above the mean high water mark MHW. The foreshore retains its characteristic relatively steep gradient.

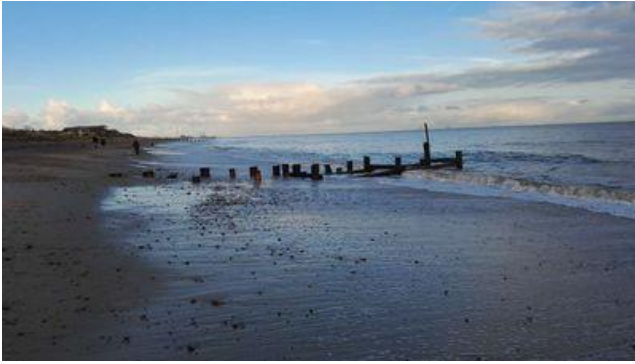
Image of exposed timber groyne:

Change in beach level relative to exposed timber groyne opposite Grand Avenue: Moderately lower

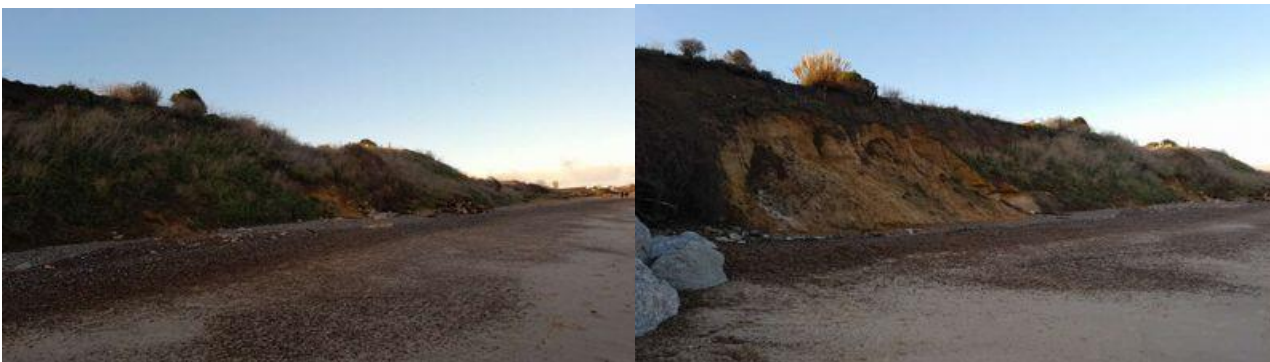
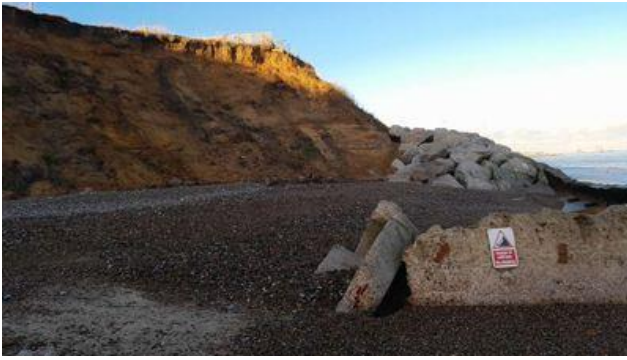
Photos of soft unconsolidated sand cliffs:

Changes to soft unconsolidated sand cliffs north of rock: Slumped material on cliff face; denuding and loss of vegetation; cliff-face steepening and overhanging; scree at base of cliff; fallen vegetation at base of cliff.

Changes to soft unconsolidated sand cliffs south of rock armour: Slumped material on cliff face; denuding and loss of vegetation; evident cliff top recession; cliff-face steepening and overhanging; scree at base of cliff; fallen vegetation at base of cliff.

Comments: The one remaining northern caravan, seaward of The Cliffs access road, has been removed. Three remaining concrete slab bases in this location have been broken up and are awaiting removal from site. The caravan park building demolition was almost complete. To the south of this, it appears there has been some removal of fencing and concrete slabs (some remain near to, or overhanging, the cliff edge). There were still reasonably healthy beach levels on the north and south sides of the rock however, the bases of the cliffs had been reached by seas during the past month, causing some disturbance.

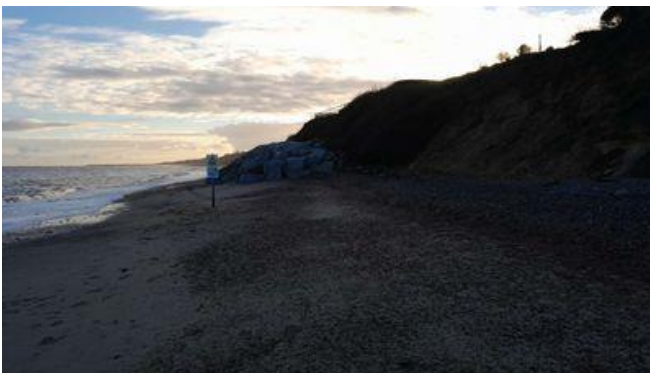
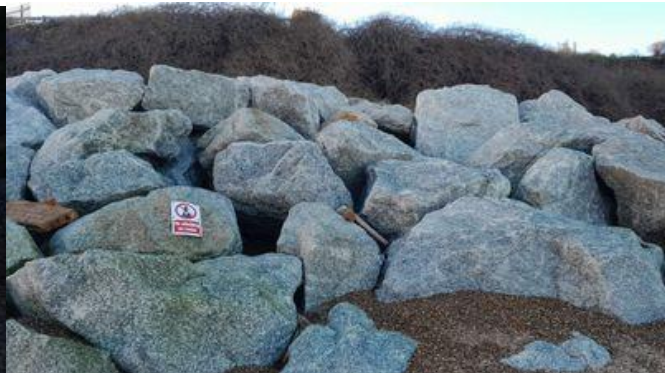
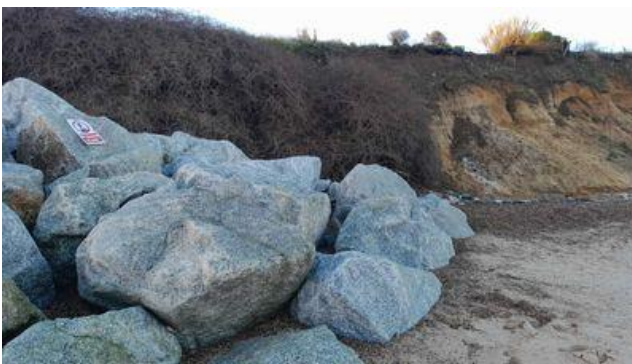
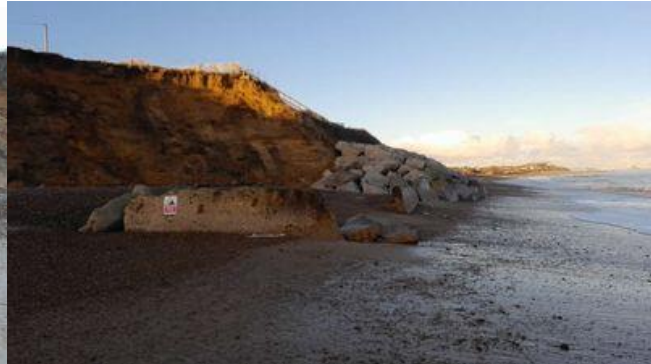
Photos of rock armour:

Beach levels surrounding rock armour: Improved beach level around most of the rock toe (particularly at the north end) and also behind the concrete walling, which is consistent with beach characteristics to the north.

Stability of cliff behind rock armour: As previous, no obvious or significant change apparent behind the main body of the rock structure, as viewed from the beach (vegetation growth obscures part of the cliff face).

Asset condition grade: 2 Good; rock armour condition satisfactory; no change in protection

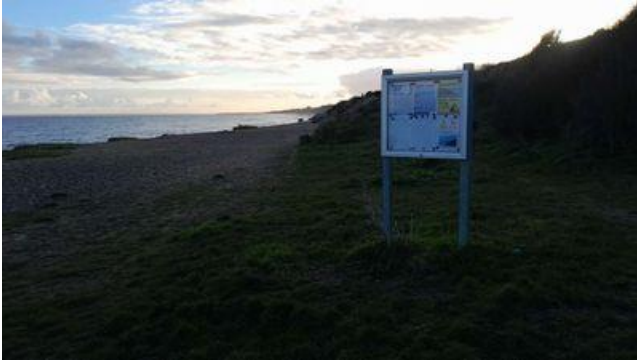
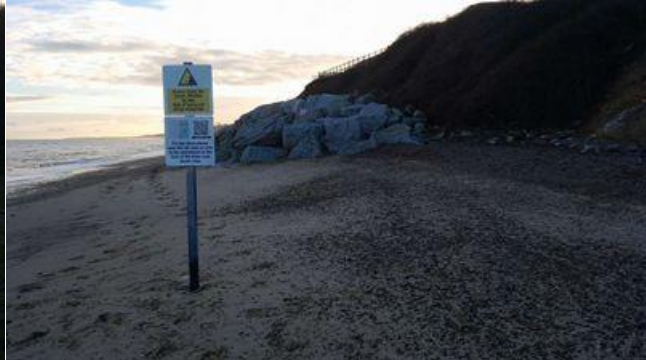
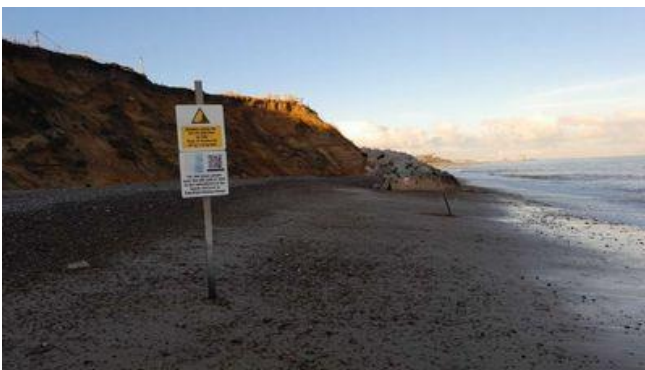
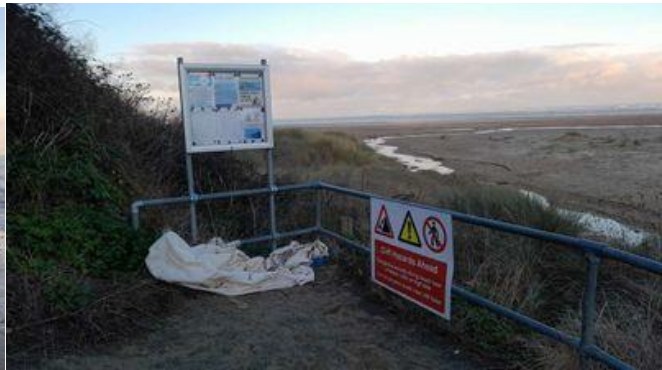
Photos of signage and any issues:

Provision of tidal information: Up to date & legible - Monitor

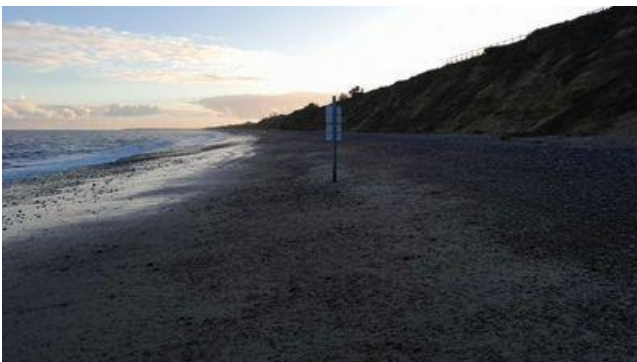
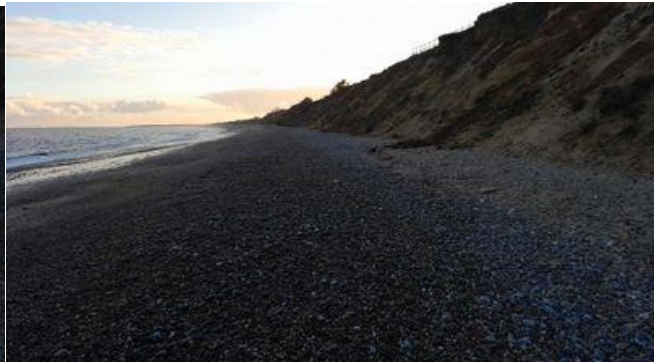
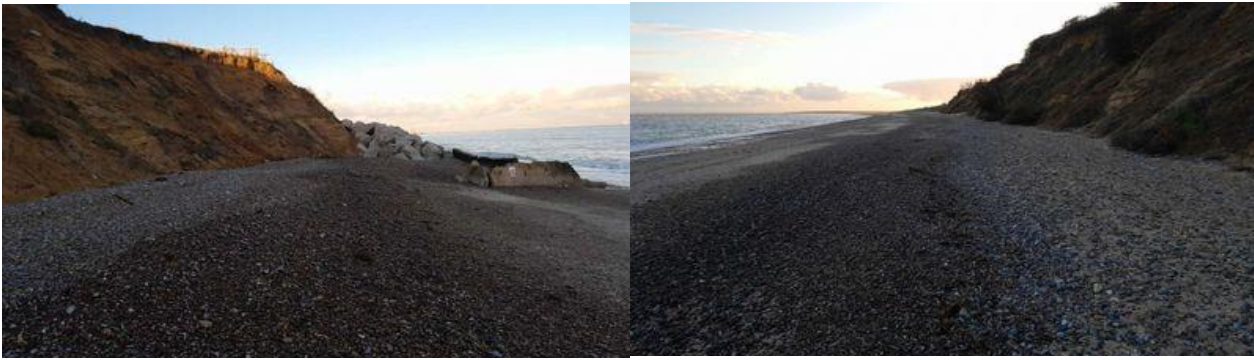
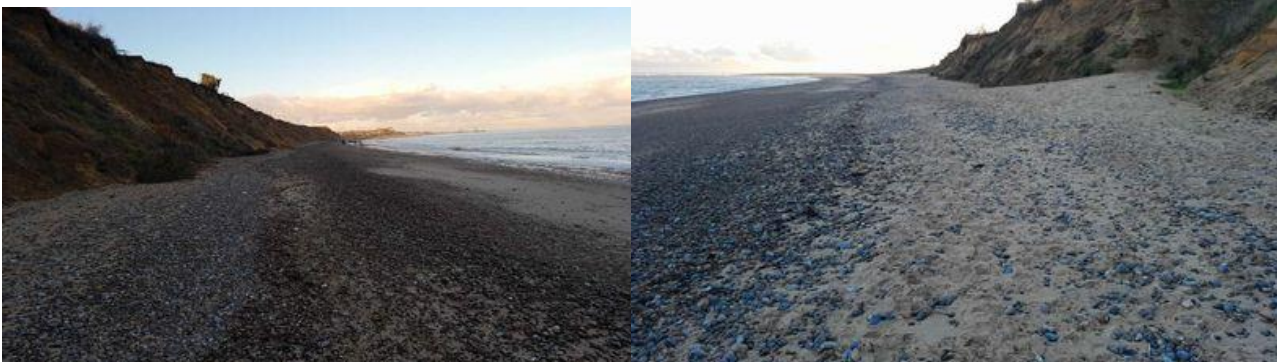
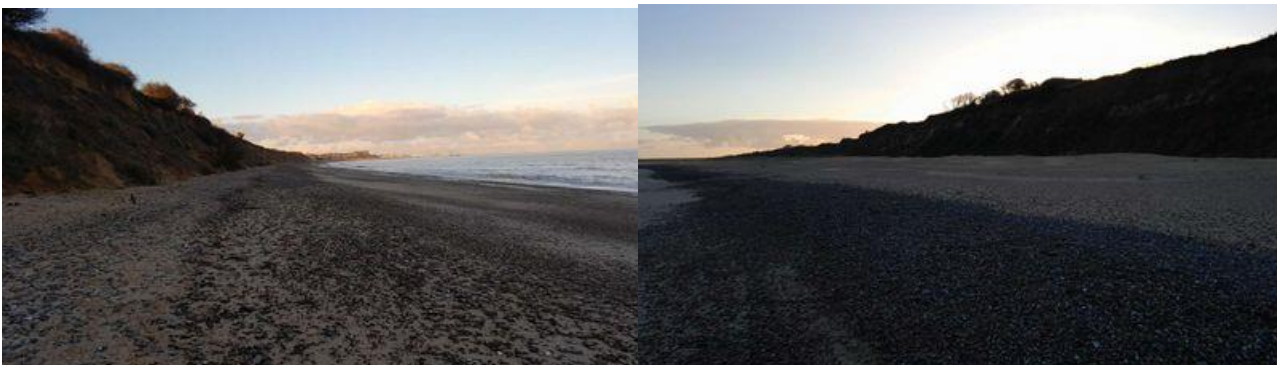
Photos of southern beach:

Comments on change to southern beach: There appeared to have been an increase in foreshore level to south.

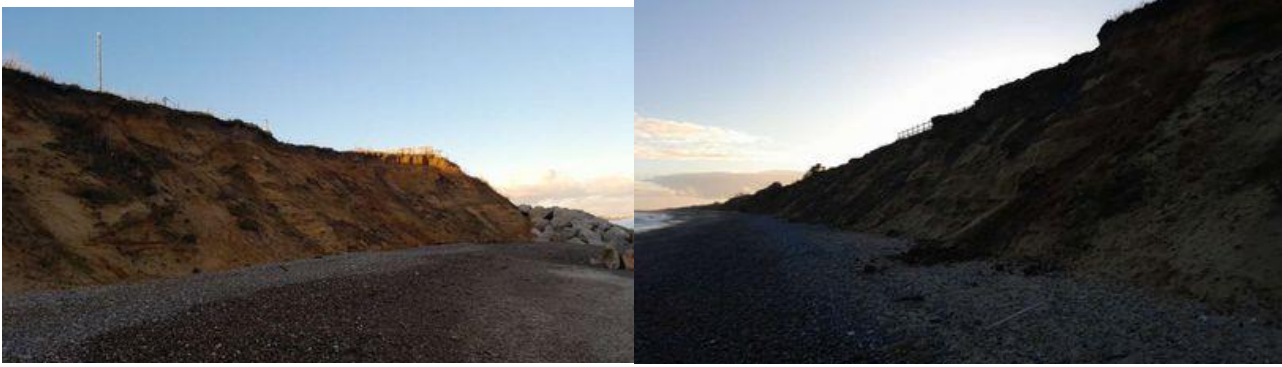
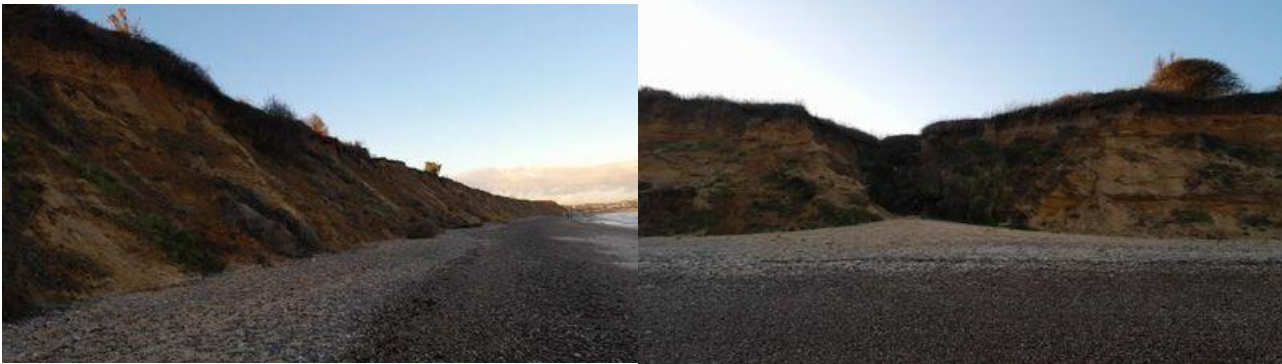
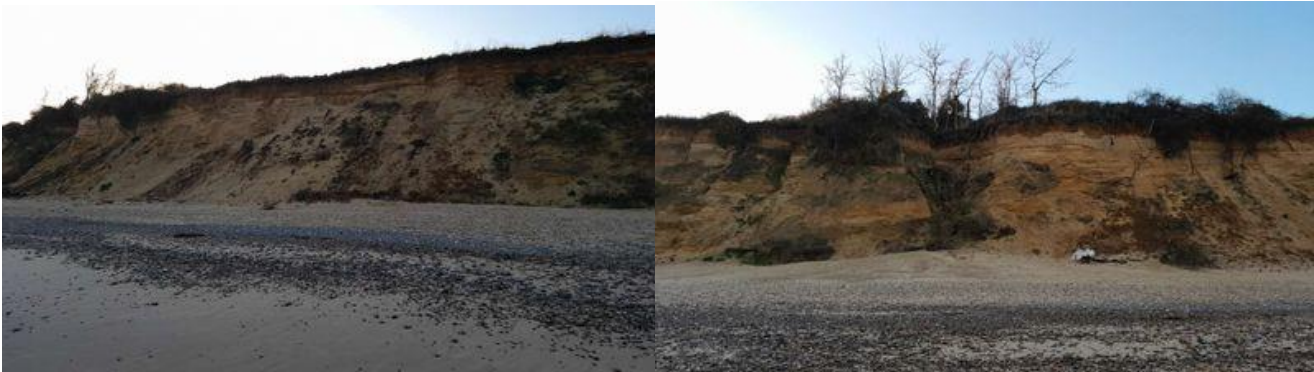
Photos of southern cliffs:

Changes to southern cliffs: Slumped material on cliff face; denuding and loss of vegetation; cliff-face steepening and overhanging; scree at base of cliff; fallen vegetation at base of cliff.

Comments on cliff change and any risk posed: See final report. Overnight increased HT and wave action neared southern cliff base as wrack mark.

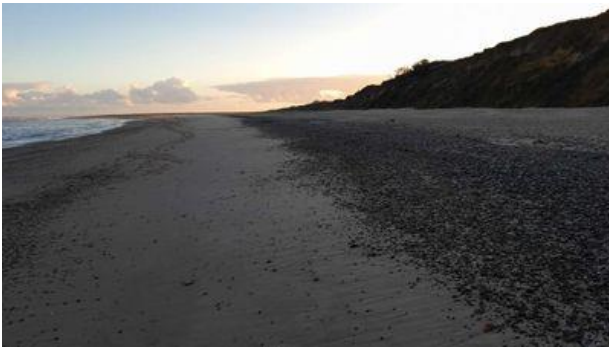
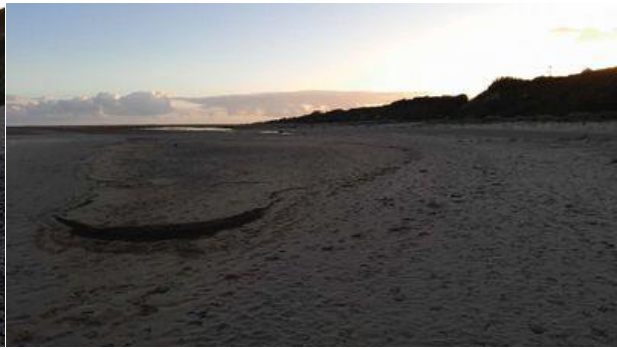
Photos of Pontins frontage and Benacre Ness:

Comments on change at Benacre Ness: Considerable surface water outflow from near the Pontins beach access due to recent increased amounts of precipitation. Much of this surface water is now being retained on The Ness feature as it continues to migrate northward.
