Pakefield Monthly Monitoring Report

Date & Time of survey: December 30, 2024 12:59

Reason for Inspection: Scheduled

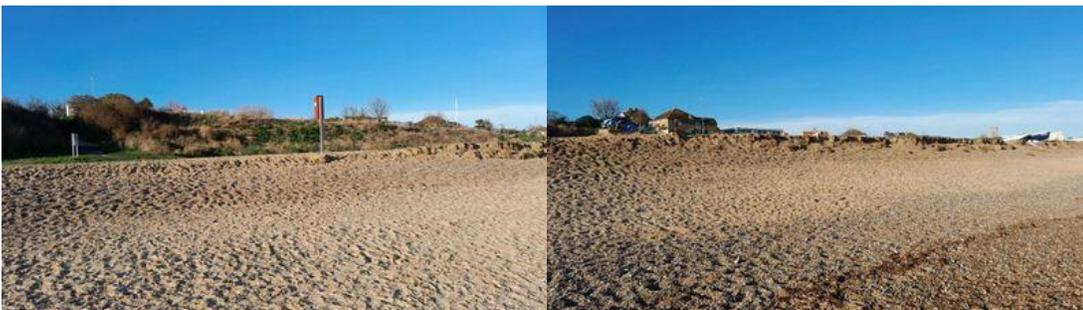
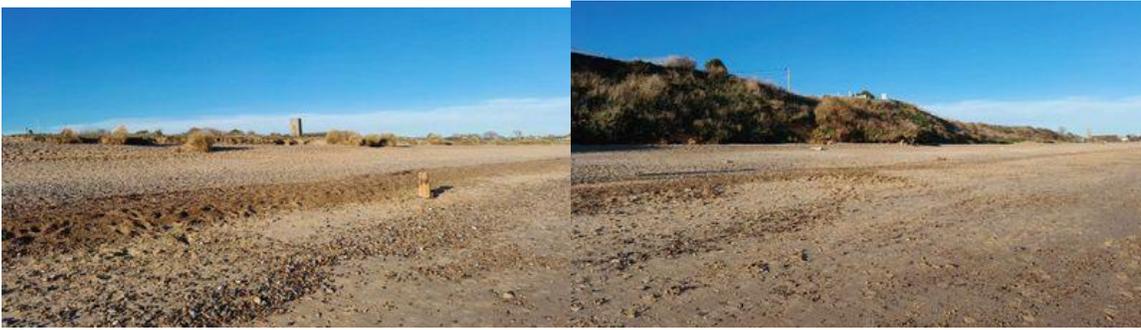
Beach photos:

Extension of beach cliffing alongshore: Significant northward extension

Landward recession of beach cliff: Significant landward recession

Change in gradient of beach cliff face: Slightly steeper (wave action at toe)

Maximum height of beach cliff (m): 2

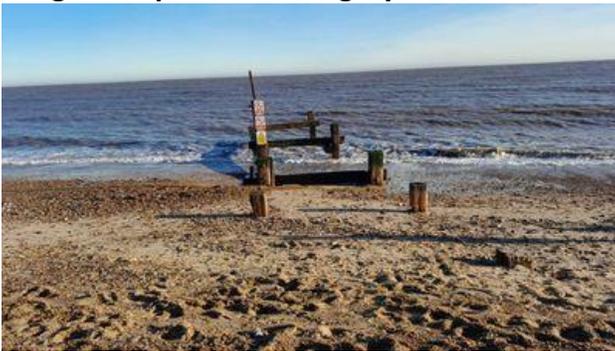
Image of exposed timber groyne:

Change in beach level relative to exposed timber groyne opposite Grand Avenue: Slight recent increase

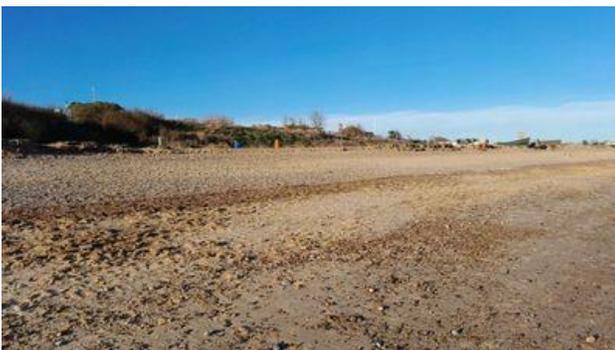
Images of beach north of Arbor Lane:

General impression of beach volume: Overall reduced

Comments on change in beach geomorphology: There was significant reworking of beach material during the periods of unsettled conditions and increased high tide levels. On inspection, there had been subsequent recovery around the Mean High Water Mark MHW and the lower foreshore. Dune faces have been eroded causing undermining and exposure of some equipment etc, with the areas of this type of erosion extending further northward.

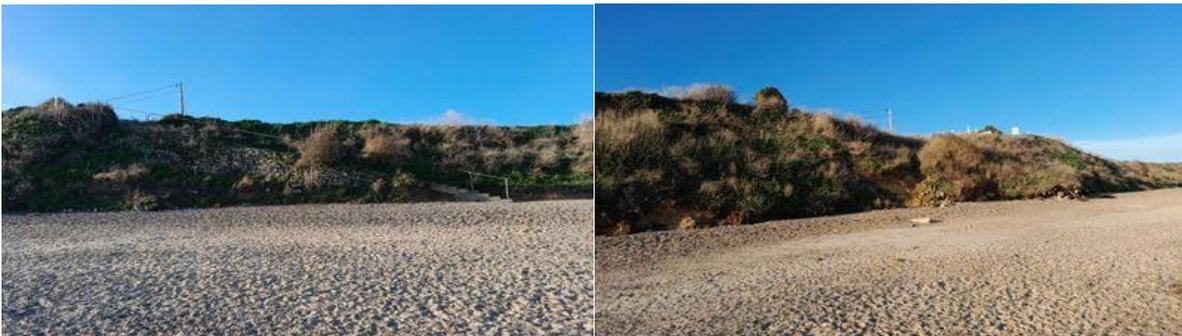
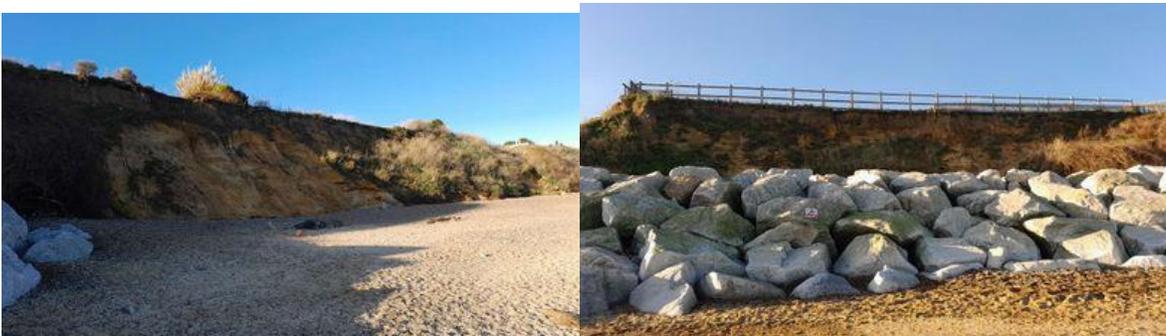
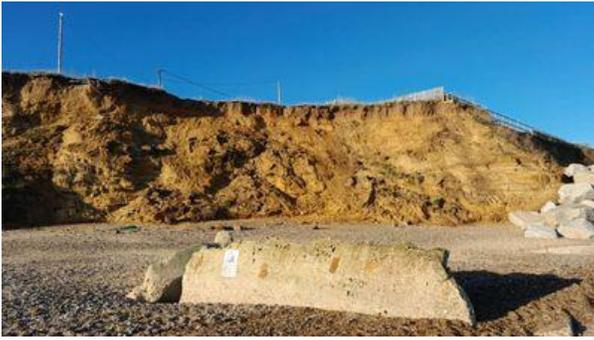
Photos of cliffs supporting property:

Changes to cliffs supporting property north of rock armour: Some areas of cliff toe recession and undermining; slumped material on cliff face; denuding and loss of vegetation; cliff-face steepening and overhanging; scree at base of cliff; fallen vegetation at base of cliff.

Changes to cliffs supporting property south of rock armour: Some areas of cliff toe recession and undermining; slumped material on cliff face; denuding and loss of vegetation; cliff-face steepening and overhanging; scree at base of cliff; fallen vegetation at base of cliff.

Changes to cliffs supporting properties both North & South of rock armour : December conditions disturbed the cliff base to the north and south sides of the rock in places and caused some localised falls. Above the south end of the rock the clifftop fence and concrete base, remain exposed. Further south along the clifftop, the line of operational caravans has been set back as part of the recent work of building demolition. The beach level behind the concrete walling has been reduced since the last inspection. Remaining concrete caravan bases to the seaward side of The Cliffs access road have been removed, and a new fence has been erected.

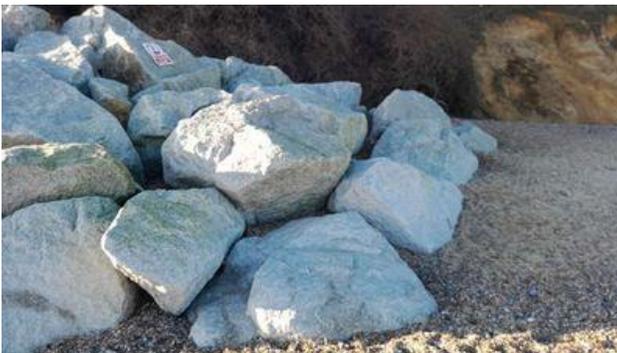
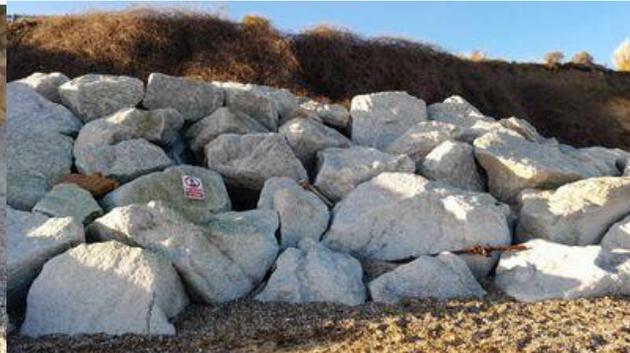
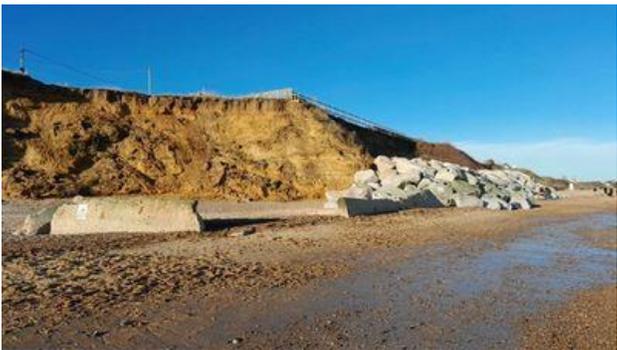
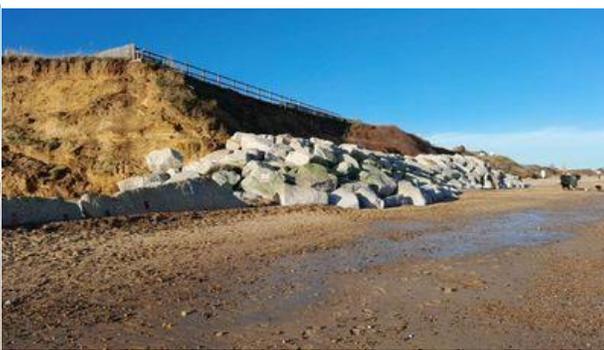
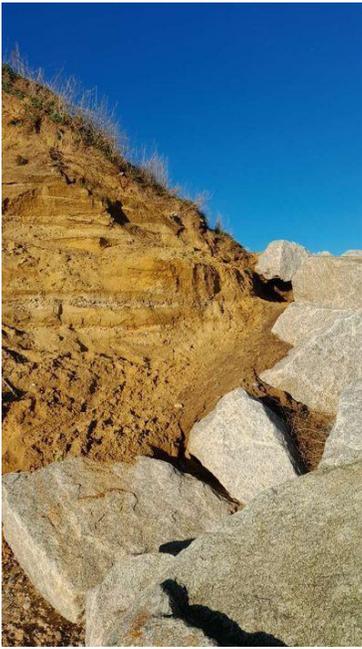
Photos of rock armour:

Beach access around the rock armour: Dry access available past rock armour around times of low tide

Beach levels surrounding rock armour: Negligible change

Exposure of geotextile: Negligible change

Hazards/debris within structure: Negligible change

Stability of cliff behind rock armour: As previous, no obvious or significant change apparent behind the main body of the rock structure, as viewed from the beach (vegetation growth obscures part of the cliff face).

Asset condition grade: 2 Good; rock armour condition satisfactory; no change in protection

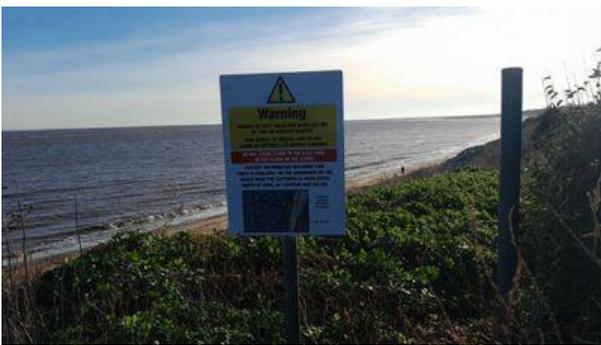
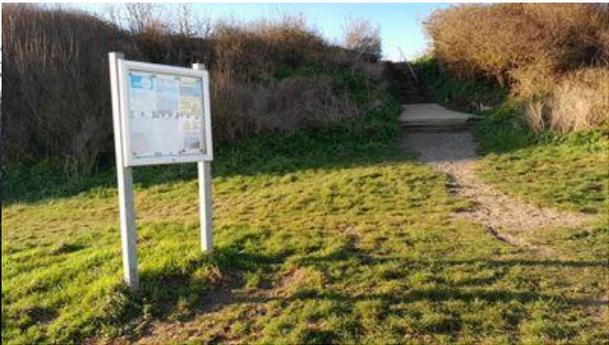
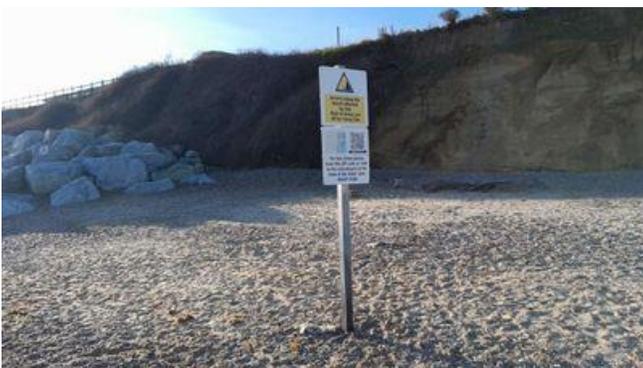
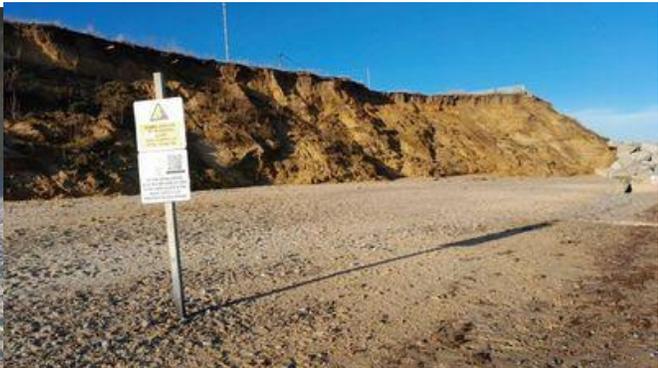
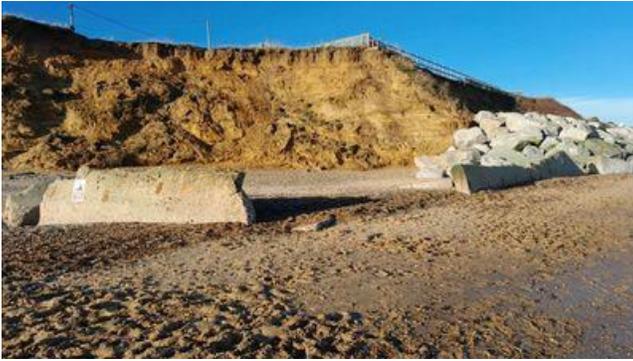
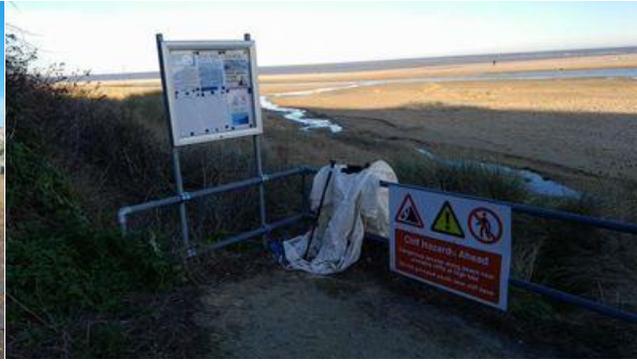
Photos of signage and any issues:

Provision of tidal information: Up to date & legible - Monitor

Comments on signage: One damaged sign has been replaced on rock

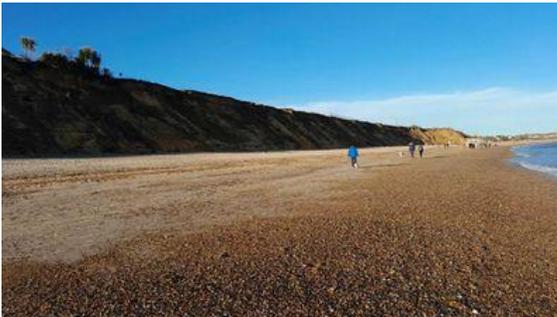
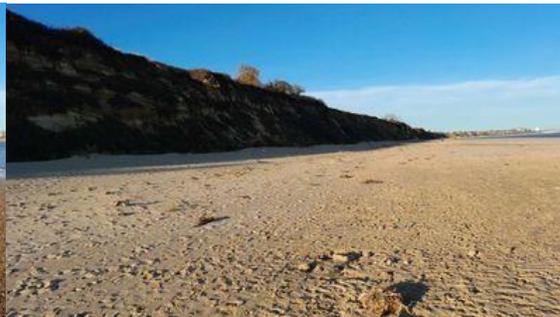
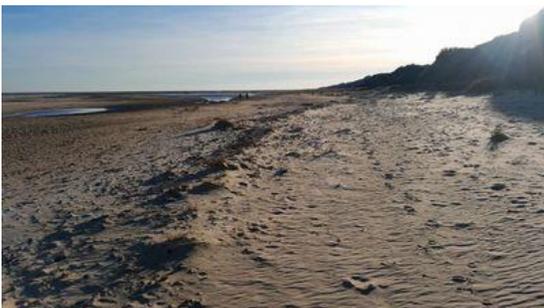
Photos of southern beach:

General impression of beach volume: Recent recovery around MHW and lower foreshore – consistent with beaches to north.

Comments on change to southern beach: As noted above.

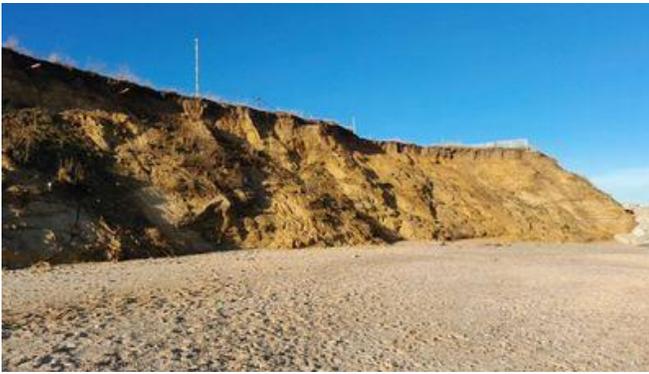
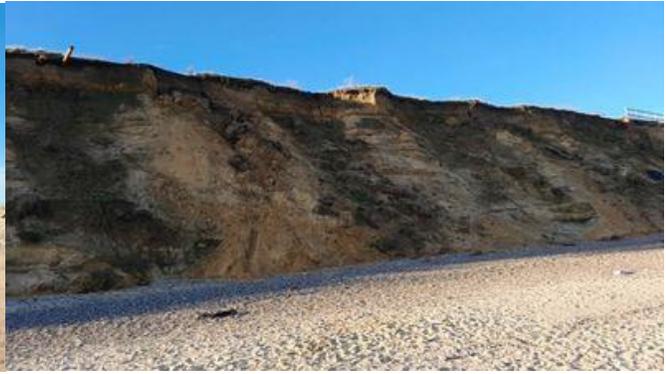
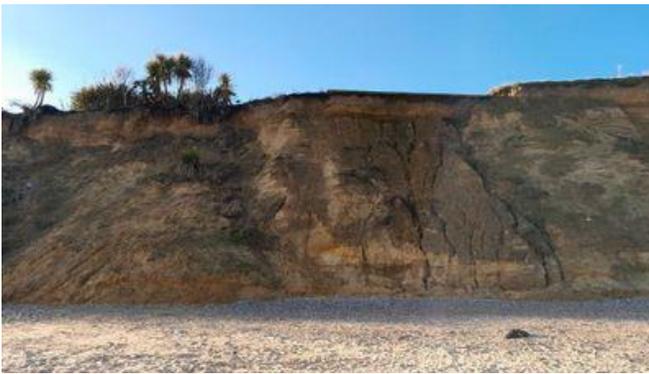
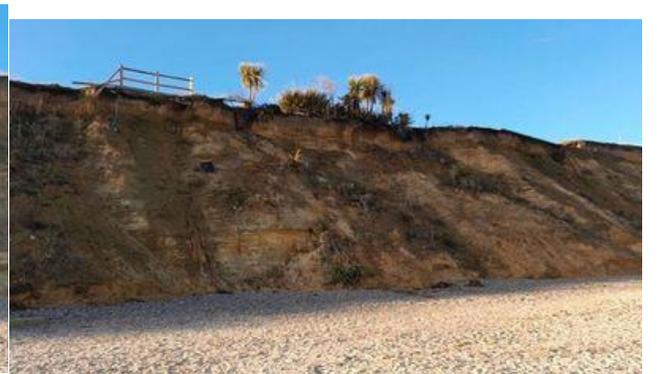
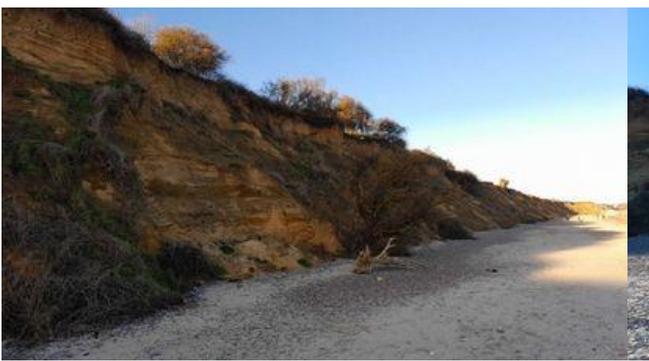
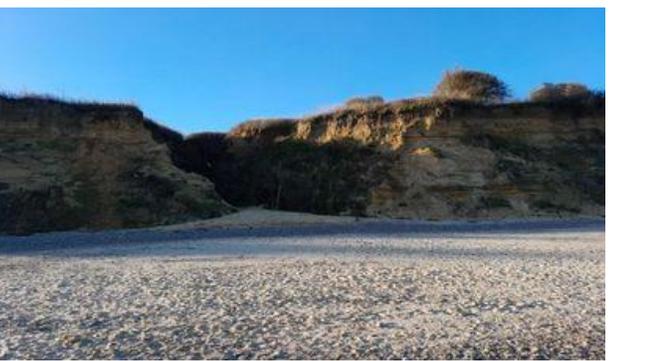
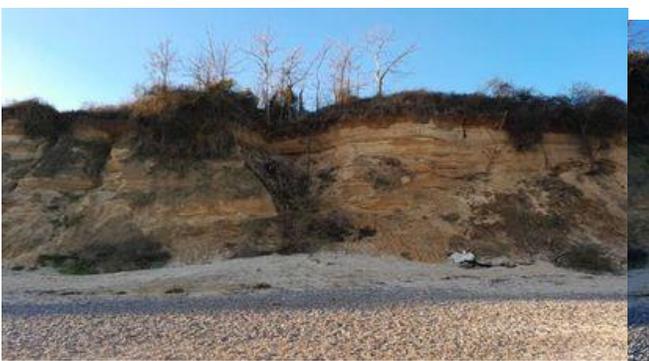
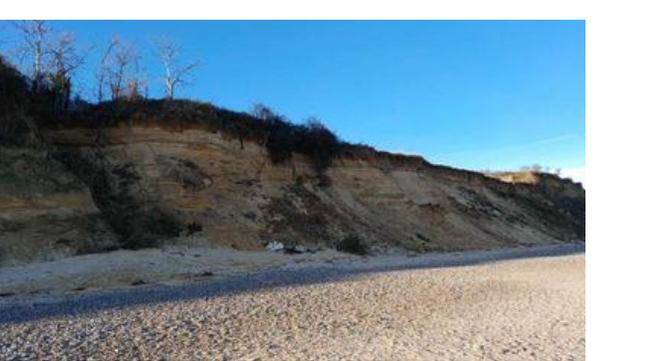
Photos of southern cliffs:

Changes to southern cliffs: Slumped material on cliff face; denuding and loss of vegetation; cliff-face steepening and overhanging; scree at base of cliff; fallen vegetation at base of cliff.

Comments on cliff change and any risk posed: Some continuing gradual change in places by processes described previously. December sea conditions reached more exposed cliff bases creating some additional instability and localized falls. Southern cliffs continue to be afforded greater protection by widening beaches.

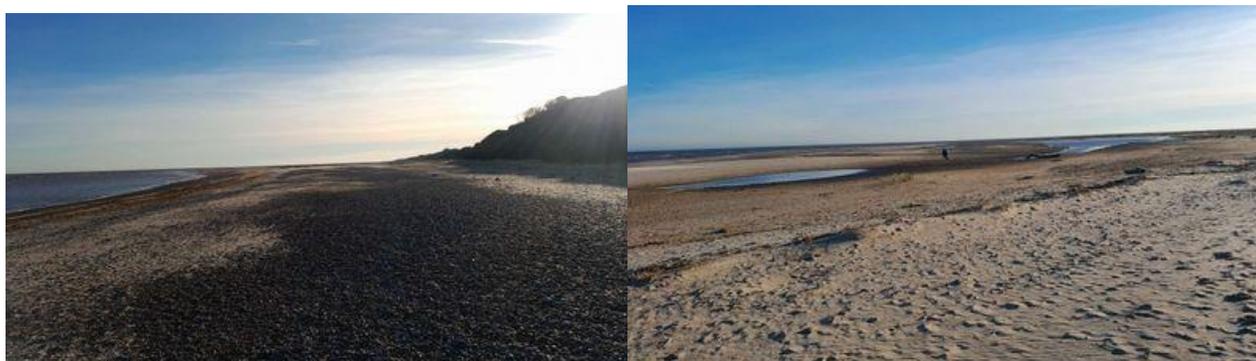
Photos of Pontins frontage and Benacre Ness:

Changes to beach geomorphology: Beach widening processes described previously continuing.

Comments on change at Benacre Ness: Further outflow onto the beach from near the Pontins access. Areas of surface water on The Ness feature appear to have receded from an earlier maximum, but remain extensive .

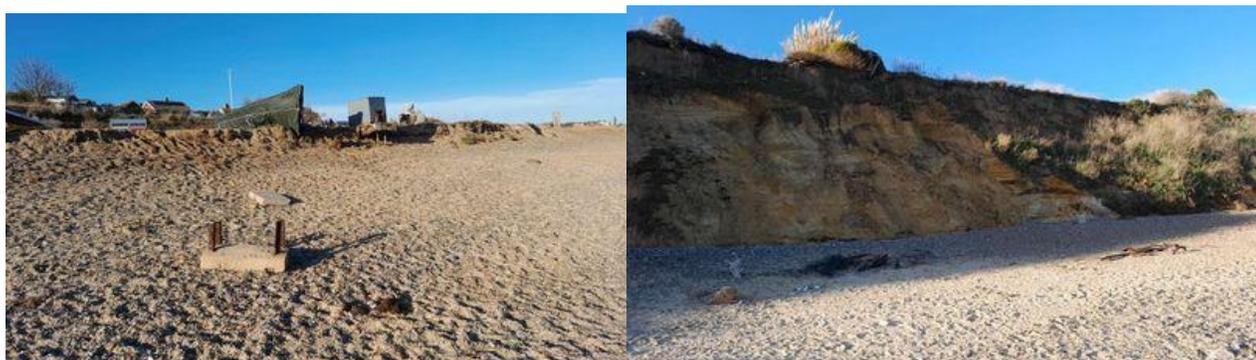
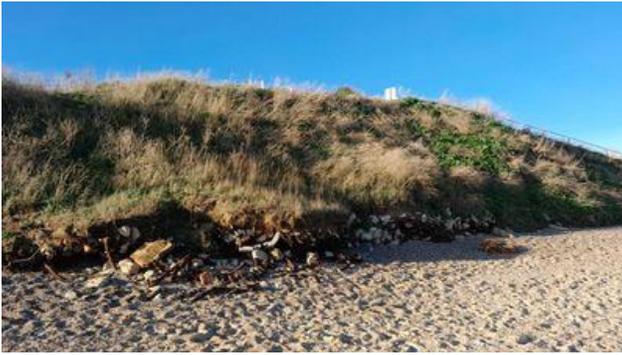
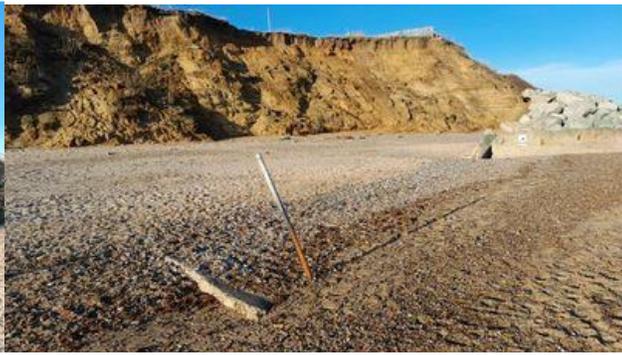
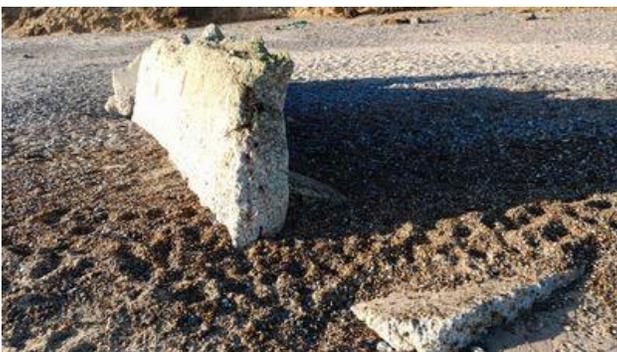
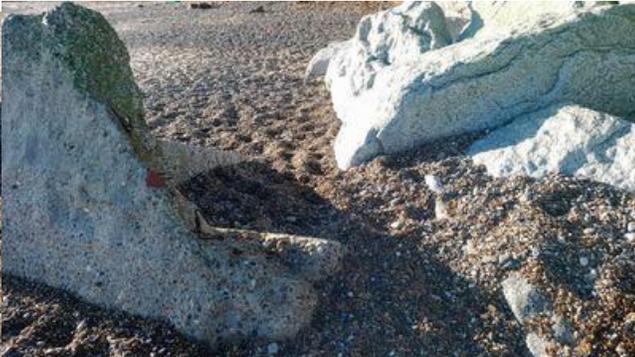
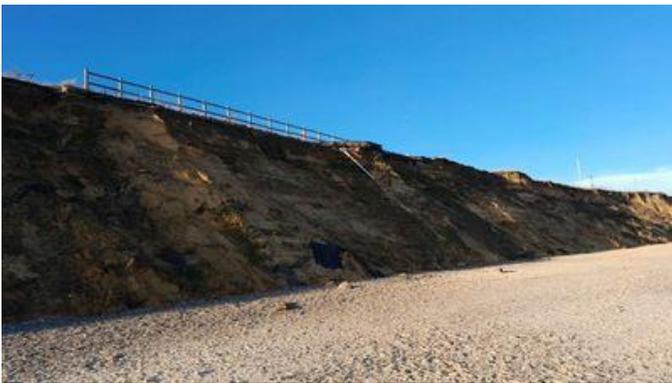
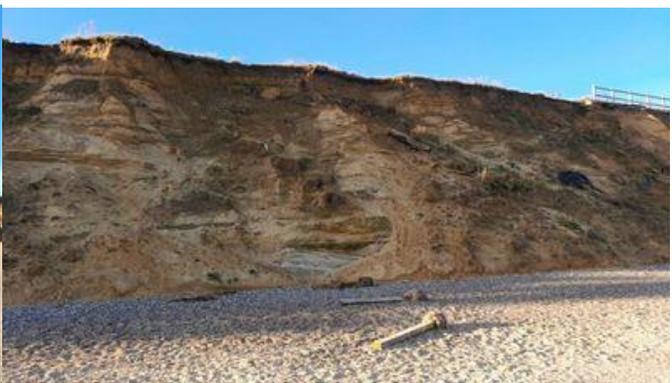
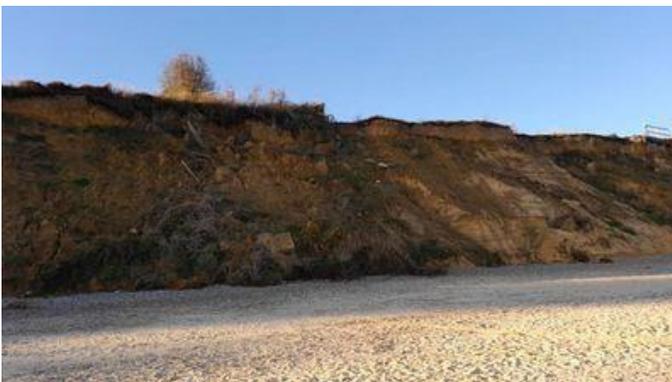
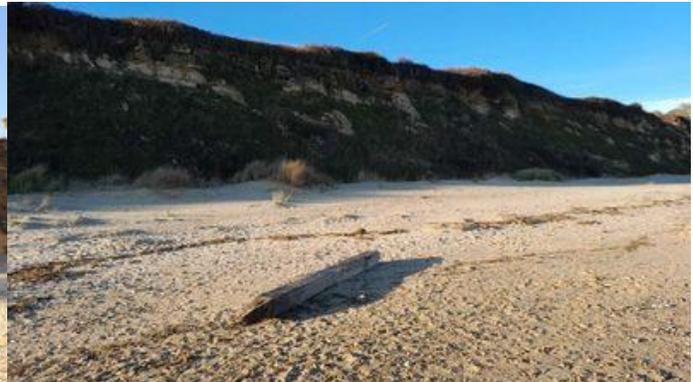
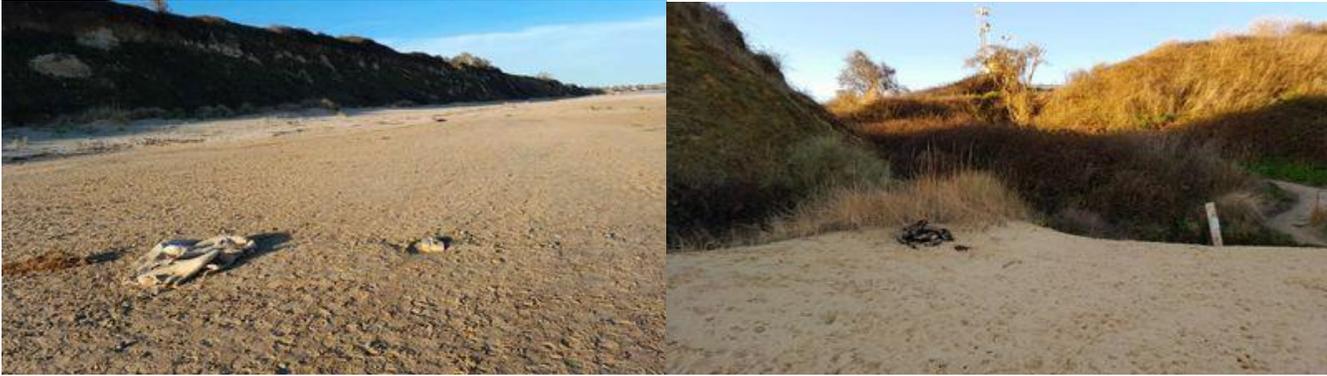
Photos of hazard/debris:

Comments on hazard/debris: Timber groynes hazards have been removed and additional safety signage installed.

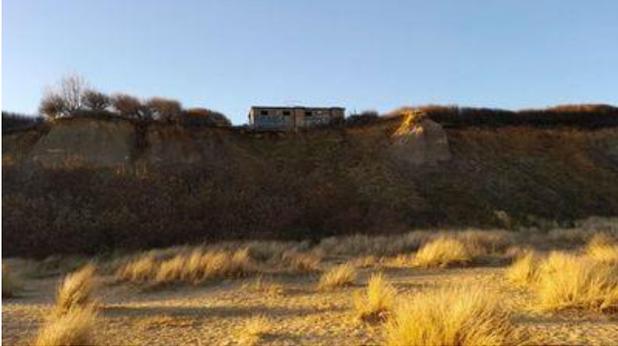
Kessingland Cliff top structure

Changes in cliff stability: No obvious change apparent from beach
