## **Thorpeness Monthly Monitoring Report**

**Date and Time of Survey:** February 5<sup>th</sup>, 2025, 09:15

**Inspector:** Thomas Hayden

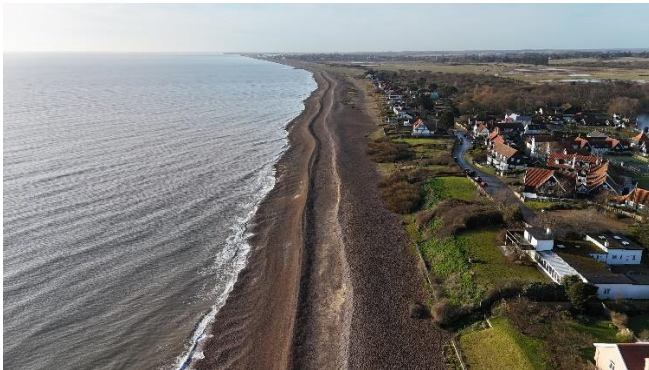
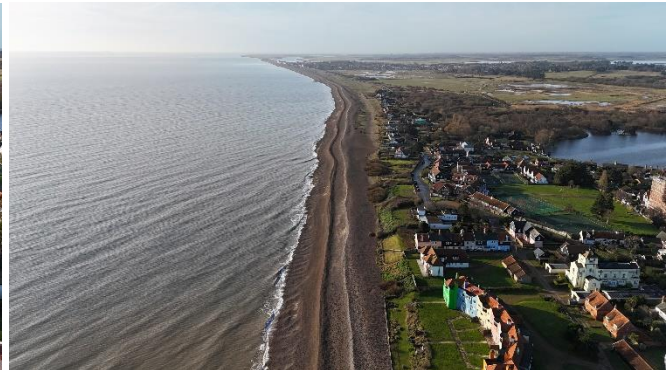
Photos of the southern UNDEFENDED frontage:

Comments on the Current Beach Levels over the southern UNDEFENDED frontage: Beach levels have recovered since the last inspection. The ridge on the upper beach has built, with a secondary ridge in front on the lower beach. This is due to the lower beach building, with the high tide mark approximately in the middle of the beach.

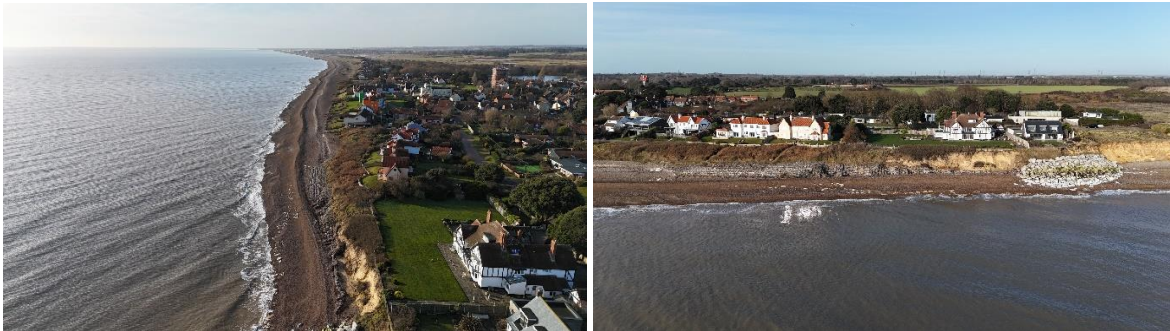
Photos of the central DEFENDED frontage:

Comments on the current beach levels over the DEFENDED frontage: Beach levels have recovered significantly since the last inspection. The geobags have nearly all been re-covered, with only a few exposed through the lower beach. The lower gabions have been recovered with beach material from the upper beach.

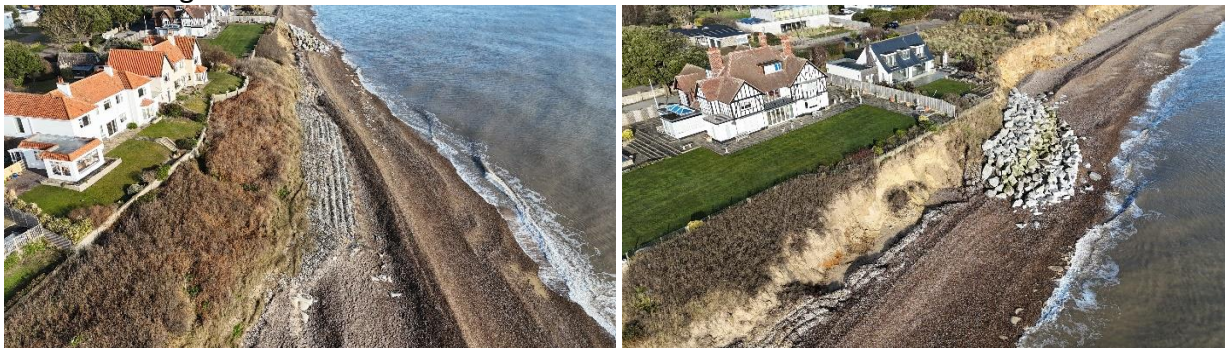
Photos of the gabions:

Comments on gabion condition: The southern end of the gabions are still standing and have not sustained any damage. However, the gabions adjacent to the south side of the rock have been impacted over last inspection period, with the lower gabions having slipped slightly. More of the cliff material has been eroded from above the gabions, with a gap between the base of the cliff and the gabions.

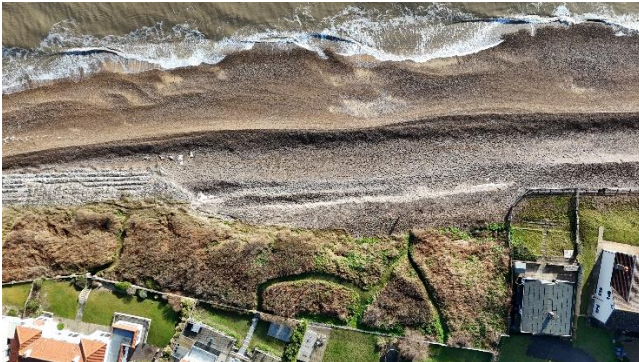
Photos of Phase 1 Geobags:

Comments on Phase 1 Geobag condition: Phase 1 geobags remain mostly covered. Some of the bags are uncovered at towards the southern end of the installation. These are approximately halfway up, above the high tide mark. These bags are not damaged.

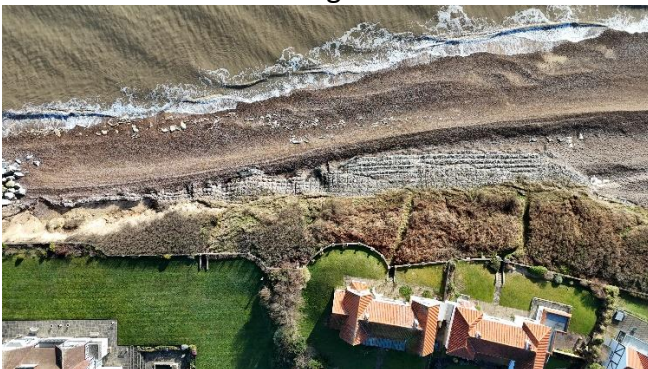
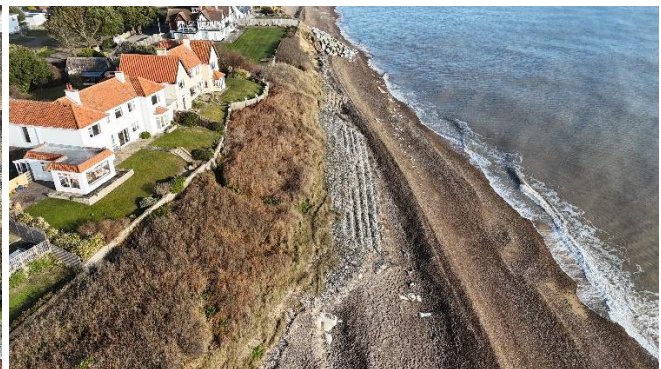
Photos of Phase 2 Geobags:

Comments on Phase 2 Geobag condition: These geobags have been largely recovered since the last inspection. Some of the lower bags remain uncovered, mainly within the intertidal zone.

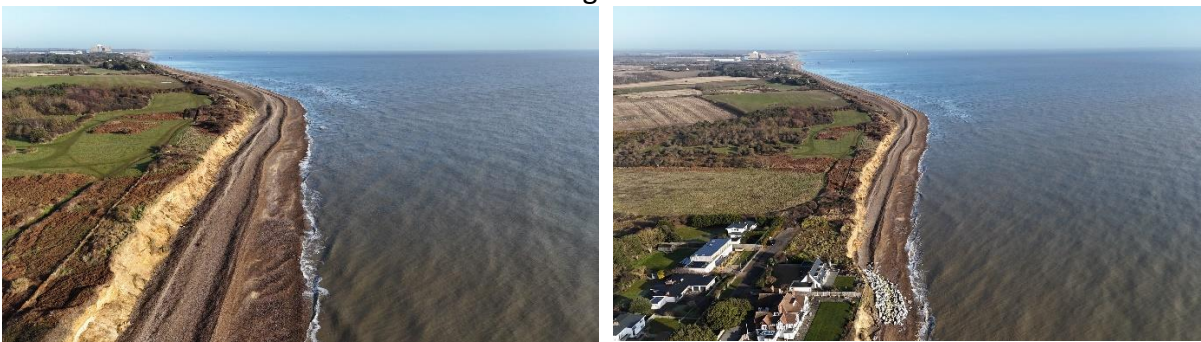
Photos of the northern UNDEFENDED Frontage:

Comments on the current beach levels, north of defence termination: Beach levels have recovered since the last inspection. The high tide mark has moved away from the base of the cliffs, with the lower beach building as a result. This has meant that the bay profile of the beach running North to South has filled out, to result in a straighter line from the ness to the rock. A second ridge line has formed on the upper beach, at the base of the cliffs. The cliffs have been eroded some more and have lost some material along the length of this part of the frontage.
