Pakefield Monthly Monitoring Report

Date and Time of survey: February 4, 2025 07:30

Reason for Inspection: Scheduled

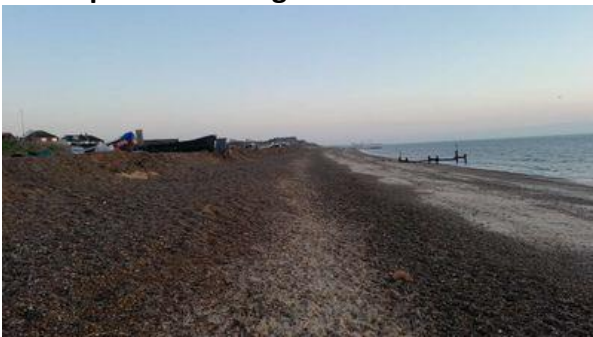
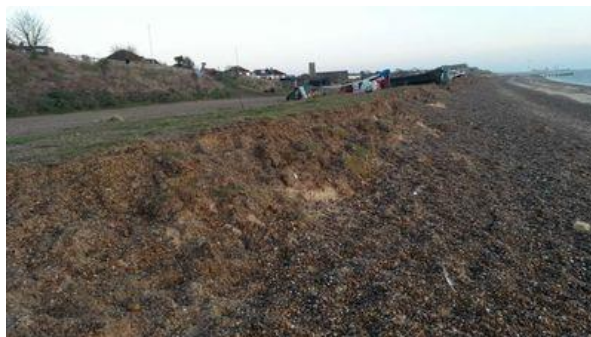
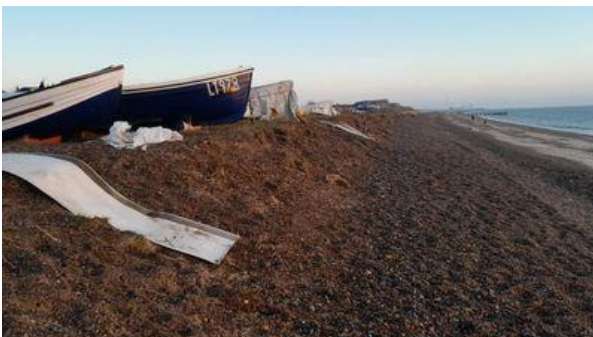
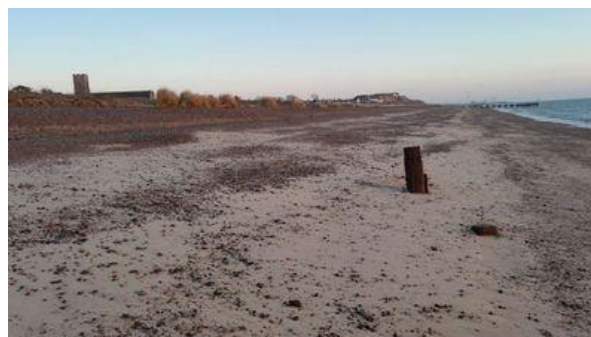
Beach photos looking north:

Extension of beach cliffing alongshore: Negligible change since last inspection

Landward recession of beach cliff: Slight landward recession

Change in gradient of beach cliff face: Slightly flatter (accumulation or trampling)

Maximum height of beach cliff (m): 1.5

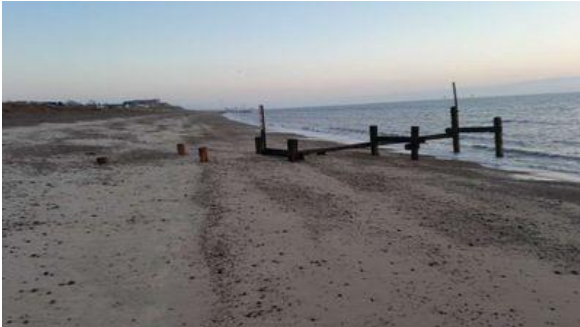
Photo of exposed timber groyne:

Change in beach level relative to exposed timber groyne opposite Grand Avenue: Negligible change

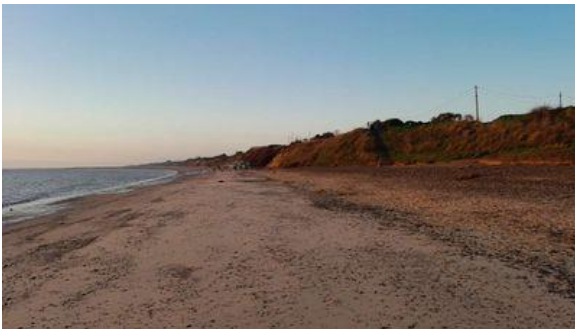
Photos of beach north of Arbor Lane:

General impression of beach volume: Not significantly changed from previous inspection

Comments on change in beach geomorphology: Levels relatively healthy above mean high water mark with shingle rich berm at base of the dune face. Trampling of the remaining dune face. Lower foreshore retains characteristic steep gradient.

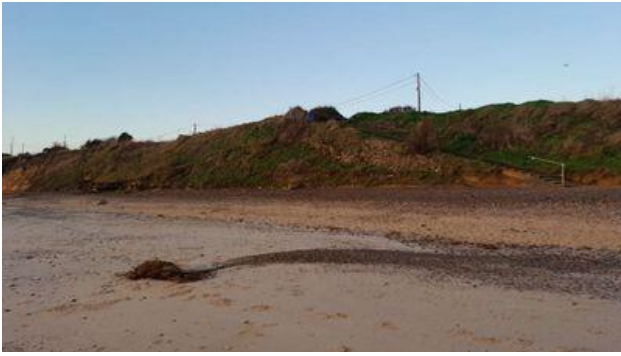
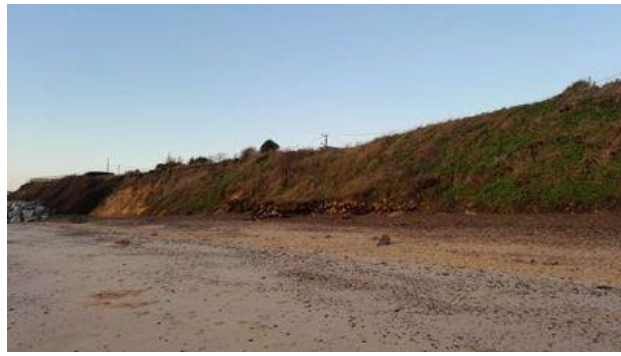
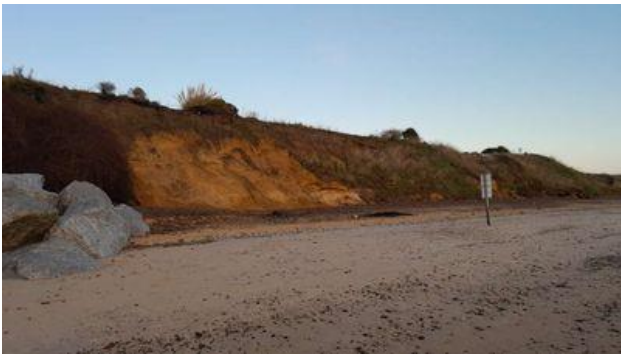
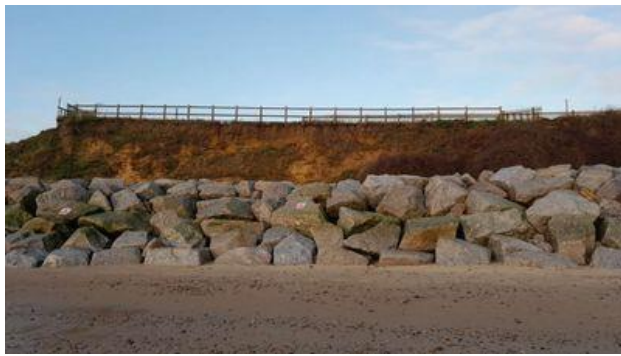
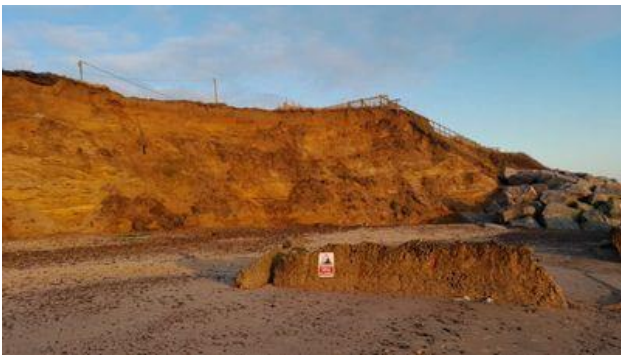
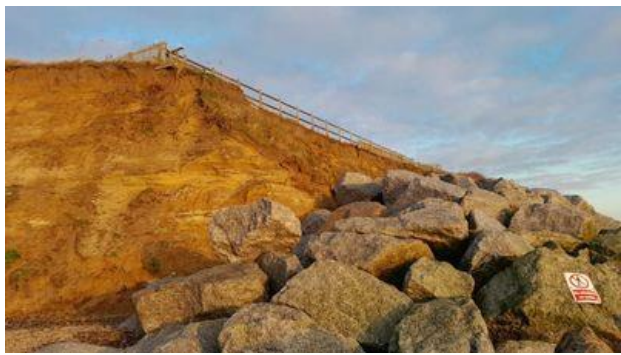
Photos of soft unconsolidated sand cliffs:

Changes to soft unconsolidated sand cliffs north of rock armour: Some areas of cliff toe recession and undermining, slumped material on cliff face, denuding and loss of vegetation, cliff-face steepening and overhanging, scree at base of cliff, fallen vegetation at base of cliff

Changes to soft unconsolidated sand cliffs south of rock armour: Some areas of cliff toe recession and undermining, slumped material on cliff face, denuding and loss of vegetation, cliff-face steepening and overhanging, scree at base of cliff, fallen vegetation at base of cliff

Comments on risk to cliff-top assets: Conditions remain similar to those noted in the December report. Early January conditions caused some disturbance to the more exposed cliff bases

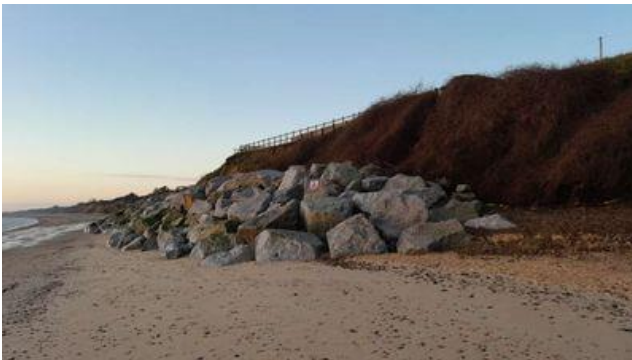
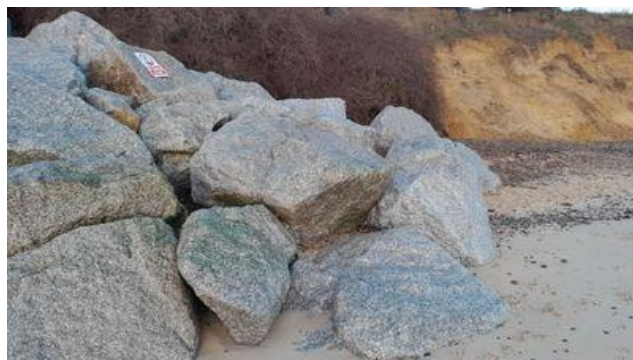
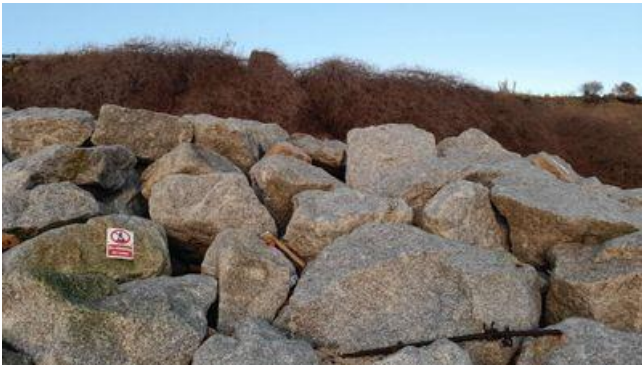
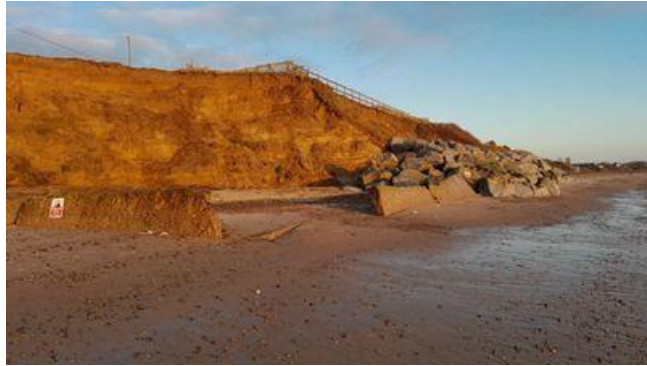
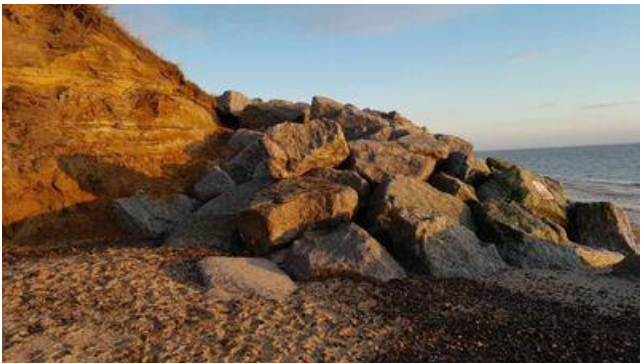
Photos of rock armour:

Packing of rock: Overall satisfactory

Cross-sectional profile: Satisfactory

Beach levels surrounding rock armour: Average

Stability of cliff behind rock armour: As previous, no obvious change apparent behind the main body of the rock structure, as viewed from the beach (vegetation growth obscures part of the cliff face).

Asset condition grade: 2- Good; rock armour condition satisfactory; no change in protection

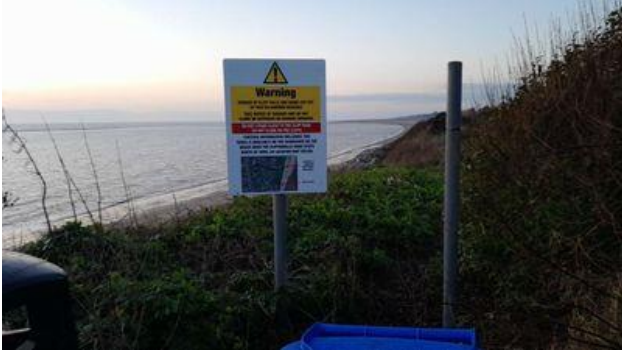
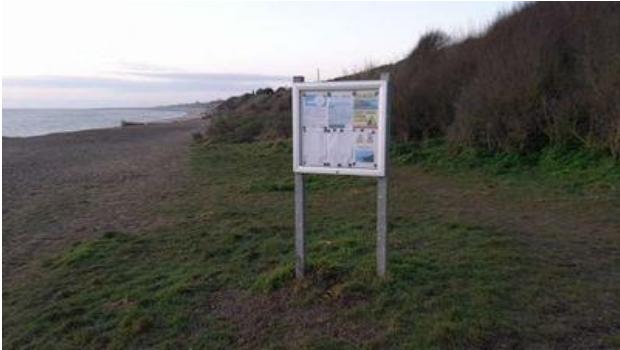
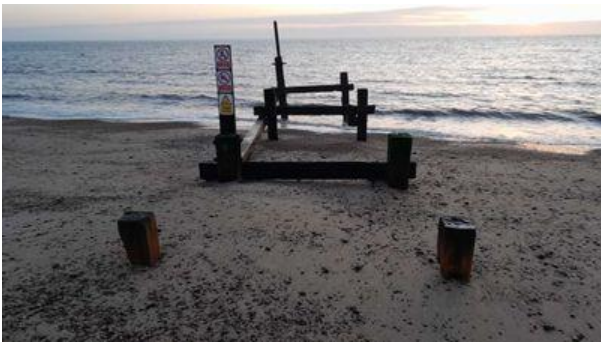
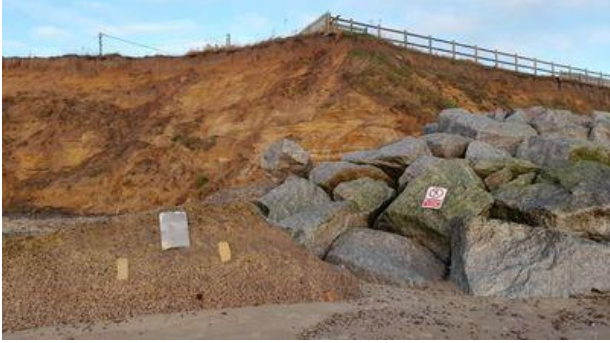
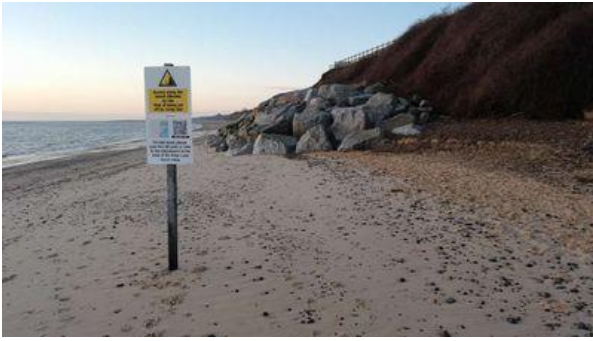
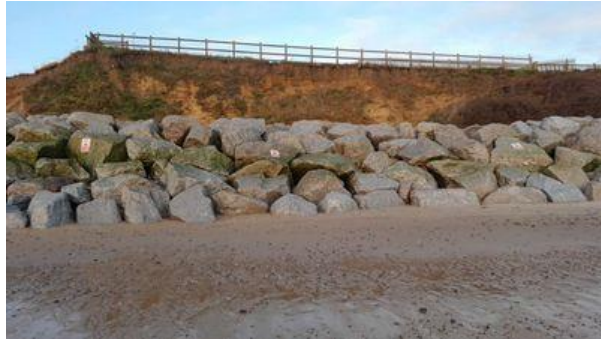
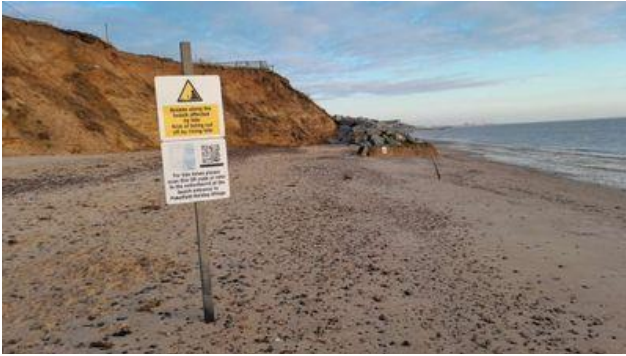
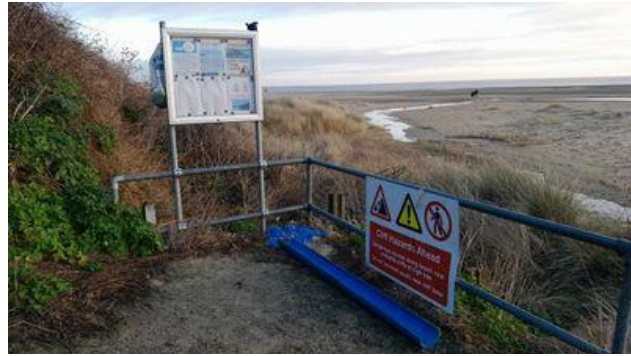
Photos of signage:

Signage in place, intact and fixings secure? - Yes

Adequacy of signage: Satisfactory

Provision of tidal information: Up to date and legible - Monitor

Comments on signage: No change from previous month's report

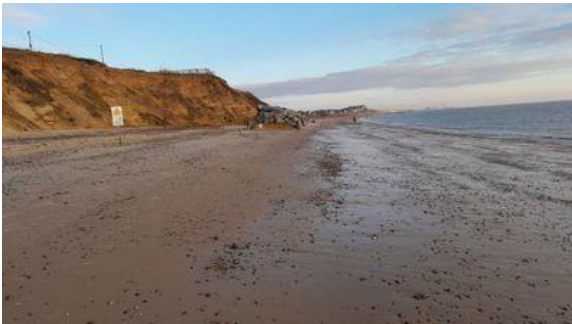
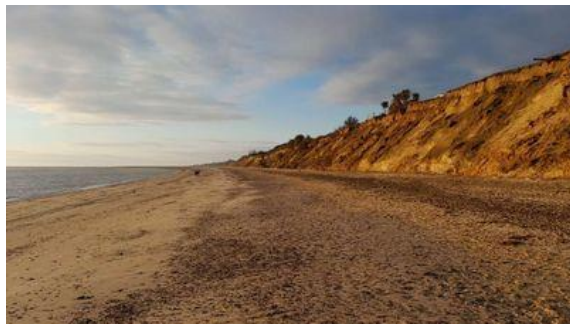
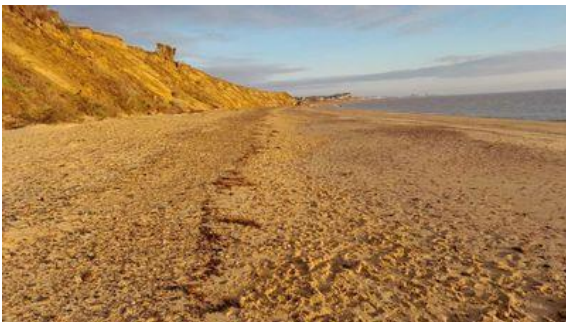
Photos of southern beach:

General impression of beach volume: No significant change from previous month's inspection

Comments on change to southern beach: Similar characteristics to northern beaches with relatively healthy level above high water mark at the base of the cliffs. At the south end of the rock beach levels are currently less favourable.

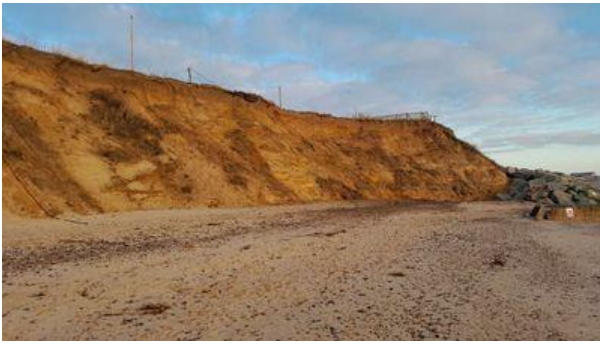
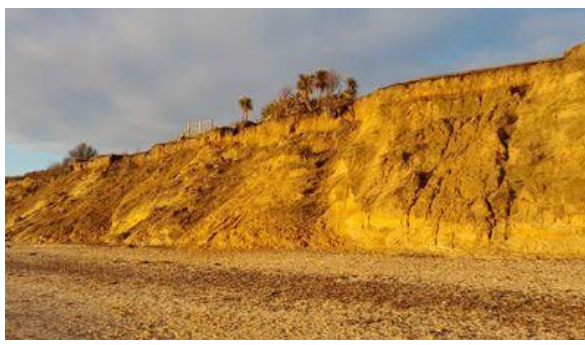
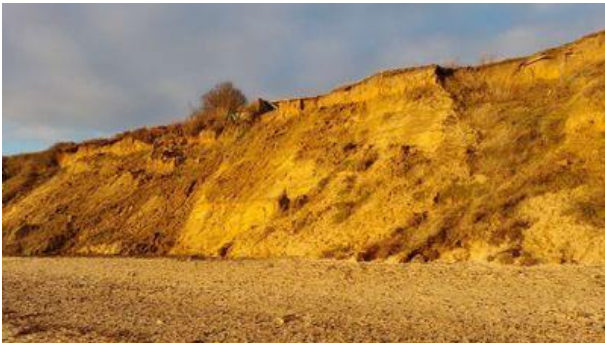
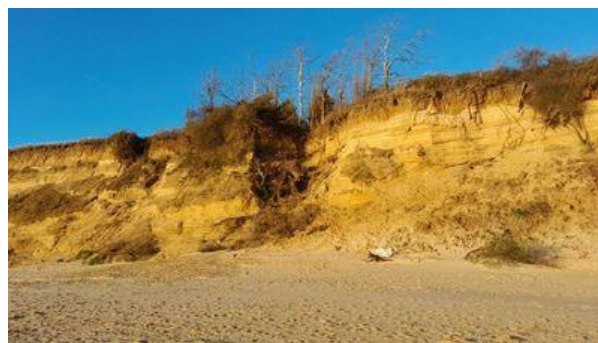
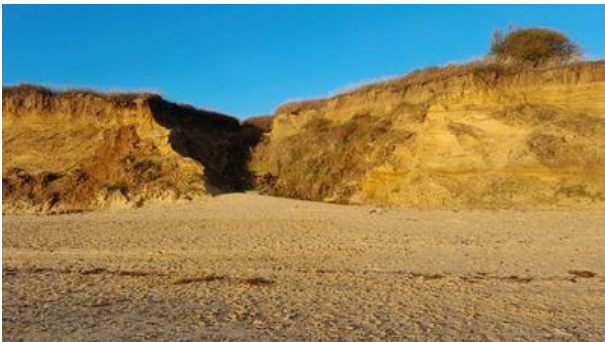
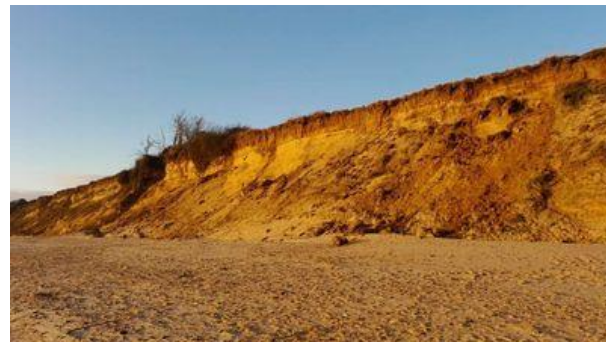
Photos of southern cliffs:

Changes to southern cliffs: Some areas of cliff top recession and undermining, slumped material on cliff face, denuding and loss of vegetation, evident cliff top recession, cliff-face steepening and overhanging, scree at base of cliff, fallen vegetation at base of cliff

Comments on cliff change and any risk posed: Southern cliffs continue to benefit from healthy beach levels. To the immediate south side of the rock, cliffs were potentially more exposed to seas.

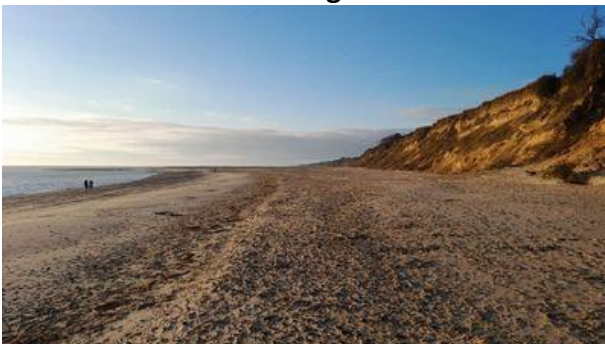
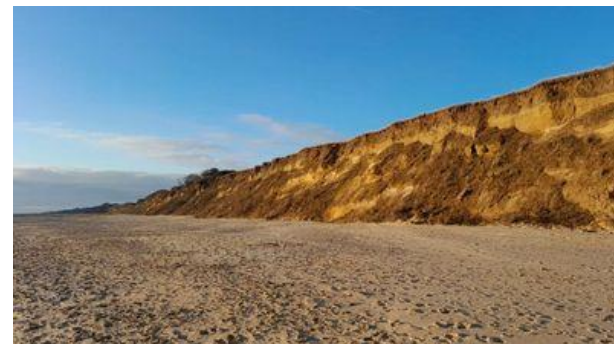
Photos of Pontins frontage and Benacre Ness:

Changes to beach geomorphology: Processes described previously continuing.

Comments on change at Benacre Ness: Very good spring low tide level on inspection revealing seaward Ness features. Impression is that beaches continue to widen from the south. Surface water outflow is being retained on the Ness.

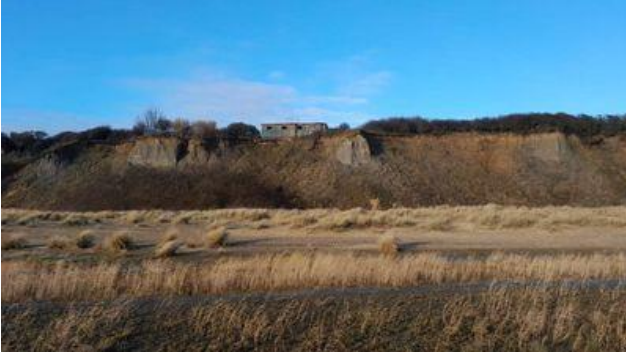
Photo of cliff top structure:

Changes in cliff stability: No obvious change apparent from beach
