Pakefield Monthly Monitoring Report

Date and Time of survey: July 30, 2024 10:35 Inspector Name: Keith Roper Time of Low Tide: 11:15 Height of Low Tide (m ODN): -0.3 Reason for Inspection: Scheduled

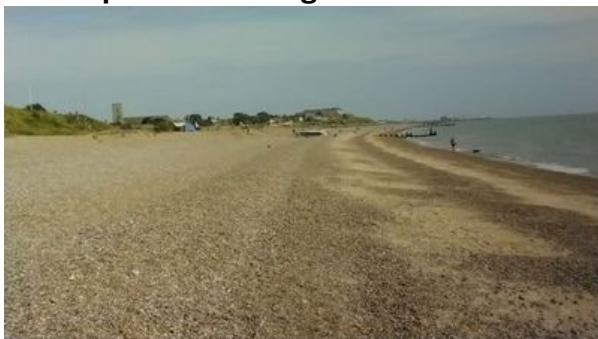
Extension of beach cliffing alongshore: Negligible change Landward recession of beach cliff: Slight landward recession (trampling) Change in gradient of beach cliff face: Slightly flatter (trampling) Maximum height of beach cliff (m): 2 Beach photos looking north:

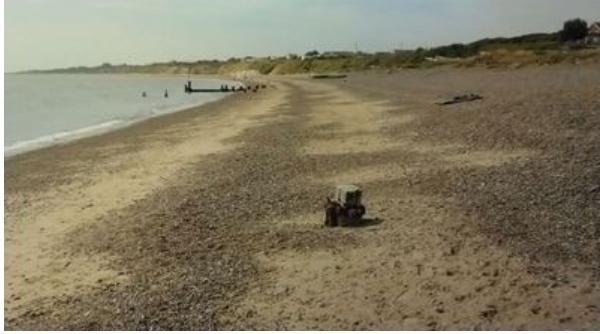
Beach photos below taken further north than usual inspection area showing new timber exposure – seaward of Nightingale Road: Beach level in relation to timber - similar to previous.

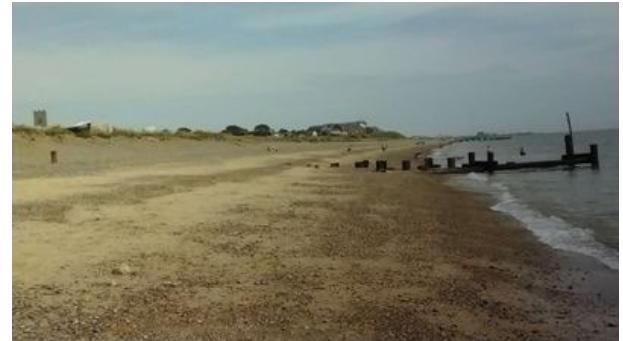
Change in beach level relative to exposed timber groyne opposite Grand Avenue: Little change Photo of exposed timber groyne:

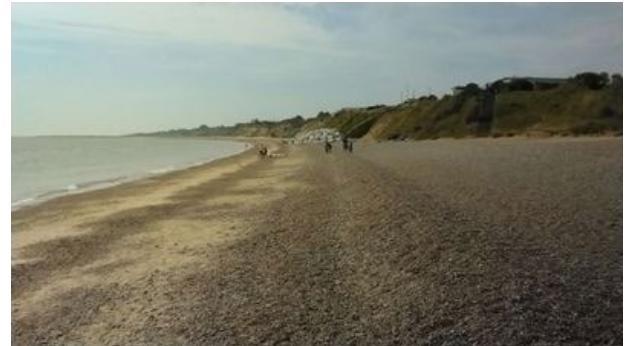
General impression of beach volume: No significant change **Photos of beach north of Arbor Lane:**

Comments on change in beach geomorphology: A continuous shingle berm remains near the high water mark, although it has been partially reworked by wave action. Below this there has been some accretion of shingle rich material but overall volumes are little changed, and the lower foreshore retains a typically steepened gradient.

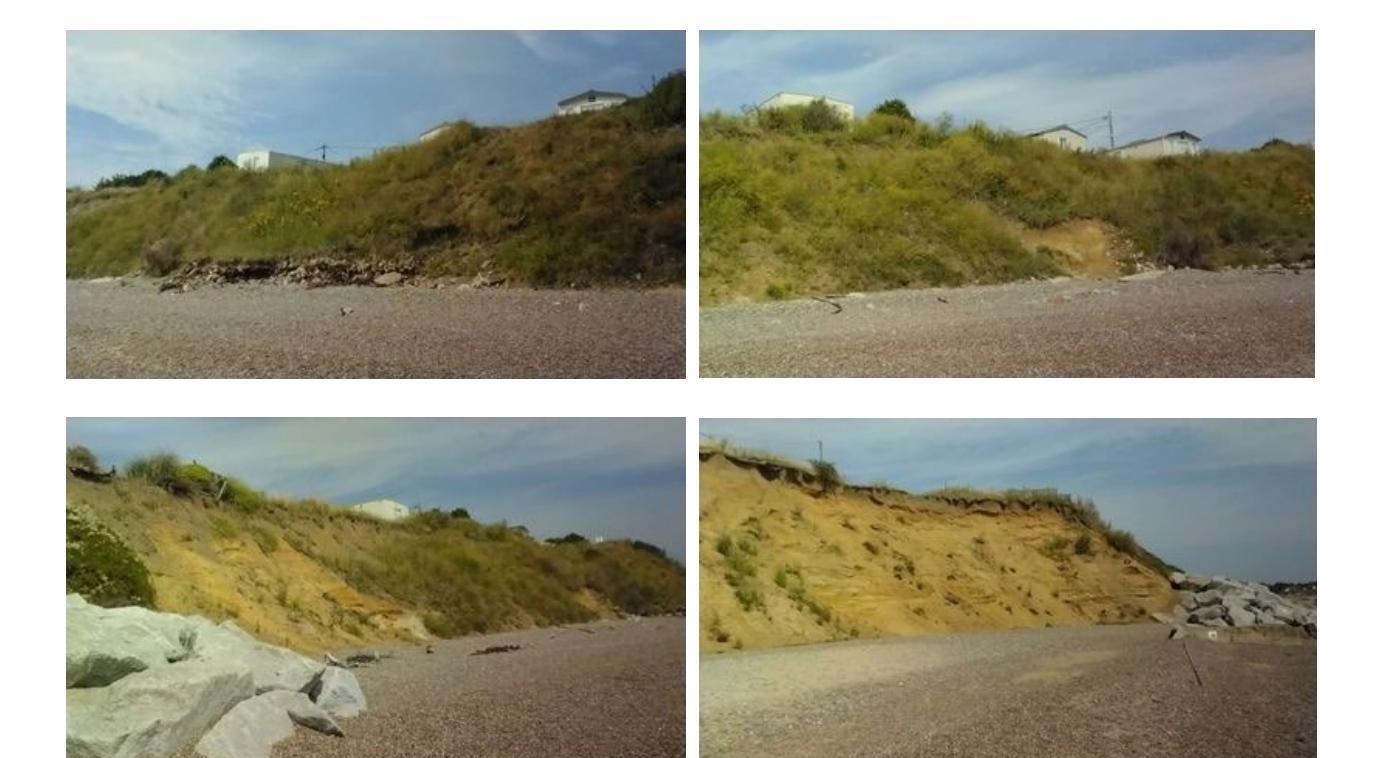
Photos of cliffs supporting property:

Changes to cliffs supporting property north of rock armour: Slumped material on cliff face; denuding and loss of vegetation; scree at base of cliff; fallen vegetation at base of cliff.

Changes to cliffs supporting property south of rock armour: Slumped material on cliff face; denuding and loss of vegetation; cliff-face steepening and overhanging; scree at base of cliff; fallen vegetation at base of cliff.

Comments on risk to cliff-top assets: There appeared to be three caravans visible from the beach to the seaward side of The Cliffs (photos below), however, on later inspection there were two, with the southern one displaying "awaiting removal" information (as previously). Seas have not impacted the cliffs since the last inspection, but the material is very dry and fine, and continues to be lost from exposed faces. To the south side of the rock this process has created an overhang of the upper topsoil layer, and probably instability (photo below). Extensive vegetation growth continues to obscure much of the cliff face in this area.

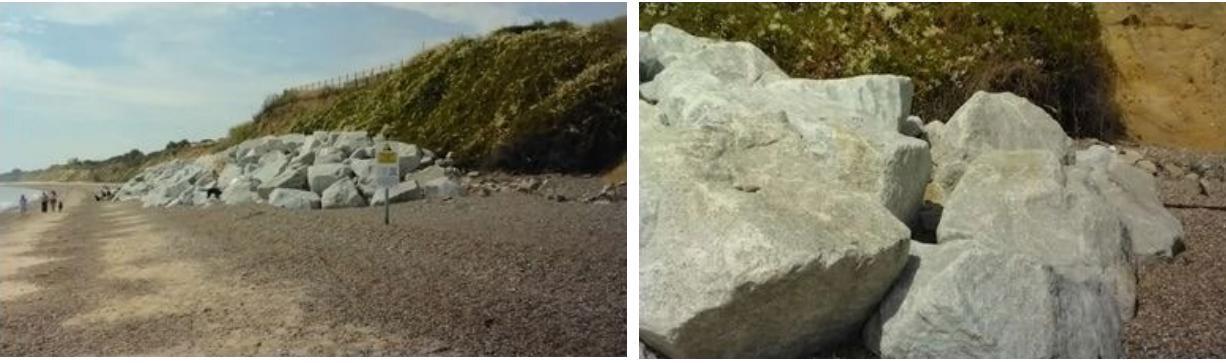
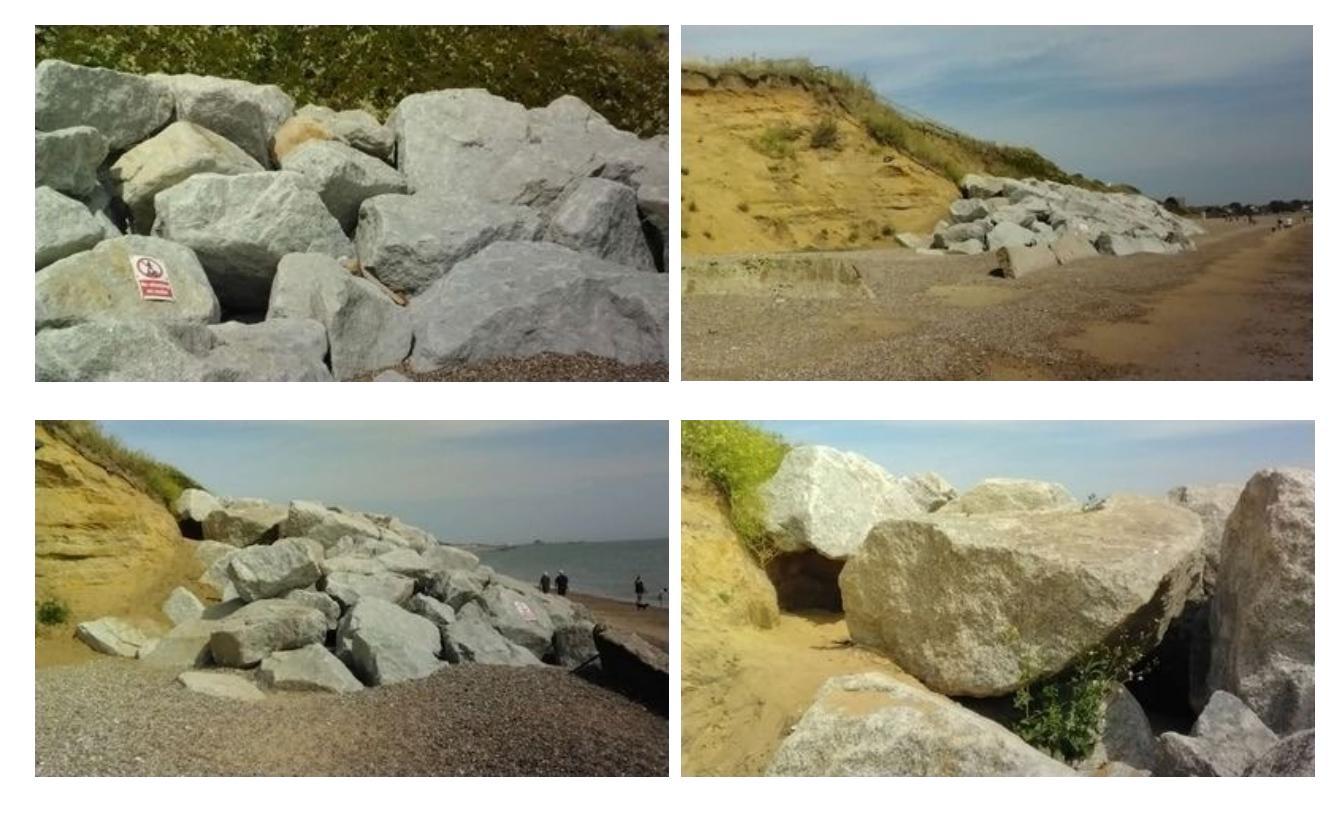
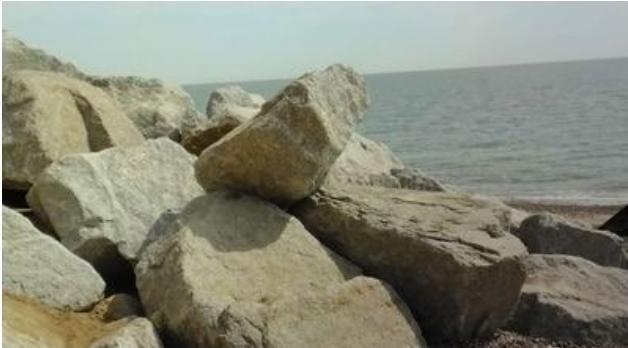
Displacement of rock from structure: Yes - Some - Monitor

Beach access around the rock armour: Dry access available past rock armour around time of low tide **Settlement, movement, undermining of structure:** Yes - Some - Monitor

Exposure of geotextile: Yes - Some - Monitor

Hazards/debris within structure: Yes - Some - Monitor

Asset condition grade: 2 Good; minor defects that do not reduce overall performance **Photos of rock armour:**

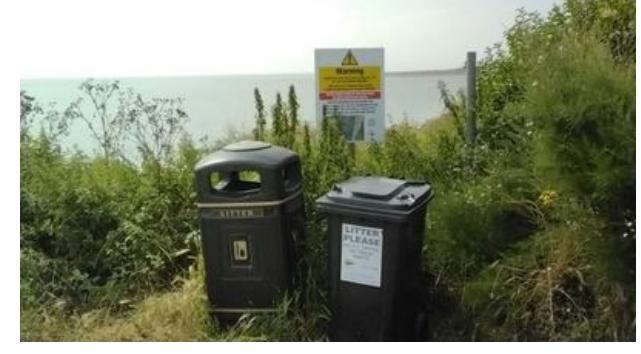
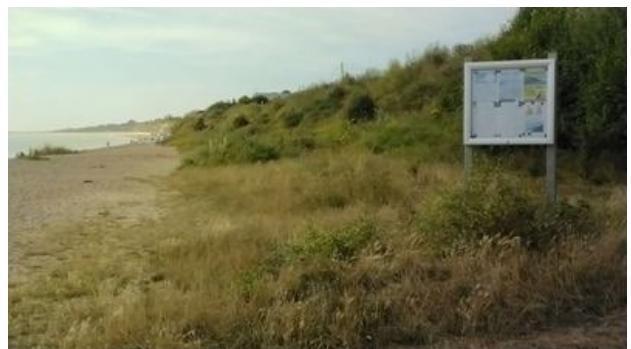
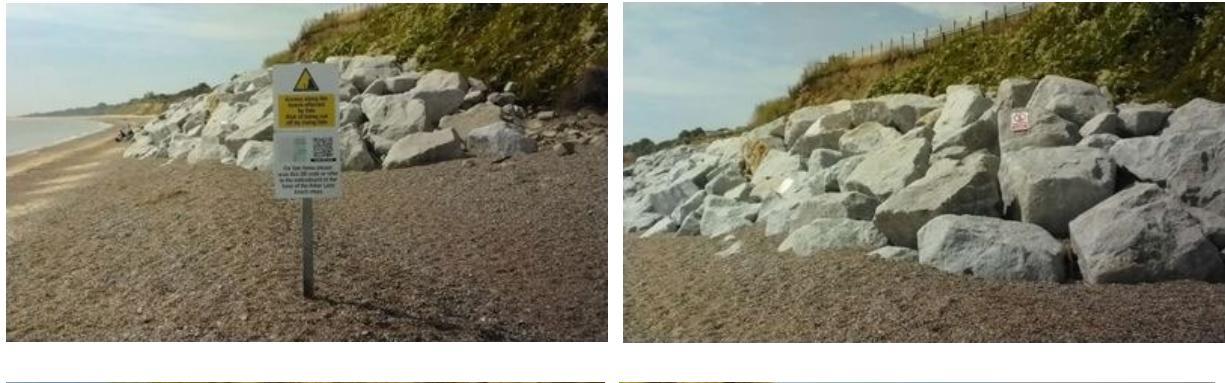
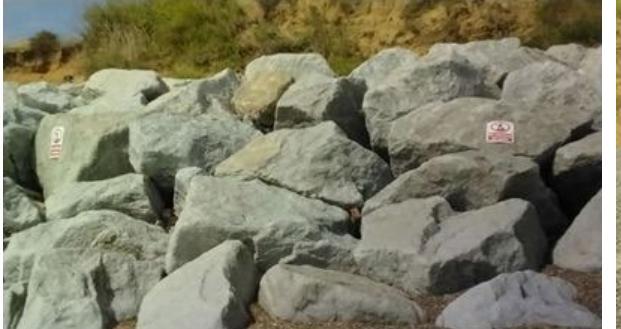
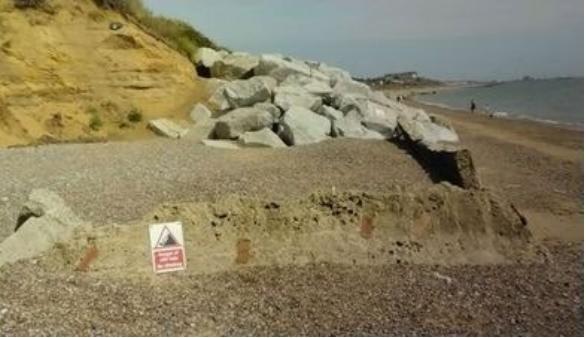
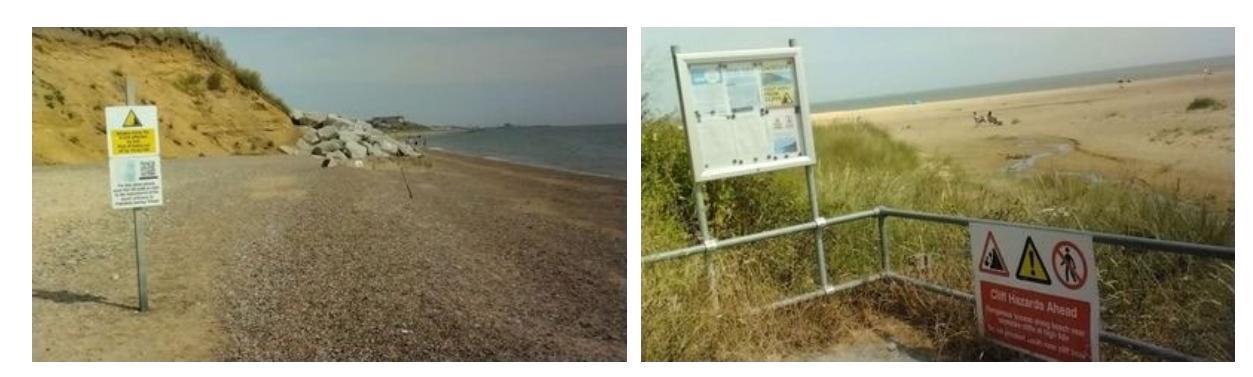
Photos of signage and any issues:

Comments on signage: Arbor Lane steps information sign is again becoming partially obscured by vegetation

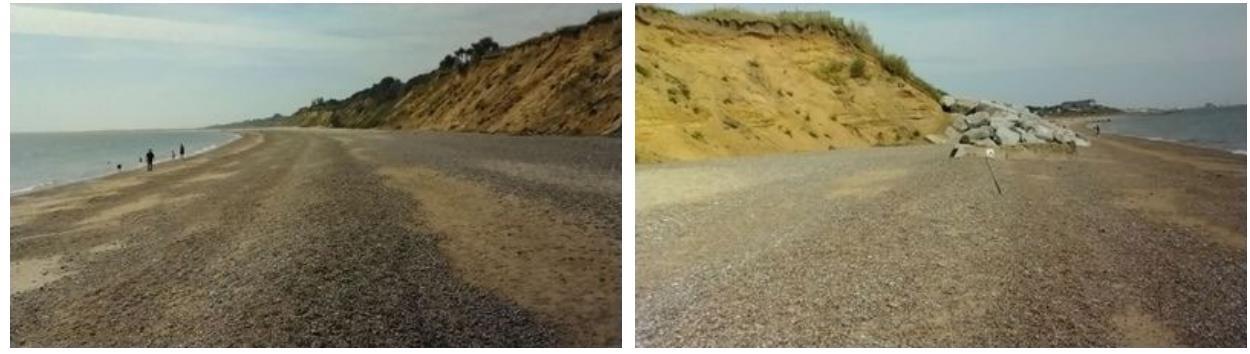
Southern Pakefield beach and cliffs General impression of beach volume: Slightly increased Photos of southern beach:

Comments on change to southern beach: Similar characteristics to the northern frontage with reworking of the shingle berm near high water mark and some recent accretion below this. **Changes to southern cliffs:** Slumped material on cliff face; denuding and loss of vegetation; cliff-face steepening and overhanging; scree at base of cliff; fallen vegetation at base of cliff. **Photos of southern cliffs:**

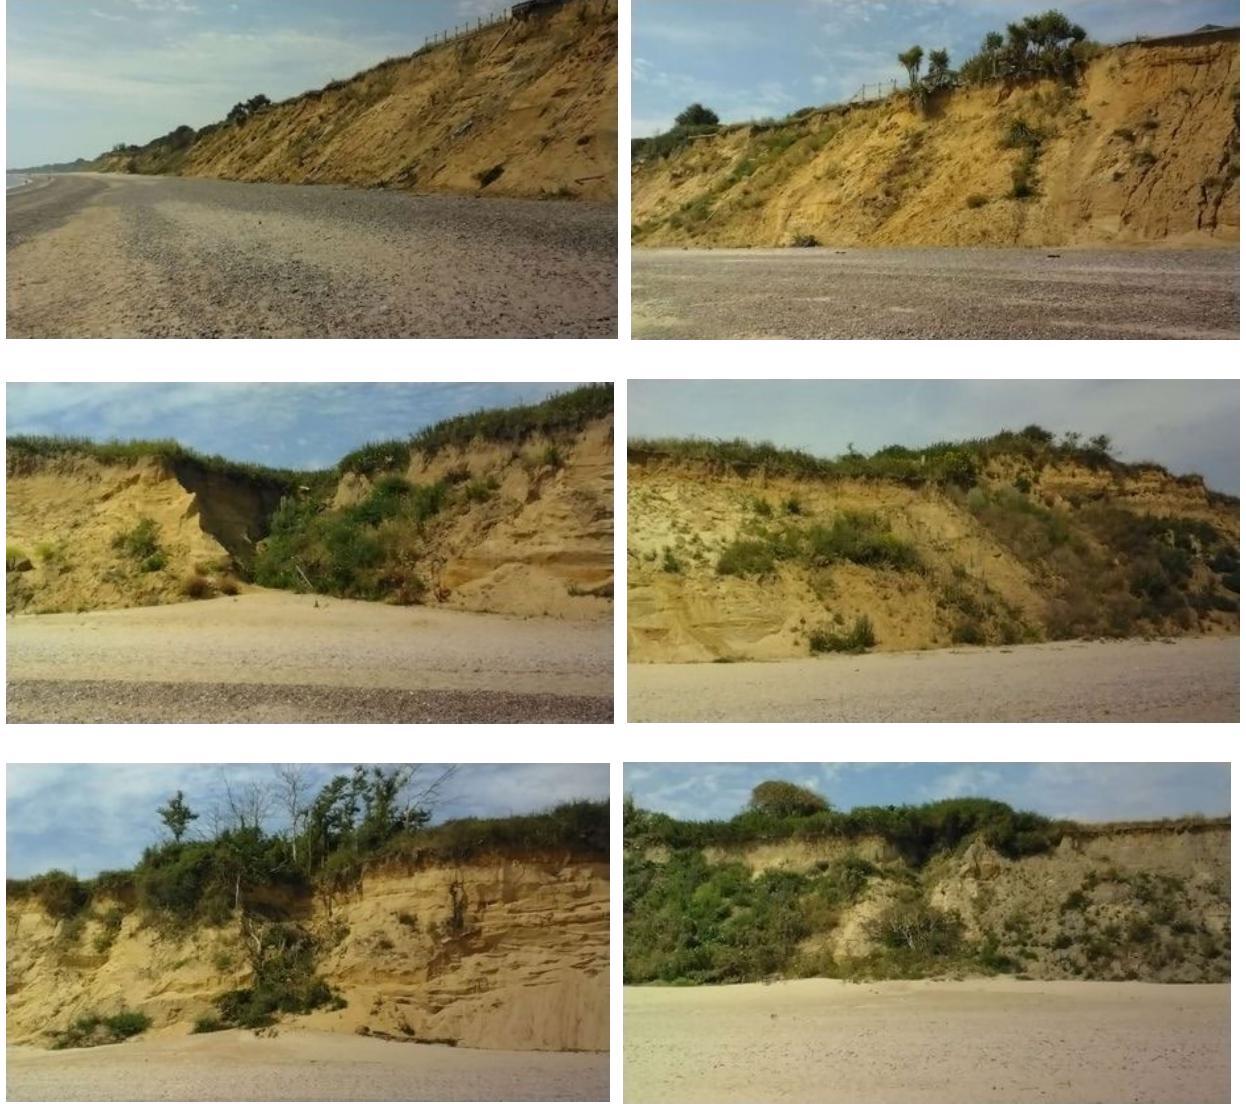
Comments on cliff change and any risk posed: No impacts from seas this past month but noticeable losses of very dry material where faces are exposed and steepened.

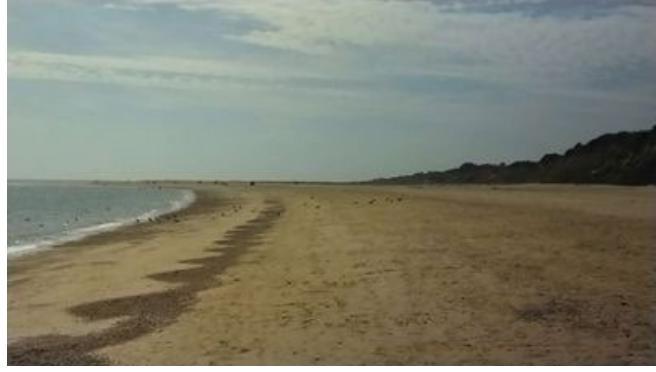
Photos of Pontins frontage and Benacre Ness:

Changes to beach geomorphology: Beaches stable and broadened along the Pontins frontage with noticeable re-establishment of vegetation.

Comments on change at Benacre Ness: Impression remains of widening beaches. There was only slight surface water outflow from adjacent the Pontins beach access, and relatively small, shallow areas of standing water further seaward and south.

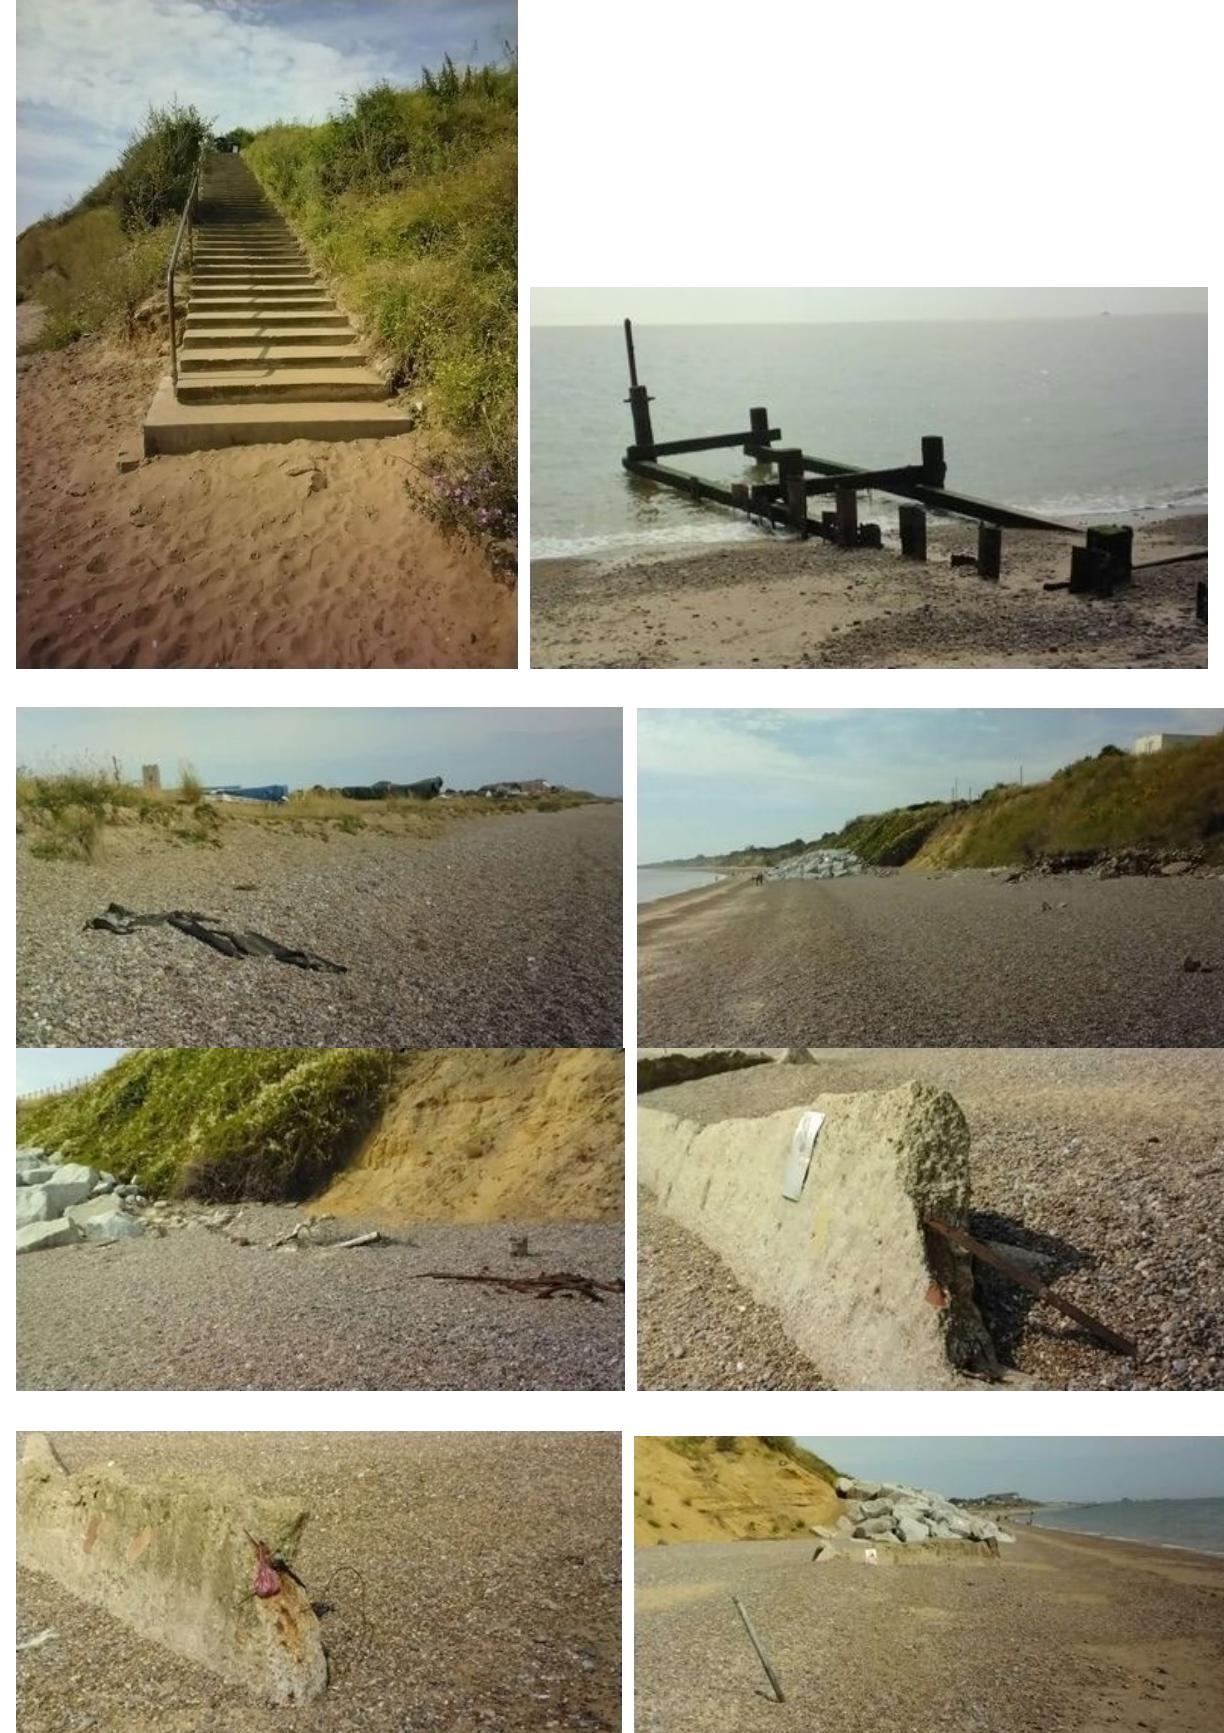
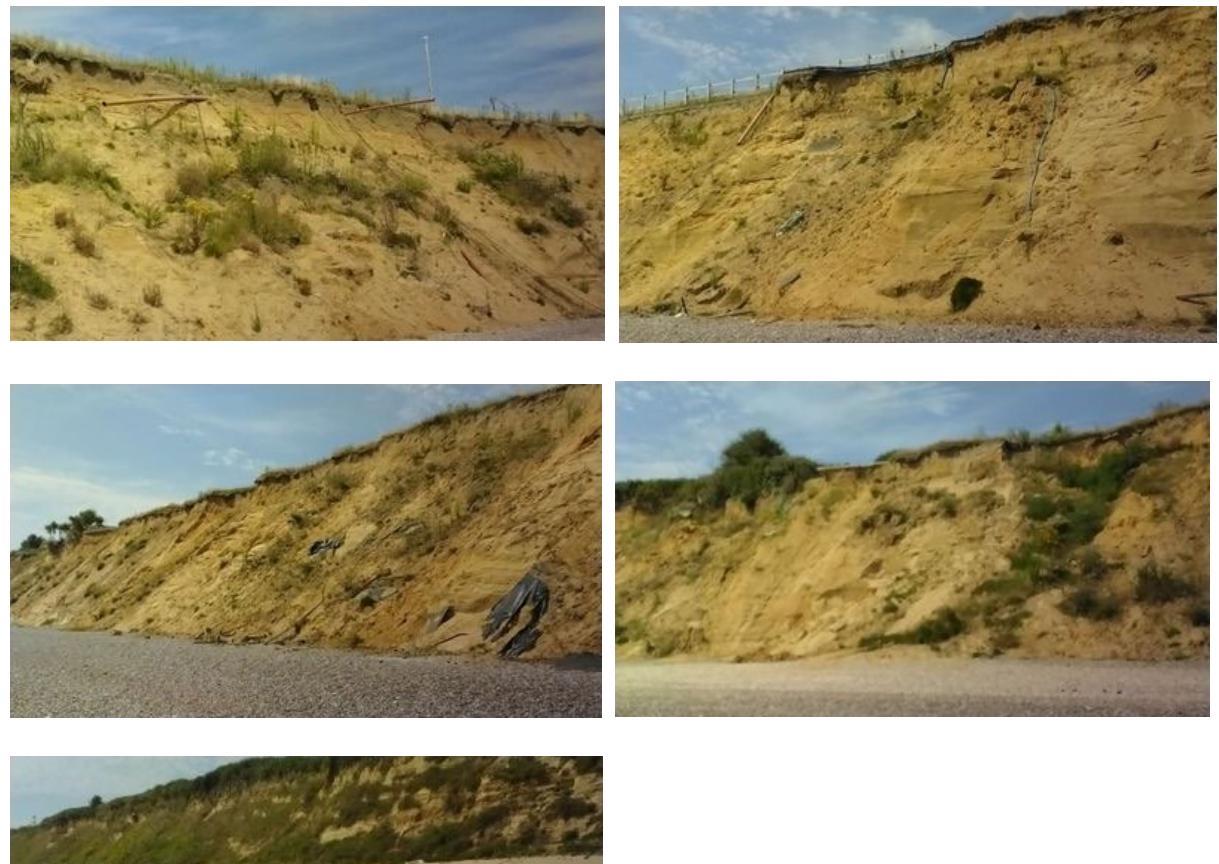
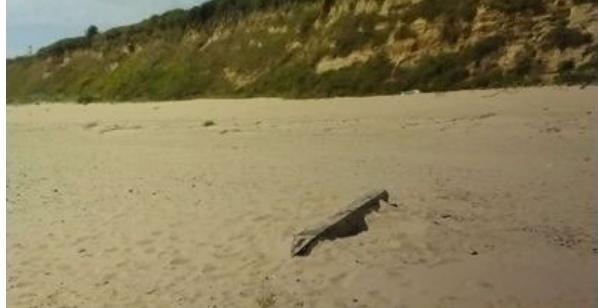
Comments on hazard/debris: Arbor Lane beach access steps have been cleared of the overgrowing vegetation. Concrete debris has been placed at bottom of the steps, presumably to reduce the step height to the beach. The northern foreshore cables reported last month were not seen.
