Pakefield Monthly Monitoring Report

Date and Time of survey: March 28, 2024 13:48 Inspector Name: Keith Roper Time of Low Tide: 15:45 Height of Low Tide (m ODN): -0.7 Reason for Inspection: Scheduled

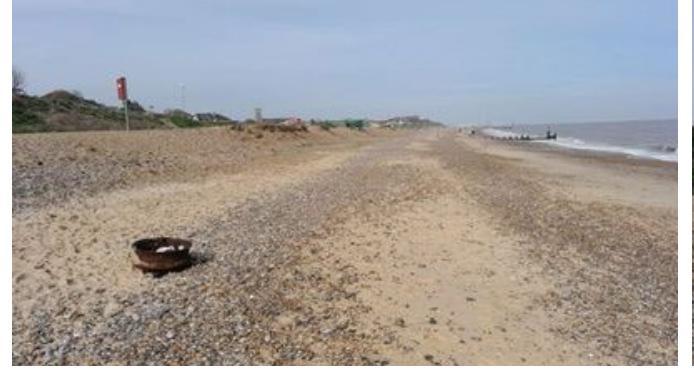
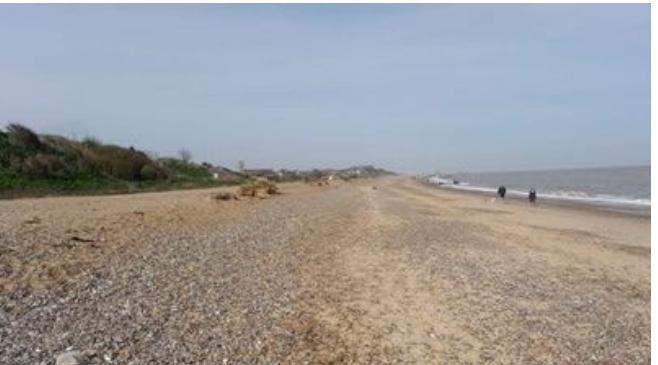
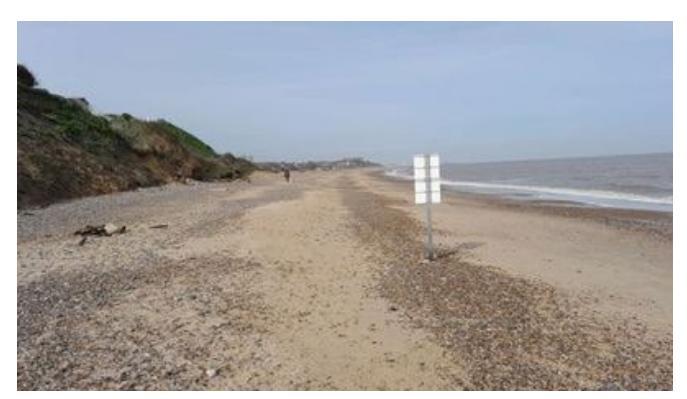
Extension of beach cliffing alongshore: Sea conditions have not extended the cliffing northward
Landward recession of beach cliff: Slight landward recession due to trampling
Change in gradient of beach cliff face: Similar gradient to previous month with an increase in relative height due to beach lowering

Maximum height of beach cliff (m): 2 Beach photos looking north:

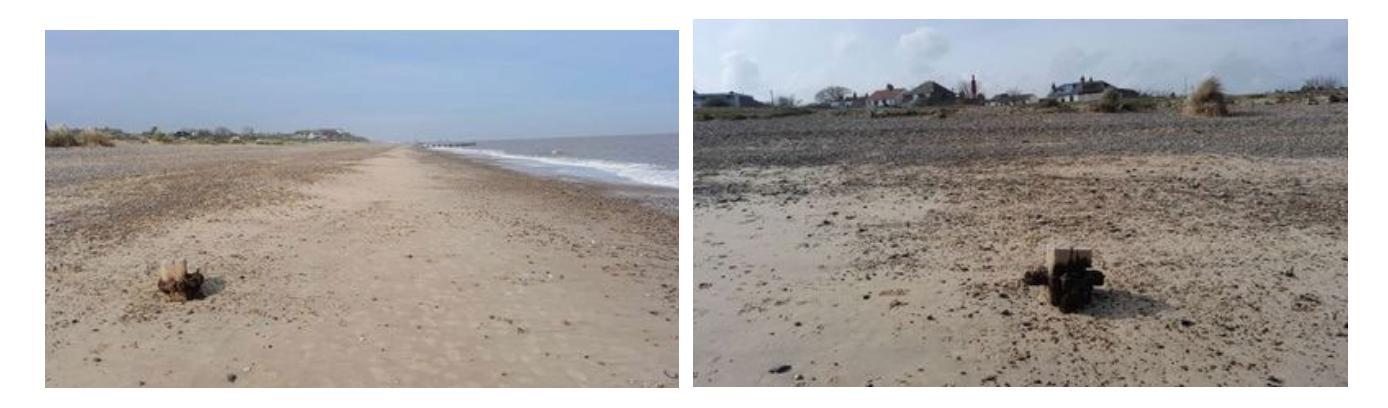
Beach photos below taken further north than usual inspection area showing new timber exposure – seaward of Nightingale Road:

Comments on change in beach geomorphology: Beach levels have lowered and have exposed timber, which may be part of another groyne, just north of the usual inspection area. This may be evidence of a continuation of the trend for northward progression of beach lowering. The lowered foreshore level has increased the relative height of the dune face. The wide, shingle rich berm noted previously above the mean high water mark has been dispersed.

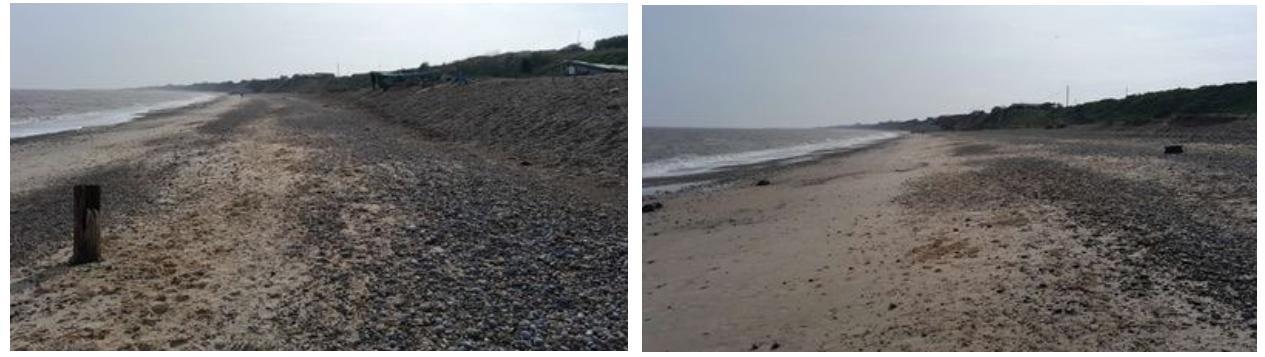
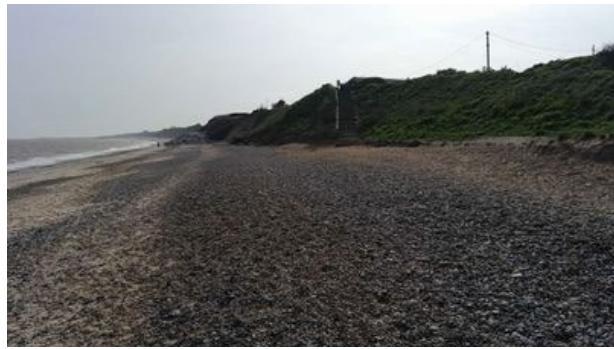
Beach photos looking south:

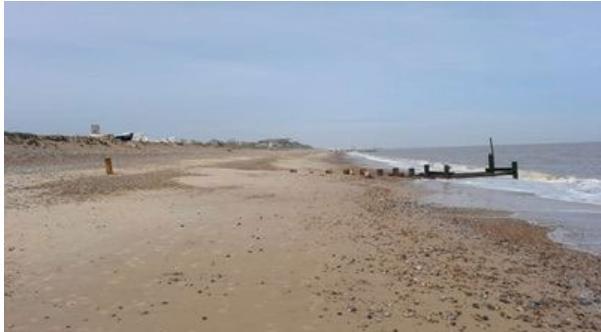
Change in beach level relative to exposed timber groyne opposite Grand Avenue: Slight lowering **Photo of exposed timber groyne:**

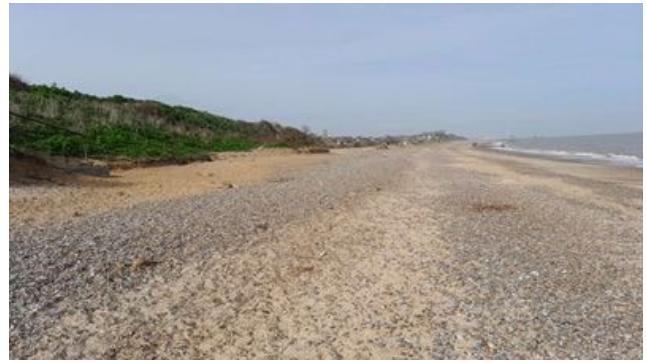
General impression of beach volume: Moderately Lower **Photo of beach north of Arbor Lane:**

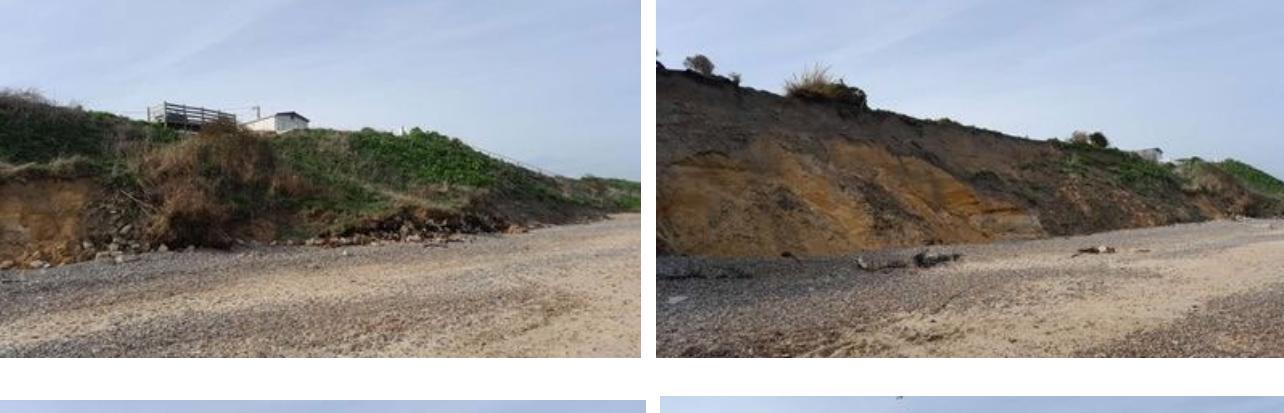
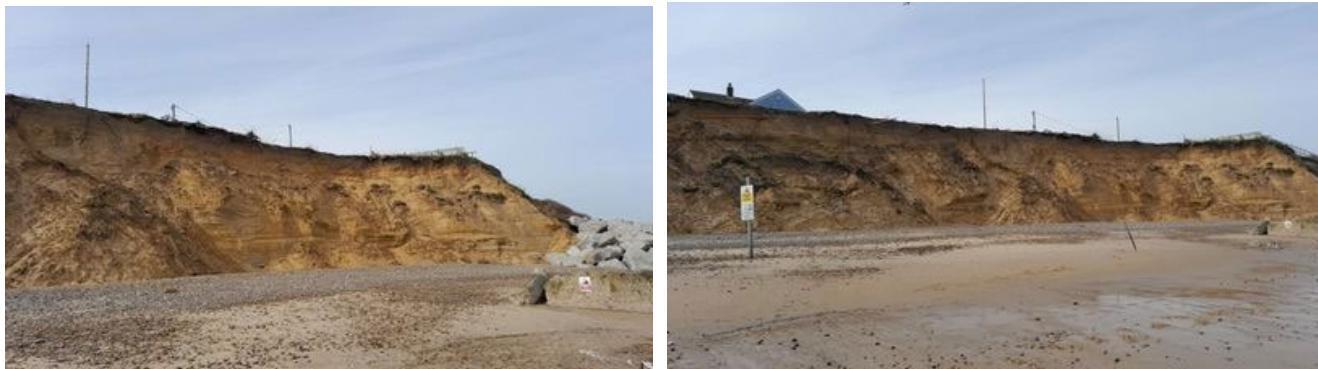
Photos of cliffs supporting property:

Changes to cliffs supporting property north of rock armour: Low back beach levels; slumped material on cliff face; denuding and loss of vegetation; cliff-face steepening and overhanging; scree at base of cliff; fallen vegetation at base of cliff.

Changes to cliffs supporting property south of rock armour: Slumped material on cliff face; denuding and loss of vegetation; evident cliff top recession; cliff-face steepening and overhanging; scree at base of cliff; fallen vegetation at base of cliff.

Comments on risk to cliff-top assets: Risks remain similar to previous although there does not appear to have been obvious undermining of the cliffs by seas during March. Although lower beach levels have been reduced, the relatively healthy upper beach persists, particularly south of the rock. The steep cliff face at the south end of the rock has not changed significantly. One further caravan has been removed from the seaward side of The Cliffs (one remains).

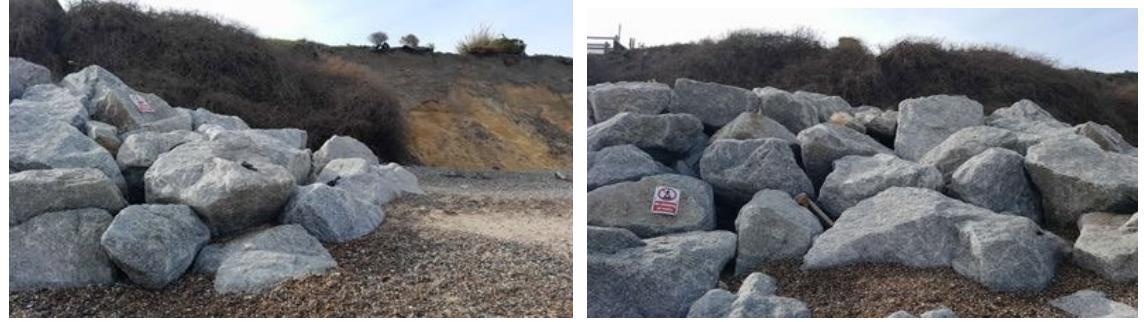
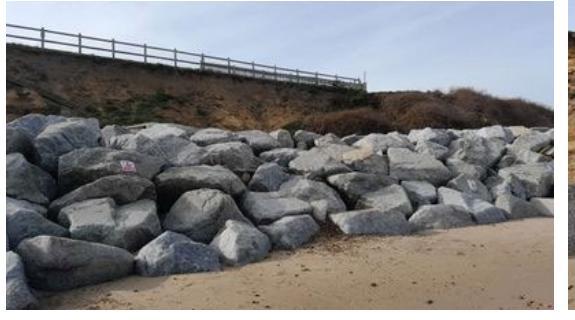
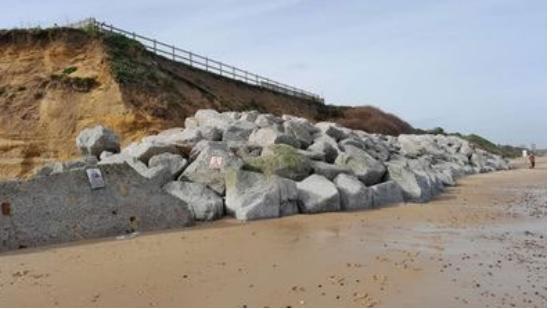
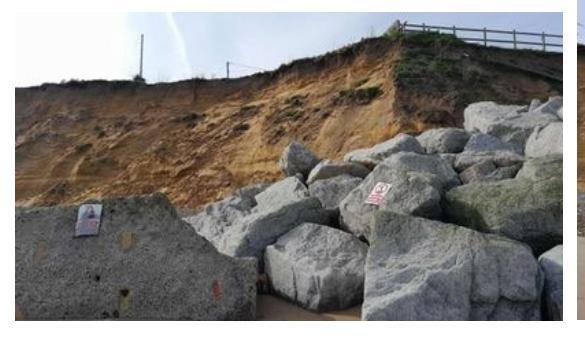
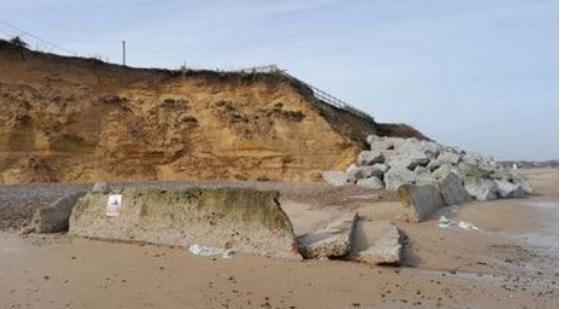
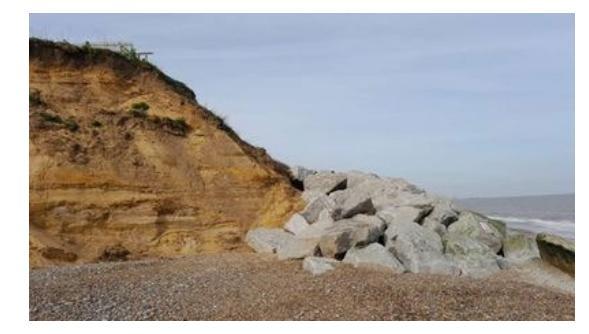
Displacement of rock from structure: Yes - Some - Monitor

Packing of rock: Less tightly packed in places (north and south ends noted previously) Cross-sectional profile: Satisfactory

Beach levels surrounding rock armour: Accreted material at the north end has been retained. Seaward foreshore level slightly lowered.

Beach access around the rock armour: Dry access past the rock remained available around low tide Settlement, movement, undermining of structure: Yes - Some - Monitor

Exposure of geotextile: Yes - Some - Monitor

Hazards/debris within structure: Yes - Some - Monitor

Stability of cliff behind rock armour: No obvious significant change apparent from beach **Asset condition grade:** 2 Good; minor defects that do not reduce overall performance **Photos of rock armour:**

Comments on condition of, or risk posed by rock armour: No significant change from previous reporting

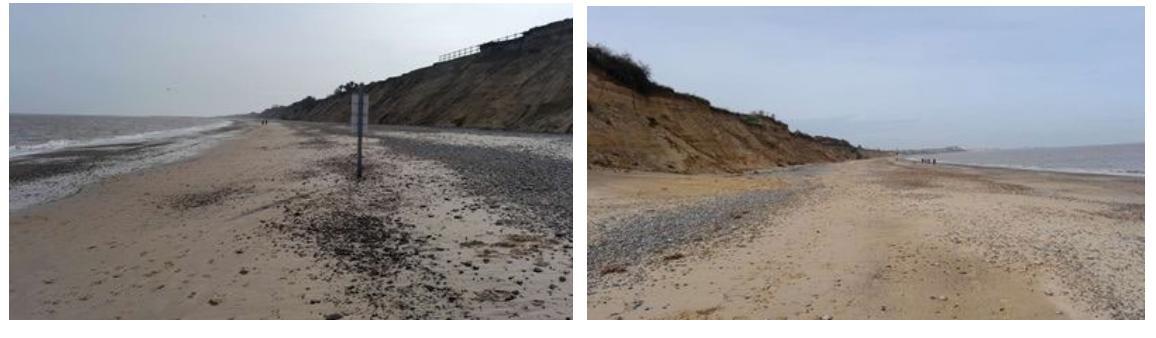
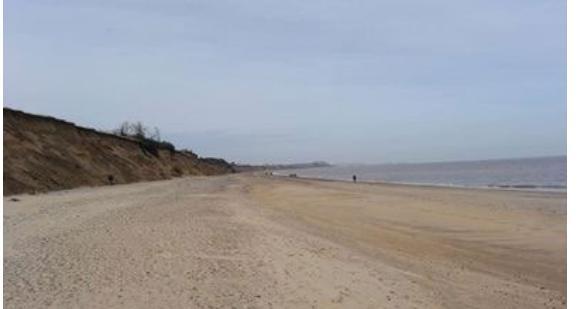
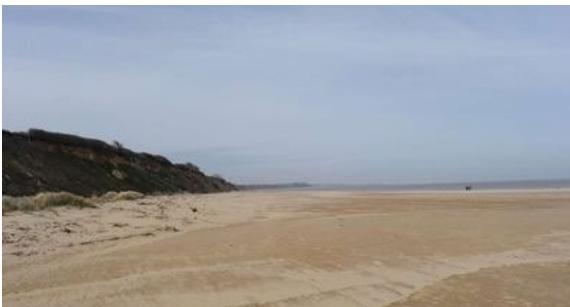
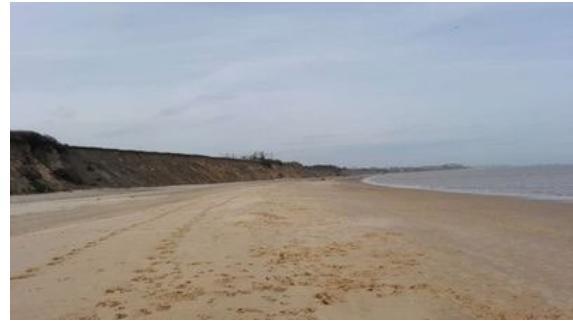
General impression of beach volume: Foreshore decreased south to the Pontins frontage **Photos of southern beach:**

Beach level above the mean high water mark remains relatively healthy (probably not reached by sea conditions over the past month). There is a wider, less steep foreshore at the Pontins frontage with multiple raised berms above, probably influenced by the Ness. Cliffing of beaches noted last month is becoming less apparent.

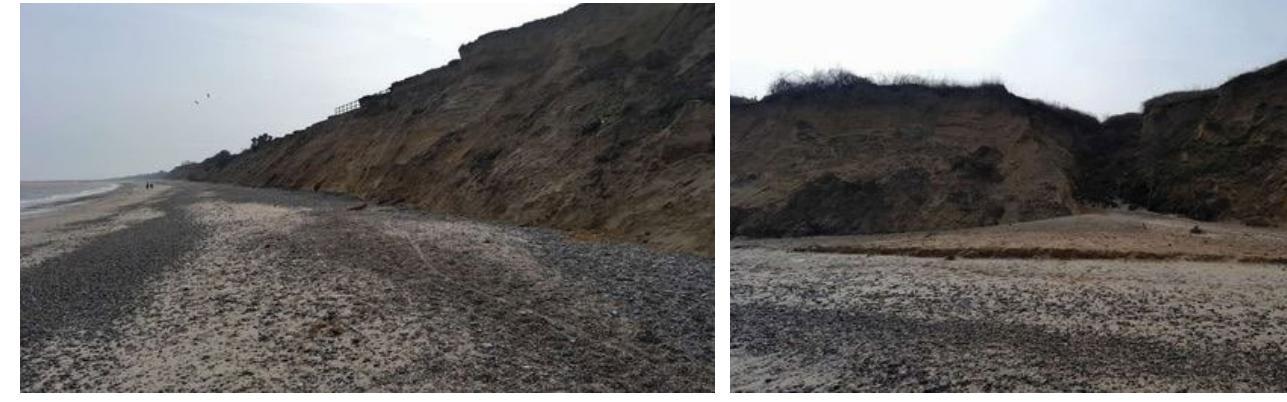
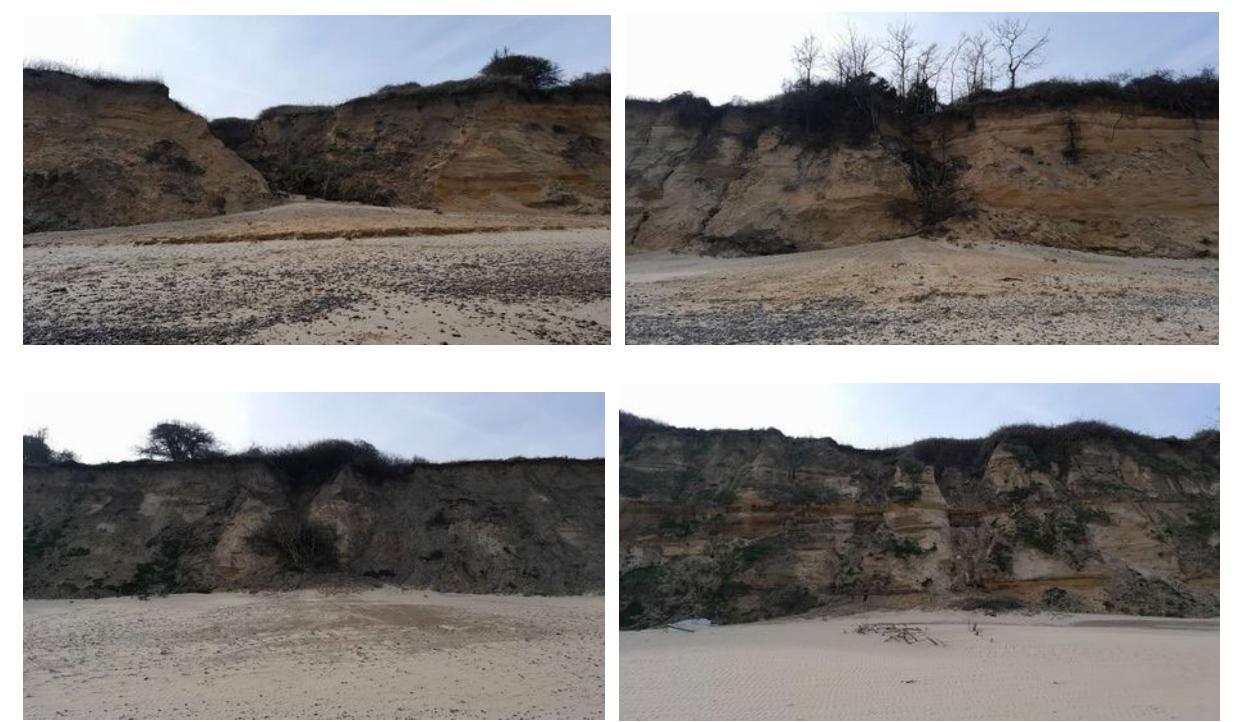
Changes to southern cliffs: Slumped material on cliff face; denuding and loss of vegetation; evident cliff top recession; cliff-face steepening and overhanging; scree at base of cliff; fallen vegetation at base of cliff. **Photos of southern cliffs:**

Comments on cliff change and any risk posed: Despite the reduced active erosion of cliffs, falls have continued where the cliffs reprofile to a more stable angle of repose. Undermining and falls of Pakefield Caravan Park assets continues. The reduced amounts of rainfall have restricted further surface water discharge along the cliff face.

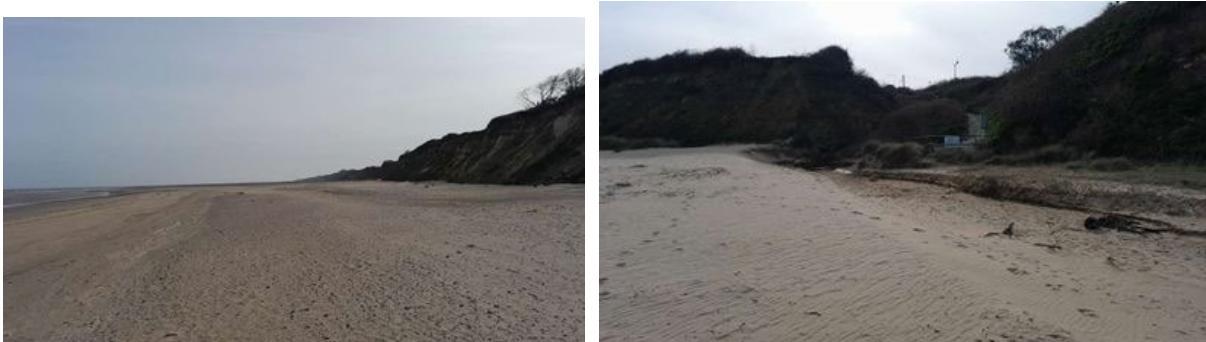
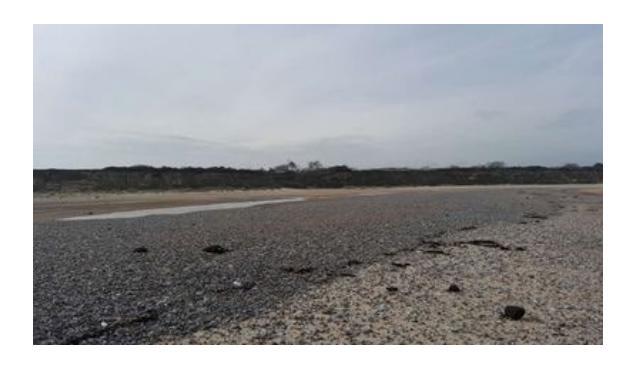
Photos of Pontins frontage and Benacre Ness:

Changes to beach geomorphology: Processes noted previously likely to be continuing, with beaches widening and progressing northward.

Comments on change at Benacre Ness: Very little surface water discharge visible near the Pontins beach access. Some areas of standing water remain on the lower parts of the Ness, behind the substantial raised seaward berm. Vegetation noted to be establishing again seaward of the Pontins frontage, including in midbeach regions.

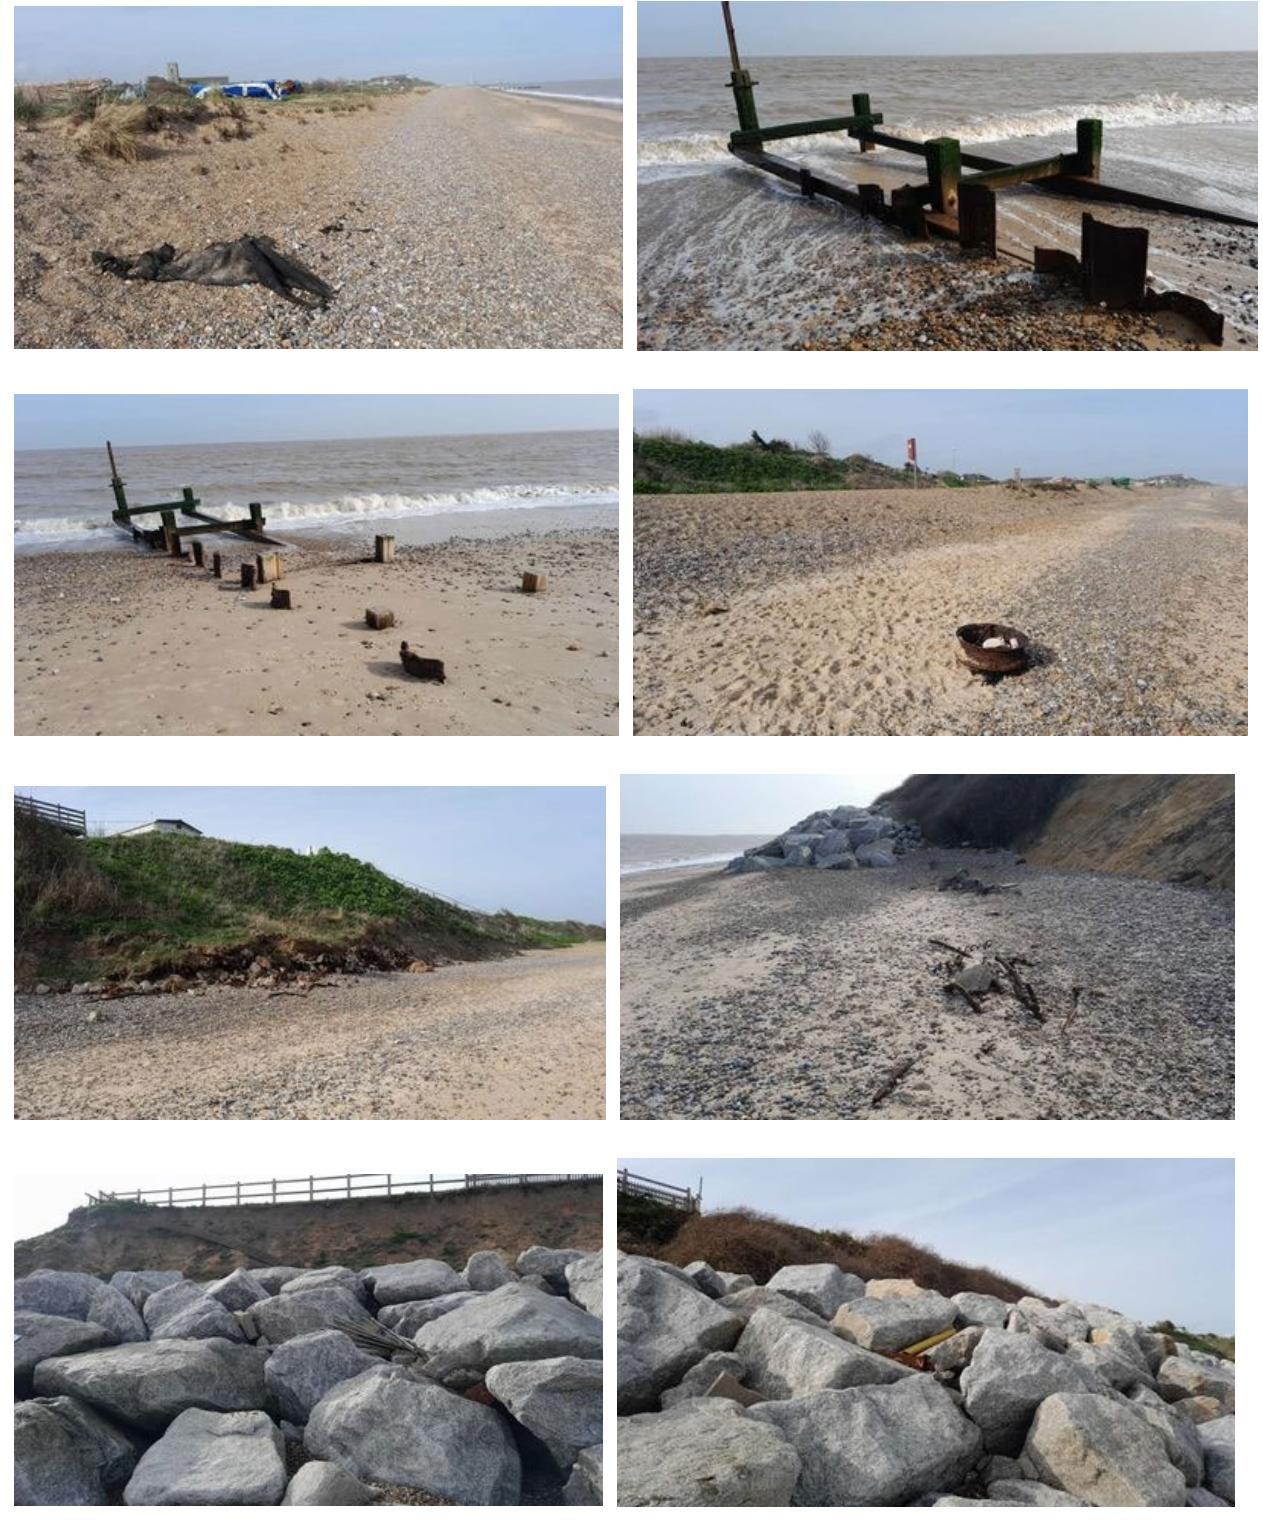
Hazards and Debris Type of hazard/debris: As noted previously and as photos and comments below Photos of hazard/debris:

Comments on hazard/debris: Reduction in foreshore level has led to some increased exposure of hazards and debris near concrete walling.
