# Coastal Processes Study: East Lane, Bawdsey, Suffolk

Final Report

September 2015

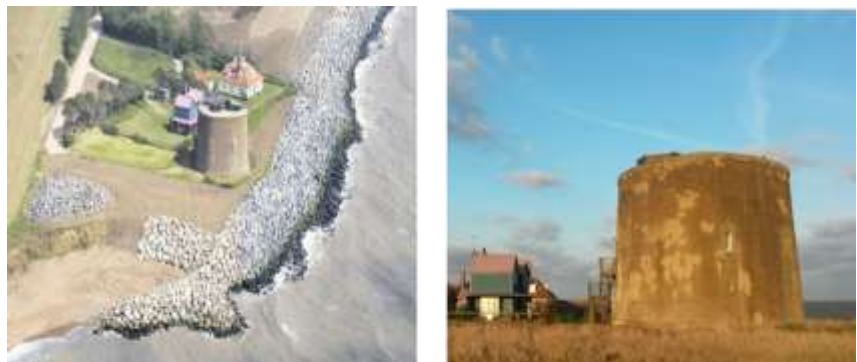
Figure 3.1: Martello Tower at East Lane, Bawdsey (with Phase 2 defences in place).

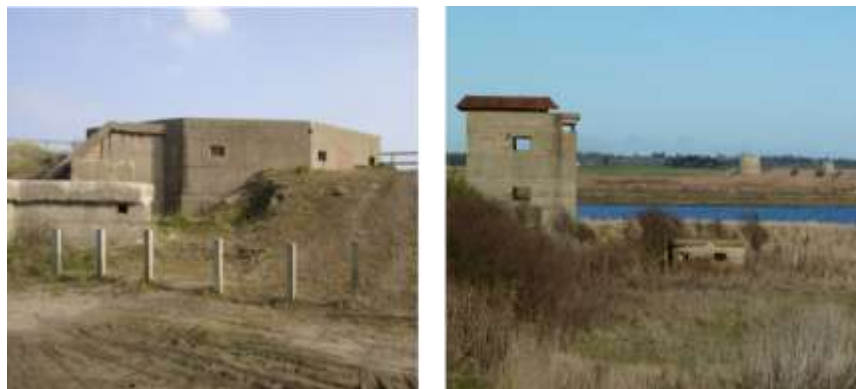
Figure 3.2: WW1 and WW2 defences, East Lane, Bawdsey

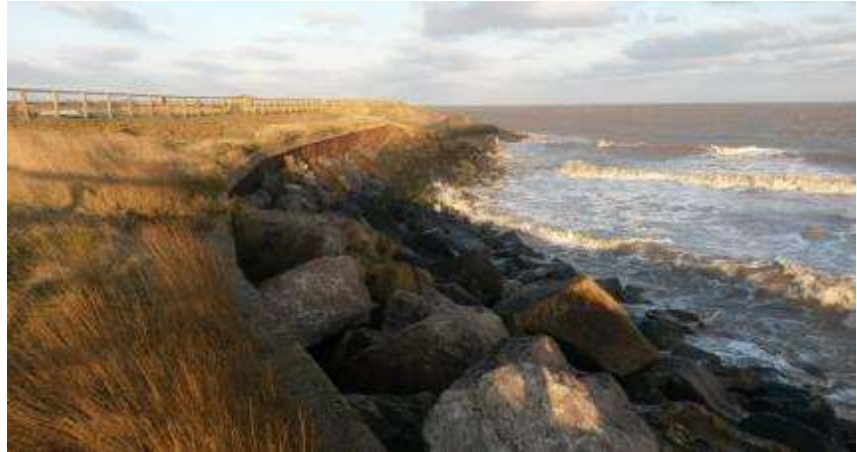
Figure 3.3: Selected images of parts of the original defences

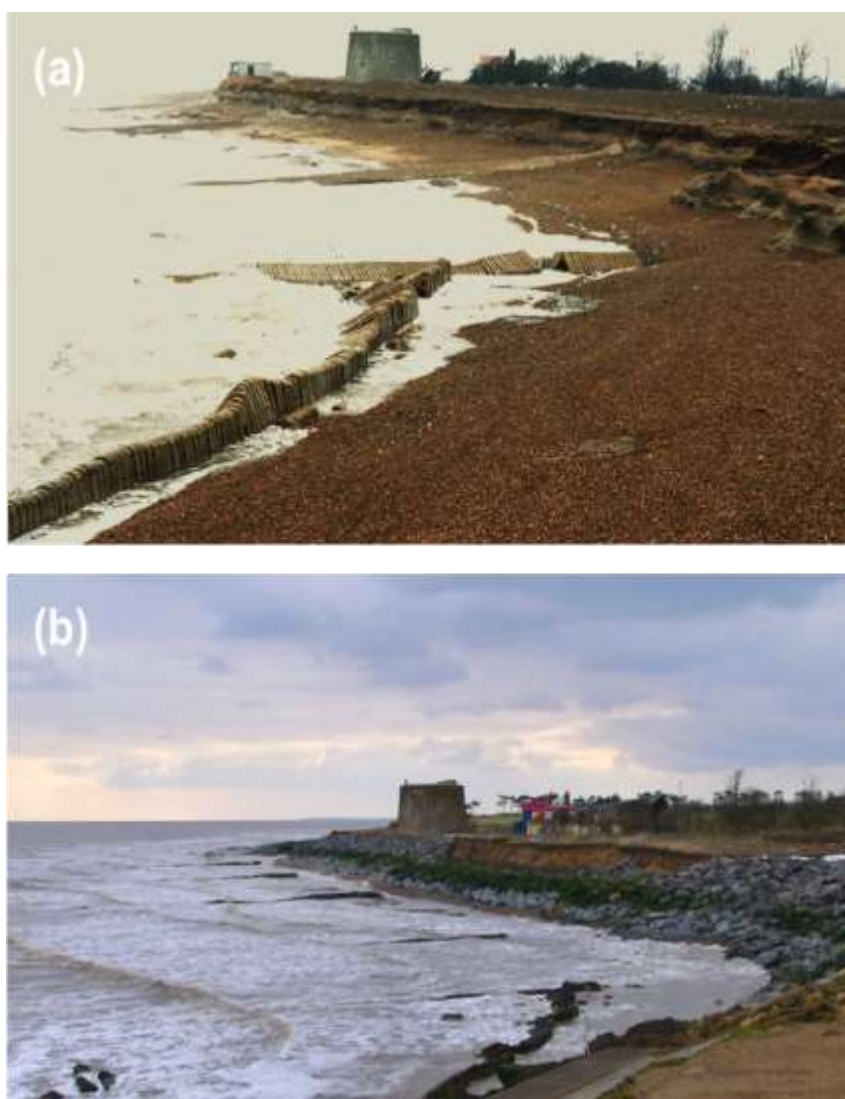
Figure 3.4: Coastal erosion south of East Lane point: (a) 1996; and (b) March 2005.

Immediately north of Bawdsey Manor, the sheet pile wall gives way to a series of shore-normal and shore-parallel concrete defence structures (like Figure 3.4a) and timber groynes in poor repair (Figure 4.13). The groynes continue northwards for approximately 1 km from this location.

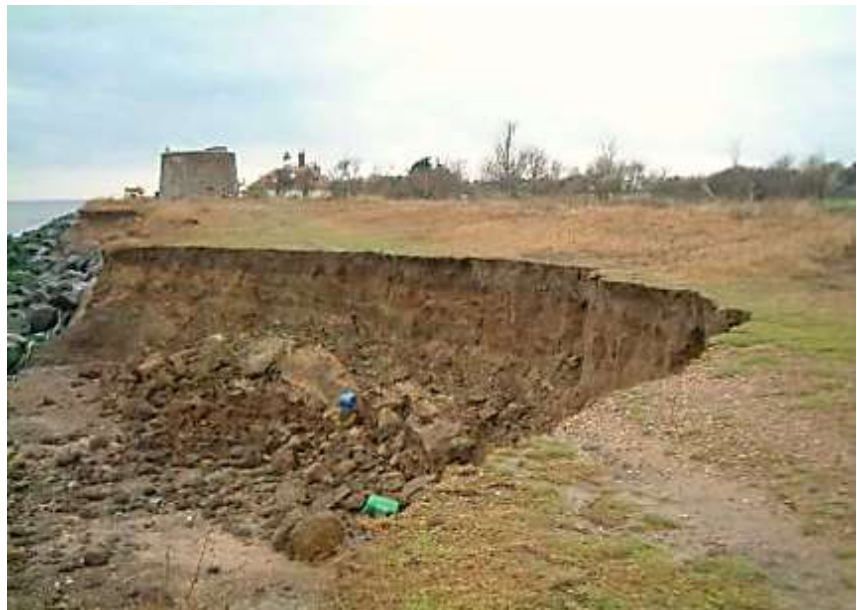
Figure 3.5: Details of coastal erosion south of East Lane point, November 2004.

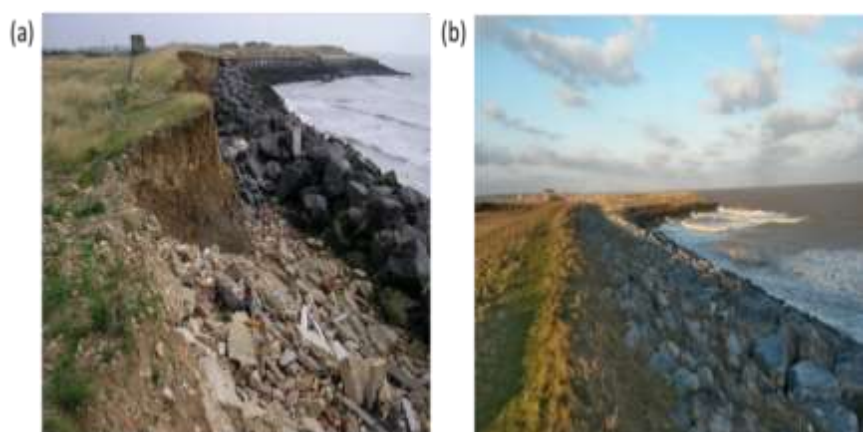
Figure 3.6: South of East Lane point (a) before repairs in 2005; (b) after repairs in 2015 (from approximately the same vantage point).

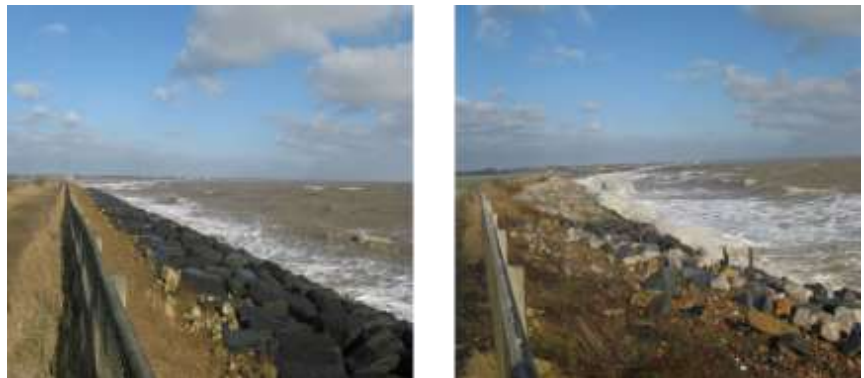
Figure 3.7: EA Phase 1 repairs, north of East Lane point.

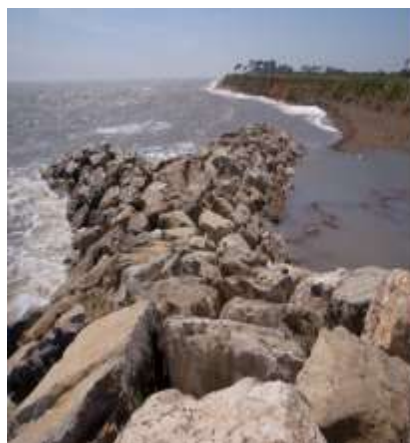
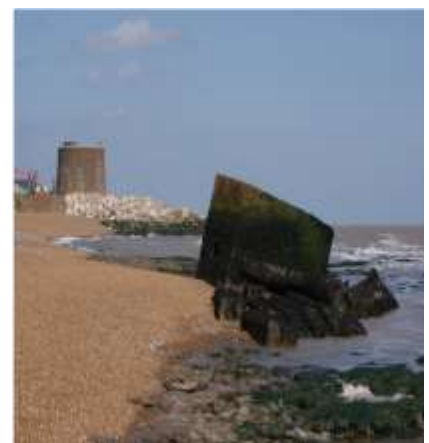
Figure 3.10: The rock armour groyne southern termination of the defended frontage in 2007.

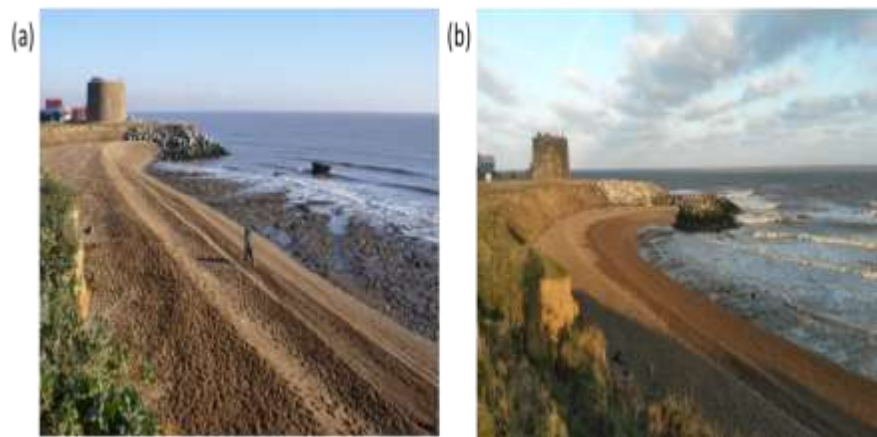
Figure 3.11: Beach conditions south of the rock armour fishtail groyne termination in February: (a) 2007; and (b) 2015.

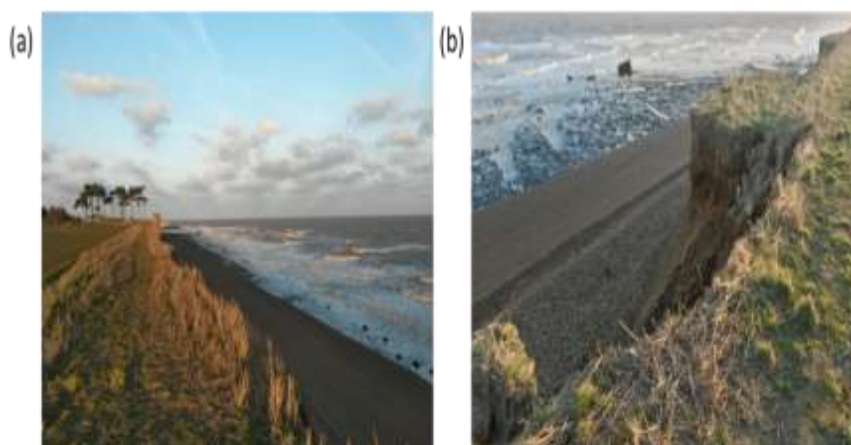
Figure 3.12: Present day cliff erosion along the embayment: (a) last year's cereal crop on the cliff edge; and (b) a typical example of cliff failure.

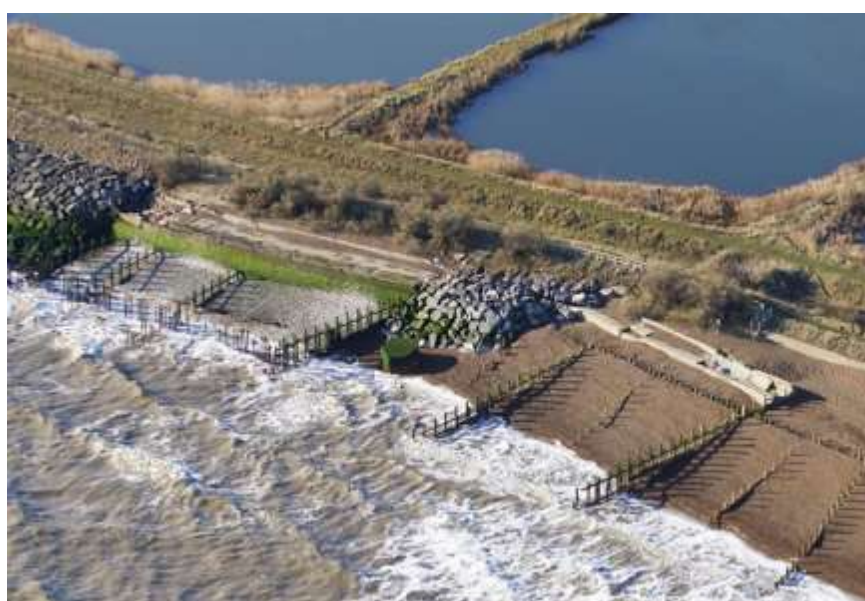
Figure 3.13: The remaining section of the Quilters Wall in 2010.

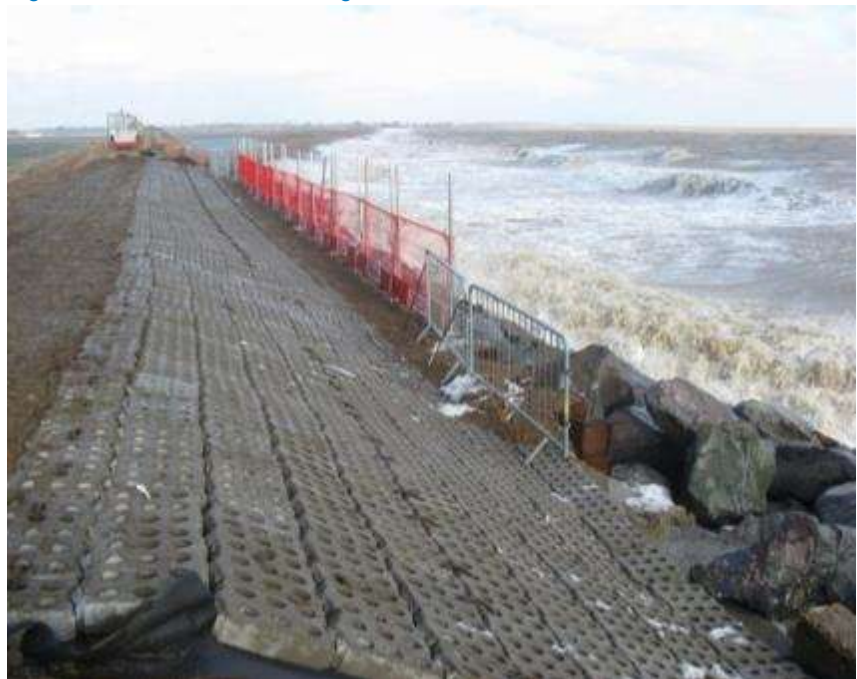
Figure 3.14: The remaining section of the Quilters Wall in 2015.

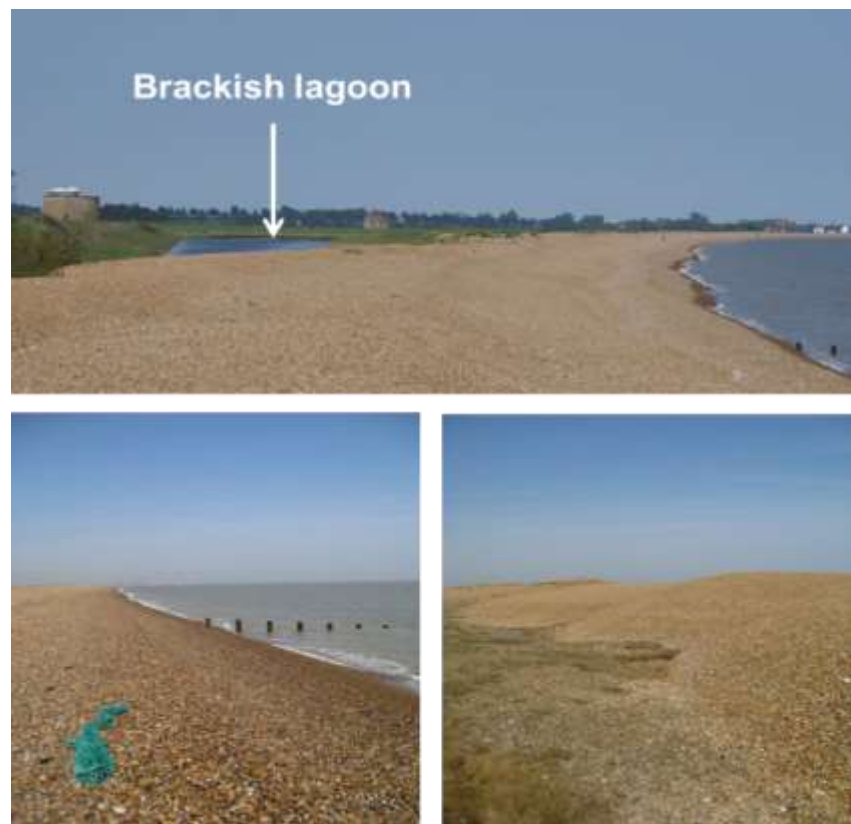
Figure 3.16: The beach north of Bawdsey in 2008

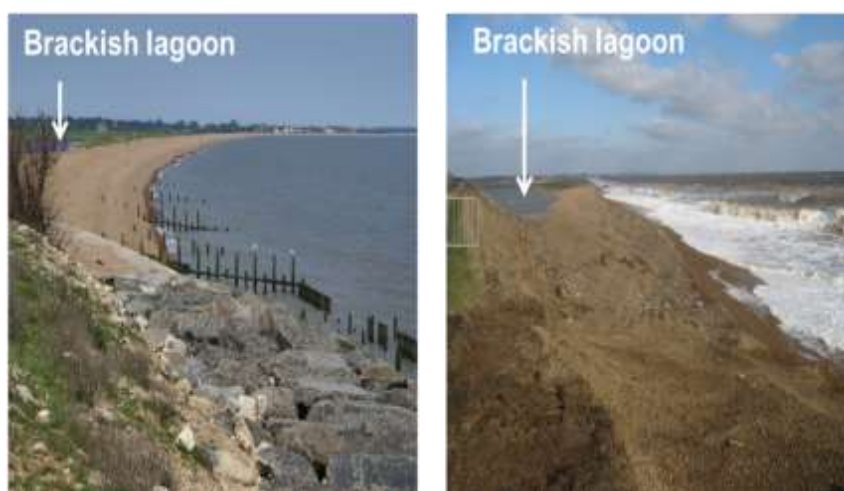
Figure 3.17: The beach north of Bawdsey in 2008 (left) and 2015 (right).

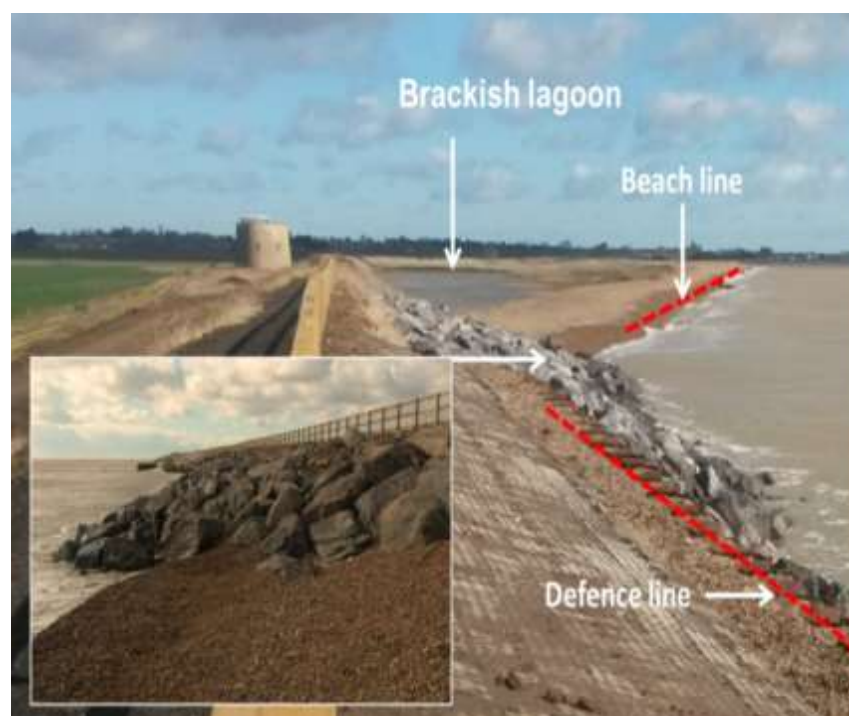
Figure 3.18: Completed defences in March 2015. The inset shows the defence termination with the natural shingle beach.

The termination between the most recent costal defence works and the beach running northwards is incomplete (Figure 3.18). In this figure the unnatural angle between the natural beach extending northwards towards Orford Ness and the Bawdsey coastal defences is seen clearly. In late March, 2015 the natural shingle beach was observed to abut the newly completed defences, albeit at an unnatural angle. It will be interesting to see if shingle accretes at this location. It is noted that the present width and height of the shingle beach immediately to the north of the recently completed defences makes it potentially vulnerable to over washing and possible breaching during a severe storm event.

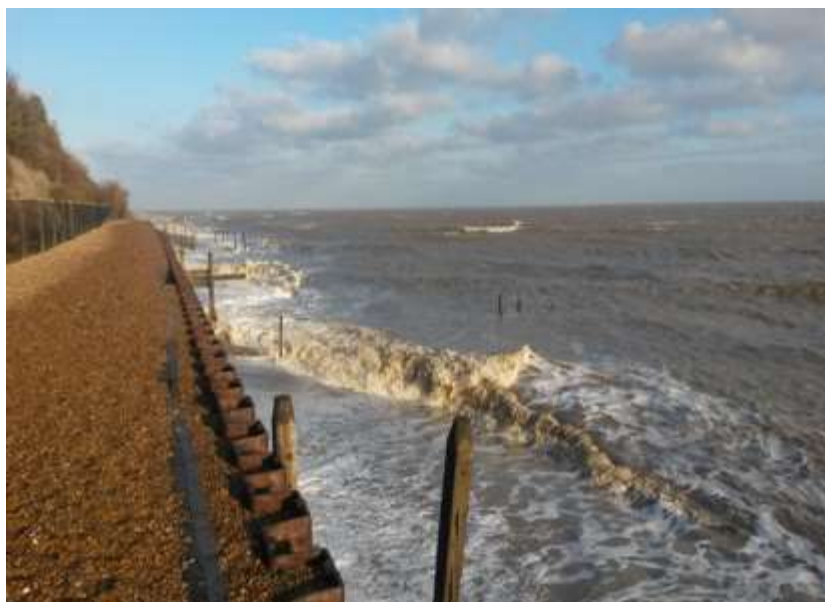
Figure 3.20: The sheet pile wall at Bawdsey Manor

progressively lowered to the extent that waves now regularly reach the sheet piles and prevent the accretion of any sediment transported south from Bawdsey. It is noted also that damage to the groynes occurred during installation of the sheet piles which reduced their ability to retain sediments on the beach.

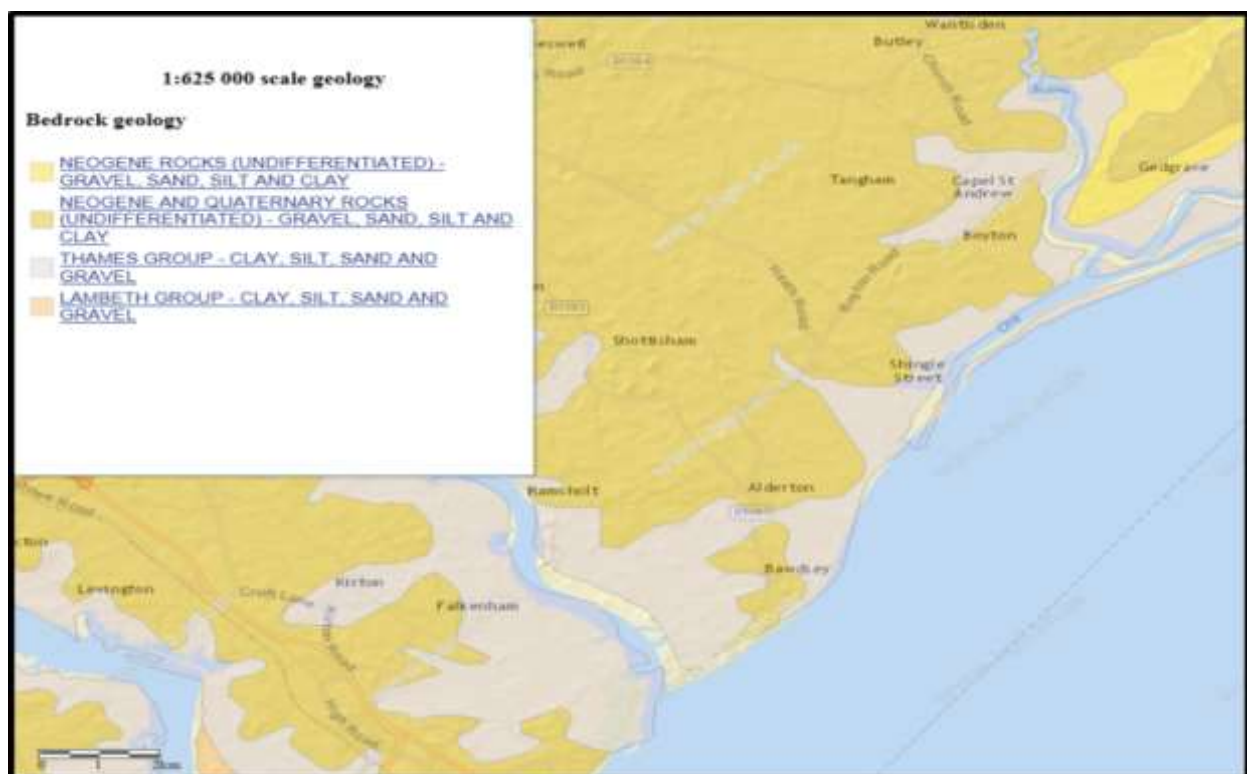
Figure 4.2: Bawdsey solid geology

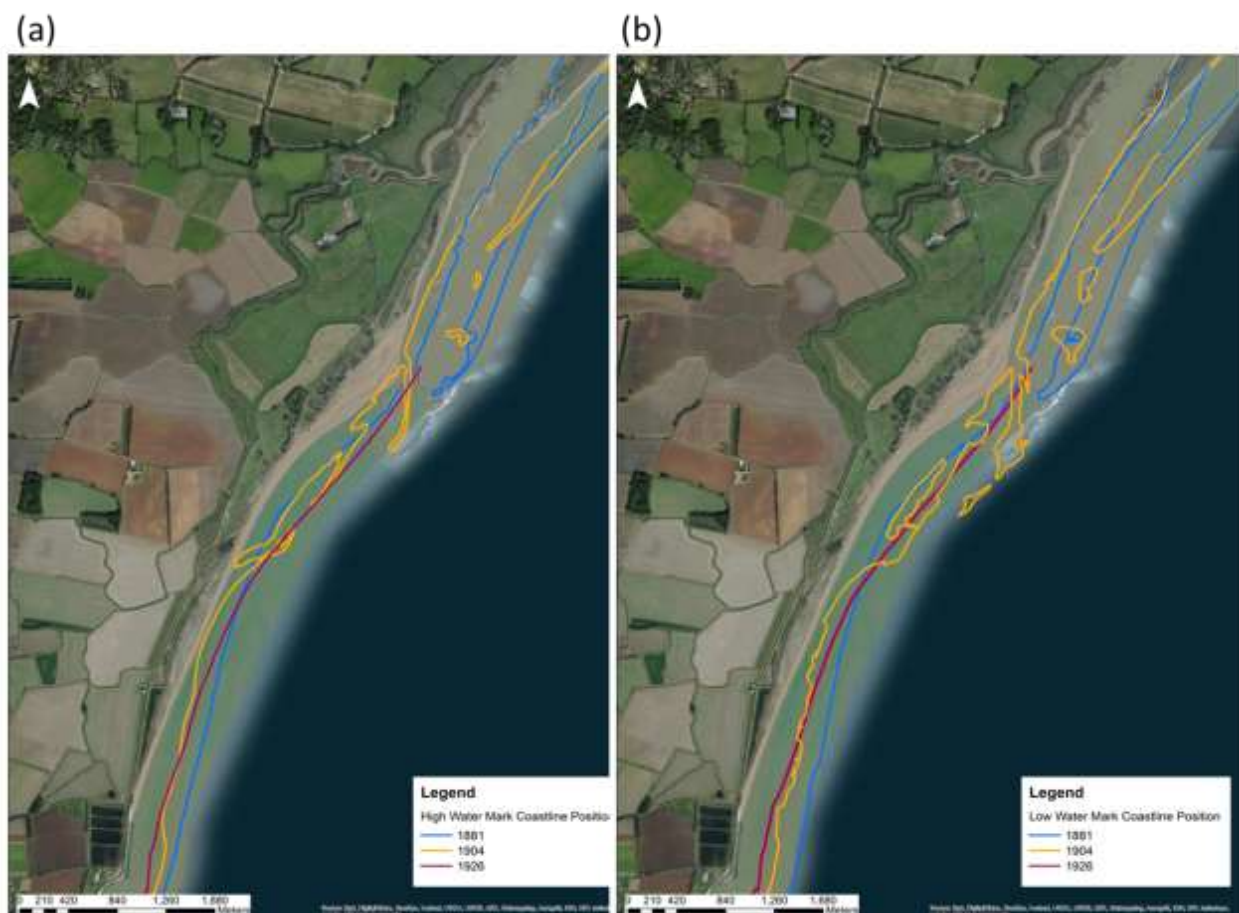
Figure 4.8: Historical changes in the Weir Point area between 1881 and 1926: (a) High water line; and (b) low water line.

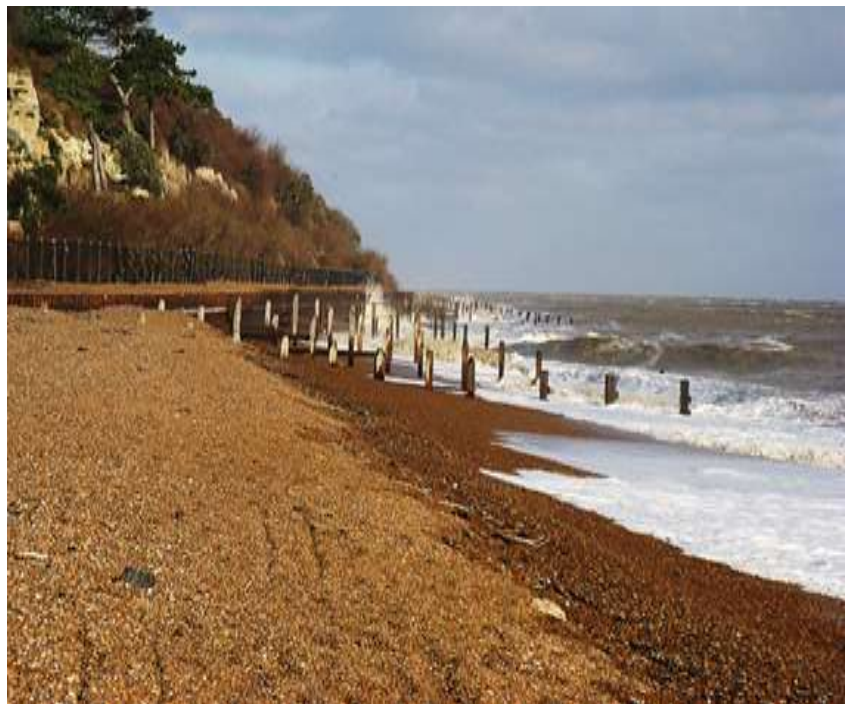
Figure 4.10: Frodingham steel sheet pile wall defending Bawdsey Manor.

A variable width shingle beach with groynes backed by low cliffs occupies the northerly 930 m of this frontage. The 310 m Bawdsey Manor frontage is defended by a Frodingham steel sheet pile wall 3 m from the toe of the cliff (Figure 4.11) and an older timber groyne field seaward of the piles is in a poor state of repair. The beach at present is depleted of sediments. To the south of Bawdsey Manor there is a 325 m length of shingle beach with steel sheet pile walls at the crest. The parts of these walls not covered by sediment are in very poor condition and have, in many locations, completely corroded (Figure 4.12). The north bank of the Deben Estuary is characterised by a large accumulation of shingle.

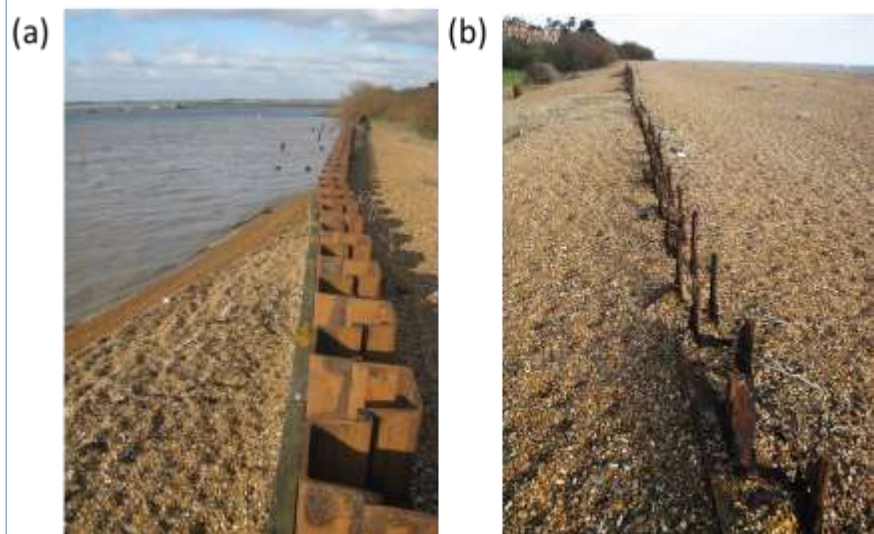
Figure 4.10: Sheet pile defences at the mouth of the Deben Estuary: (a) good condition; and (b) badly corroded.

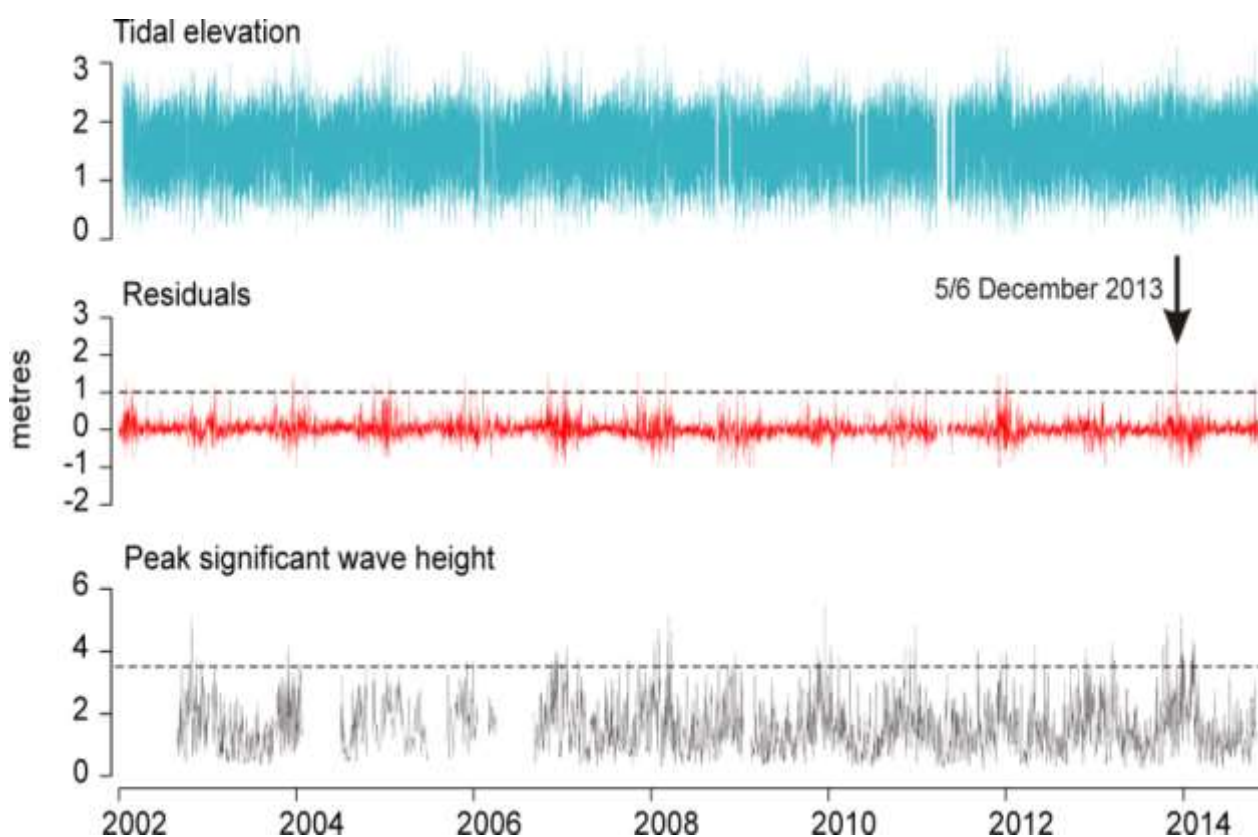
Figure 5.5: Time-series plot showing tidal elevation and tidal residuals from Lowestoft and daily peak significant wave height measured at West Gabbard for the period 2002 to 2015.

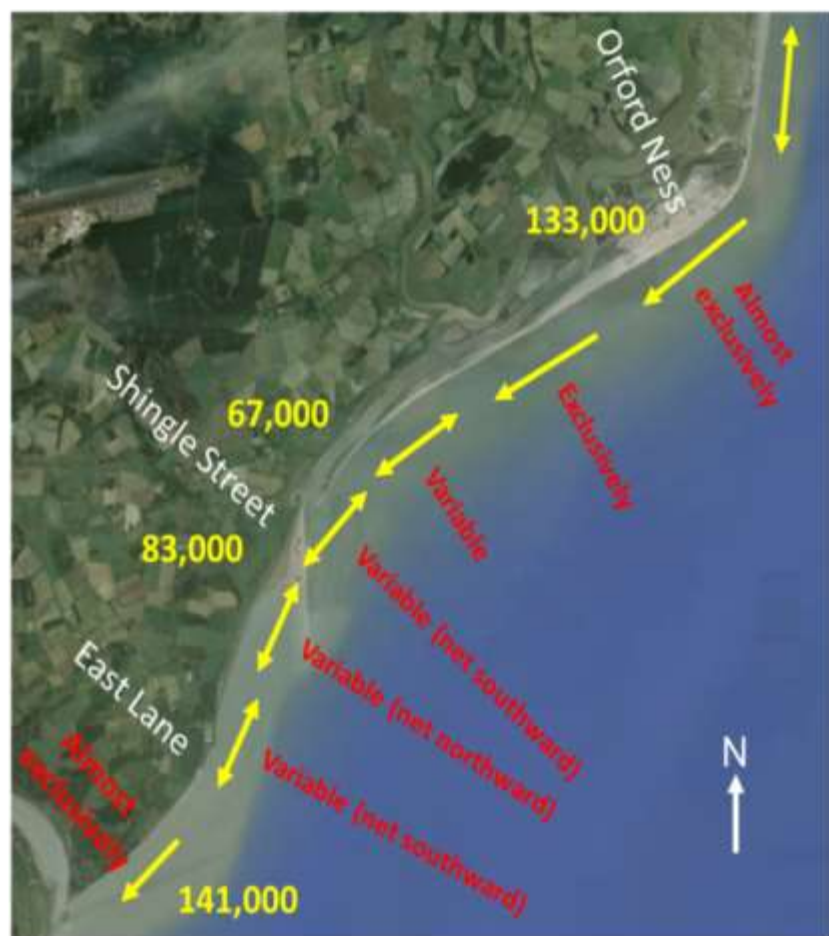
Figure 6.1 Schematic illustration of alongshore transport rates and directions

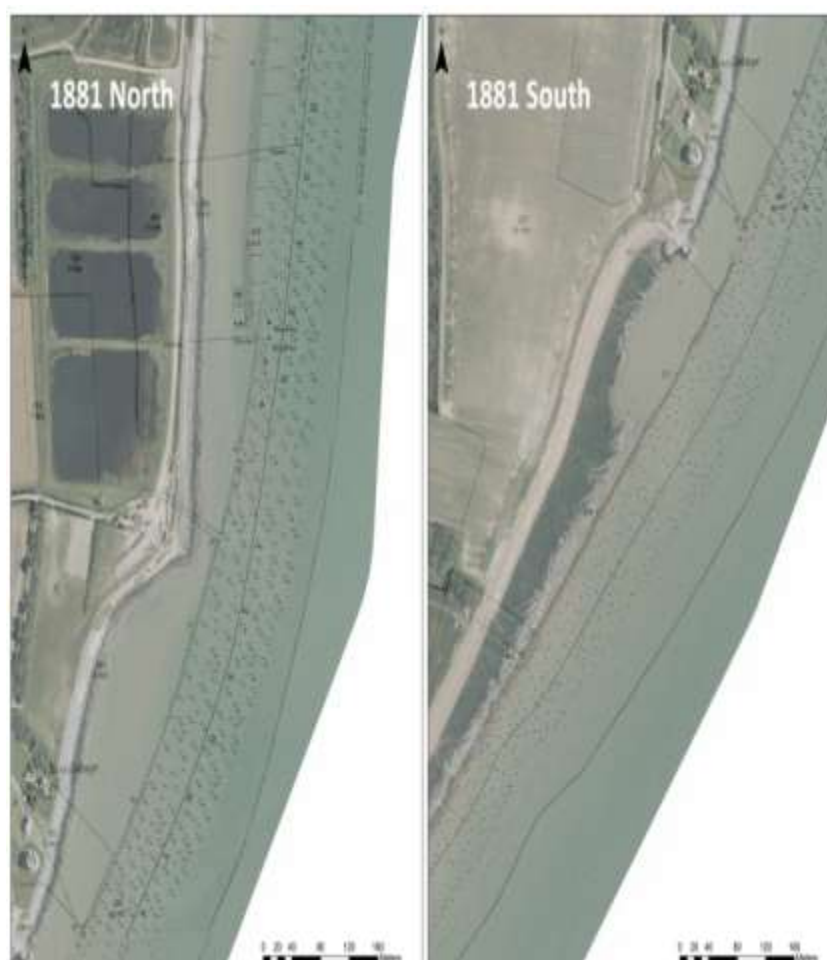
Figure 6.2: The OS map of 1881 overlain on an aerial photography from 2015 showing the historical and contemporary coastline to the north and south of East Lane, Bawdsey.

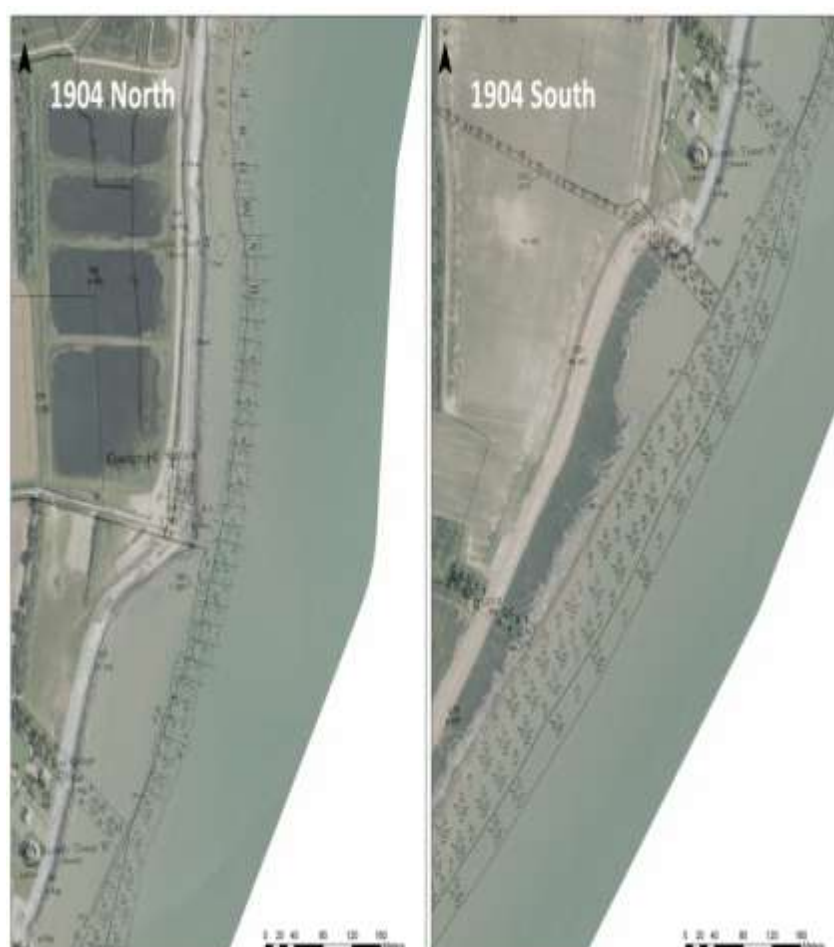
Figure 6.3: The OS map of 1904 overlain on an aerial photography from 2015 showing the historical and contemporary coastline to the north and south of East Lane, Bawdsey.

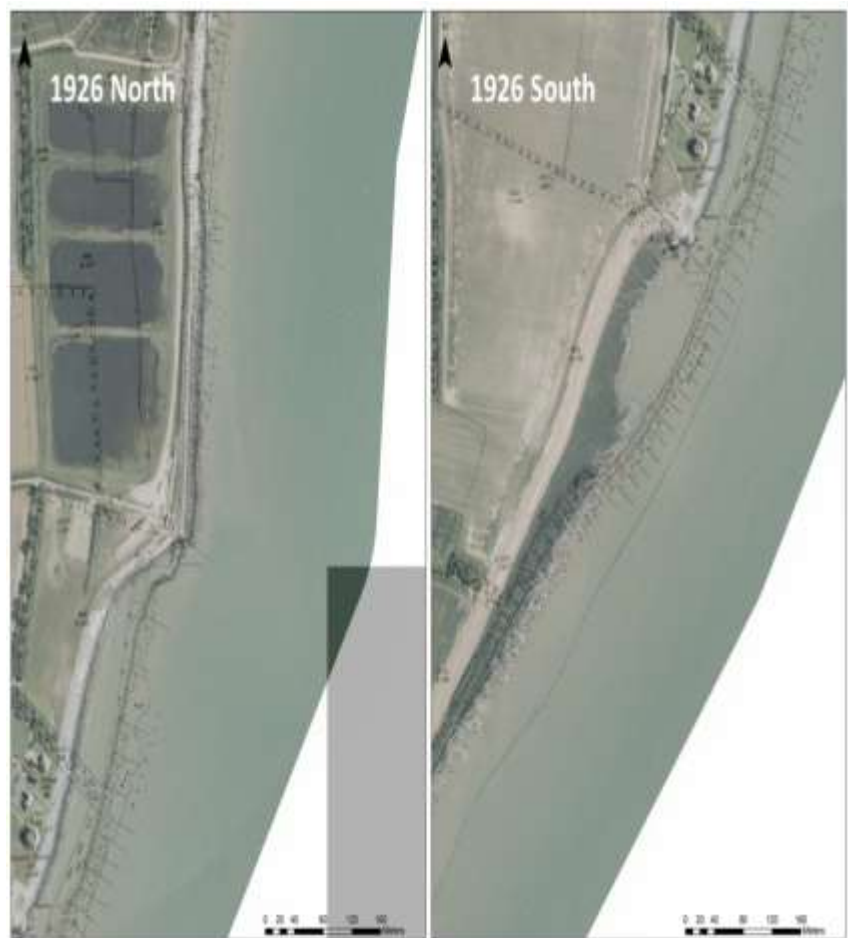
Figure 6.4: The OS map of 1926 overlain on an aerial photography from 2015 showing the historical and contemporary coastline to the north and south of East Lane, Bawdsey.

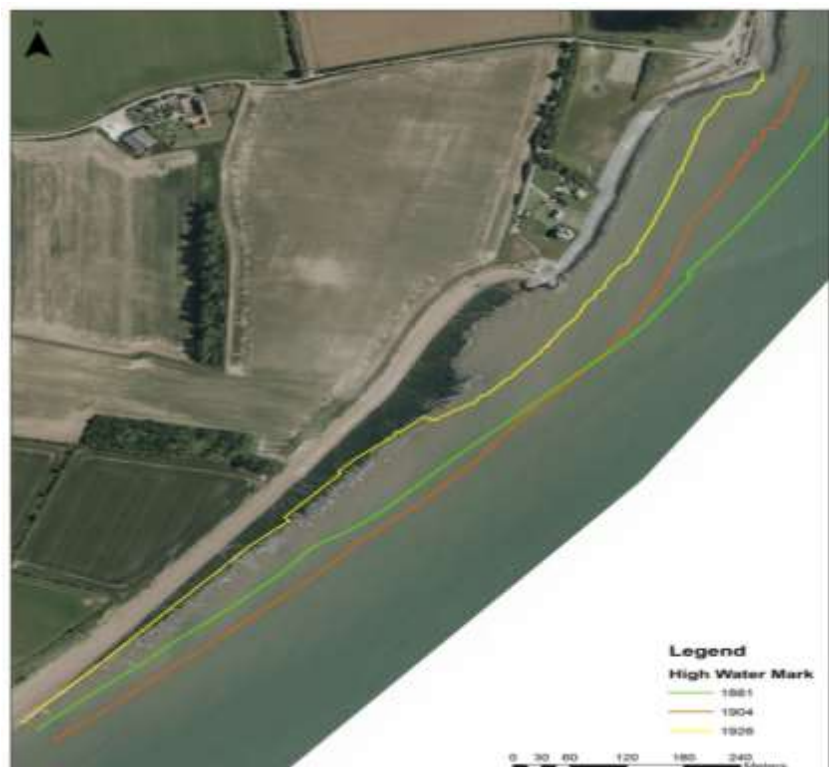
Figure 6.5: Shoreline positions defined by the high water mark derived from the OS map for 1881, 1904 and 1926 overlain on an aerial photography from 2015, East Lane, Bawdsey.

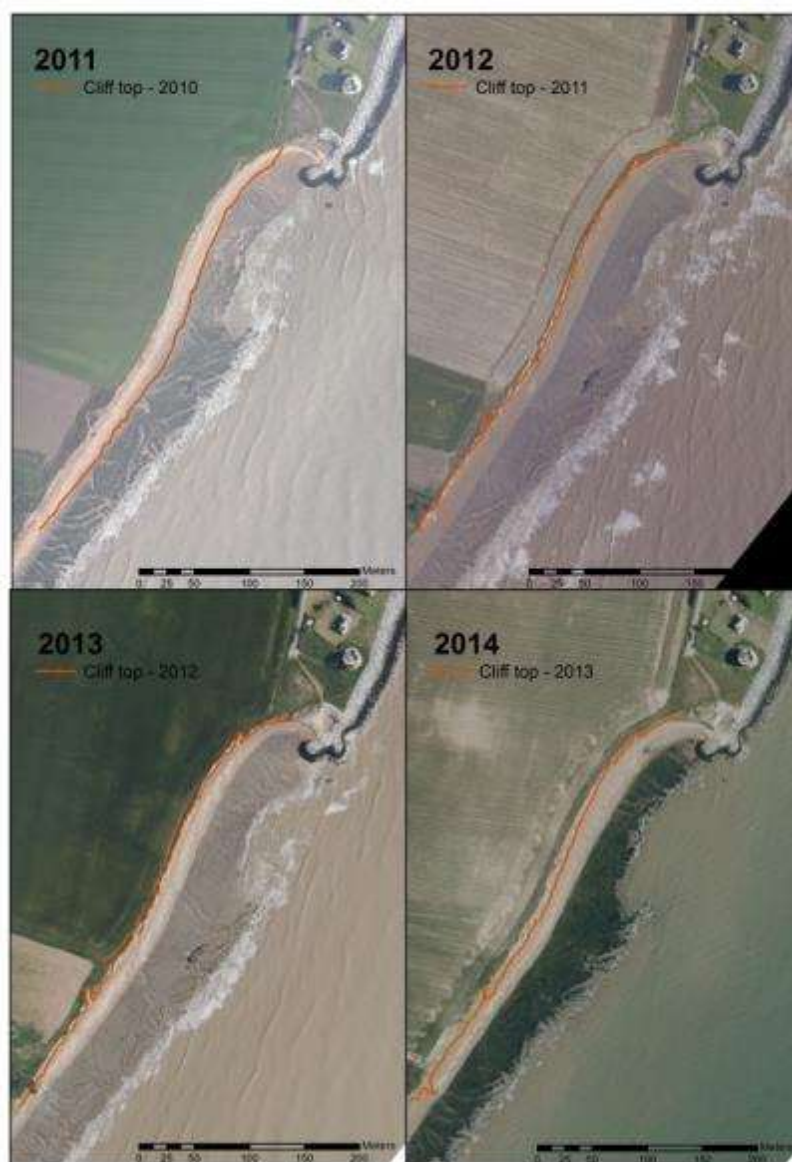
Figure 6.5: Sequence of annotated aerial photographs from 2011 to 2014, East Lane, Bawdsey.

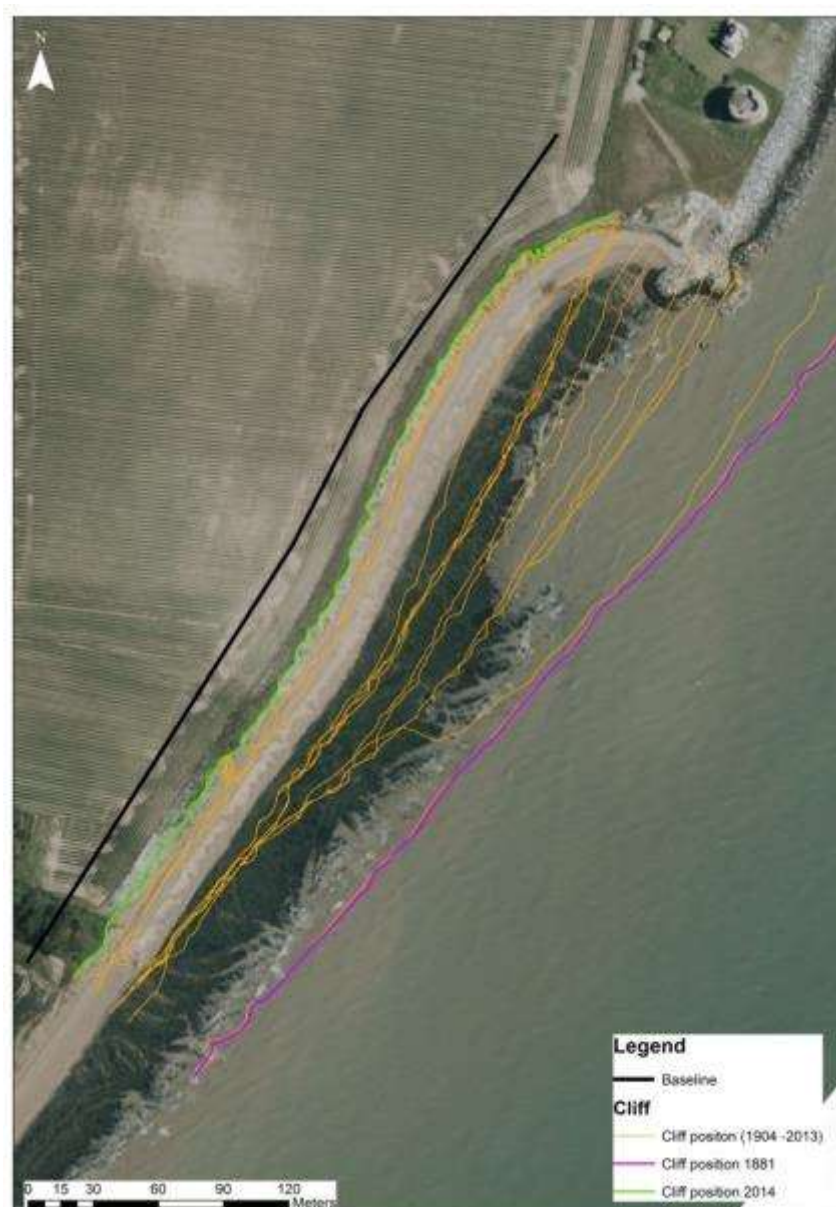
Figure 6.7: Cliff line positions derived from aerial images (1994-2014) and historical maps (1881, 1904 and 1926).

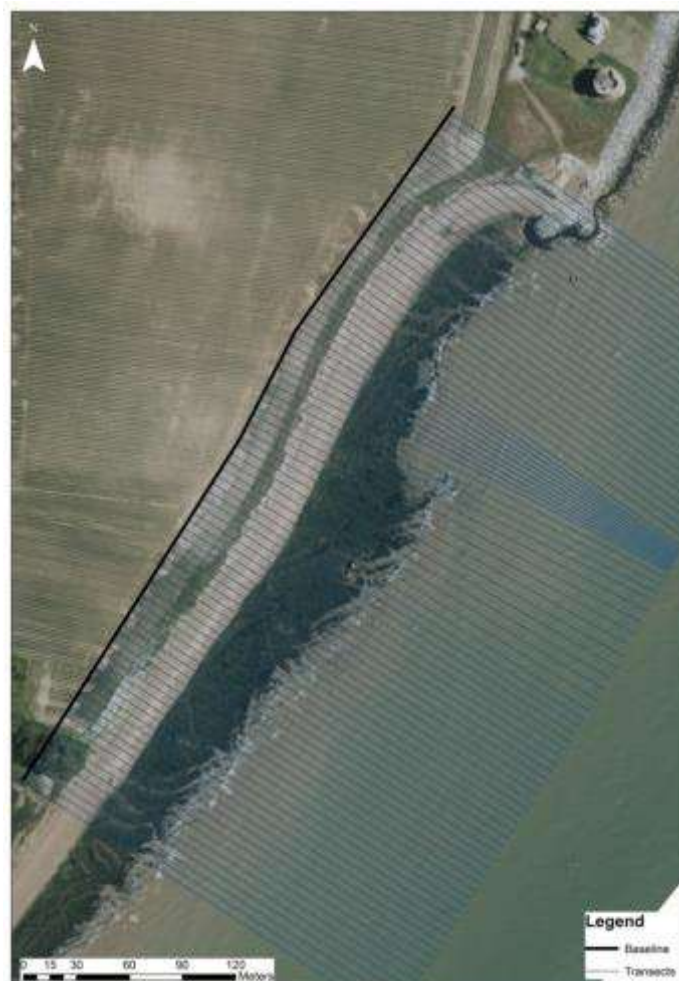
Figure 6.8: Transects defined every 5 m for the study area.

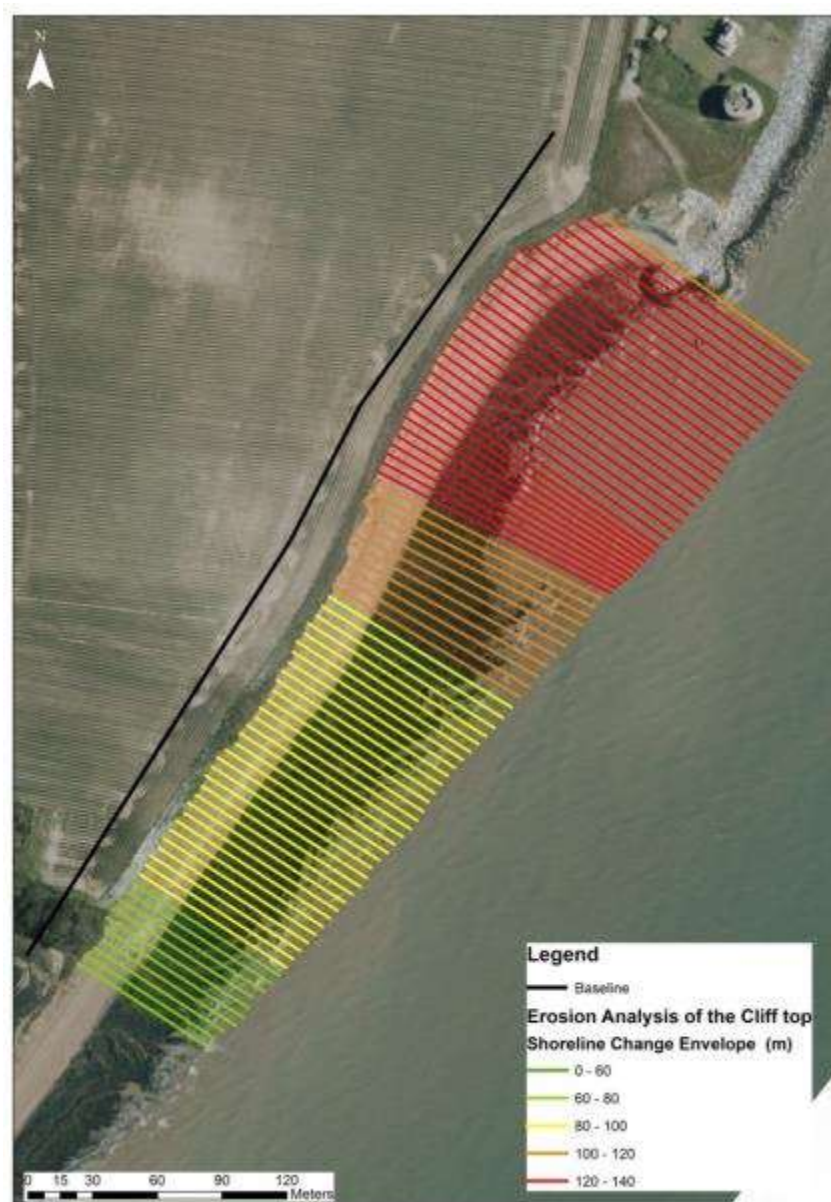
Figure 6.9: Results of the SCE analysis

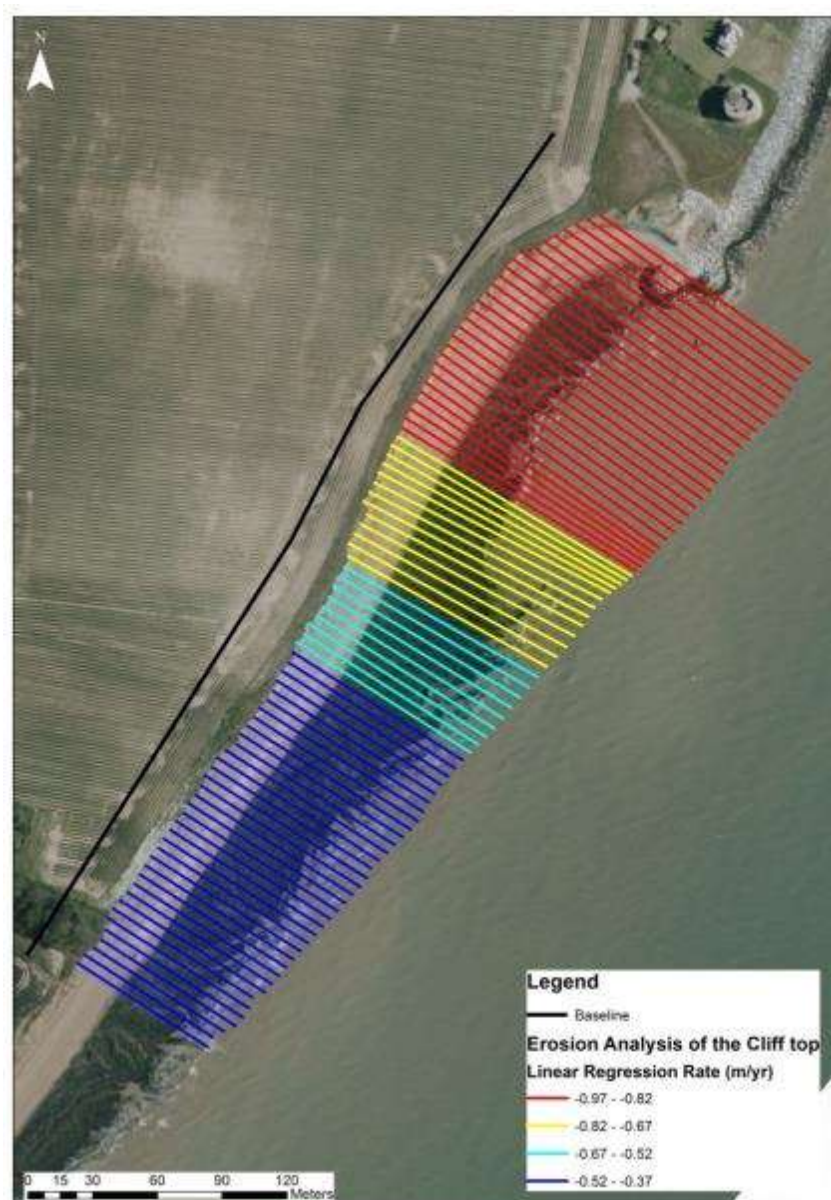
Figure 6.10: Results of the LRR analysis

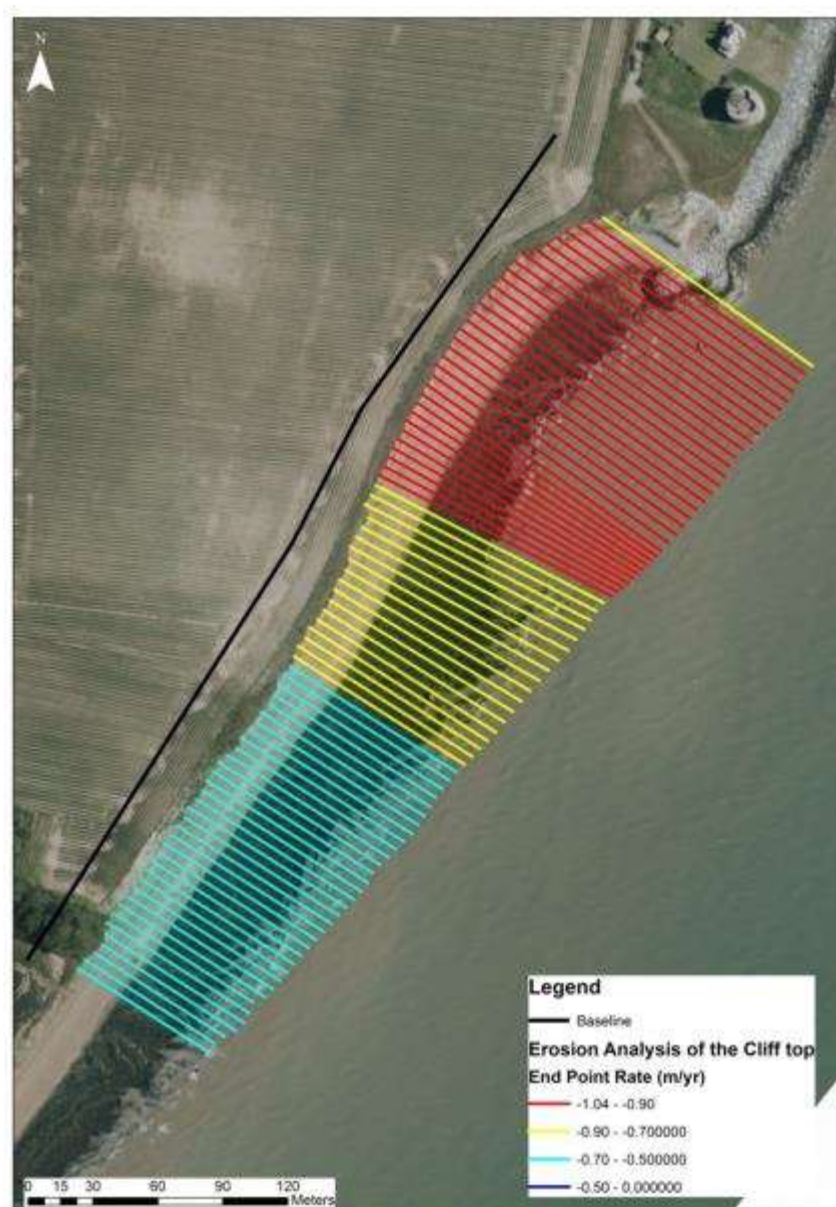
Figure 6.11: Results of the EPR analysis
