# Coastal Processes Study: East Lane, Bawdsey, Suffolk

Final Report

September 2015

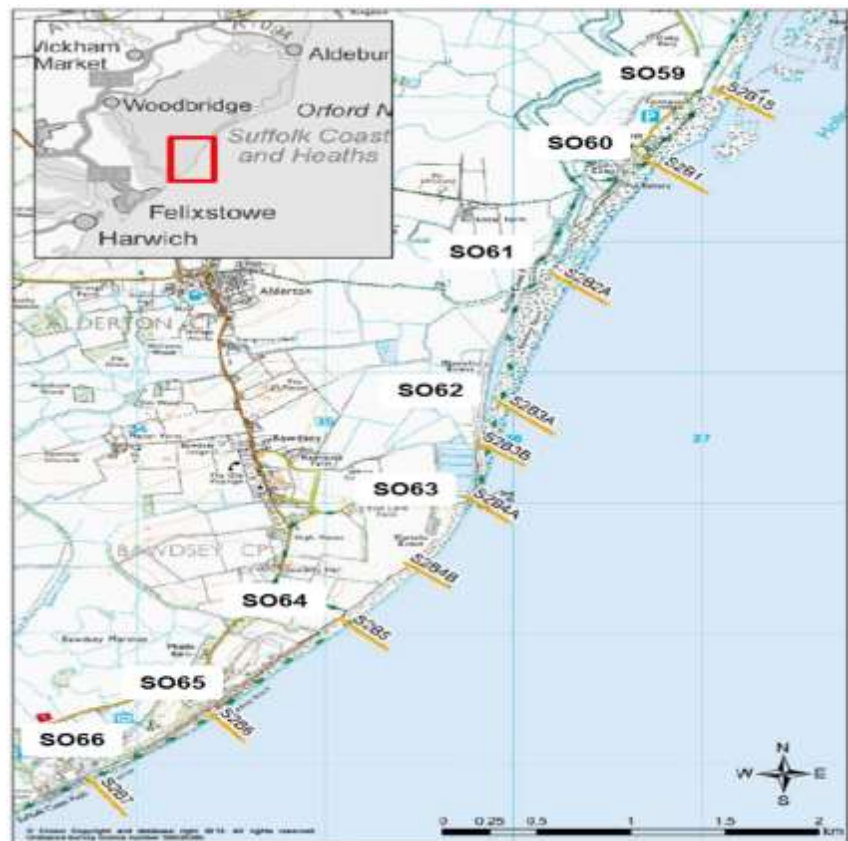
Figure 6.12: The geographical location of Suffolk coastal beach profiles.

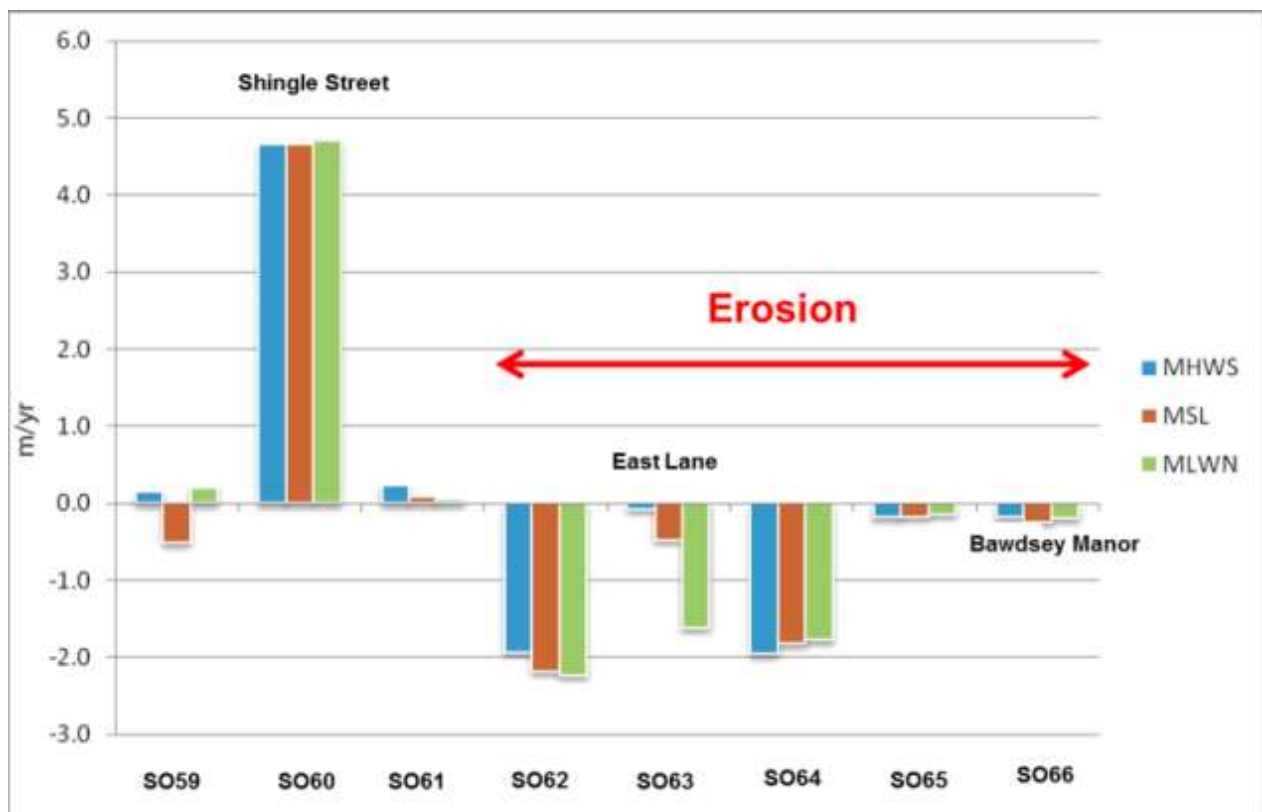
Figure 6.14: Measured change in shoreline location relative to MHWS, MSL and MLWN during the period 1991 to 2010 (Table 6.3).

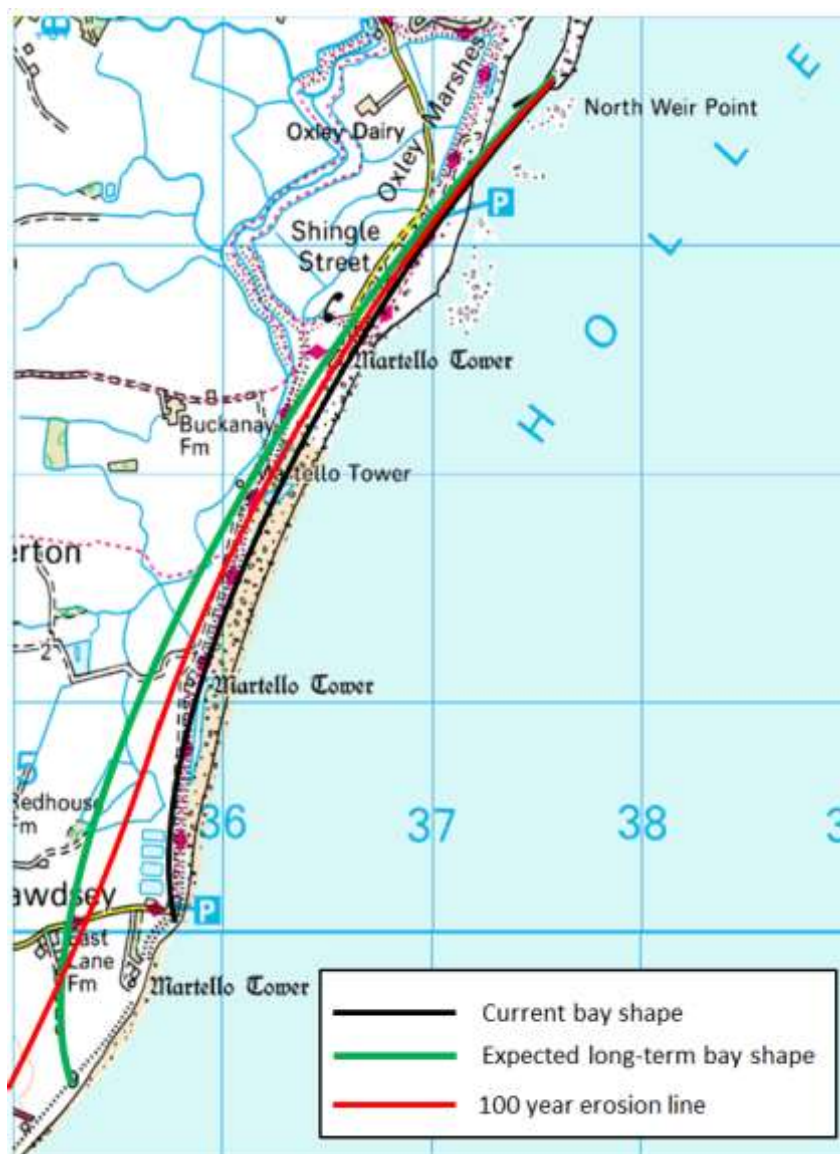
Figure 7.1: Projected change in shoreline location.
