# Thorpeness Coastal Protection

Options Appraisal Study

April 2016

Suffolk Coastal District Council

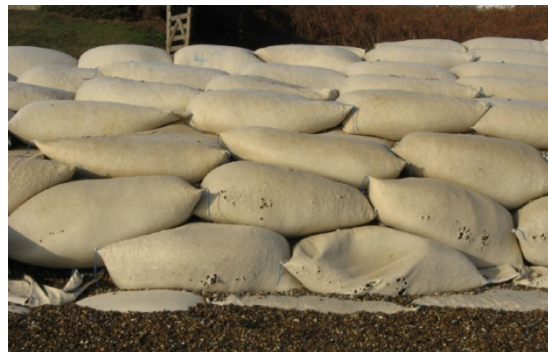
Figure 1.1: The seaward edge of the Phase 1 Geobag layers showing holing from abrasion.

In response to a major beach erosion event in 2010, approximately £700k of public and private money was invested between 2010 and 2012 to improve in two phases, protection against erosion of the northern frontage of Thorpeness Village. The resulting Geobag defences were again exposed to high erosion pressure in 2013 and although performing their coastal protection role satisfactorily, there was significant beach erosion to approximately -1 m AOD leading to concerns that the existing defences are not capable of delivering fully the outcome upon which technical approval and funding allocation were based. In addition the geobags also suffered some abrasion damage during this period of exposure, particularly around the mid-level of the stepped structure (Figure 1.1).

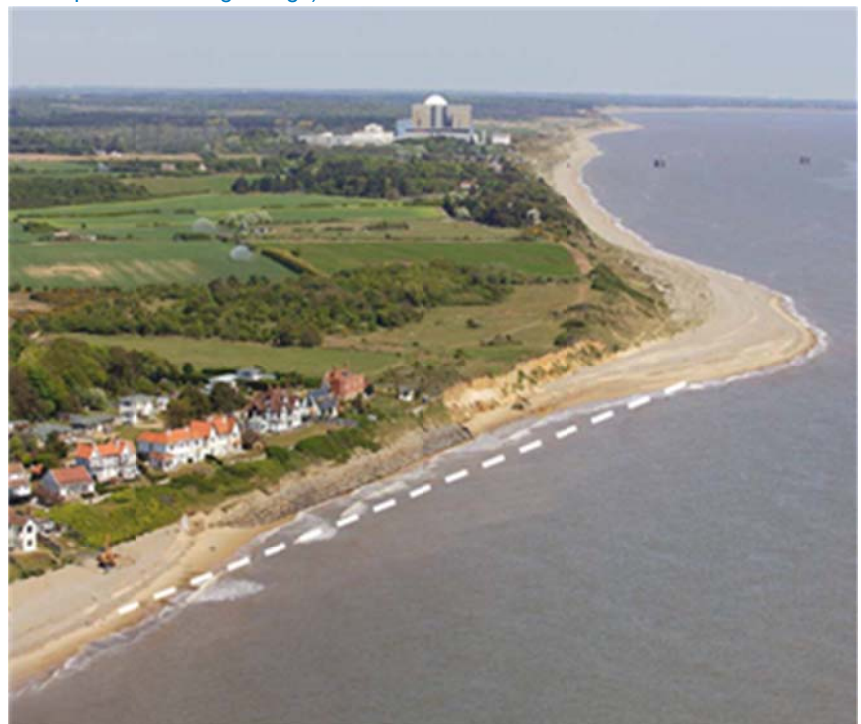
Figure 2.3: Beach set-back in front of coastal protection at Thorpeness (prior to the placement of geobags)

The beach erosion hotspot along the North End Avenue frontage in 2010 is shown in Figure 2.3. The area is relatively confined reflecting a focus (and possibly reflection of) wave energy along a very limited section of the coastline. Possible causes of this are discussed in Mott MacDonald (2014).
