Gunton and Corton Coastal Options Appraisal

Appraisal Report

Document No. 01 | 2.0

March 2022

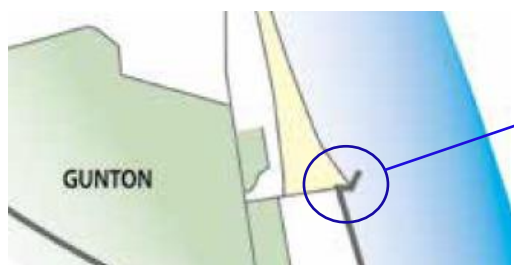
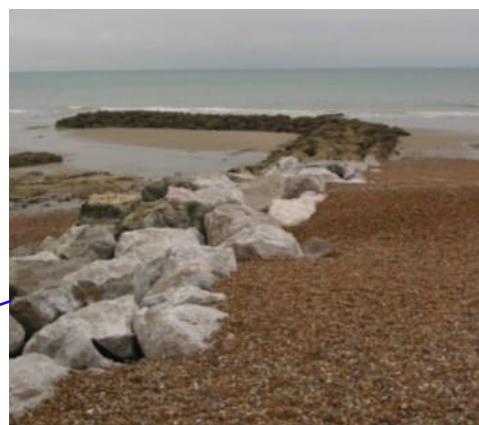
Figure 6-1: Illustration of suggested terminal structure at north end of Lowestoft North Denes wall (taken from Gorleston to Lowestoft Strategy Plan; Jacobs, 2016)

There are other considerations at this location in addition to these, including risks to the car park area and infrastructure located at Links Road. It is assumed (as per the Strategy and SMP) that the management intent remains to maintain the seawall which extends from there down to Lowestoft Ness. The Strategy proposes an L-shaped terminal groyne structure at the seaward end of Links Road, tied to holding beach material along the edge of the wall and ensuring protection there. This is an important assumption as the Strategy identifies proposed actions associated with this wall at Links Road, which would also have beneficial consequences for the southern end of Gunton Warren (see Figure 6-1). Noting that present assessment identifies further erosion at that location and evidenced by considerable draw down along edge of wall last winter, this should be a consideration now rather than in the future.

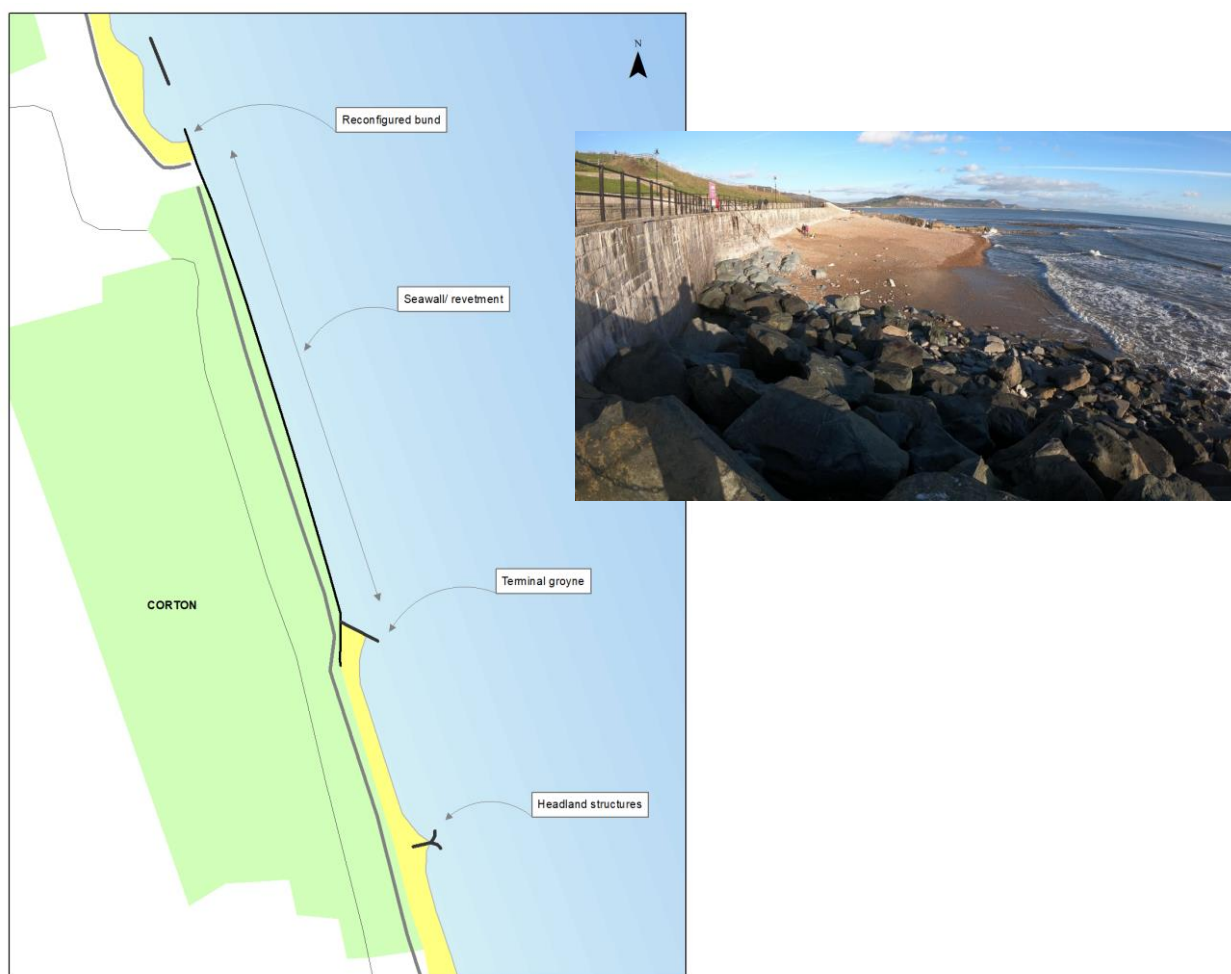
Figure 6-3: Illustration of how the proposed approach could look at Corton. The photograph shows an example of rock revetment in front of the main defence at Lyme Regis Church Cliff. Source: Love Lyme Regis Ltd 2021 (<https://lovelymeregis.co.uk/beaches/churchcliffbeach>)

A rock revetment would be a much more substantial structure than currently exists (Figure 6-3), sitting over the existing wall and rock toe, and further up the cliff face to protect the base. However, this would prevent public access along this frontage, unless some of the cliff top holiday park land can be given over to that.

A new seawall could incorporate public access at a higher elevation than present and designed to help to address upper cliff face instability issues too, but will be a more difficult construction and expensive approach. This would need to be able to address any predicted future foreshore lowering, so would more likely be a hybrid of concrete seawall fronted by a lower rock revetment.

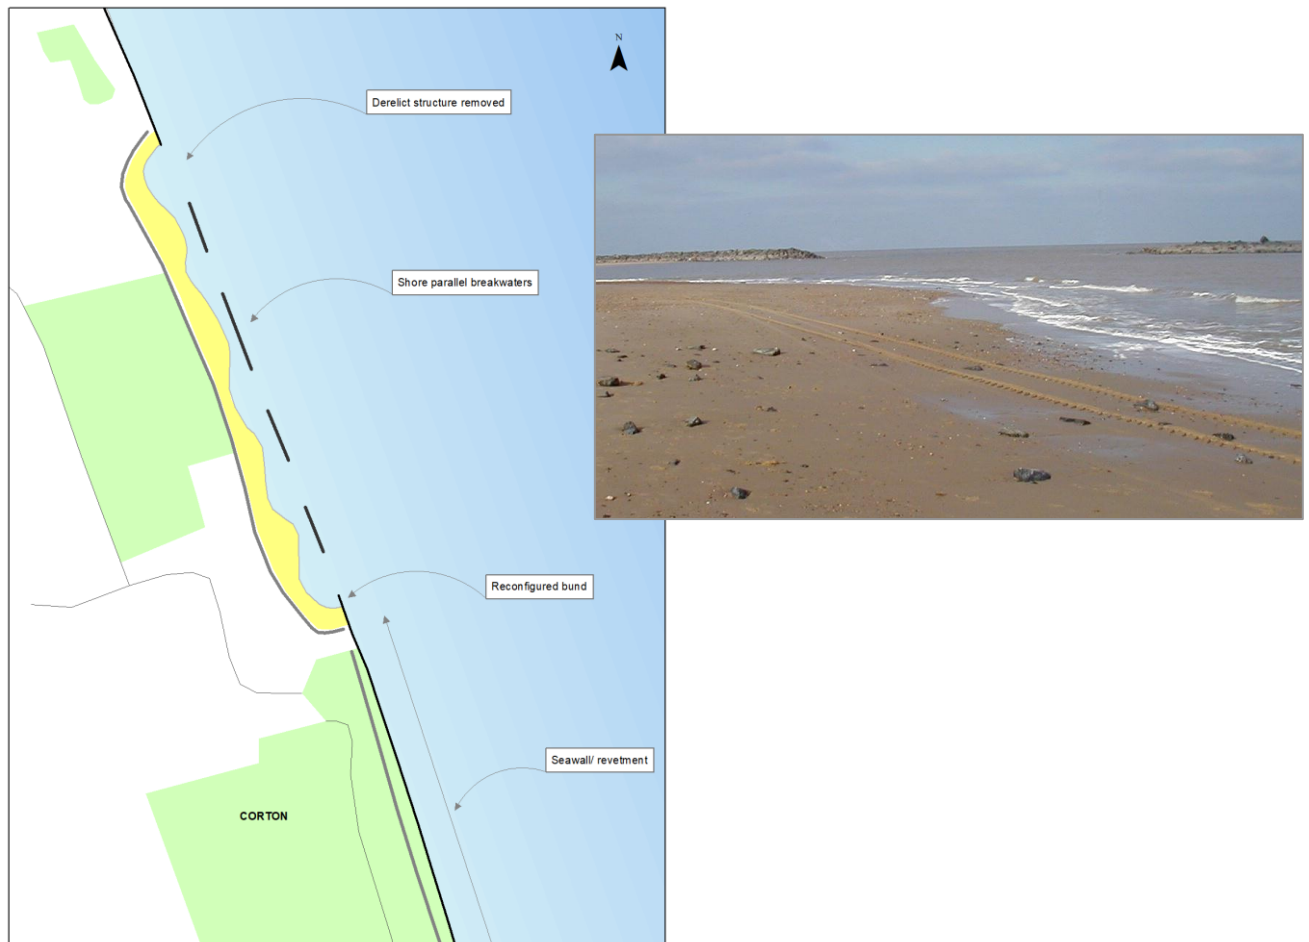
Figure 6-4: Illustration of how the proposed approach could look

These assumptions and options for management outlined in the Strategy remain valid. The Strategy presents a preferred approach for modification of the existing structures, removing some sections of the sheet piles and encasing the remainder in rock armour, to form a series of offshore breakwaters (Figure 6-4). These would provide intermediate controls on erosion by reducing and controlling (rather than completely halting) the rate of cliff erosion, reducing land loss along the cliff top and allowing safe and accessible beaches to develop. This latter point has wider strategic significance to support the wider economy, in particular tourism at Corton, and potentially Hopton.
