Thorpeness Monthly Monitoring Report

Date and Time of Survey: August 22, 2022; 08.06

Monthly inspection of the frontage between Thorpeness village and Ness. The purpose is to check signage, flag any hazards relating to public safety, inspect condition and exposure of defences and monitor geomorphological changes. This report is used to inform coastal management decision making and will be shared with the community. For best access, inspections should be done at low tide with due regard to the weather and sea state.

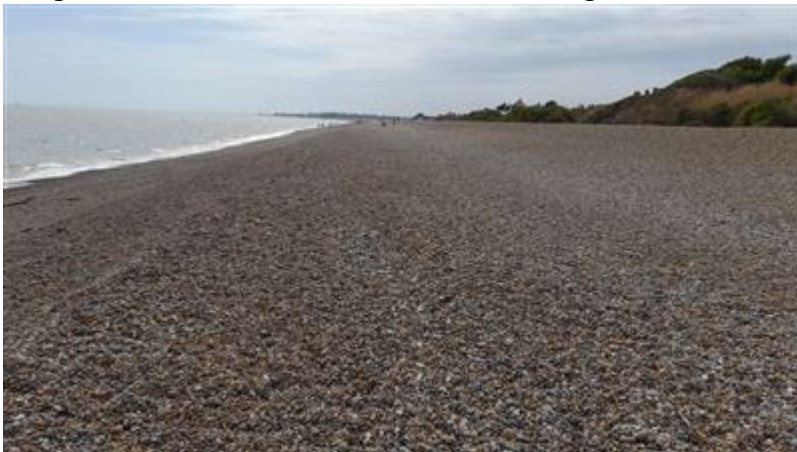
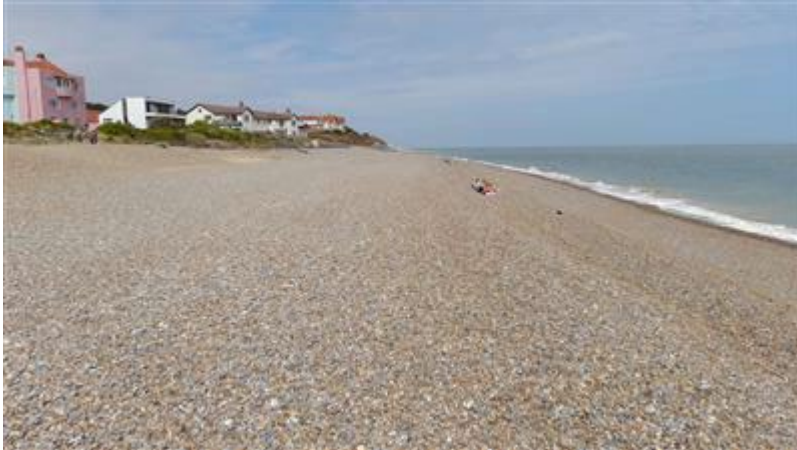
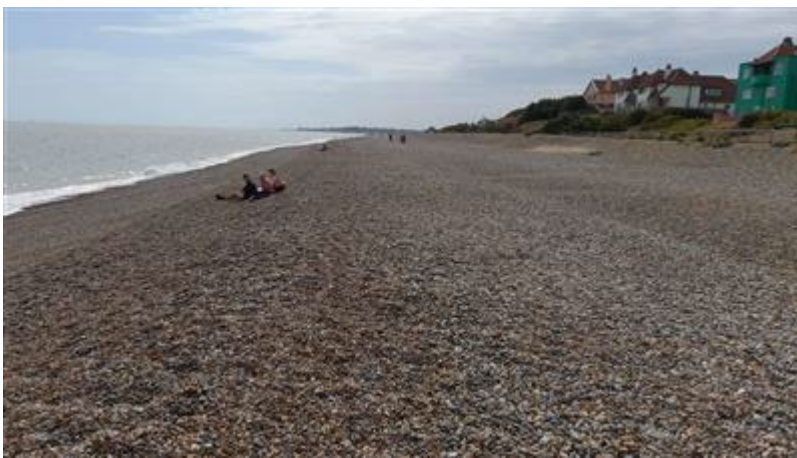
Images of the southern UNDEFENDED frontage:

Intertidal Beach volume change: Moderately Higher

Supratidal Beach volume change: No change

Comments on the geomorphological change over the southern UNDEFENDED frontage: Flatter Intertidal Zone than on last visit.

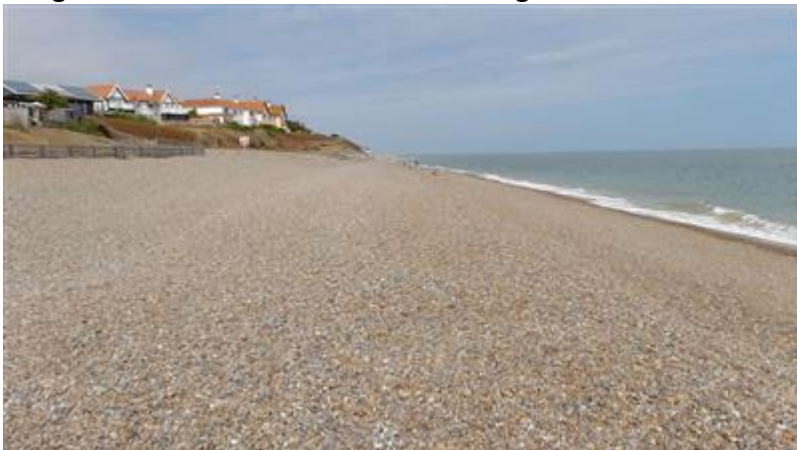
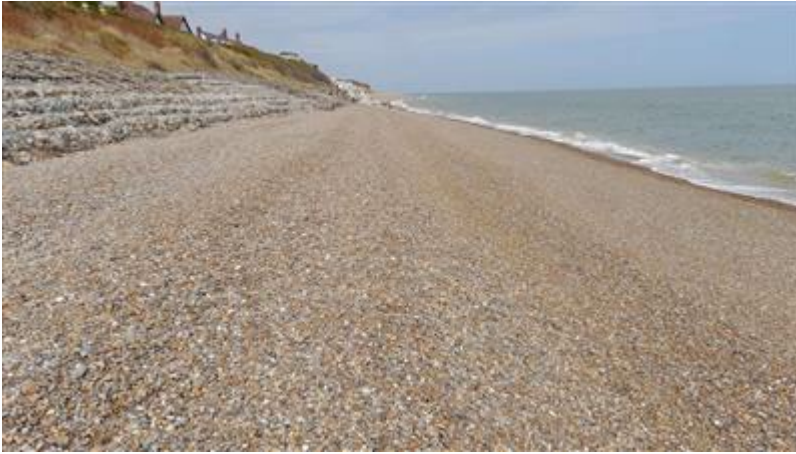
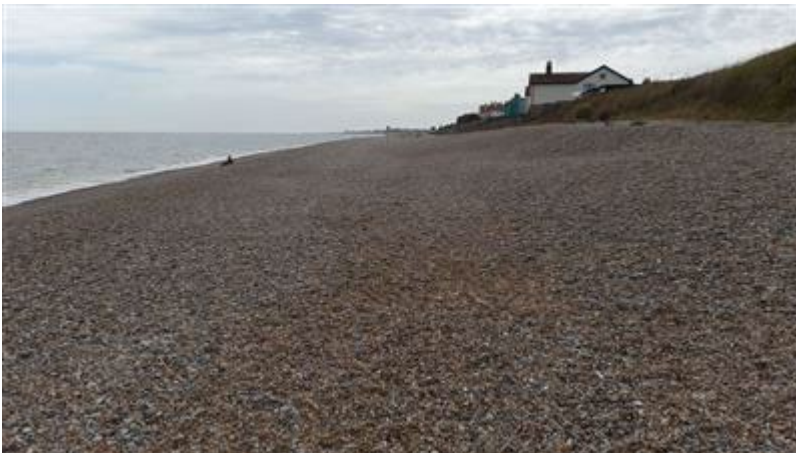
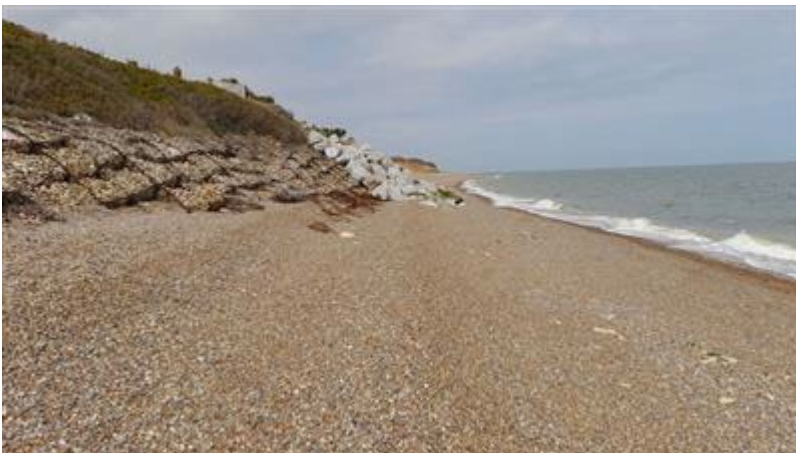
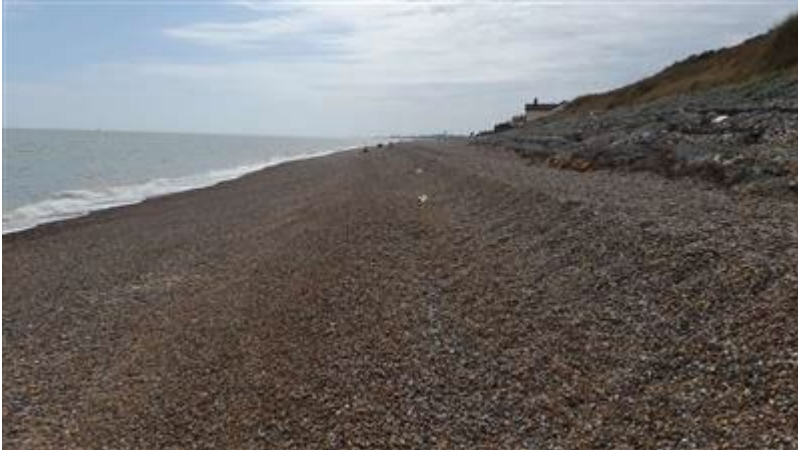
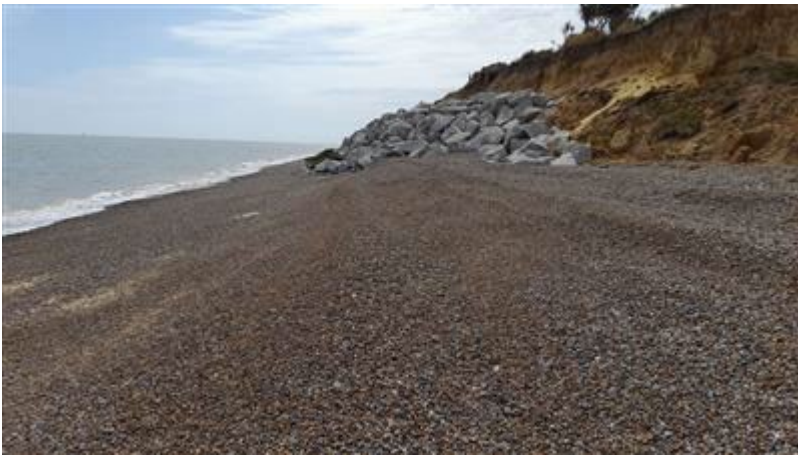
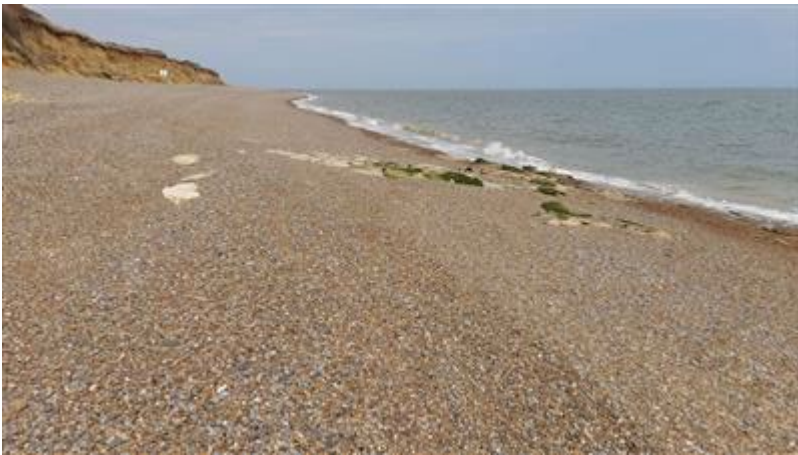
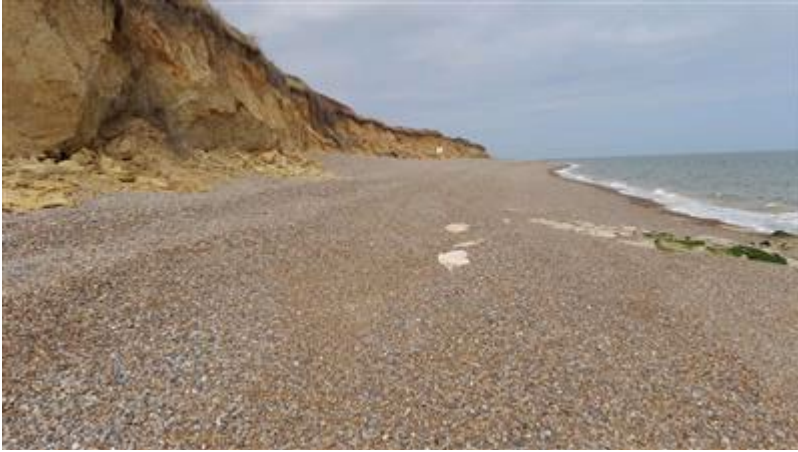
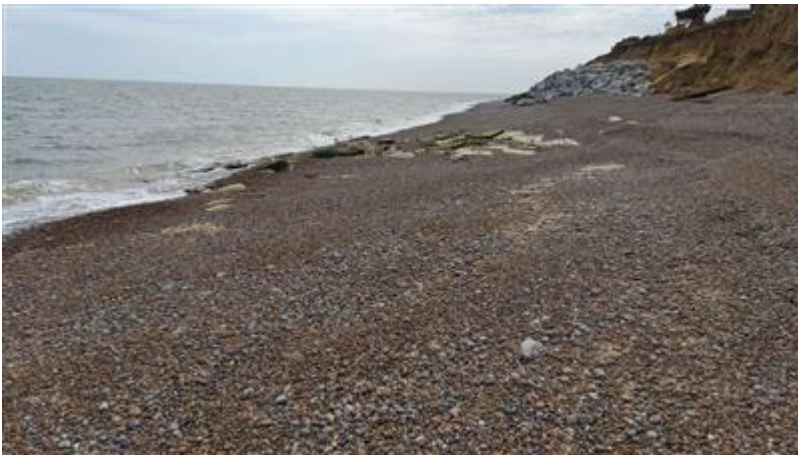
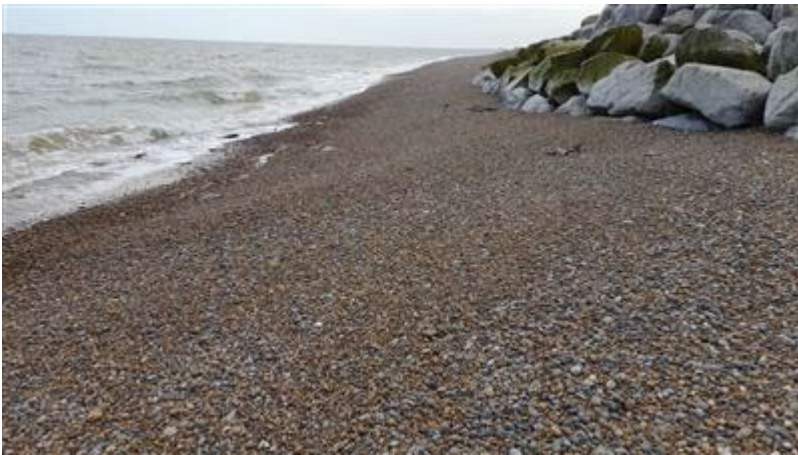
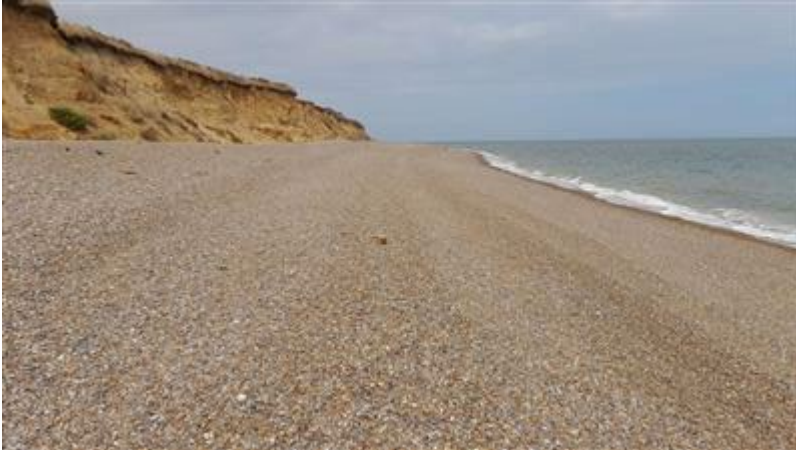
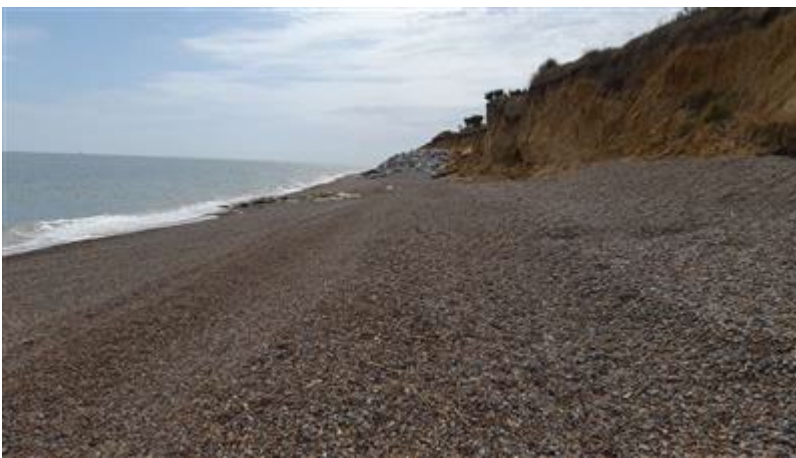
Images of the central DEFENDED frontage:

Intertidal Beach volume change: Moderately Lower

Supratidal Beach volume change: No change

Comments on the geomorphological change over the DEFENDED frontage: Some gabion wire and geobags have become exposed during the last inspection period.

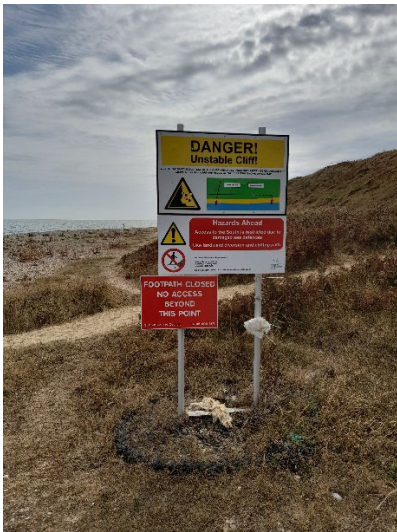
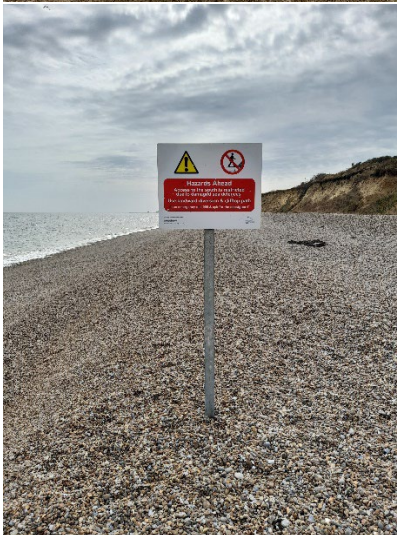
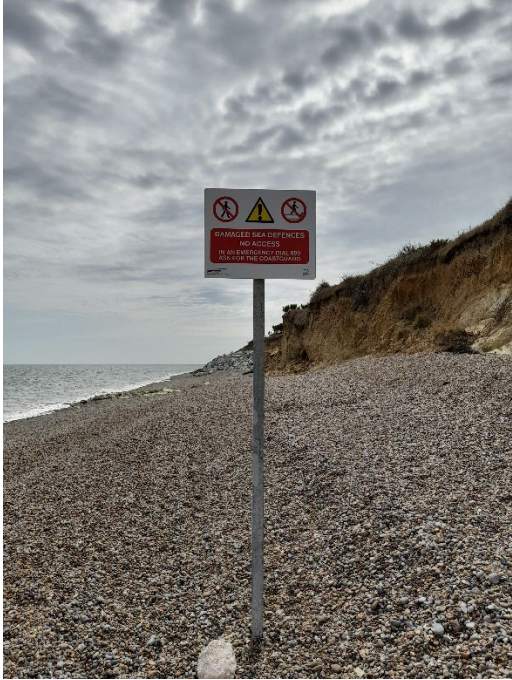
Images of signs:

Signage condition: Good

Comments on signage: Adequate and informative

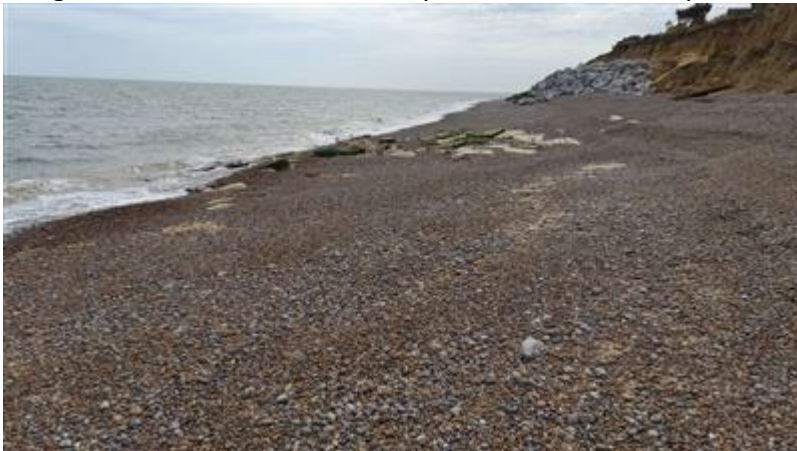
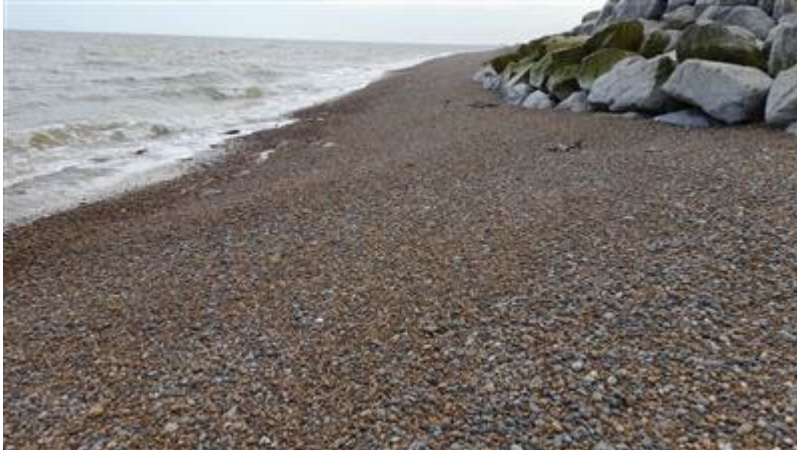
Images of Hazards/Debris: Examples recorded on inspection below.

Comments on Hazards/Debris: Northern geobag defence termination has become exposed. Some gabion wire exposed adjacent the base of the rock.

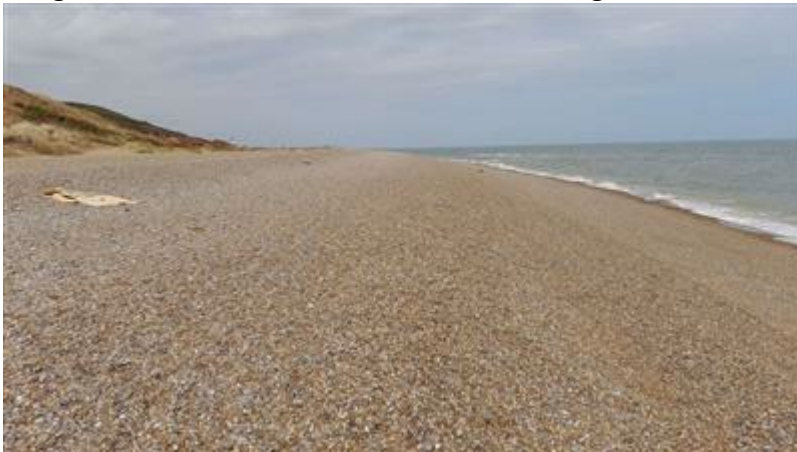
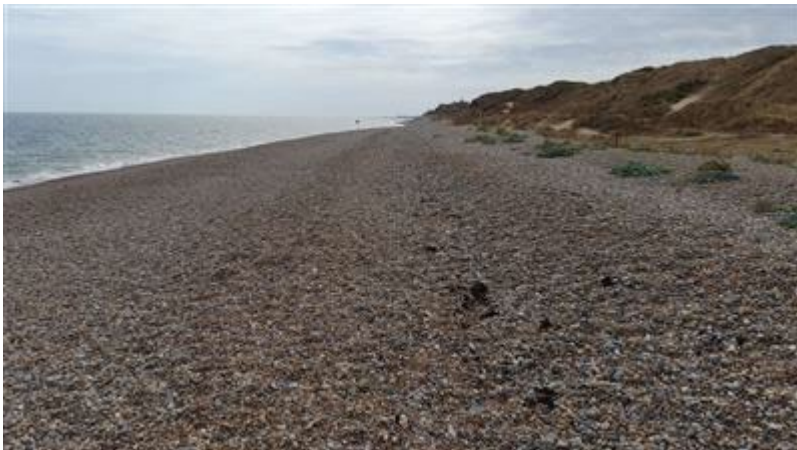
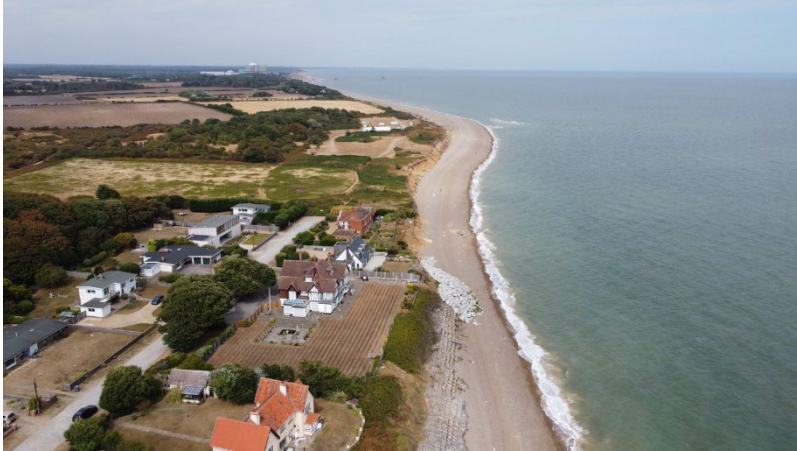
Images of the Northern UNDEFENDED Frontage:

Intertidal Beach volume, north of defence termination: No change

Supratidal Beach volume, north of defence termination: No significant change

Comments on the geomorphological change, north of defence termination: Little change to cliffs, little change to beach.
