Thorpeness Monthly Monitoring Report

Date and Time of Survey: 15th December 2022; 08:44

Inspector: Chris Finbow/Thomas Hayden

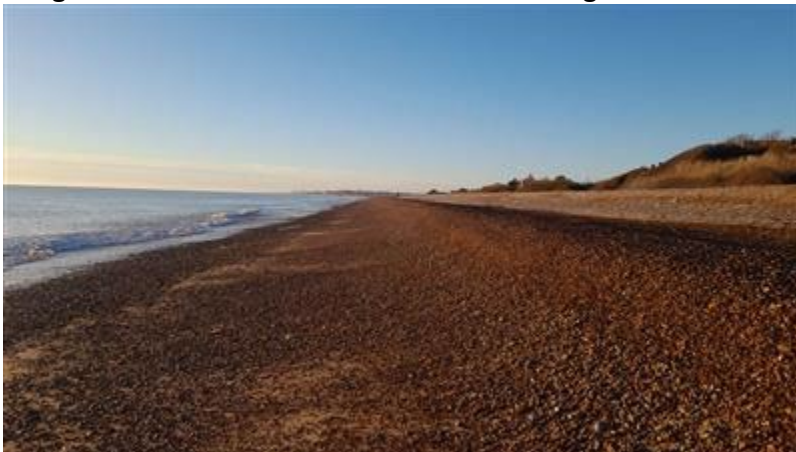
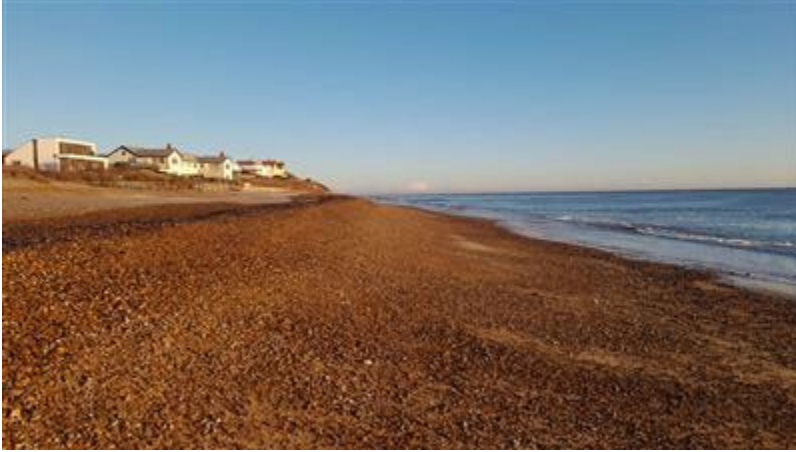
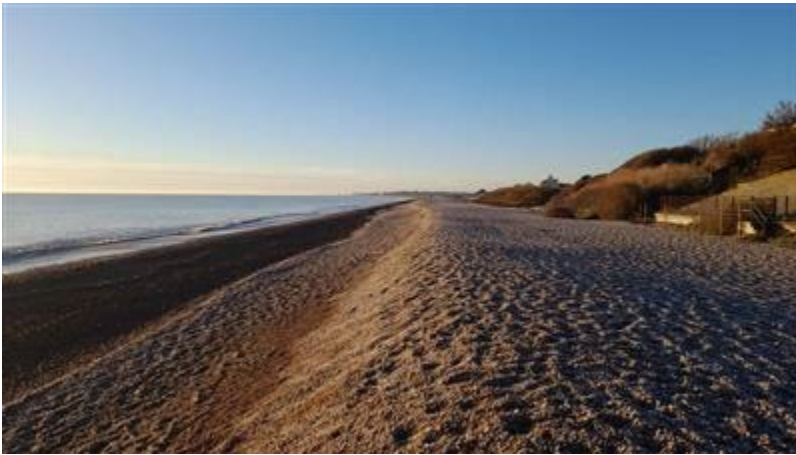
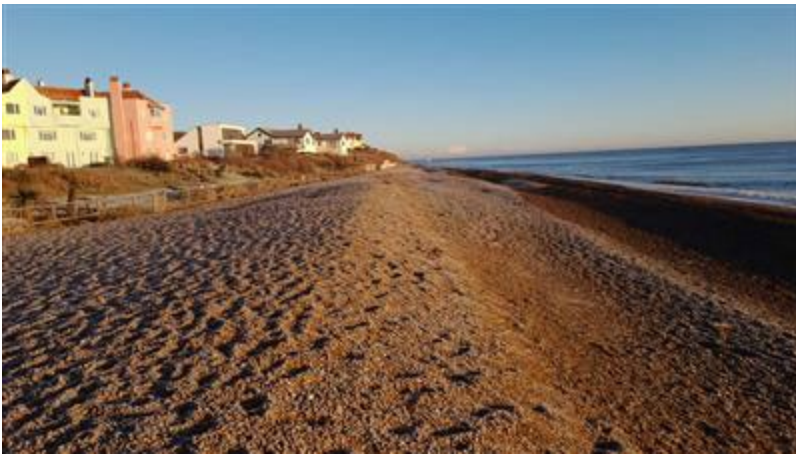
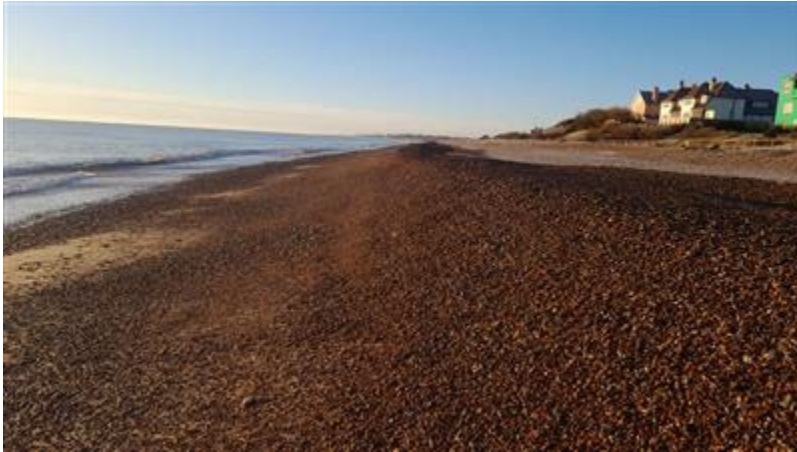
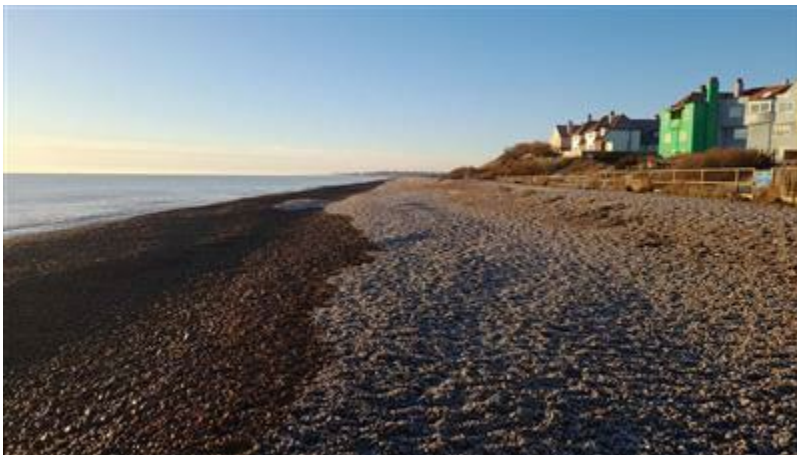
Images of the southern UNDEFENDED frontage:

Intertidal Beach volume change: Moderate Decrease

Supratidal Beach volume change: No change

Comments on the geomorphological change over the southern UNDEFENDED frontage: Loss of some beach material from the lower and intertidal beach areas. The upper beach has not changed very much.

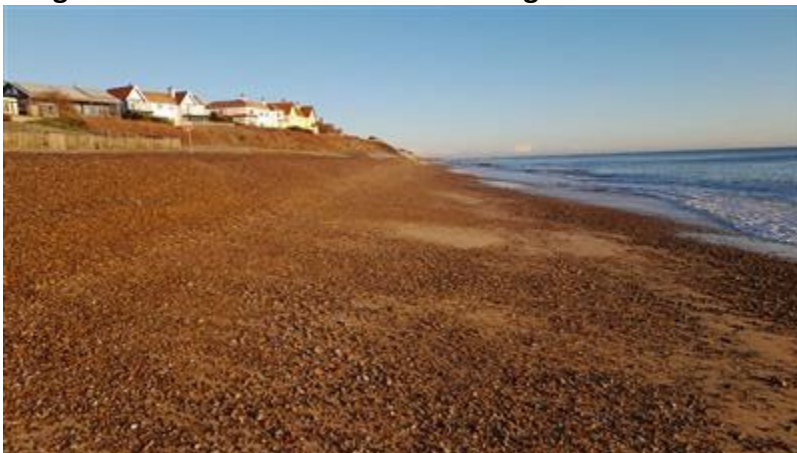
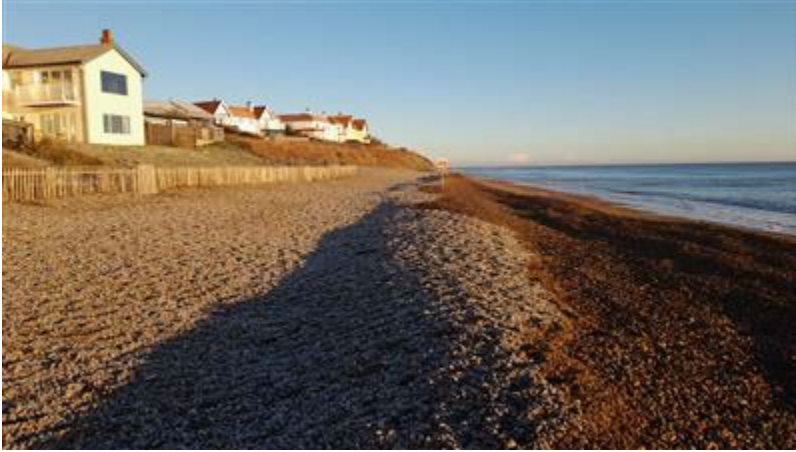
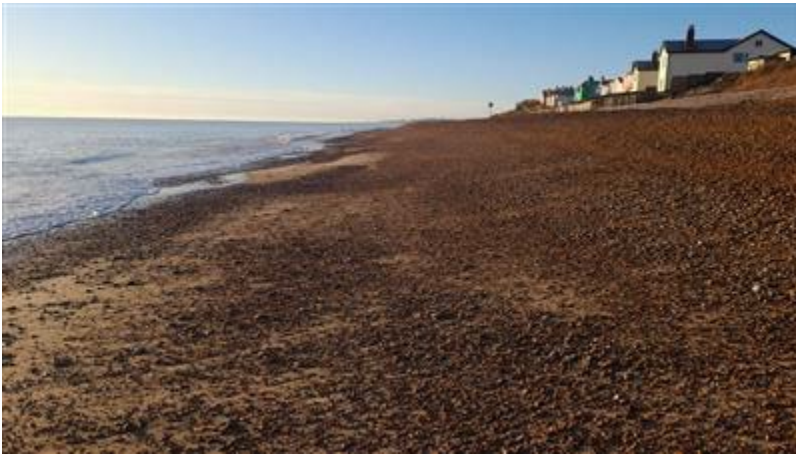
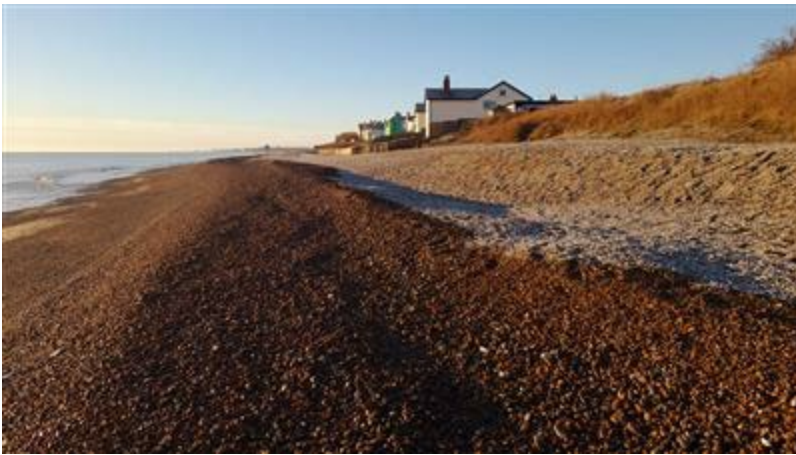
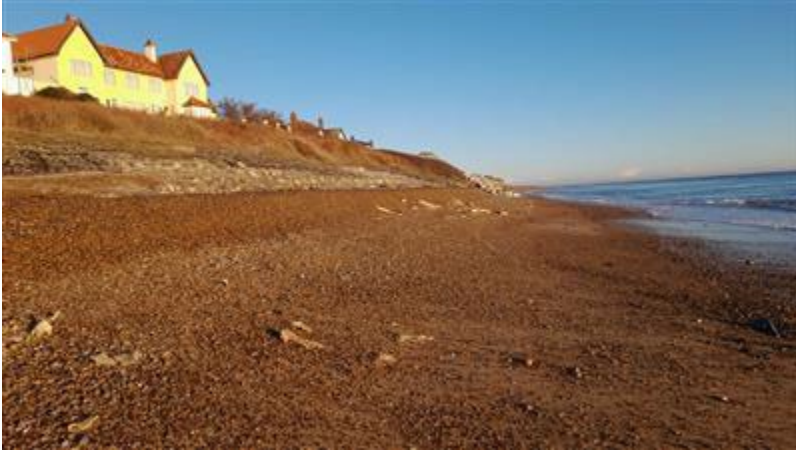
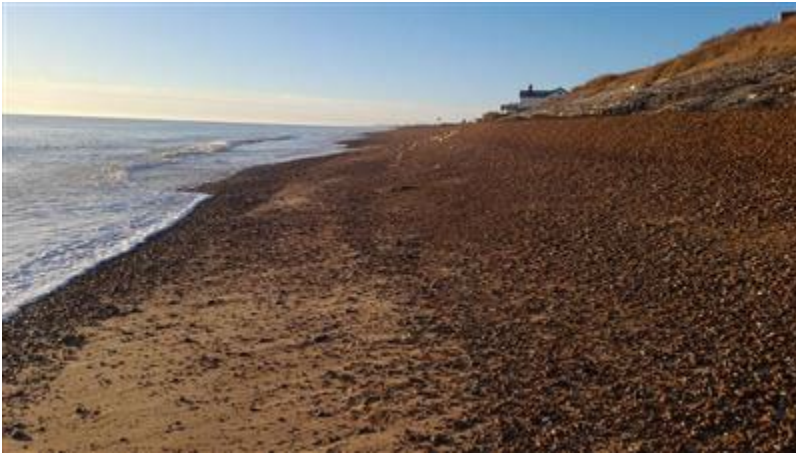
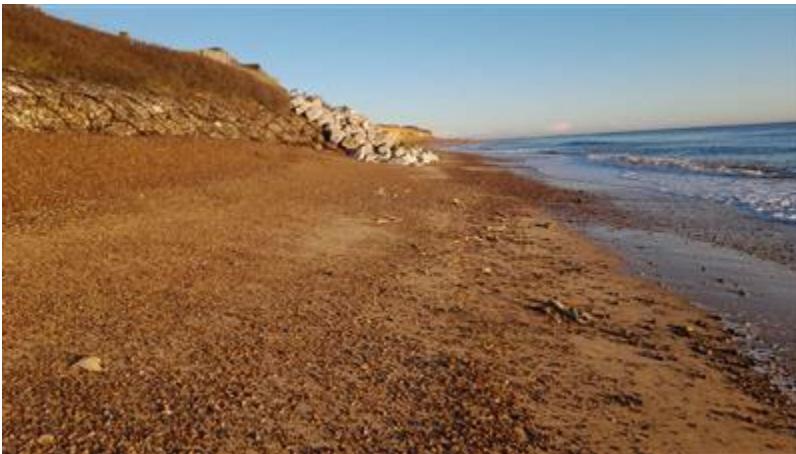
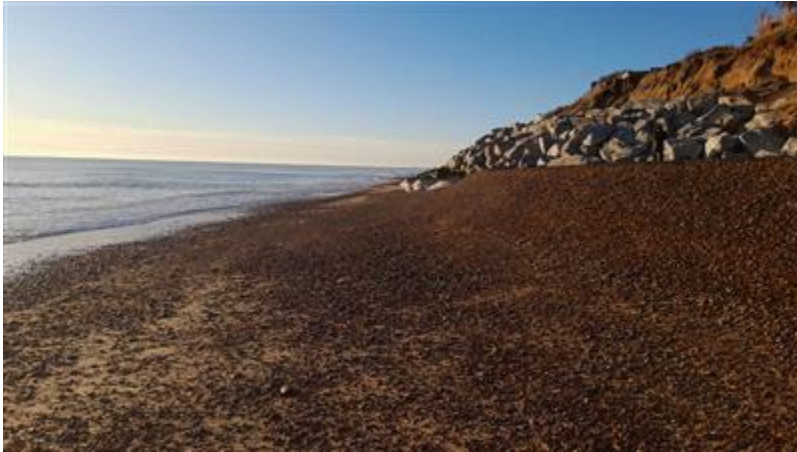
Images of the central DEFENDED frontage:

Intertidal Beach volume change: Moderate Decrease

Supratidal Beach volume change: No Change

Comments on the geomorphological change over the DEFENDED frontage: Some material has been lost at the Gabion to Rock intersection as the high tide mark has been pushed backwards up the beach.

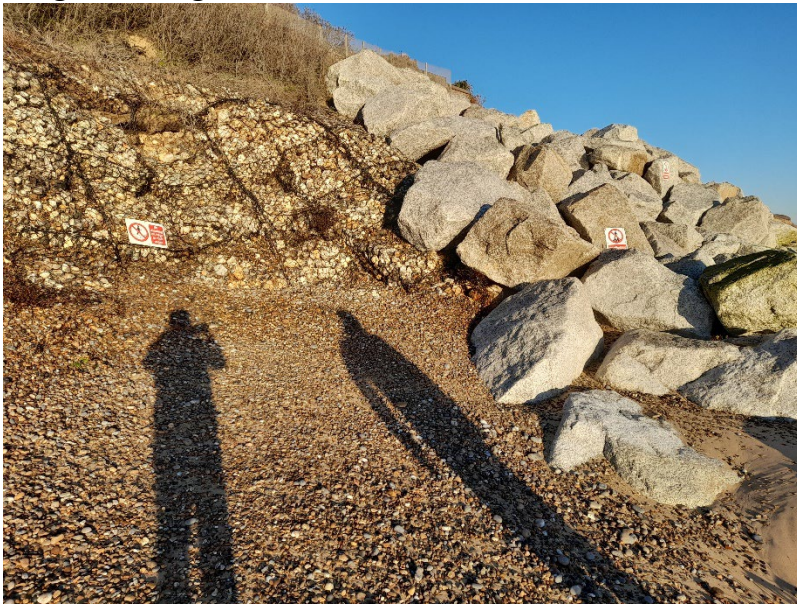
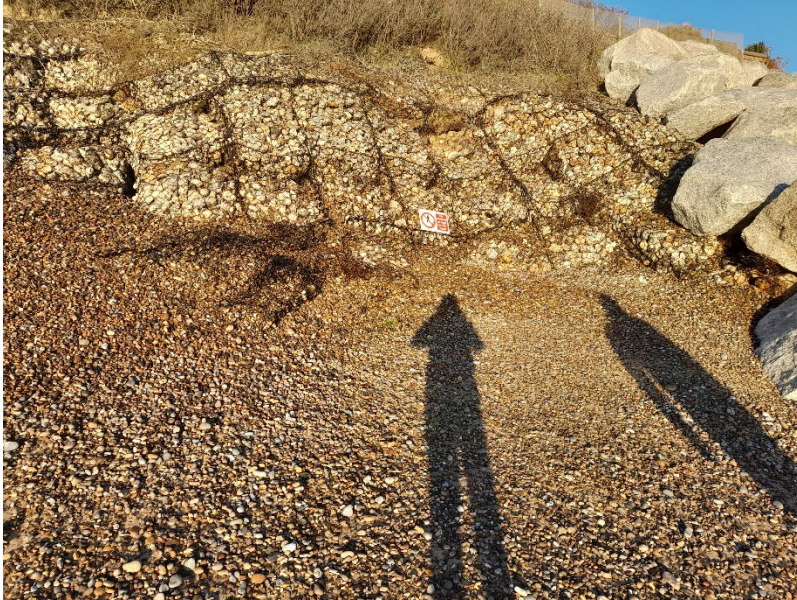
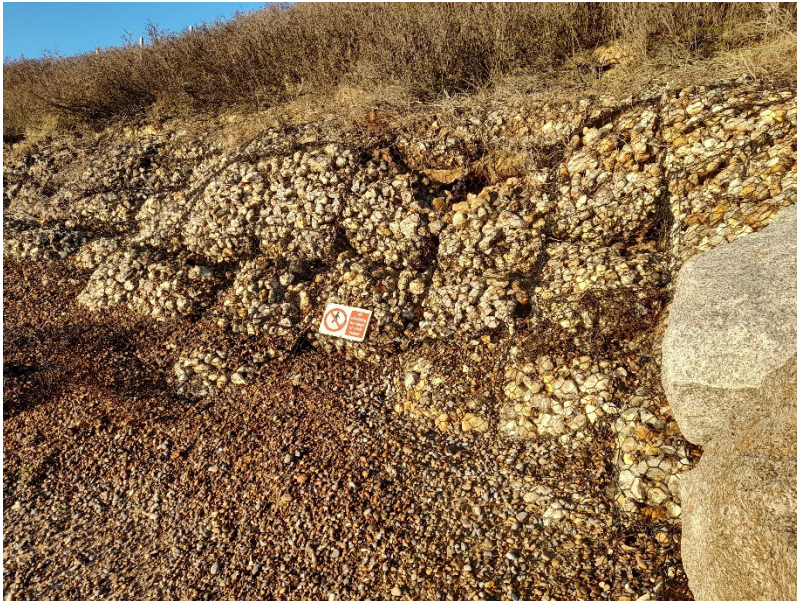
Images of the gabions:

Comments on gabion Condition: Localised steepening of the gabions immediately south of the rock field. The lower gabions have been covered by a recovery of beach material.

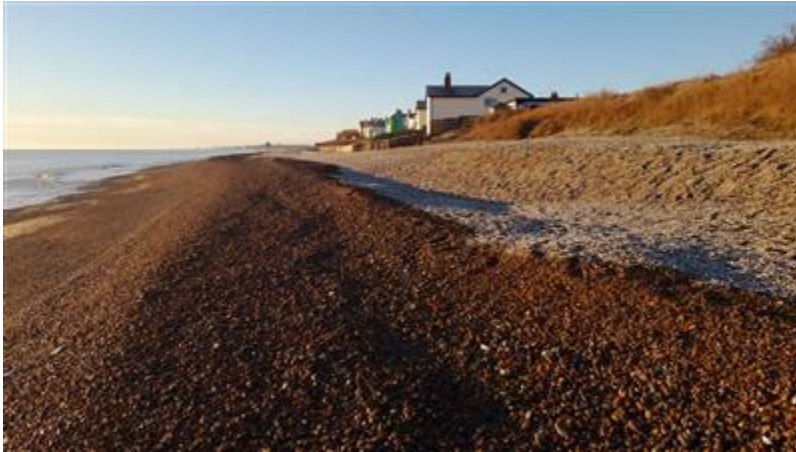
Images of Phase 1 Geobags:

Phase 1 Geobags still buried.

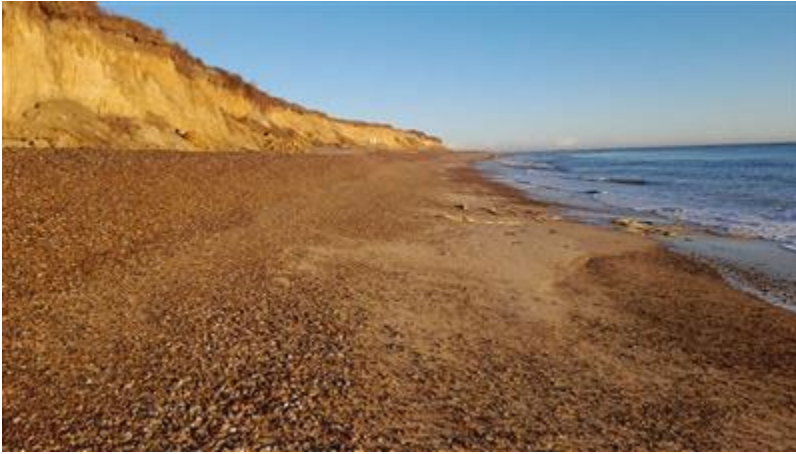
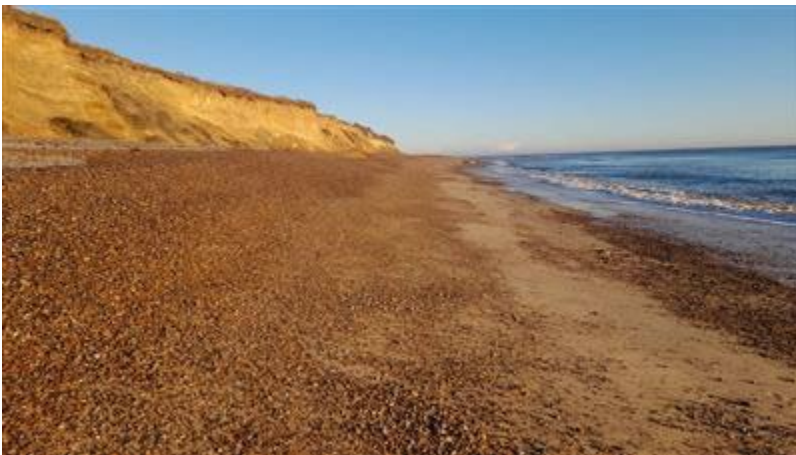
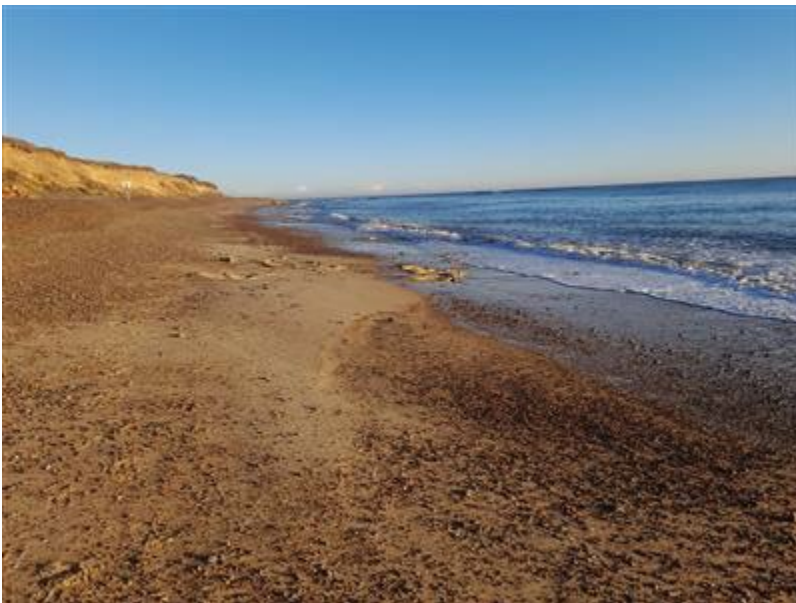
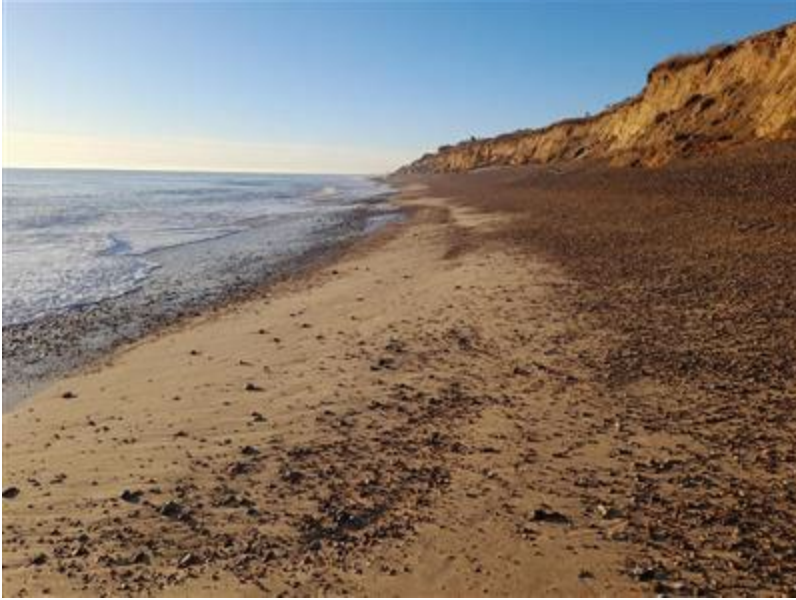
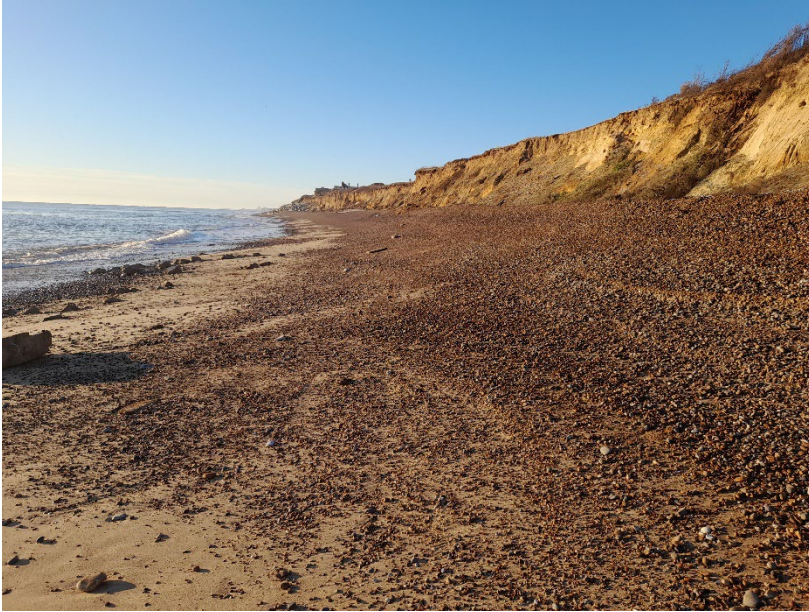
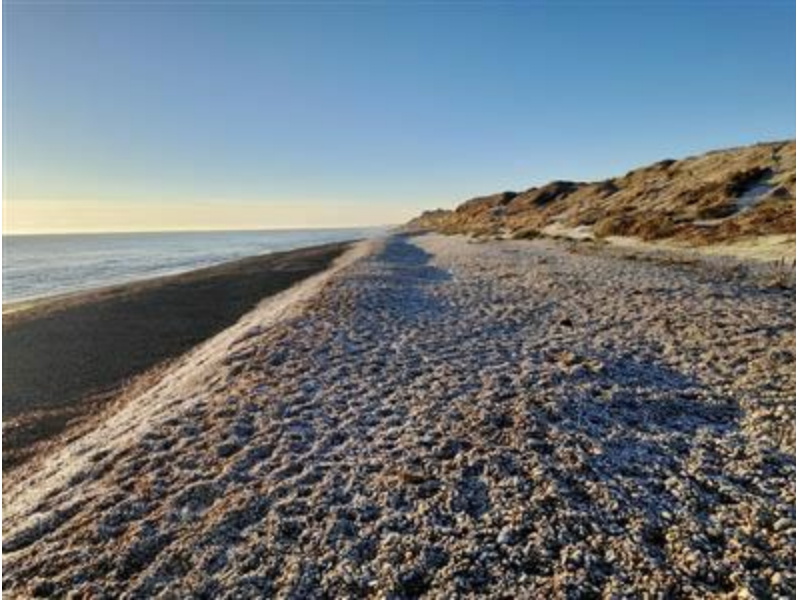
Images of the Northern UNDEFENDED Frontage:

Intertidal Beach volume, north of defence termination: Moderate Decrease

Supratidal Beach volume, north of defence termination: No change
