Gunton and Corton Options Appraisal

Appendix A - Coastal Processes Report

March 2022

Coastal Partnership East

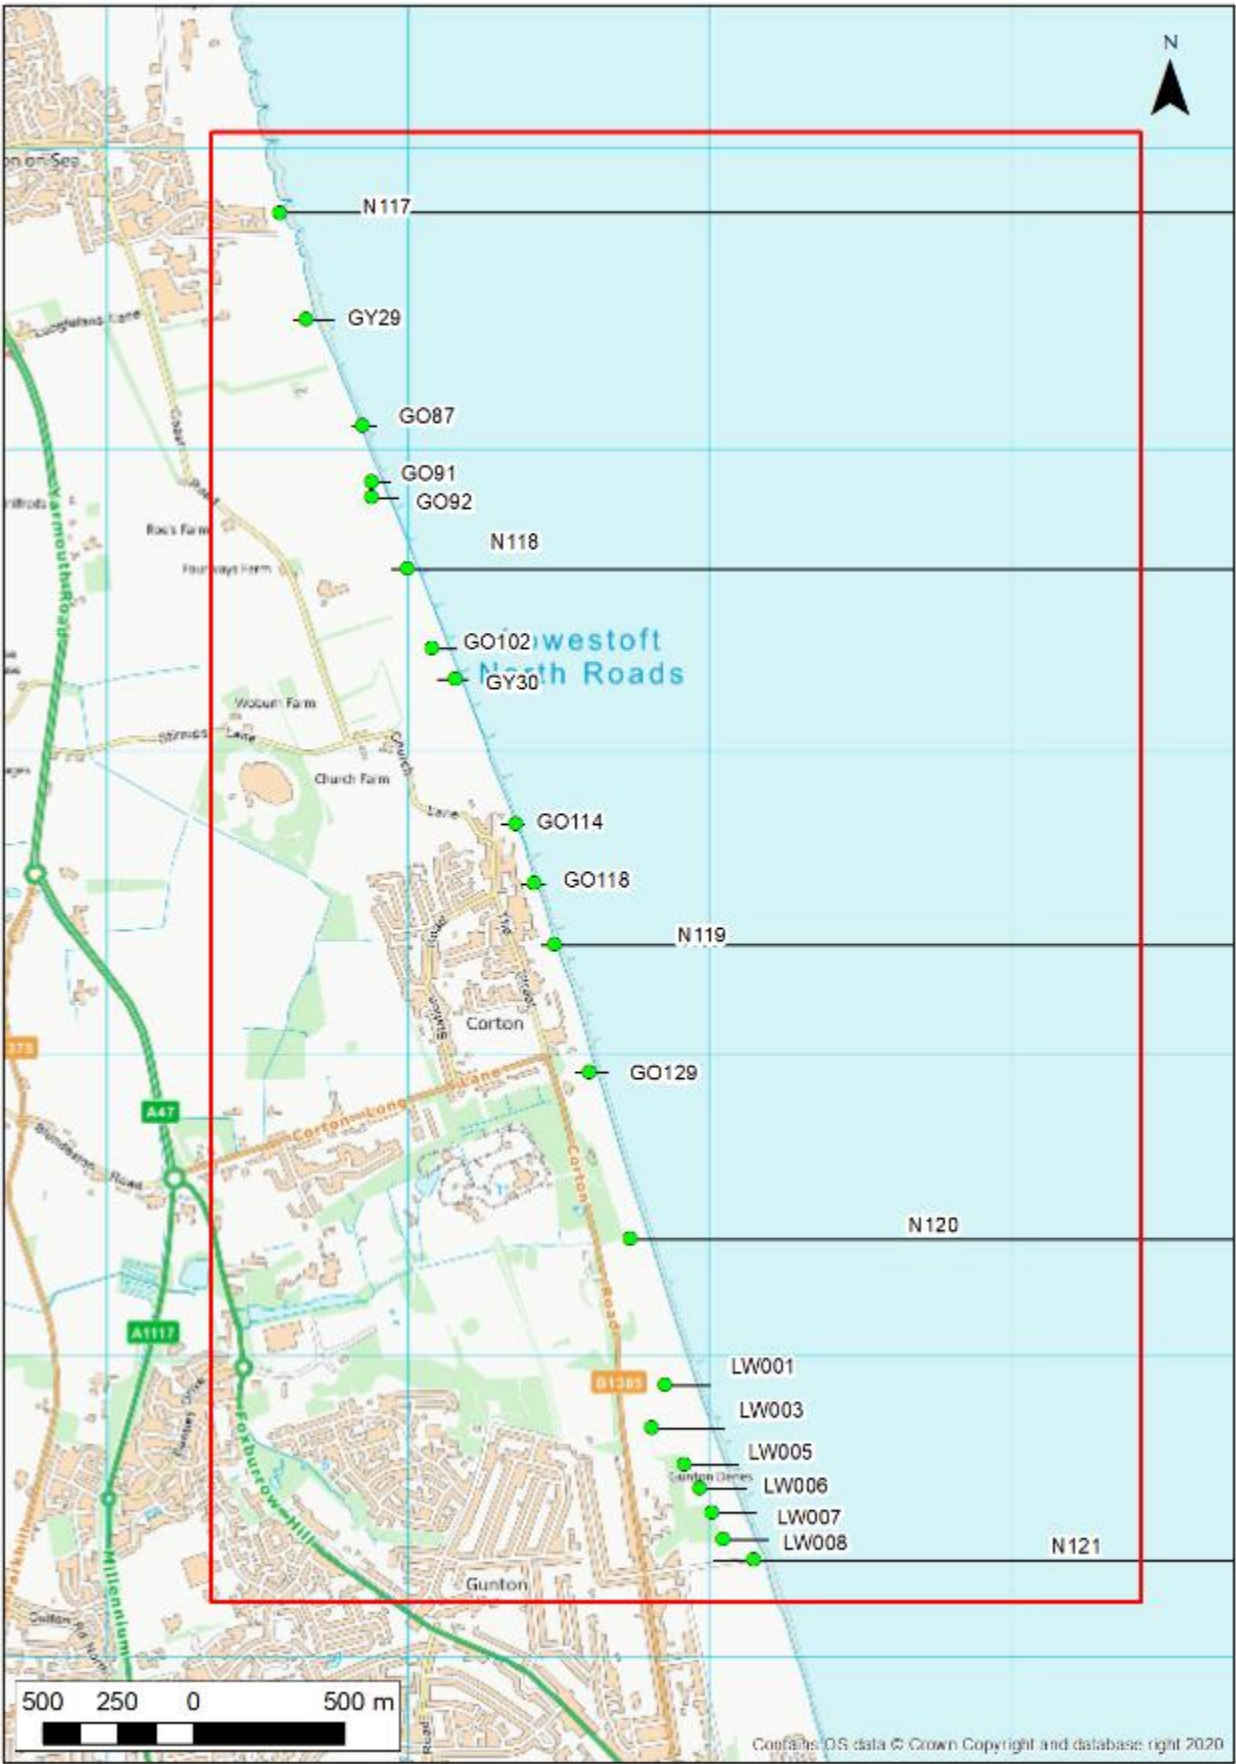
Figure 1-1: Study area for the coastal processes review

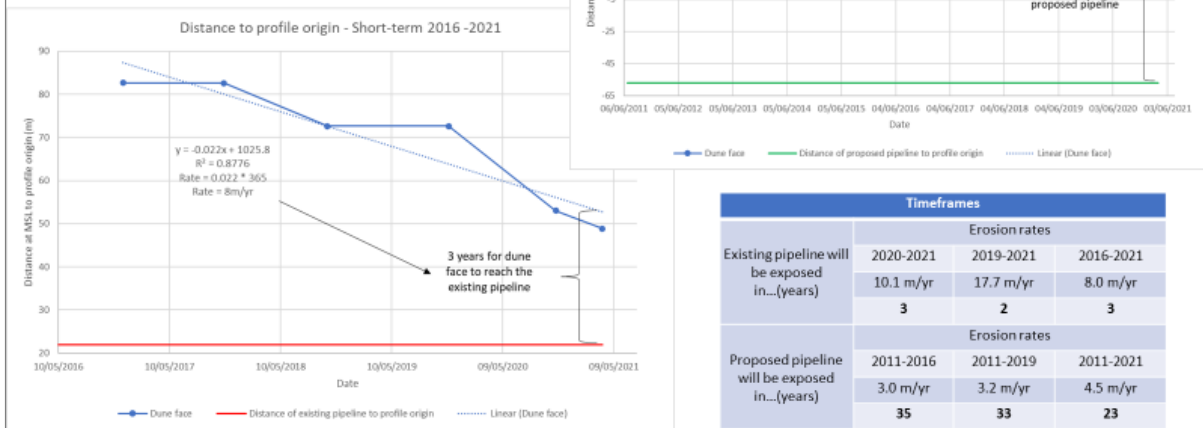
- The graph below shows the distance from dune face (measured at 3mOD) to the profile origin. The calculated rates were based on the trend line of three beach profile surveys, two LIDAR surveys and two drone surveys
- The calculated rates were based on the trend line considering different timeframes, depending on the data available
- Long-term rates: considered for the proposed pipeline
- Short-term rates: considered for the existing pipeline

Figure 2-2: Example of the regression analysis undertaken for the Southern Gunton Warren frontage

A linear regression analysis for each time period has been undertaken and used to predict the rate of change and thus the time until assets would be reached. Examples of the regression analysis undertaken are given in Figure 2-2 and Figure 2-3. Full details can be found in Annex B.

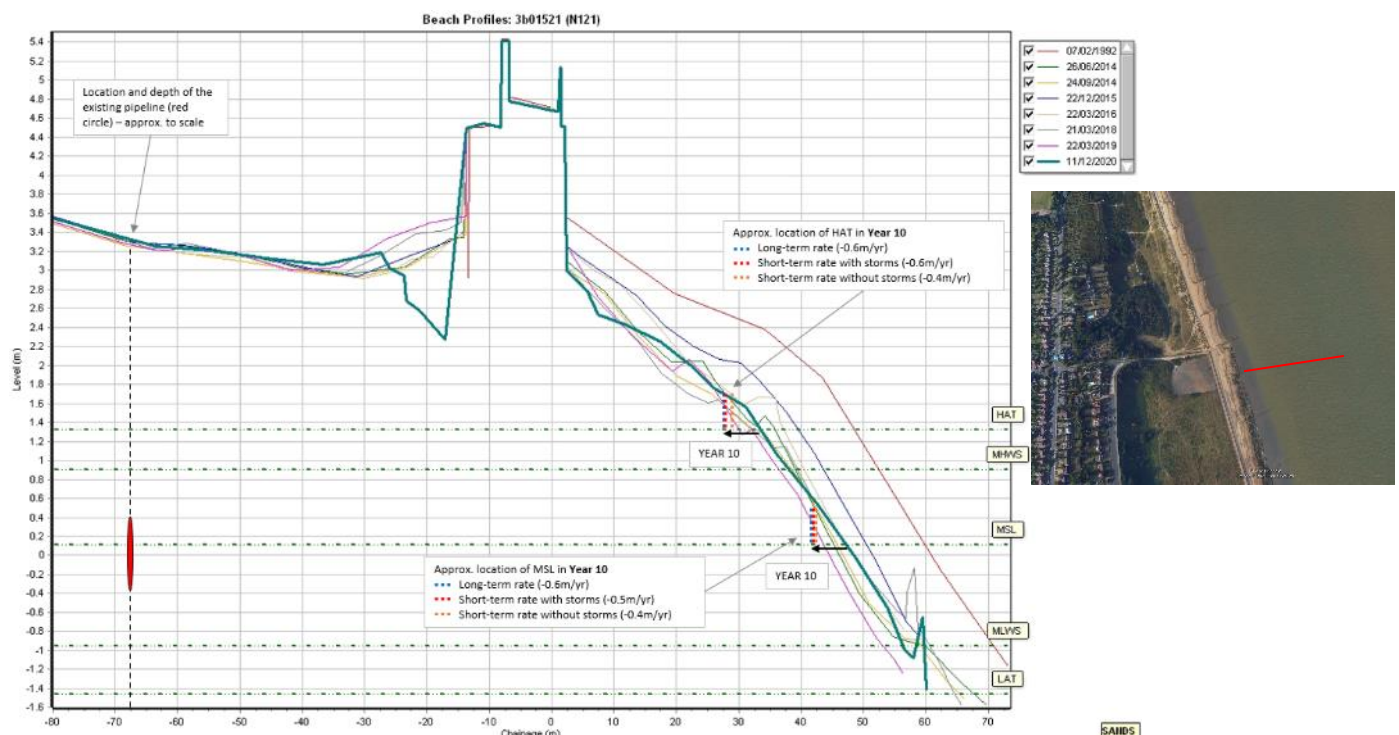
- Fluctuations in beach levels observed with some seasonal changes and onshore movement of an inshore bar.
- Beach levels in December 2015 were the highest since 1992.
- A retreat of MSL observed between December 2015 and March 2019 (around 7 m), partial recovery by December 2020 (around 4 m). Therefore, a net retreat of 3 m from March 2019 to December 2020.
- Latest survey (December 2020) shows the lowest recorded beach levels at the toe of the defence (around 3 mOD).

Figure A 1: Beach profile 3b01521 N121 – Links Road.

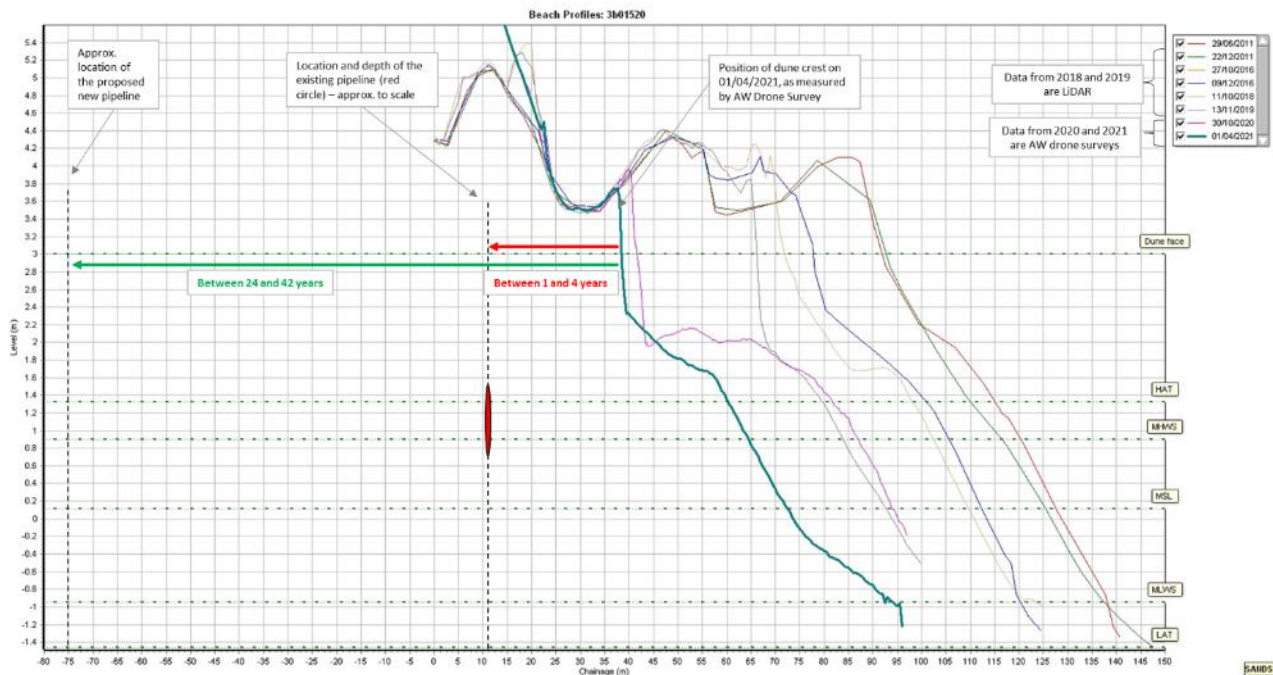
Figure A 2 shows profile 3b01520 LW008, located immediately north of Links Road, at southern Gunton Warren. Progressive retreat of the dune and beach face was observed since 2011, when records along this profile began. This figure also shows the LiDAR records for 2018 and 2019.

Figure A 2: Beach profile 3b01520 LW008 – southern Gunton Warren.

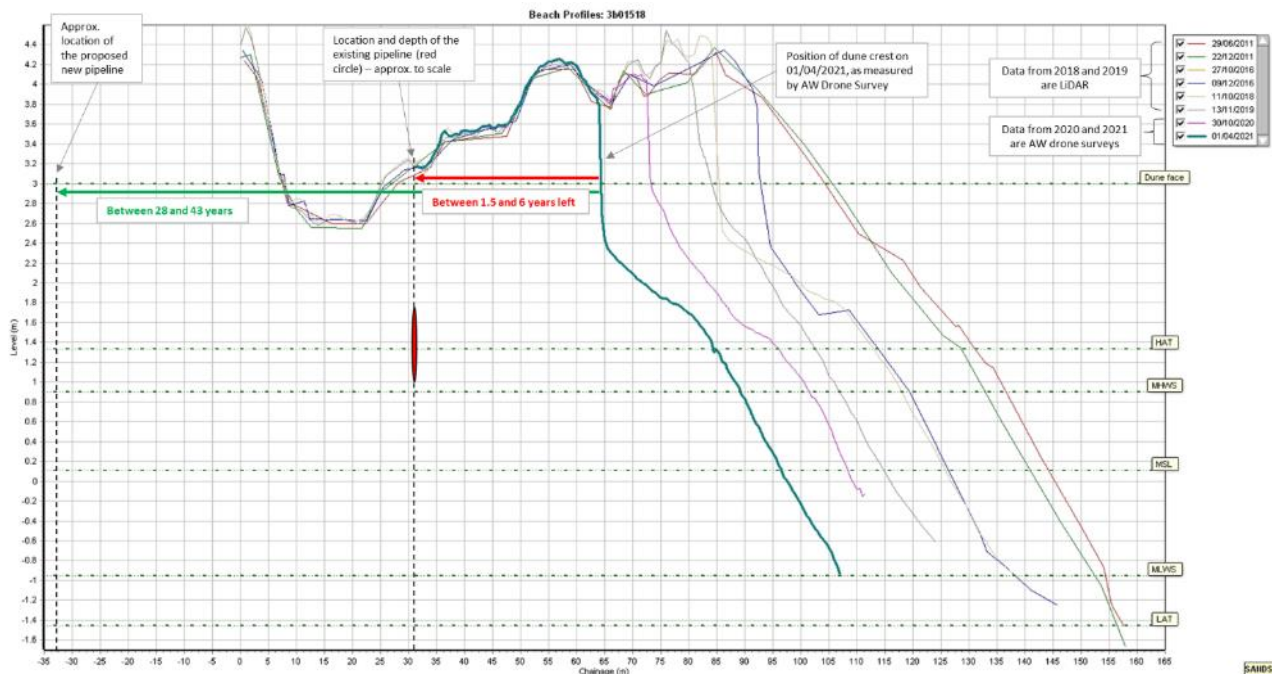
Figure A 4 shows profile 3b01518 LW006, located at southern Gunton Warren. Progressive retreat of the dune and beach face was observed since 2011, when records along this profile began. This figure also shows the LiDAR records for 2018 and 2019.

Figure A 4: Beach profile 3b01518 LW006 – southern Gunton Warren.

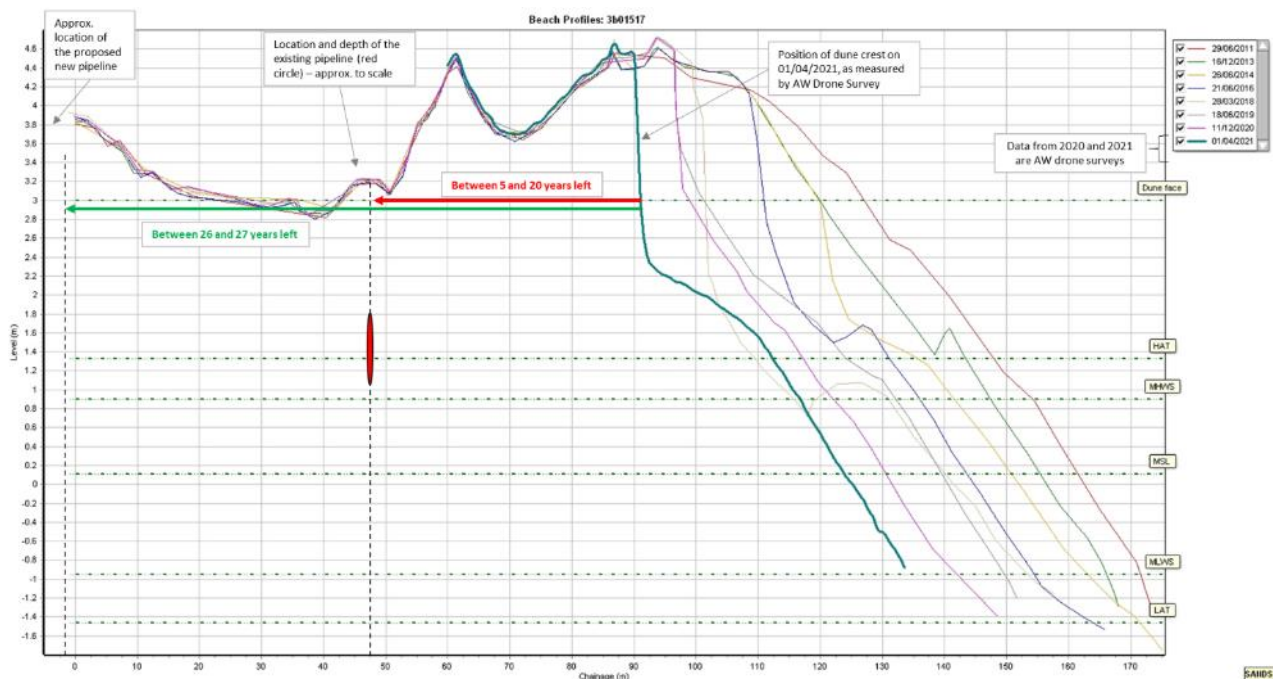
- Further scarping of the dune face and retreat of the beach occurred by June 2014 (probably due to the 2013/2014 storms), by around 7 m.
- Since then, erosion and scarping is evident, with the profile March 2018 showing the lowest recorded levels close to the dune face.
- The latest profile available (Dec 2020) shows a parallel retreat of the beach profile, with a continuation of scarping of both beach face and dune face.

Figure A 5: Beach profile 3b01517 LW005 – southern Gunton Warren.

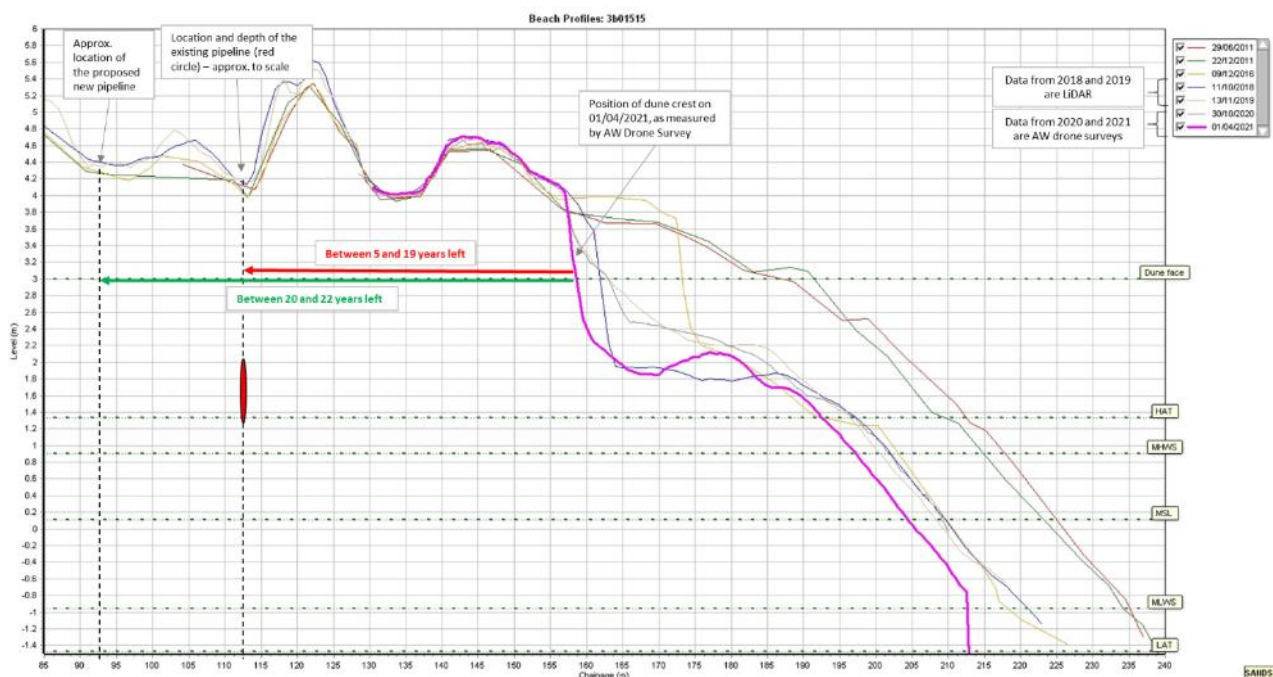
Figure A 6 shows profile 3b01518 LW006, located at southern Gunton Warren. Progressive retreat of the dune and beach face was observed since 2011, when records along this profile began. This figure also shows the LiDAR records for 2018 and 2019.

Figure A 6: Beach profile 3b01515 LW003 – southern Gunton Warren.

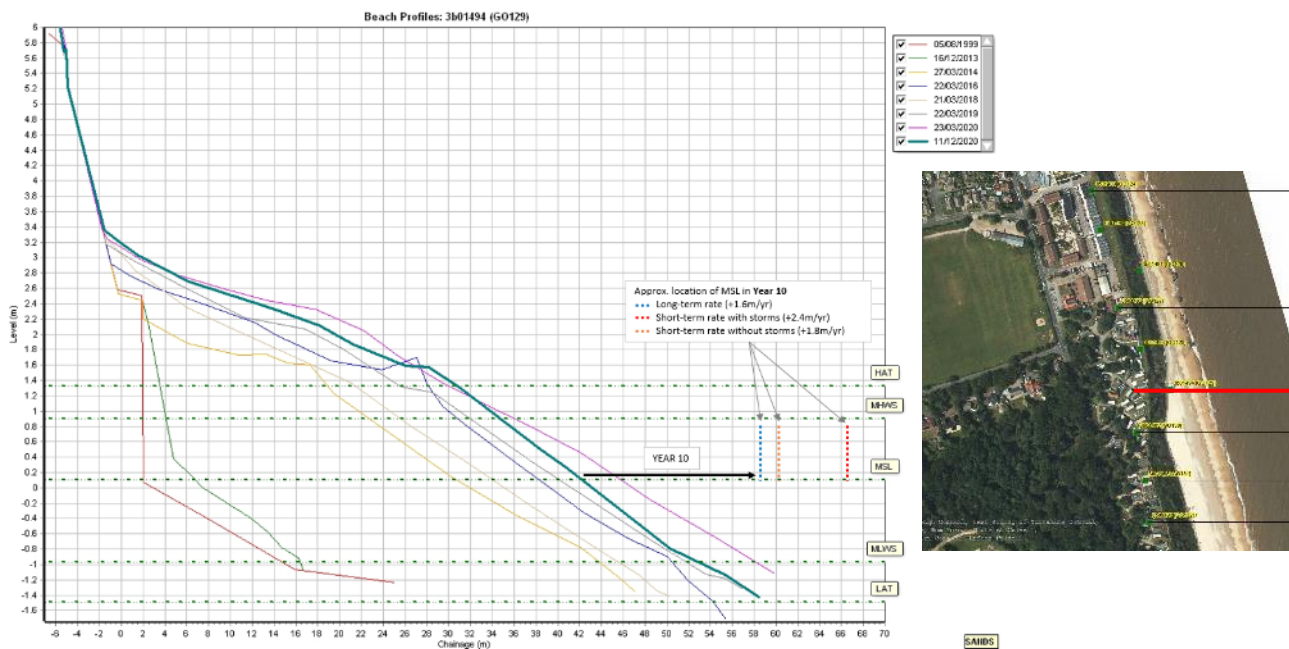
- Beach levels fluctuate with a general accretional trend (around 1.8 m/yr).
- Less fluctuation in beach levels observed since the Strategy.

Figure A 9: Beach profile 3b01494 G0129 – Corton Woods, at Corton Long Lane.

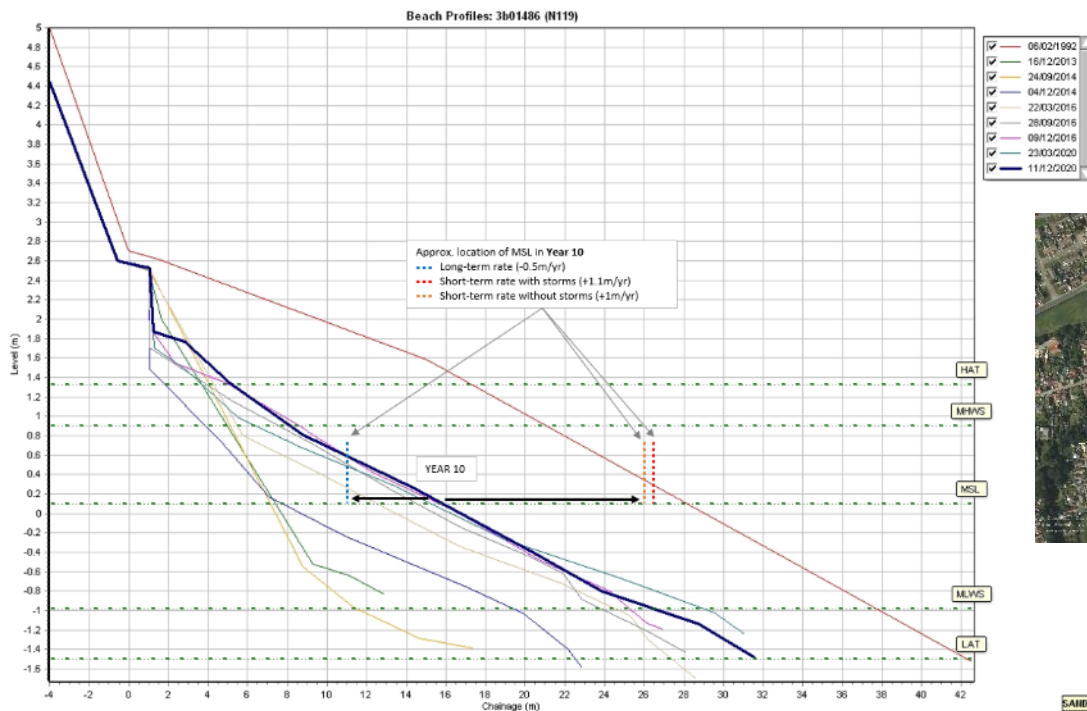
- The beach face seems to have accreted around 1.3 m between September 2014 and March 2016, although there was a substantial drop of around 1 m in December 2014 in front of the revetment.
- Beach levels dropped again in September 2016 by 0.5 m (around 2 m chainage), but beach levels continue the trend of accretion with current levels 1.4 m higher than September 2014 at MSL.

Figure A 10: Beach profile 3b01486 N119 – Corton, at Tibbenham's Score.

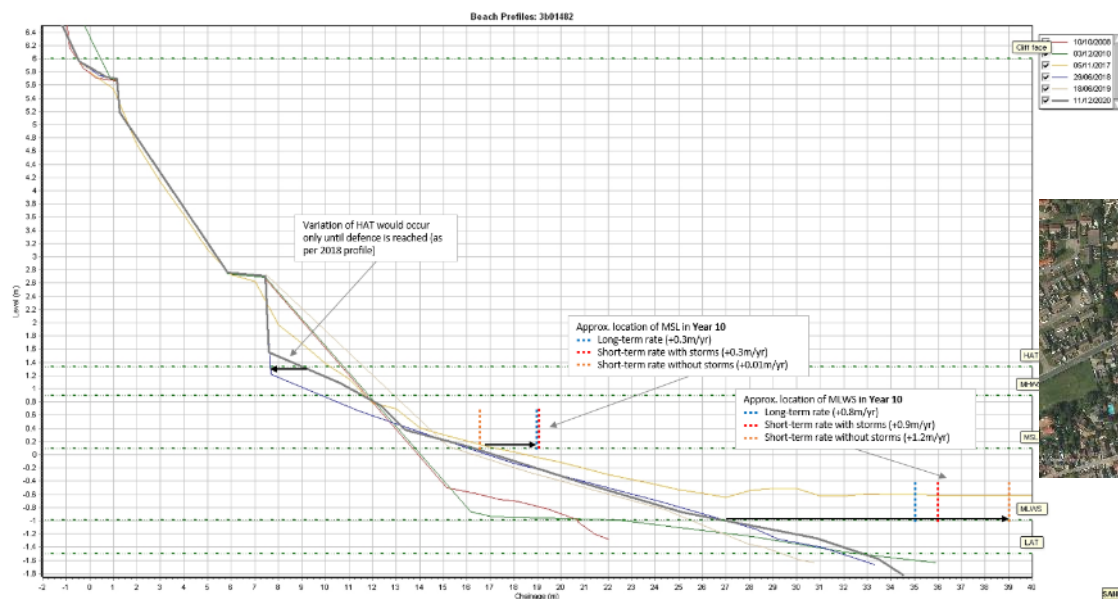
Figure A 11 shows beach profile 3b01482 G0118 at Tingdene Waterside Park. Records along this profile started in October 2008. The following was observed throughout the whole record:

- Fluctuations of beach levels reached their lowest point (at 0.8 mOD, around MHWS) in front of the defence (around 7.5 m chainage) in June 2018.
- Recovery in beach levels were observed until June 2019, before a drop again in December 2020.

Figure A 11: Beach profile 3b01482 G0118 – Tingdene Waterside park.

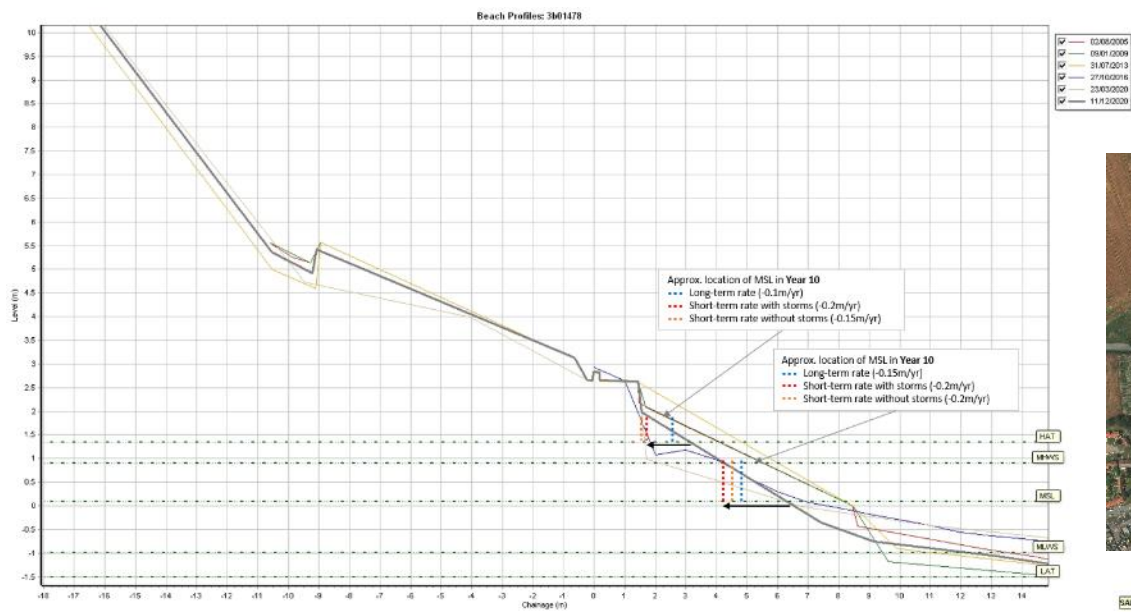
Figure A 12 shows beach profile 3b01478 G0114, at Wy-Wurry, just south of Baker's Score. Records along this profile started in August 2005. The following was observed throughout the whole record:

- Fluctuations of beach levels reached the lowest point (at 0.8 mOD, around MHWS) in front of the defence around in March 2020.
- Some recovery in beach levels occurred between March 2020 and December 2020.
- Some erosion at the landward side of the defence (around -10 m chainage) was observed until July 2013 but works have since been completed to improve the cliff protection in the area.

Figure A 12: Beach profile 3b01478 GO114 – South of Baker's Score at Wy-Wurry.

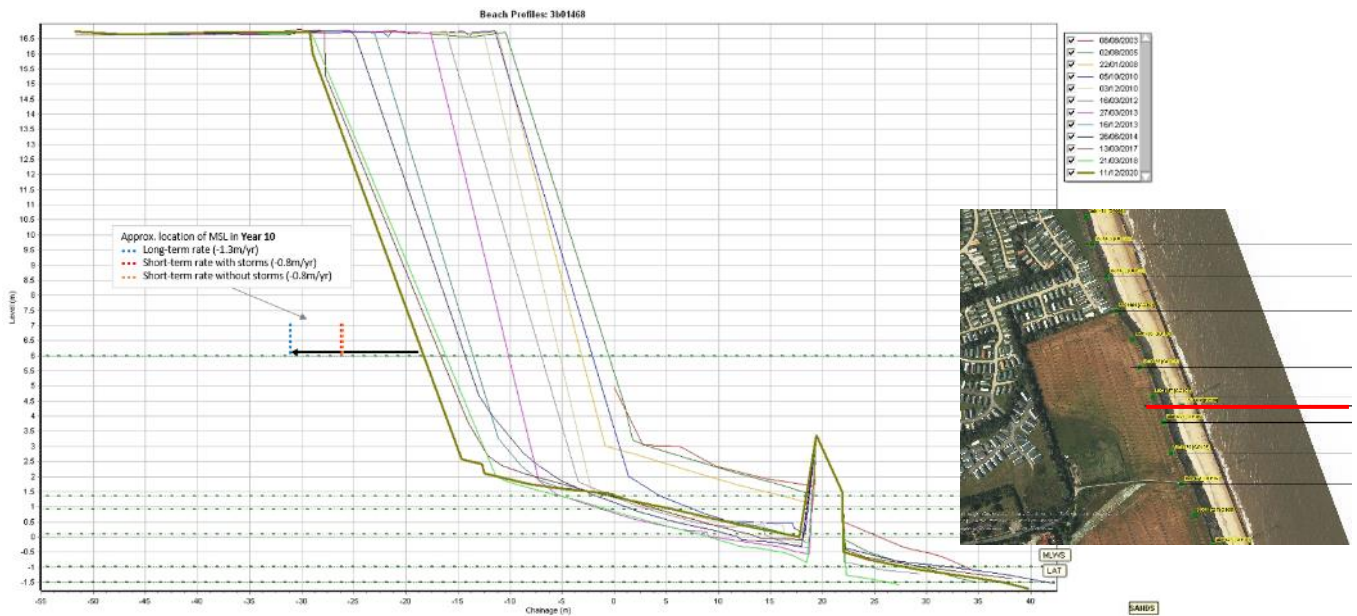
Figure A 13 shows beach profile 3b01468 GY30 at Church Farm South. Records along this profile started in August 2003. The following was observed throughout the whole record:

Figure A 13: Beach profile 3b01468 GY30 – North Corton Cliffs, Church Farm South.

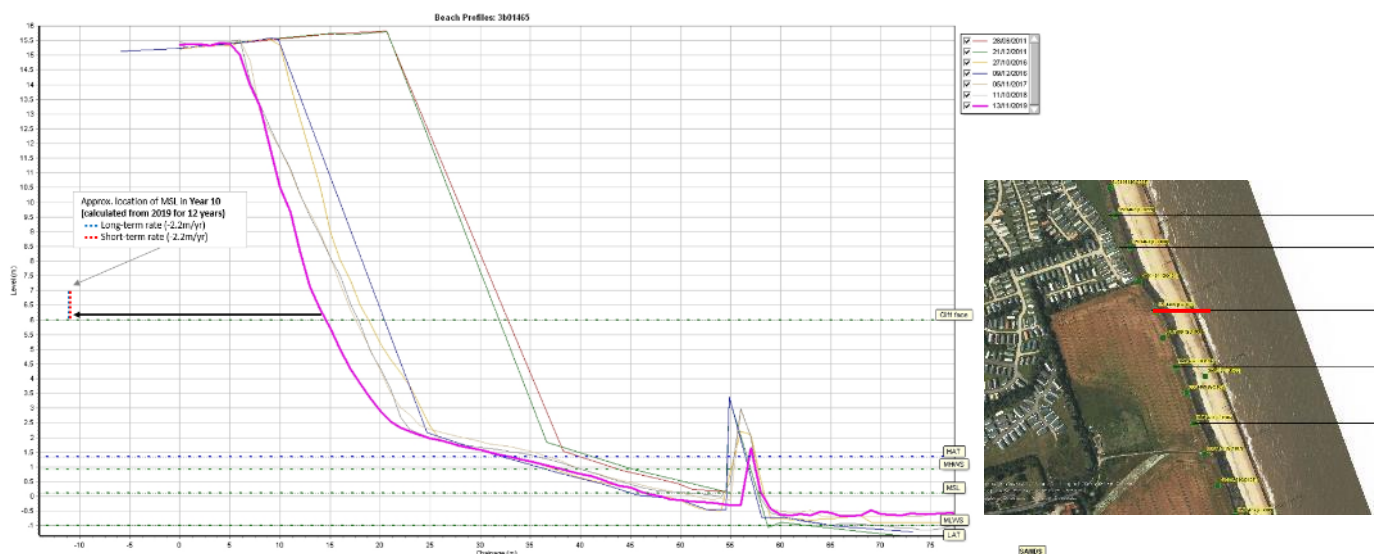
Figure A 14 shows beach profile 3b1465 G0102 at Church Farm. Records along this profile started in June 2011. The following was observed throughout the whole record:

Figure A 14: Beach profile 3b01465 G0102 – North Corton Cliffs, at Church Farm.

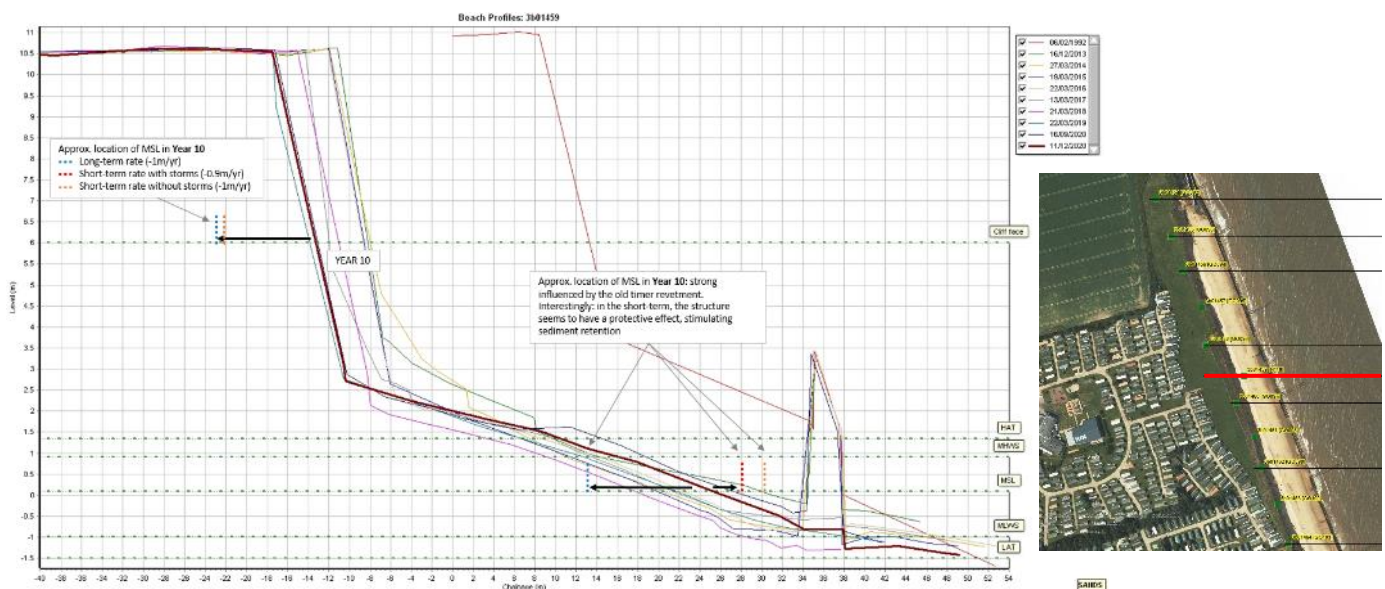
- Significant cliff erosion since 1992 (5 m retreat between 1992 and 1996).
- Beach lowering trend 1999 onwards in front of timber revetment.
- Critical condition reached in 2005 with net drop. As the cliff has eroded, there has been lateral translation of the beach profile between cliff toe and revetment but little change in front of the revetment.
- Gradual cliff retreat between 2009 and 2013 (significant cut back between July and December 2013).

- Continuation of the trends observed in the Strategy
- Between March 2016 and March 2017, a retreat of 3 m has been observed.
- 2018 storms caused beach lowering between the cliff face and the timber revetment of around 0.5 m.
- The cliff face has retreated by around 5 m between March 2014 and December 2020.
- The beach in front of the timber revetment has lowered by around 1 m since December 2013, mostly due to storms in 2014.

Figure A 15: Beach profile 3b01459 N118 – Corton Cliffs, at Broadland Sands Holiday Park.

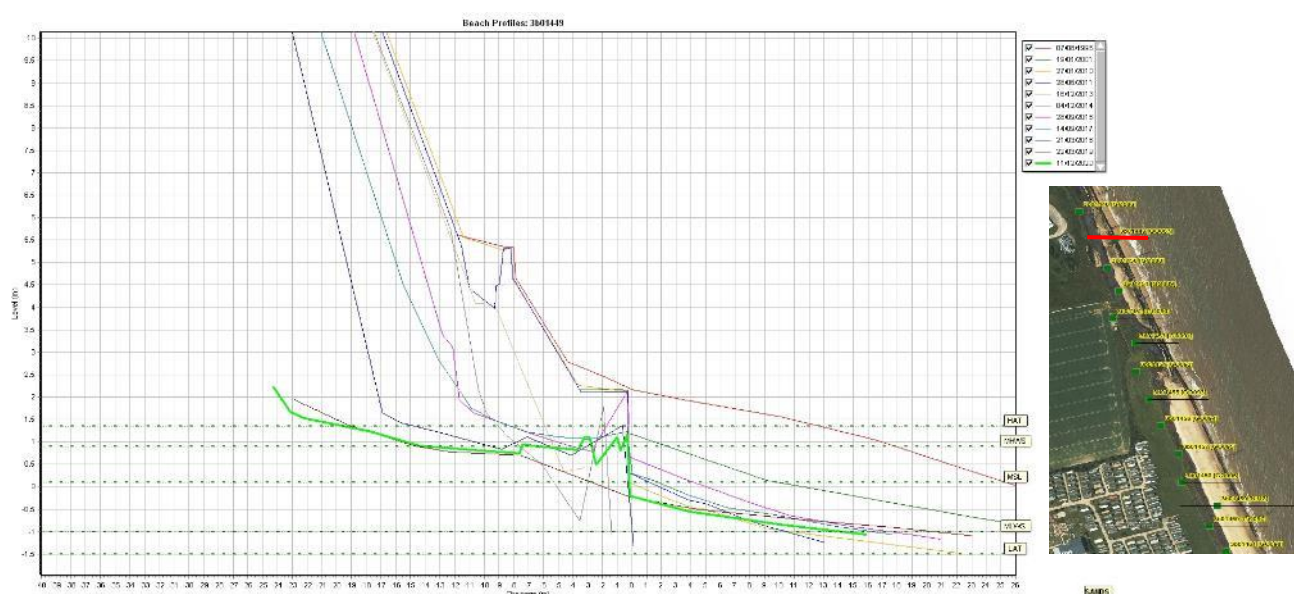
- By January 2010 beach levels dropped considerably, reaching MSL (0.2 mOD) in front of the defence.
- By June 2011, although beach levels had recovered slightly, cliff instability behind the defence is evident.
- By December 2013 (following the storms of 5th December), defences seemed to have failed and the cliff cut back. It is possible that this was a turning point in terms of cliff erosion, as cliffs have been retreating at a fast pace (4.9 m/yr measured at 2 mOD, between 2016 and 2020 – See Figure B 17).
- More recently (December 2020), beach levels in front of the defence are still around MSL, but the cliff has significantly retreated.

Figure A 18: Beach profile 3b01449 G087 – North Corton: RAF Hopton

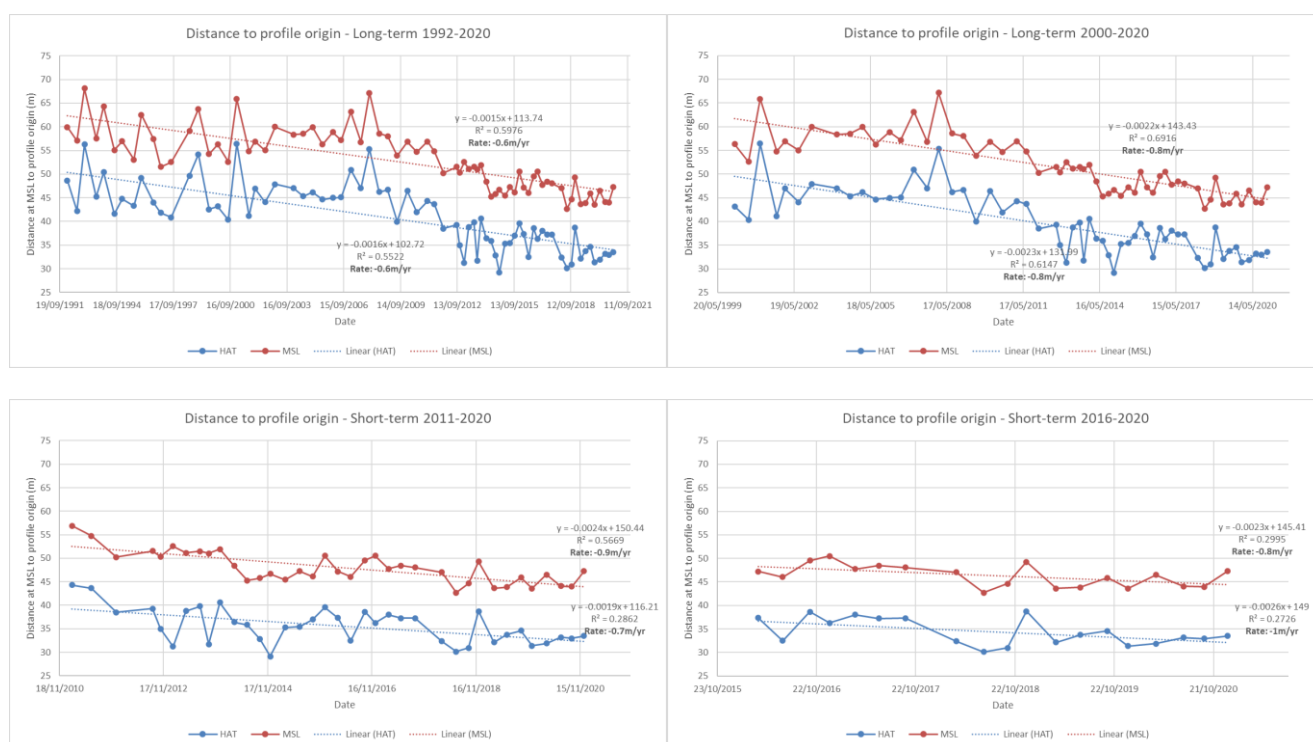
Figure B 1: Regression analysis at beach profile 3b01521 N121 – Links Road

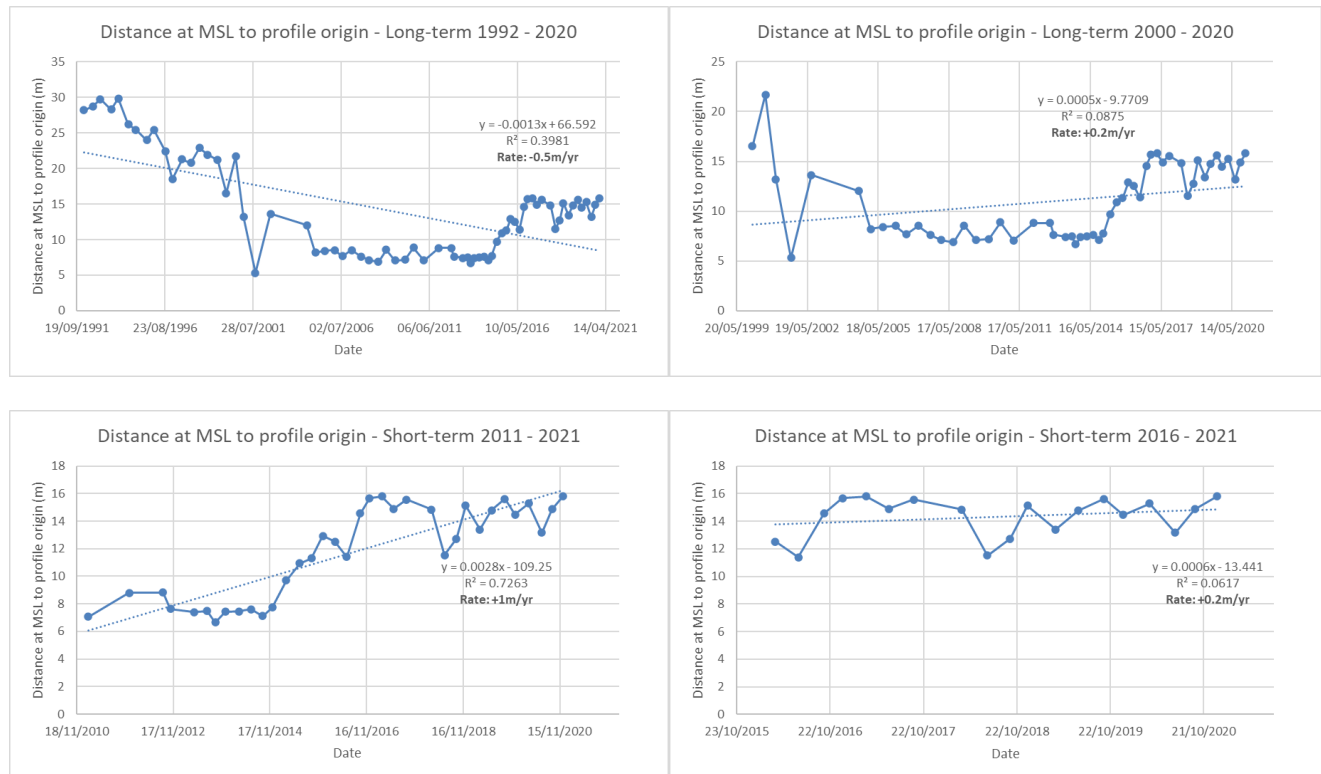
Figure B 10: Regression analysis at beach profile 3b01486 N119 – Corton, at Tibbenham's Score.

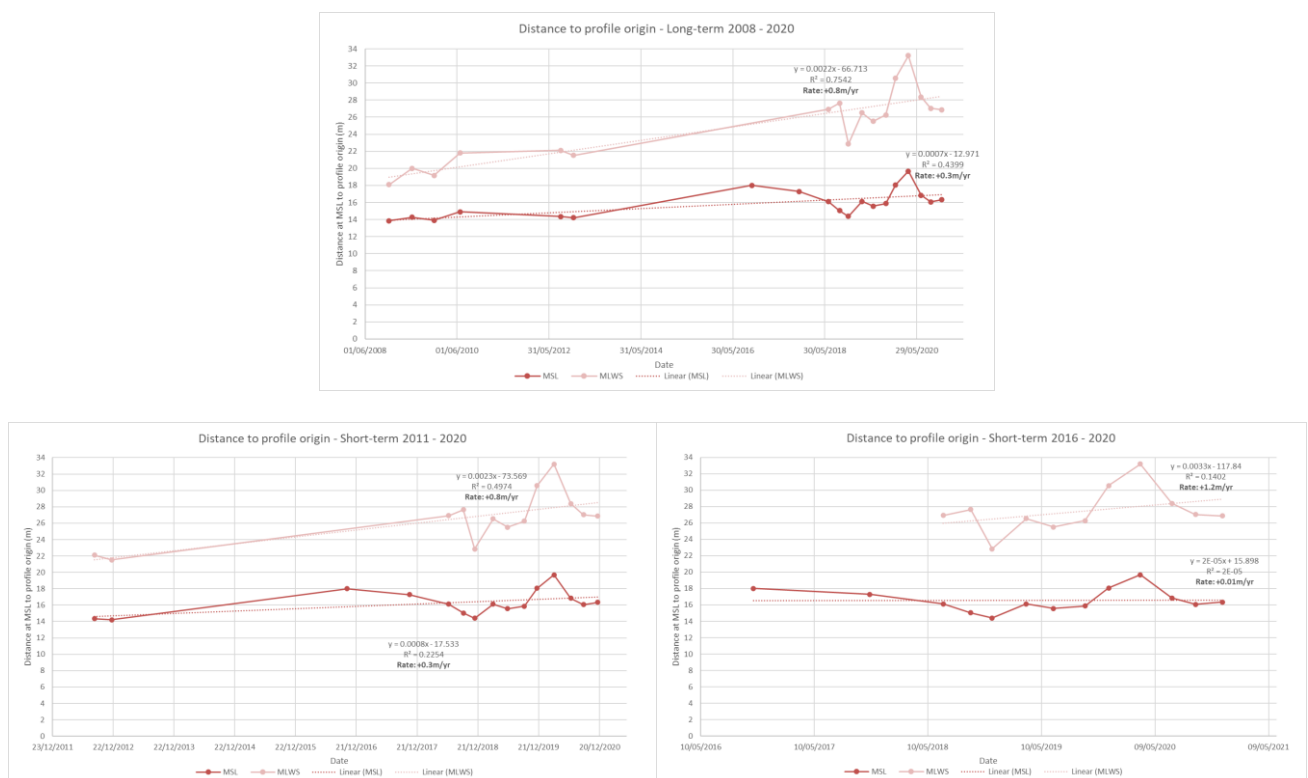
Figure B 11: Regression analysis at beach profile 3b01482 G0118 – Tingdene Waterside park.

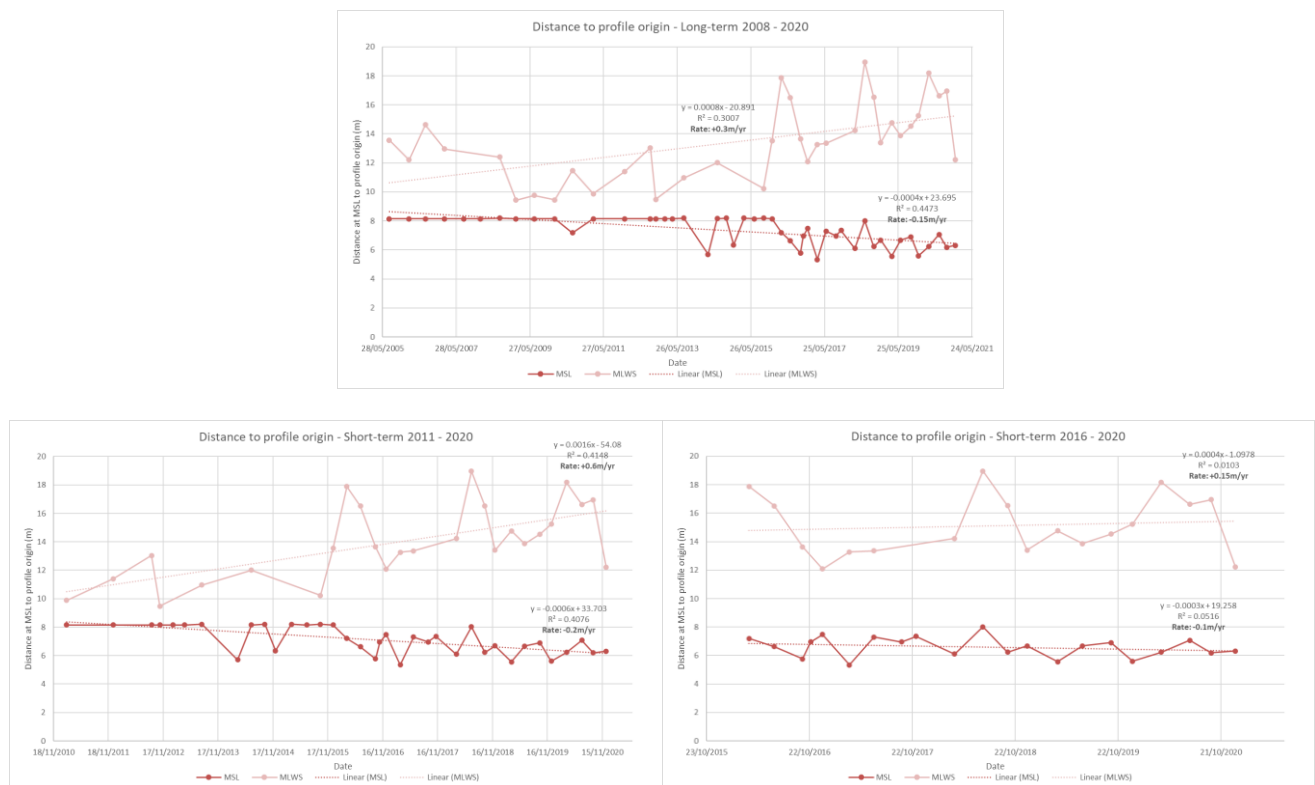
Figure B 12: Regression analysis at beach profile 3b01478 GO114 – South of Baker's Score at Wy-Wurry.

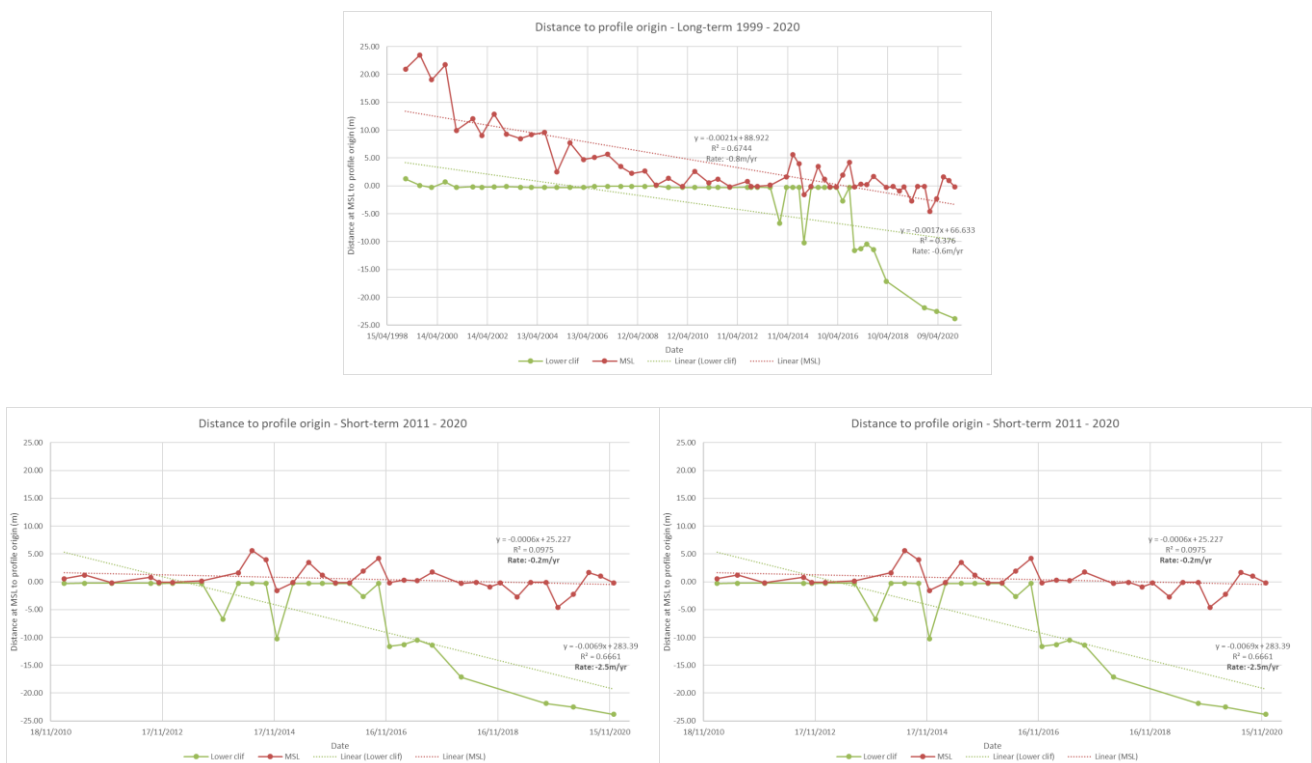
Figure B 17: Regression analysis at beach profile 3b01449 G087 – North Corton: RAF Hopton

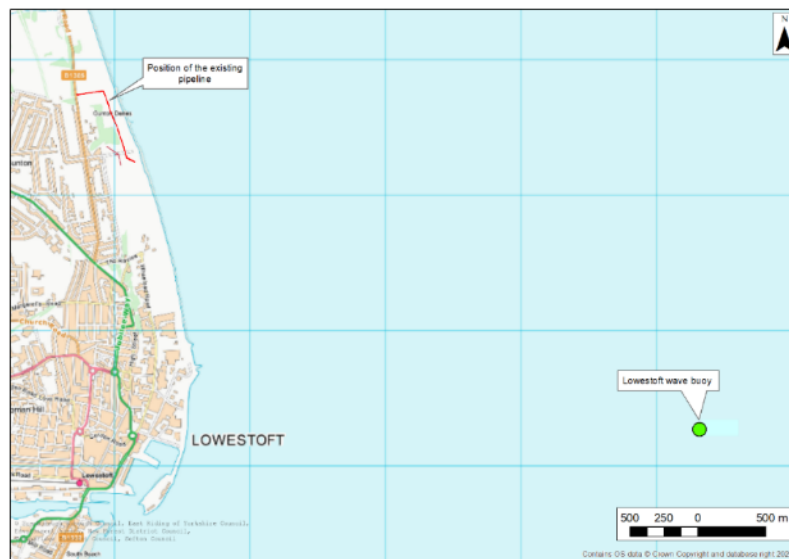
Figure D 2: Location of wave buoy used for wave climate analysis.
