Pakefield Monthly Monitoring Report

Date and Time of survey: August 28, 2024 10:41

Reason for Inspection: Scheduled

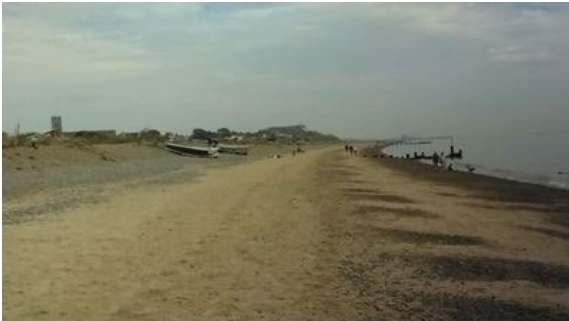
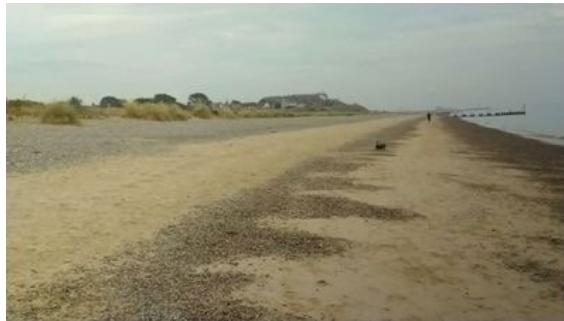
Beach photos looking north:

Extension of beach cliffing alongshore: Negligible change

Landward recession of beach cliff: Negligible change

Change in gradient of beach cliff face: Slightly flatter (trampling)

Maximum height of beach cliff (m): 2

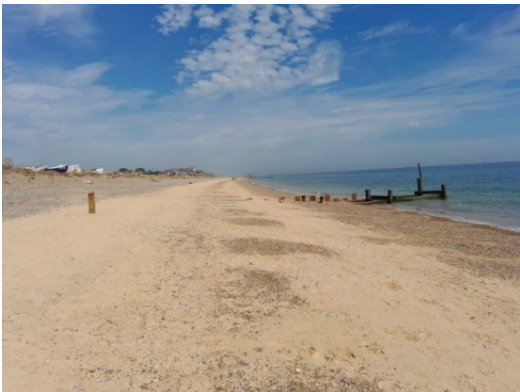
Photo of exposed timber groyne:

Change in beach level relative to exposed timber groyne opposite Grand Avenue: Slight increase (below mean high water)

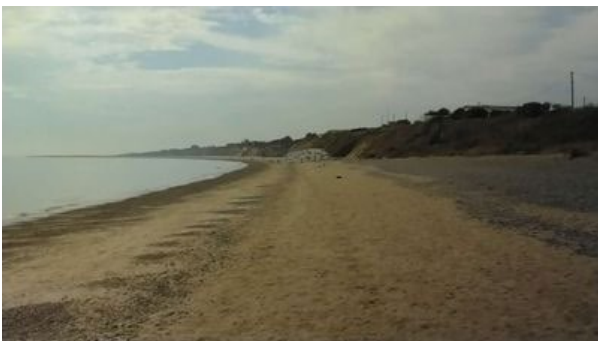
Photos of beach north of Arbor Lane:

General impression of beach volume: No Change

Comments on change in beach geomorphology: The shingle berm noted previously near the high-water mark, has been dispersed, possibly during the higher tide levels and wave action noted above. There was a slight improvement in the lower foreshore level and therefore a reduction in its characteristically steep gradient.

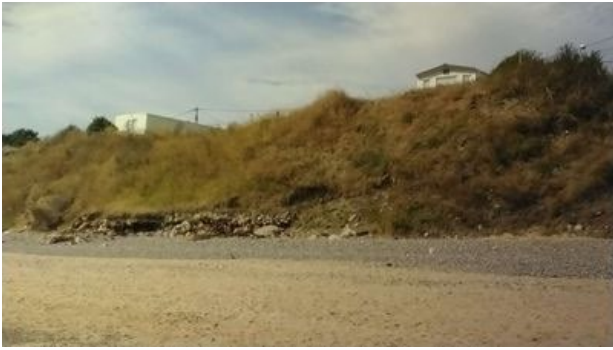
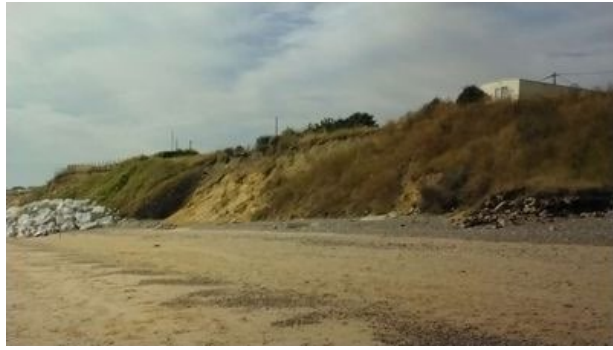
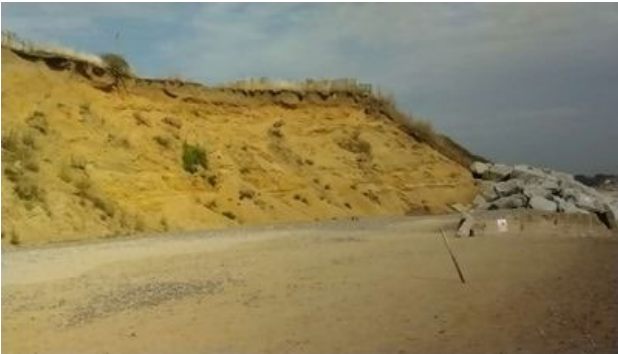
Photos of soft unconsolidated sand cliffs:

Changes to soft unconsolidated sand cliffs north of rock armour: Slumped material on cliff face; denuding and loss of vegetation; scree at base of cliff; fallen vegetation at base of cliff.

Changes to soft unconsolidated sand cliffs south of rock armour: Slumped material on cliff face; denuding and loss of vegetation; cliff-face steepening and overhanging; scree at base of cliff; fallen vegetation at base of cliff.

Comments: Recorded conditions would indicate it was unlikely that the cliffs were reached by seas in August, and there was no evidence seen to suggest otherwise. The loss of fine dry material continues however, from the steep cliff face behind the south end of the rock, leaving an overhanging (probably unstable) upper topsoil layer. It appeared that seas had reached further landward, toward the cliffs, through the gap in the concrete walling sections. North of the rock, where the cliff face was undermined and steepened by seas last winter, the process of loss of dry material is also apparent. Extensive vegetation growth continues to obscure much of the cliff face in this area. As previously there were two caravans seaward of The Cliffs access road (photo below).

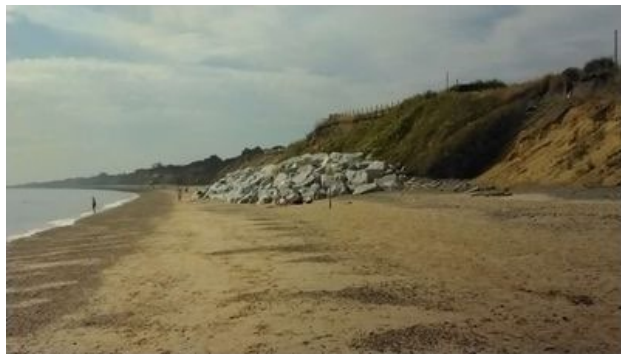
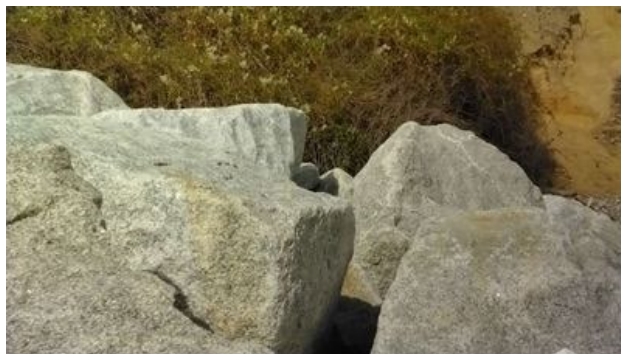
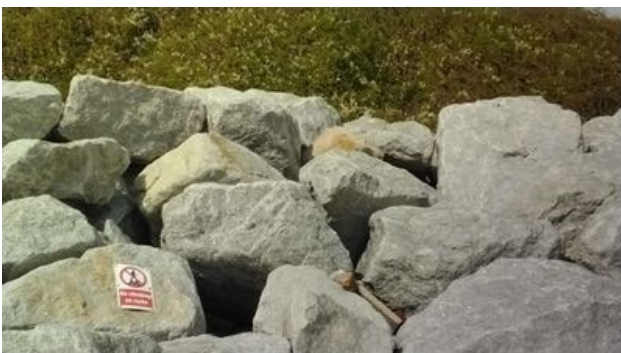
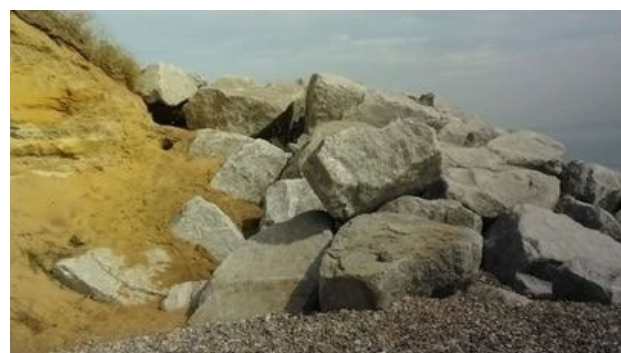
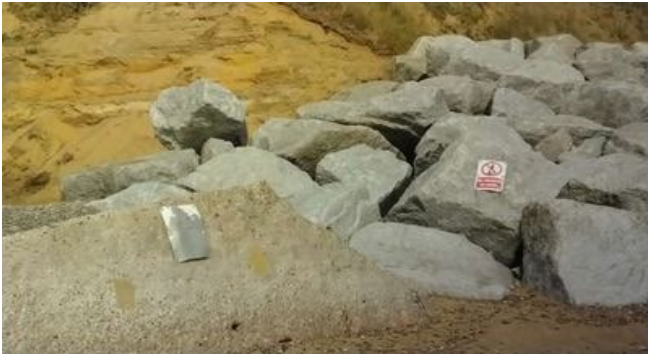
Photos of rock armour:

Packing of rock: Overall satisfactory

Cross-sectional profile: Satisfactory

Beach levels surrounding rock armour: Average

Beach access around the rock armour: Dry access available past rock armour around time of low tide

Stability of cliff behind rock armour: No obvious change apparent behind the main rock structure, as viewed from the beach (note vegetation growth obscures part of the cliff face).

Asset condition grade: 2 Good; rock armour condition satisfactory; no change in protection

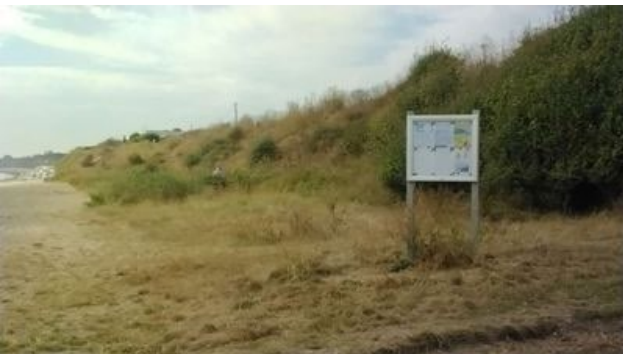
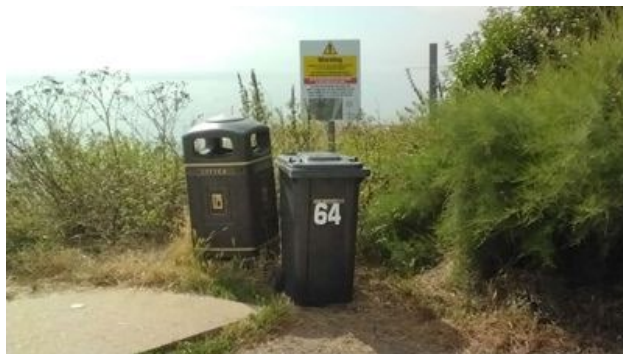
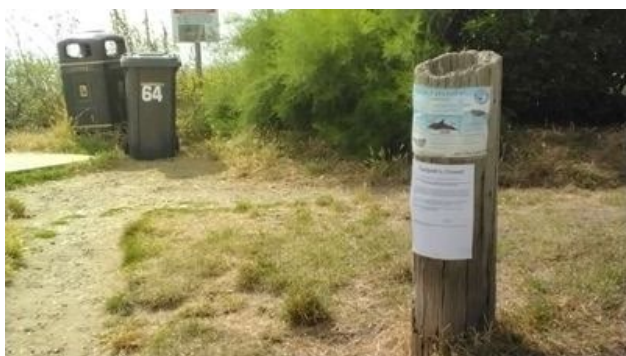
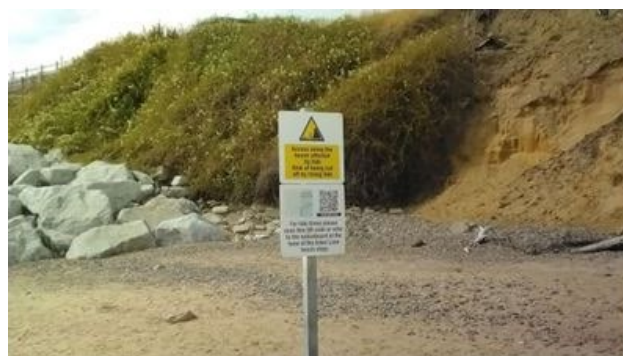
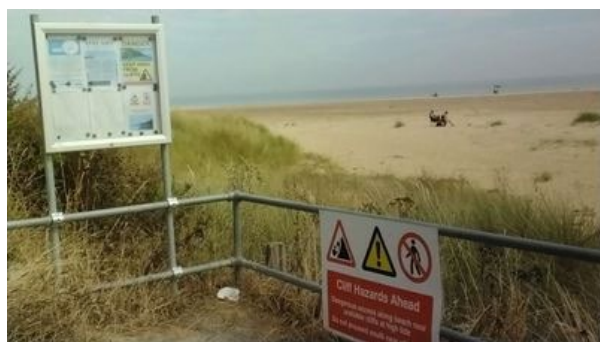
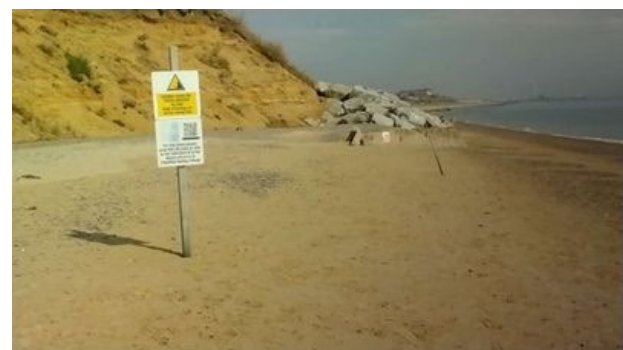
Photos of signage:

Signage in place, intact and fixings secure? Yes

Adequacy of signage: Signage and information provided is adequate.

Provision of tidal information: Both sets of tide tables were updated during the inspection

Comments on signage: Suffolk County Council have placed information near the seaward end of Arbor Lane (timber post as photo below) confirming that public footpaths have been closed for a further year until August 2025.

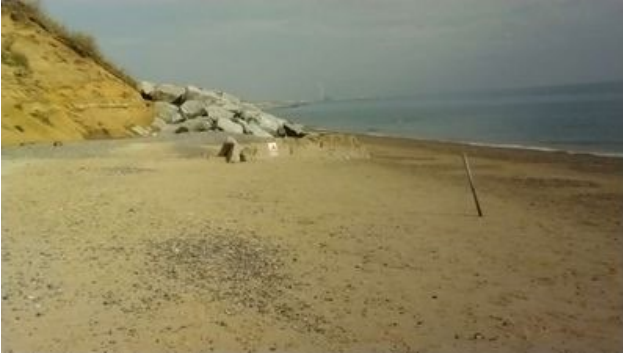
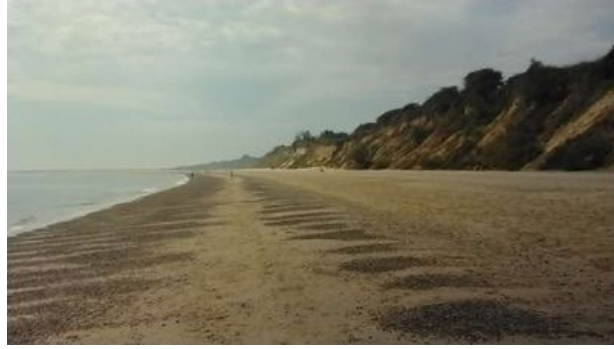
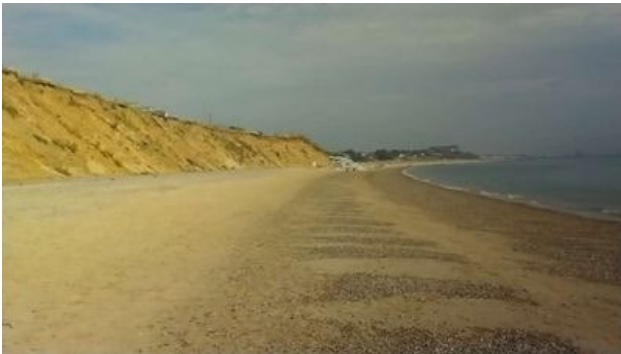
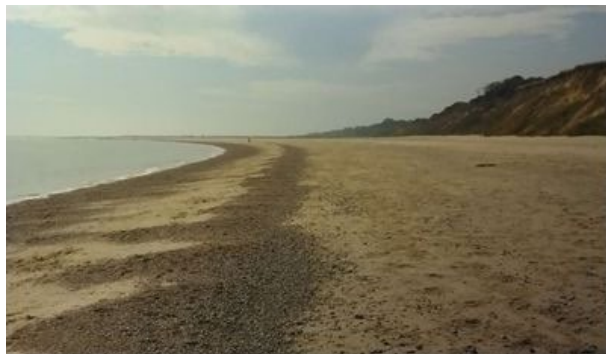
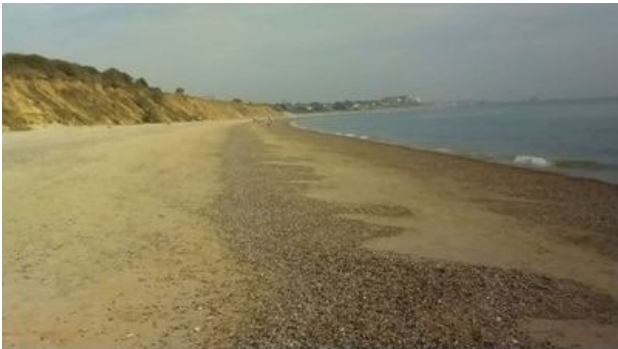
Photos of southern beach:

General impression of beach volume: Little overall change

Comments on change to southern beach: As for northern beaches, the shingle berm noted previously has been dispersed and there has been a slight increase in the lower foreshore levels.

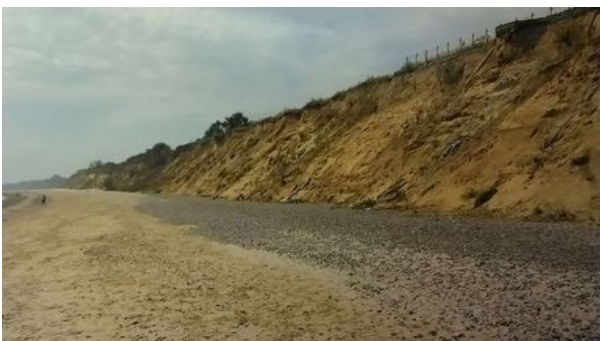
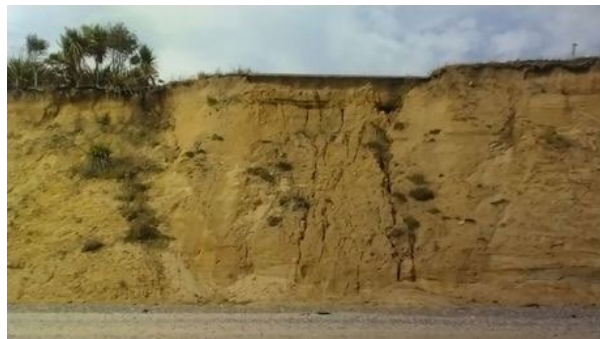
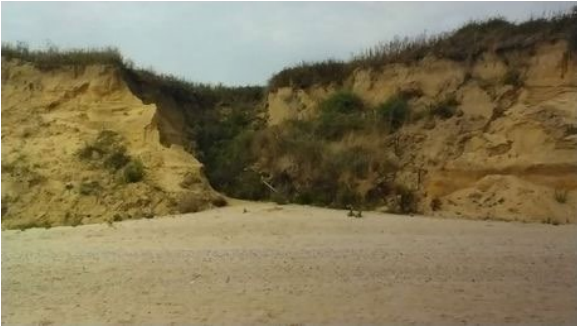
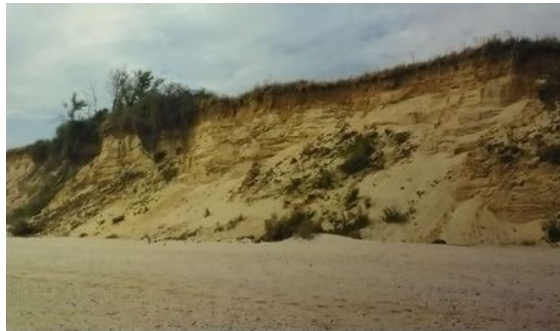
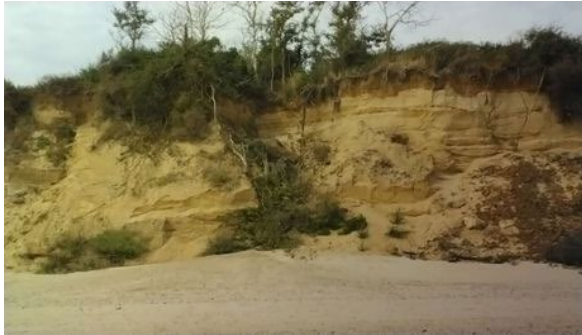
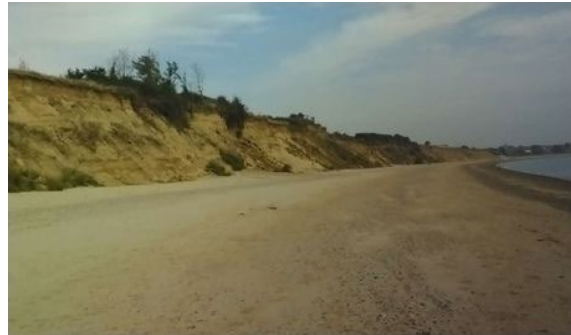
Photos of southern cliffs:

Changes to southern cliffs: Slumped material on cliff face; denuding and loss of vegetation; cliff-face steepening and overhanging; scree at base of cliff; fallen vegetation at base of cliff.

Comments on cliff change and any risk posed: As noted above, there was no evidence cliffs had been reached by seas during the previous month. Loss of dry and poorly consolidated material from cliff faces continues in places.

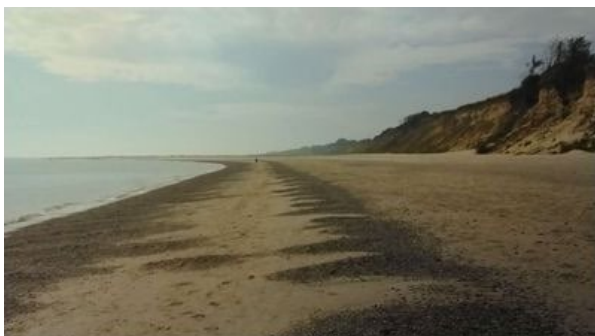
Photos of Pontins frontage and Benacre Ness:

Changes to beach geomorphology: Increased establishment of vegetation, and accumulations of wind-blown sand establishing raised beach areas.

Comments on change at Benacre Ness: Trend for widening beach appears to be continuing. No evidence of surface water discharge from adjacent the Pontins beach access and very little standing water remaining visible on The Ness.

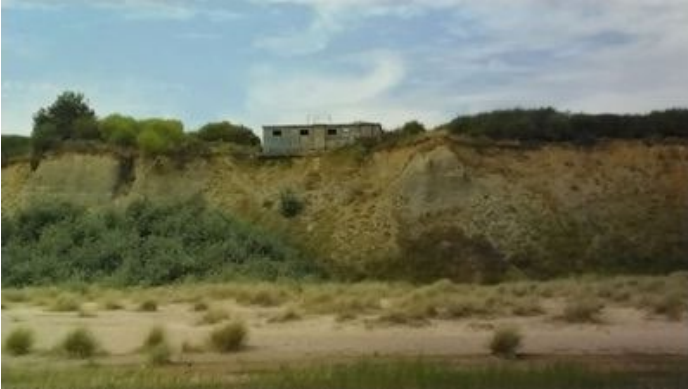
Photo of cliff top structure:

Changes in cliff stability: No obvious change apparent from beach
