Pakefield Monthly Monitoring Report

Date and Time of survey: March 5, 2025 06:57

Reason for Inspection: Scheduled

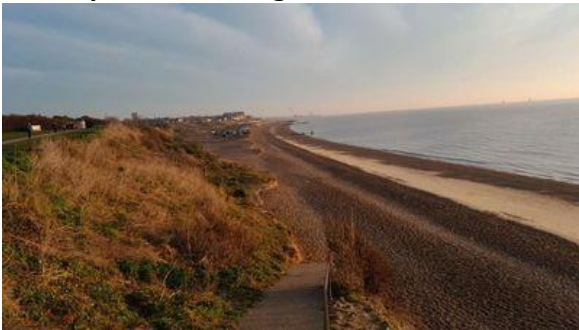
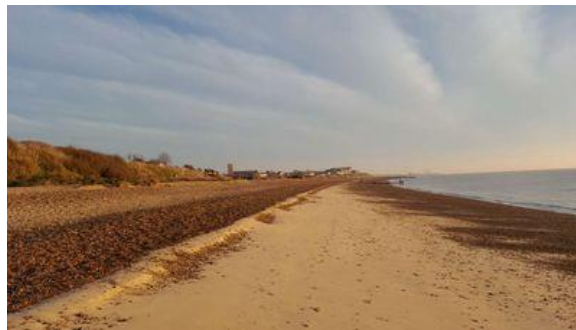
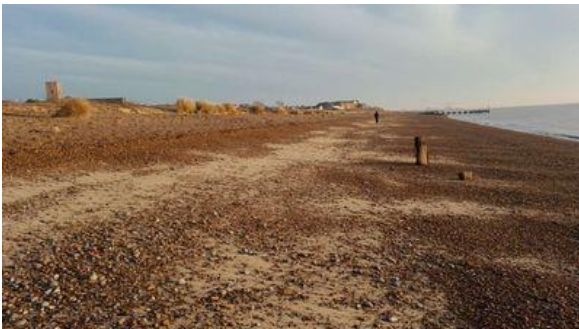
Beach photos looking north:

Extension of beach cliffing alongshore: Negligible change

Landward recession of beach cliff: Negligible change

Change in gradient of beach cliff face: Slightly flatter (accumulation or trampling)

Maximum height of beach cliff (m): 1.5

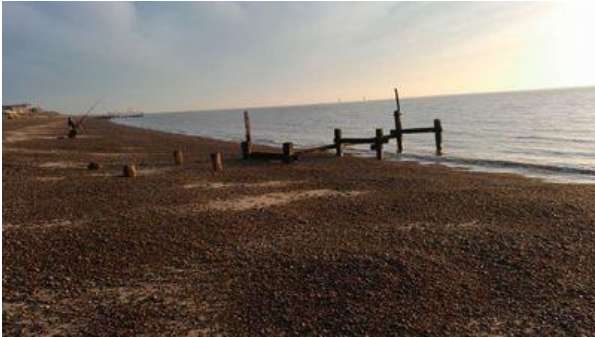
Change in beach level relative to exposed timber groyne opposite Grand Avenue: Negligible change
Photo of exposed timber groyne:

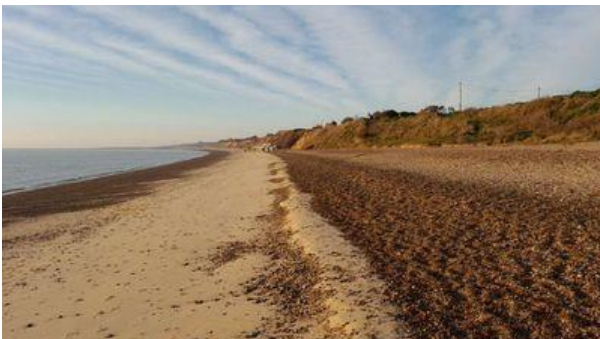
General impression of beach volume: Overall, moderately increased
Photos of beach north of Arbor Lane:

Comments on change in beach geomorphology: There has been an extension seaward of the shingle rich berm around the spring high tide level. Its seaward edge has been 'cliffed' slightly by most recent conditions. The impression was of improvement of the foreshore levels and reduction in gradient.

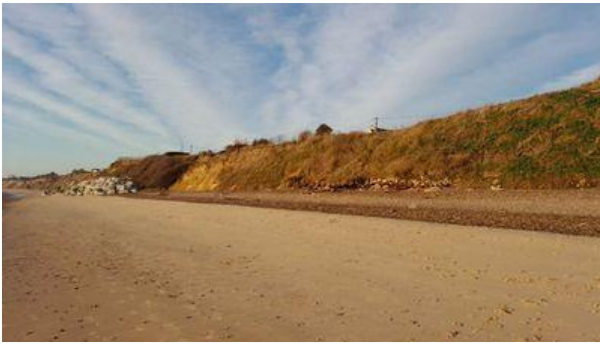
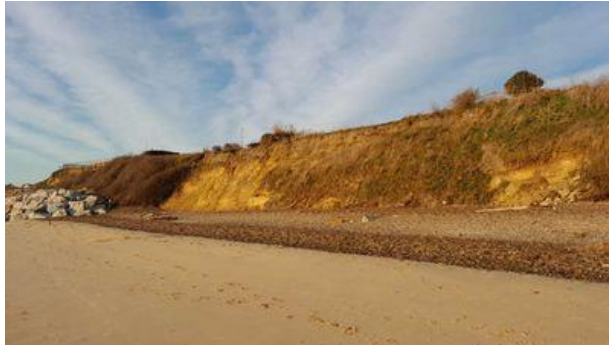
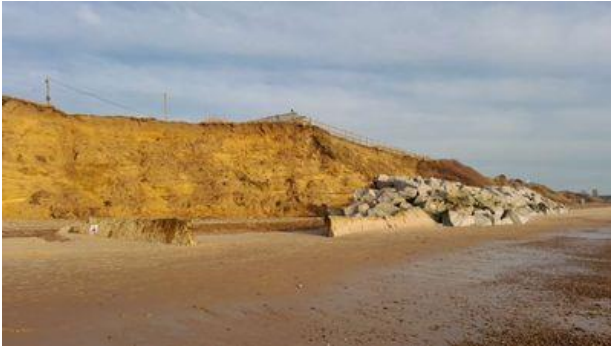
Photos of soft unconsolidated sand cliffs:

Changes to soft unconsolidated sand cliffs north of rock armour: Slumped material on cliff face; denuding and loss of vegetation; cliff-face steepening and overhanging; scree at base of cliff.

Changes to soft unconsolidated sand cliffs south of rock armour: Slumped material on cliff face; denuding and loss of vegetation; cliff-face steepening and overhanging; scree at base of cliff; fallen vegetation at base of cliff.

Comments on risk to cliff-top assets: No clear evidence that seas have reached the cliffs during the past month, although in places they retain steepened faces. Beaches above Mean High Water are currently relatively healthy.

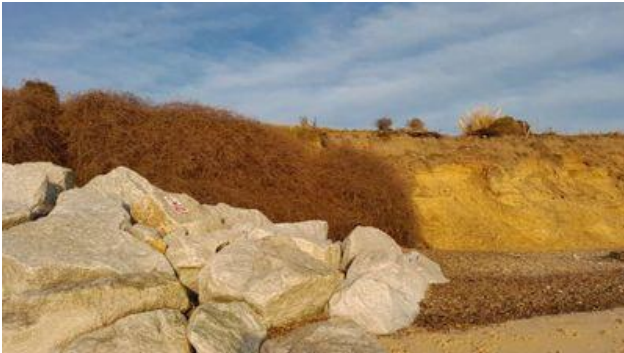
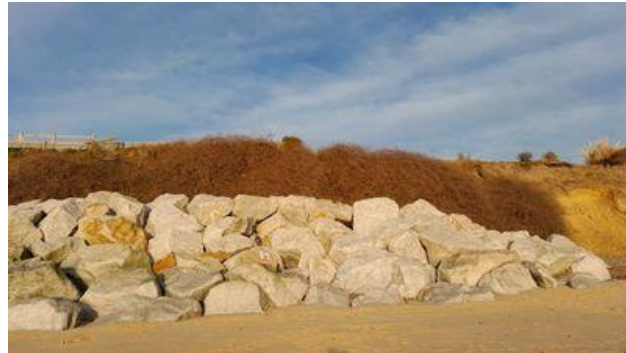
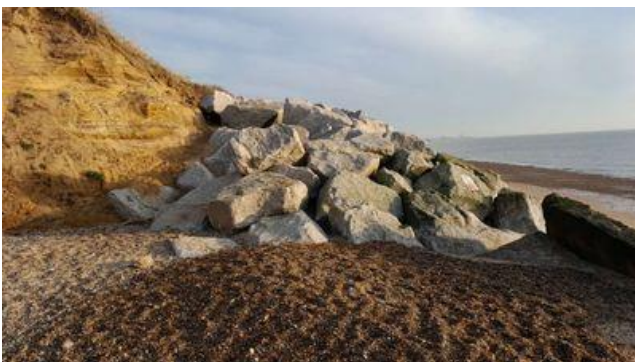
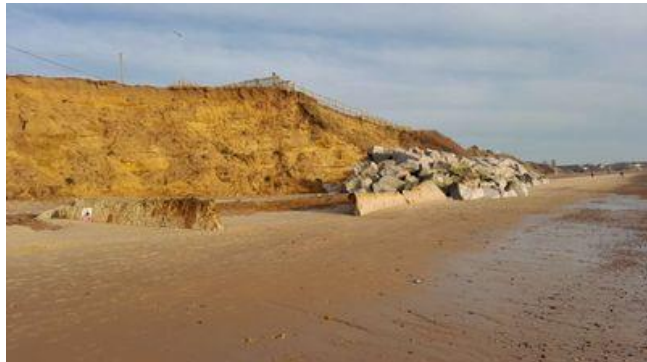
Photos of rock armour:

Packing of rock: Overall satisfactory

Cross-sectional profile: Satisfactory

Beach levels surrounding rock armour: Average

Beach access around the rock armour: Dry access available past rock armour around times of low tide

Stability of cliff behind rock armour: As previous, no obvious or significant mass change apparent behind the main body of the rock structure, as viewed from the beach (vegetation growth obscures part of the cliff face).

Asset condition grade: Asset condition grade: 2 Good; rock armour condition satisfactory; no change in protection

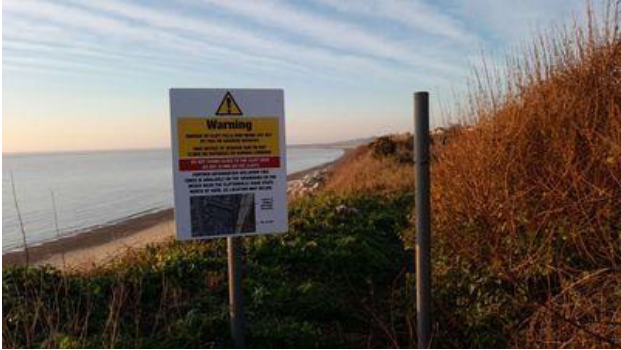
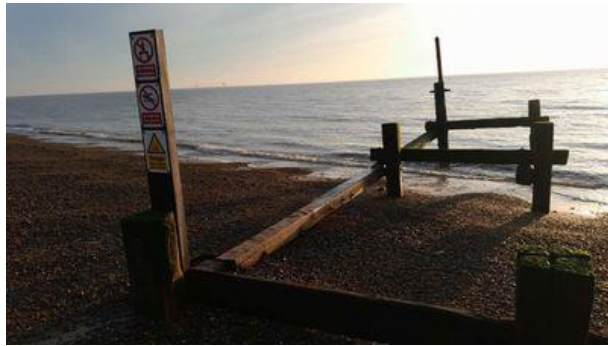
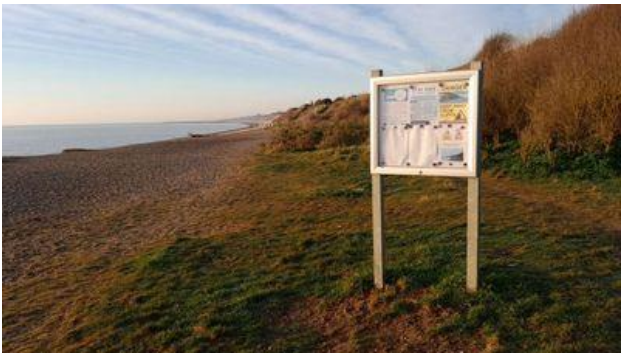
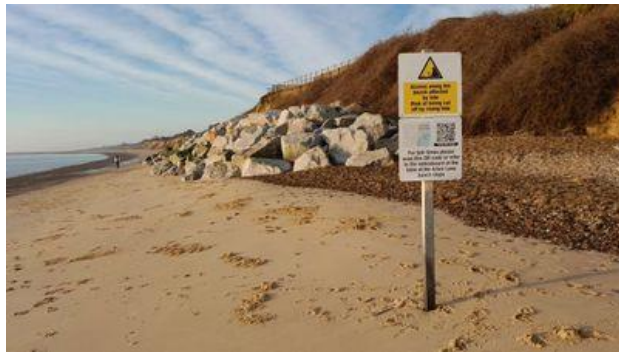
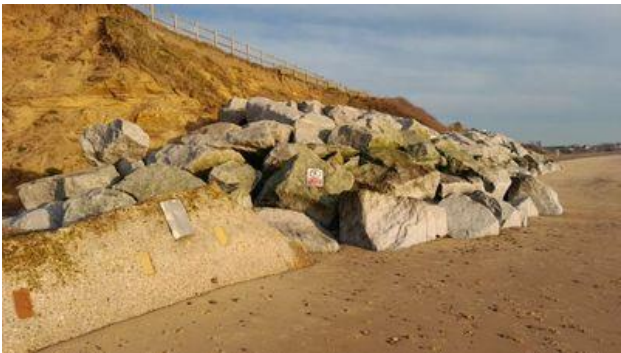
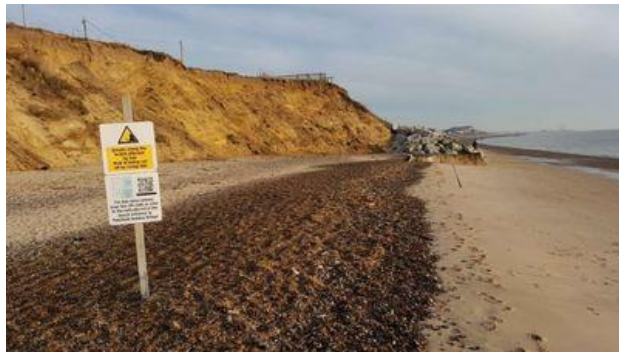
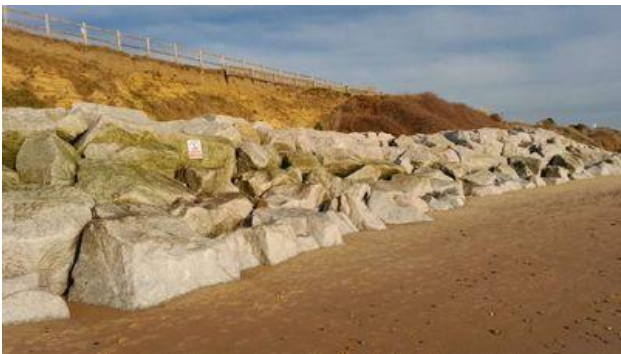
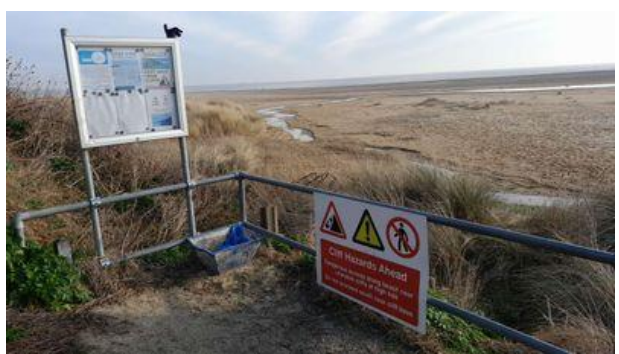
Photos of signage:

Signage in place, intact and fixings secure? Yes

Adequacy of signage: Satisfactory

Provision of tidal information: Up to date and legible – Monitor

Comments on signage: No change from previous month's report

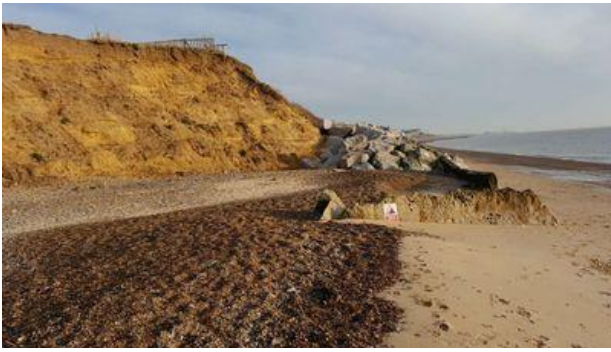
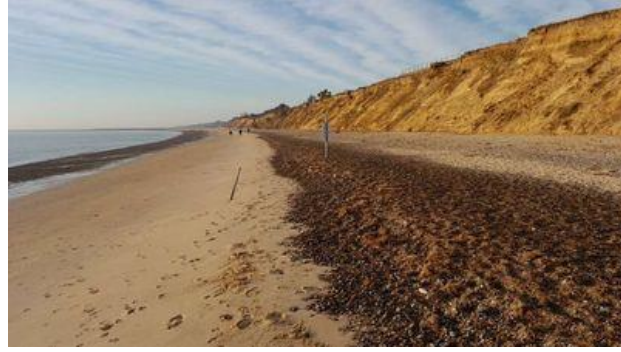
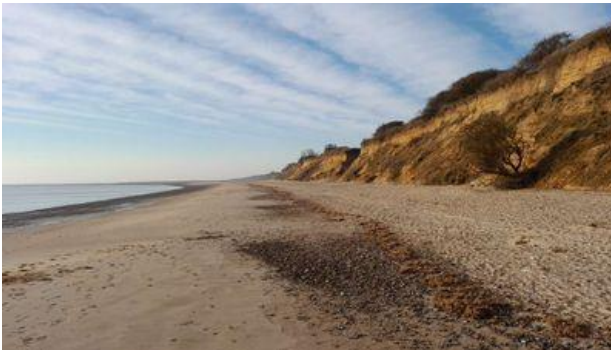
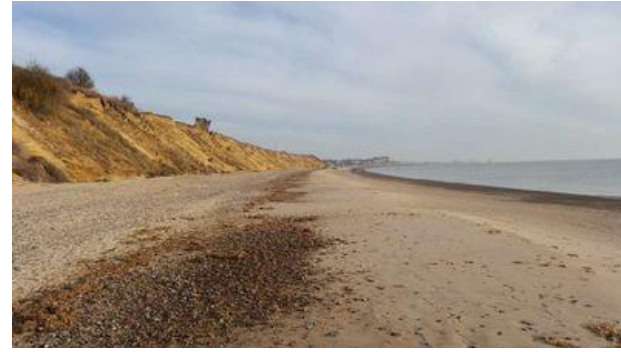
Photos of southern beach:

General impression of beach volume: Moderately increased

Comments on change to southern beach: Consistent with the beaches to the north, an increased berm has developed around spring high tide level. The beach level around the south end of the rock, and the concrete walling, has improved.

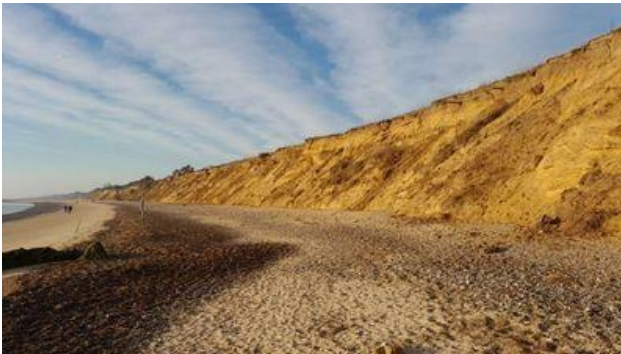
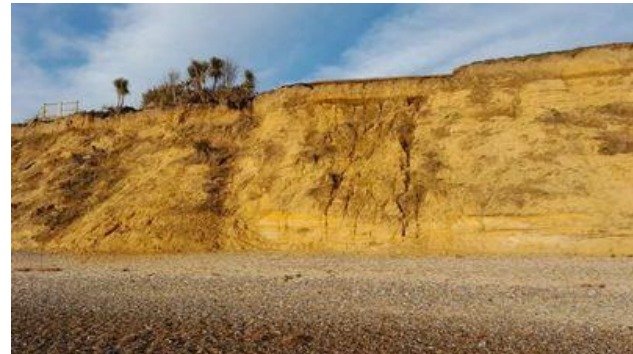
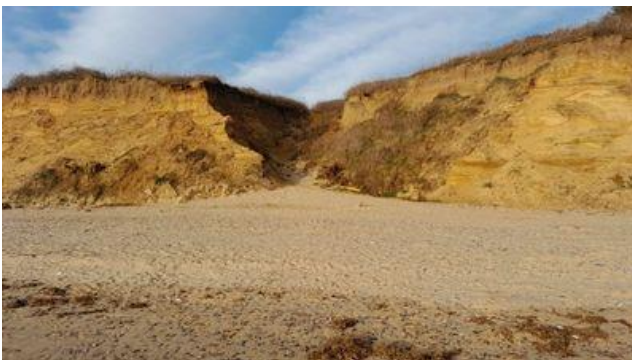
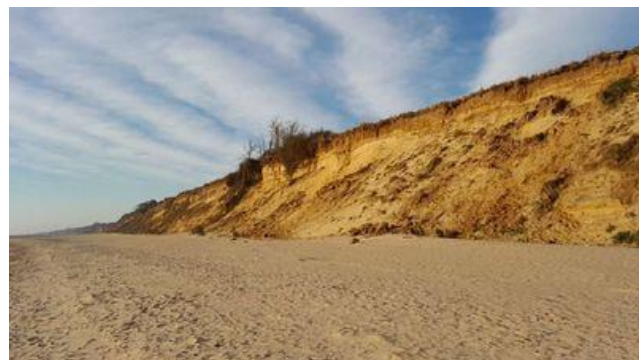
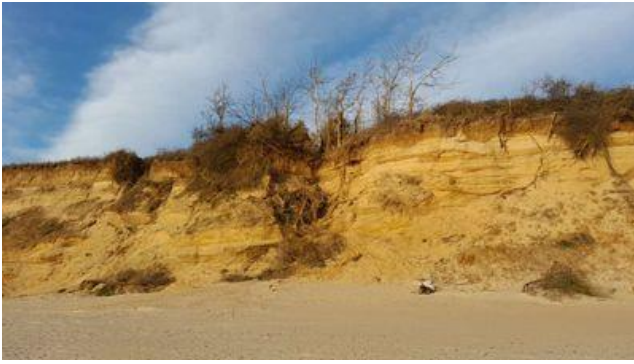
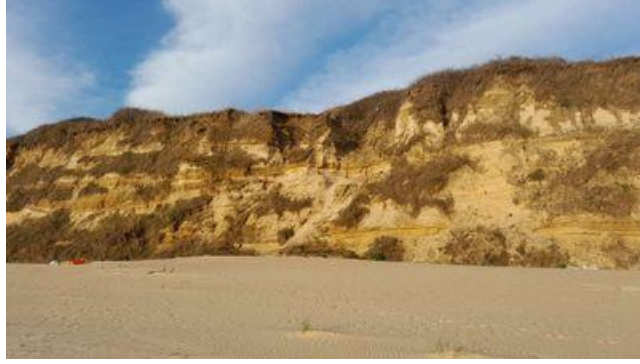
Photos of southern cliffs:

Changes to southern cliffs: Slumped material on cliff face; denuding and loss of vegetation; cliff-face steepening and overhanging; scree at base of cliff; fallen vegetation at base of cliff.

Comments on cliff change and any risk posed: Continuation of processes recorded previously. Rainfall run-off can be seen to have affected some areas of the cliff face.

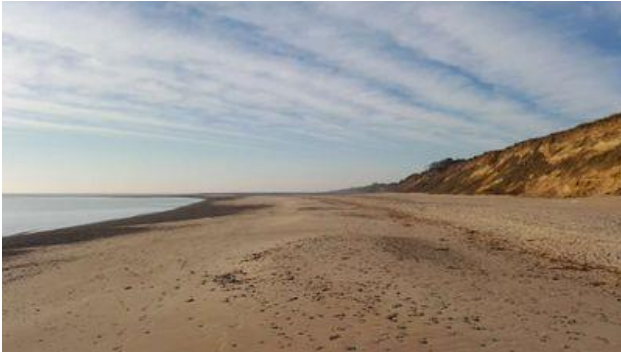
Photos of Pontins frontage and Benacre Ness:

Changes to beach geomorphology: Processes described previously continuing.

Comments on change at Benacre Ness: Another good, low Spring tide level seen on inspection, revealing seaward Ness features. Impression remains that beaches continue to widen from the south. Surface water outflow from near the Pontins access continues to be retained on the Ness.

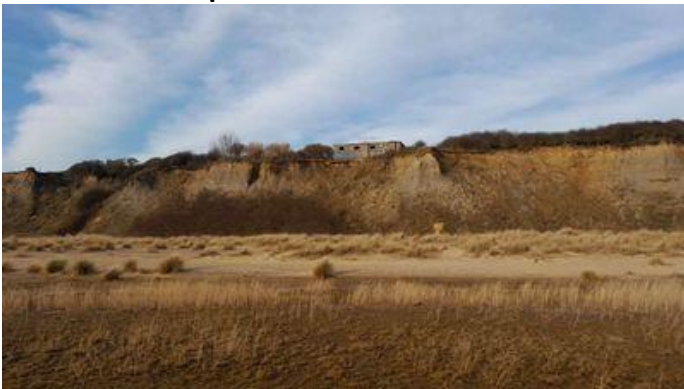
Photo of cliff top structure:

Changes in cliff stability: No obvious significant change apparent from beach.

Comments on cliff top structure: No obvious significant change apparent from beach.
