Pakefield Monthly Monitoring Report

Inspection Date & Time: 08/28/2020 10:56 AM

Reason for Inspection: Post weather / high water level event

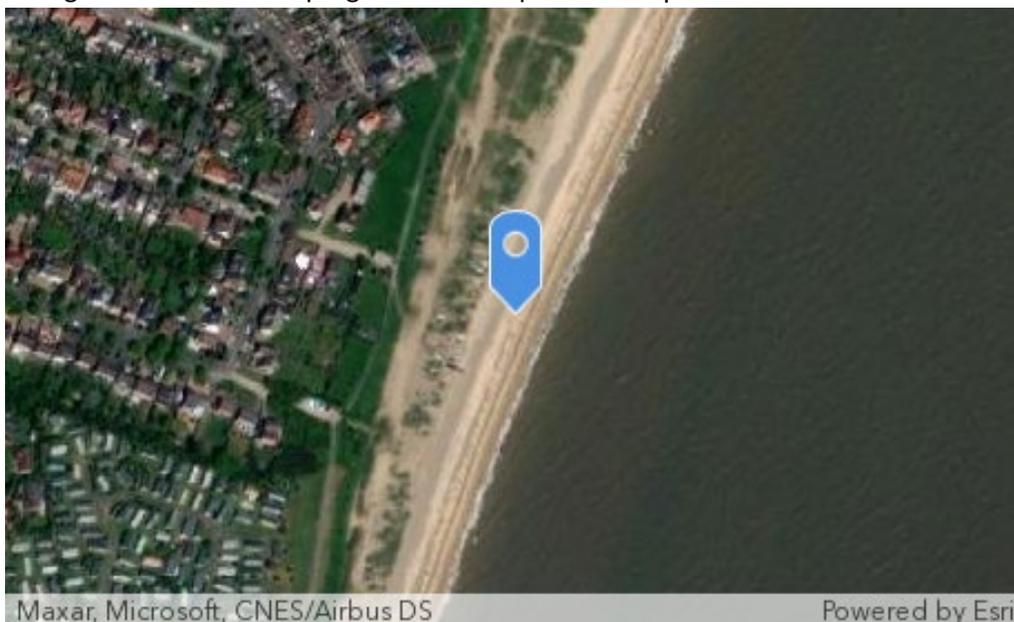
Northern extent of beach cliff: Beach Cliff northern extent is opposite Nightingale road & in front of fishing boats.

No significant northward progression since previous inspection.
