East Lane Bawdsey

Cliff recession study

Waveney District Council

26 July 2011

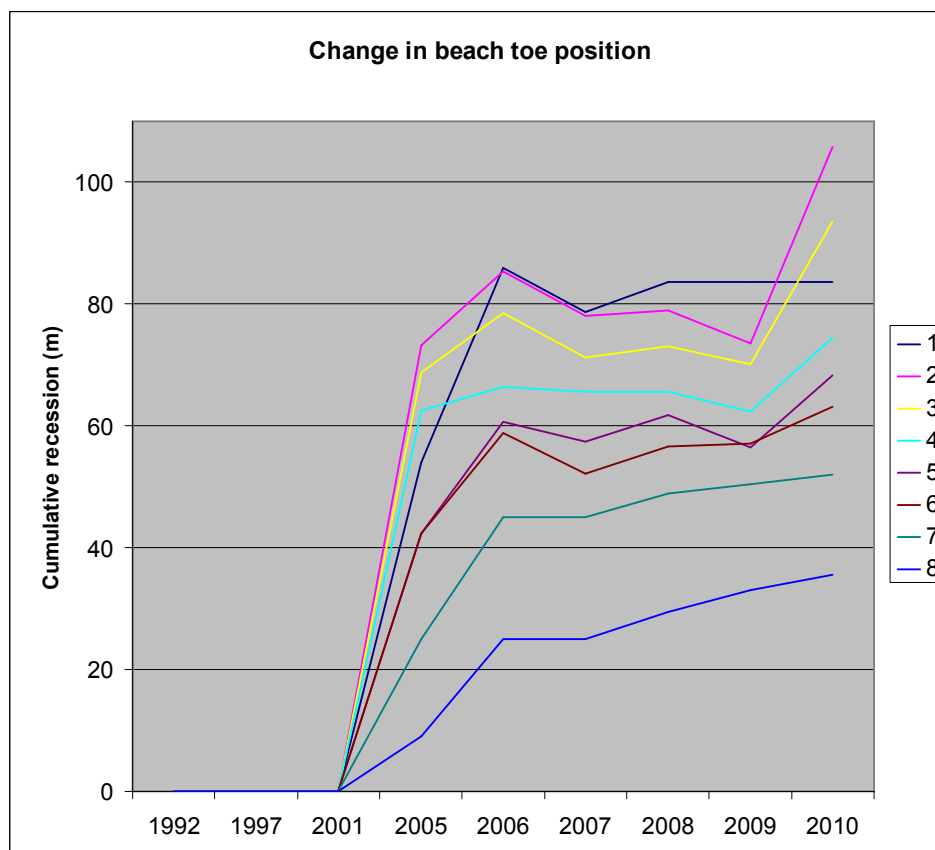
Figure 2.4. Location of the beach toe.

The results are shown in Figure 2.4 which illustrates the cumulative recession of the beach toe and exposure of the shore platform in each of the photographs. It is assumed that the 1994/1997 image represents 1997. Key observations are as follows:

- Small fluctuation in beach toe position between 2005 and 2009 with an overall net increase in width in transects (2, 3, 4, 5).
- Second phase of dramatic retreat in most transects between 2009 and 2010, with a further retreat of up to 30m of beach.

- The pattern of beach retreat and exposure of the shore platform is most marked in the northern transects that lie within the recently eroded bay (transects 1-4). However, the southern profiles, which lie beyond the area currently experiencing erosion and bay formation, have also experienced marked retreat.

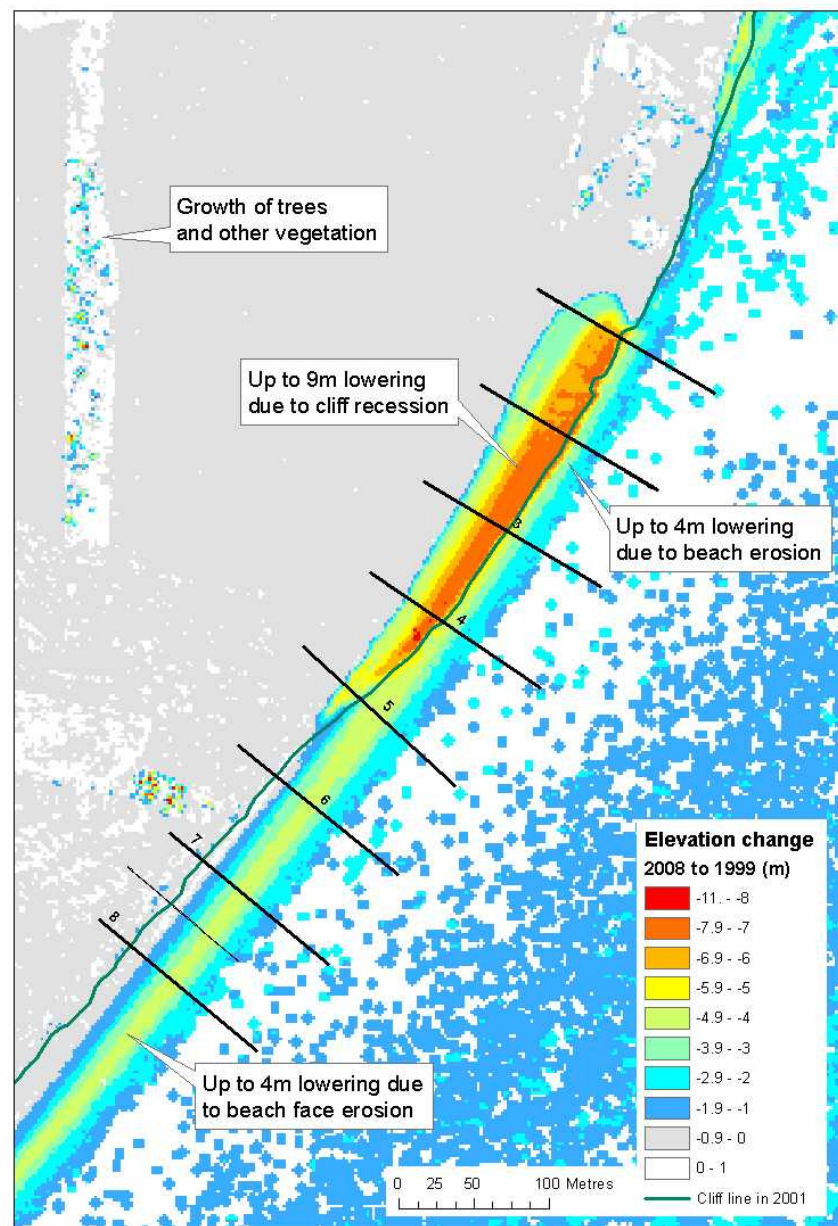
Figure 2.6. Difference in elevation between 1999 and 2008 LiDAR surveys

Due to the accuracies of the data, any change calculated to be less than 40cm is unreliable. The changes in beach elevation are shown in Figure 2.6, which highlights the following observations:

- Up to 4m lowering of the beach in the vicinity of the bay due to loss of beach sediment between 1999 and 2008
- Up to 9m lowering in the hinterland of the bay due to cliff erosion and removal of sediment
- Up to 4m lowering of the beaches south of the bay due to erosion of the beach face

These observations corroborate the evidence from aerial photographs and beach profiles.

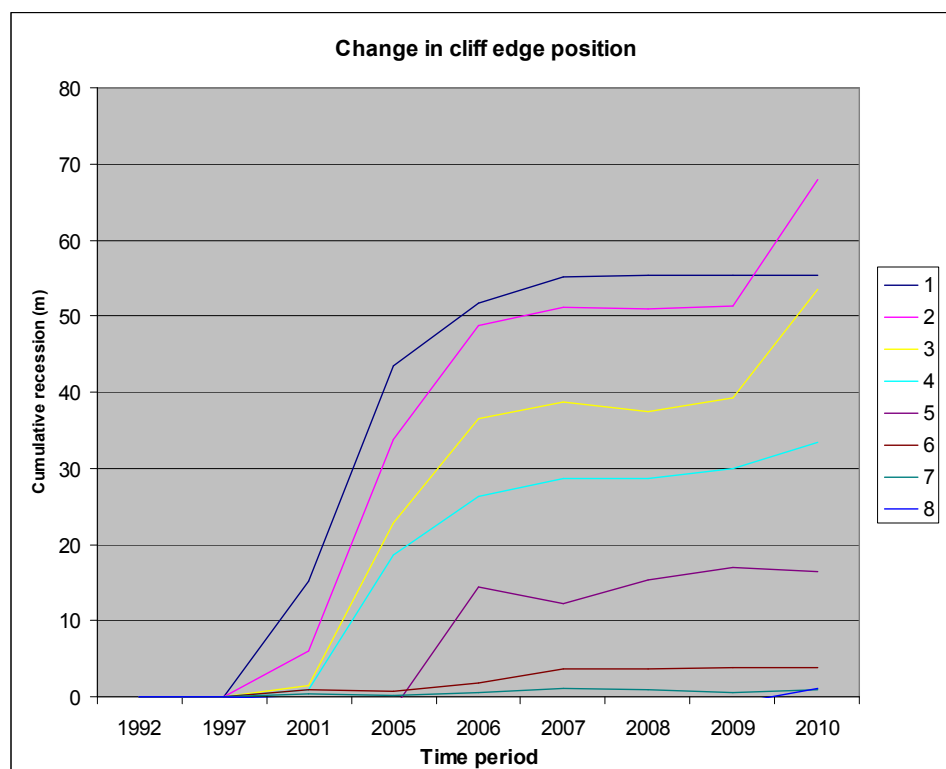
Figure 2.7. Location of the cliff top south of East Lane since 1992.

- Very limited erosion between 1992 and 1997, when aerial photography shows the cliffs were stable and well-vegetated.
- The northern-most profile (1) shows a high rate of erosion from 1997 onwards. In 1997 to 2001 the average recession is c. 4m/yr and this rises to almost 8m/yr during 2005 to 2006.

- Profiles 2, 3, 4 show erosion from 1997 to 2001, with rates of under 2m/yr. Erosion in these profiles accelerates from 2001 and reaches a peak rate of c. 15m/yr in 2005 to 2006.
- All profiles record limited erosion between 2006 and 2009, with rates of change under 1m/yr.
- Northernmost profiles (2, 3) record a second phase of erosion between 2009 and 2010 when erosion rates again exceeded 15m/yr. (NB at this time profile 1 is protected by the rock armour end structure)
- Between 1992 and 2010, northernmost profiles (1, 2, 3) show average recession rates of 3 to 4m/yr, which is significantly more than the historical long term average of 1 to 2m/yr. Over the same time period, central profiles (4, 5) show recession rates of c. 1 to 2m/yr. Southern profiles (6, 7, 8) have changed little between 1992 and 2010, and show a long-term recession rate of under 0.5m/yr.

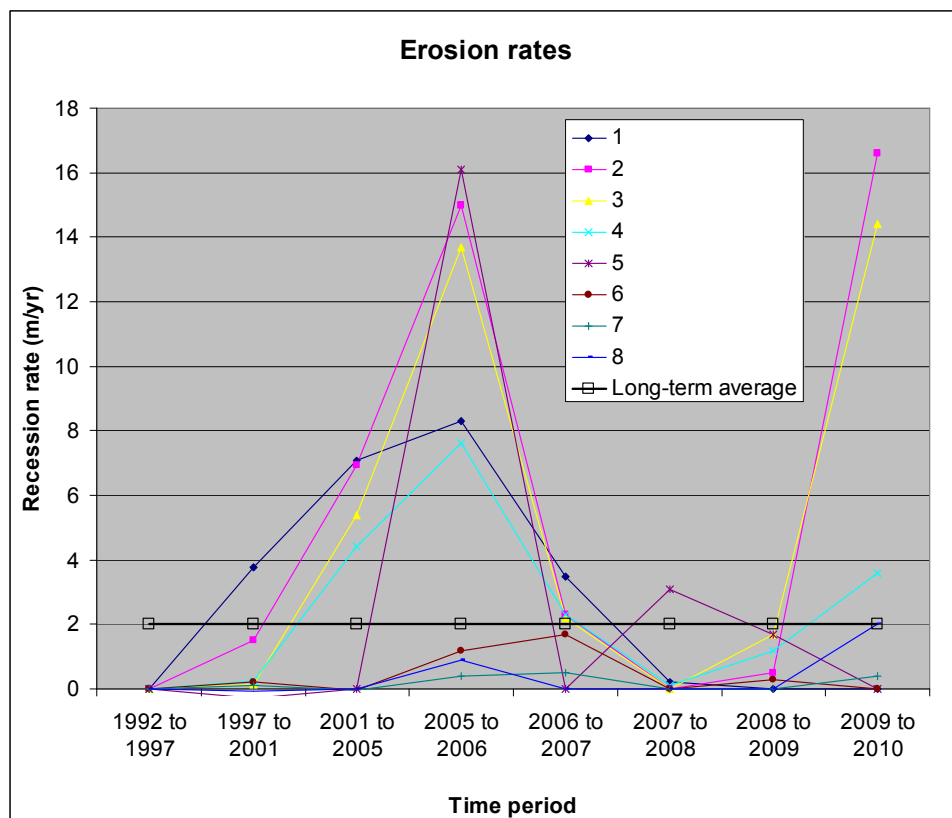
Figure 2.8. Cliff recession rates south of East Lane. Long-term average (1850/90 to 1960/70) is highlighted

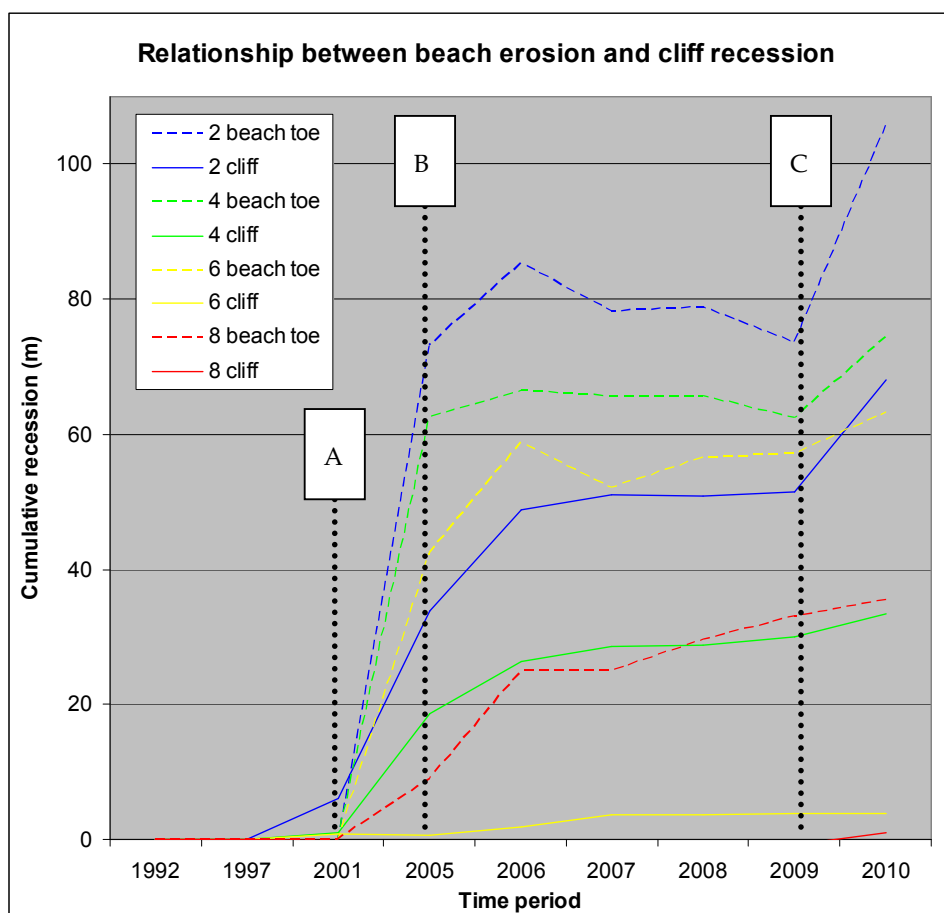
This pattern is illustrated in Figure 4.1 which highlights the relationship between cliff and beach erosion and phases of major coastal engineering. Only four profiles are shown for clarity. Profile 2 lies in the centre of the eroded bay, profile 4 is immediately south of the bay in an area of recently reactivated cliff and profiles 6 and 8 are south of the area currently affected by erosion, where cliffs are inactive.

Figure 4.1. Relationship between cliff recession, beach erosion and coastal engineering. Note. Dotted lines indicate phases of engineering: A, rock armour extended to front Martello; B, outflanking measures installed; C, offshore breakwater installed and shore platform excavated

The pattern of coastal response to engineering is clearly evident in the coastal monitoring data. Beach erosion is intimately linked to cliff recession and both can be associated with phases of engineering, as has been highlighted in Figure 4.1. The differences between individual profiles shown in this figure reveal that erosion is most marked in the north, in the area directly affected by the coastal defences and engineering works. However, beach loss and associated cliff recession are also evident in profiles further south, which are unlikely to be directly influenced by the recent coastal engineering. For example, the beach toes in profiles 6 and 8 have been eroding continuously since 1992, albeit at a lower rate to other profiles. By contrast, the cliff in profile 6 has experienced slight erosion, but the cliffs at profile 8 have been unaffected.
