## Thorpeness Monthly Monitoring V2

Submitted By: lucy.goodman\_CoastalPE

**Date & Time of Survey:** 09/29/2020 4:11 PM

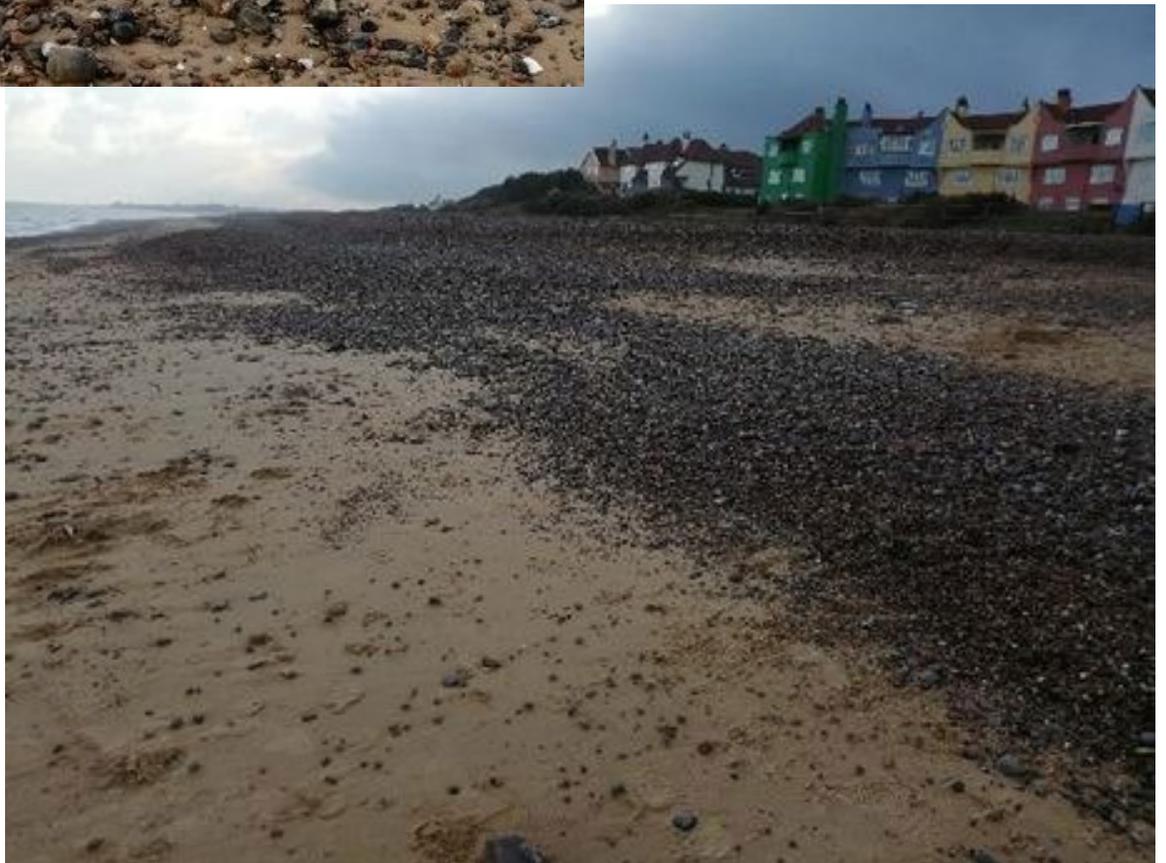
**Geomorphological change over southern UNDEFENDED frontage:**

Three distinct berms, laterally continuous along shore (Dunwich to Aldeburgh). Landward storm berm max 1.5m South of Headlands. Steep wide foreshore. Fine shingle on landward berm shows extent of wave run up. More material added to supra tidal beach in front of Headlands. Large cobbles on lower foreshore indicates high energy and sediment transport capacity. No lowering of beach levels, improvement if anything.
