# Initial Assessment Report

Scheme or project location name	Southwold FCRM Southwold, Suffolk
---------------------------------	--------------------------------------

Date	(December 2018)
Version	0

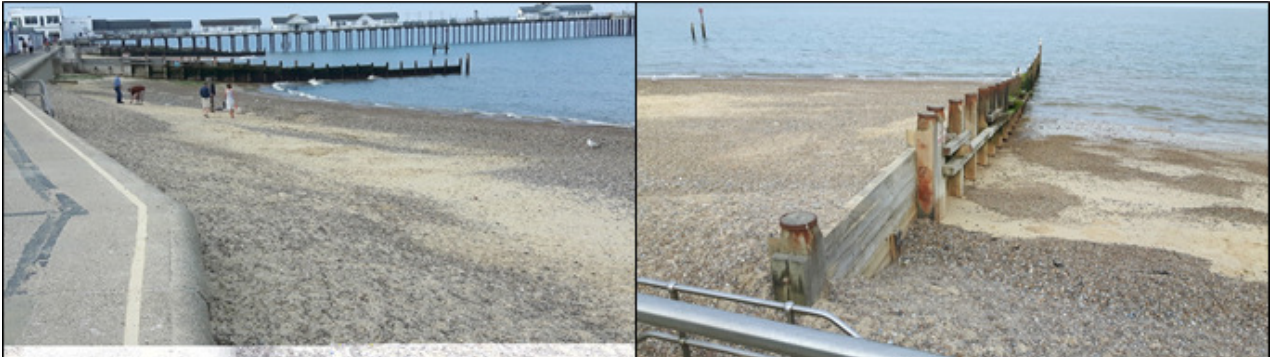
The existing seawall and promenade at the town frontage was constructed around the 1940s and 50s and consists of a mass concrete bull nose wave return wall with steel sheet pile toe which protects a reinforced concrete promenade along with a groyne field which has been modified and re-configured several times, most recently as part of the 2006 works where the timber and steel groynes were replaced by timber only groynes (see Figure 5). Buried remnants of the old steel piled groynes remain.

*Figure 5 Left - looking along the Southwold Town frontage towards the pier (taken 16 July 2018), Right - Typical timber groyne (taken 16 July 2018)*

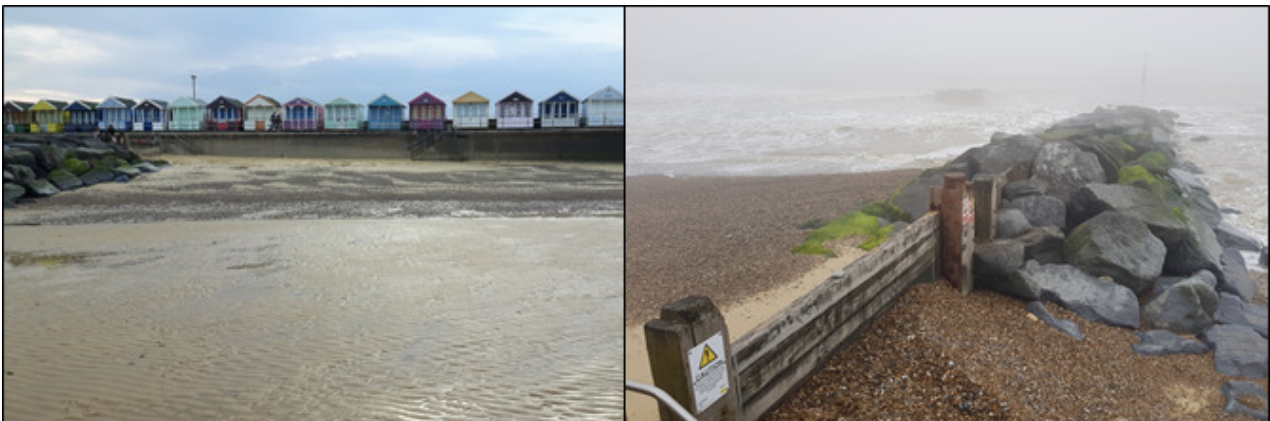
The WDC seawall at Easton Marshes north of the pier was constructed around the 1960s. Fronting the defence was a timber and steel groyne field. These groynes were replaced with rock groynes as part of the 2006 works and included timber roots to allow plant access between bays. As with the section to the south of the pier, the seawall is a bull nose wave return wall with a sheet pile toe and promenade (see Figure 6). At the transition between the Waveney and Environment Agency frontage is a sloped beach access ramp with a flood gate at its crest.

*Figure 6 Left - WDC Easton Marshes seawall (taken 16 July 2018), Right - Typical WDC Easton Marshes groyne with timber root (taken 11 April 2018)*

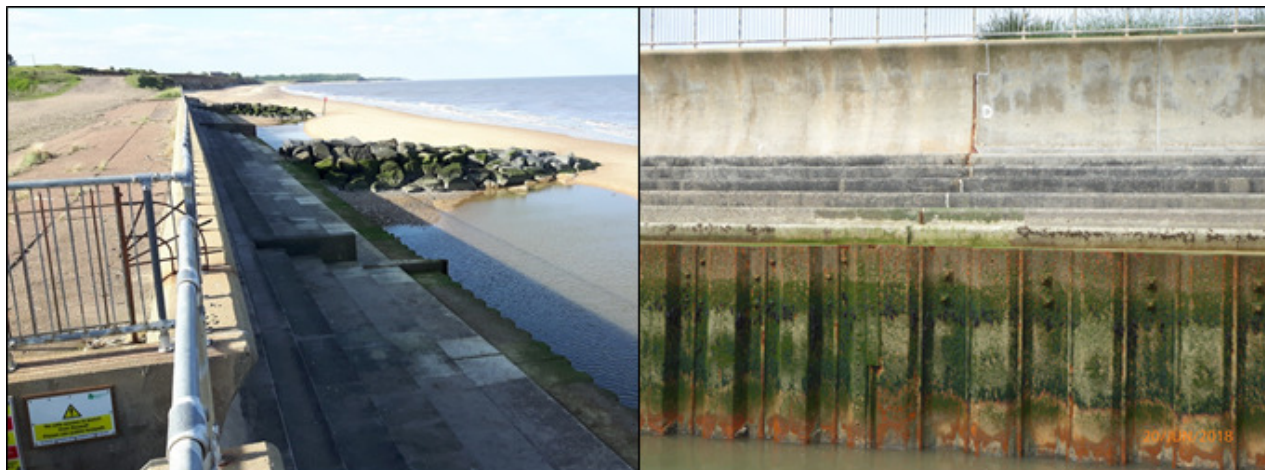
The Environment Agency (then Anglian Water Authority) seawall along the Easton Marshes frontage was constructed in the 1970s and consists of a stepped concrete seawall/revetment with a bull-nose wave return wall and a sheet pile toe. This structure was extended to the north in the 1980s (See Figure 7).

*Figure 7 Left - EA Easton Marshes concrete stepped seawall (taken 14 June 2018), Right - where the 1980s seawall extension joined existing seawall (taken 20 June 2018)*

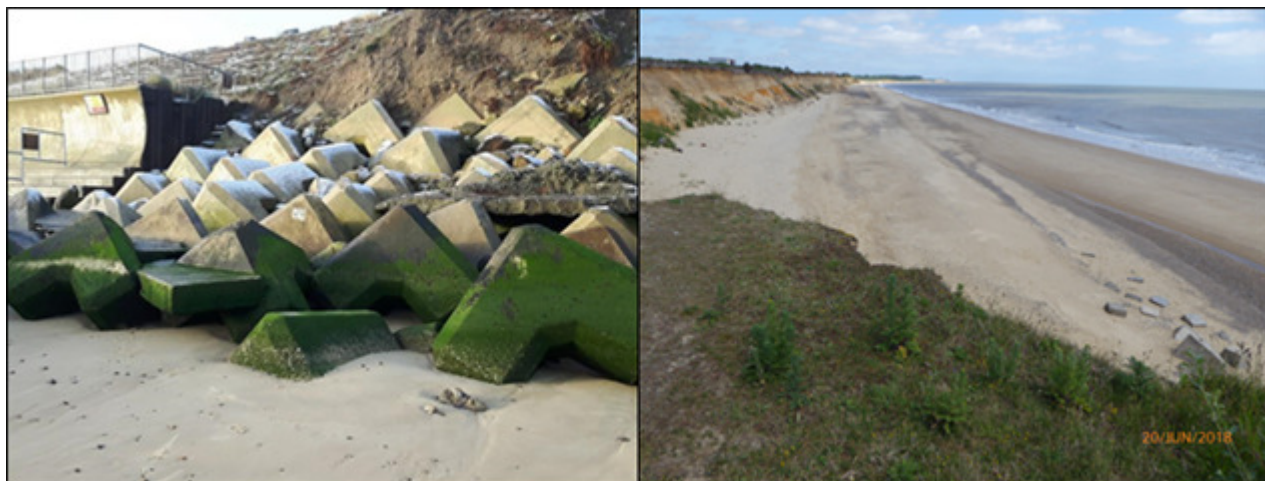
At the northern extent of the Easton Marshes seawall, concrete tripod armour units were installed prior to the 2006 works, to provide some protection to the terminal sheet pile of the seawall. These tripods are still present (see Figure 8).

In addition to the concrete tripods, unapproved private cliff protection works in the form of an earth bund was placed along the front of the exposed cliff (between 2002 and 2005) in an attempt to protect the clifftop properties above from erosion. The approximate amount of material added to the beach during these private works was around 1 km in length by 15-20 m wide by 8 m in height; however, this material has now largely been eroded away (EA, 2010) and no further dumping was undertaken. Some of the dumped material remains, protected by the tripod units, off the northern end of the EA frontage (see Figure 8). North of the tripods there is a band of concrete rubble which can be seen in Figure 8 (right hand side photo).

*Figure 8 Concrete tripods at transition (taken 12 December 2017), Right - Looking towards Easton Bavents (taken 20 June 2018)*

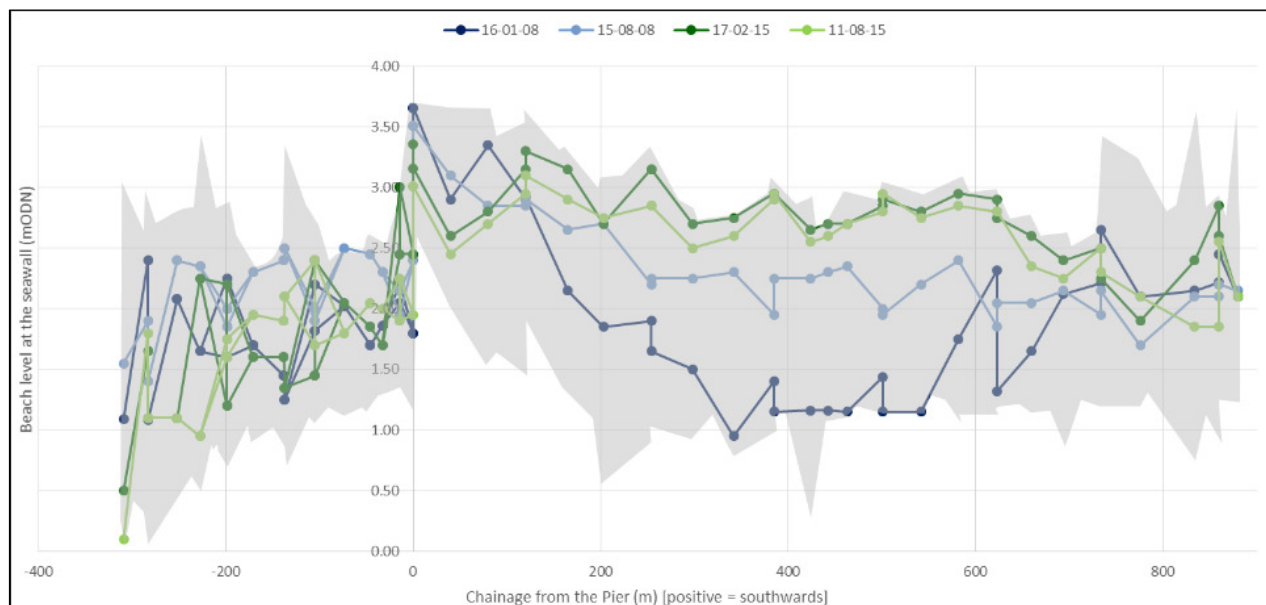
Figure 24 presents beach dip analysis undertaken by ENBE, 2016. The shaded envelope represents the full extent of all the dip surveys. Also shown as line data are the surveys for the first and last winter and summer covered by the data providing a snapshot of the dip data following the scheme and at the time of the ENBE study.

Figure 24 Beach dip information 2008 (Post Scheme) and 2015 (ENBE, 2016)

North of the pier, there is a general trend of reduction in beach level and an increase in variability towards the transition to the EA Easton Marsh section. There seems to be a split at approximately -200m where north of this point 2015 levels are below the 2008 levels. However, south of this point, towards the pier, levels are generally at or above the 2008 levels. Volatility generally increases away from the pier.

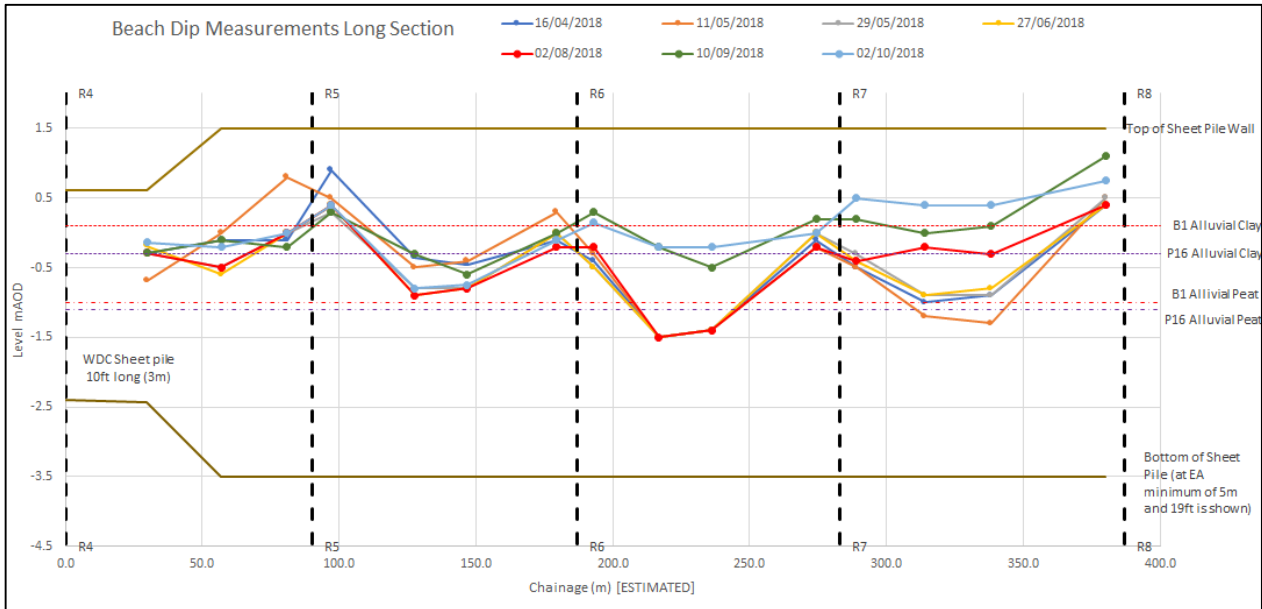
Since the start of the Initial Assessment study, WDC have been undertaking beach dip measurements along the EA frontage between groynes R4 and R8, and this data is shown in

Figure 25. The graph includes indications of the level of the clay layer at the frontage based on borehole (B1) and trial pit (P16) investigations undertaken prior to the PAR stage (S.I.C., 2003). The clay layer has historically been felt to be an important defence consideration, since its loss through erosion would expose the more easily erodible strata beneath, potentially accelerating exposure of the sheet piled toe of the defence. The location of the ground investigation data is within bay R4-R5 and may not be representative of the ground levels along the entire Easton Marshes wall, particularly as the boreholes are south of the location of a former estuary. Bays R4-R6 have generally been stable for the 6 months of the survey but the centre of the bays are generally at or below the emergency trigger levels. Bays R6 to R8 have shown significant variability with the bays filling in significantly over the last two months although levels are still below the action trigger levels. The emergency level at the WDC Easton Marshes is -0.3 m ODN and at EA Easton Marshes section is -2.2 m ODN (see Table 4).

Figure 25 Beach dip analysis R4-R8

The dip data indicates that the greatest degree of pile exposure has been between R6 and R8, and illustrates a general recovery of levels over the 2018 summer, likely in response to the prevalence of mild northerly conditions creating southerly drift of material from the north being carried across the Easton Marshes frontage. The southerly passage of material was evidenced by the creation of a 'spit' of beach extending across the seaward ends of the groynes (see Figure 26 below). Although the conditions brought about a modest increase in beach levels at the toe, as of September 2018, conditions have not been conducive to promote significant onshore movement of this material and a more substantial recovery of the beaches within the bays.

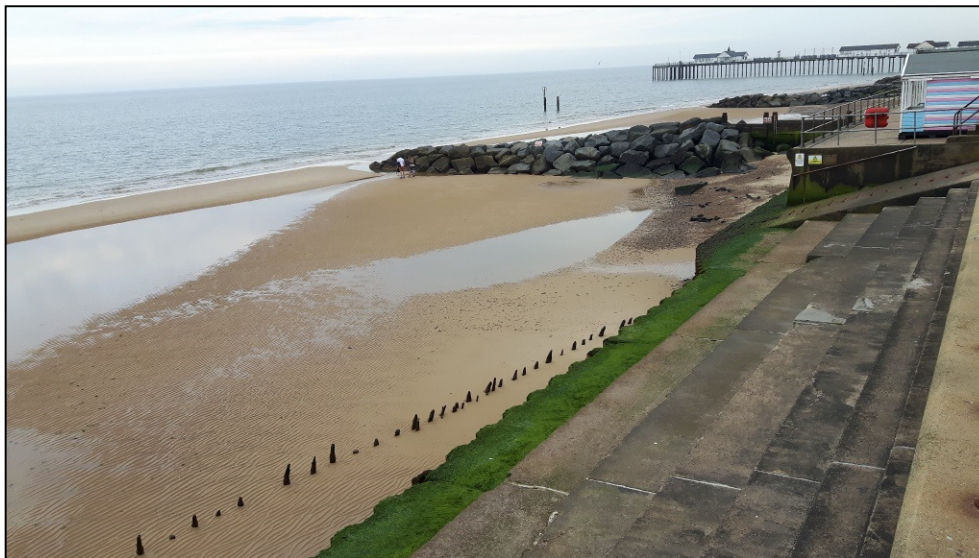
*Figure 28 View from EA seawall towards access ramp (taken 16 July 2018)*

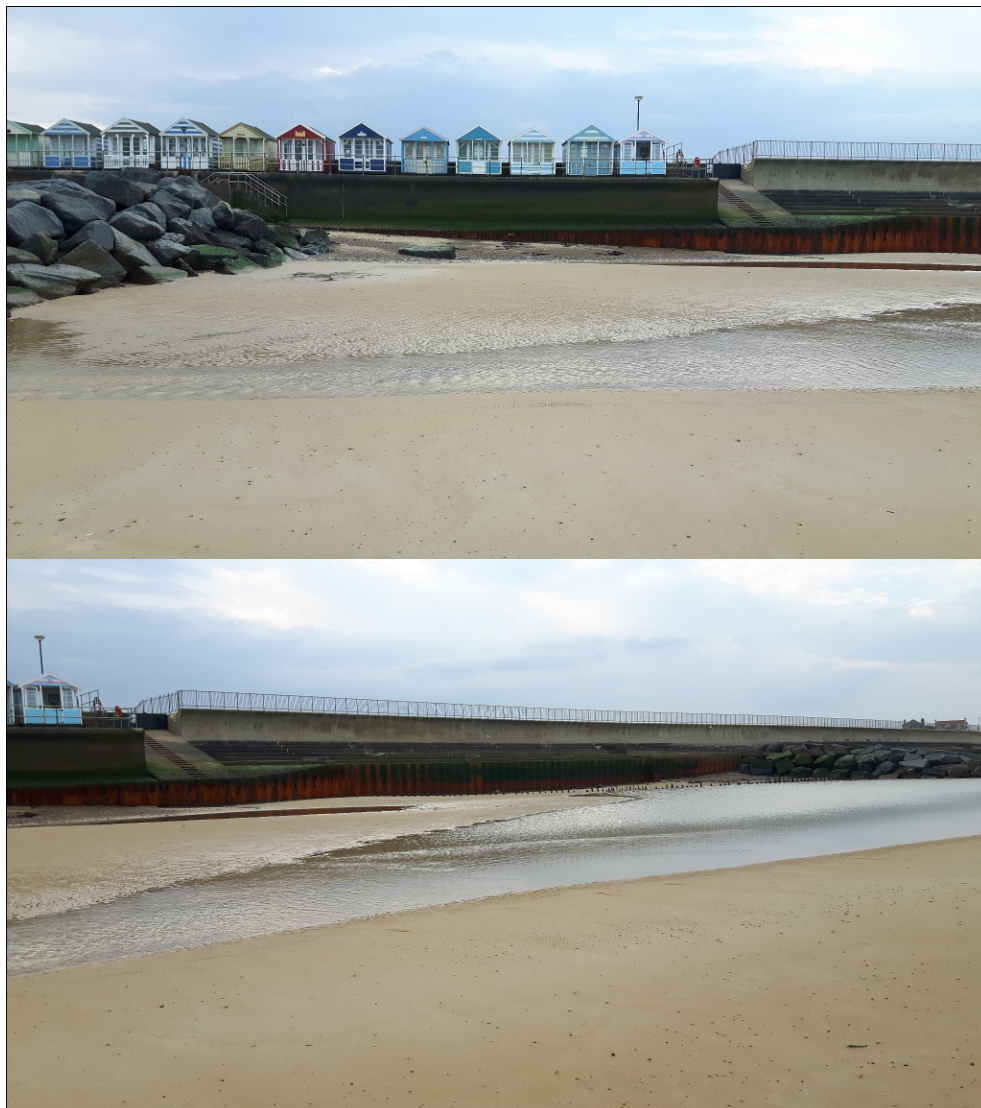
The beach access ramp is located immediately to the north of groyne R4 (Figure 28) and marks the transition between the WDC and EA frontage. At this location the beach is significantly lower than the seaward end of the ramp (Figure 27 and Figure 29) making plant access to the beach very difficult. The sheet pile is exposed and showing visible signs of significant deterioration (see Figure 15 and Figure 16). Beach Profile SW21 is located closest to this location and the survey data suggests that the profile is now at the levels shown before the PAR scheme (see beach volatility analysis). This profile also shows the greatest erosion rate likely due to its location at the change of alignment of the seawall at the location of the ramp (ENBE, 2016).

*Figure 29 Front view of ramp (pictures taken 16 July 2018)*

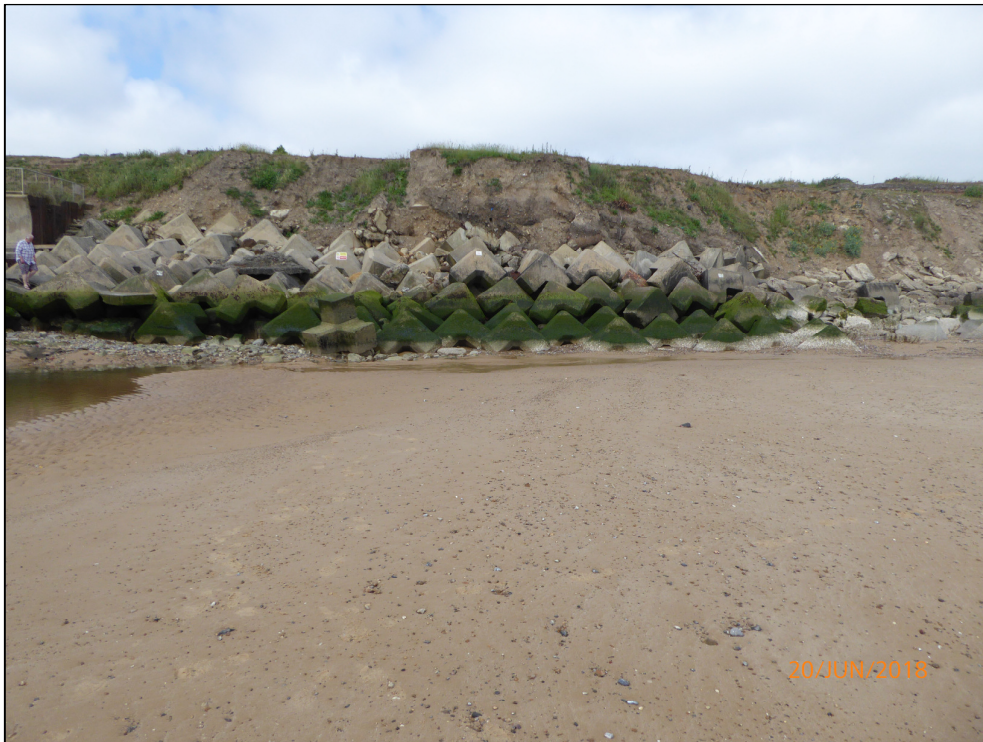
currently only an ad hoc arrangement (see Figure 32 and Figure 33). If scheme proposals involve works in this location, then this will provide an opportunity to create safer public access onto the beach at the northern end of the scheme. As discussed in the previous section, the only current beach access for maintenance is the existing ramp at the transition with the WDC frontage which is a considerable distance from this location and is also vulnerable to beach level fluctuation. If a scheme were to incorporate improved public and plant access at its northern end, this would greatly improve the ability and reliability of beach access for maintenance, particularly over the EA section and on to Easton Bvents.

*Figure 32 Extent of Tripod armour units (picture taken 20 June 2018)*

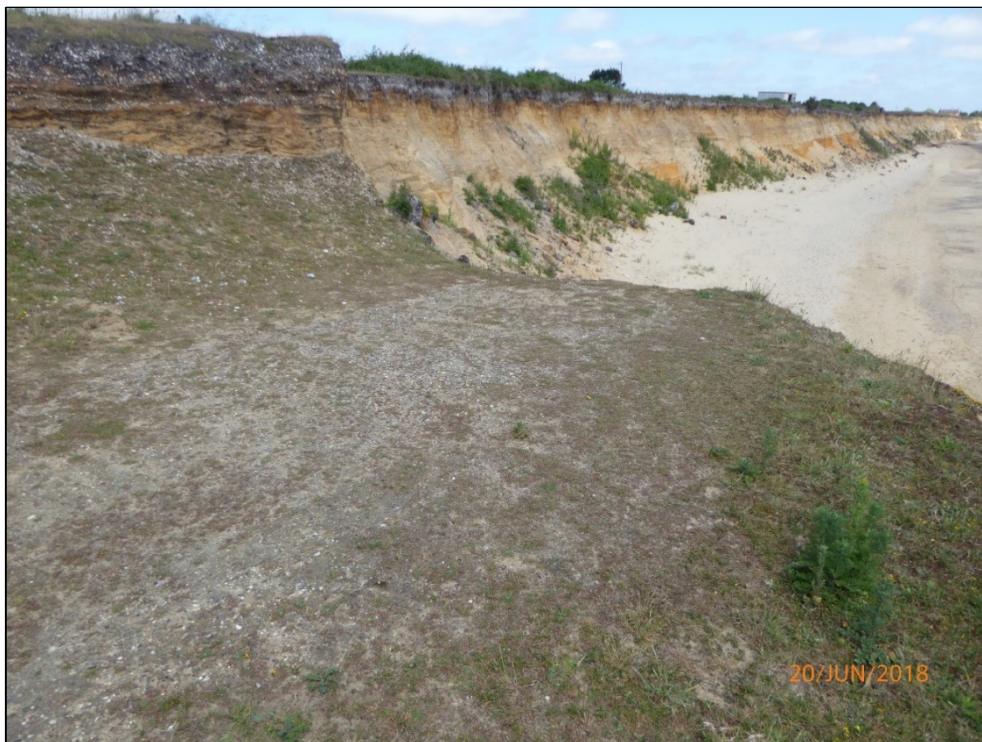
**Figure 36 Looking from atop promontory, to the north along Easton Bvents Cliffs (picture taken 20 June 2018)**

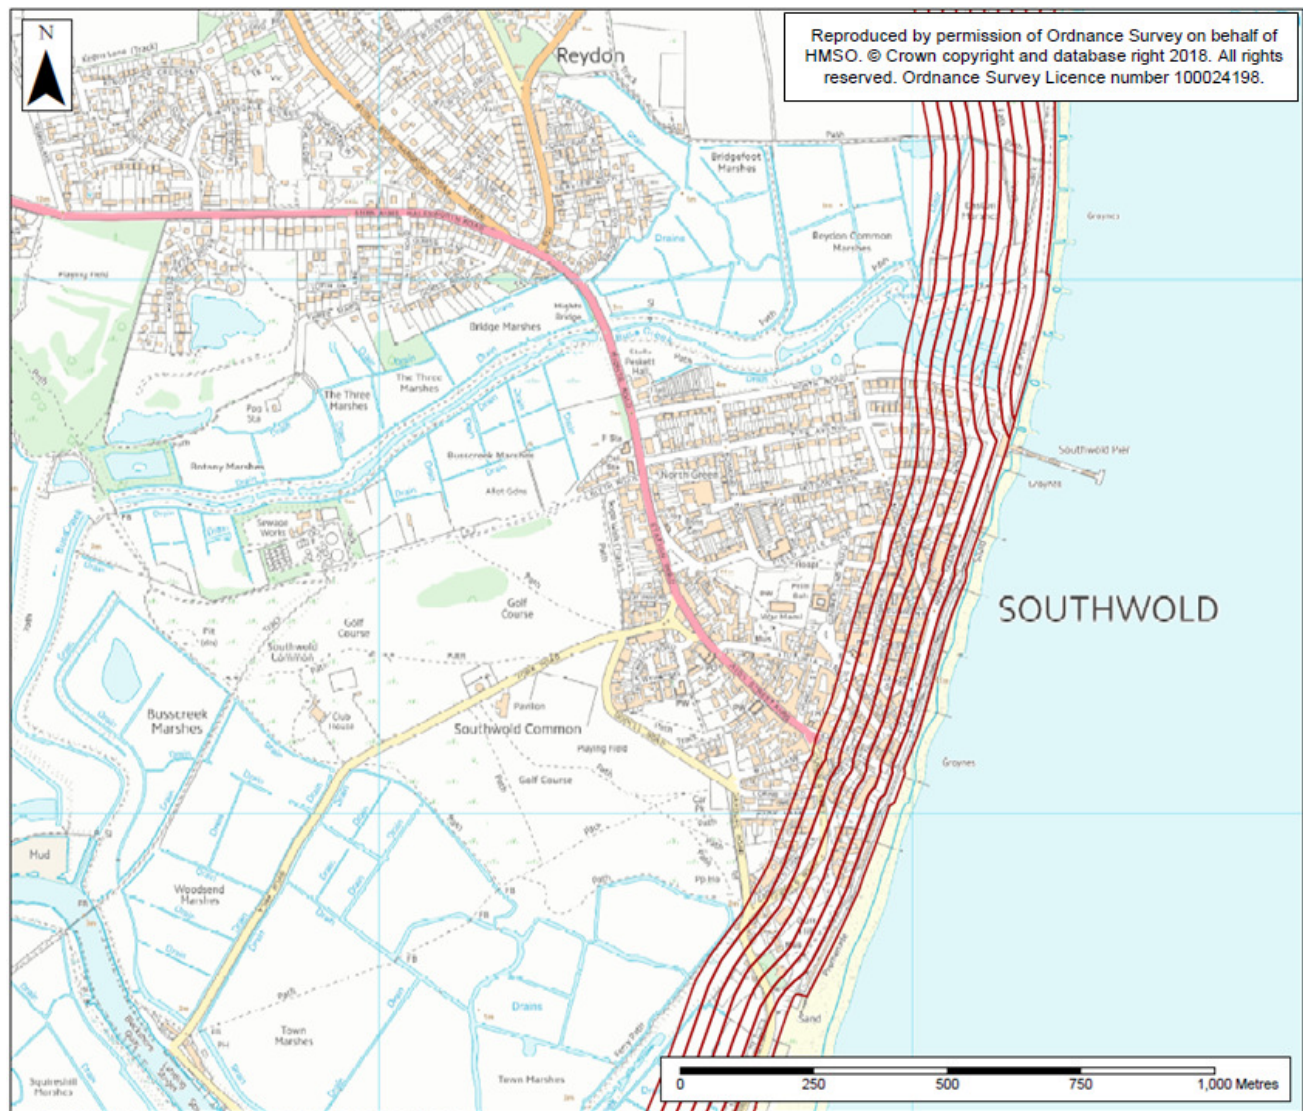
The 2005 PAR assessed historic erosion rates for the Southwold frontage. The erosion rate assessment was undertaken by comparing the alignment of the coastline from historic maps at two known dates prior to the construction of the defences. Erosion damages were calculated in blocks of ten years following failure of the defences (see Figure 37).

Figure 37 Erosion damage contours in 10 year epochs (EA and WDC, 2005a)

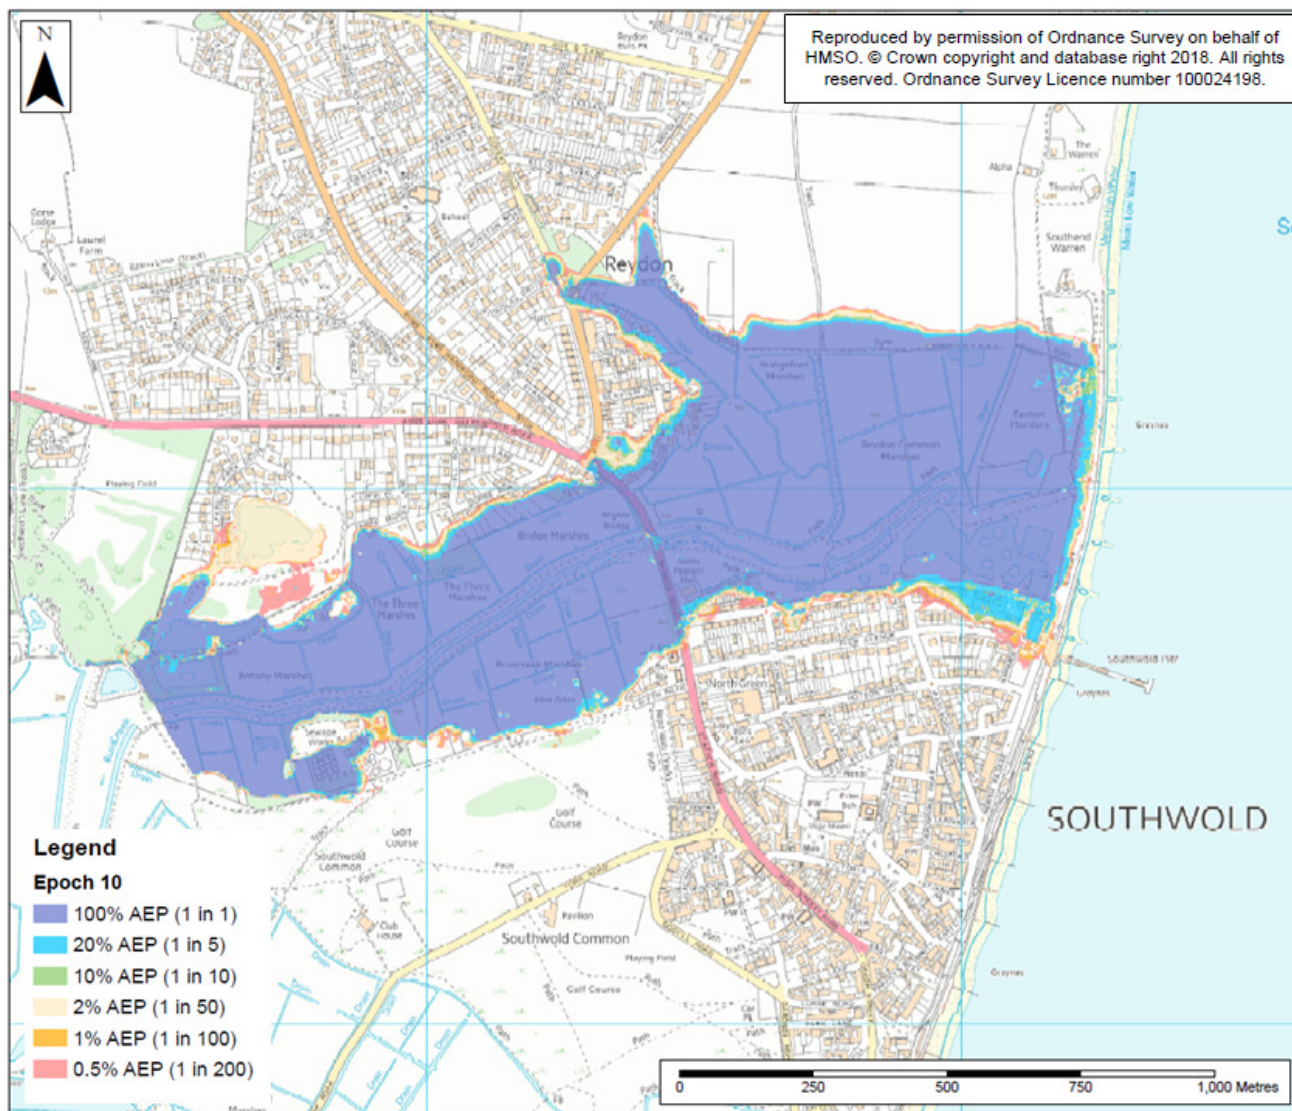
For the 2005 PAR, a flood distribution model was used to predict the extent and depth of flooding over a topographic grid as a result of an assumed 100m breach in the seawall (See Figure 38 for Epoch 10, further epoch contained in Appendix C but for Do-Nothing epoch of approximately 2014 is most relevant). The western limit of the flood extent is defined by the embankment at Botany Marshes which was constructed as a recommendation of the 2005 PAR.

Figure 38 Flood extents epoch 10 (EA and WDC, 2005a)
