## **Gunton and Corton Options Appraisal**

### **Appendix B - Cliff Instability Assessment**

**Document No. 03 | 2.0**

**Coastal Partnership East**

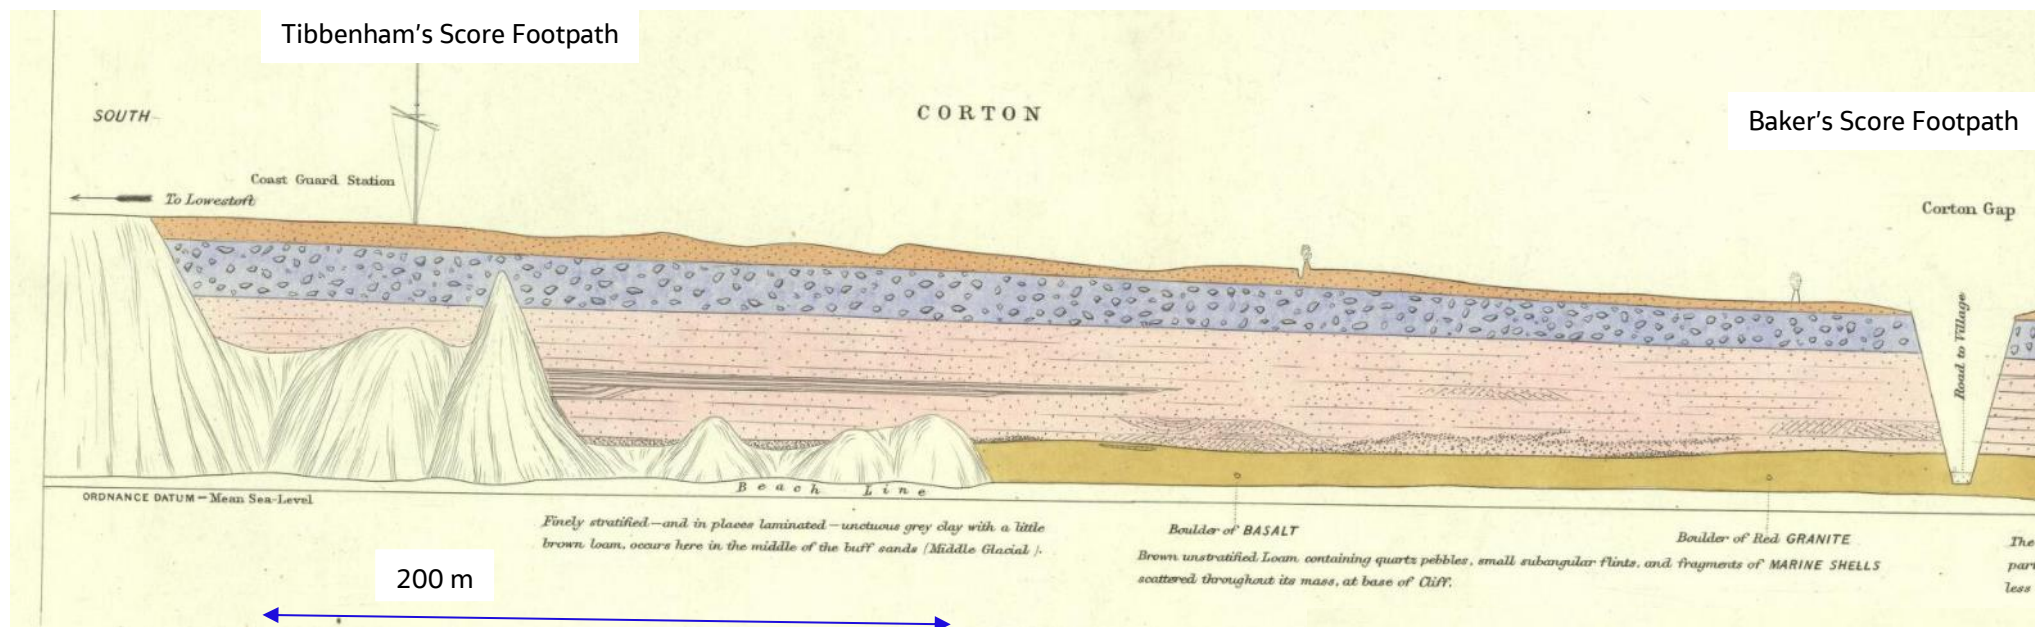
Figure 2-1. 1884 section of the Corton frontage prior to construction of the original late 19th century defences (modified after Blake 1884)

The geology of the site comprises a sequence of generally weak, unlithified sediments deposited in the Middle and Early Pleistocene between around 1 million and 0.5 million years ago. The sediments are summarised in Table 2-1. A 19<sup>th</sup> Century sketch of the cliffs (Blake, 1884) is provided in Figure 2-1, and a more recent sketch of the cliffs (Banham, 1971) is shown in Figure 2-2. Both show essentially the same stratigraphy. Images of the sediments exposed are provided in Figure 2-3. The cliffs were first described by the British Geological Survey in the late 19<sup>th</sup> century (Blake, 1890), when rapid cliff recession was reported for the coastline, which was freely eroding at the time.

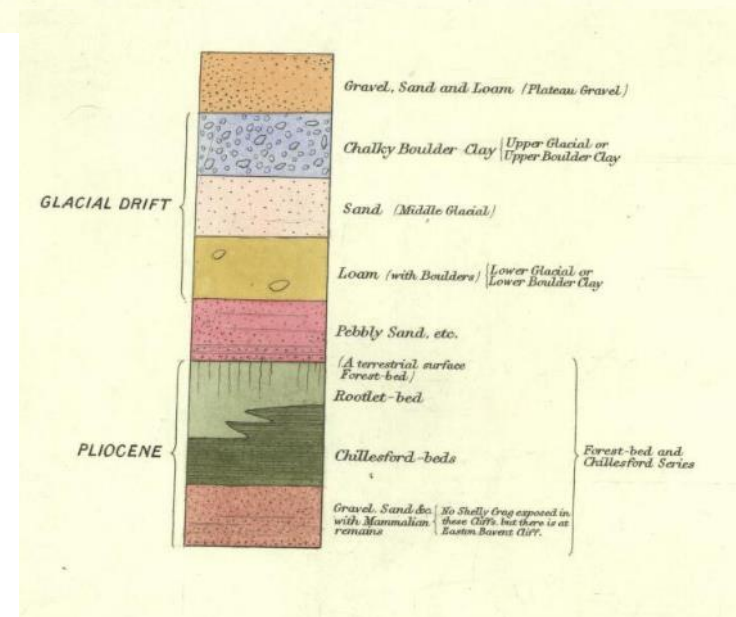
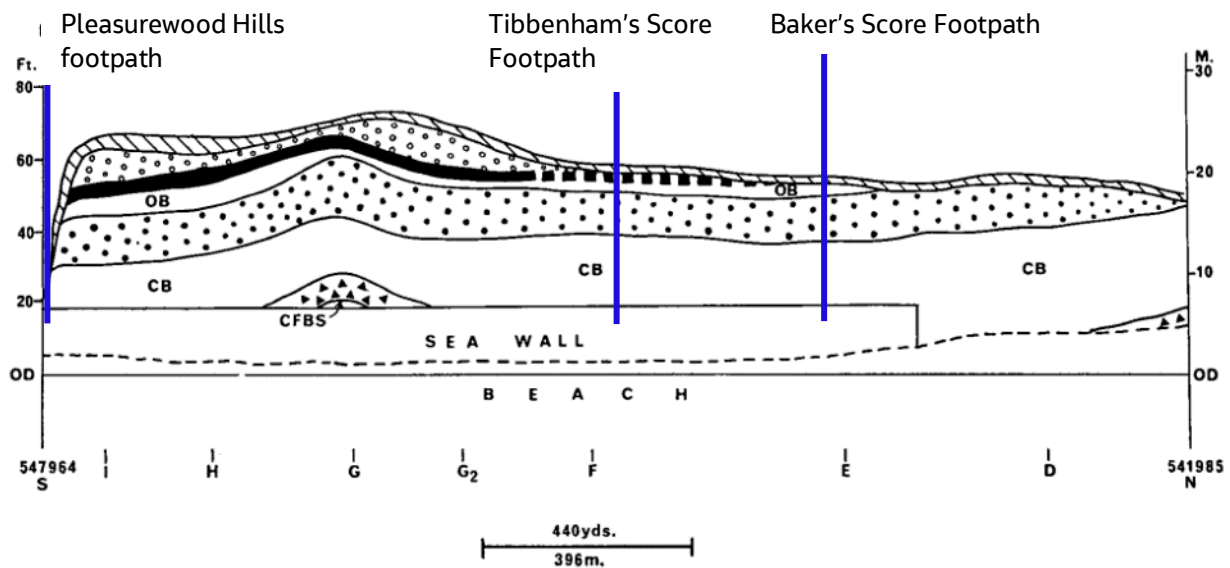
Figure 2-2. Schematic section of the Corton frontage after improvement of defences in the late 1960s/early 1970s (modified after Banham, 1971)

Figure 1. Horizontal section of the cliffs to the south of Corton, Suffolk. Explanation of symbols: CFBS—Cromer Forest Bed Series; black triangles—Cromer Till/Norwich Brickearth; CB—Corton Sands (Beds); black dots—Lowestoft Till; OB—Oulton Beds; black—Pleasure Gardens Till; open circles—Plateau Gravels; oblique lines—soil and blown sand; F.P.—footpath; D-I—sites of measured vertical sections.

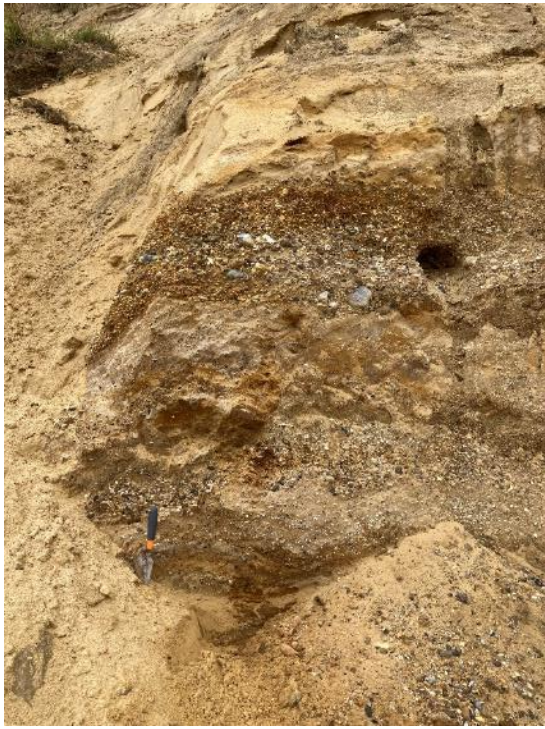
The Cromer Forest-bed is overlain by the Cromer Till, which is a stiff and over-consolidated brown sandy diamicton (i.e., an unsorted sediment comprising a wide range of grain sizes) that contains gravel erratics of Scandinavian origin and marine shells (Figure 2-3A). It is well jointed, with joints often marked by iron-staining, sometimes banded, and sometimes with beds of gravel at its upper contact with the Corton Sand (Figure 2-3B and D). The Cromer Till was deposited by a Scandinavian ice sheet that advanced into the region from a north-easterly direction. A regional study by Lee (2001) shows that most outcrops of this deposit are subglacial tills, but that the sediments exposed at Corton were deposited at a debris fan by a floating ice sheet. As this ice sheet retreated the pro-glacial lake grew in size and was progressively infilled with outwash sediments, represented on site by the Corton Sands. This unit comprises a thick sequence of fine to medium-grained well-bedded sands that sometimes contain silty/clay-rich beds (Figure 2-3C).

<p>A. Cromer Till. Stiff brown sandy diamicton with occasional gravel deposited beneath a floating ice sheet. Note iron stained bedding and joints.</p>	<p>B. Interbedded gravel and diamicton sometimes seen at upper part of the Cromer Till. Deposited as a debris flow from a floating ice sheet.</p>

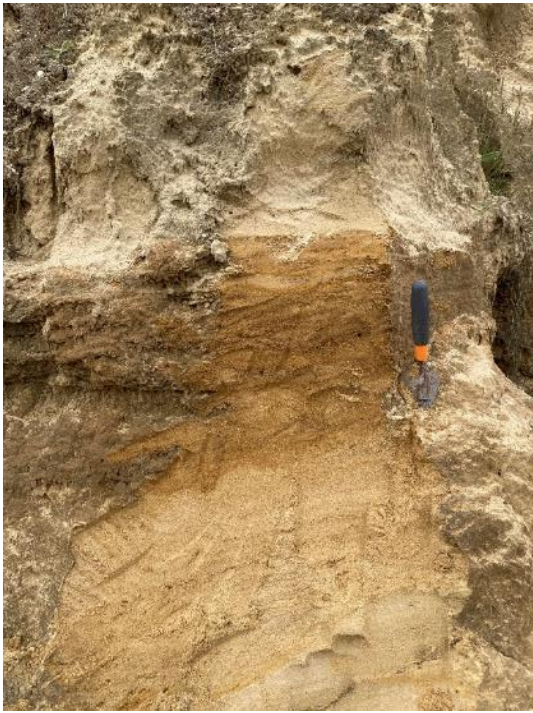
Figure 2-3. Glacial sediments exposed along the Corton frontage.

<p>C. Corton Sand with darker silty/clay layer in middle of photo.</p>	<p>D. Banded diamicton and sand and gravel. Cromer Till.</p>

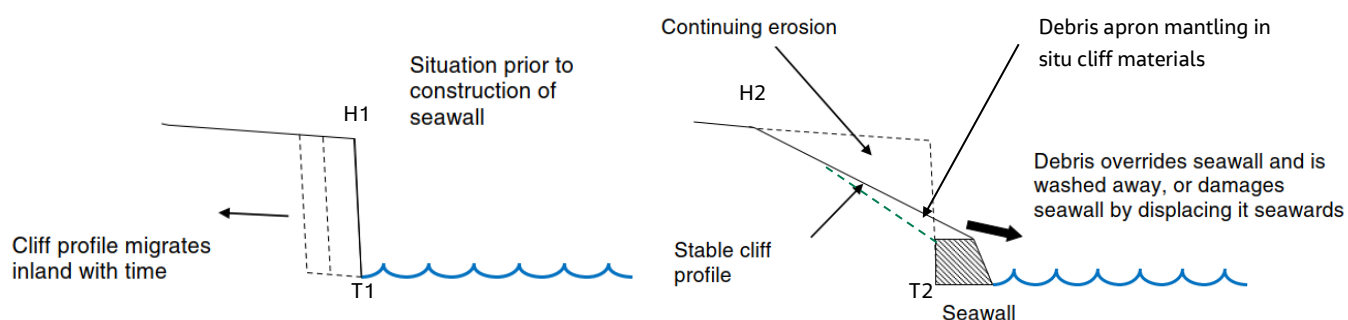
Figure 2-4 . Impact of toe protection measures on cliff behaviour (after Moore and Davis, 2015).

These observations suggest that prior to construction of coastal defences the cliffs were freely degrading, with periods of low activity where a debris apron accumulated on the cliff, and periods of greater activity where the debris apron was subsequently removed by wave action, the base of the cliff was cut, and cliff failures resulted in retreat of the clifftop. Once coastal protection measures were installed, toe erosion ceased but the upper cliff face has continued to degrade. The impact of toe protection is shown conceptually in Figure 2-4. In an undefended cliff the toe (T1) and clifftop (H1) retreat at the same rate, and the cliff angle remains constant over time. Debris from cliff erosion may periodically accumulate at the cliff toe, but over time it is reworked into the coastal system. Once toe protection measures are in place, the cliff toe (T2) is fixed but the clifftop (H2) degrades and retreats through weathering and mass wasting processes forming a debris apron above the toe protection measures. The cliff angle is reduced over time until a stable slope angle is achieved. Note that the actual form of the actively eroding and freely-degrading cliff will be affected by the properties of the constituent strata.

The LiDAR data indicate that despite the presence of toe protection measures, most of the Corton cliff shows evidence of change in the period since 2003 (Figure 2-5). The data confirms widespread and repeated reactivation of the debris apron that mantles the cliff with losses in the upper to middle part of the cliff, and accretion in the lower cliff, often with runout that extends over the promenade and rock armour. As shown by the review of aerial imagery, clifftop retreat rarely occurs. This implies an increase in the cliff angle, since the toe has retreated but the clifftop has been stable. This reflects erosion of the debris apron mantling the cliff rather than erosion of the in situ cliff materials (see Figure 2-4).
