Thorpeness Monthly Monitoring Report

Date and Time of Survey: 31st October, 2022; 09:40 Time of Low Tide: 08:00

Inspector: Chris Finbow/Thomas Hayden

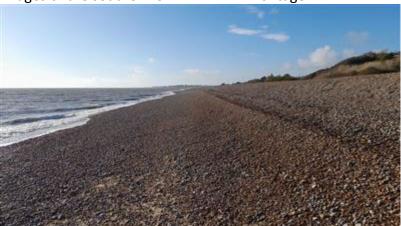
Comments on the geomorphological change over the southern UNDEFENDED frontage: Some accretion of the upper beach over the last inspection period.
