Pakefield Monthly Monitoring Report

Date and Time of survey: July 3, 2024 11:33

Inspector Name: Keith Roper

Reason for Inspection: Scheduled

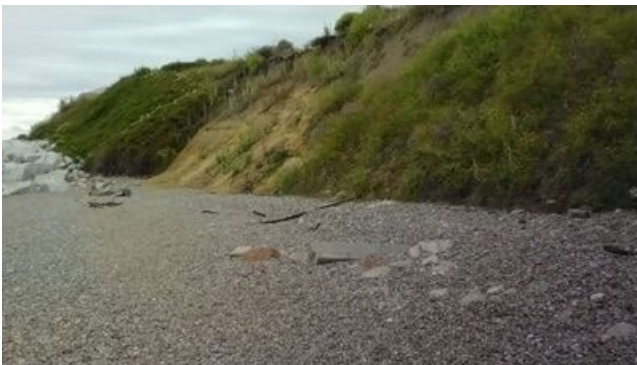
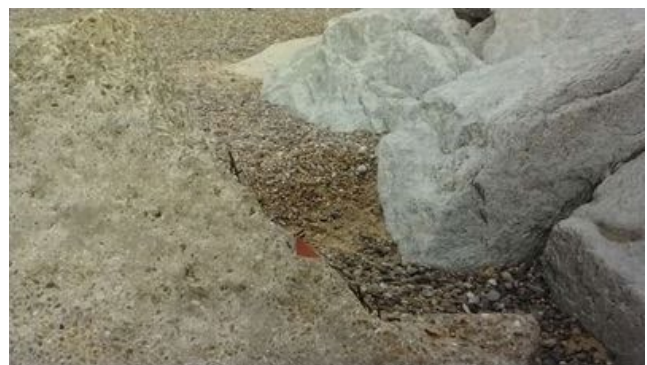
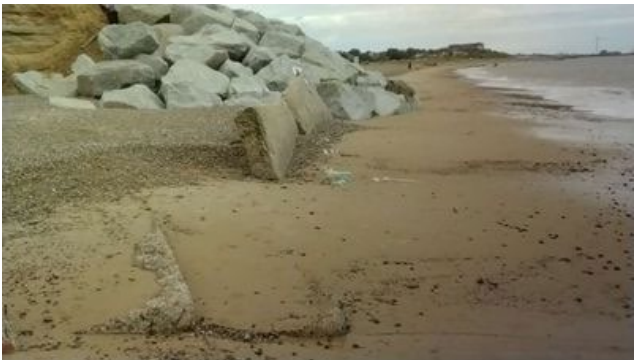
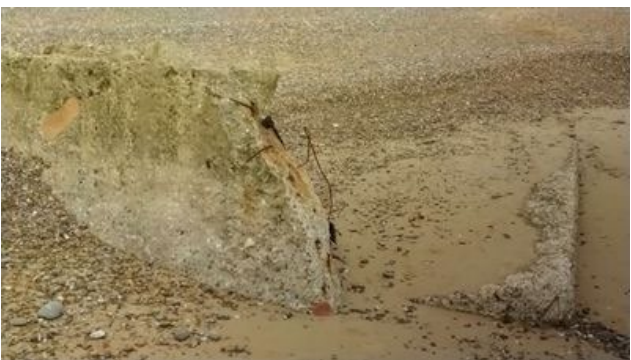
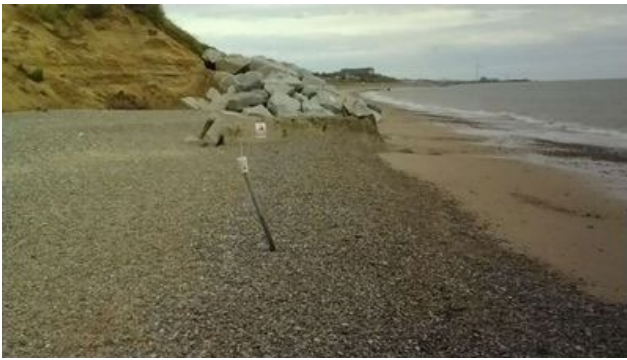
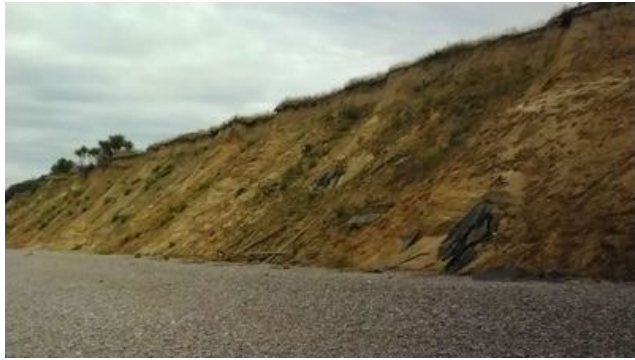
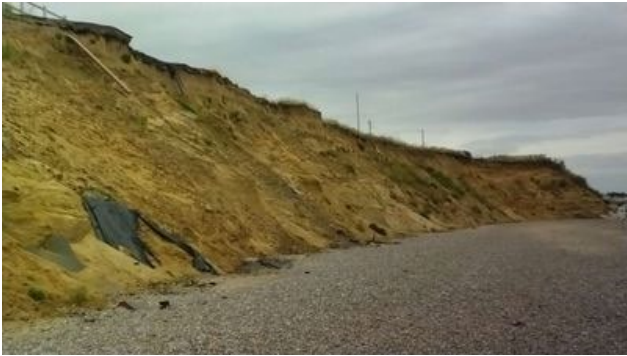
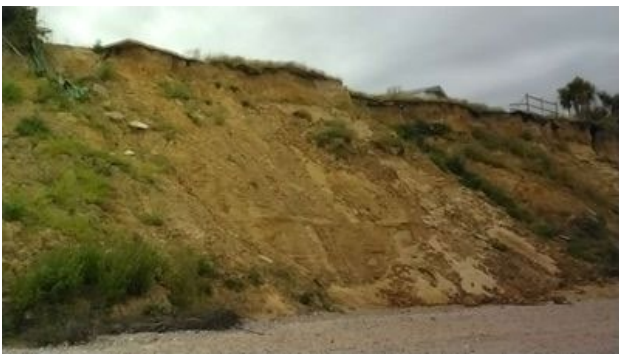
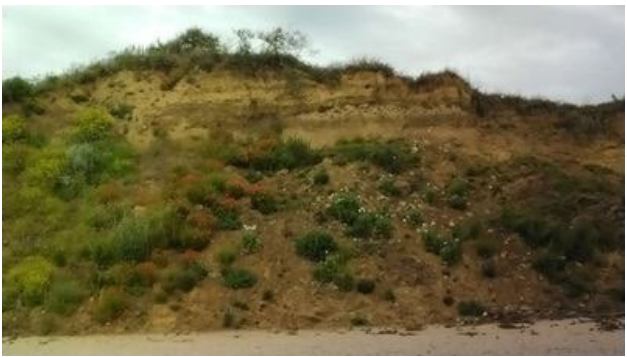
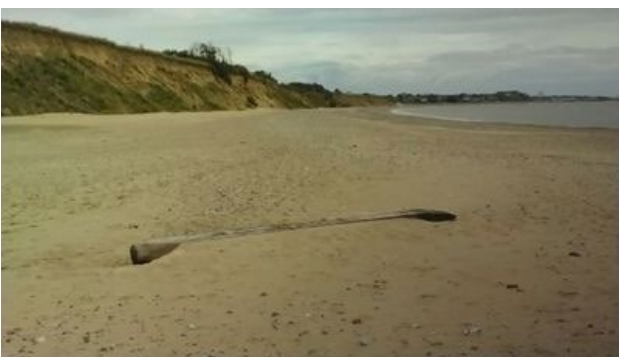
Comments on hazard/debris: Beach access steps seaward end of Arbor Lane remain partially overgrown. Two cables were seen approximately seaward of Nightingale Road and those thought to have management responsibility have been notified.
