Pakefield Monthly Monitoring Report

Date and Time of survey: July 30, 2024 10:35 Inspector Name: Keith Roper Time of Low Tide: 11:15 Height of Low Tide (m ODN): -0.3 Reason for Inspection: Scheduled

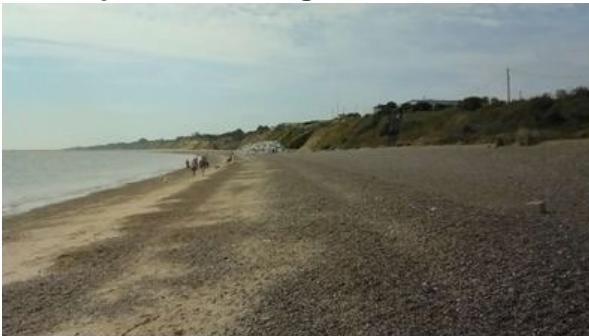
Beach photos looking south:

Change in beach level relative to exposed timber groyne opposite Grand Avenue: Little change Photo of exposed timber groyne:

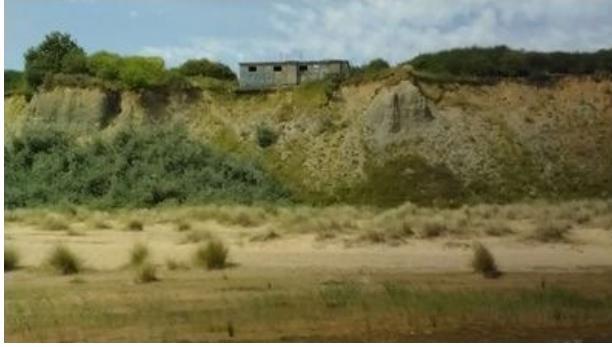
Changes in cliff stability: No obvious change apparent from beach **Photo of cliff top structure:**

Comments on cliff top structure: None
