Pakefield Monthly Monitoring Report

Date and Time of survey: March 28, 2024 13:48 Inspector Name: Keith Roper Time of Low Tide: 15:45 Height of Low Tide (m ODN): -0.7 Reason for Inspection: Scheduled

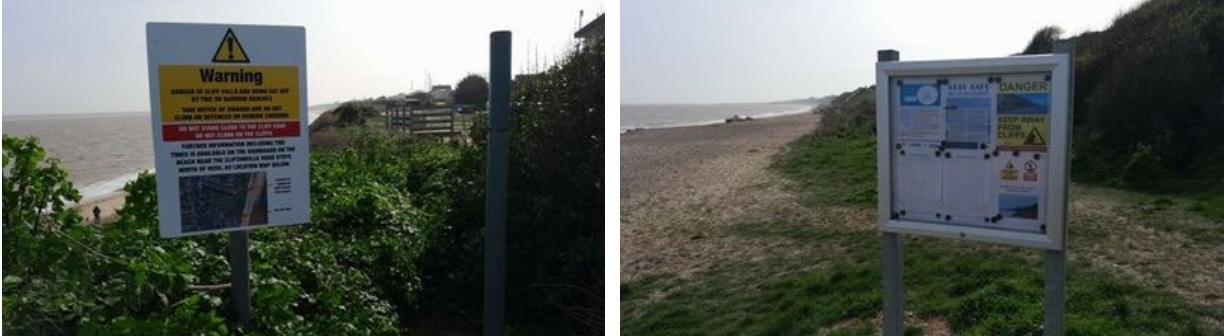
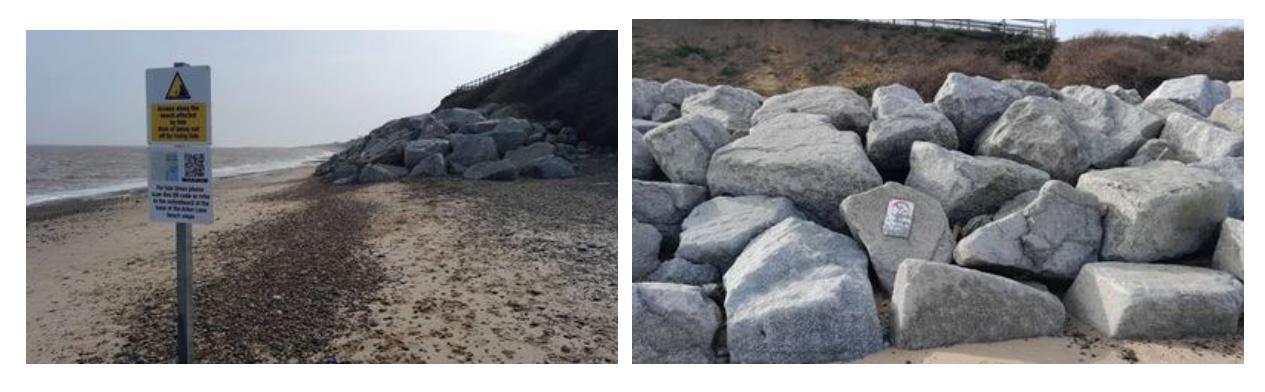
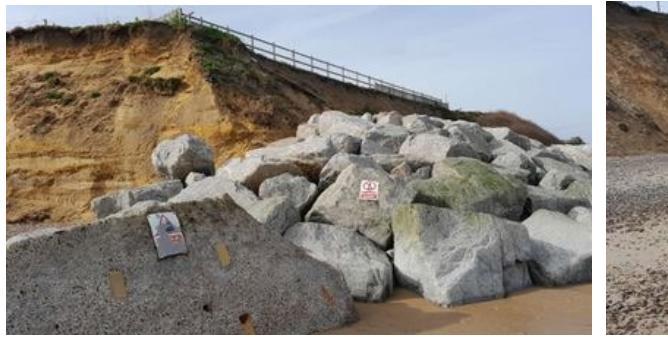
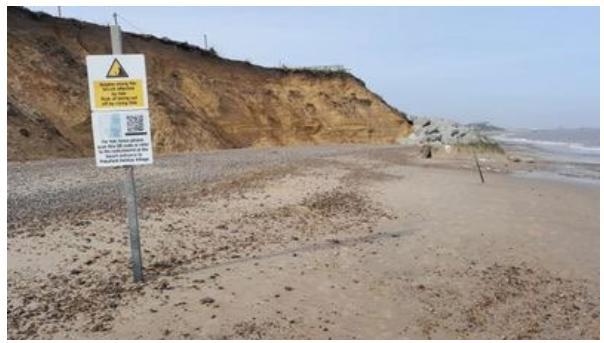
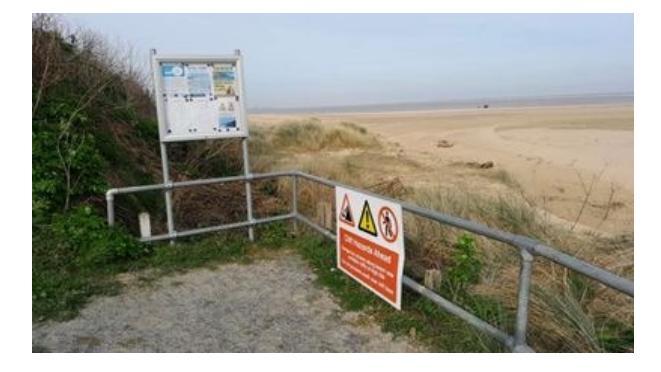
Comments on condition of, or risk posed by rock armour: No significant change from previous reporting

Comments on signage: Covered above
