Pakefield Monthly Monitoring Report

Date & Time of survey: December 3, 2024 14:13

Reason for Inspection: Scheduled

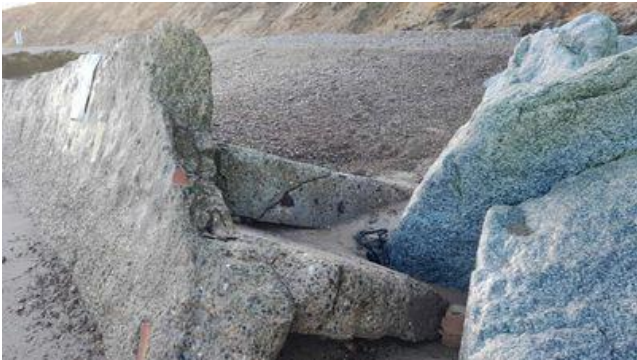
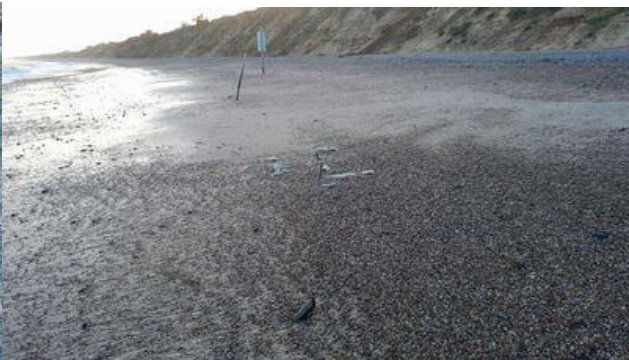
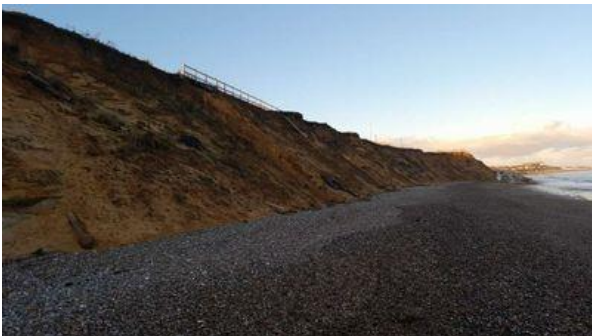
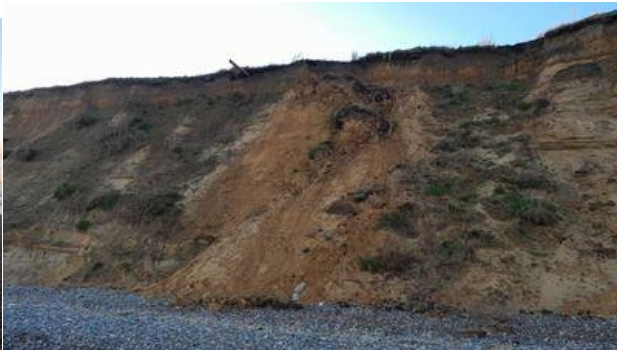
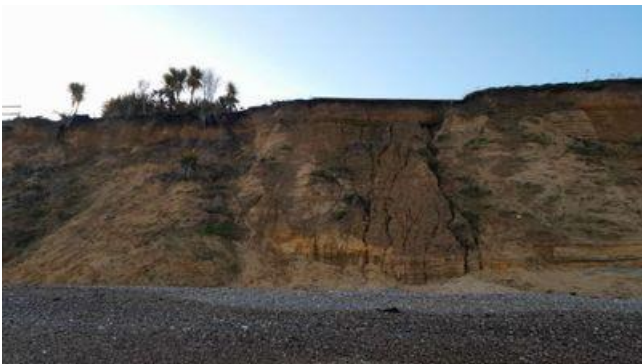
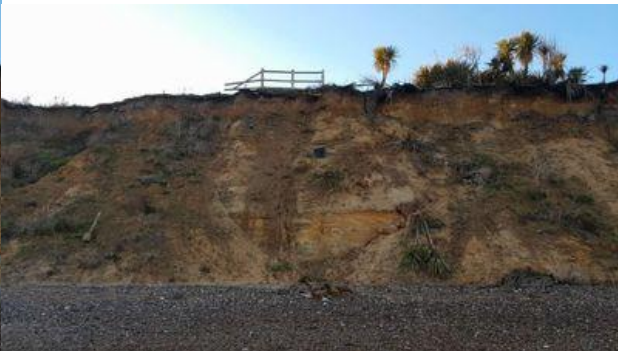
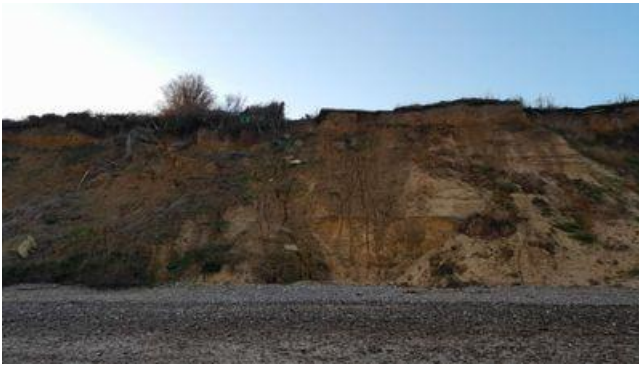
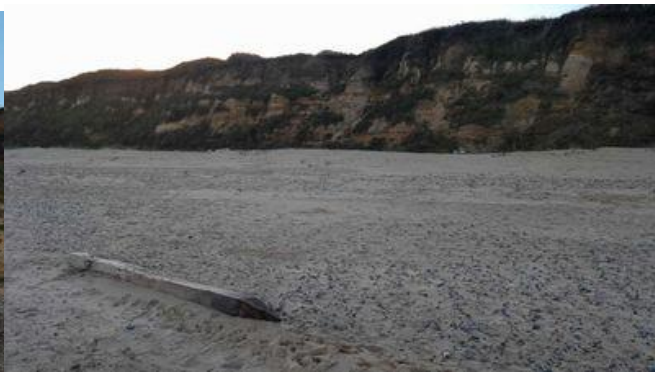
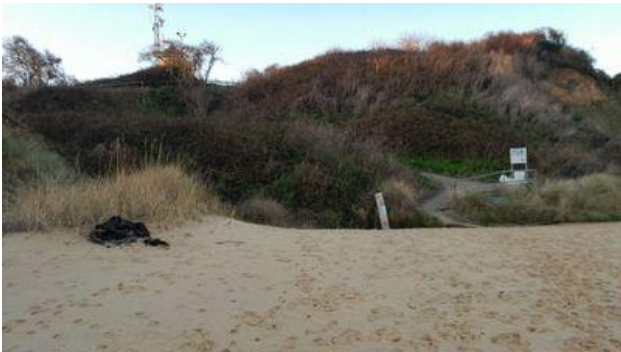
Hazards and Debris

Comments on hazard/debris: ESC works to groyne hazards and signage have been programmed for December, subject to weather and sea conditions.
