Thorpeness Coastal Management Consultation Report

Working with you to explore how we manage the coastline at Thorpeness, now and for the future

This report is an iteration within the consultation process of coastal management decision-making at Thorpeness.

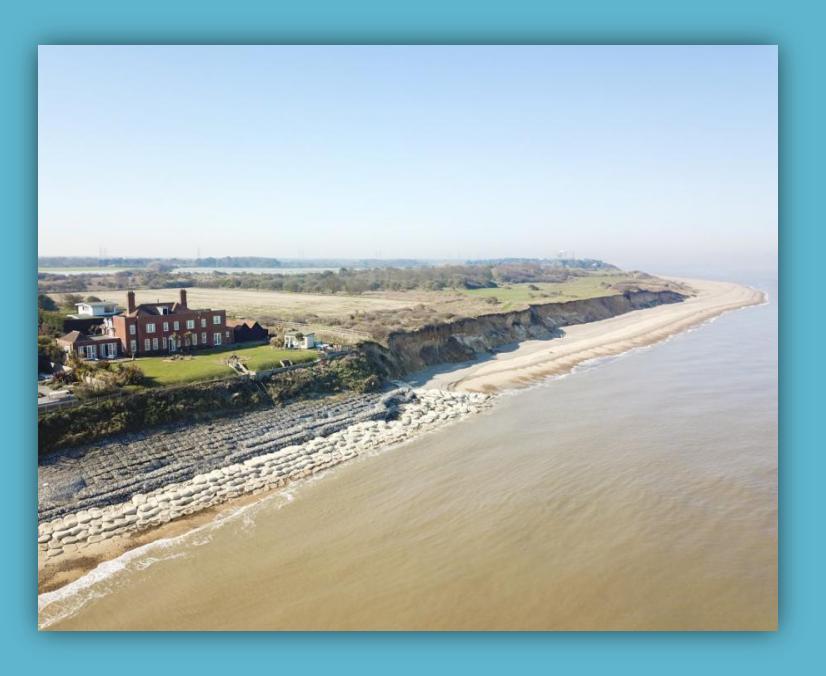
Left: Complete exposure of existing defenses below Thorpeness House; cliff erosion to the north; and the Ness itself on the far right of the photo.

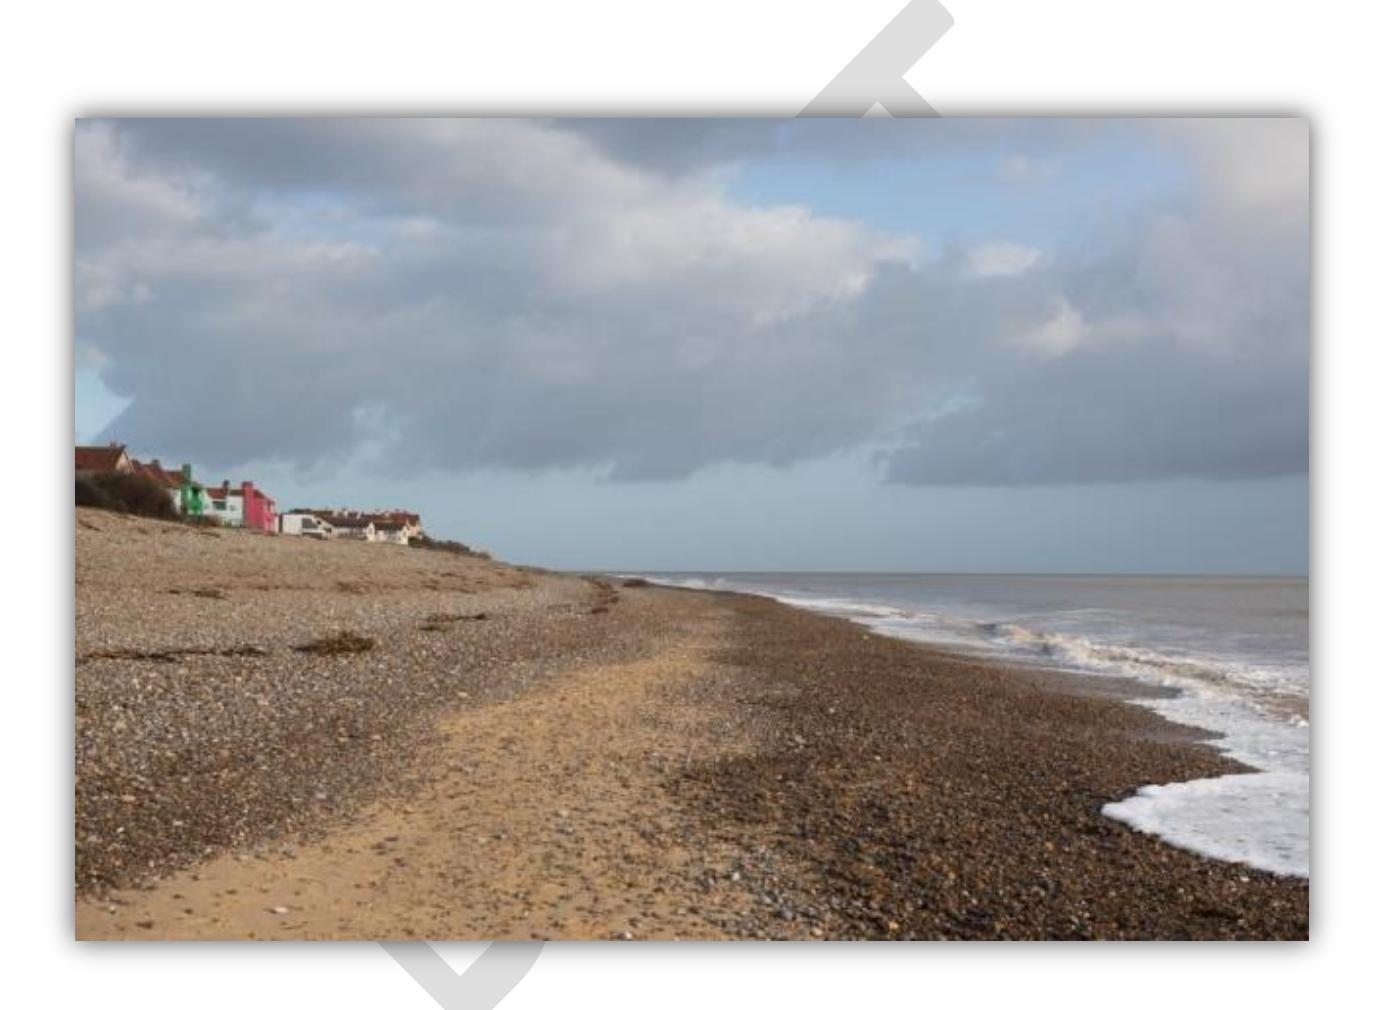
Above: Thorpeness mixed sand and gravel beach, looking North on a calm day. The water levels of recent neap and spring high tides are visible by the strand lines atop the gravel berms. Picture by Sarah Lucy Brown

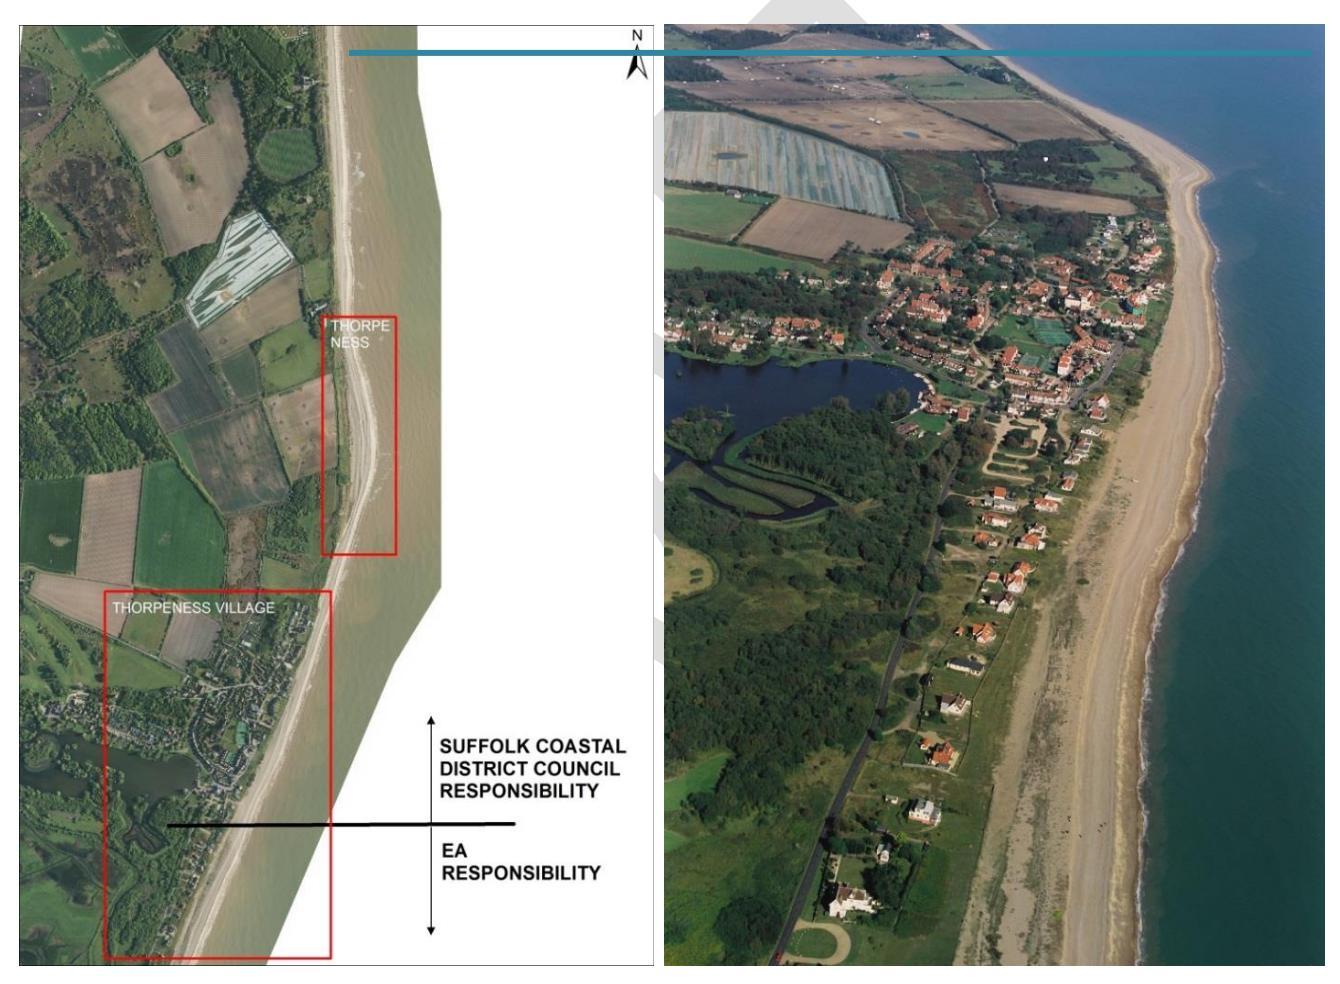
Aerial Image showing coastal responsibility at Thorpeness and the surrounding area.

Aerial oblique looking North showing Thorpeness Village and the Thorpe Ness promontory.

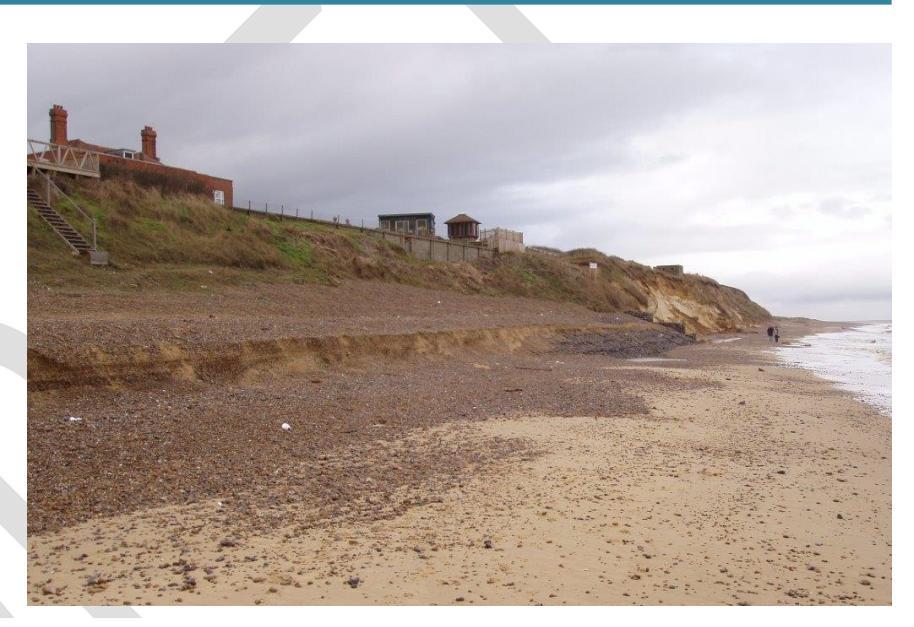
The **above** photo, taken in 2002 before the placement of geobags, shows the northern extent of gabion defence works. The gabions are covered with beach material however a cliff exists at the base of the slope due to erosion and lowering of beach levels. Note the active erosion of the cliff face to the north and the Pill Box located atop the cliff, which is now on the beach.

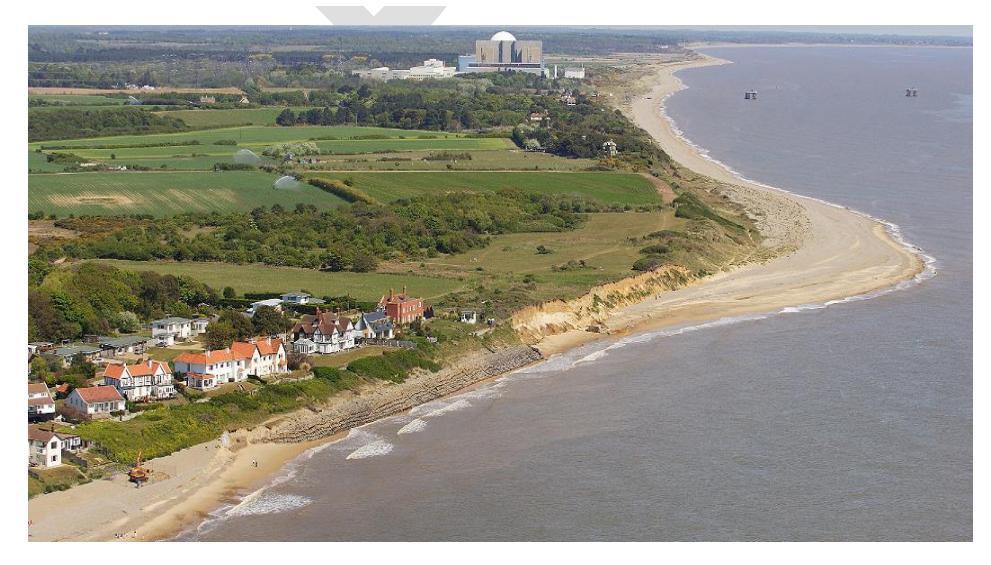
Left: This photo from 2010, illustrates the almost complete exposure of the 1976 gabion defence slope. Serious cliff erosion to the north and beach level lowering to the south can also be seen.

In response to this damage, SCDC strategically placed ~2750 geotextile bags over the northern Thorpeness village frontage in a two-phased approach completed in 2012. Drawings of the phase 1 and 2 defences are in Appendix 1. A 'Phase1' Geobag wall covering ~120m was built in 2010/11 to south of the 1976 works. The Phase 2 works included patch repairs works to the gabion cages, a Geobag bank was built at the toe of the gabion slope, and a short spur groyne/breakwater at the northern end. The latter was to manage the risk of outflanking of the defence via retreat of the adjacent undefended cliff. The defence type selected was deliberately soft and 'designed to fail' to avoid creating a hard promontory that would impede sediment conveyance. A hard point would also compromise conservation interests and the strategic objective to allow natural long-term evolution of the beach. Essentially they function as a buried backstop that can become exposed by destructive conditions and decreasing beach levels on an infrequent and ephemeral basis. This exposure of the geotextile bags was always anticipated to increase over time with regard to a potential increase in the frequency and severity of future erosion pressure, and sea level rise. The more seaward position of the Phase 2 geobag slope makes it more likely to be exposed, and to suffer damage, than the Phase 1 slope.

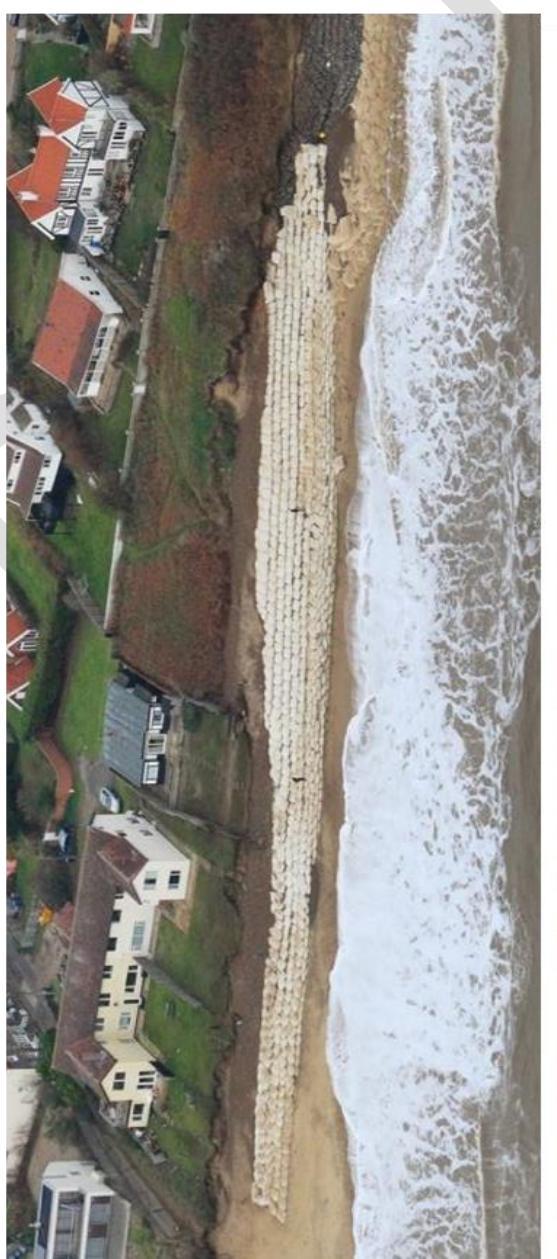
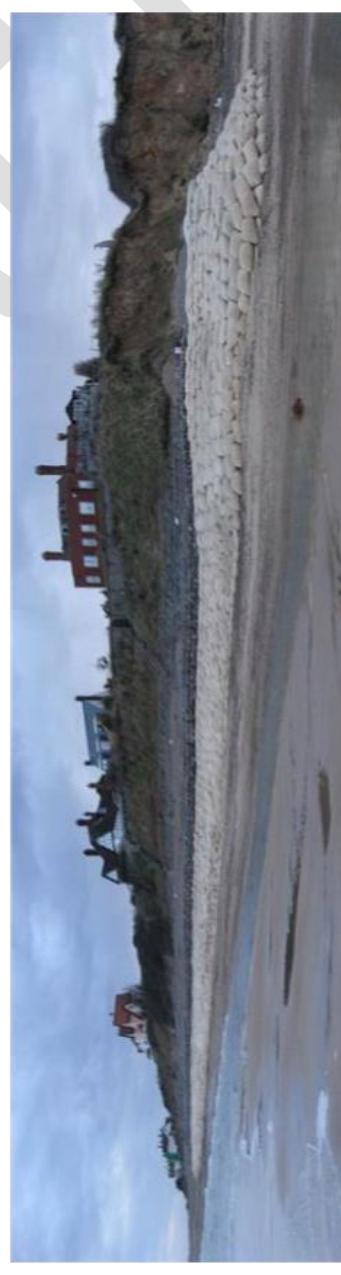
beach levels in 2013. Patch repairs to the damaged face of lower bags can be seen. Some bags in Right: This photo shows full exposure of the phase 2 geobags during a period of sustained low rows 5 and 6 from top were severely abraded and partially emptied of fill. The gabion repairs above the bags are intact.

Below: Phase 2 geobag defence exposed by erosion in 2013 with the 1976 gabion slope behind. Above: The phase 1 geobag defence exposed by erosion in 2013.

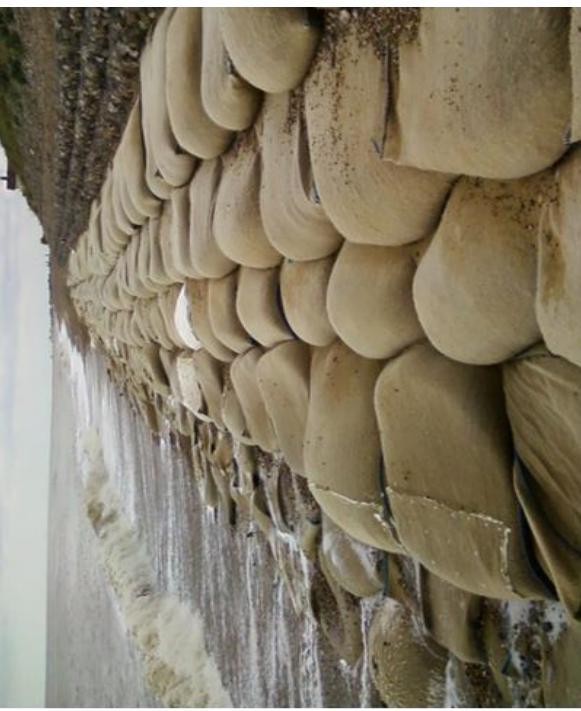
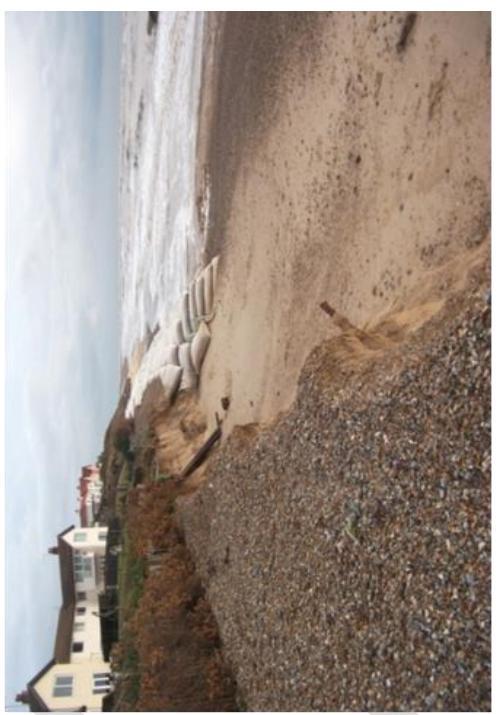
Above: Photos show exposure of the phase 1 bag slope and erosion of the beach to the south caused by the October 2013 storm. $\overline{\mathbf{0}}$

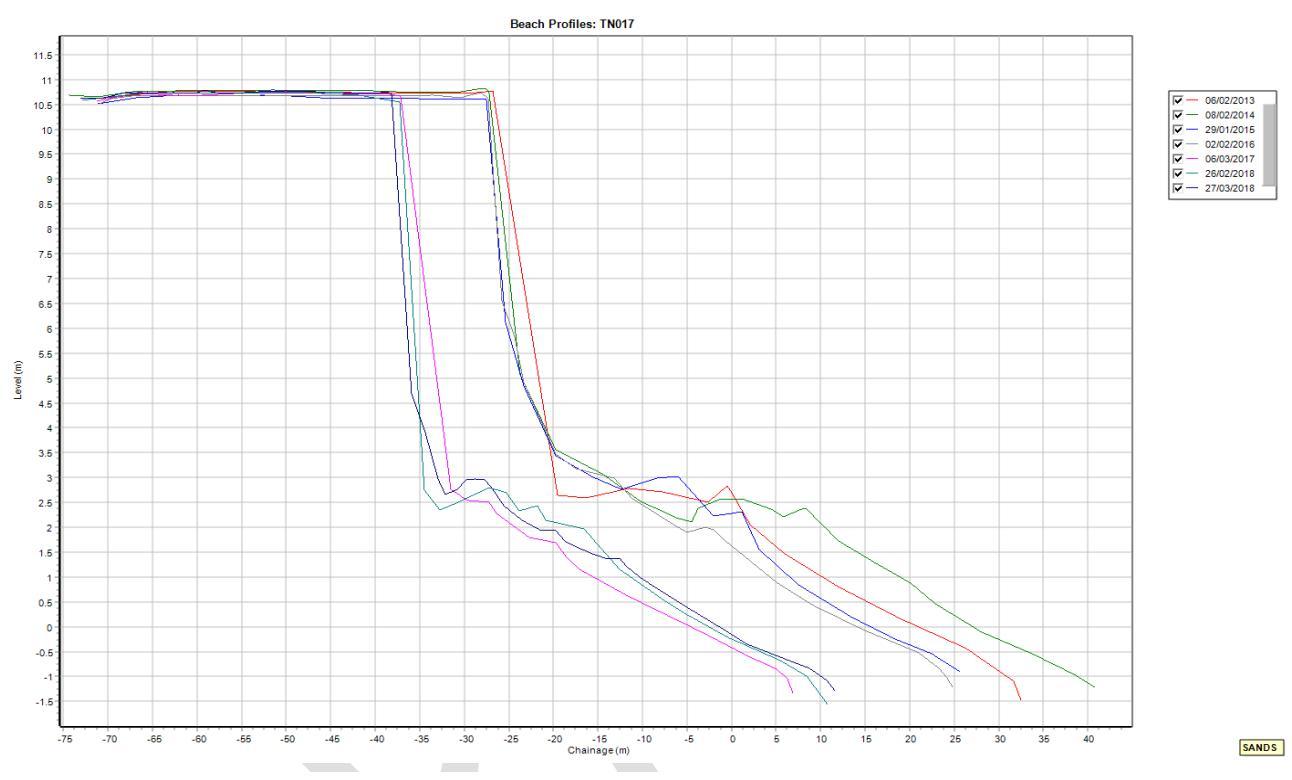
Cliff profiles to north of Thorpeness between 2013 and 2018 showing ~10m of cliff retreat over the winter of 2016/17. For more on this see Wave RADAR interim report #3.

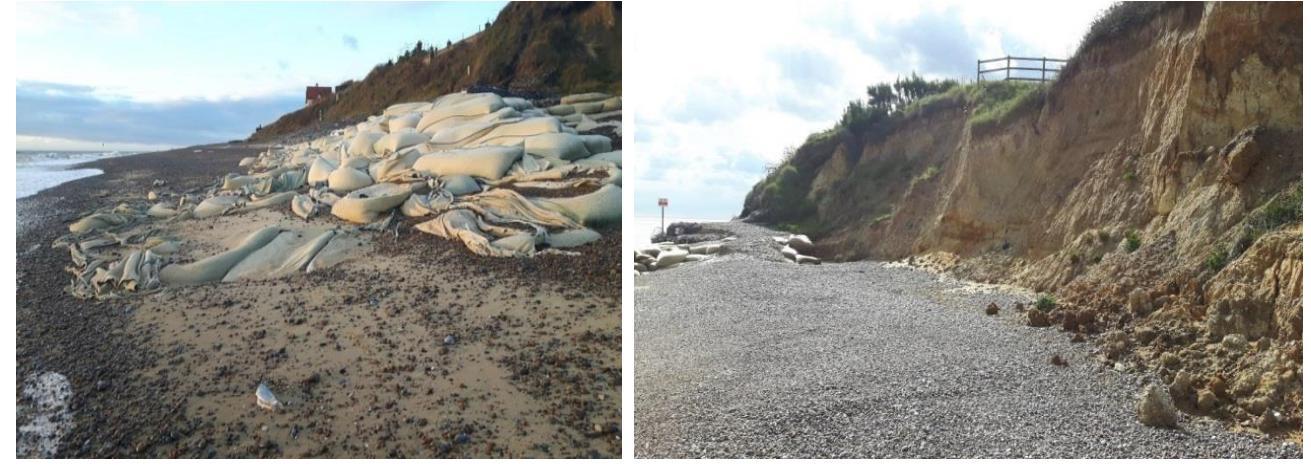
Geotextile placed in 2012 was exposed over the northern part of the phase 2 defence in June **2018.** In September 2018 geotextile placed in 1976 below the gabion slope was also exposed. By autumn **2018** the condition of the geobag defence and seaward parts of the breakwater at the northern end were 'very poor', with an estimated 70% of the bags either damaged or displaced and its design function perceptively impaired. Significant damage is also evident to geobags and gabions on the adjoining linear defence to the south.

Left: Breakwater damage. June 2018.

Right: Cliff erosion behind the breakwater. October 2018.

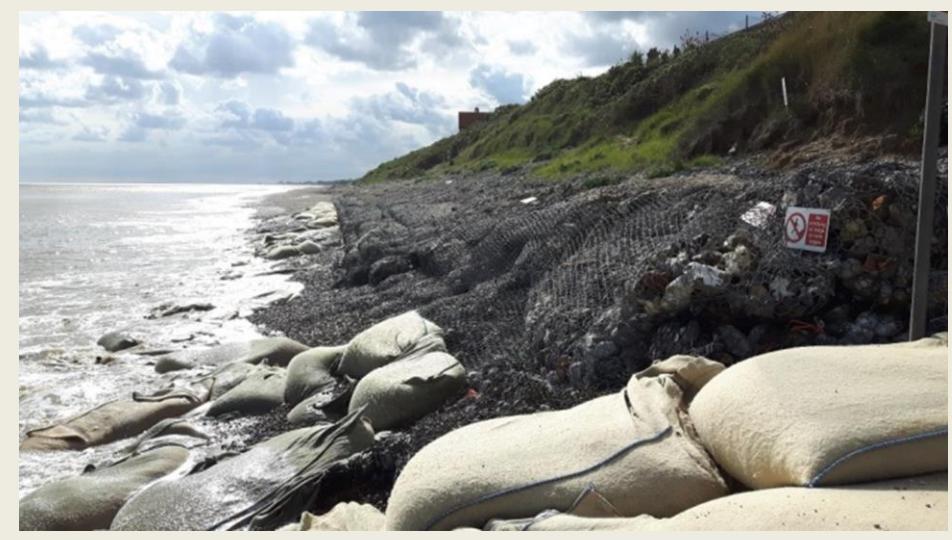
Left: The picture below illustrates the potential long-term beach profile condition under which the phase 2 bag defences will be deemed to have failed a test of environmental sustainability. This is a preliminary position and may change over time.

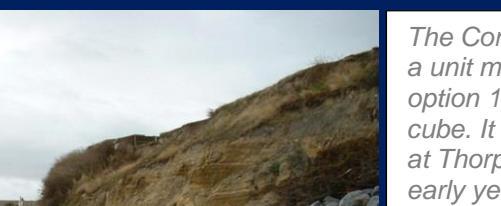
The Corton rock armour slope, shown left, has a unit mass of ~ 30tns/m – similar to MML option 10c. The average rock size is a 1.2m cube. It is shown with a low beach level. If used at Thorpeness less rock would be visible in the early years. Small rock pieces are shown above the beach armour rock, over the lower cliff, in the position occupied by gabions at Thorpeness.

Rock armour slopes are a tried and trusted method of providing a, flexible and robust toe defence. The MML proposal allows for ~30 tonnes of 3-6 tonne armour per linear metre of defence. This volume of rock has potential to provide protection to a crest level to ~2m above Mean sea level (MSL), i.e. to cover the geobag face; with a foundation level of 1m below MSL. The rock slope would be built in the space currently occupied by phase 2 geobags and potentially in front of the phase 1 geobags, assuming their condition was sound at time of works. This is preferable to placing the rock slope in front of the phase 2 geobag slope which will result in earlier exposure and impact on alongshore sediment movement. Illustrations of potential small rock slope profiles for use in the phase 1 and 2 frontages are shown in Appendix 10.

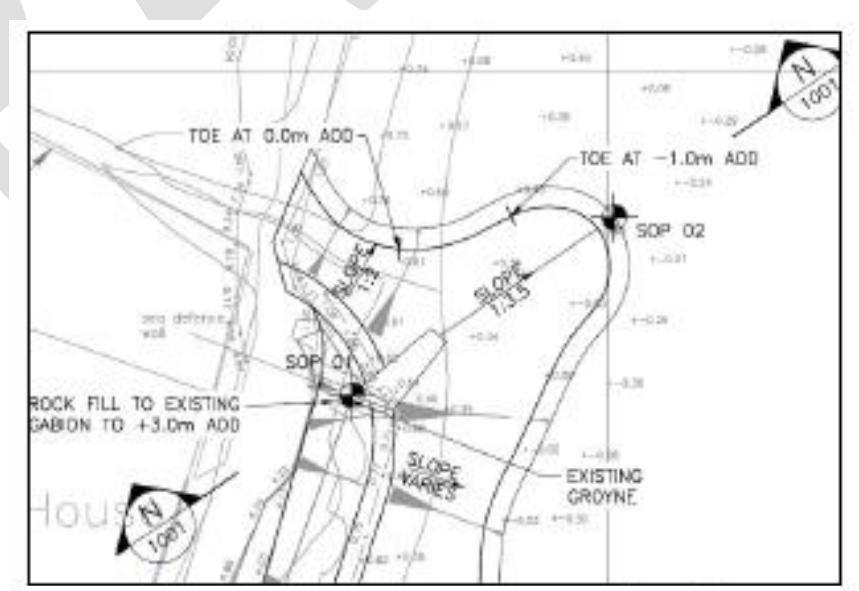
The original RHDHV design concept was for works at this point to minimise cliff retreat over a ~30m frontage to the north. RHDHV concluded that this was best achieved by a breakwater rather than armouring to the retired cliff line. If a breakwater is to be retained, then it should be made of resilient materials that are appropriate to its increasingly exposed location e.g. rock armour. If softer materials are used, then there will be a need to replace it at ~10-year intervals reducing

Image above shows RHDHV breakwater design 2010.

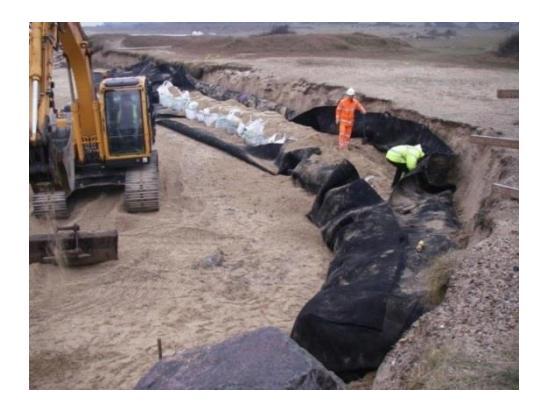
A further alternative is use of the **Hawes geotextile tube** design that has been installed at Orford and Kessingland -as shown in the photo to the right (Photo courtesy of A. Hawes). This would provide a similar type and quality of backstop erosion protection

However, their performance at a site of similar exposure (Orford Lighthouse), including their ability to be repaired and added to, makes them worthy of consideration as a medium-term solution in areas of low or intermittent exposure such as the south end transitions or the phase 1 frontage and as a limited life measure to patch isolated areas of major geobag failure in high pressure areas.

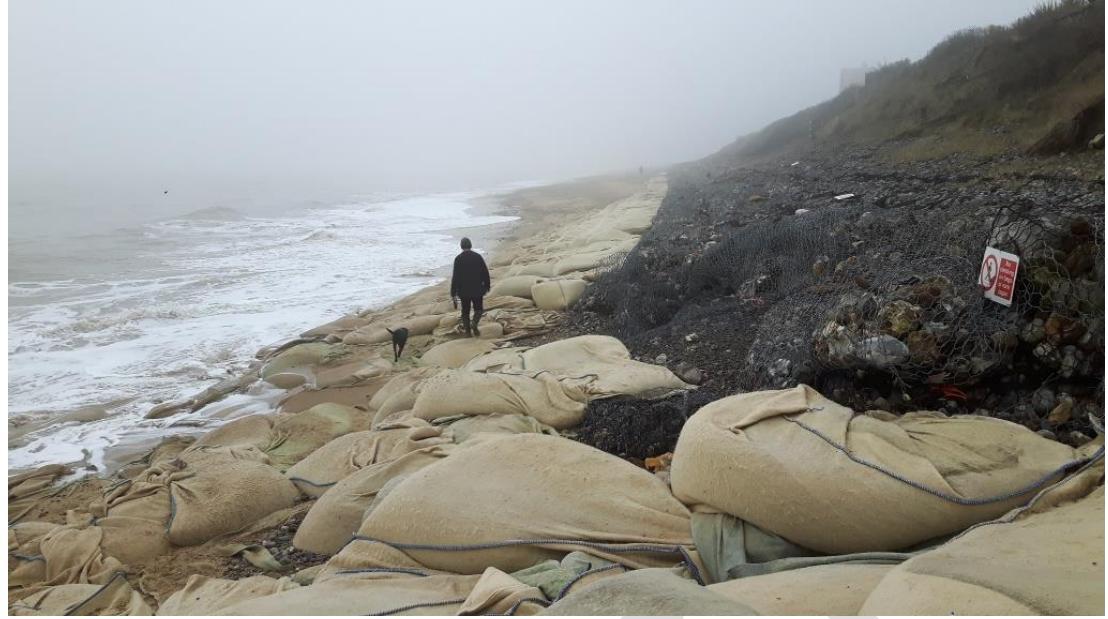
Existing defences tend to suffer significant damage whenever exposed to an active eroding beach and are difficult to repair to a standard that allows safe public passage over them. After an assessment of the risk and consideration of options for response, the Council's view is that when adjacent beach levels are low and beach walkers are forced onto the defences at some states of tide, public access over the defences poses an unacceptable risk that cannot be reduced and so must be controlled by hazard warning signs and diversions.

Member of the public walking on defences at high tide 2018

At times of low beach levels, the Council has erected notices to advise beach users to not walk on the beach below North End Avenue owing to exposed hazardous defences, and to divert inland. Signs to this effect are in place at Old Homes Road and on the Ness beach. This work was delivered in consultation with and with agreement from parties including SCC Rights of Way team and landowners.
